DOE/NV--1473

# Post-Closure Inspection Report for the Tonopah Test Range, Nevada

## For Calendar Year 2011

U.S. Department of Energy  
National Nuclear Security Administration  
Nevada Site Office

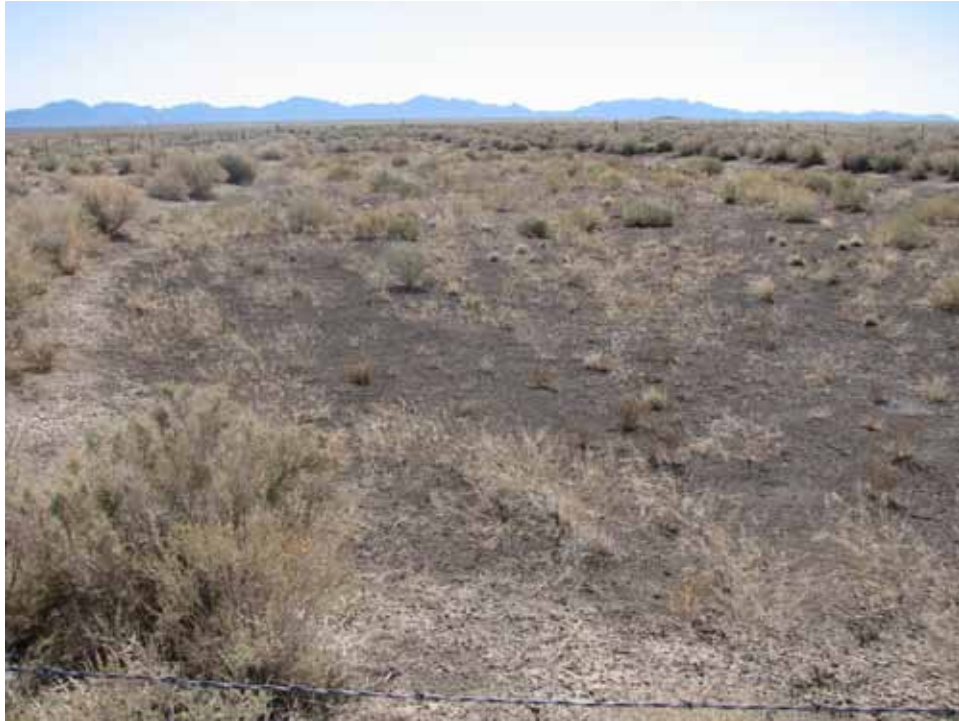
The Five Points Landfill is shown in Figure 2 of Appendix A. Vegetation monitoring was conducted in June 2011, and the results are included in Appendix F. The annual inspection was conducted on May 4, 2011. Fencing was in good condition, and the vegetation appeared healthy. No issues or concerns were noted, and maintenance and repairs were not required. Inspections and vegetation monitoring at the Five Points Landfill should continue as scheduled.

Photograph 1: CAU 400 Five Points Landfill, Looking West, 05/04/2011

The Five Points Landfill was in good condition. No maintenance or repairs were required. Inspections and vegetation monitoring will continue as scheduled.

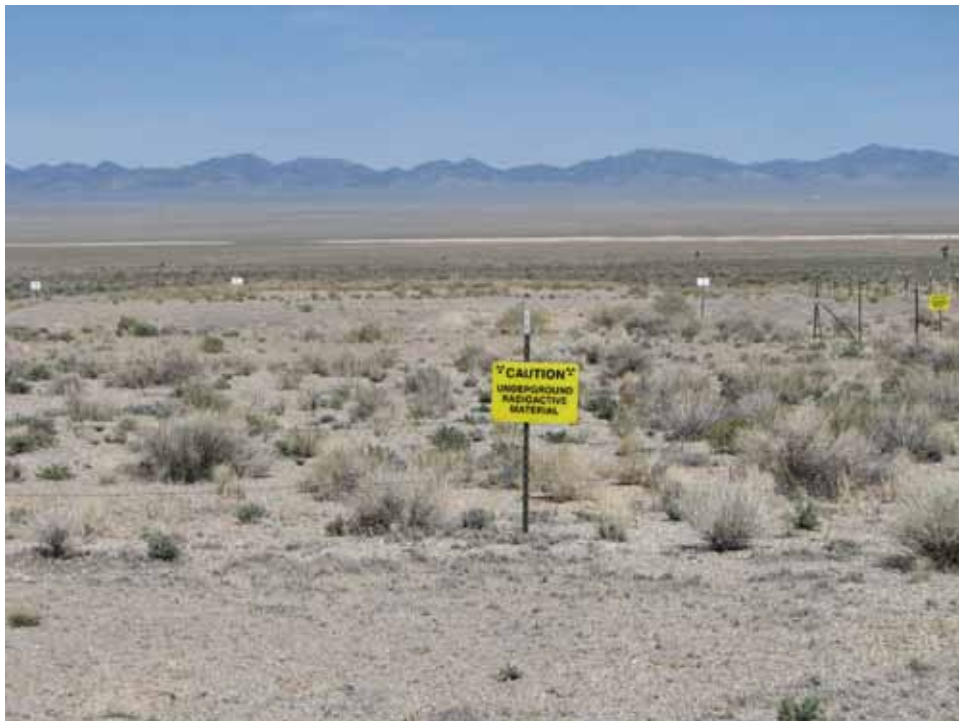
The site is shown in Figure 3 of Appendix A. Vegetation monitoring was conducted in June 2011, and the results are included in Appendix F. The annual inspection was conducted on May 3, 2011. The signs, fencing, and cover were in good condition, and the vegetation appeared healthy. No issues or concerns were noted, and maintenance and repairs were not required. As a best management practice, the use restriction warning signs were replaced with standard *Federal Facility Agreement and Consent Order* signs on July 13, 2011. Inspections and vegetation monitoring should continue as scheduled.

Photograph 2: CAU 407, Looking East, 05/03/2011

The site was in good condition. No maintenance or repairs were required. As a best management practice, the use restriction warning signs were replaced with standard *Federal Facility Agreement and Consent Order* signs on July 13, 2011. Inspections and vegetation monitoring will continue as scheduled.

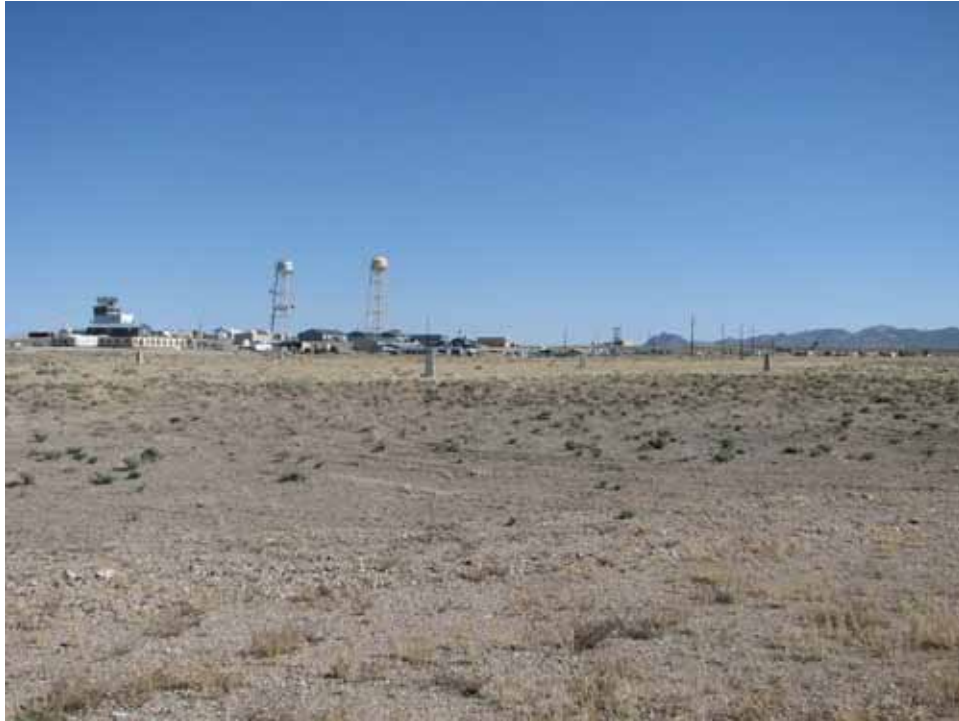
Landfill Cell A3-1 (CAS 03-08-001-A301): The signs, survey markers, monuments, and cover were in good condition. No issues or concerns were noted, and maintenance and repairs were not required. Inspections should continue as scheduled.

Photograph 3: CAU 424, Landfill Cell A3-1, Looking Southeast, 05/03/2011

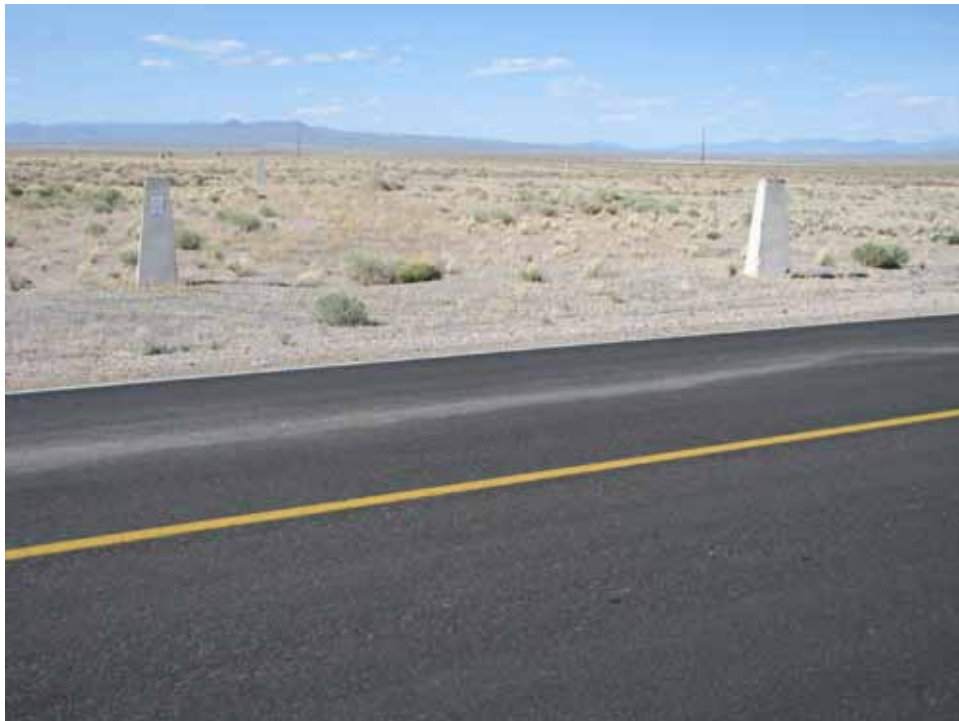
Landfill Cell A3-2 (CAS 03-08-002-A302): The signs, brass survey markers, concrete monuments, and landfill cover were in good condition. No issues or concerns were noted, and maintenance and repairs were not required. Inspections should continue as scheduled.

Photograph 4: CAU 424, Landfill Cell A3-2, Looking North, 05/03/2011

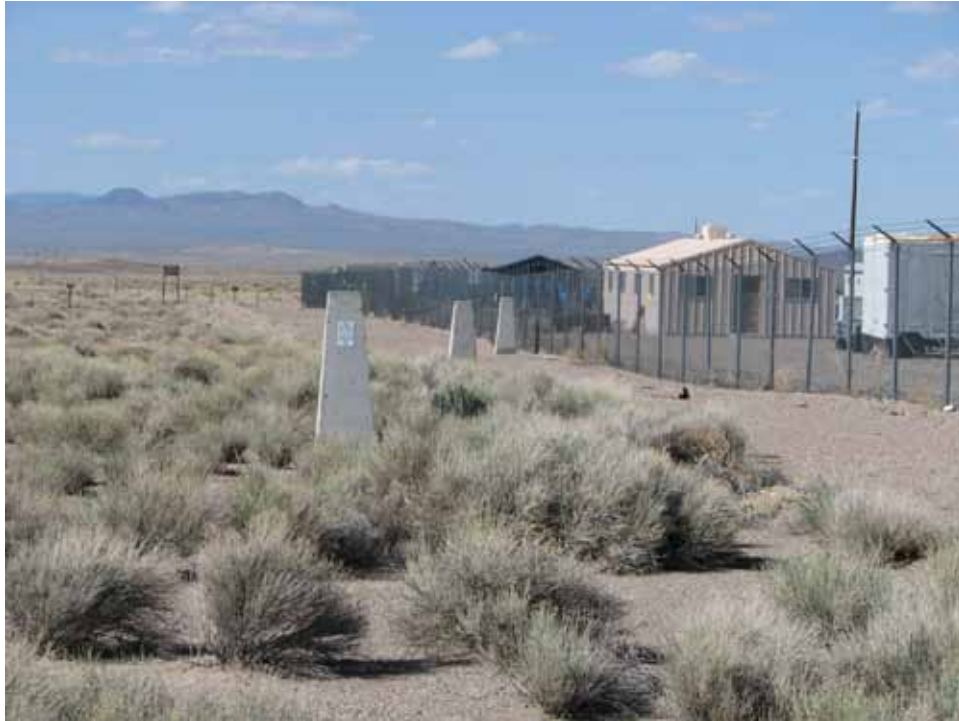
Landfill Cell A3-3 (CAS 03-08-002-A303): The monuments, brass survey markers, signs, and cover were in good condition. Two of the three surface grade monuments at the eastern cell of the landfill could not be located during the inspection. The two monuments were located and marked with lava rock on July 13, 2011. Inspections should continue as scheduled.

Photograph 5: CAU 424, Landfill Cell A3-3, Looking Northwest, 05/03/2011

Two surface grade monuments at Landfill Cell A3-3 could not be located during the inspection. The two monuments were located and marked with lava rock on July 13, 2011. No other maintenance or repairs were required. Inspections will continue as scheduled.

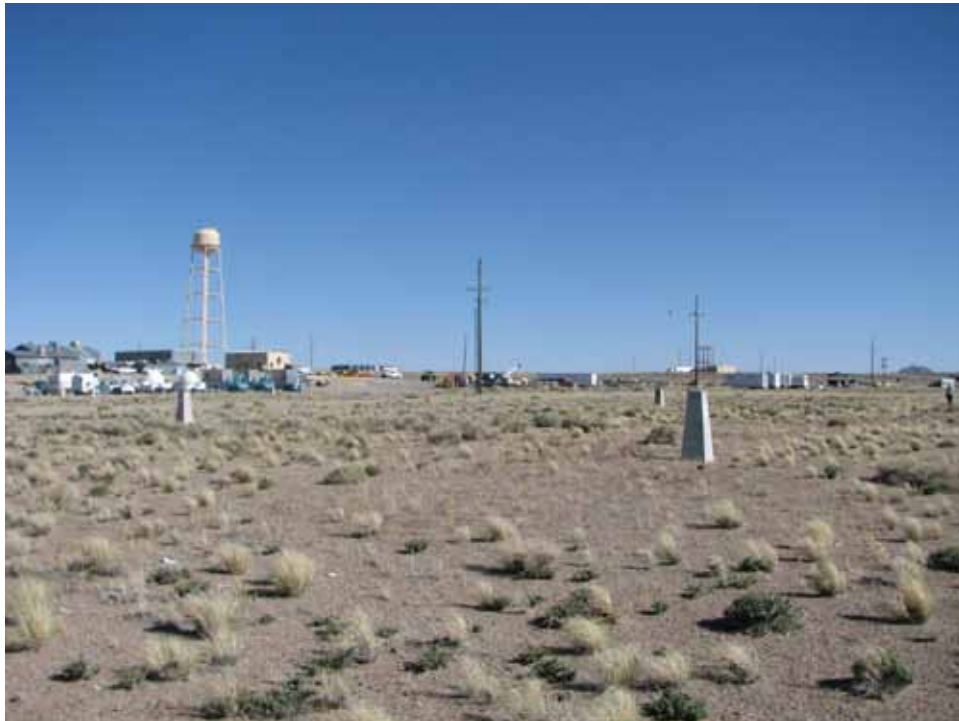
Landfill Cell A3-4 (CAS 03-08-002-A304): The monuments, brass survey marker, and signs were in good condition. No issues or concerns were noted, and maintenance and repairs were not required. Inspections should continue as scheduled.

Photograph 6: CAU 424, Landfill Cell A3-4, Looking North, 05/03/2011

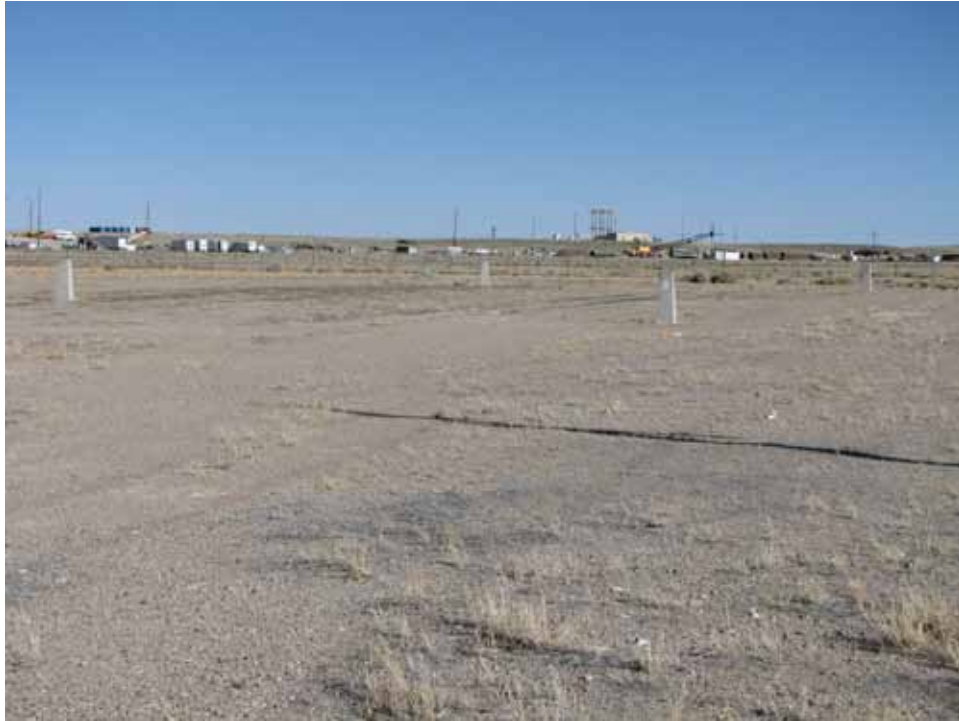
Landfill Cell A3-5 (CAS 03-08-002-A305): The monuments and attached signs, brass survey markers, and cover were in good condition. No issues or concerns were noted, and maintenance and repairs were not required. Inspections should continue as scheduled.

Photograph 7: CAU 424, Landfill Cell A3-5, Looking Southeast, 05/03/2011

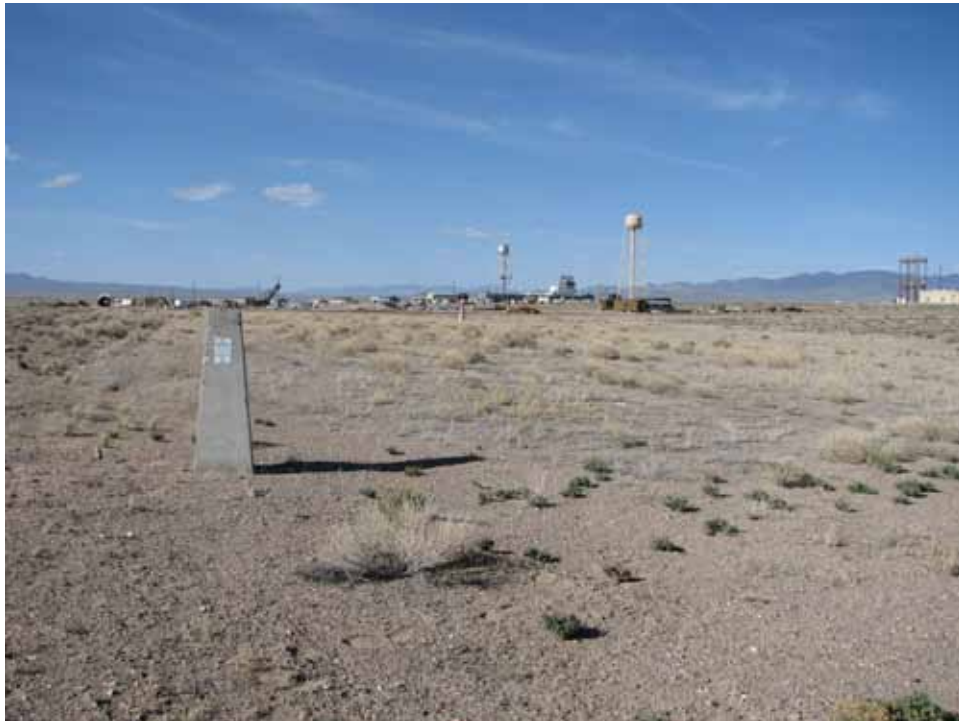
Landfill Cell A3-6 (CAS 03-08-002-A306): The monuments and attached signs, brass survey markers, and cover were in good condition. No issues or concerns were noted, and maintenance and repairs were not required. Inspections should continue as scheduled.

Photograph 8: CAU 424, Landfill Cell A3-6, Looking East, 05/03/2011

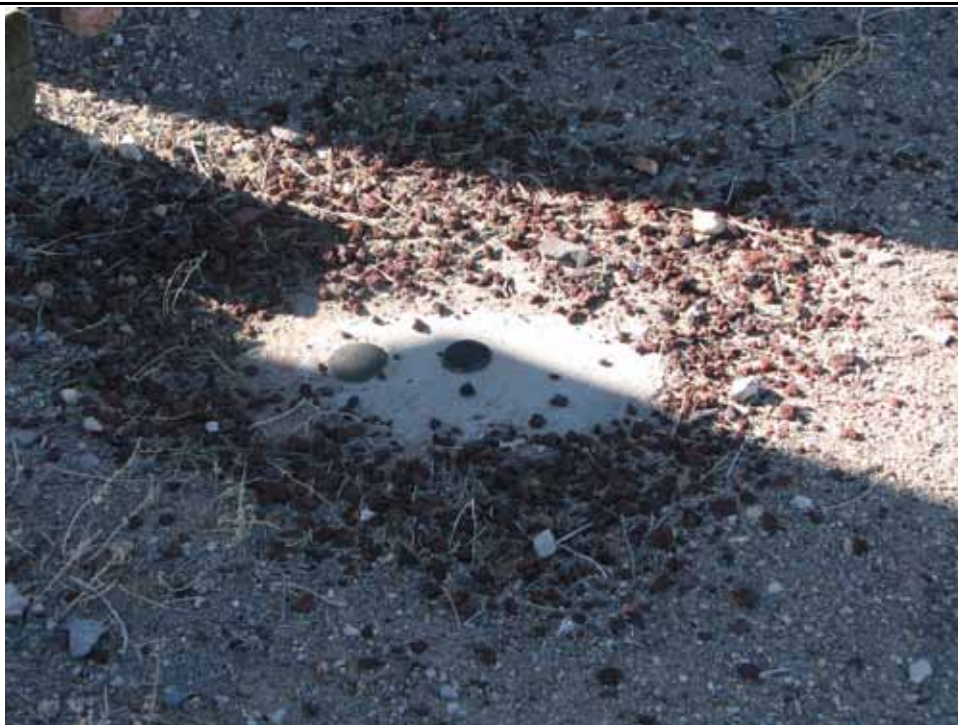
Landfill Cell A3-8 (CAS 03-08-002-A308): The brass markers and cover were in good condition. No issues or concerns were noted, and maintenance and repairs were not required. Inspections should continue as scheduled.

Photograph 9: CAU 424, Landfill Cell A3-8, Surface Monument, 05/03/2011

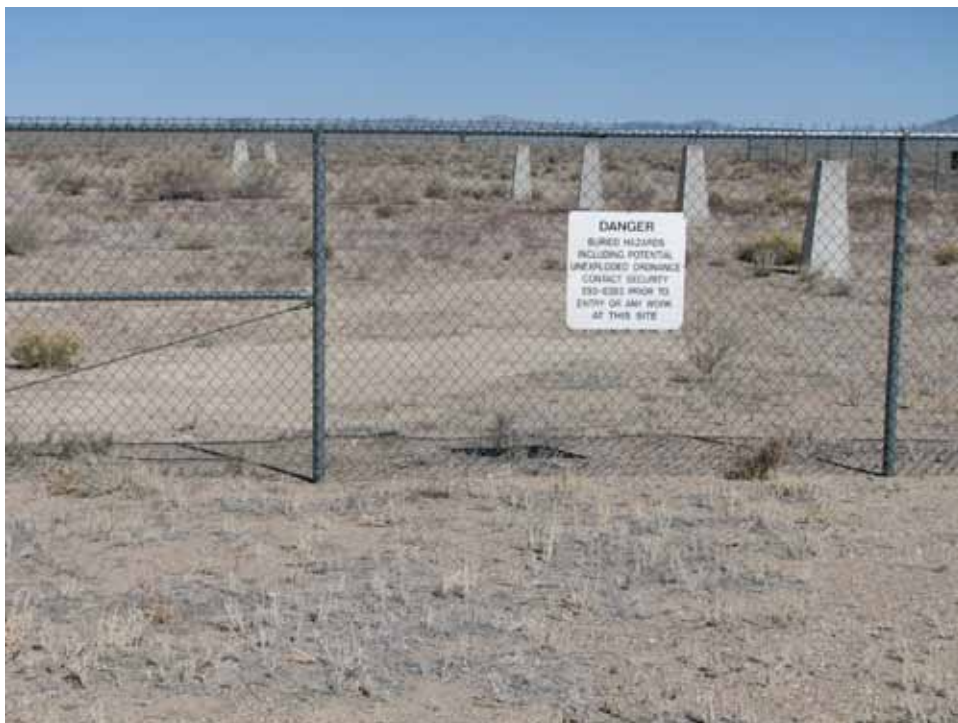
The site is shown in Figure 5 of Appendix A. The annual inspection was conducted on May 4, 2011. The fence, signs, and monuments were in good condition. There was evidence of animal burrowing. Animal burrows were backfilled on July 13, 2011. Inspections should continue as scheduled.

Photograph 10: CAU 453, Looking Northwest, 05/04/2011

Animal burrows observed during the annual inspection were backfilled on July 13, 2011. Inspections will continue as scheduled.

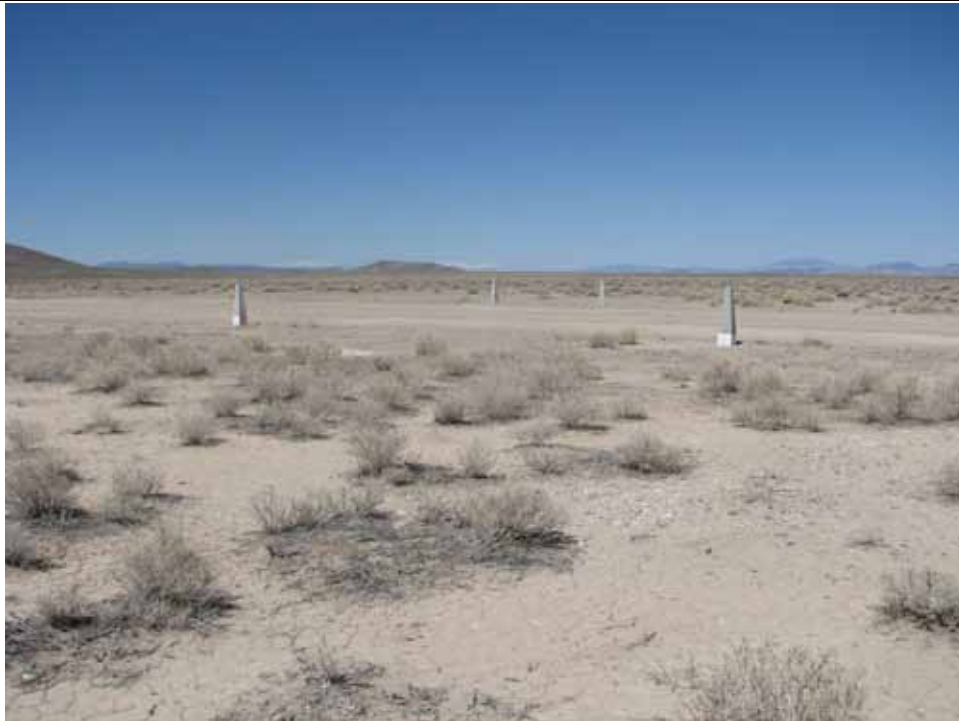
The site is shown in Figure 6 of Appendix A. The annual inspection was conducted on May 4, 2011. One use restriction warning sign was missing, and wording was faded on the remaining signs. A large animal burrow was also present. The signs were replaced, and the animal burrow was backfilled on July 12, 2011. Inspections should continue as scheduled.

Photograph 11: CAU 487, A-8 Anomaly, Looking North, 05/04/2011

One use restriction warning sign was missing, and wording was faded on the remaining signs. A large animal burrow was also present. The signs were replaced, and the animal burrow was backfilled on July 12, 2011. No other maintenance or repairs were required. Inspections will continue as scheduled.

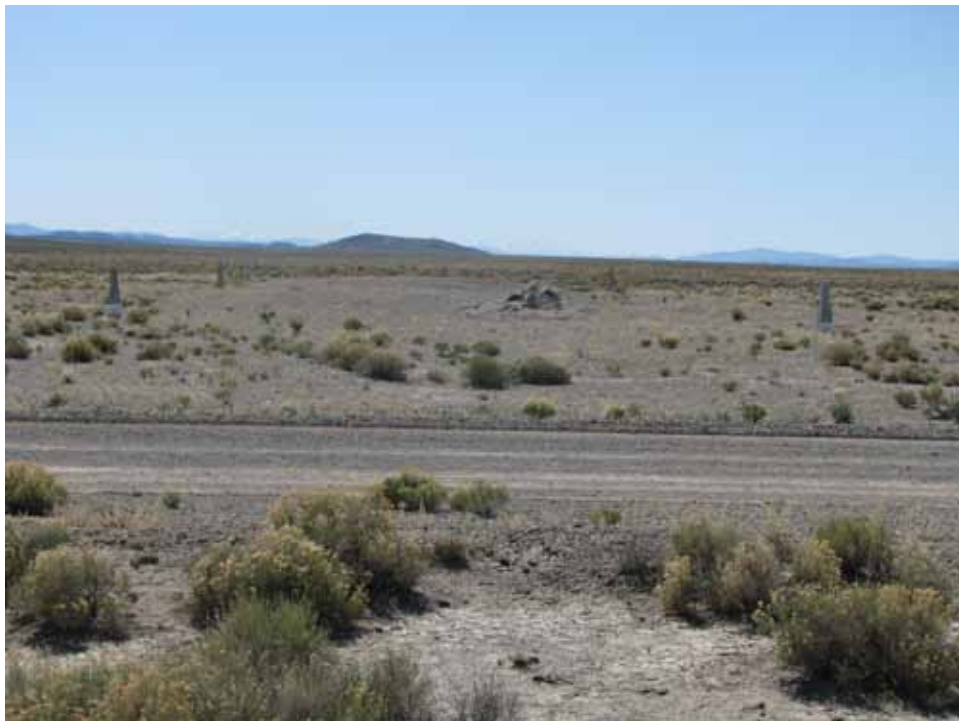
Photograph 12: CAU 487, A-17 Anomaly, Looking West, 05/04/2011
