Bathymetric and Velocimetric Surveys at Highway Bridges Crossing the Missouri River in and into Missouri during Summer Flooding, July–August 2011

Scientific Investigations Report 2012–5204

By Richard J. Huizinga

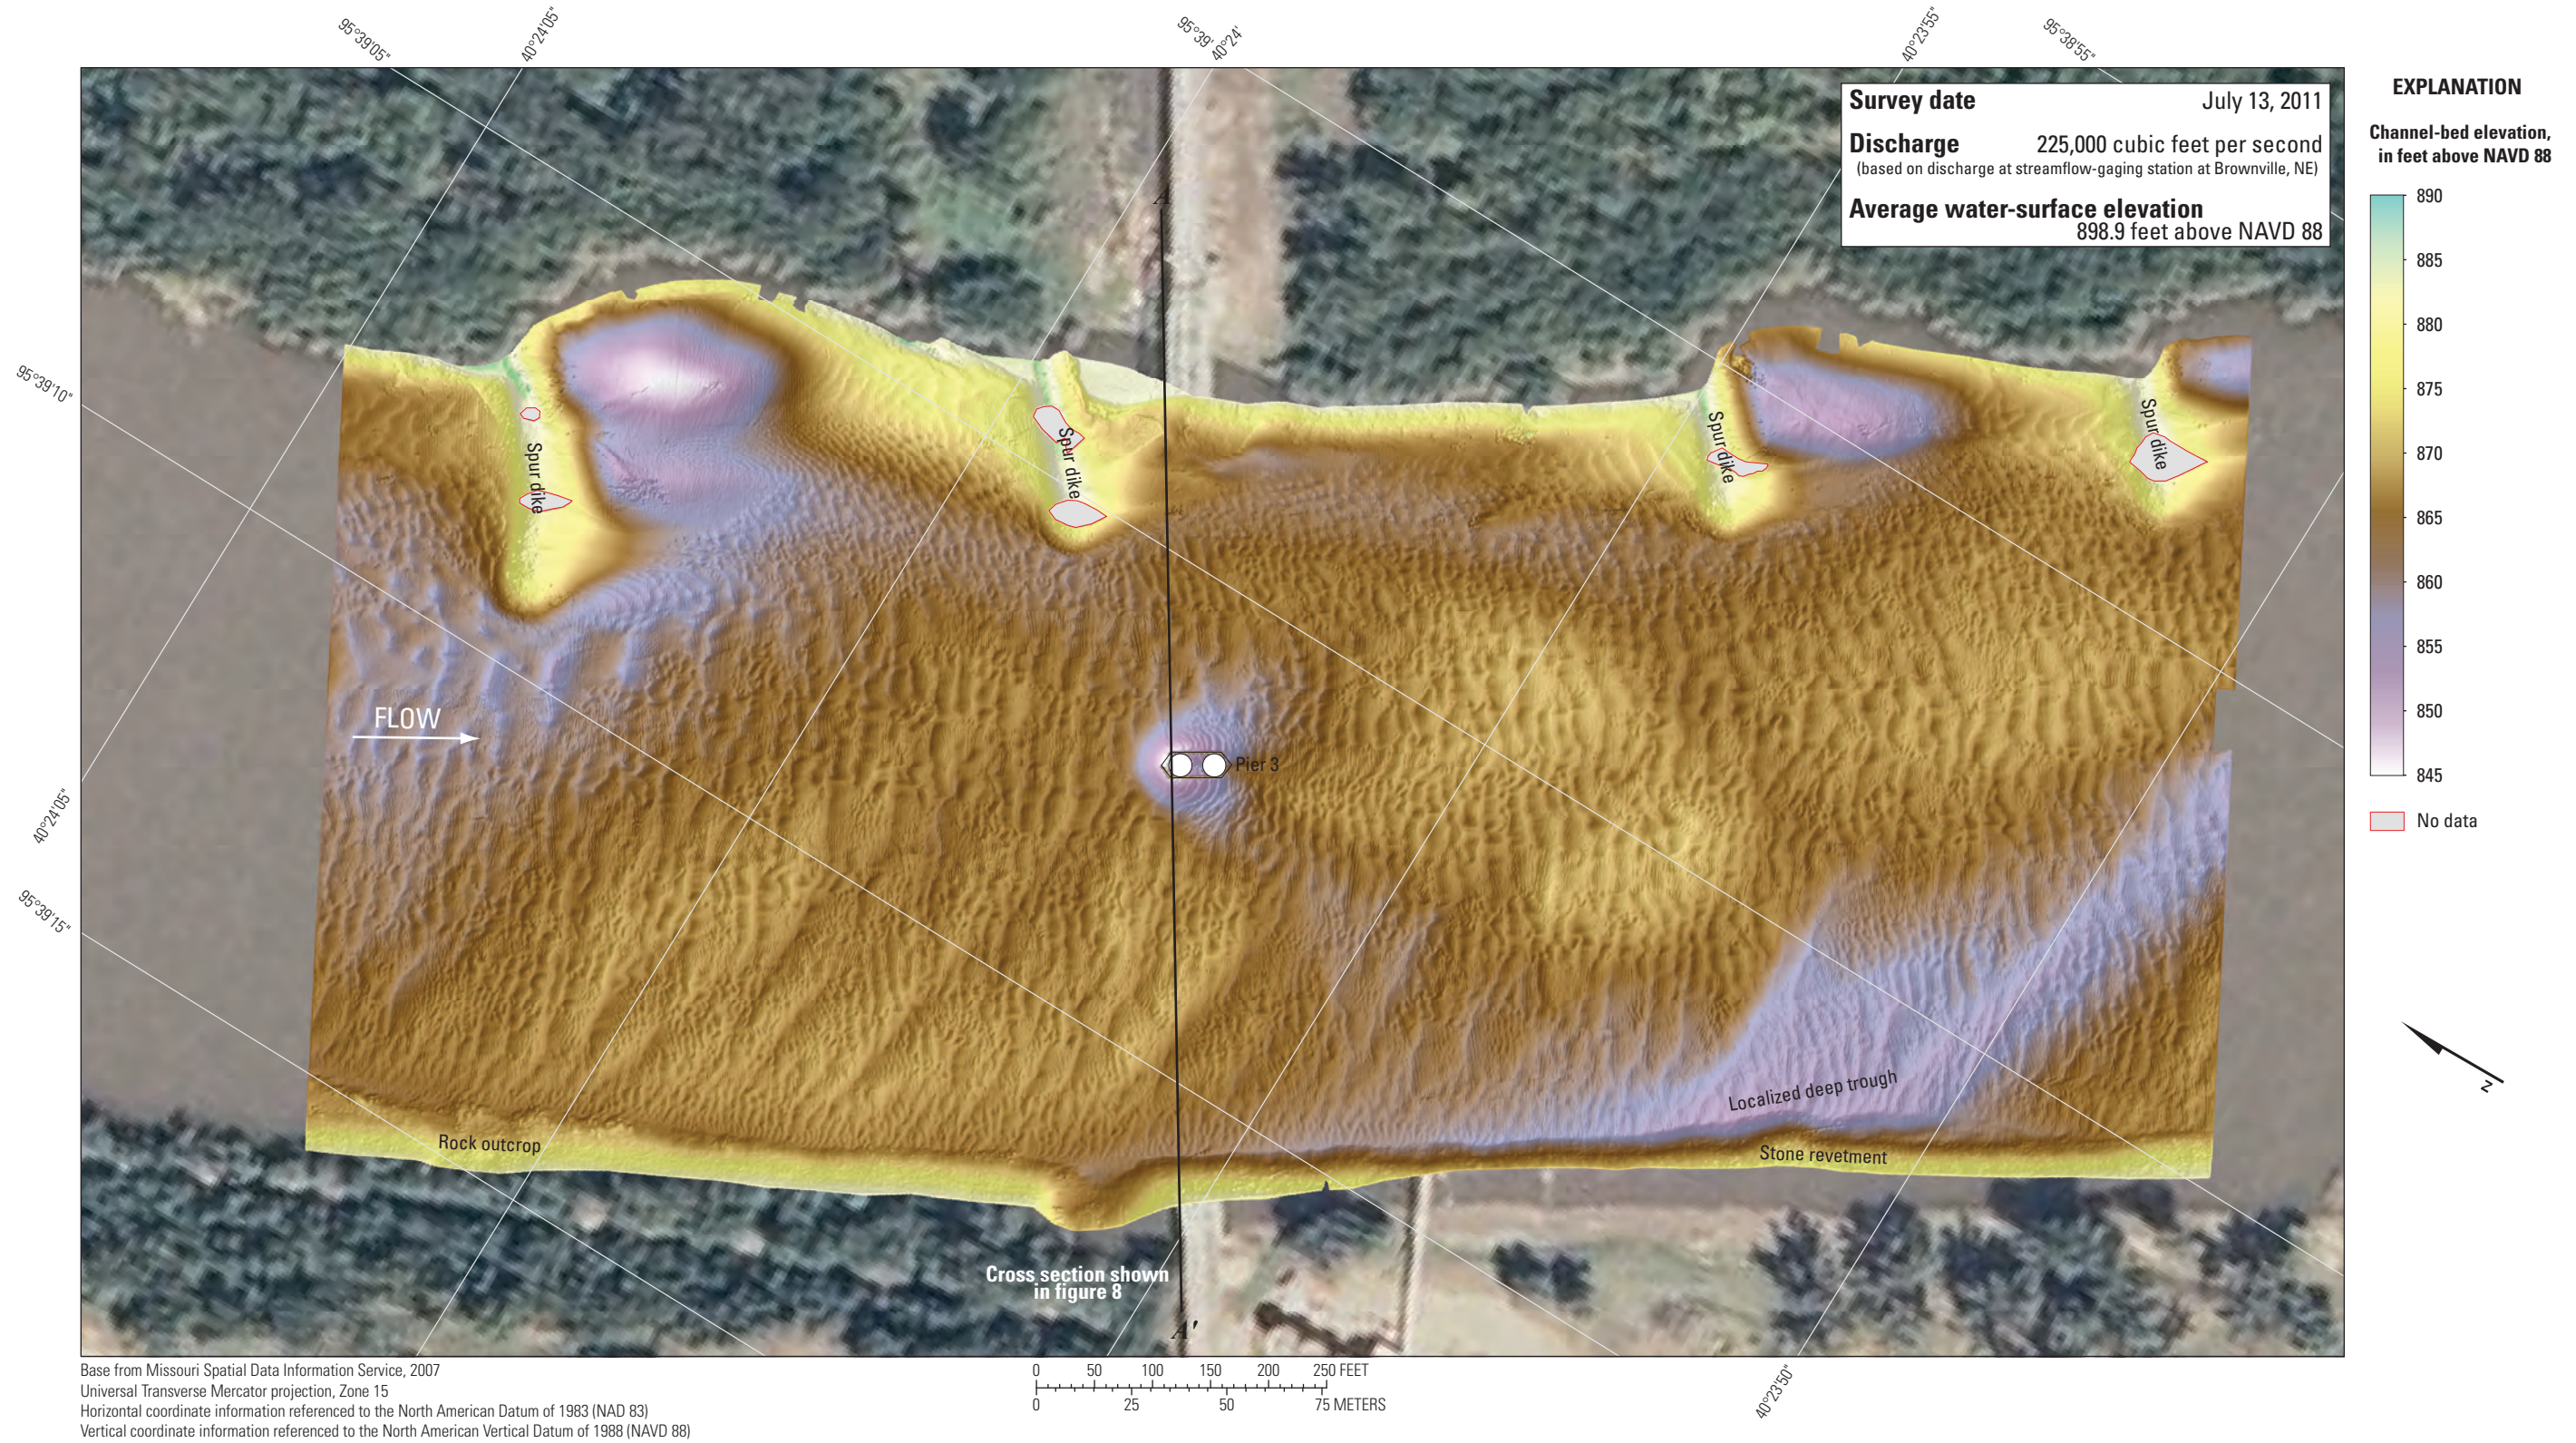
In the vicinity of main channel pier 3, a local scour hole had a minimum channel-bed elevation of approximately 846.0 ft (table 6), about 17 ft below the average channel bed immediately upstream from the pier (fig. 7). Information from bridge plans indicates that pier 3 is founded on sheet piling caissons on bedrock, with about 31 ft of bed material between the bottom of the scour hole and bedrock at the upstream face of the pier (fig. 8; table 6). The unique configuration of the sheet pile caissons and ice breaker of the pier are clearly seen in a point cloud visualization of the multibeam depth points obtained during the survey (fig. 9).

Figure 7. Bathymetric survey of the Missouri River channel in the vicinity of structure L0098 on U.S. Highway 136 at Brownville, Nebraska.

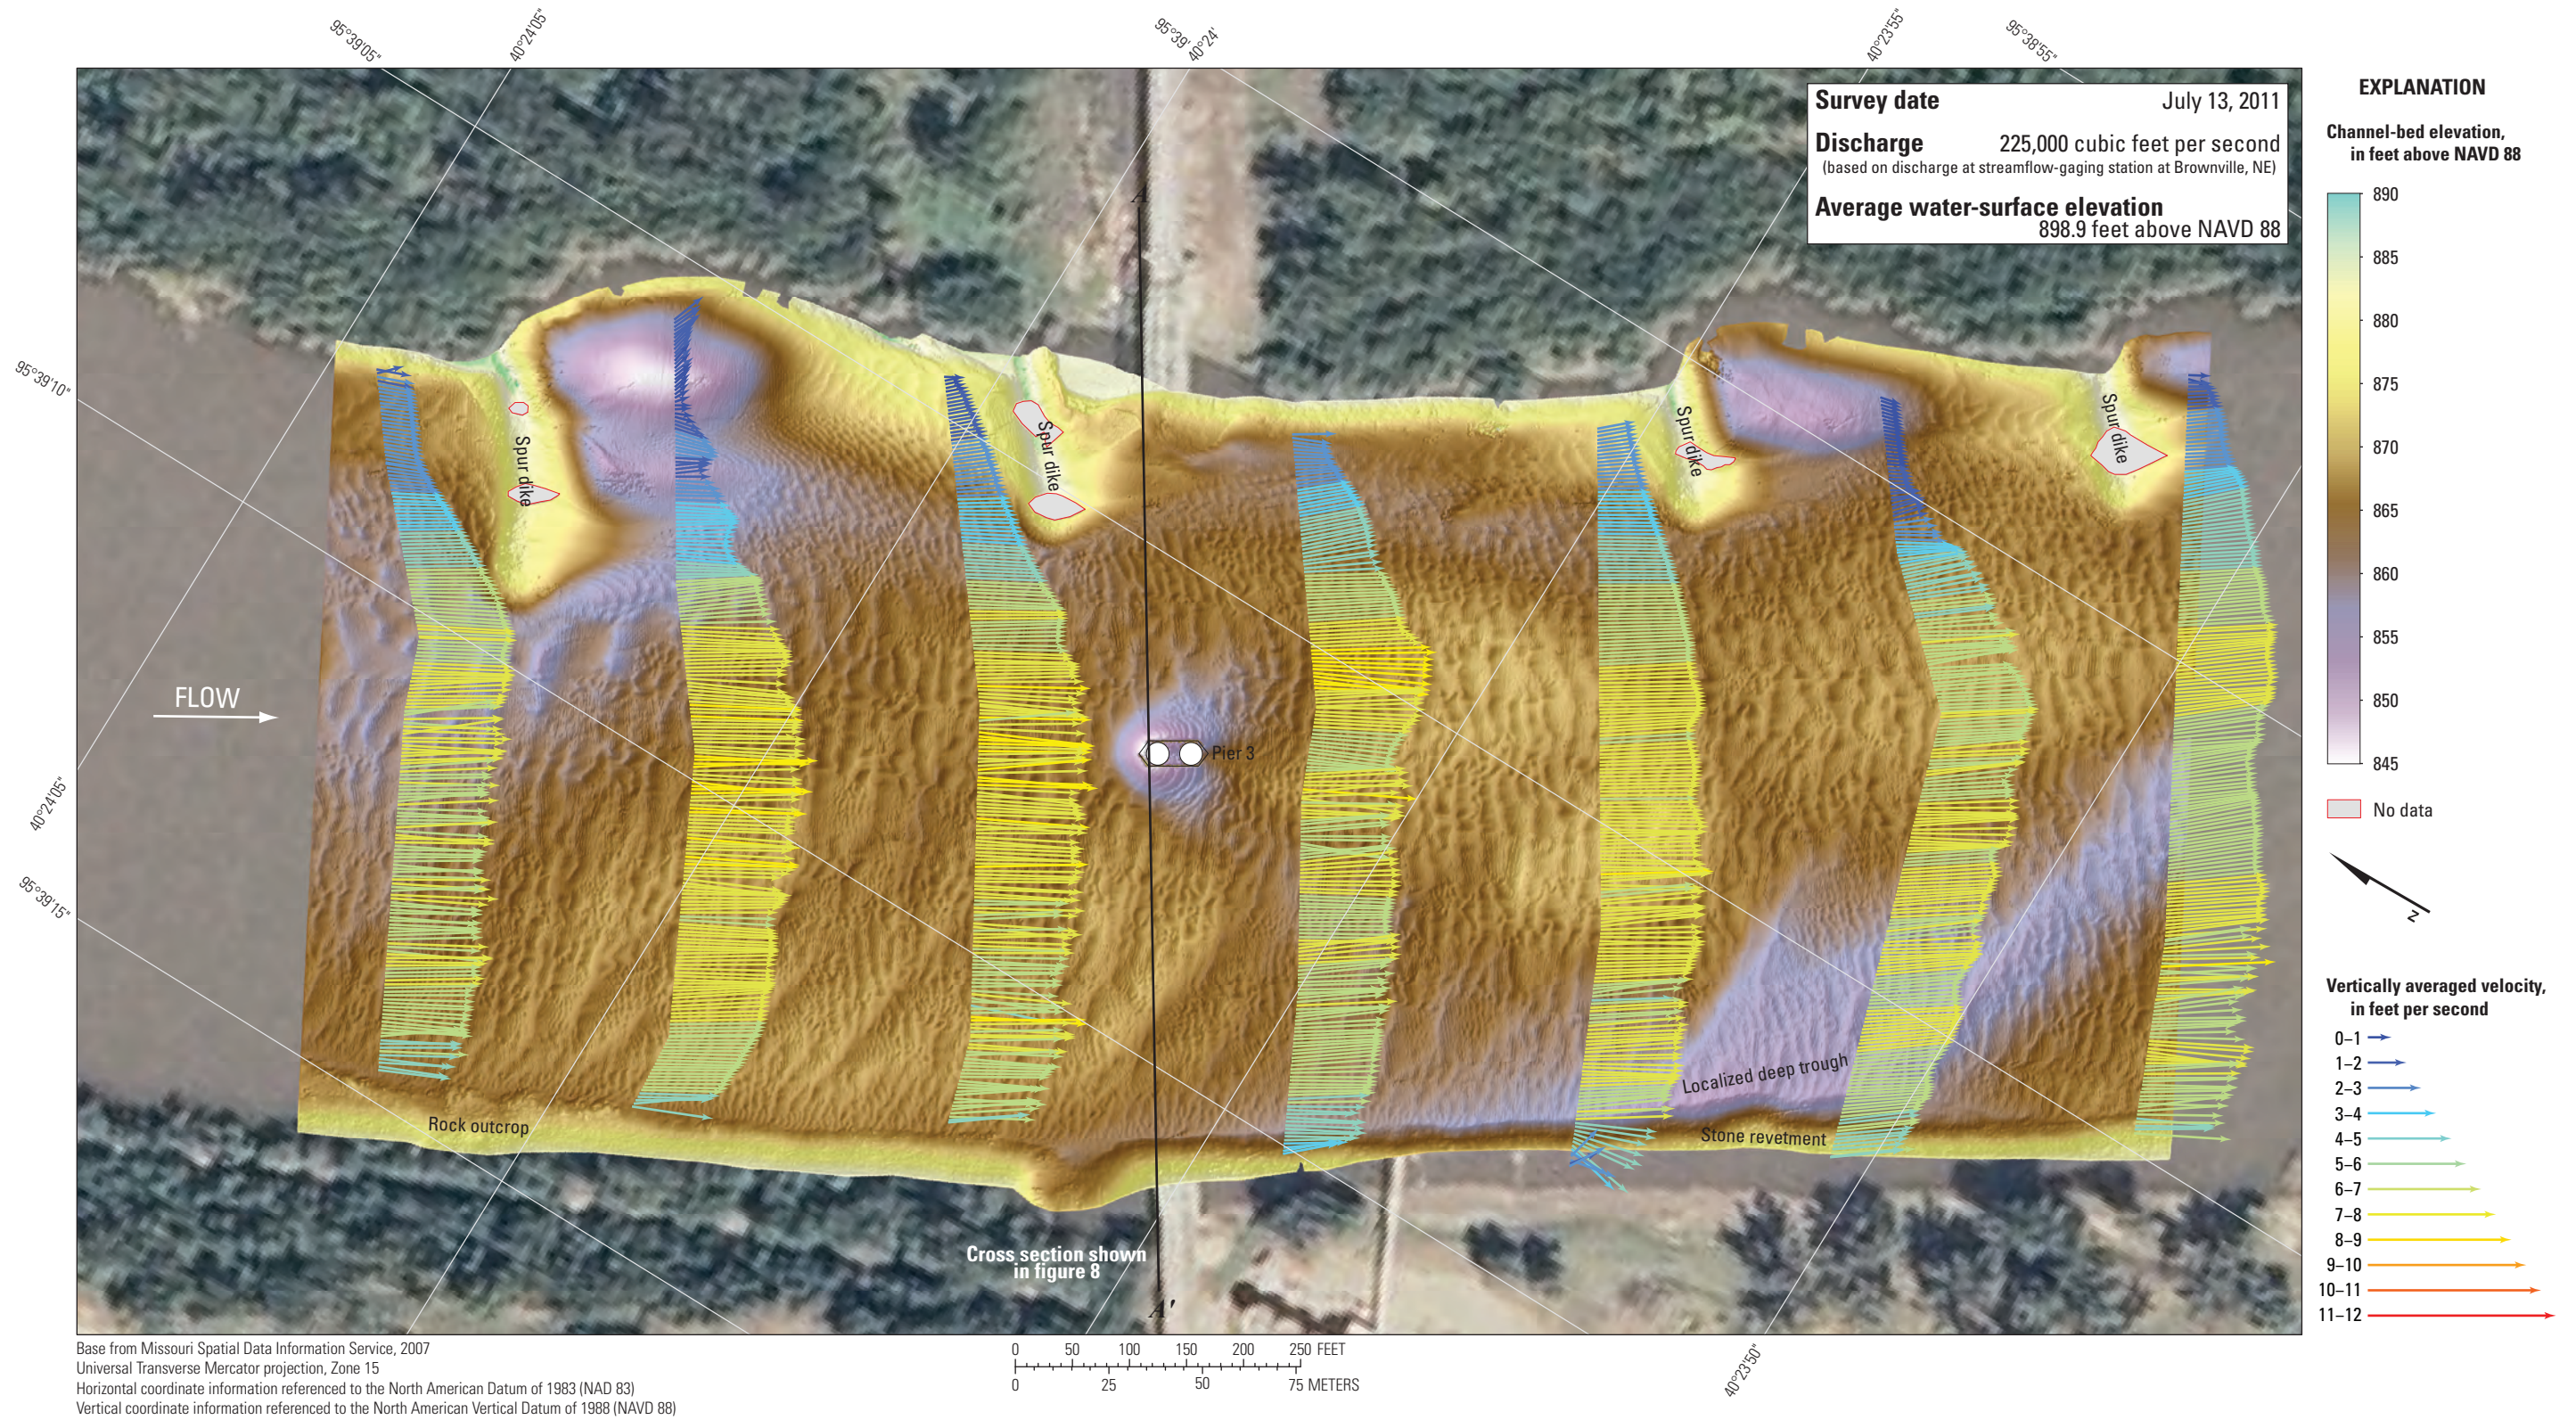
The vertically averaged velocity vectors indicated mostly uniform flow at between 5 and 8 feet per second (ft/s) in the main channel, except downstream from the spur dikes (fig. 10). The turbulence downstream from main channel pier 3 was not pronounced, and appeared to be no greater than the general turbulence observed in the channel. The slightly shallower channel near the bridge resulted in slightly higher velocities compared with the deeper, slower flows observed near the upstream end of the reach and in the localized deep trough at the downstream end of the reach.

Figure 10. Bathymetry and vertically averaged velocities of the Missouri River channel in the vicinity of structure L0098 on U.S. Highway 136 at Brownville, Nebraska.

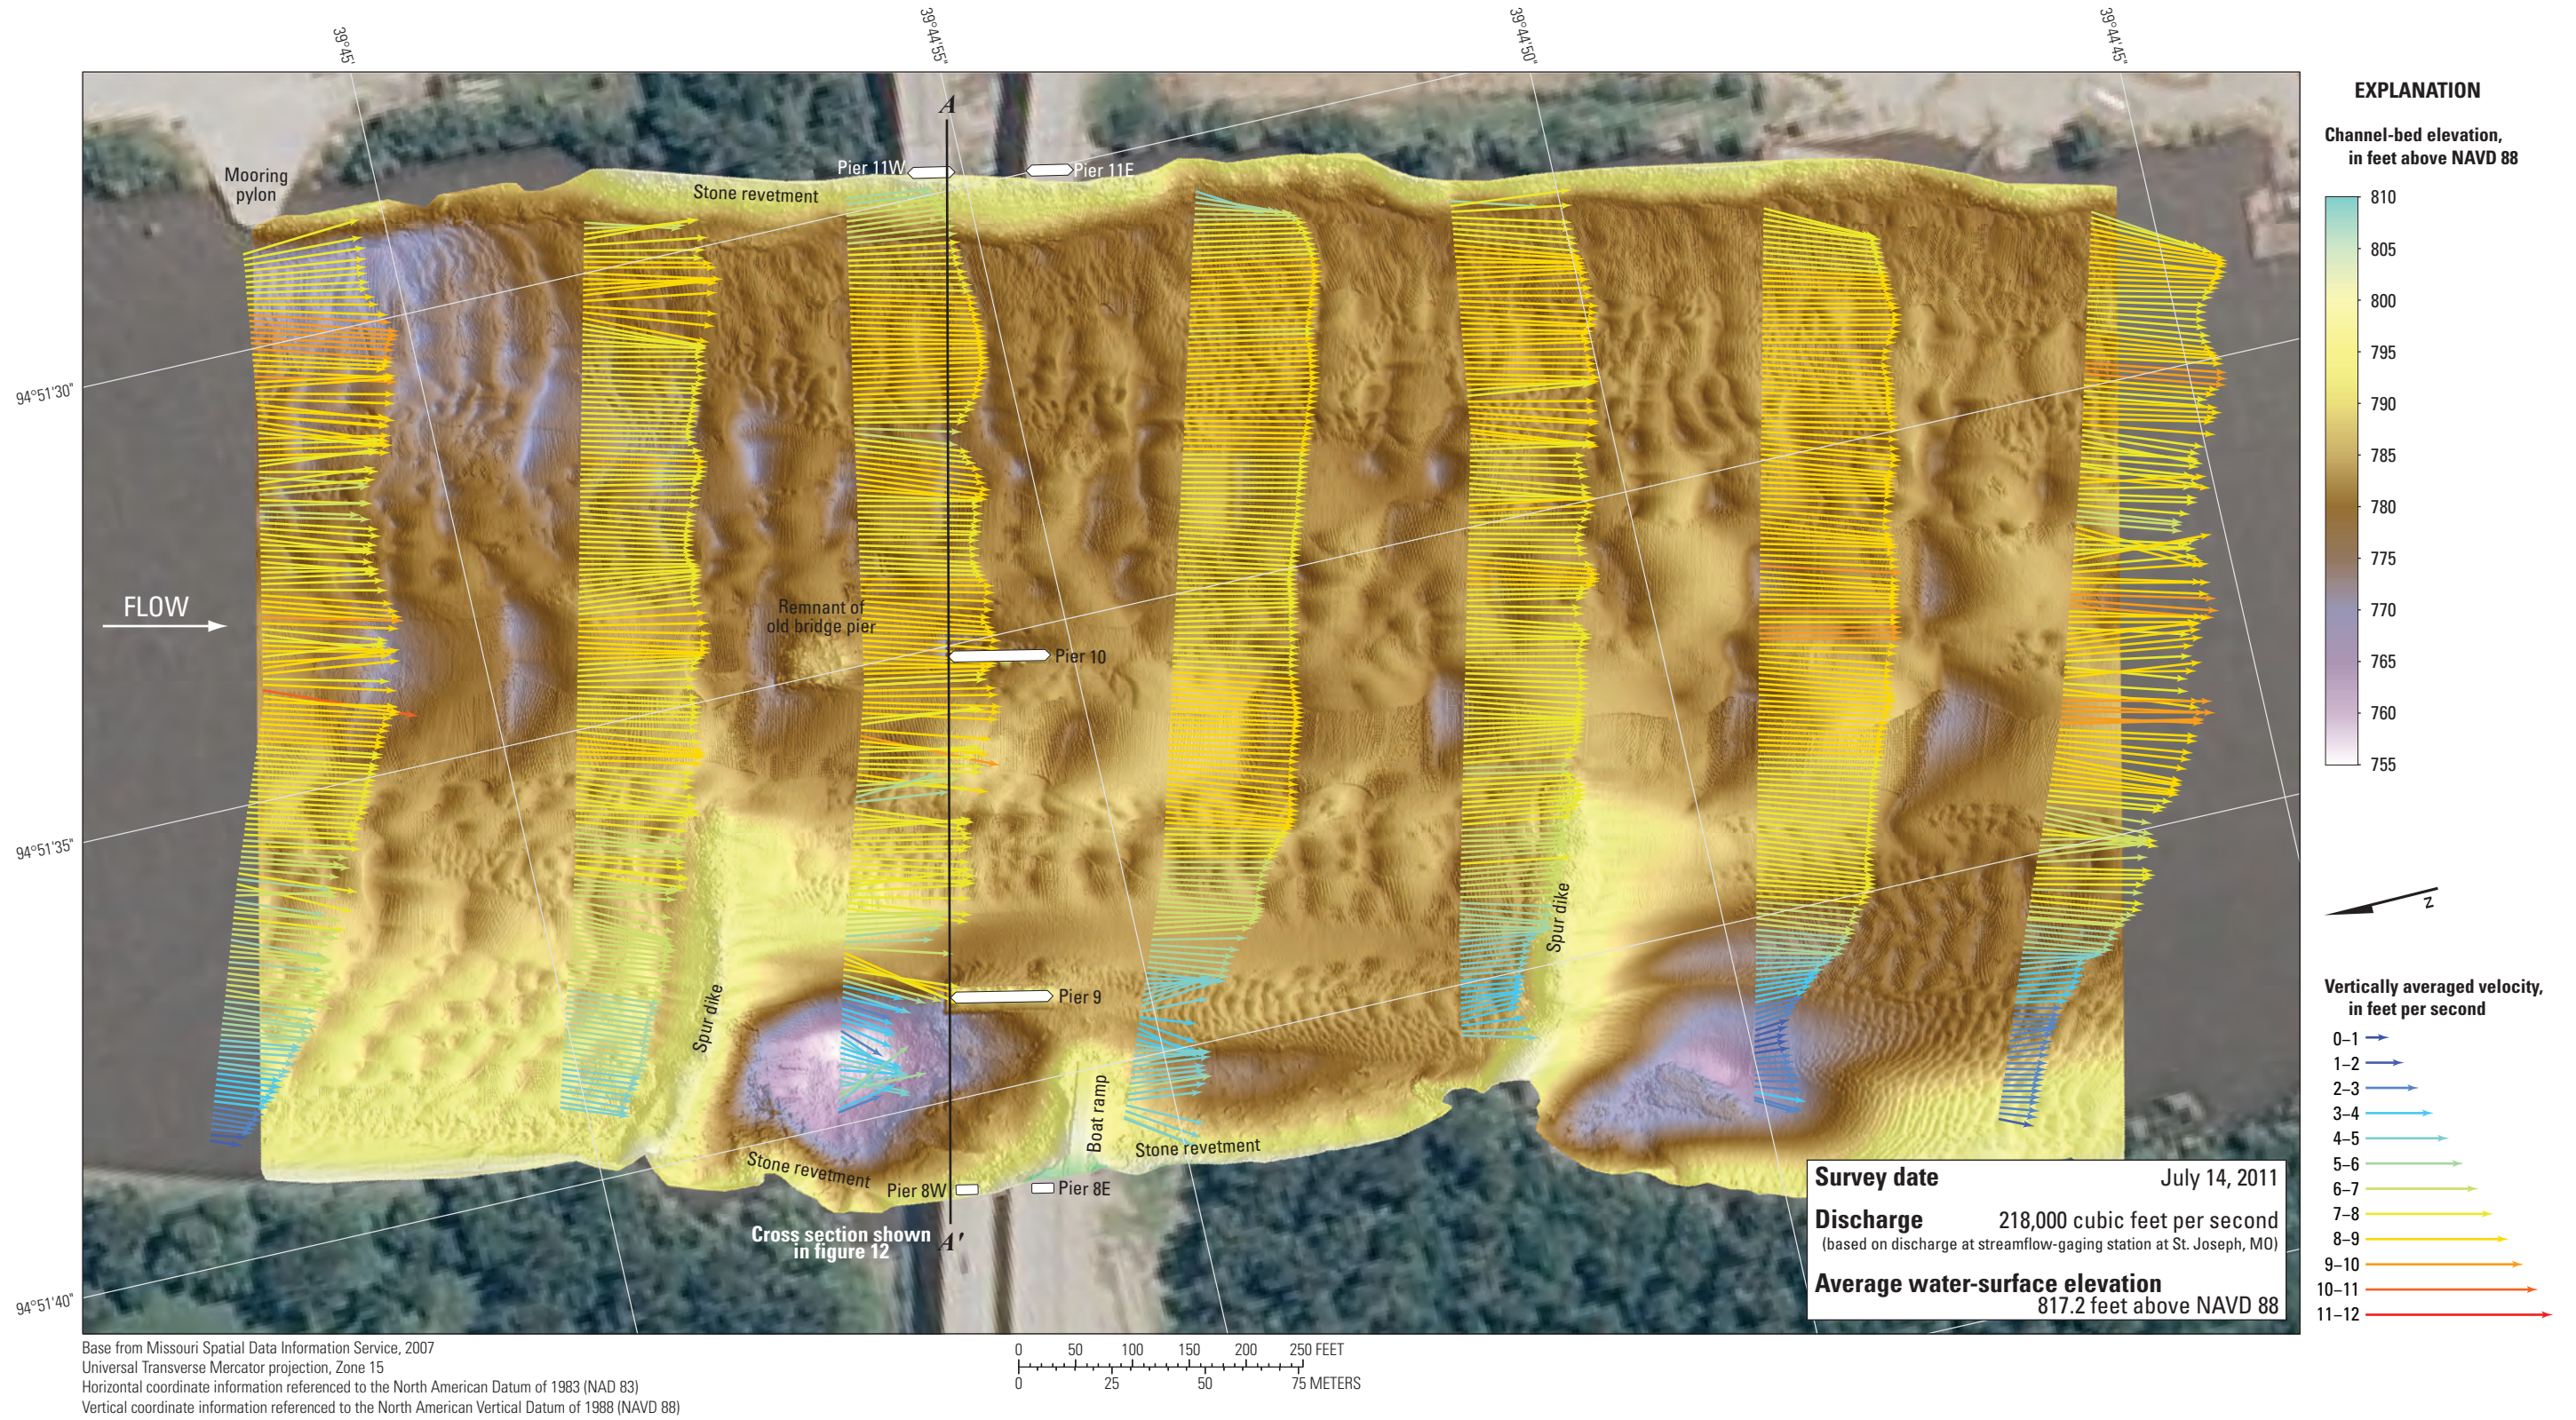
The vertically averaged velocity vectors indicated mostly uniform flow at between 6 and 8 ft/s in the main channel, except downstream from the spur dikes (fig. 13) and a few localized areas of higher velocity near the upstream mooring pylon and in the downstream part of the reach. The turbulence downstream from main channel pier 10 was not pronounced, and appeared to be no greater than the general turbulence observed in the channel. The turbulence downstream from piers 8 and 9 may be a function of the turbulence caused by the upstream spur dike (fig. 13). The downstream spur dike did not cause as much turbulence as the upstream spur dike (fig 13).

Figure 13. Bathymetry and vertically averaged velocities of the Missouri River channel in the vicinity of dual bridge structure A3664 on U.S. Highway 36 at St. Joseph, Missouri.

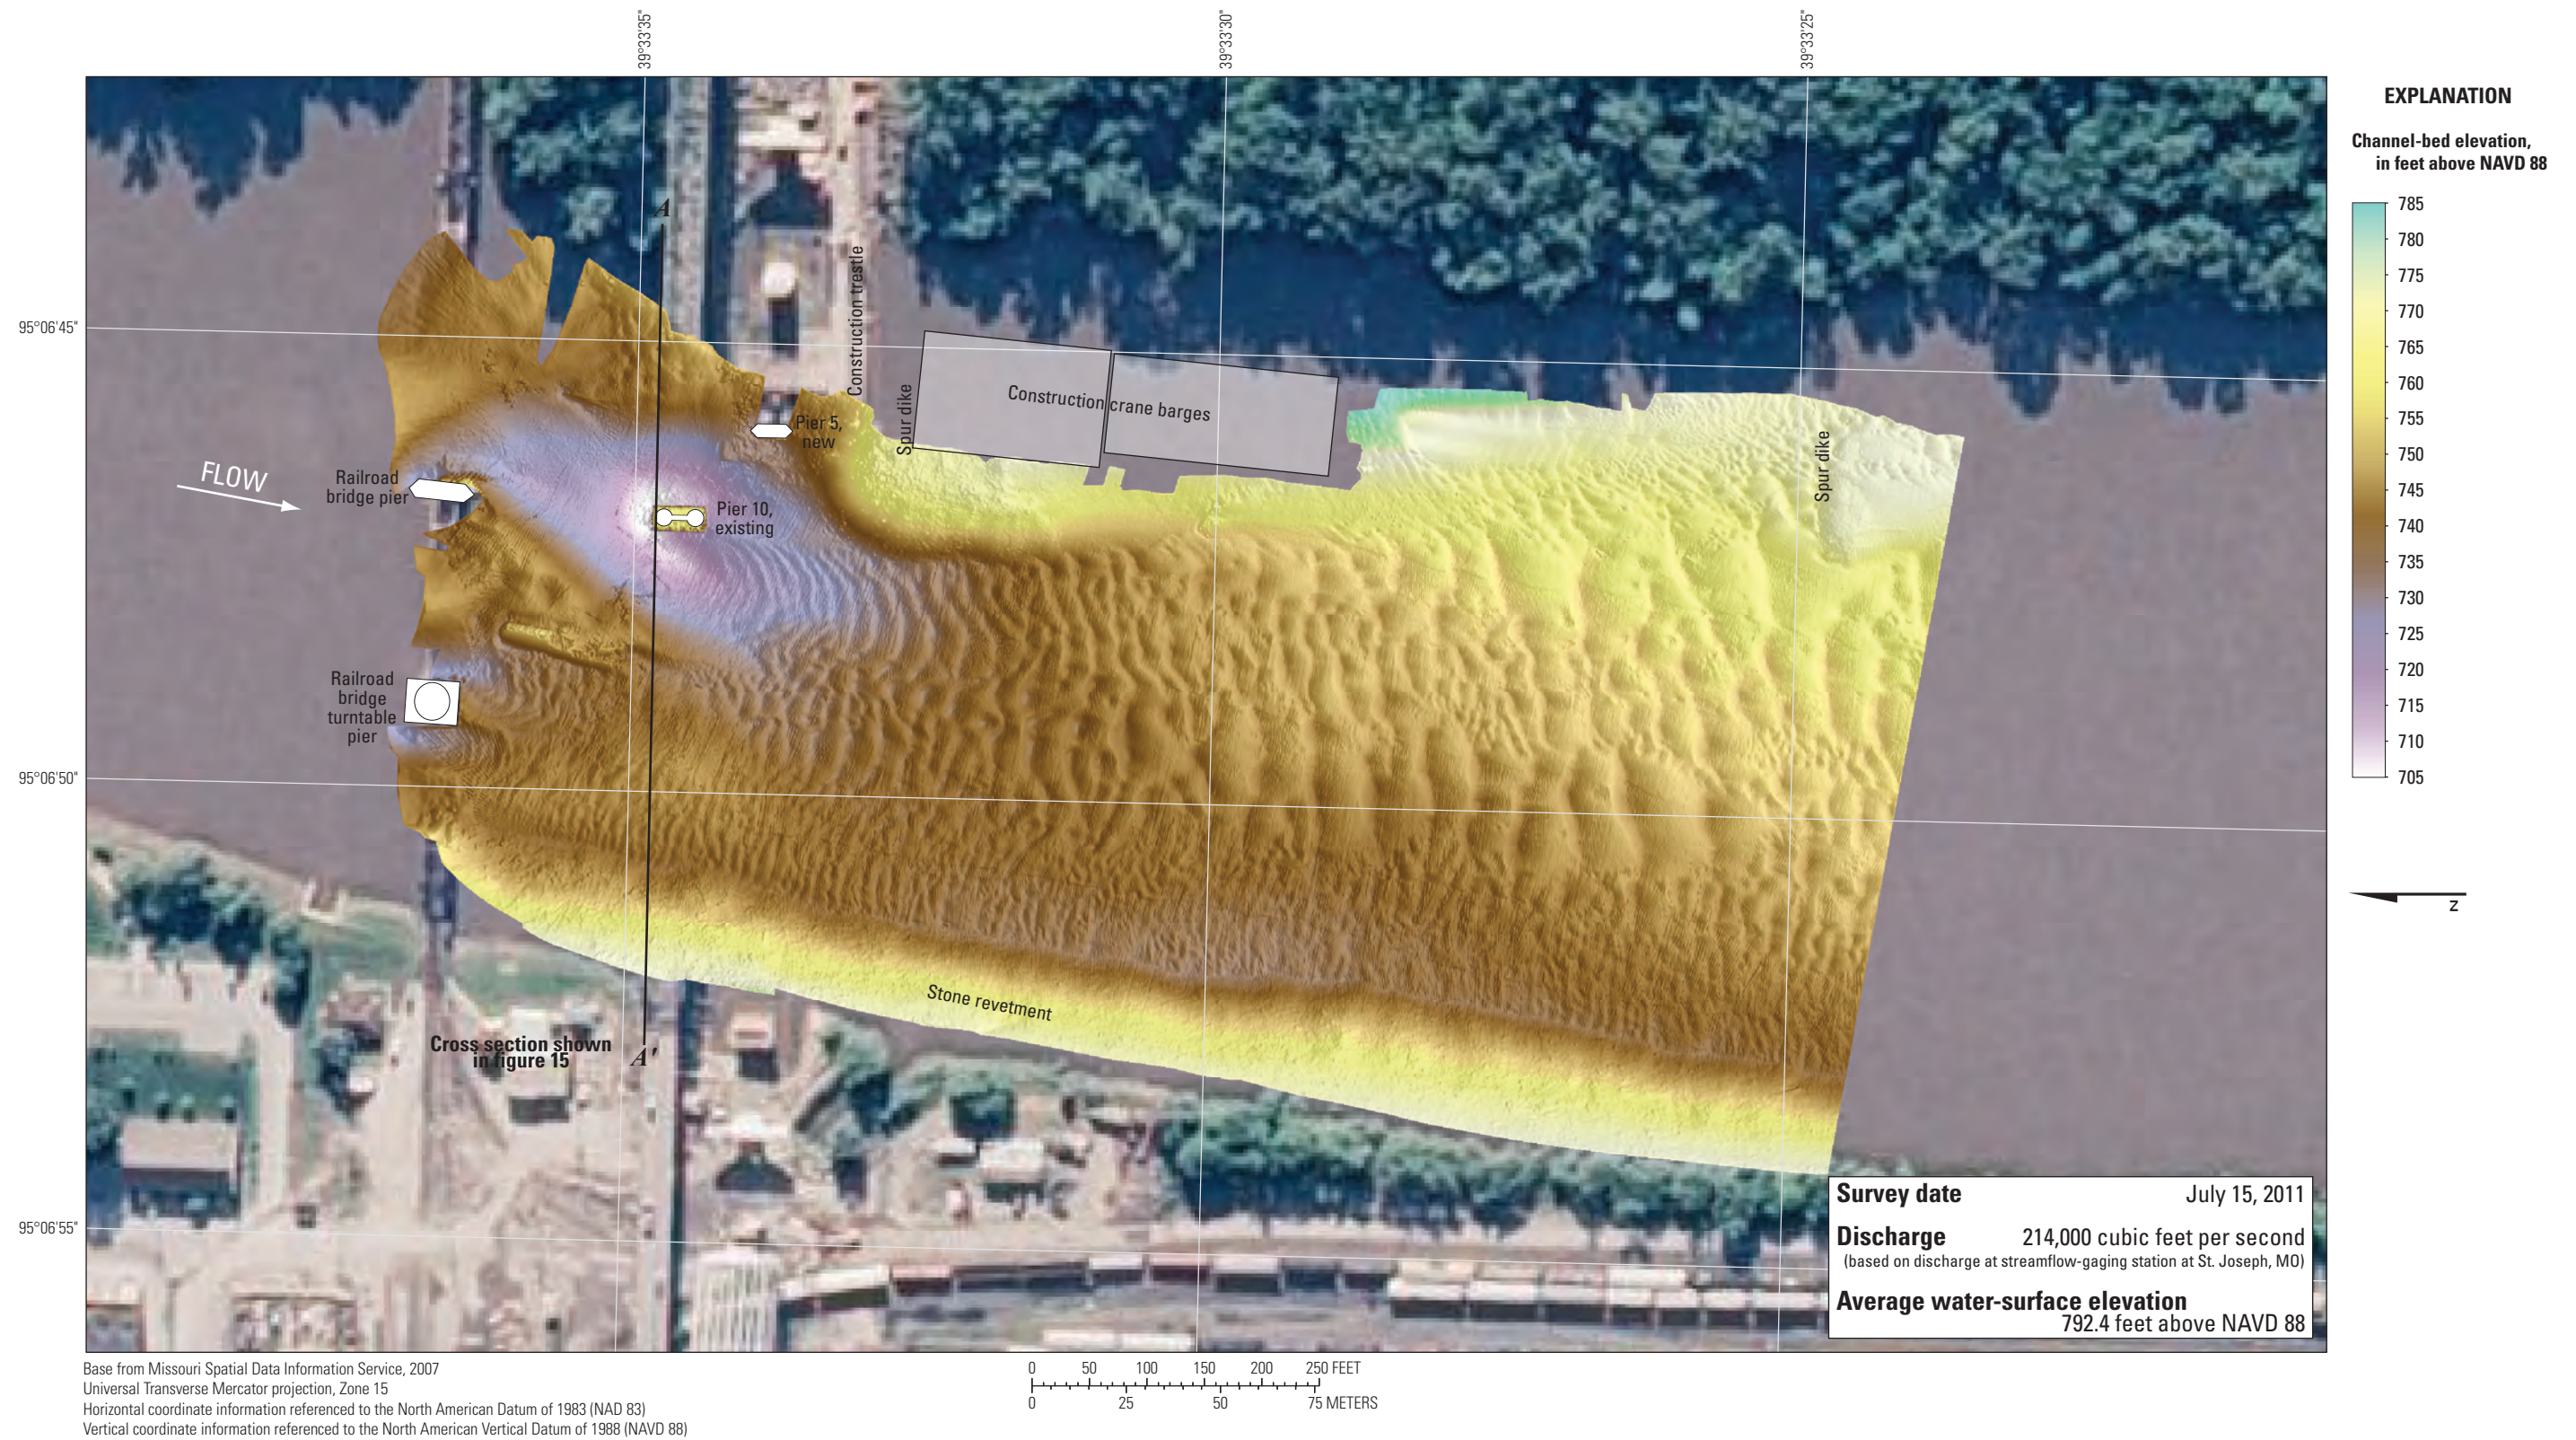
In the vicinity of main channel pier 10, the scour hole had a minimum channel-bed elevation of approximately 705 ft (table 6), about 34 ft below the average channel bed to either side of the pier (fig. 14). This scour hole was substantially affected by local scour caused by the railroad bridge pier upstream (fig. 14). Information from bridge plans indicates that pier 10 is founded on a caisson on bedrock, with only about 4 ft of bed material between the bottom of the scour hole and bedrock at the upstream face of pier 10 (fig. 15; table 6). In modern construction, bridge substructural elements usually are pinned or socketed to bedrock (American Association of State Highway Transportation Officials, 2012; Brown and others, 2010), but full exposure of usually buried substructural elements warrants special consideration and observation, particularly at an older bridge such as structure 59-3-16.38 (013).

Figure 14. Bathymetric survey of the Missouri River channel in the vicinity of structure 59-3-16.38 (013) on U.S. Highway 59 at Atchison, Kansas.

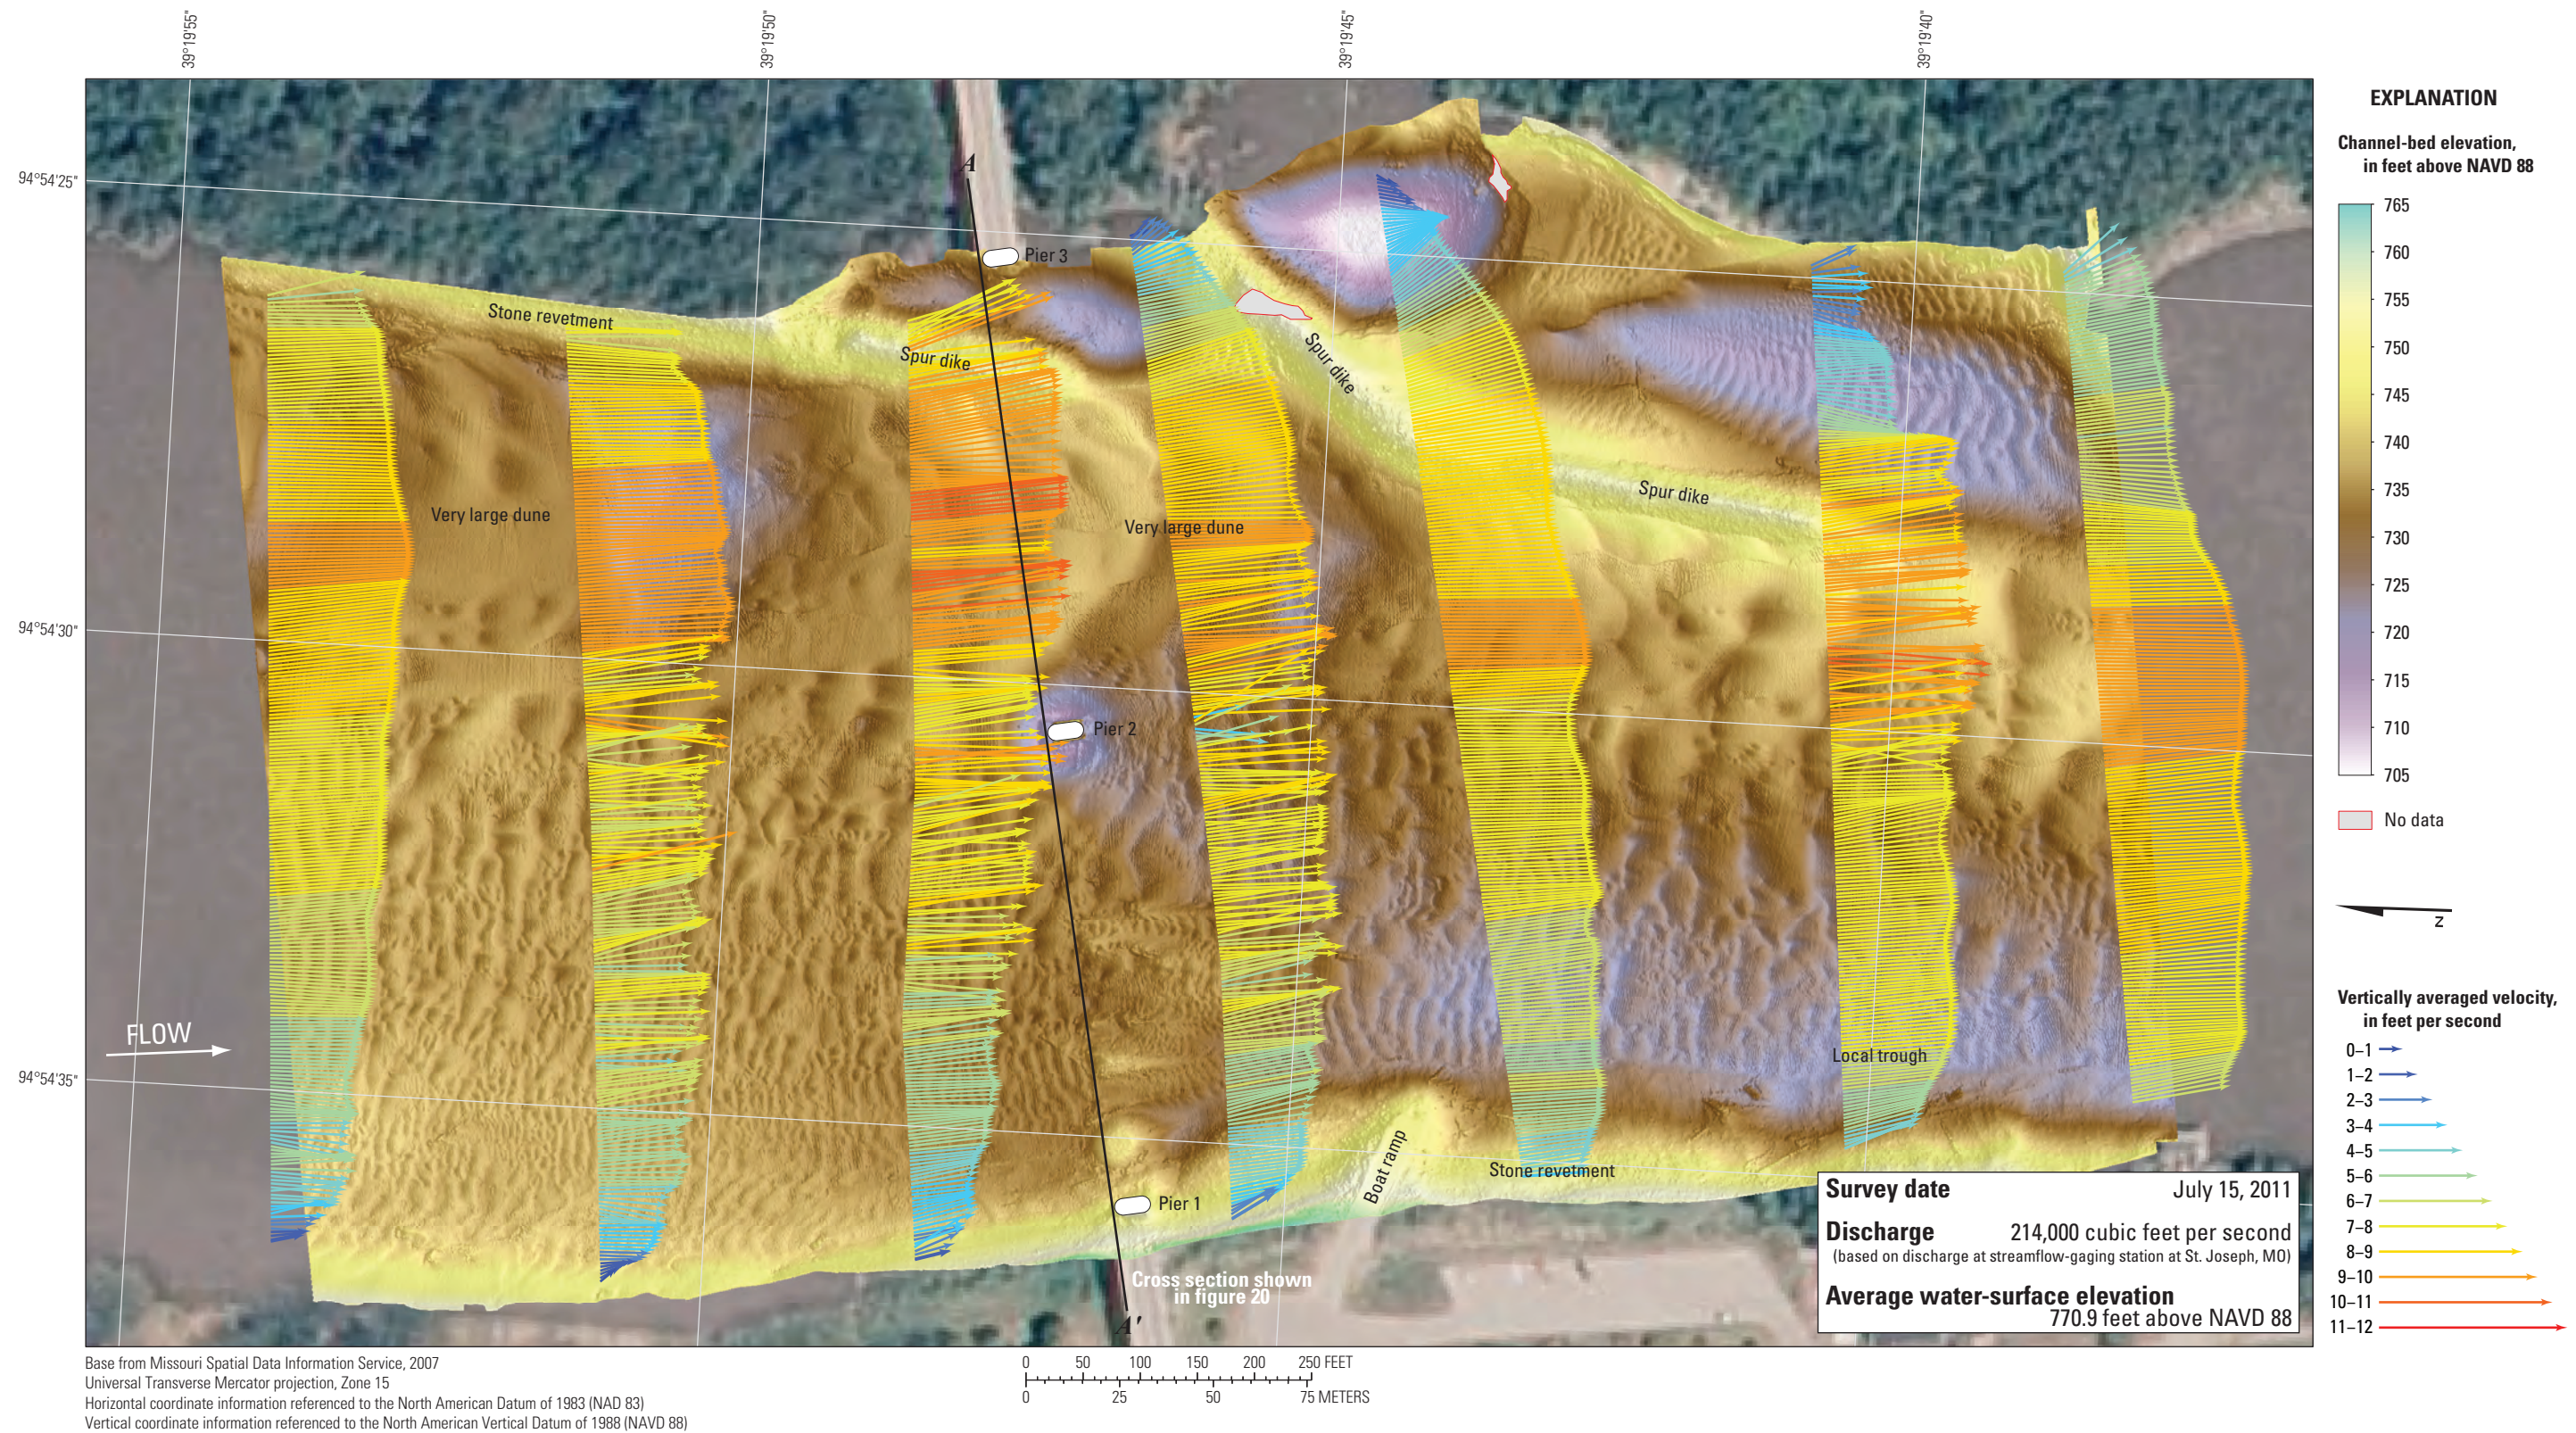
The vertically averaged velocity vectors indicated mostly uniform flow, with velocities ranging from 5 to 9 ft/s in the main channel, except along the banks and downstream from the spur dikes (fig. 21). Velocities reached a local maximum of almost 11 ft/s near the crest of the very large dune features and the shallow areas on the left (east) side of the channel (fig. 21). The turbulence downstream from main channel pier 2 was not pronounced, and appeared to be no greater than the general turbulence observed in the channel upstream from the pier (fig. 21).

Figure 21. Bathymetry and vertically averaged velocities of the Missouri River channel in the vicinity of structure 92-52-18.48 (026) on State Highway 92 at Leavenworth, Kansas.
