Bathymetric and Velocimetric Surveys at Highway Bridges Crossing the Missouri River in and into Missouri during Summer Flooding, July–August 2011

Scientific Investigations Report 2012–5204

By Richard J. Huizinga

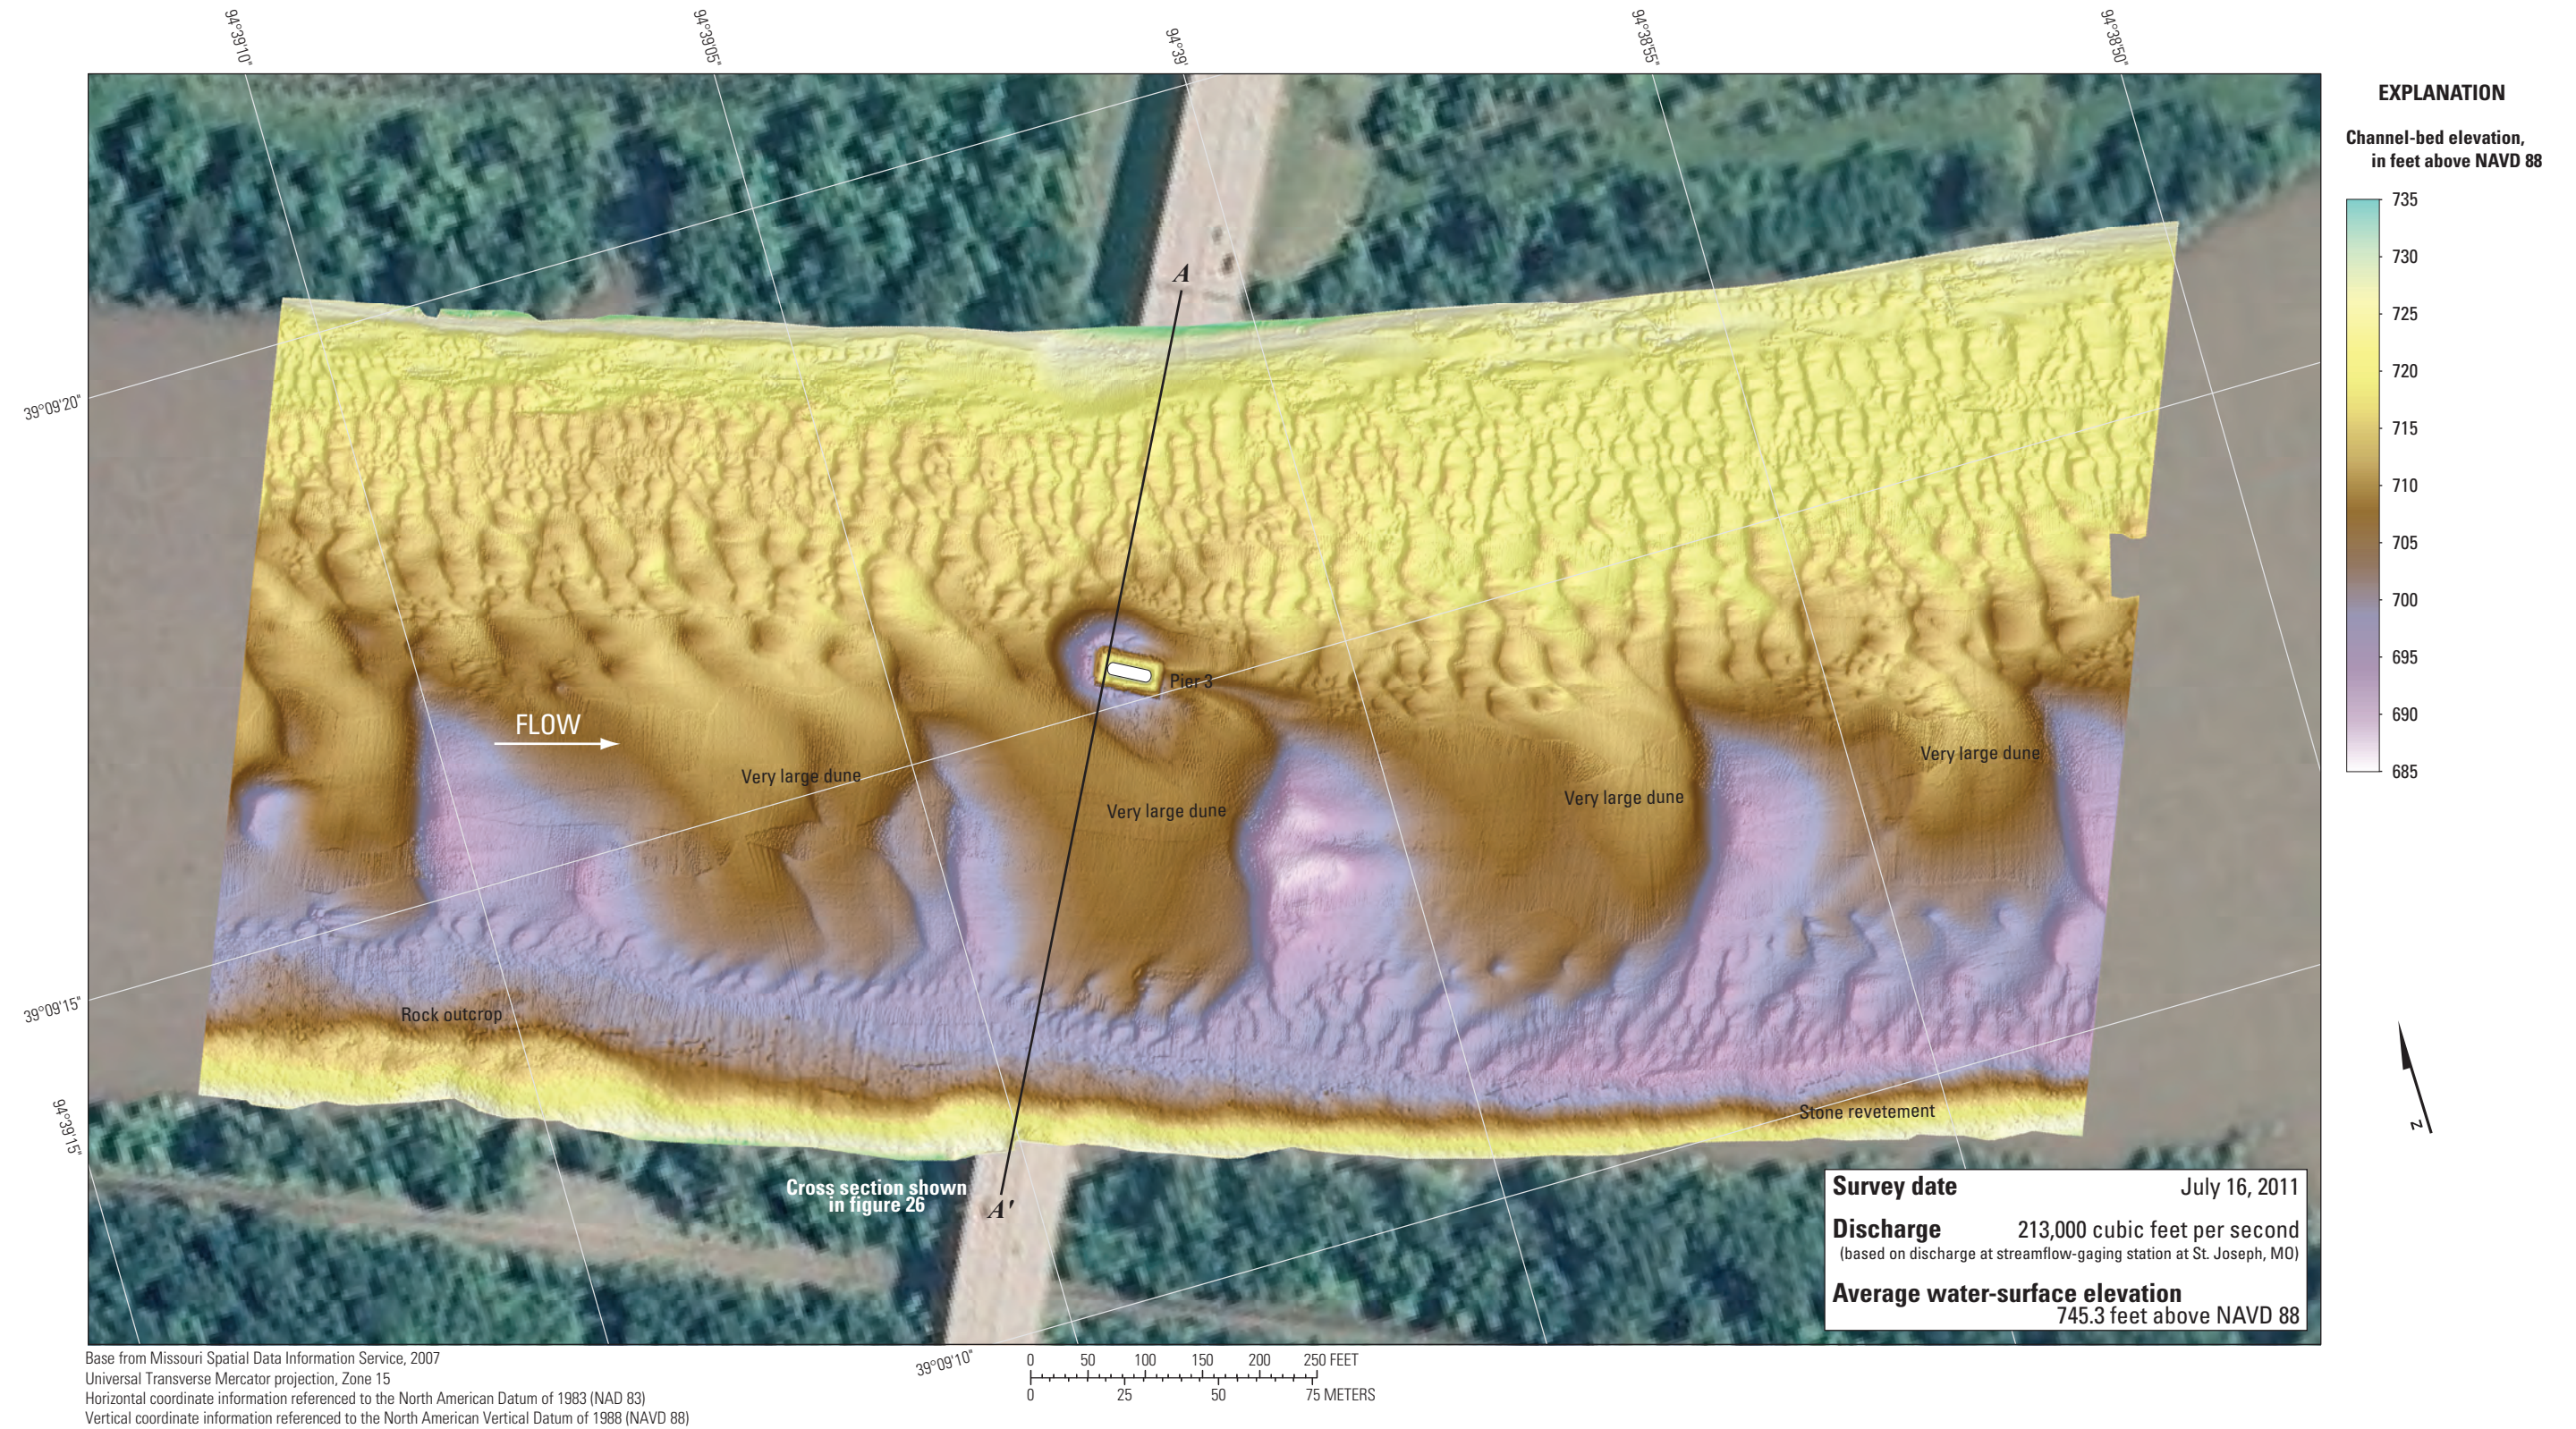
Figure 25. Bathymetric survey of the Missouri River channel in the vicinity of structure A1800 on Interstate 635 in Kansas City, Missouri.

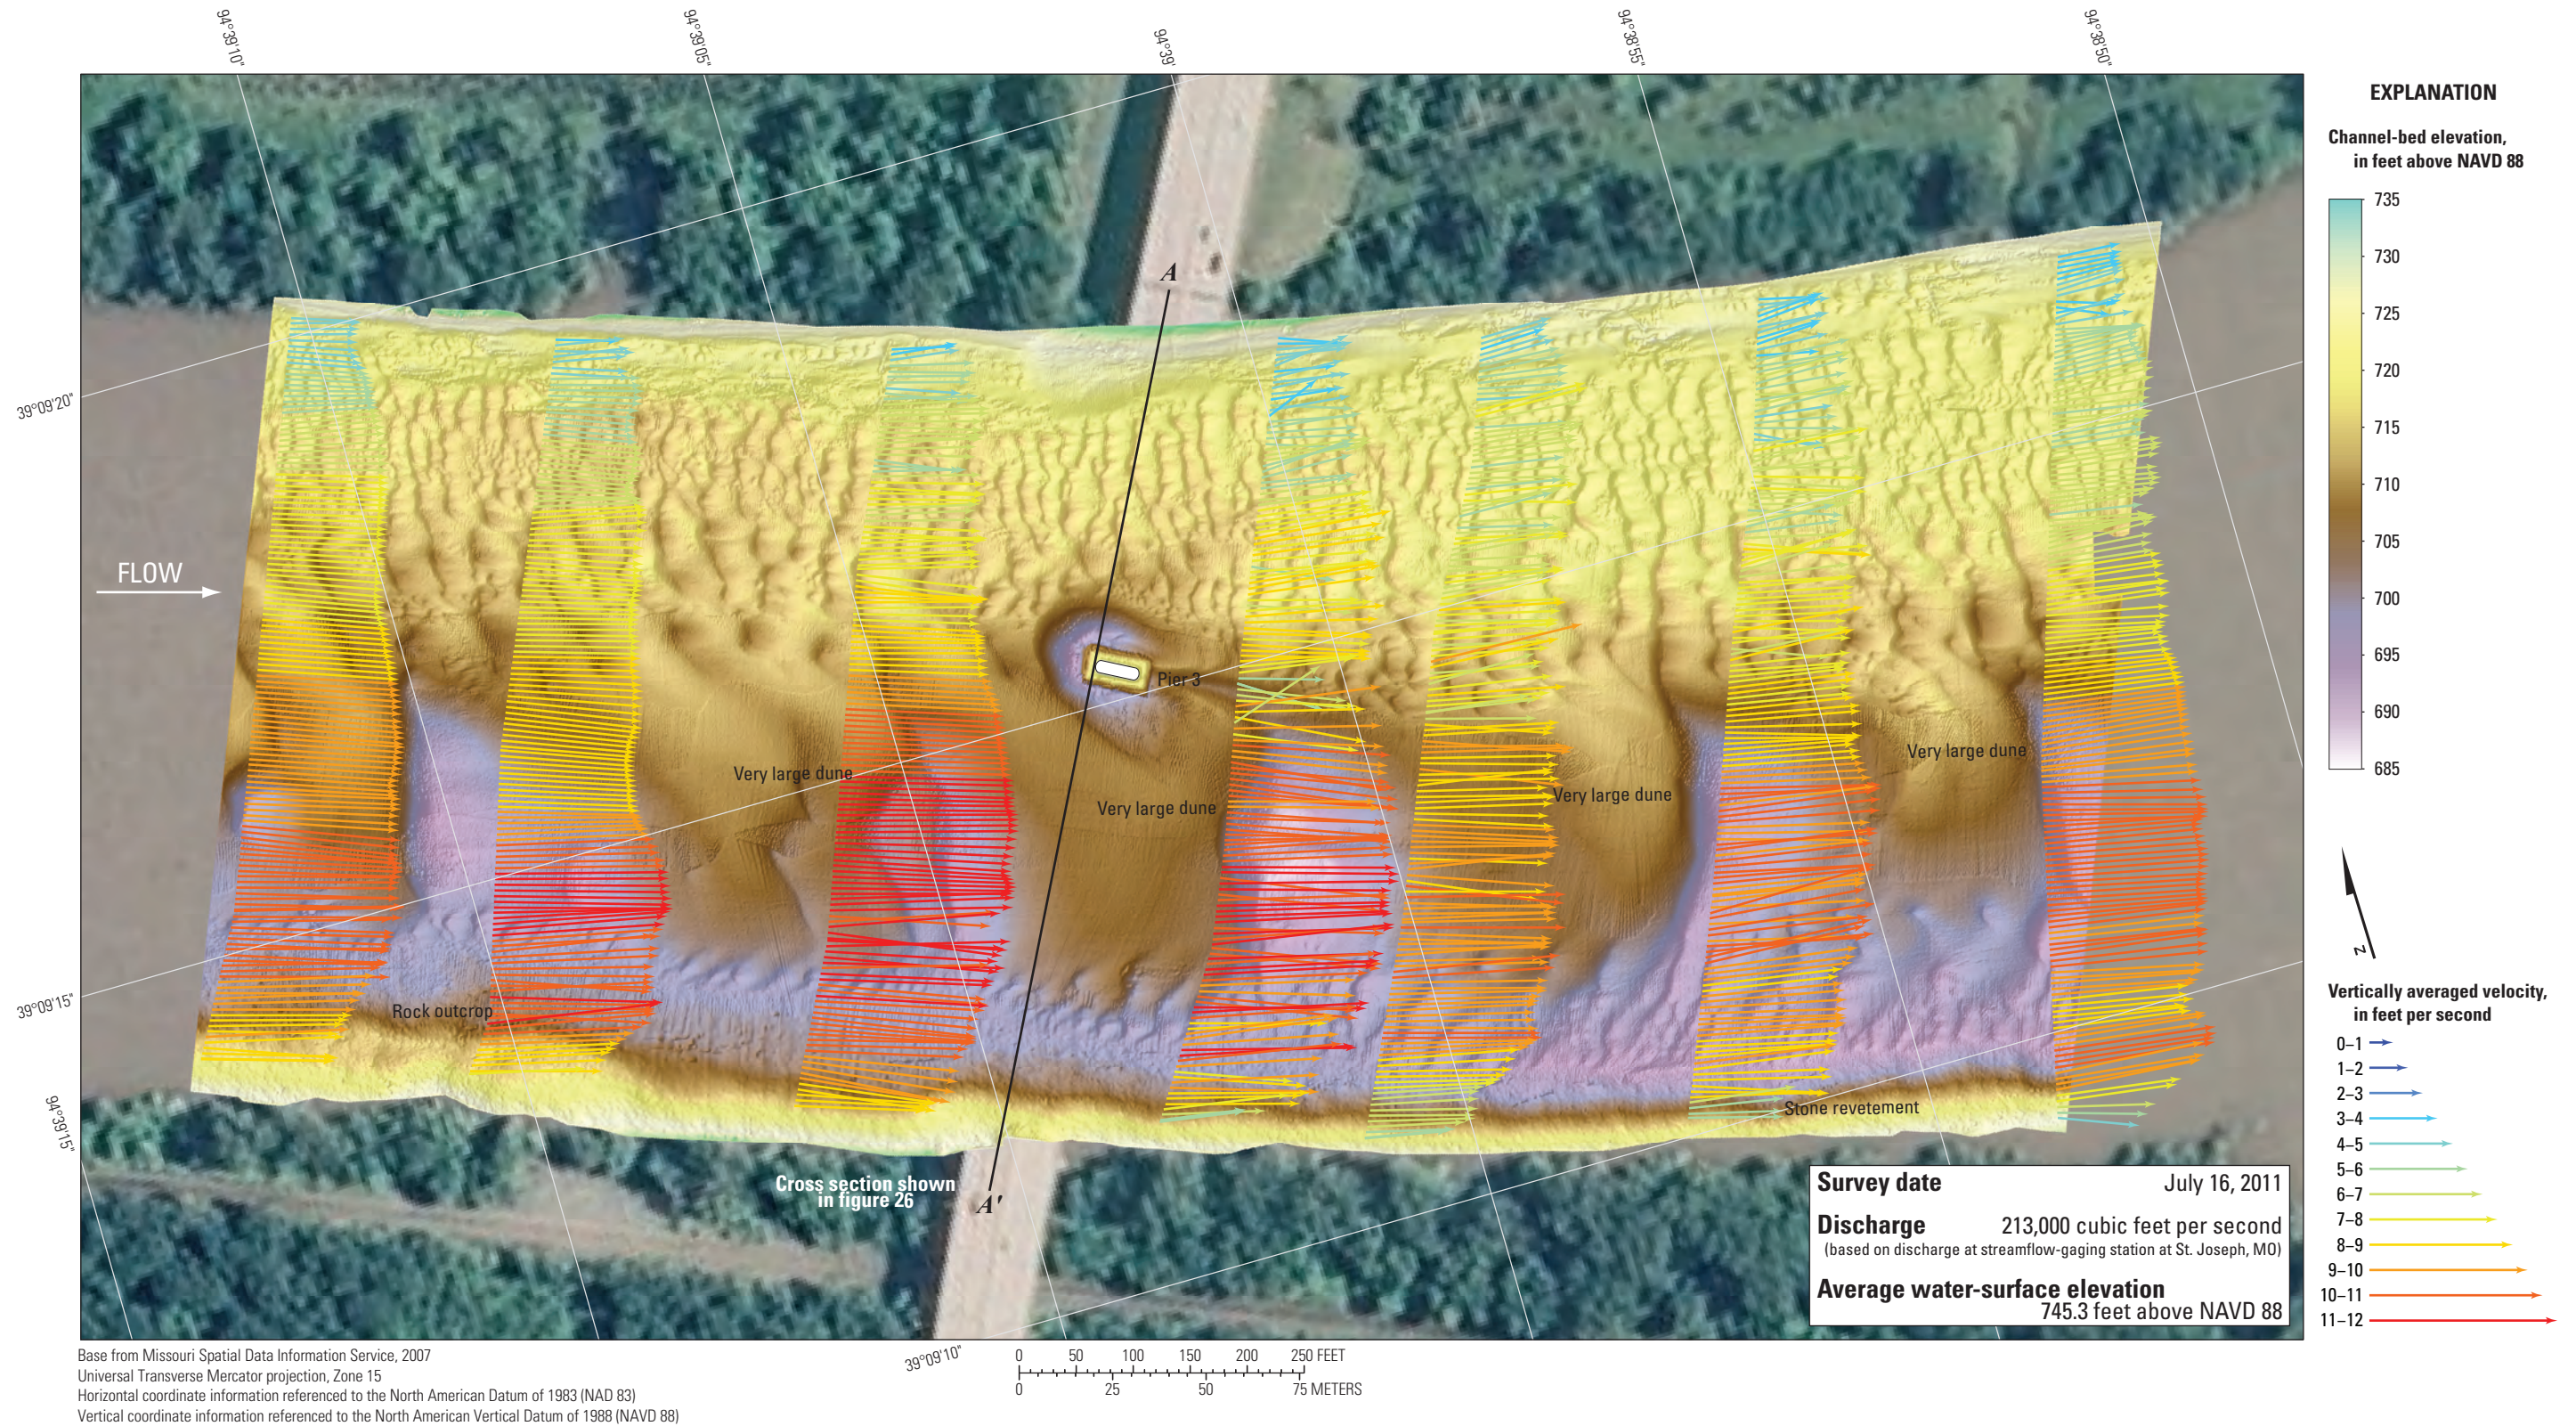
The vertically averaged velocity vectors indicate mostly uniform flow upstream from the bridge, with a maximum velocity of 12 ft/s in the channel thalweg and a minimum of 4 ft/s along the inside of the bend on the left (north) bank (fig. 28). Substantial turbulence was observed in the vicinity of pier 3, likely exacerbated by the pier being skewed to flow (fig. 28). A uniform flow pattern was present in the downstream-most section (fig. 28).

Figure 28. Bathymetry and vertically averaged velocities of the Missouri River channel in the vicinity of structure A1800 on Interstate 635 in Kansas City, Missouri.

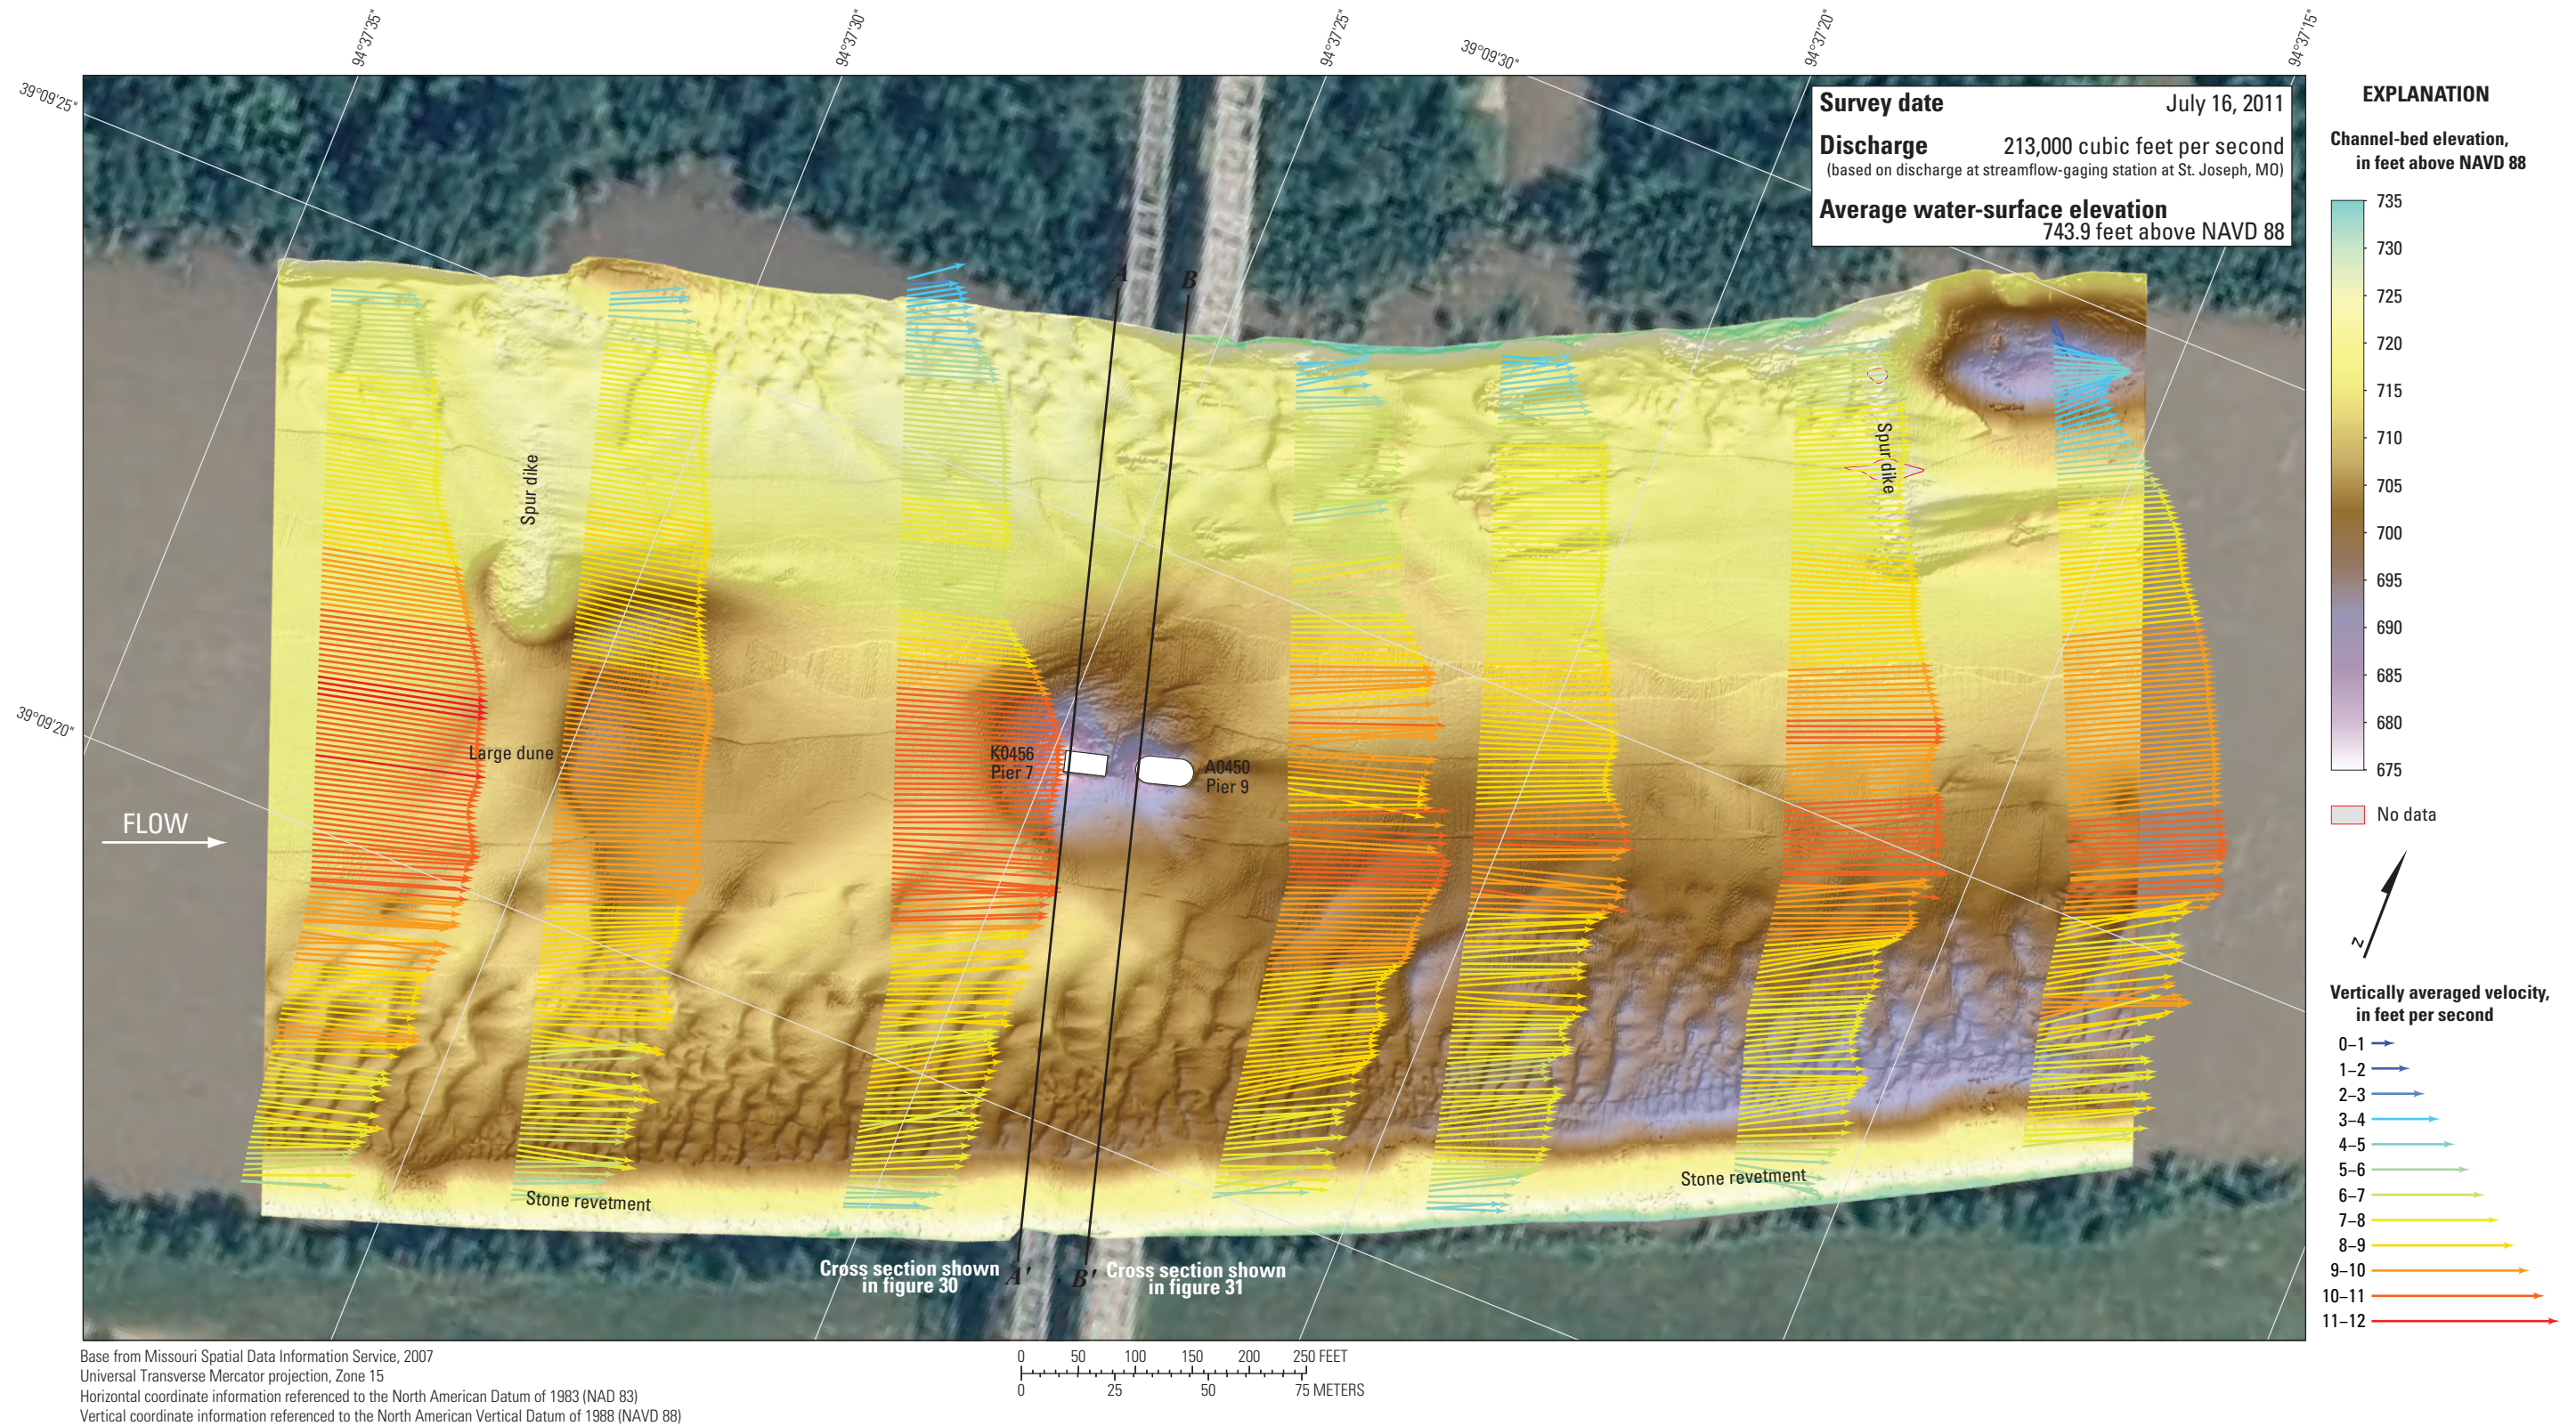
The vertically averaged velocity vectors indicate mostly uniform flow upstream from the bridge, with a maximum of 12 ft/s in the middle of the channel decreasing to about 4 ft/s along the banks (fig. 33). Velocities were higher in the center of the channel than in the thalweg, likely because flow was uniform and shallower in the center. Minor turbulence was observed in the downstream vicinity of the main channel piers and along the right (south) bank (fig. 33).

Figure 33. Bathymetry and vertically averaged velocities of the Missouri River channel in the vicinity of structures K0456 and A0450 on U.S. Highway 69 in Kansas City, Missouri.

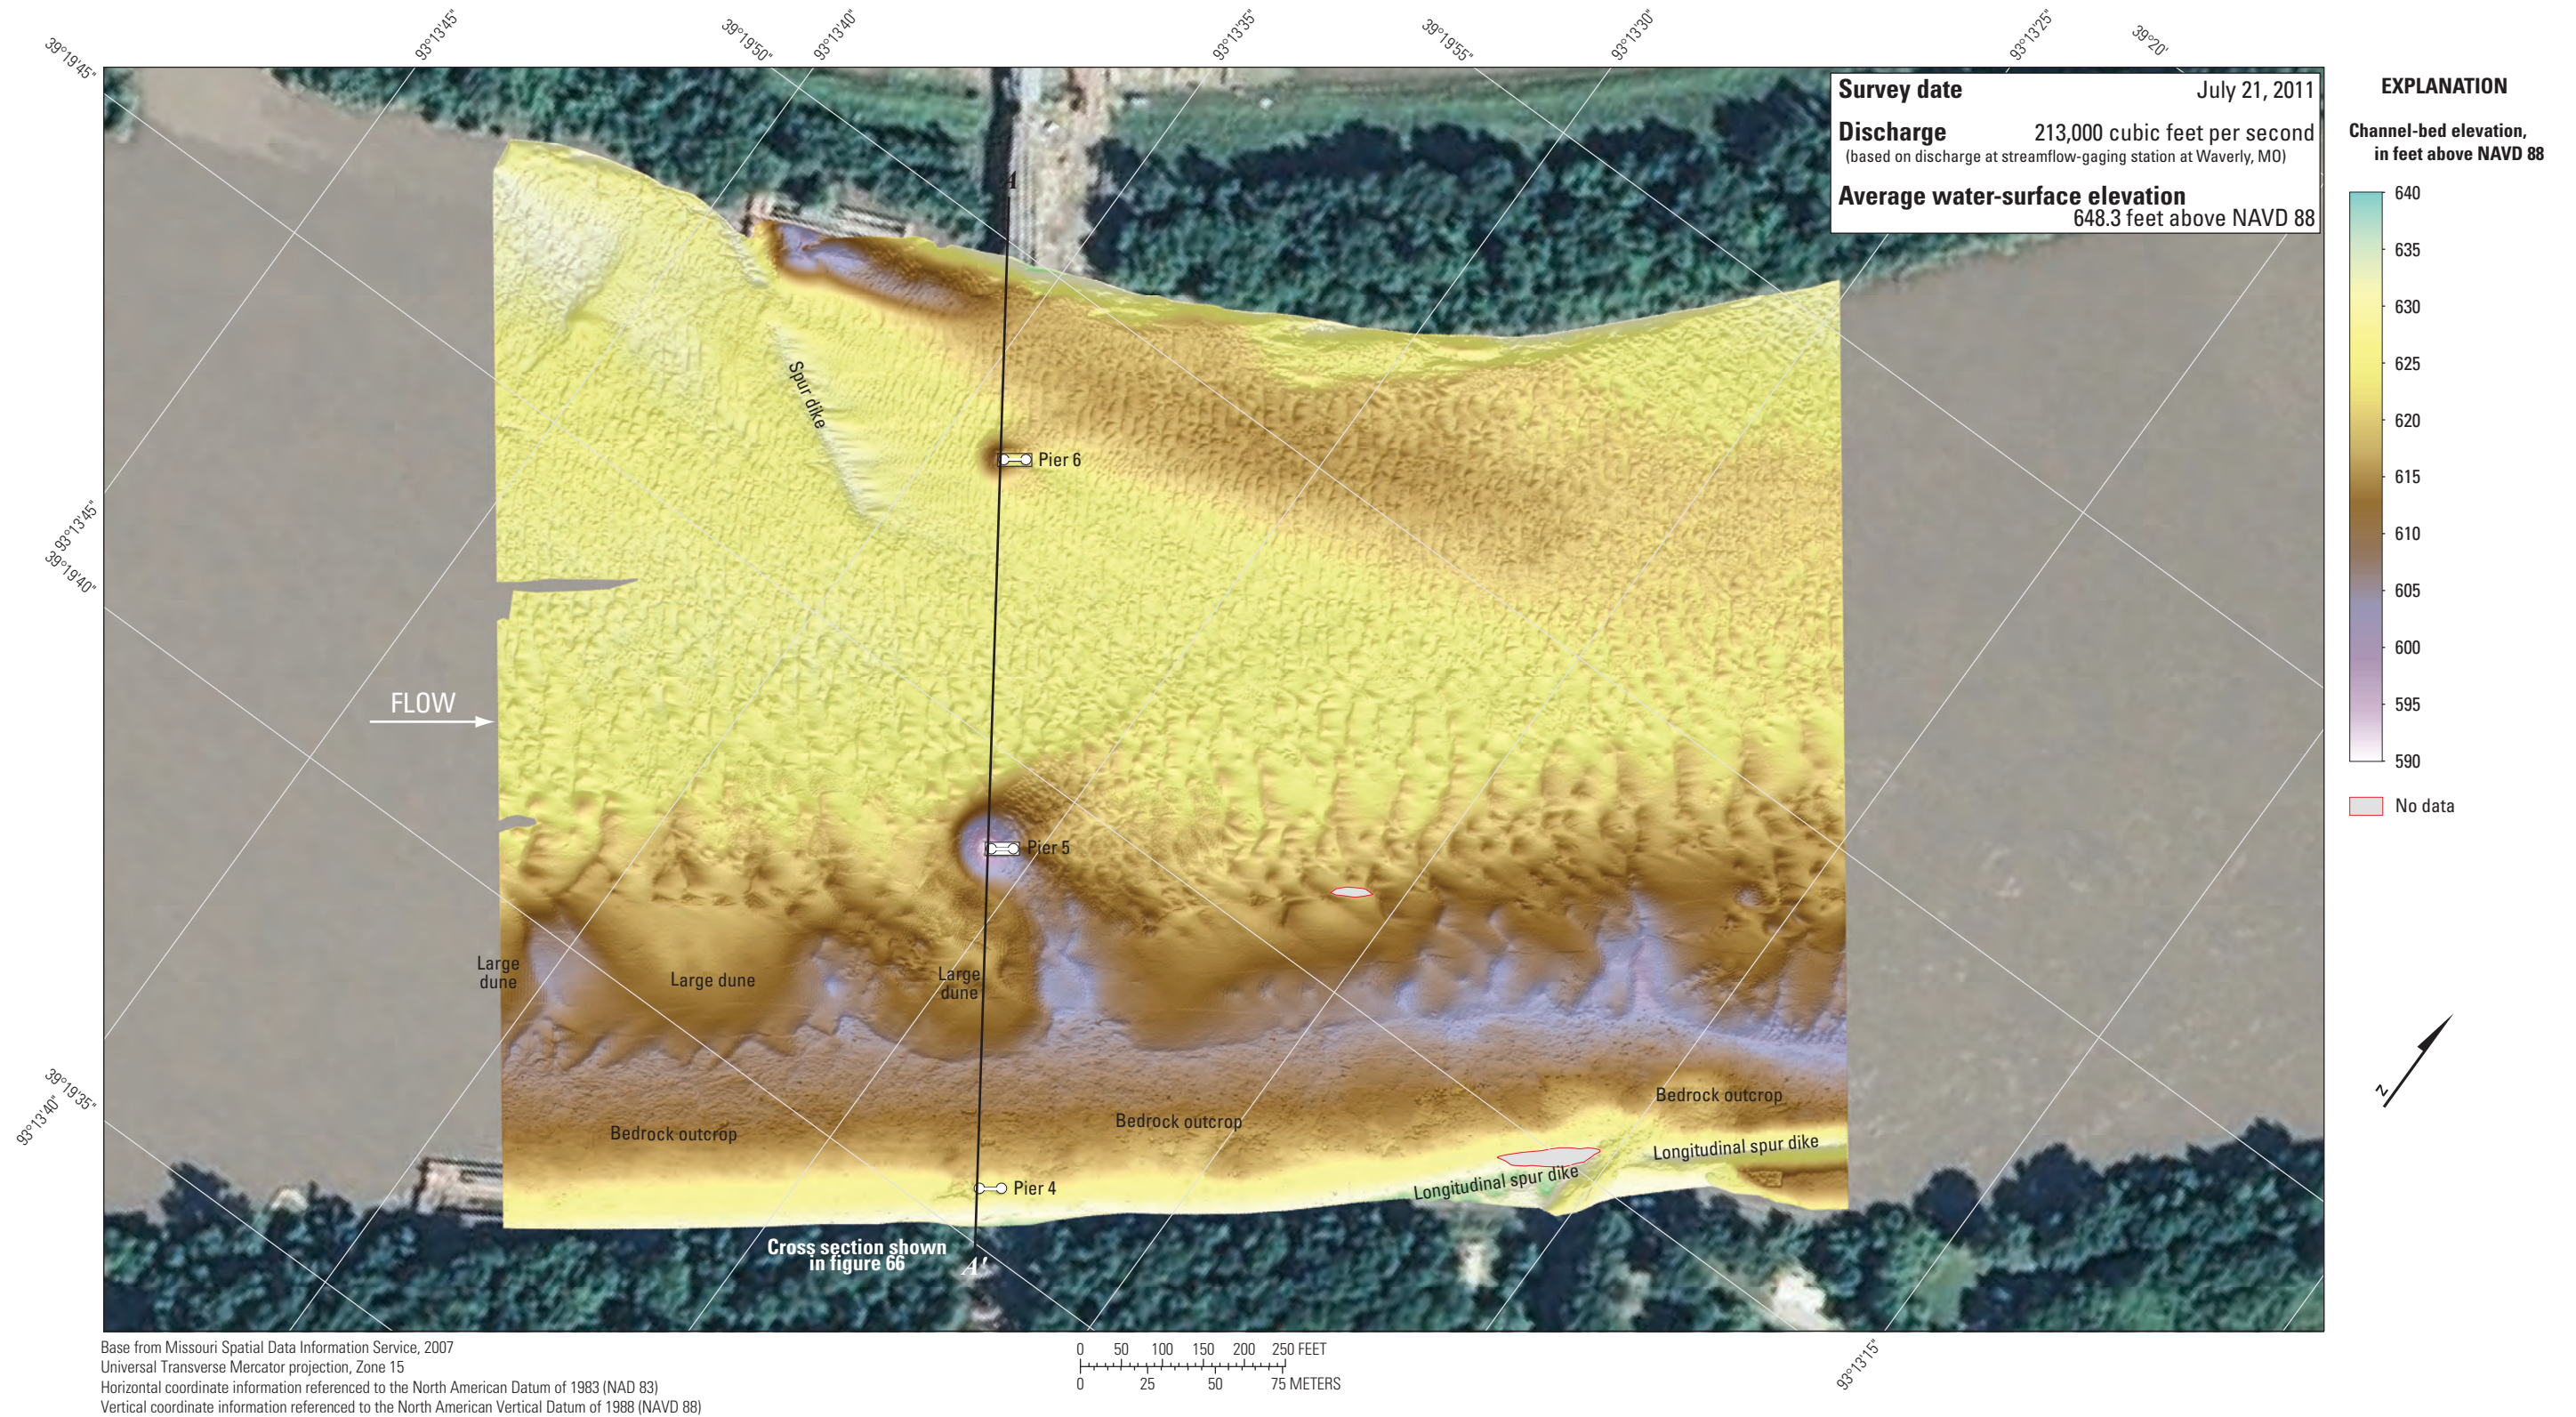
Scour holes were observed near two of the three piers in water. In the vicinity of pier 6 (fig. 65), a moderate scour hole had a minimum channel-bed elevation of about 609 ft (table 8), about 14 ft below the average channel bed upstream

Figure 65. Bathymetric survey of the Missouri River channel in the vicinity of structure K0999 on State Highway 41 at Miami, Missouri.
