Bathymetric and Velocimetric Surveys at Highway Bridges Crossing the Missouri and Mississippi Rivers on the Periphery of Missouri, June 2014

Scientific Investigations Report 2015–5048

By Richard J. Huizinga

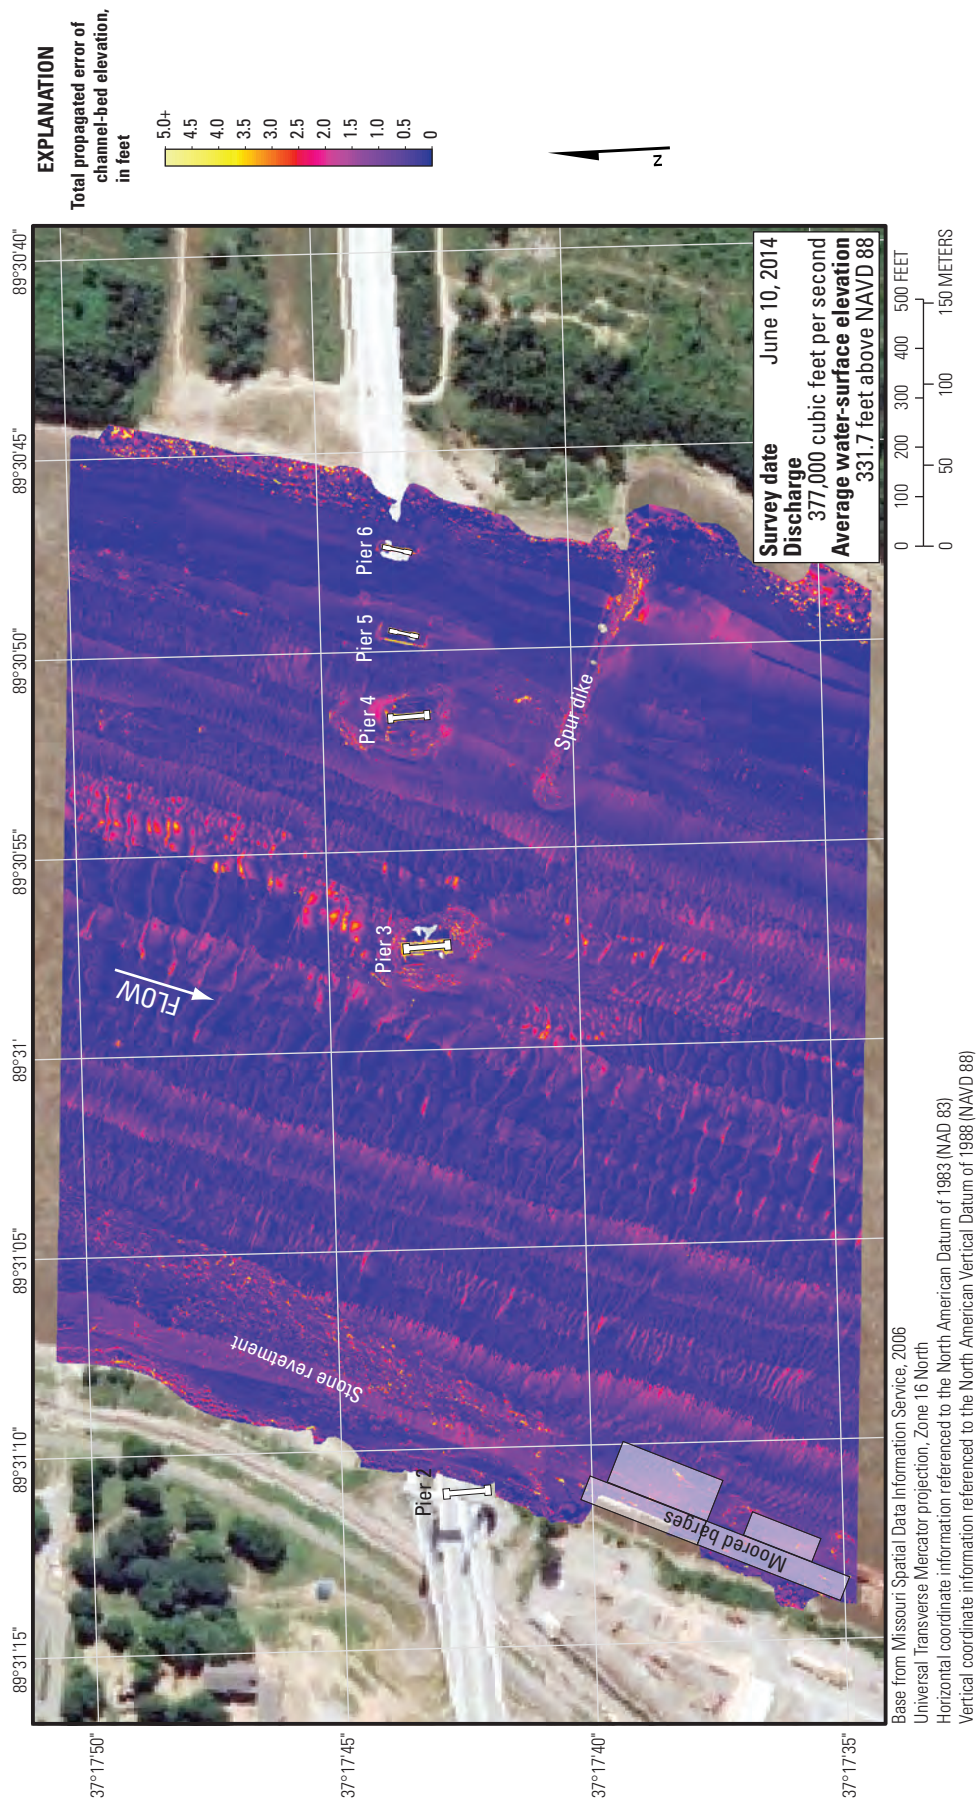
The largest TPU in this group of surveys was about 11.38 ft (table 6); however, as noted in previous studies, TPU values of this magnitude typically occurred near high-relief features, such as the front or side of a pier footing (fig. 5).

The survey at structure A5076 on State Highway 34 at Cape Girardeau, Mo., had the highest mean and median values of TPU, as well as generally the lowest percentage of bathymetry points that were less than the various TPU value cutoffs (table 6). There were no substantial impediments to flow or surveying at this site and the survey was obtained with relatively smooth longitudinal swathes (fig. 5), and that was the case at nearly all of the sites surveyed in this study. The magnitude and distribution of TPU values observed at this site are representative of those observed at all of the other surveyed sites.

Figure 5. Total propagated uncertainty of bathymetric data from the Mississippi River channel in the vicinity of structure A5076 on State Highway 34 at Cape Girardeau, Missouri.

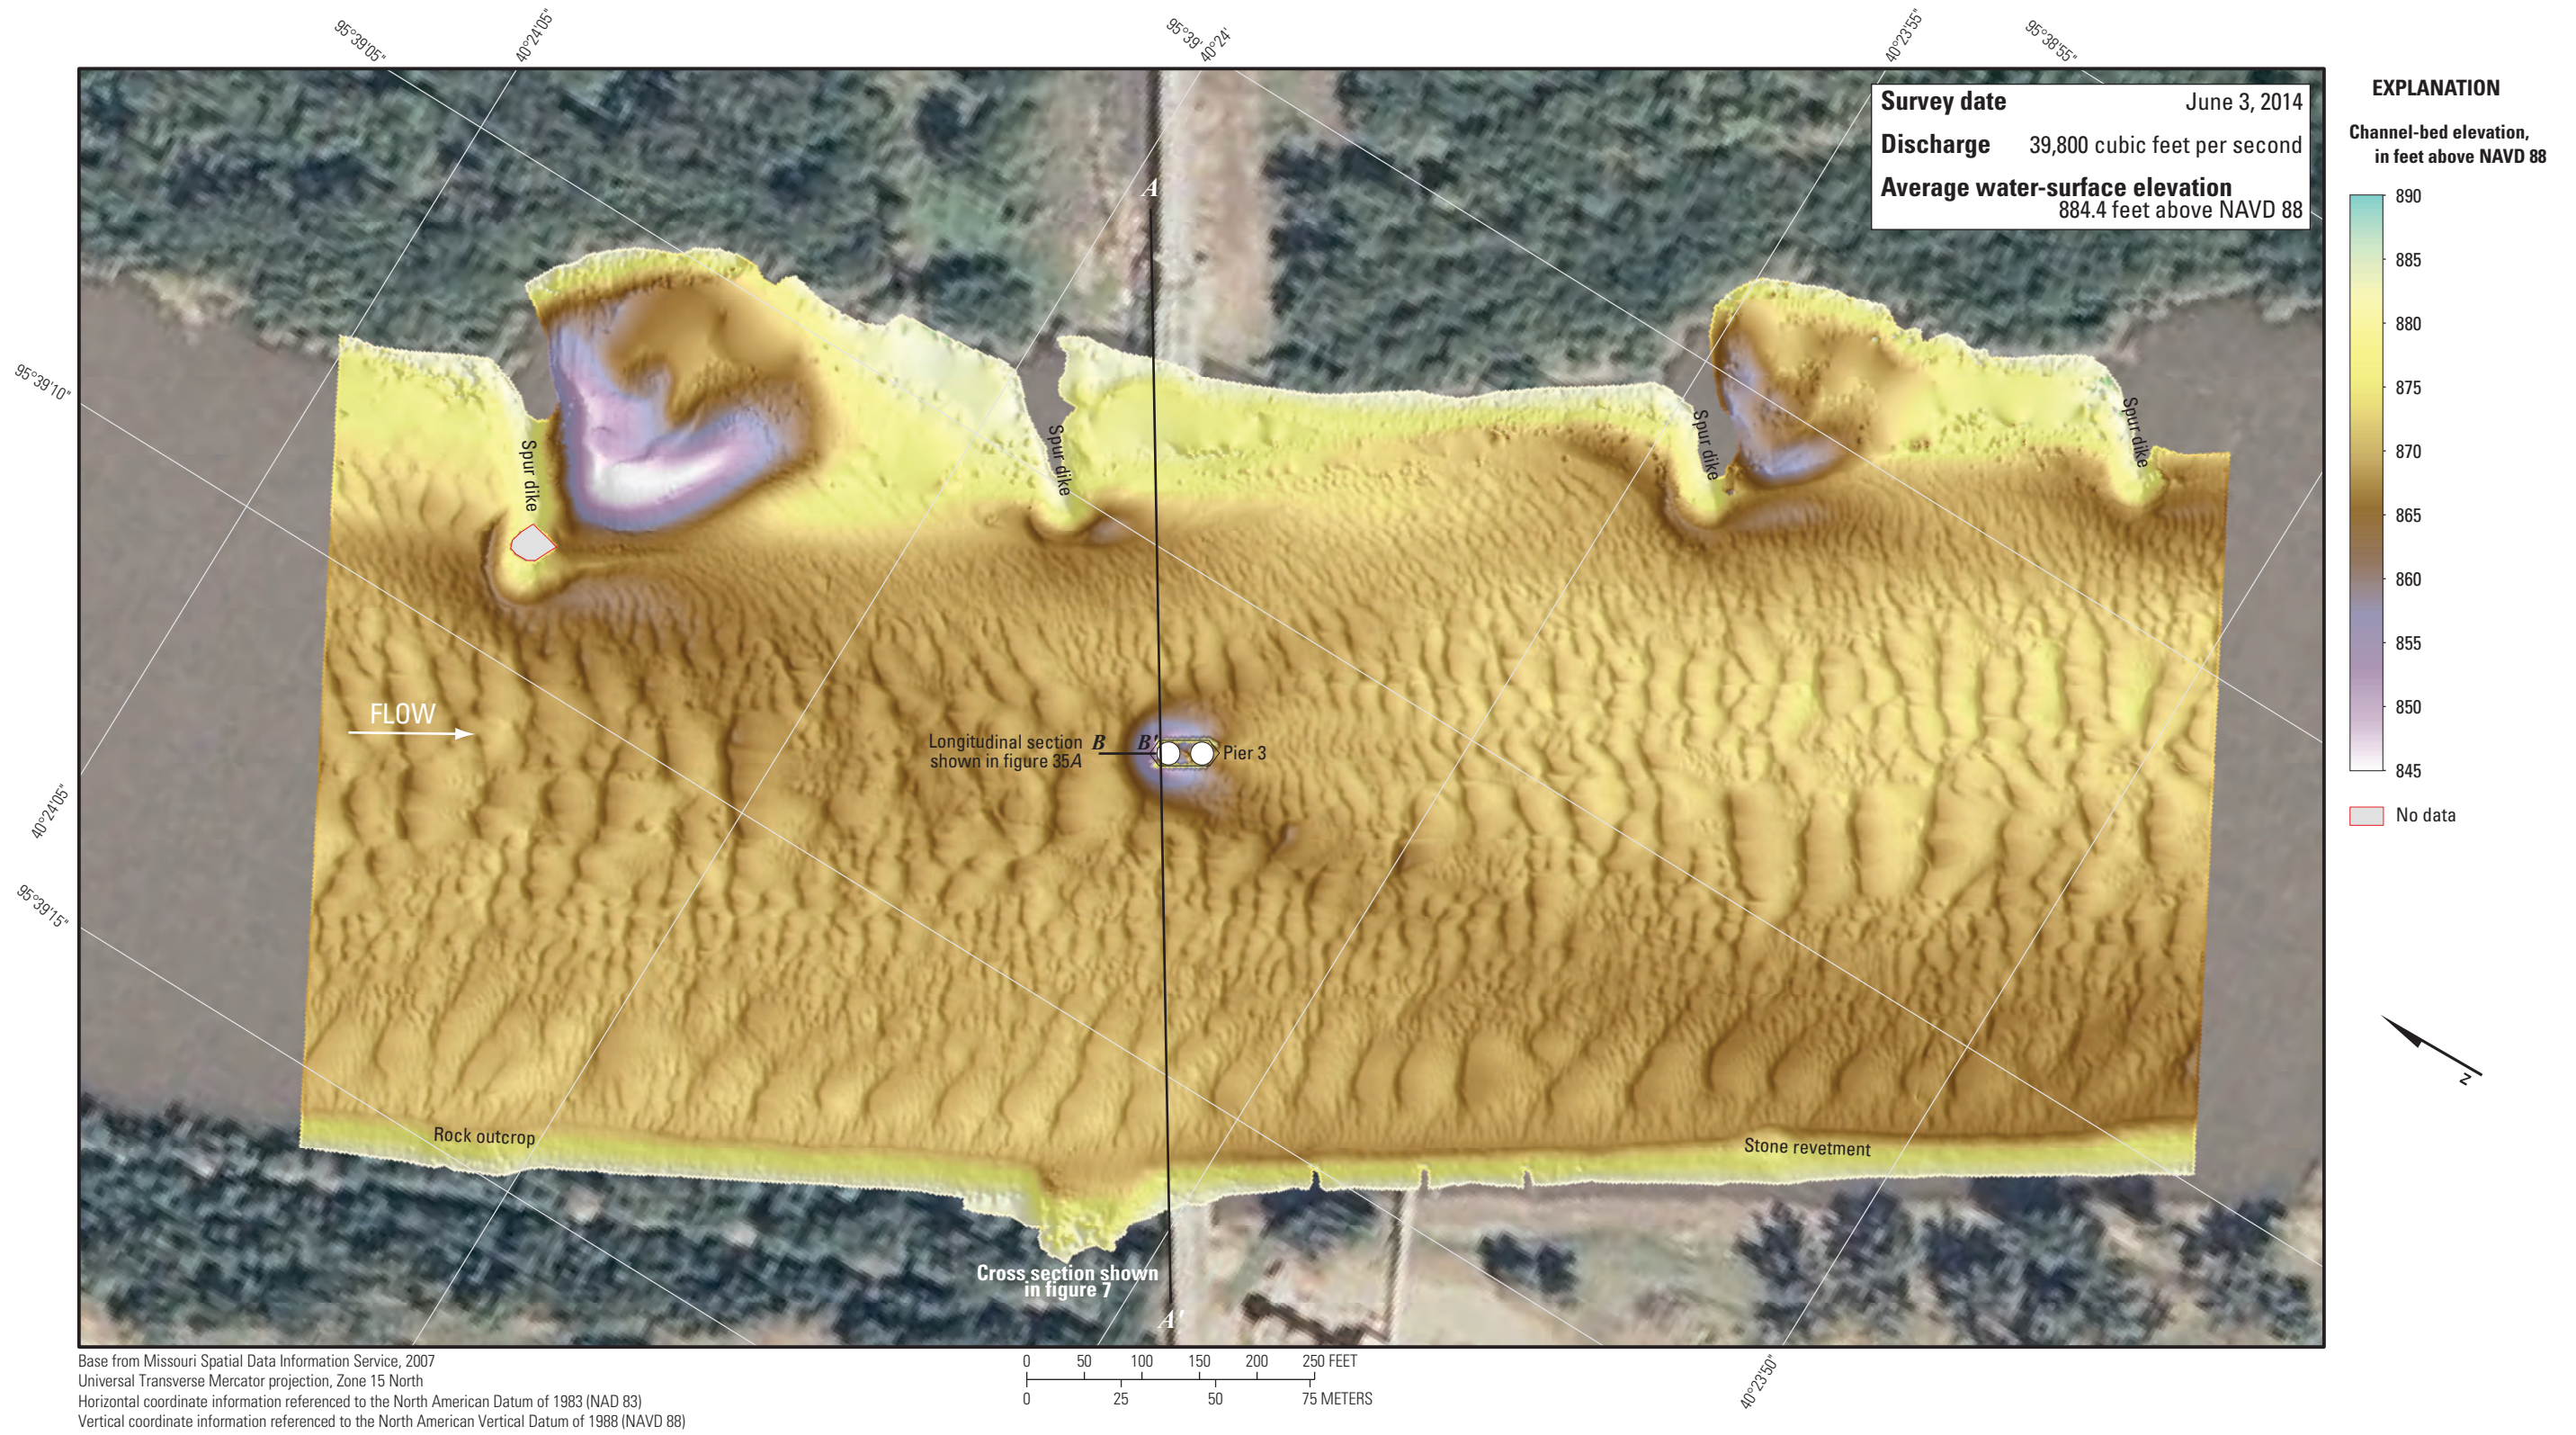
In the vicinity of main channel pier 3, a local scour hole had a minimum channel-bed elevation of approximately 849.0 ft (table 7), about 19 ft below the average channel bed immediately upstream from the pier (fig. 6). Information from bridge plans (Missouri Department of Transportation, written commun., 2002) indicates that pier 3 is founded on sheet piling caissons on bedrock, with about 34 ft of bed material between the bottom of the scour hole and bedrock at the

Figure 6. Bathymetric survey of the Missouri River channel in the vicinity of structure L0098 on U.S. Highway 136 at Brownville, Nebraska.

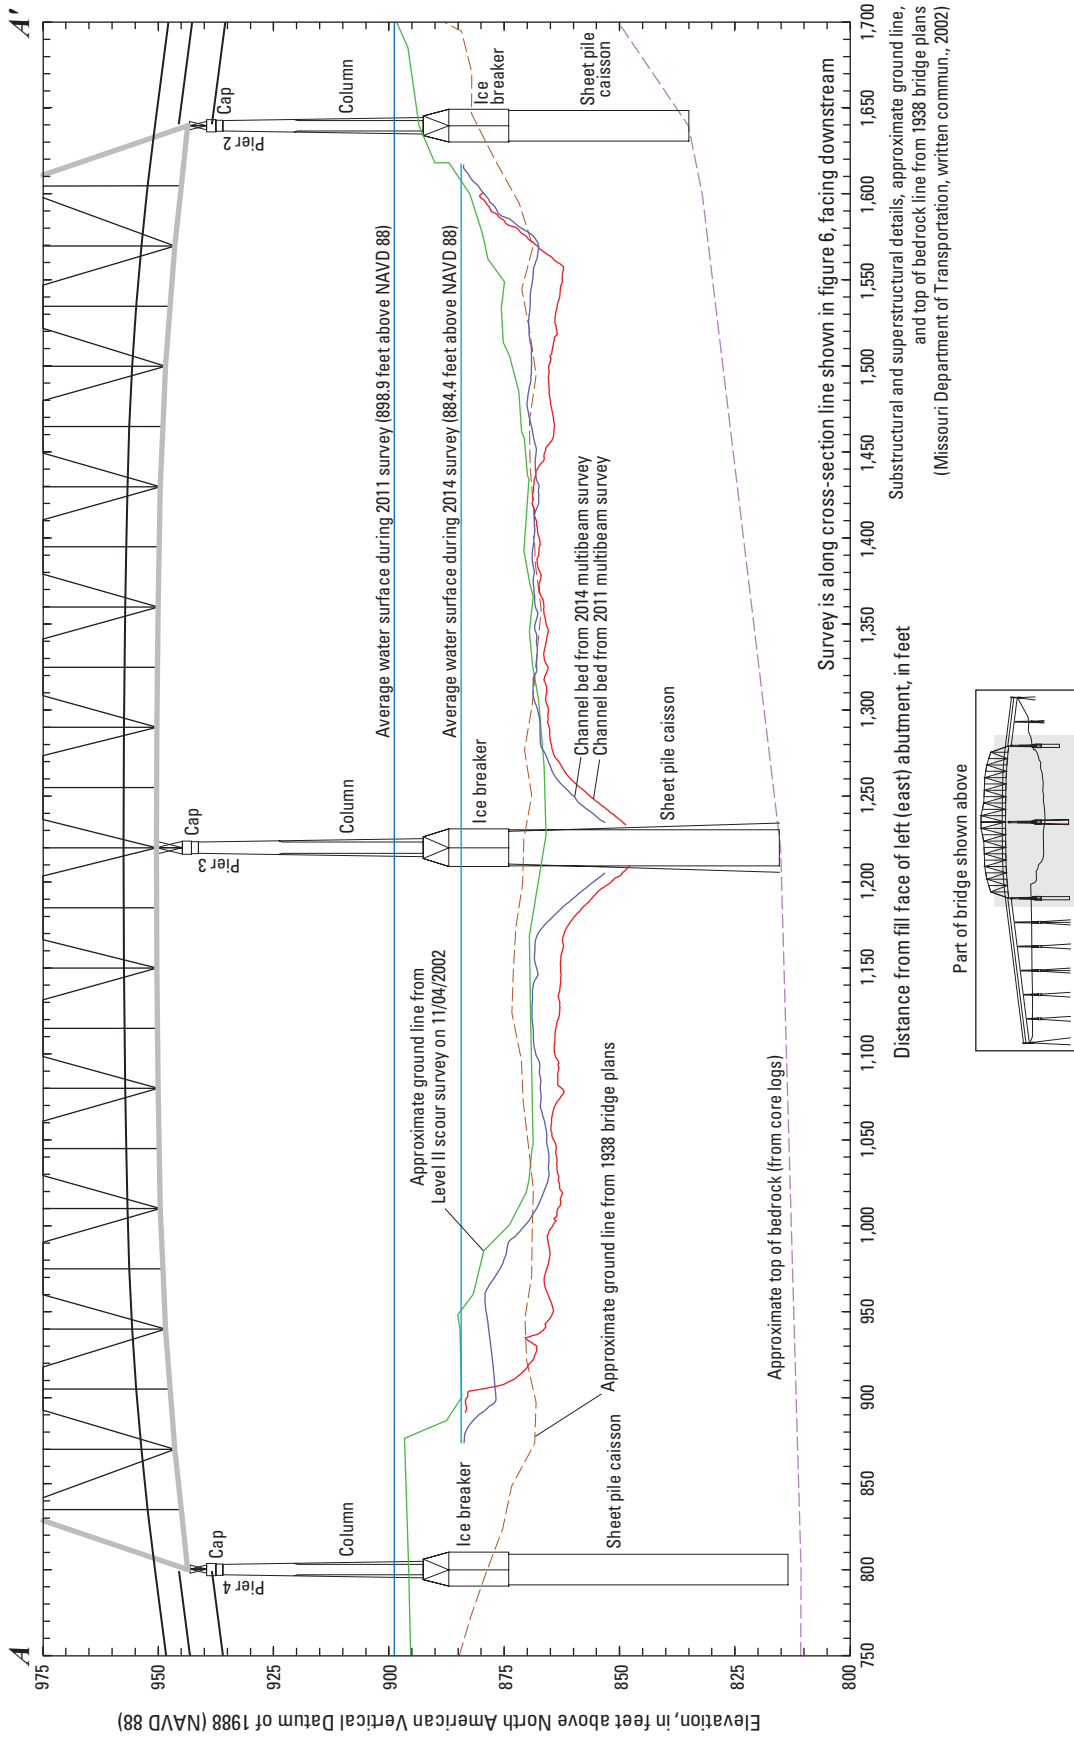
Figure 7. Key features, substructural and superstructural details, and surveyed channel bed of structure L0098 on U.S. Highway 136 over the Missouri River at Brownville, Nebraska.

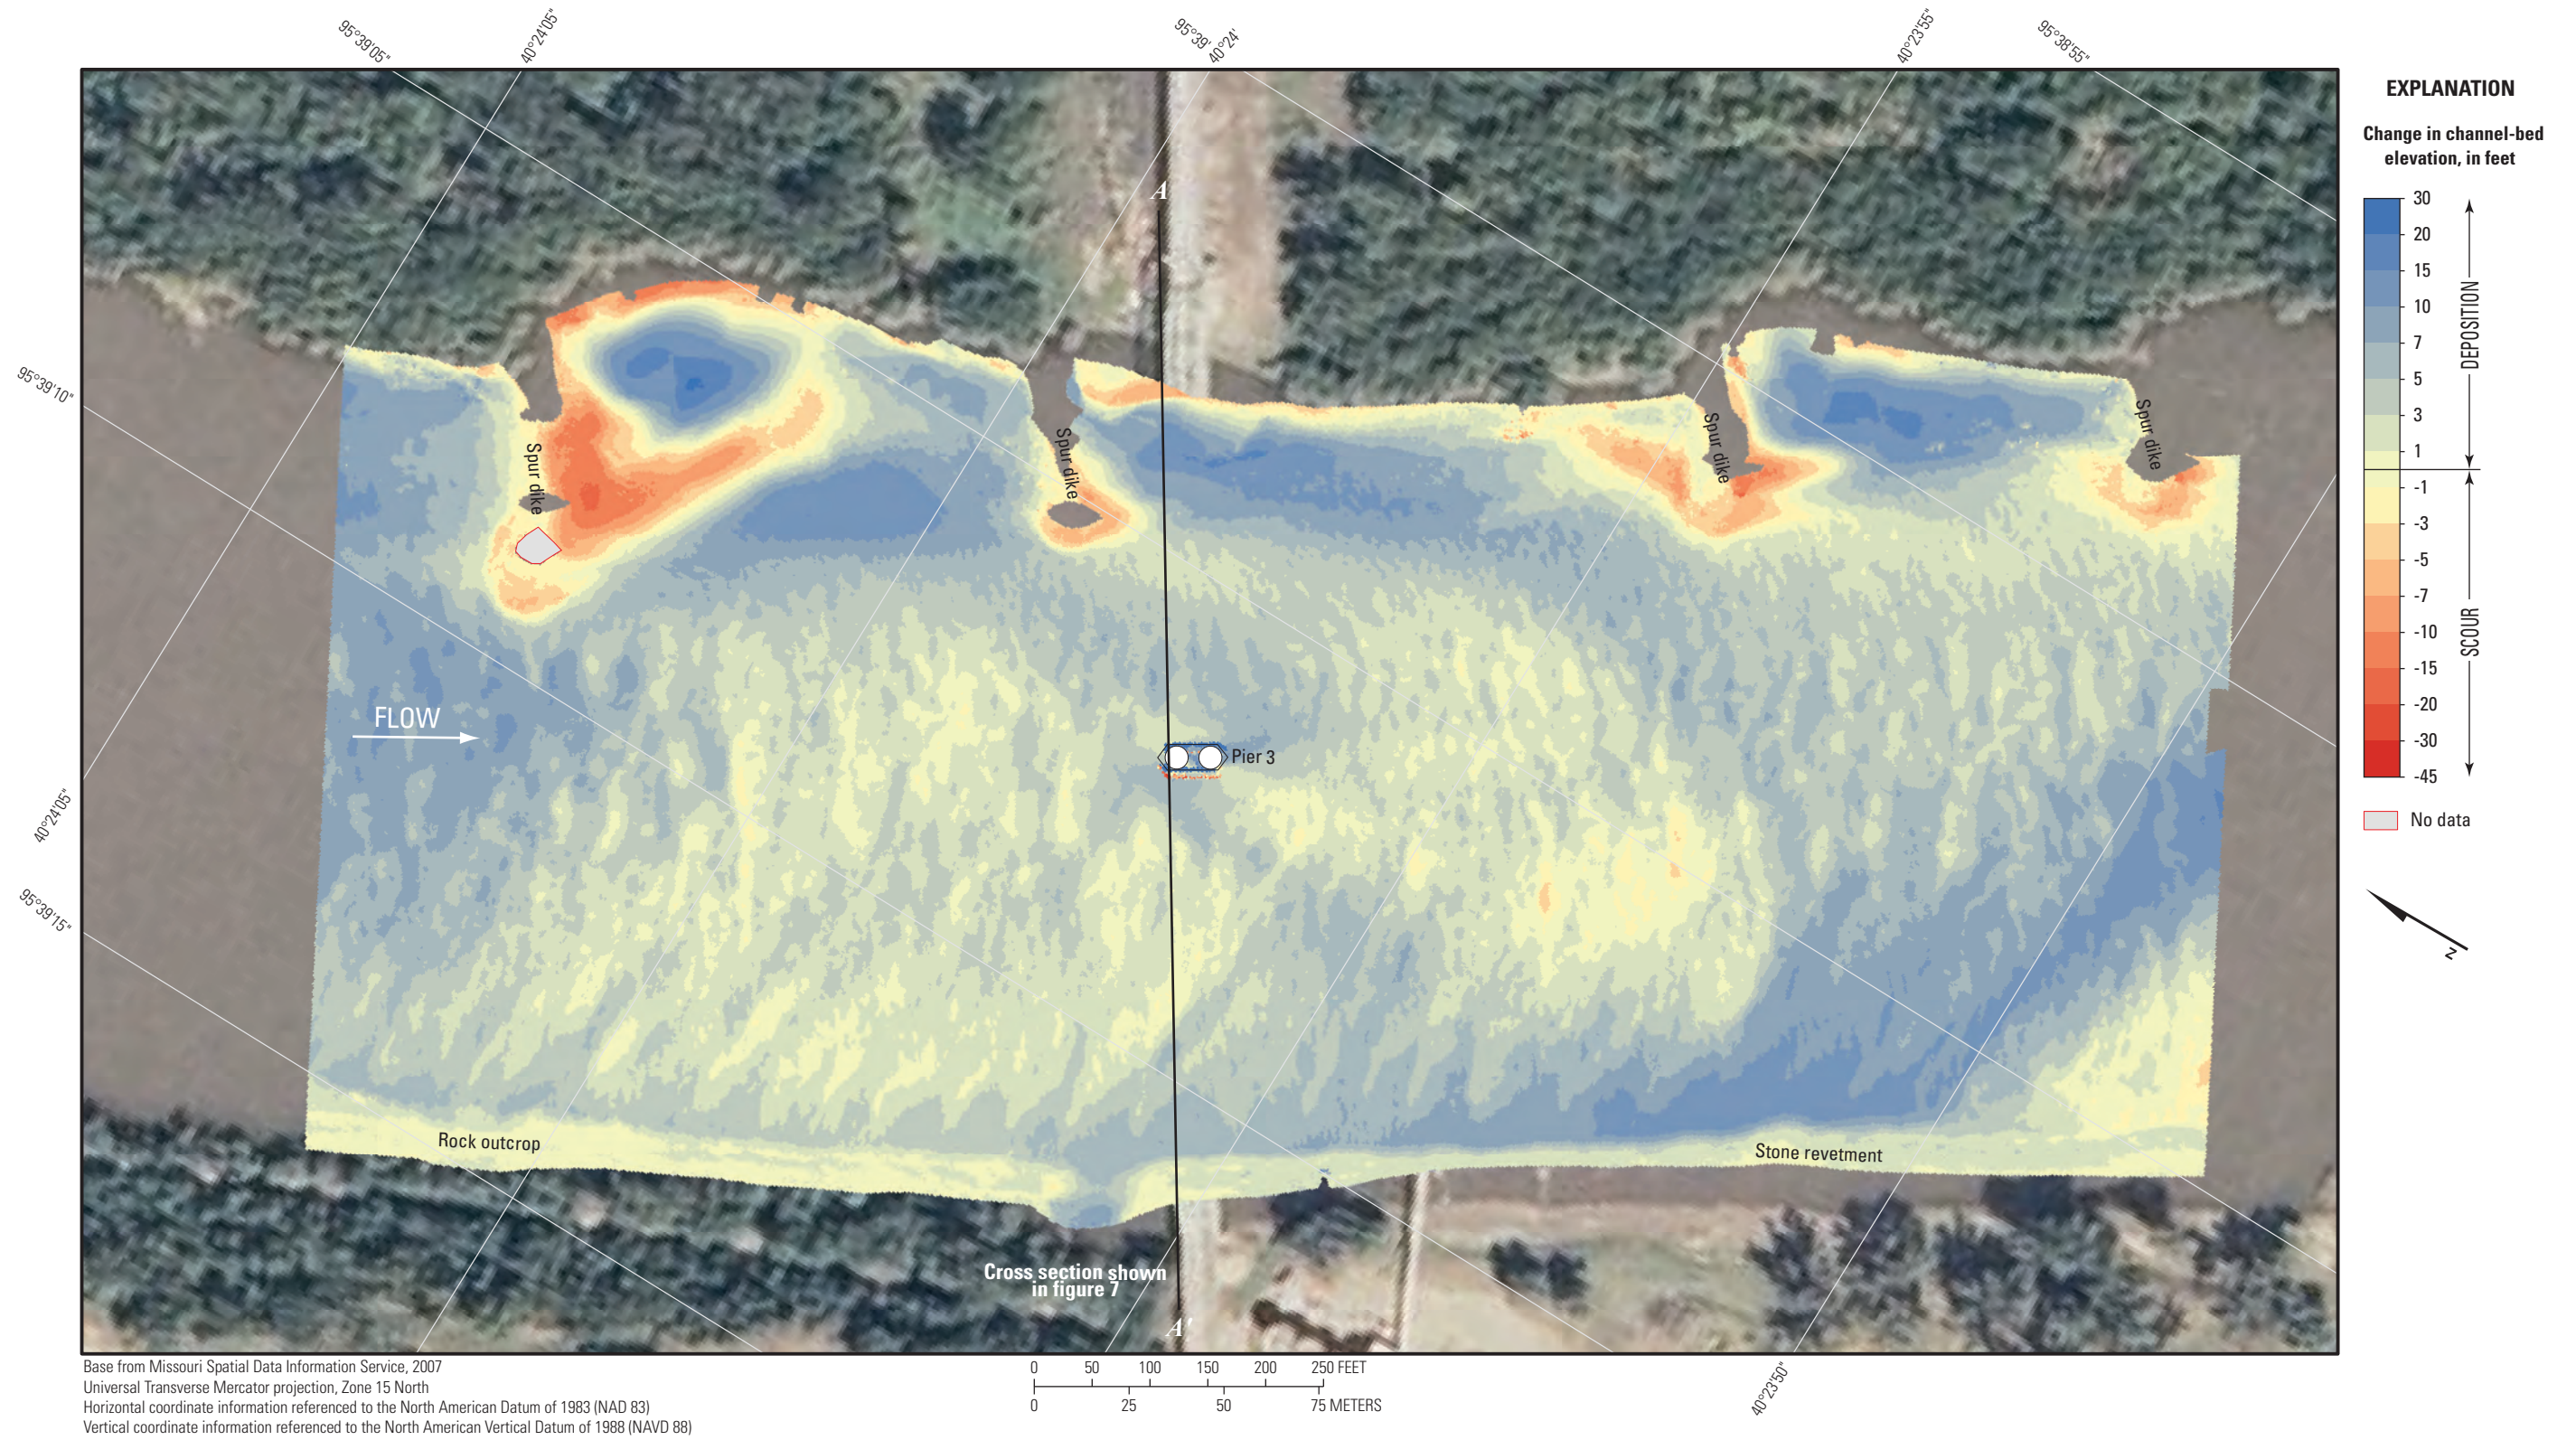
Figure 8. Difference between bathymetric surfaces created from surveys of the Missouri River channel in the vicinity of structure L098 on U.S. Highway 136 at Brownville, Nebraska, on June 3, 2014, and July 13, 2011.

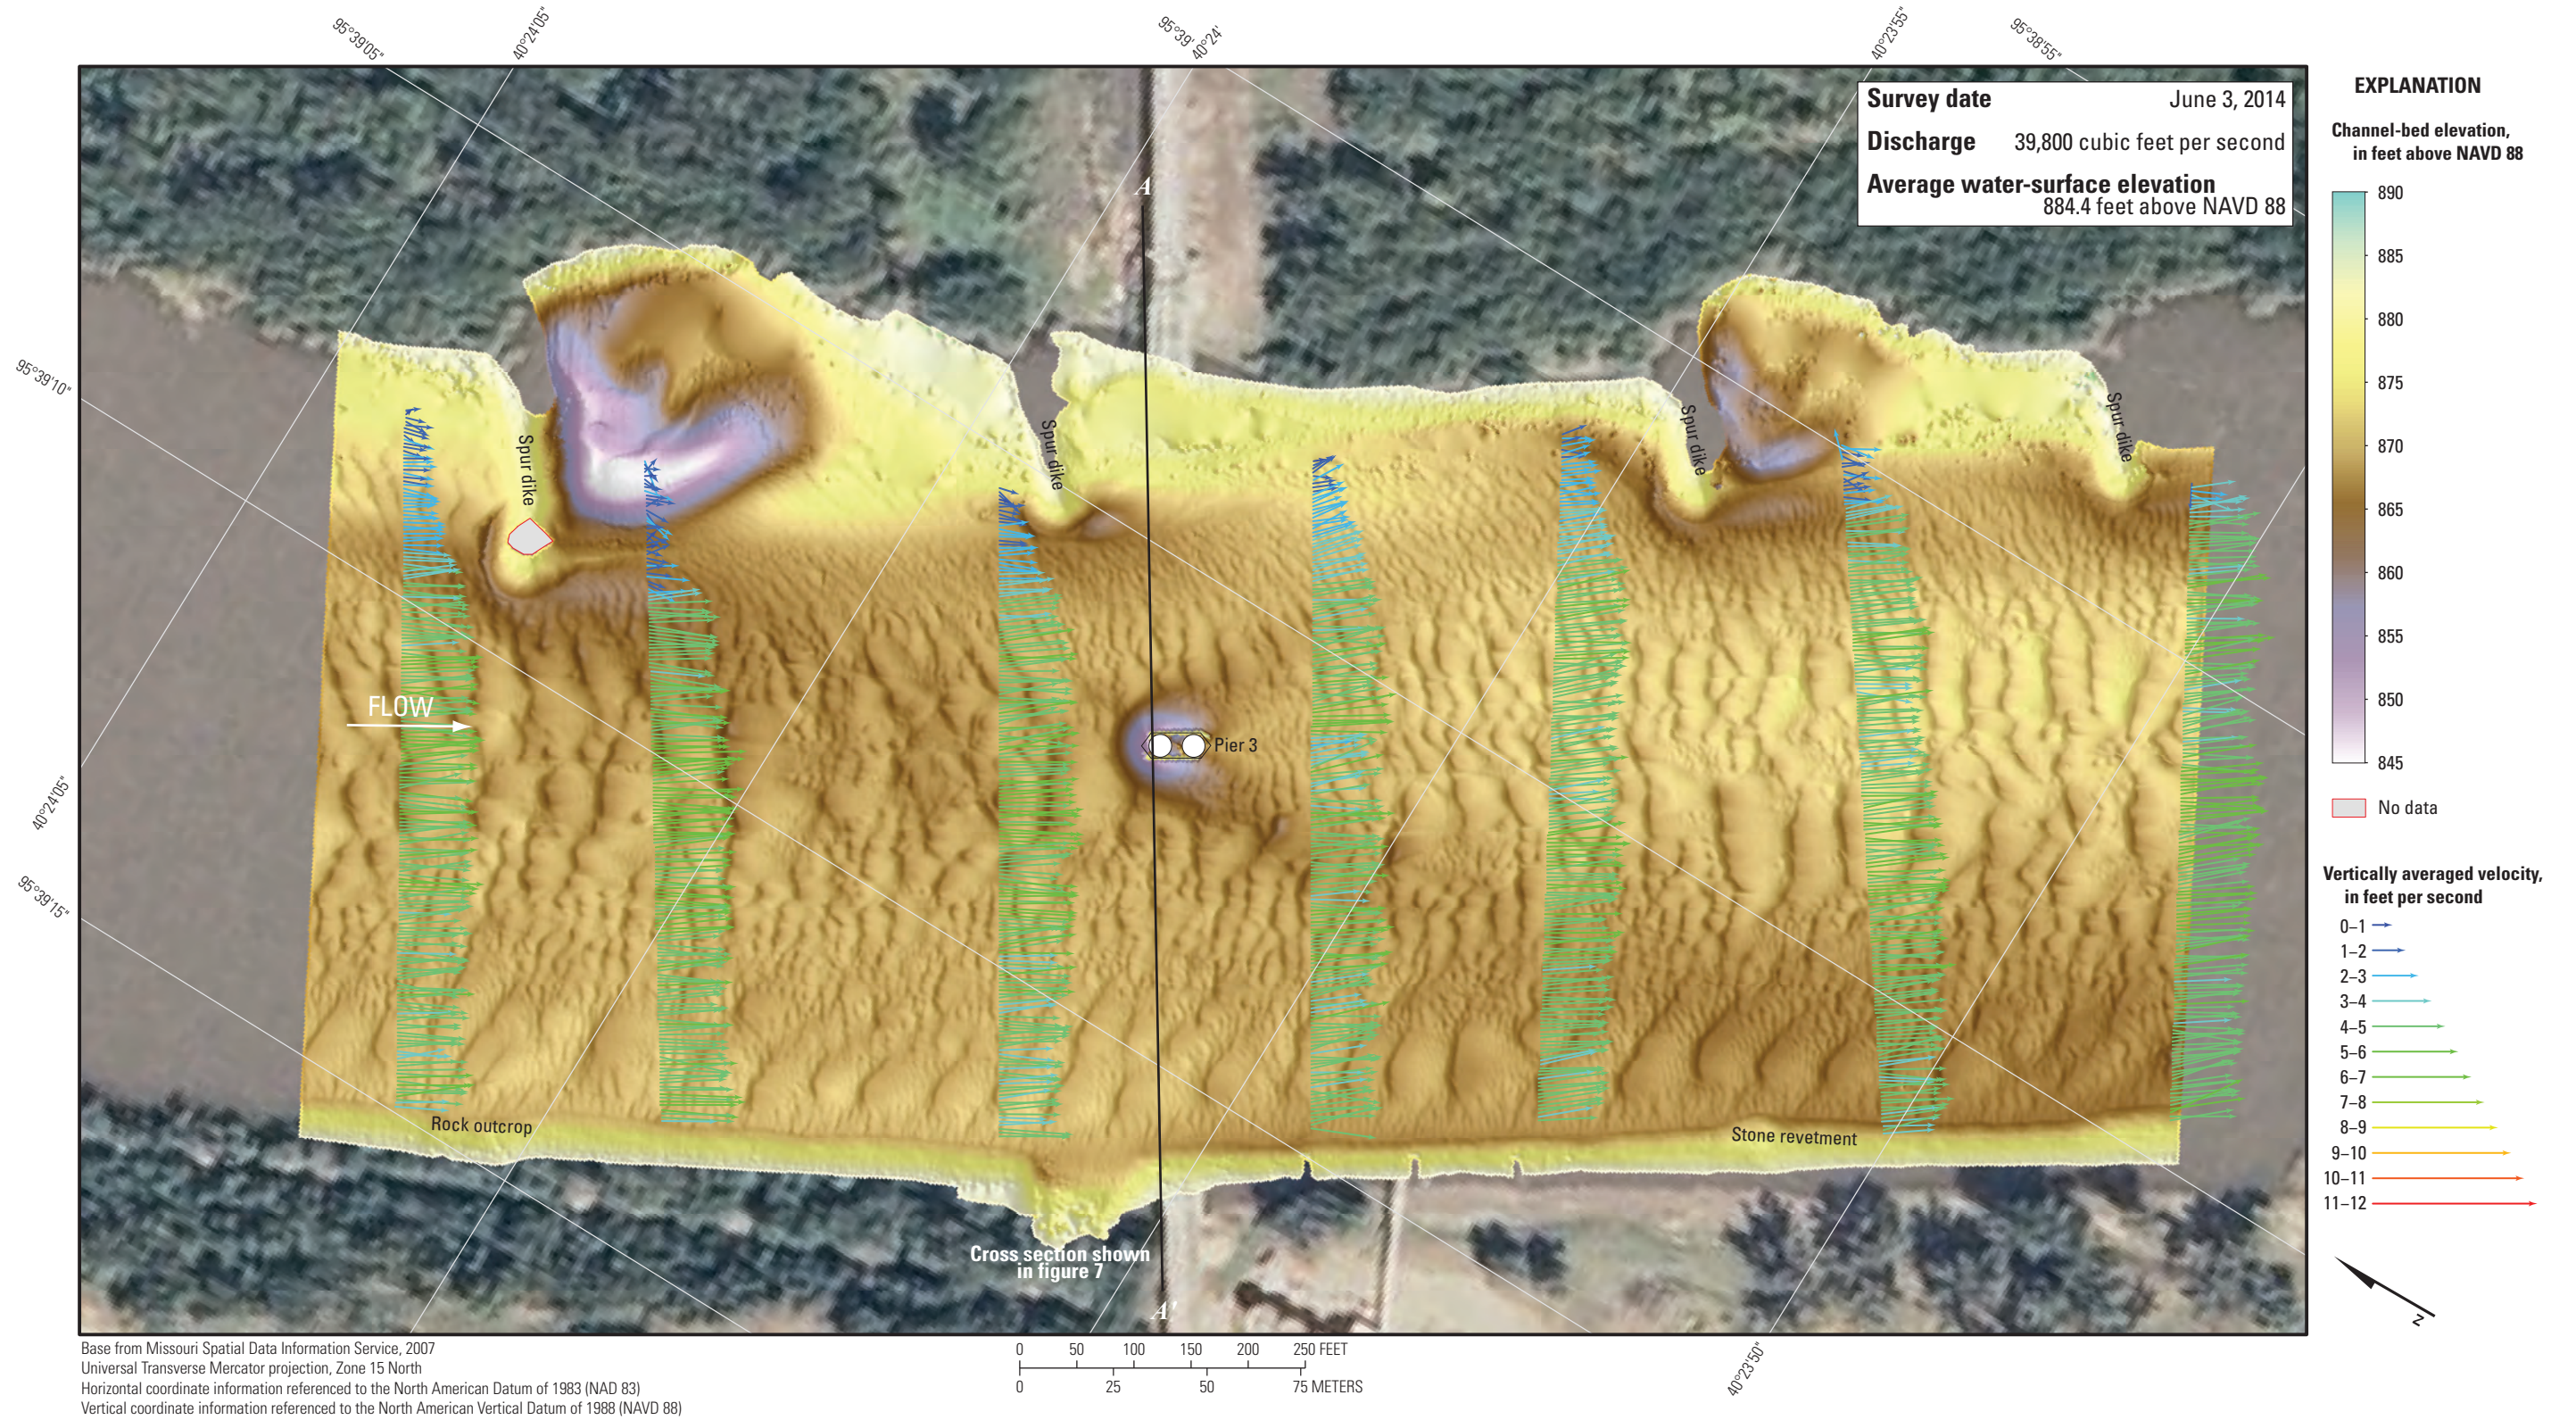
The vertically averaged velocity vectors indicated mostly uniform flow at between 4 and 6 feet per second (ft/s) in the main channel, except near the spur dikes (fig. 9). The wake vortices downstream from main channel pier 3 were not pronounced, and seemed to be no greater than the general non-uniformity of flow observed in the channel.

Figure 9. Bathymetry and vertically averaged velocities of the Missouri River channel in the vicinity of structure L0098 on U.S. Highway 136 at Brownville, Nebraska.

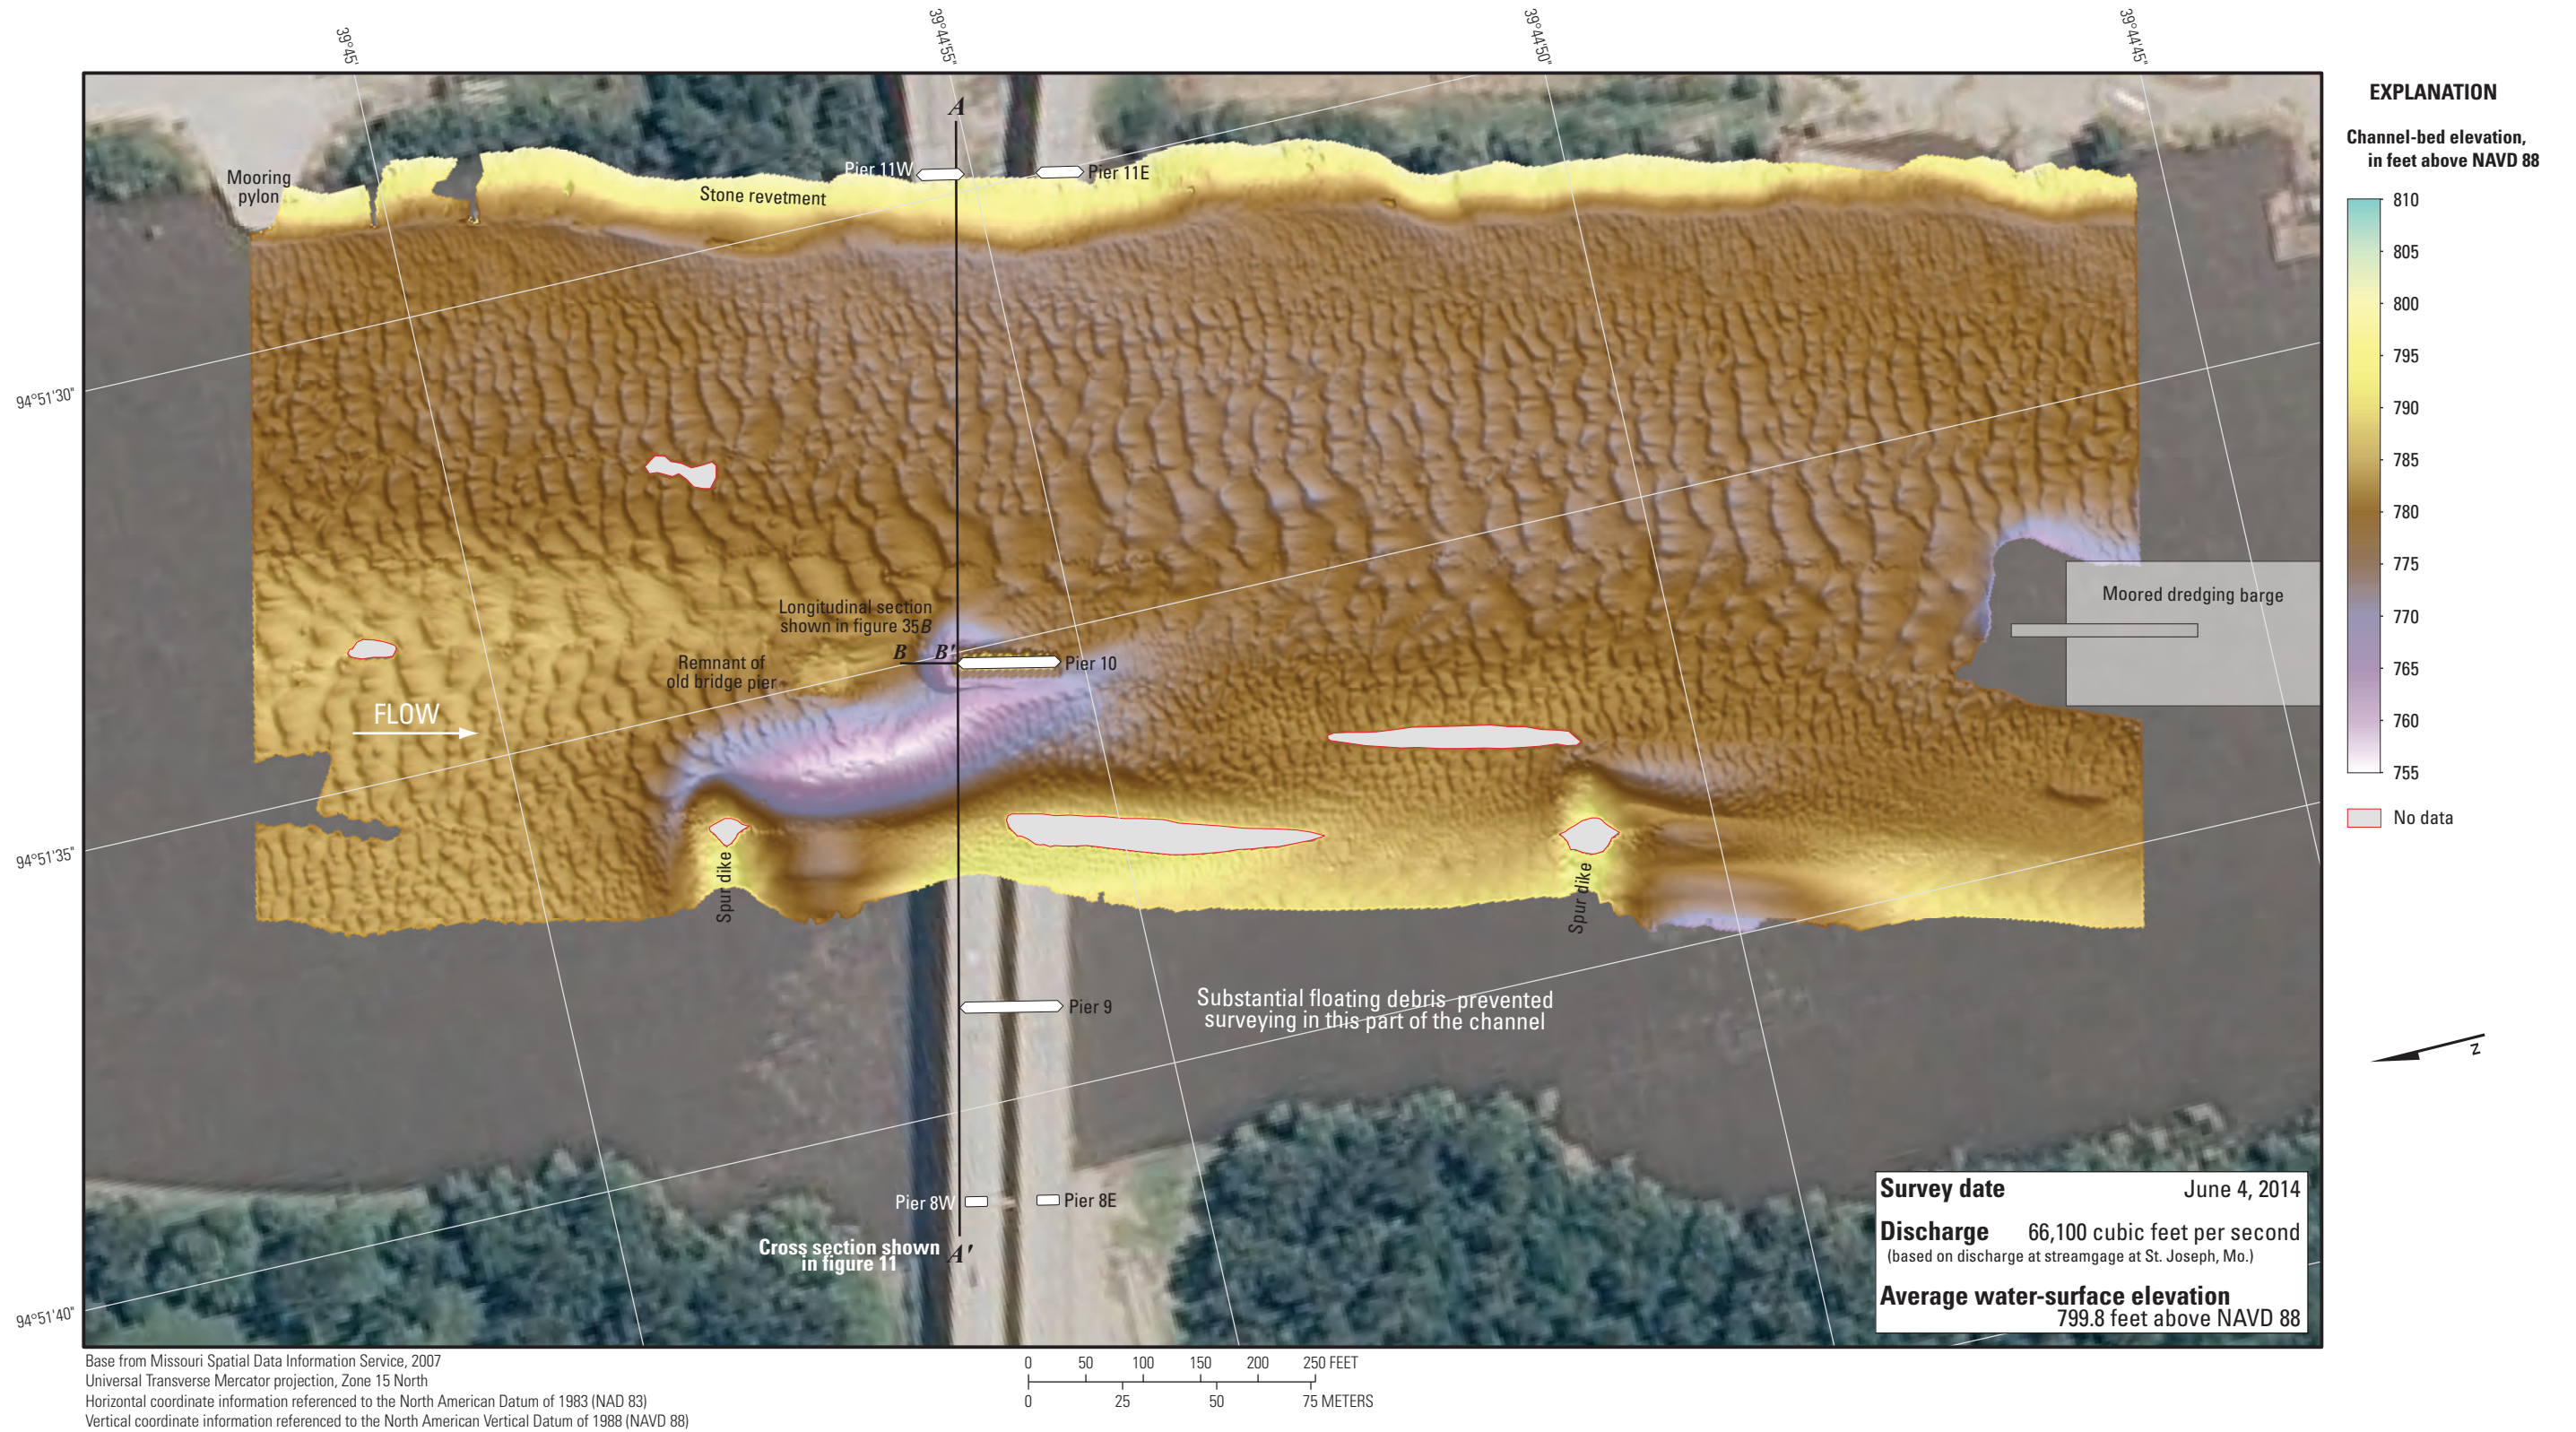
In the vicinity of main channel pier 10, a local scour hole had a minimum channel-bed elevation of approximately 763 ft (table 7), about 19 ft below the average channel bed immediately upstream from the pier (fig. 10). The large local scour hole downstream from the upstream spur dike extended toward pier 10. Information from bridge plans (Missouri Department of Transportation, written commun., 2011) indicates that pier 10 is founded on shafts drilled into bedrock, with about 18 ft of bed material between the bottom of the scour hole and bedrock at the upstream face of pier 10 (fig. 11; table 7).

Figure 10. Bathymetric survey of the Missouri River channel in the vicinity of dual bridge structure A3664 on U.S. Highway 36 at St. Joseph, Missouri.

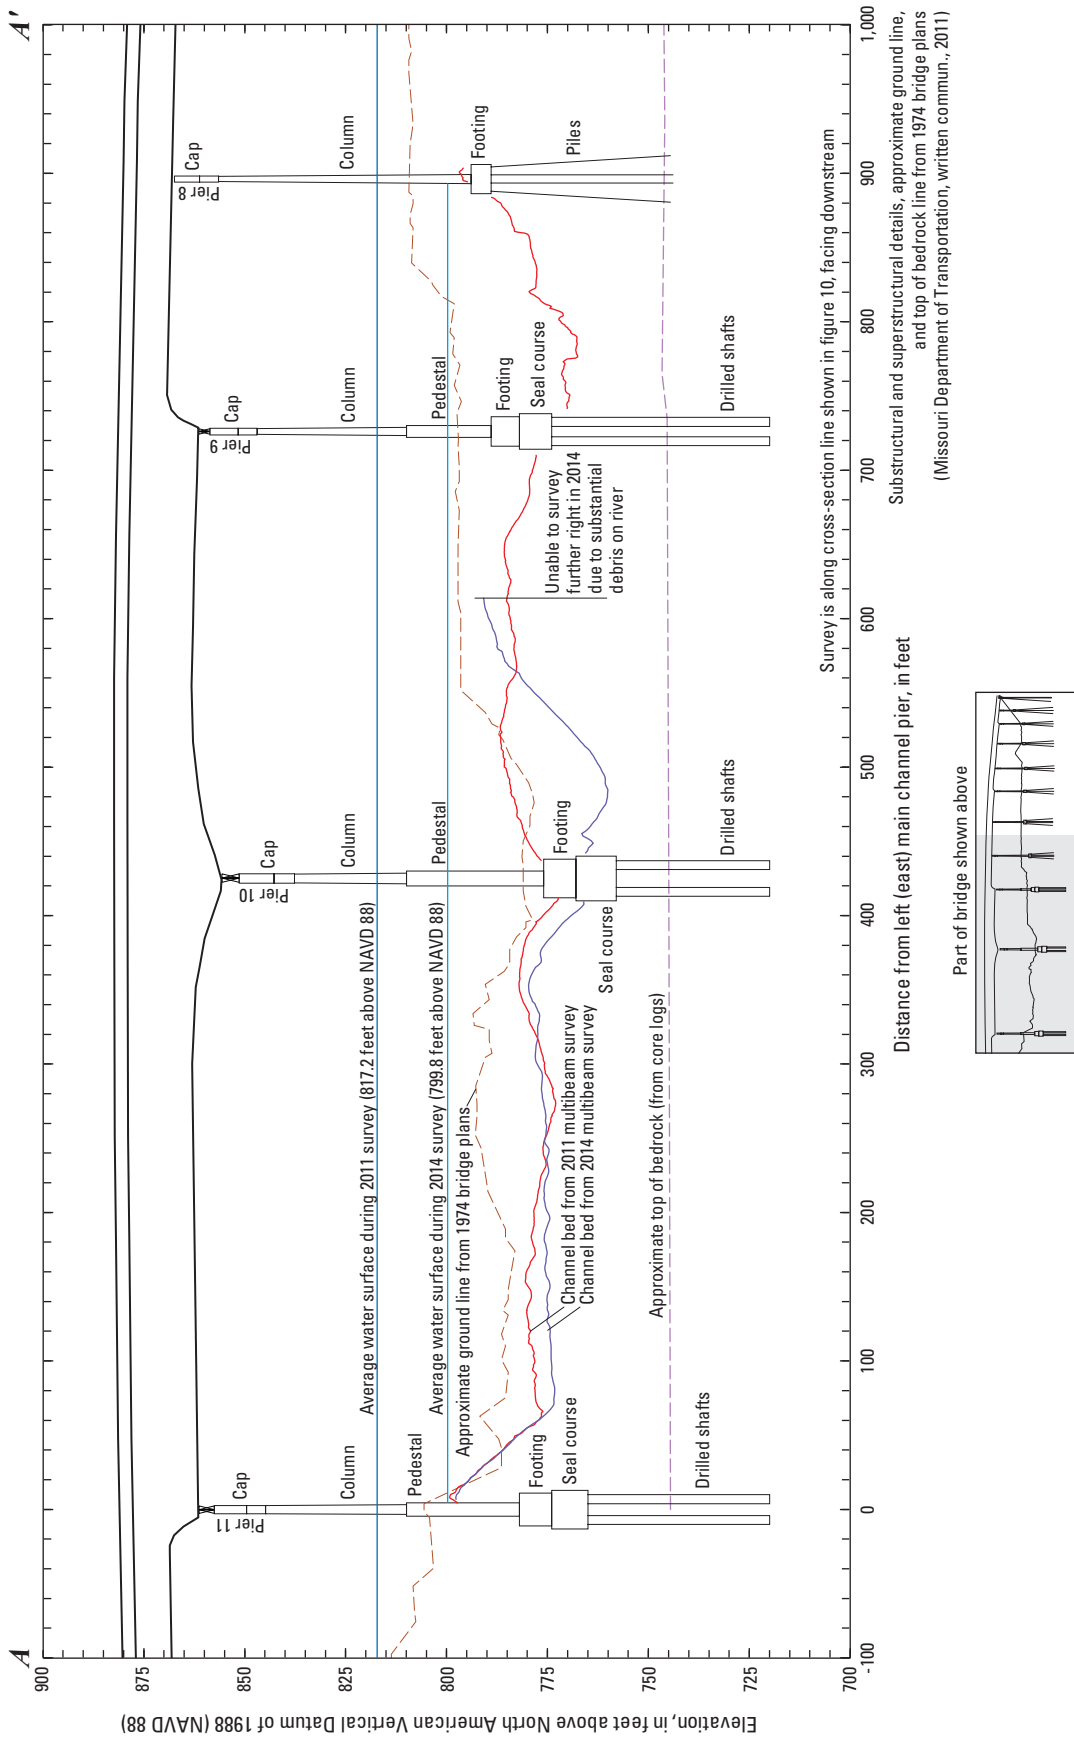
Figure 11. Key features, substructural and superstructural details, and surveyed channel bed of dual bridge structure A3664 on U.S. Highway 36 over the Missouri River at St. Joseph, Missouri
