Bathymetric and Velocimetric Surveys at Highway Bridges Crossing the Missouri and Mississippi Rivers on the Periphery of Missouri, June 2014

Scientific Investigations Report 2015–5048

By Richard J. Huizinga

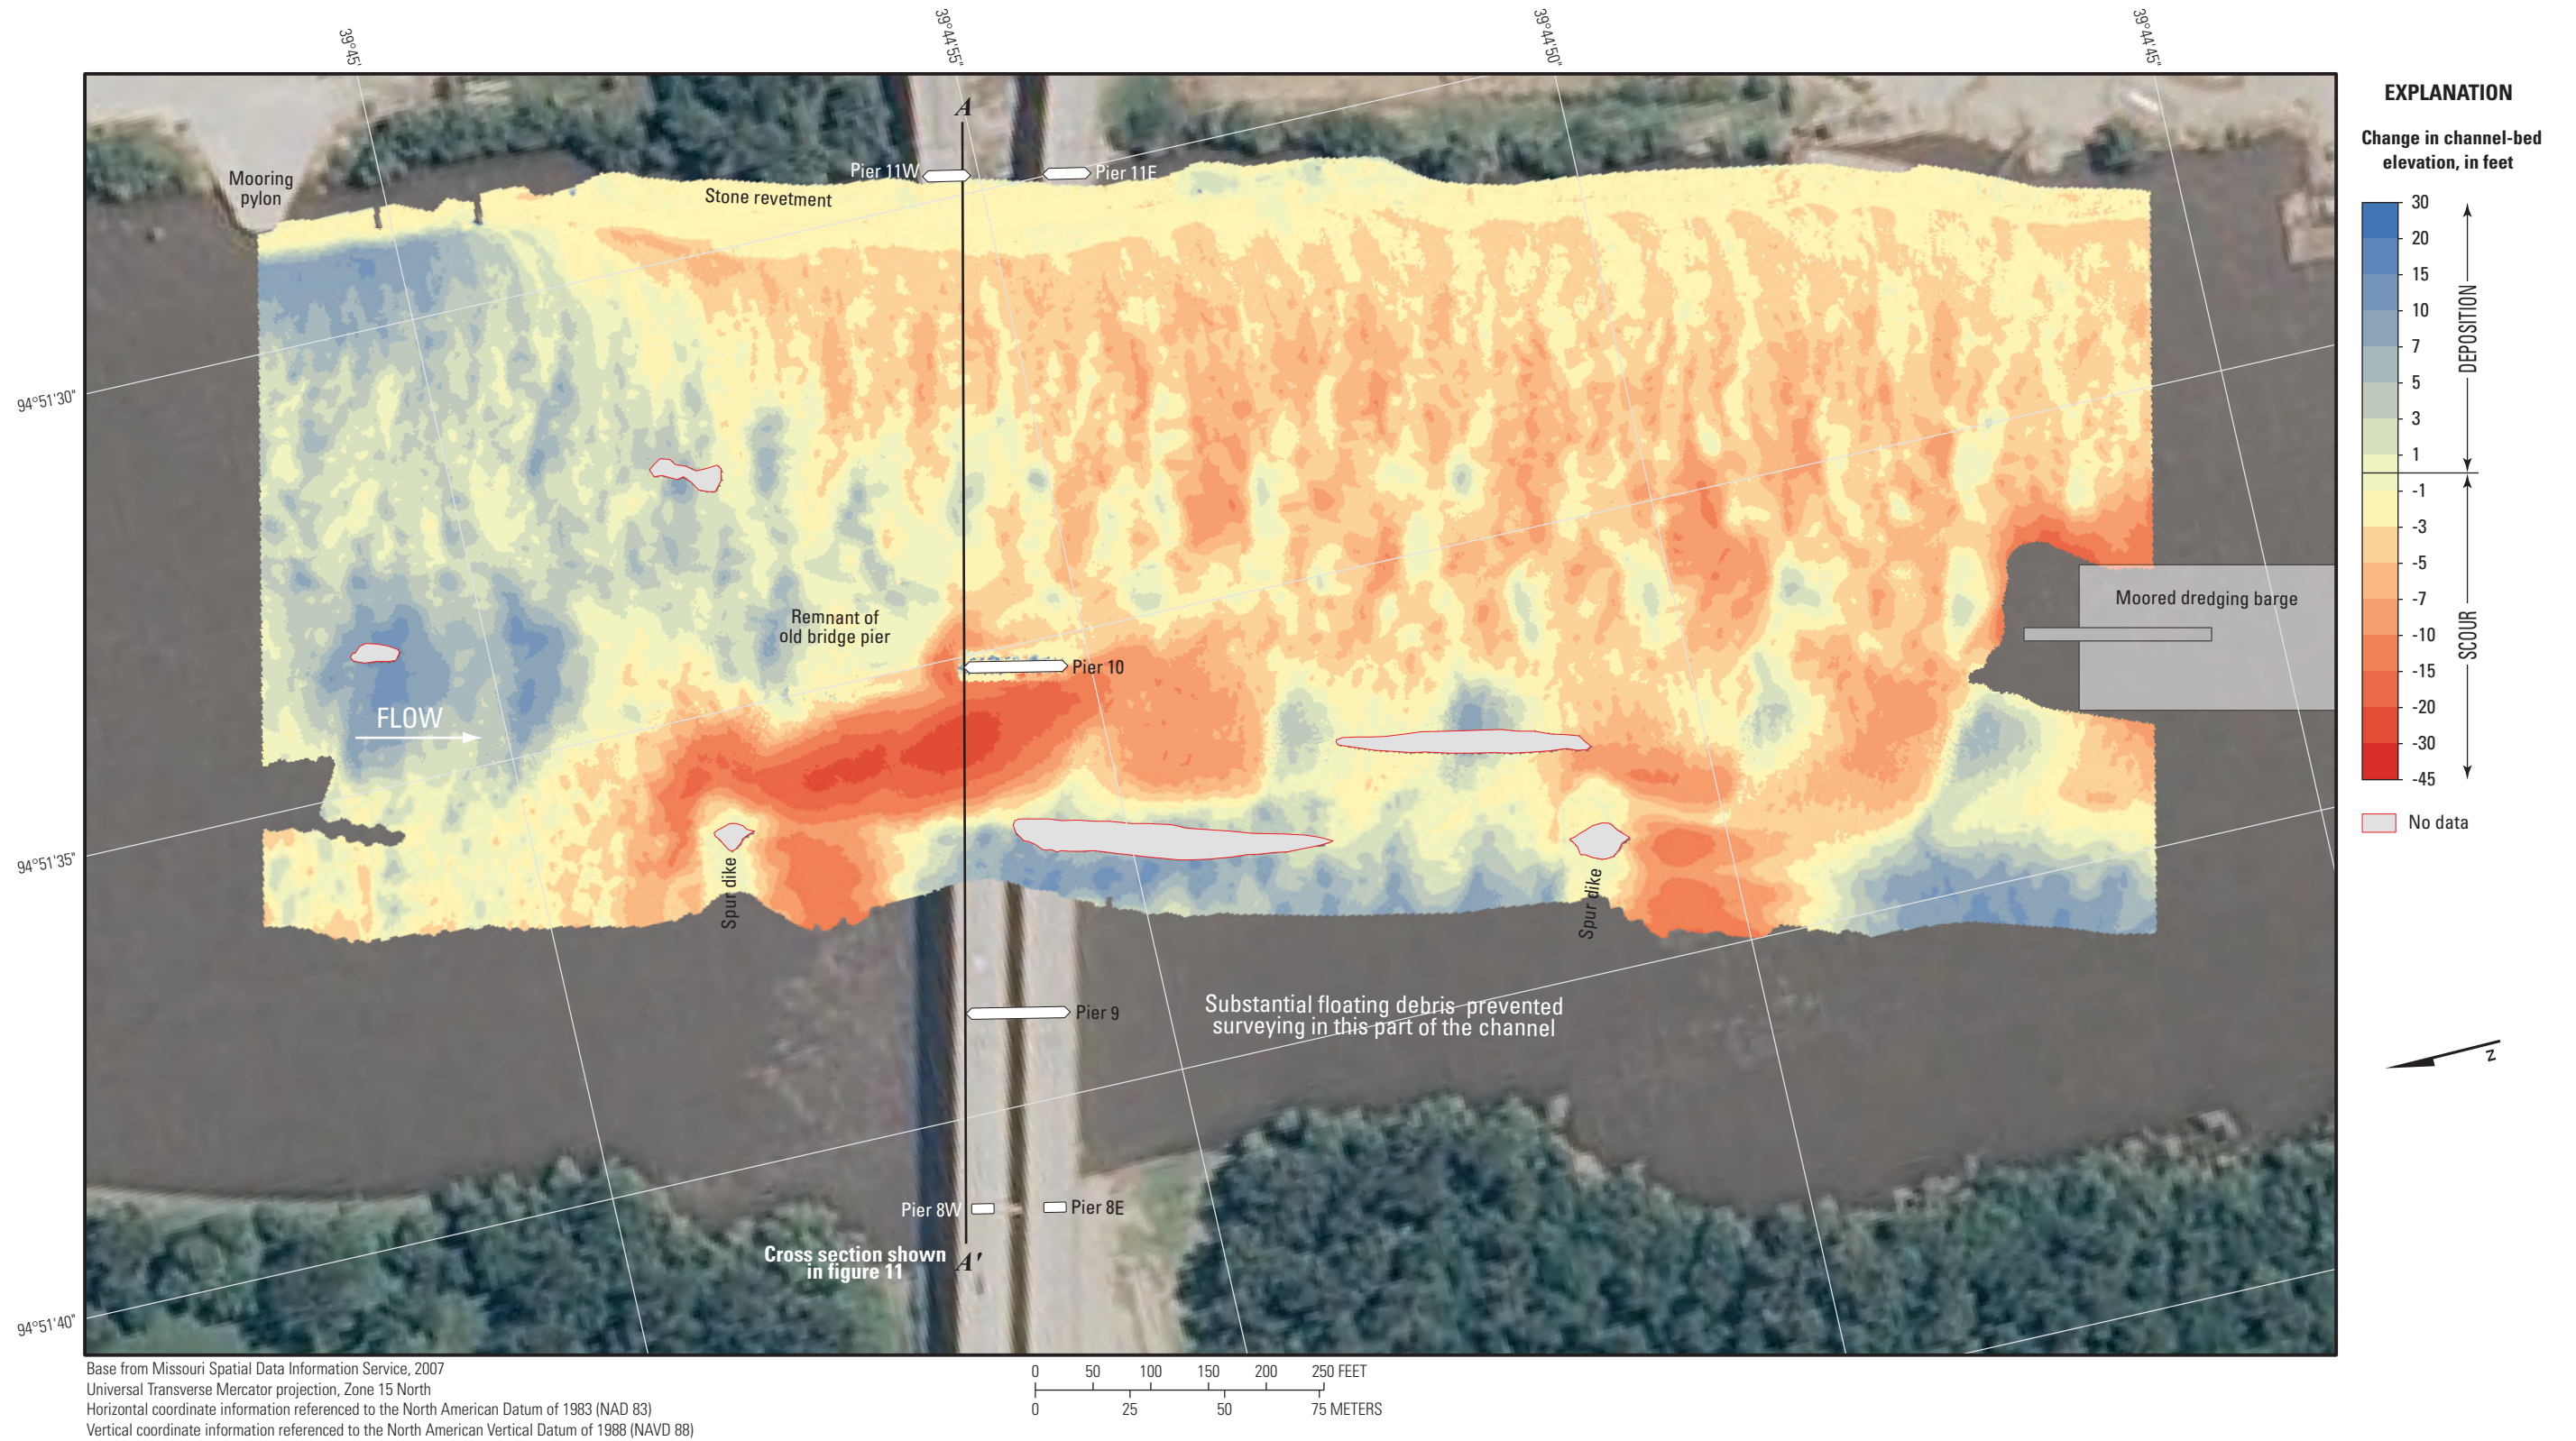
Figure 12. Difference between bathymetric surfaces created from surveys of the Missouri River channel in the vicinity of dual bridge structure A3664 on U.S. Highway 36 at St. Joseph, Missouri, on June 4, 2014, and July 14, 2011.

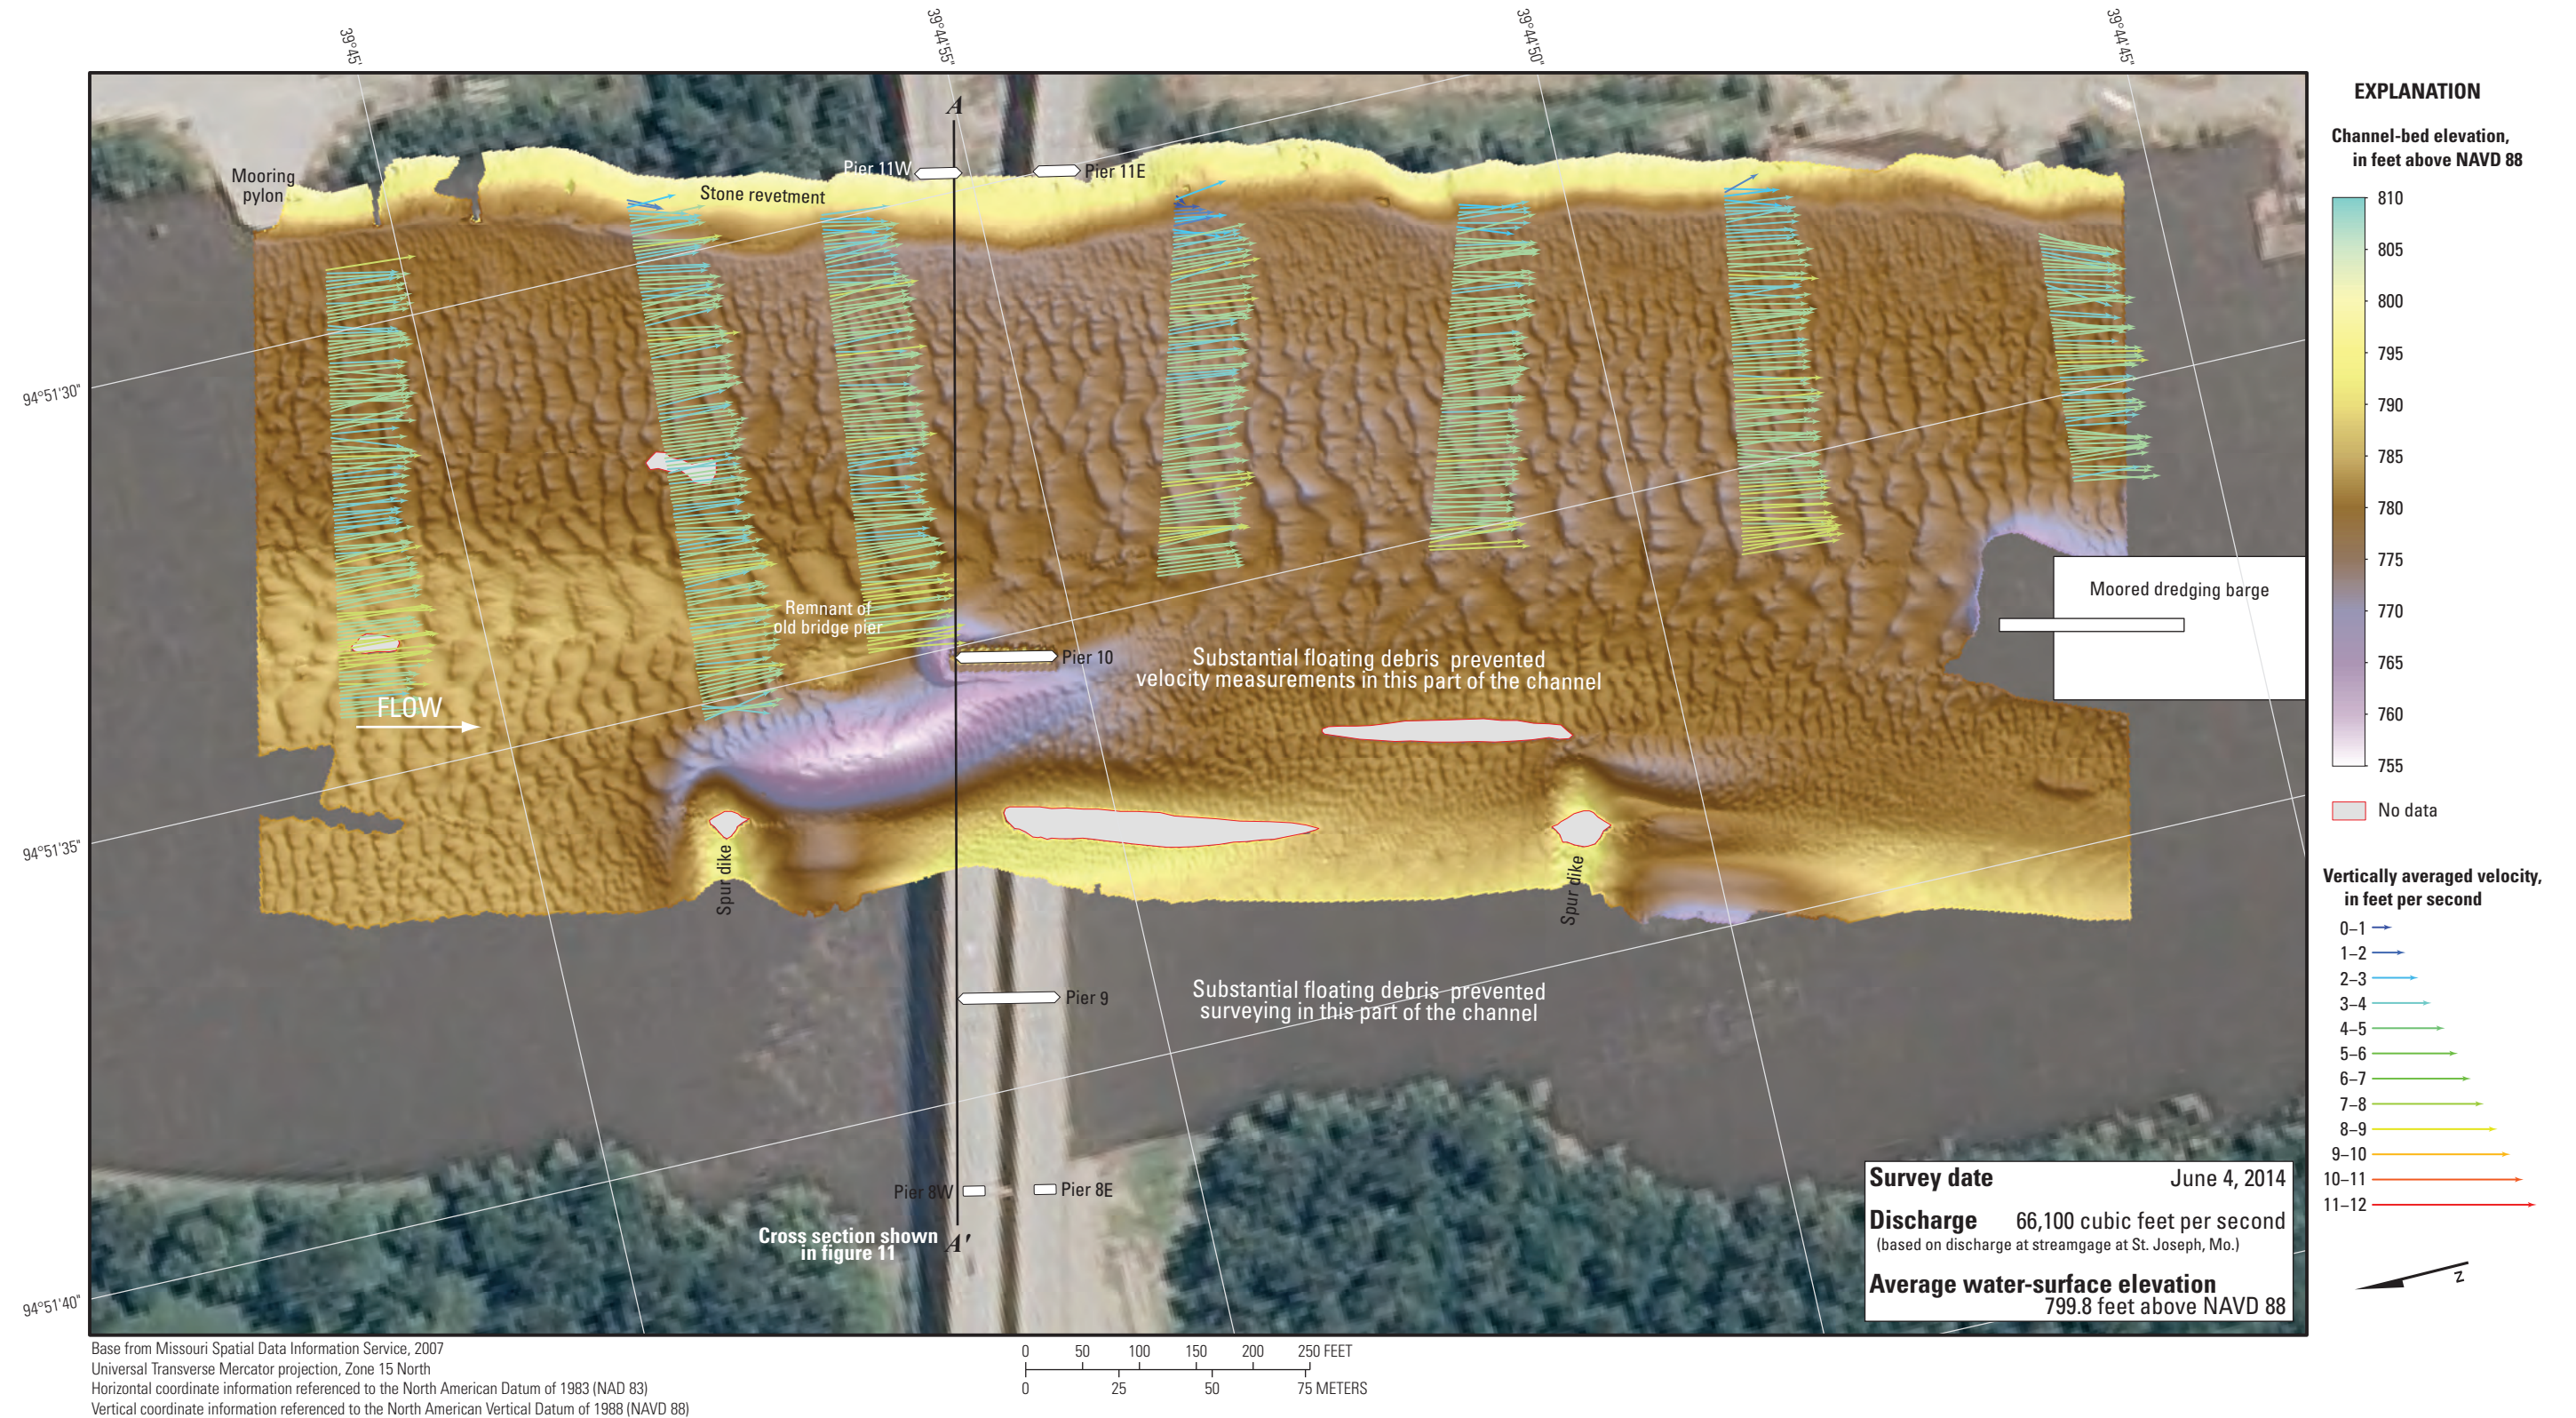
Figure 13. Bathymetry and vertically averaged velocities of the Missouri River channel in the vicinity of dual bridge structure A3664 on U.S. Highway 36 at St. Joseph, Missouri.

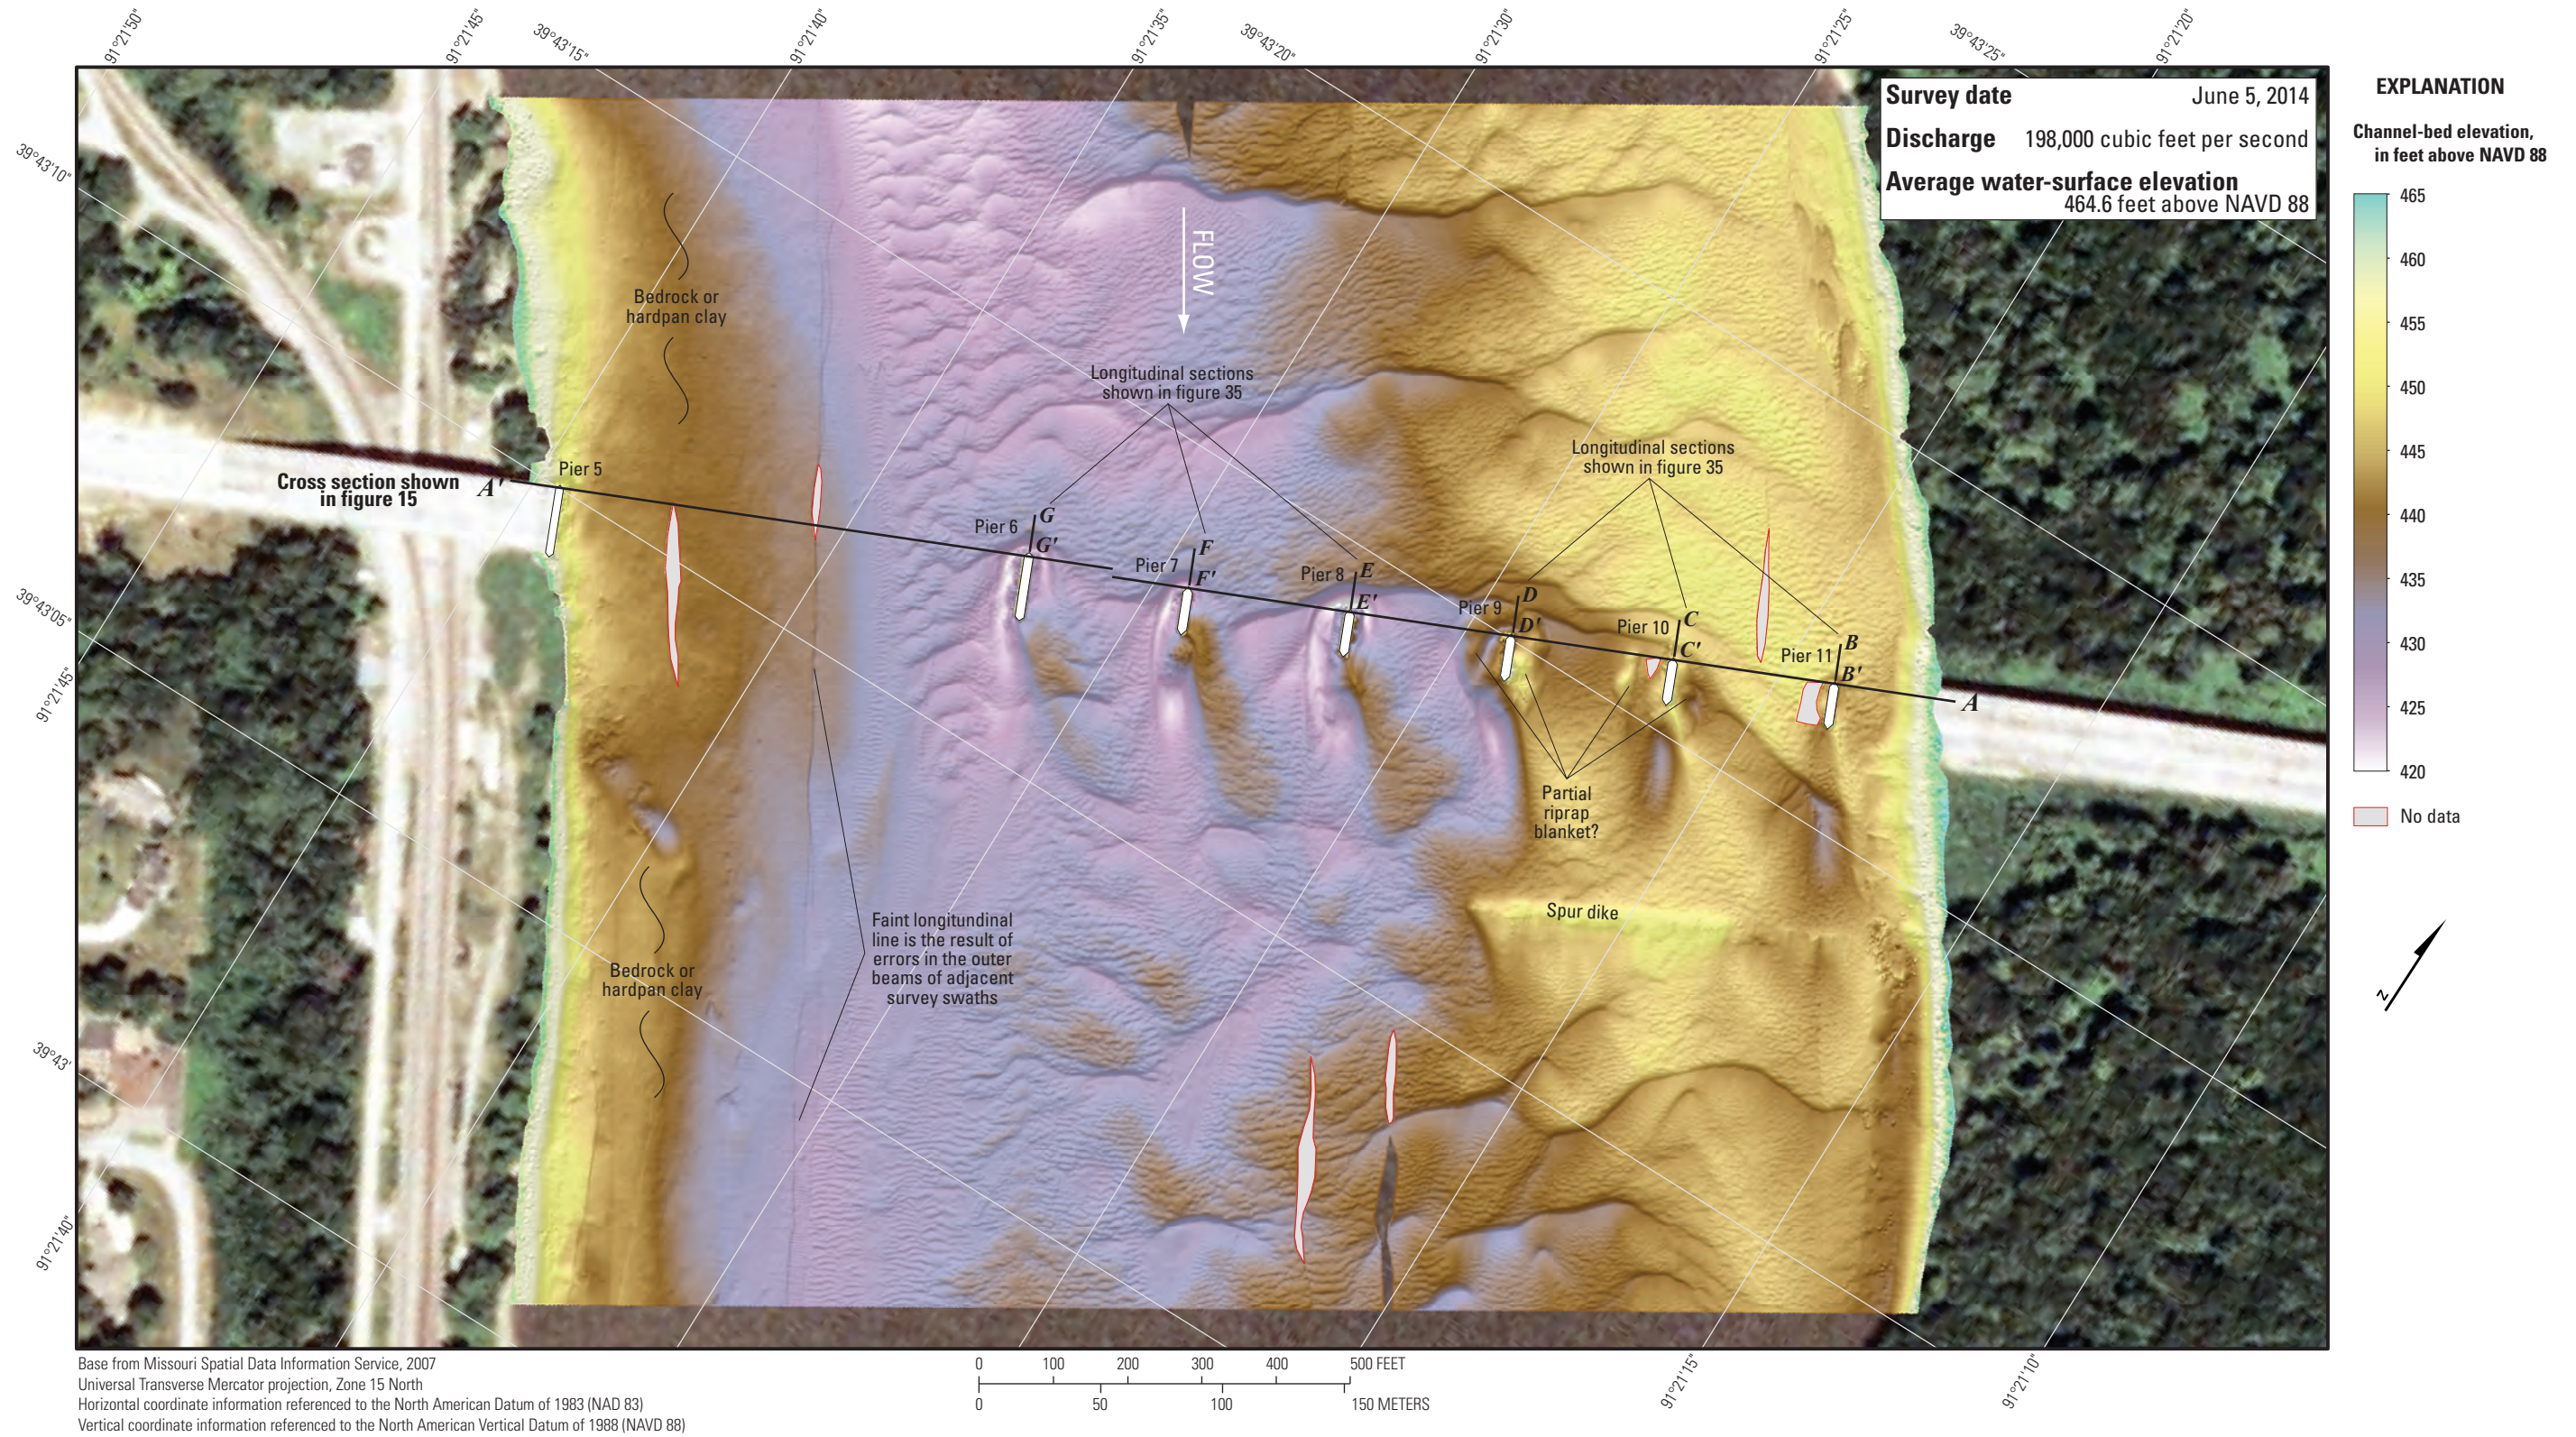
Figure 14. Bathymetric survey of the Mississippi River channel in the vicinity of structure A5054 on Interstate 72 at Hannibal, Missouri.

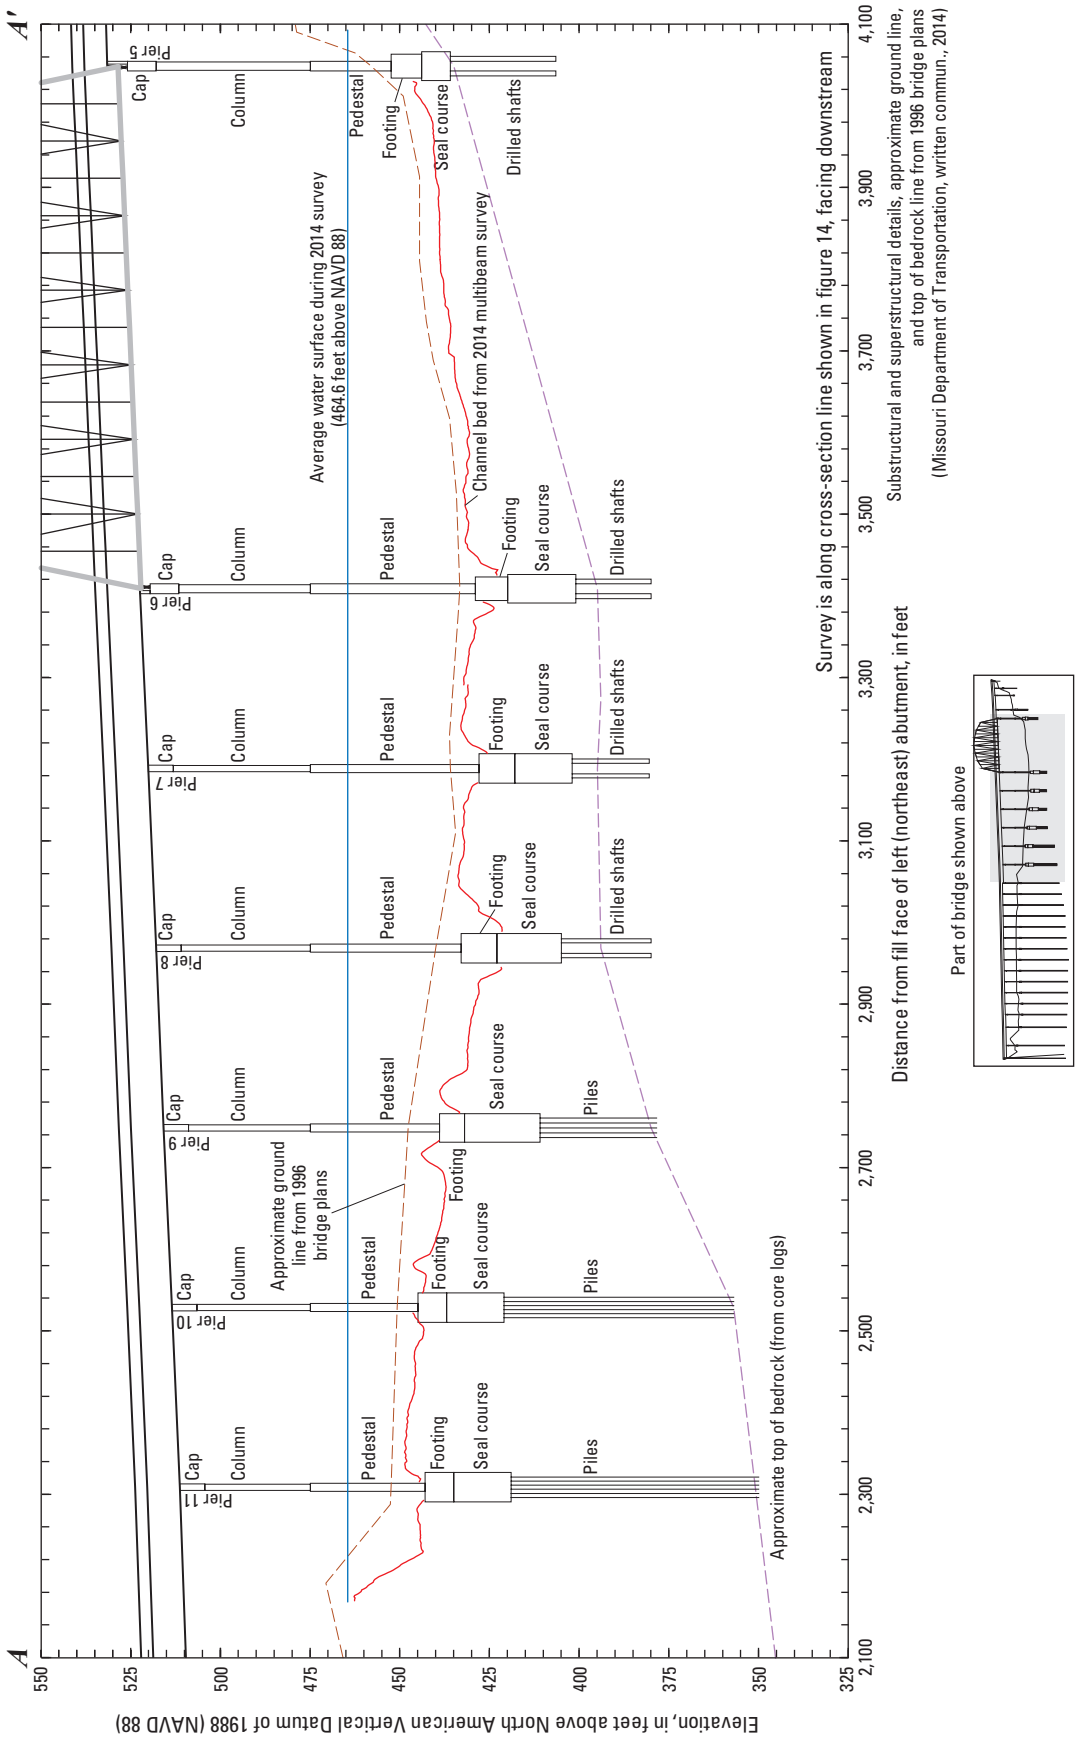
Figure 15. Key features, substructural and superstructural details, and surveyed channel bed of structure A5054 on Interstate 72 at Hannibal, Missouri.

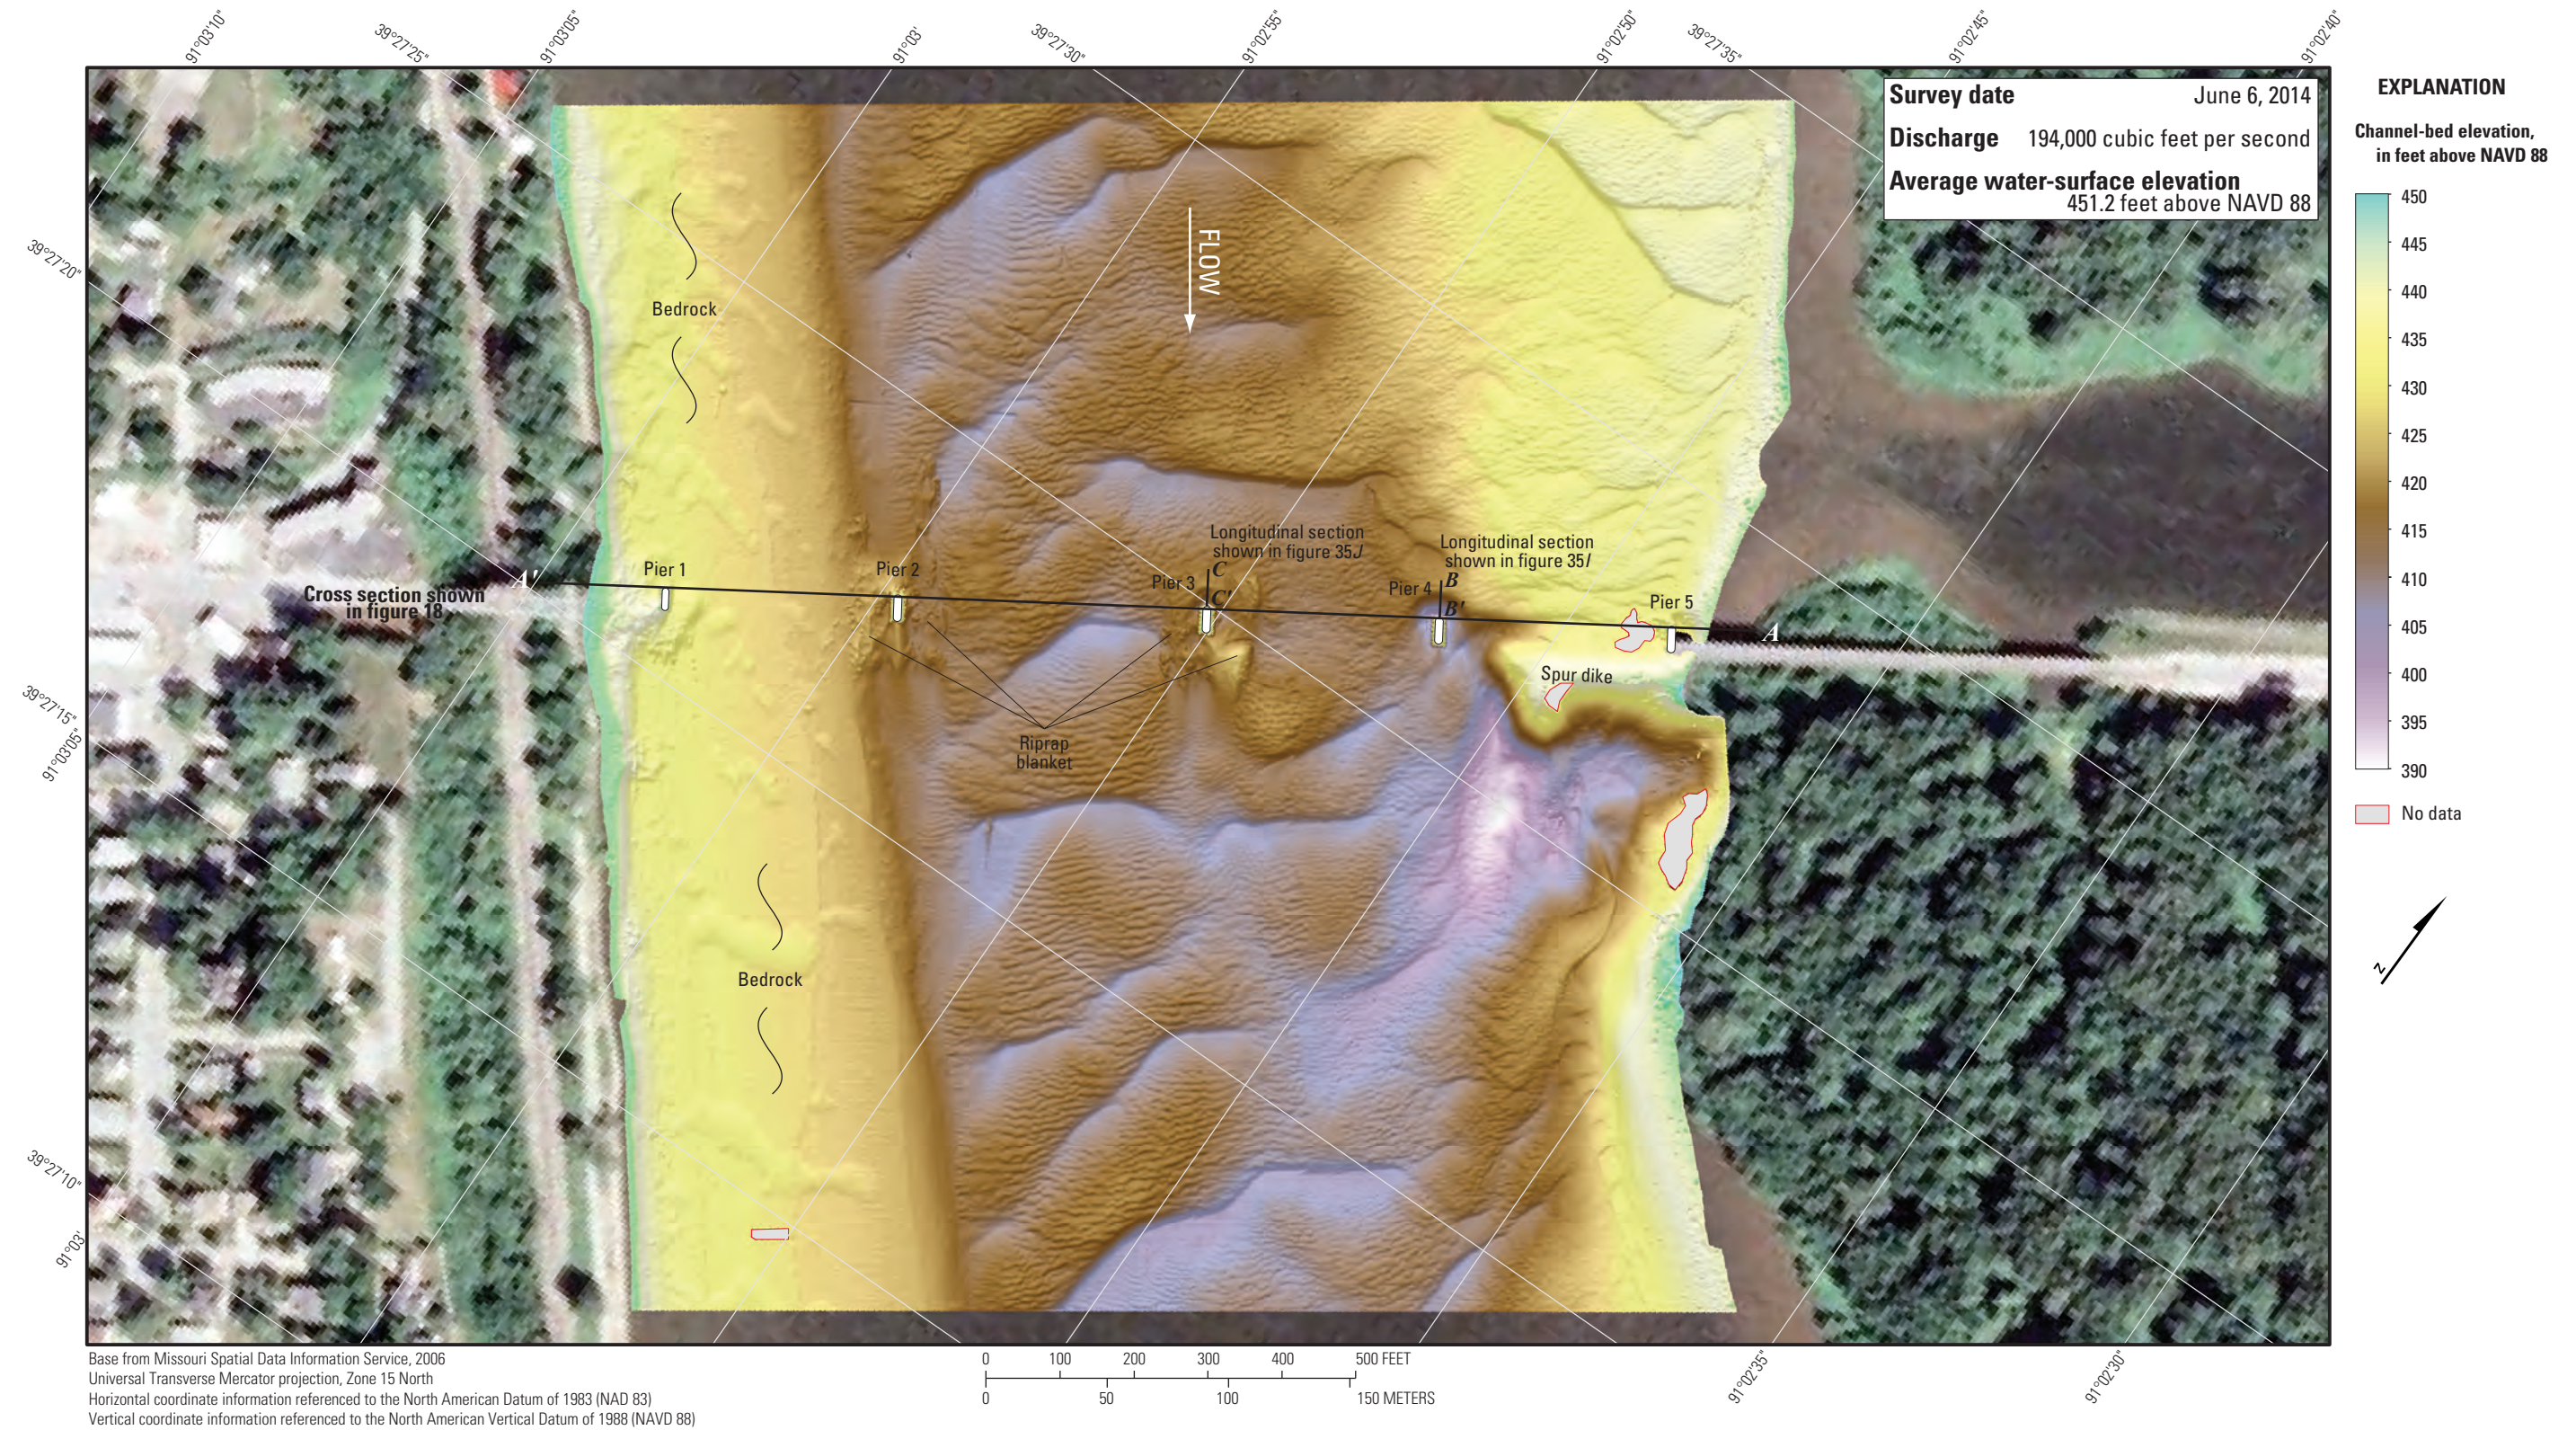
Figure 17. Bathymetric survey of the Mississippi River channel in the vicinity of structure K0932 on U.S. Highway 54 at Louisiana, Missouri.

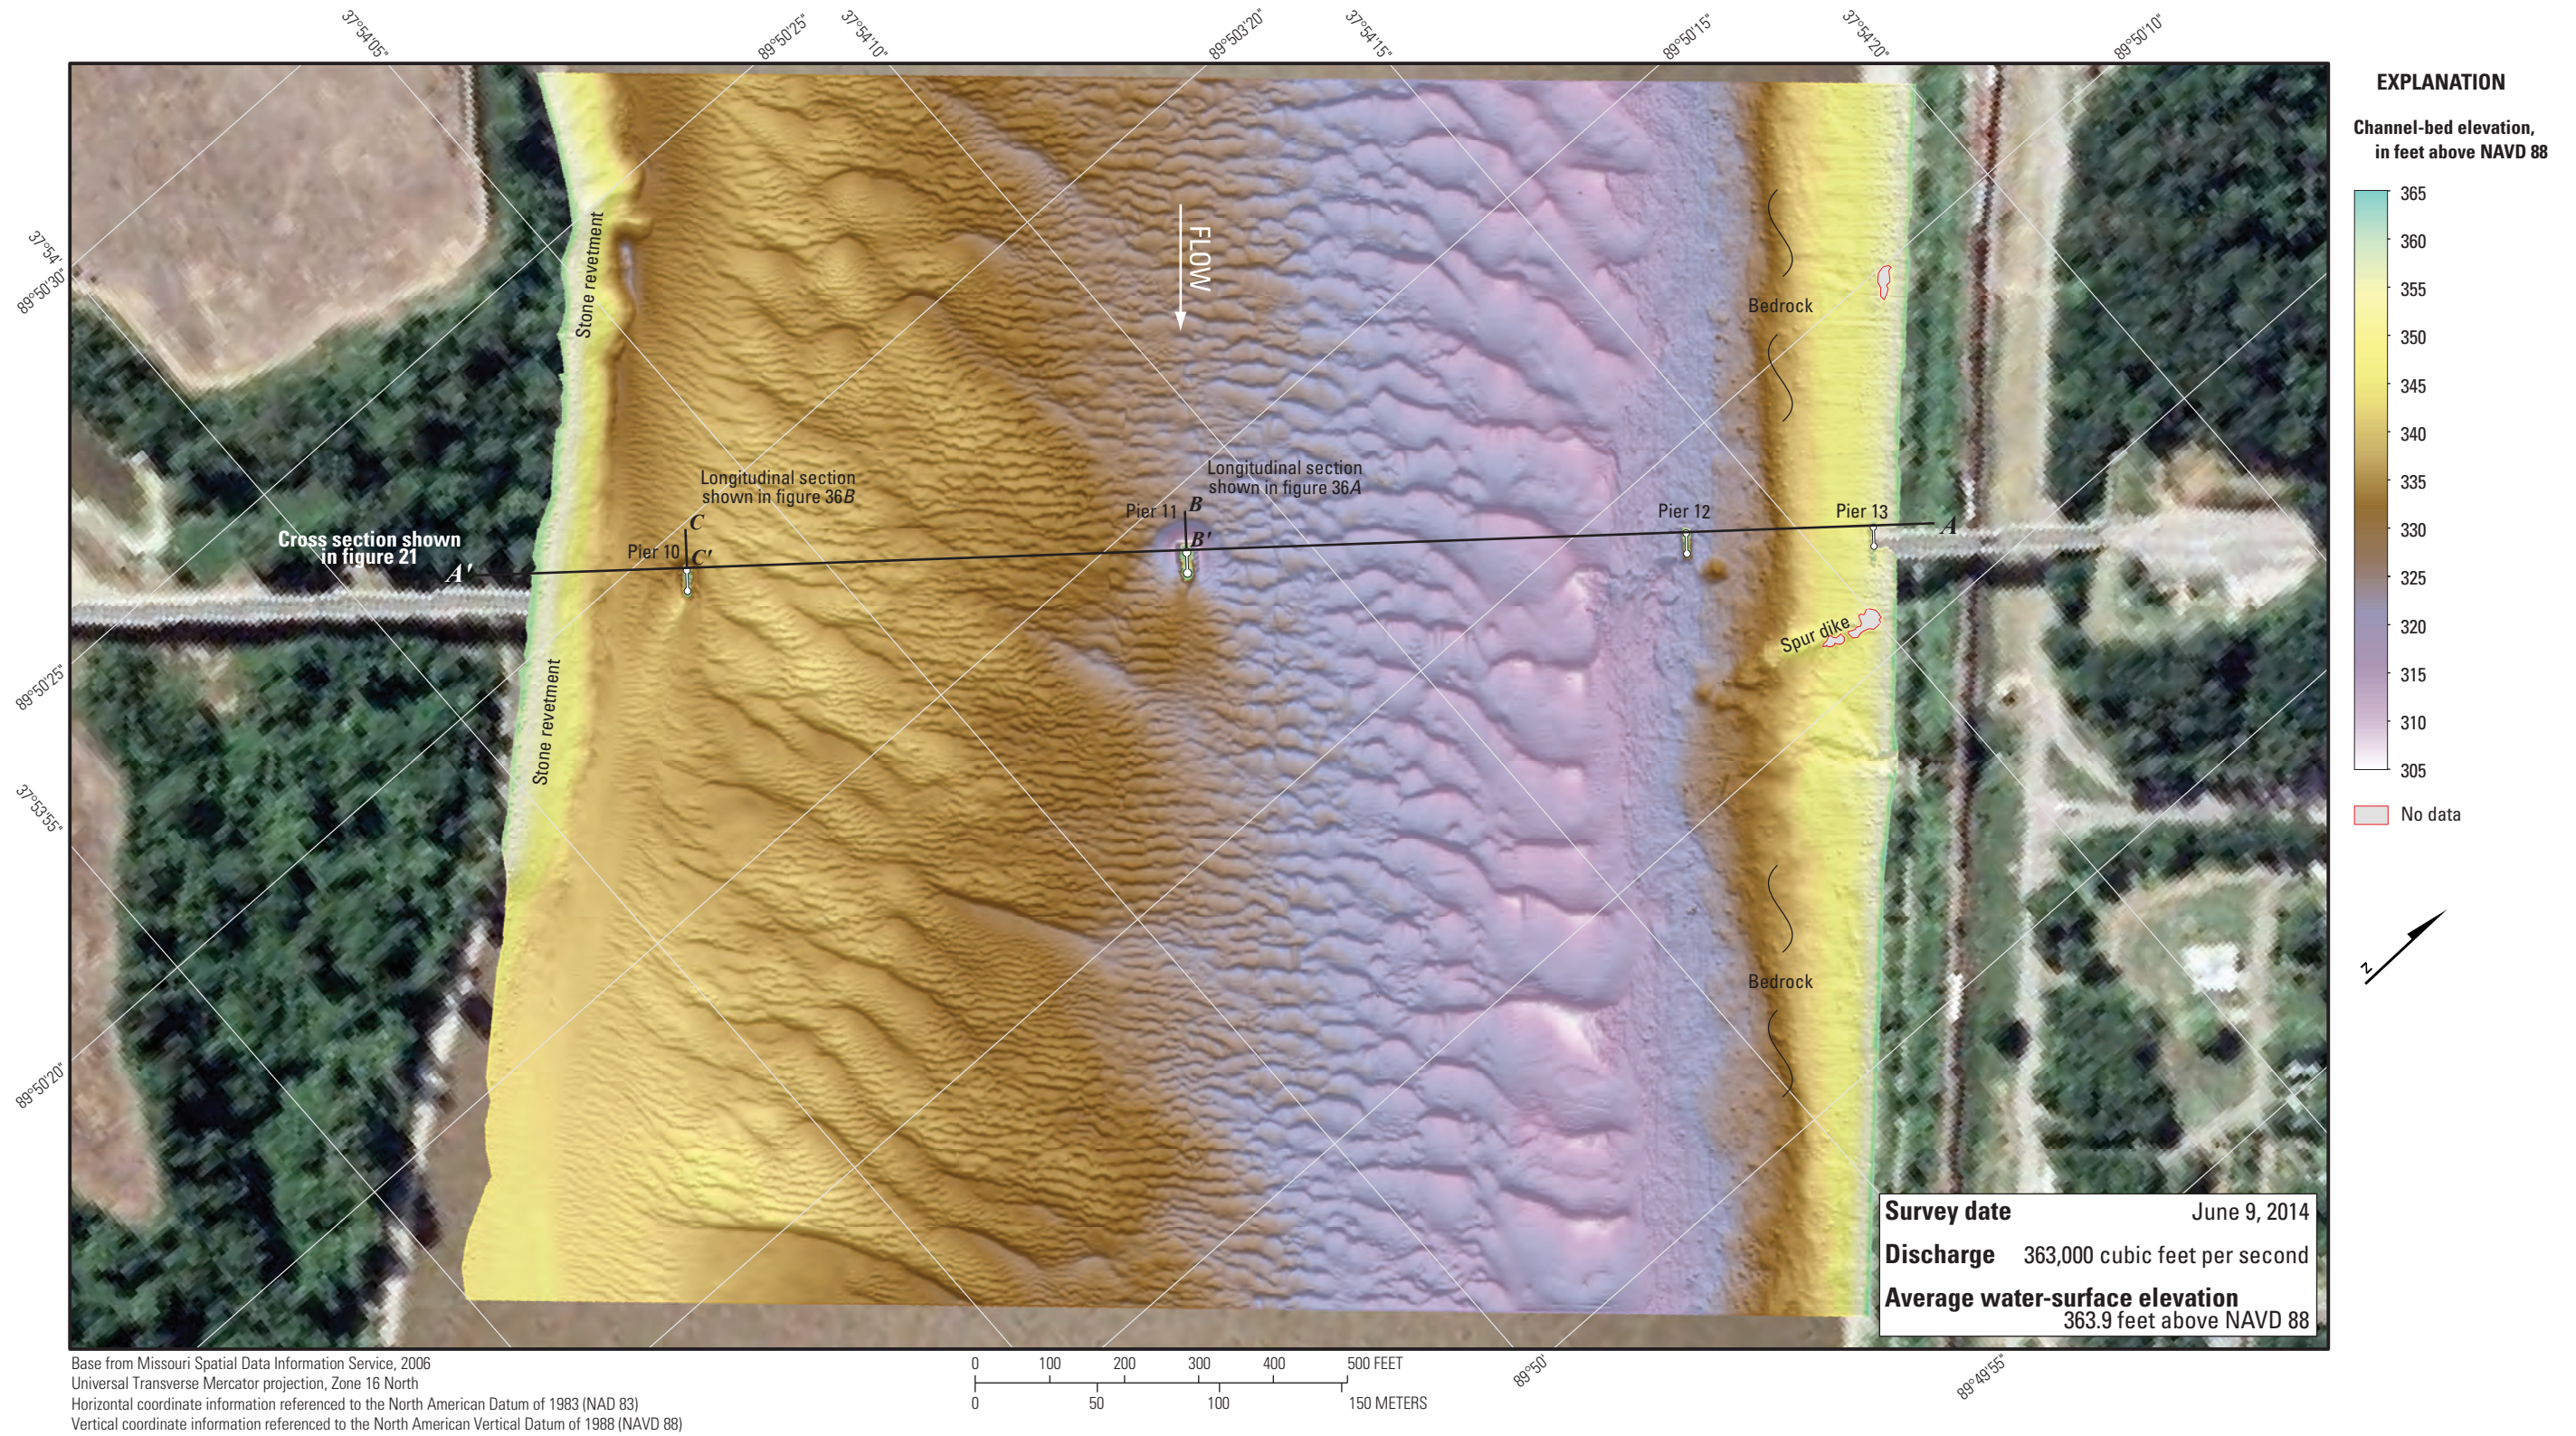
Figure 20. Bathymetric survey of the Mississippi River channel in the vicinity of structure L0135 on State Highway 51 at Chester, Illinois.

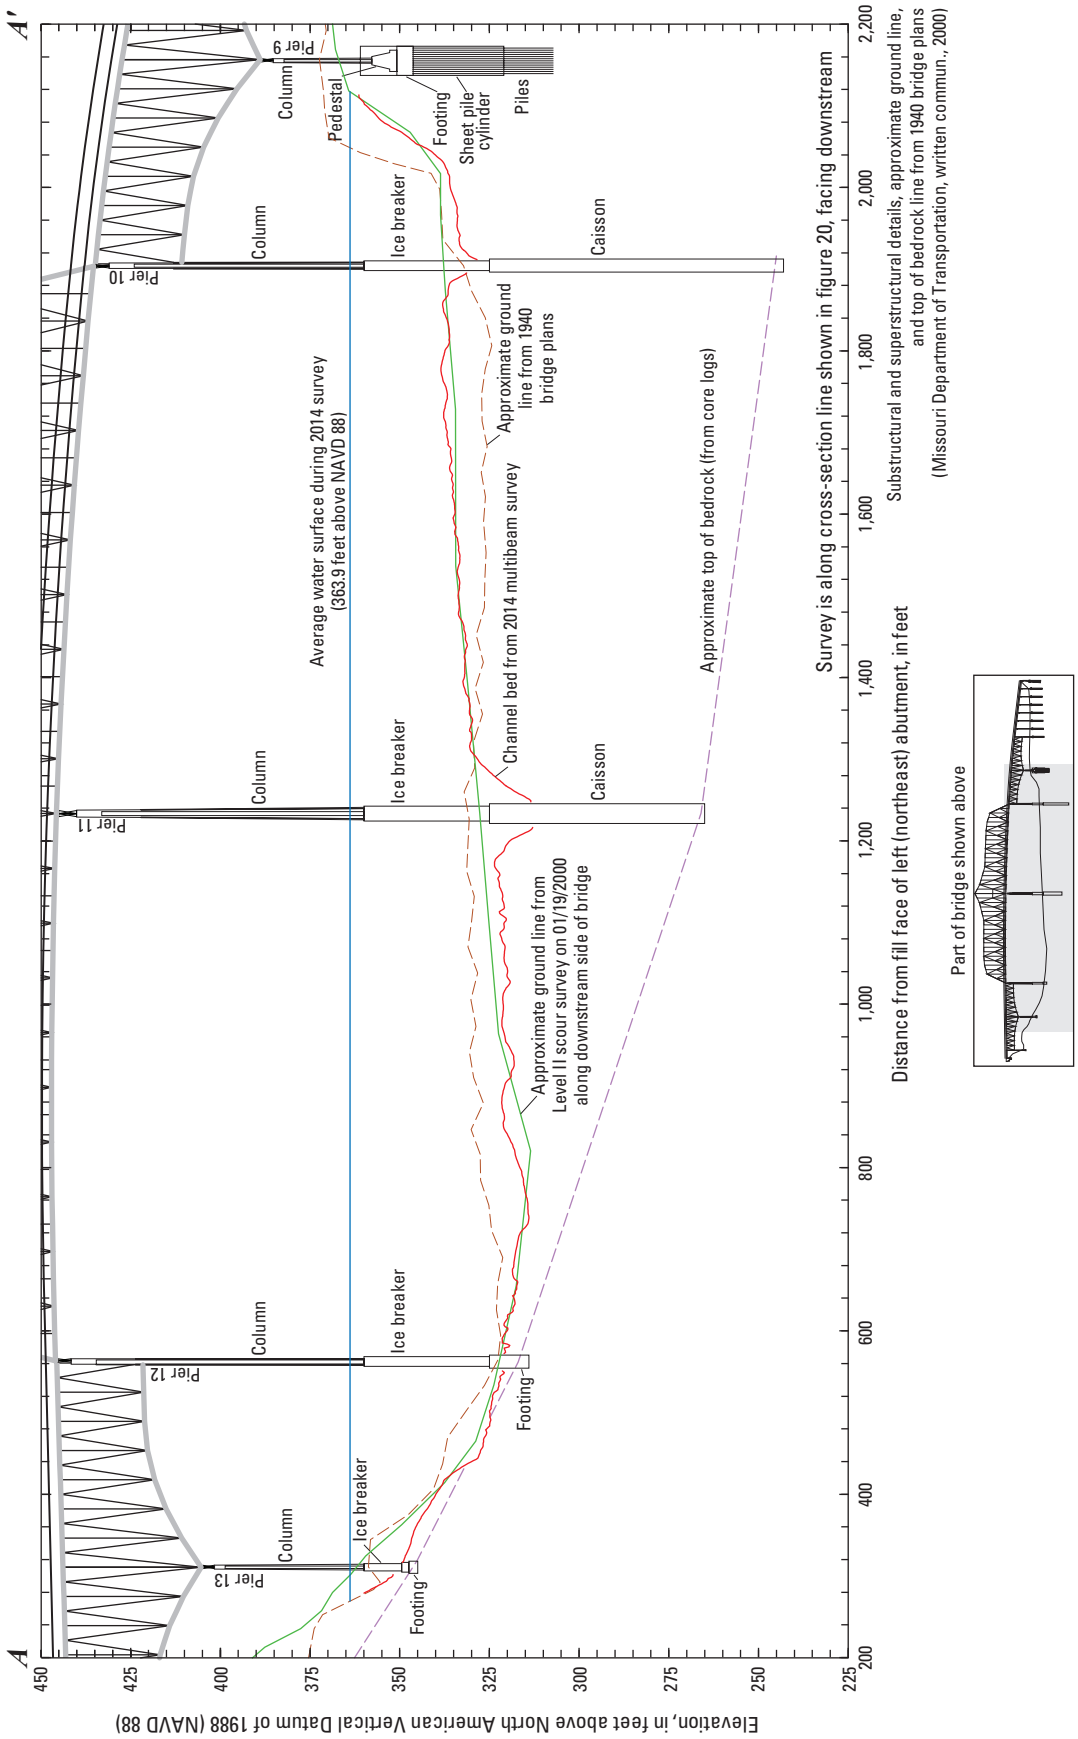
Figure 21. Key features, substructural and superstructural details, and surveyed channel bed of structure L0135 on State Highway 51 over the Mississippi River at Chester, Illinois.
