Bathymetric and Velocimetric Surveys at Highway Bridges Crossing the Missouri and Mississippi Rivers on the Periphery of Missouri, June 2014

Scientific Investigations Report 2015–5048

By Richard J. Huizinga

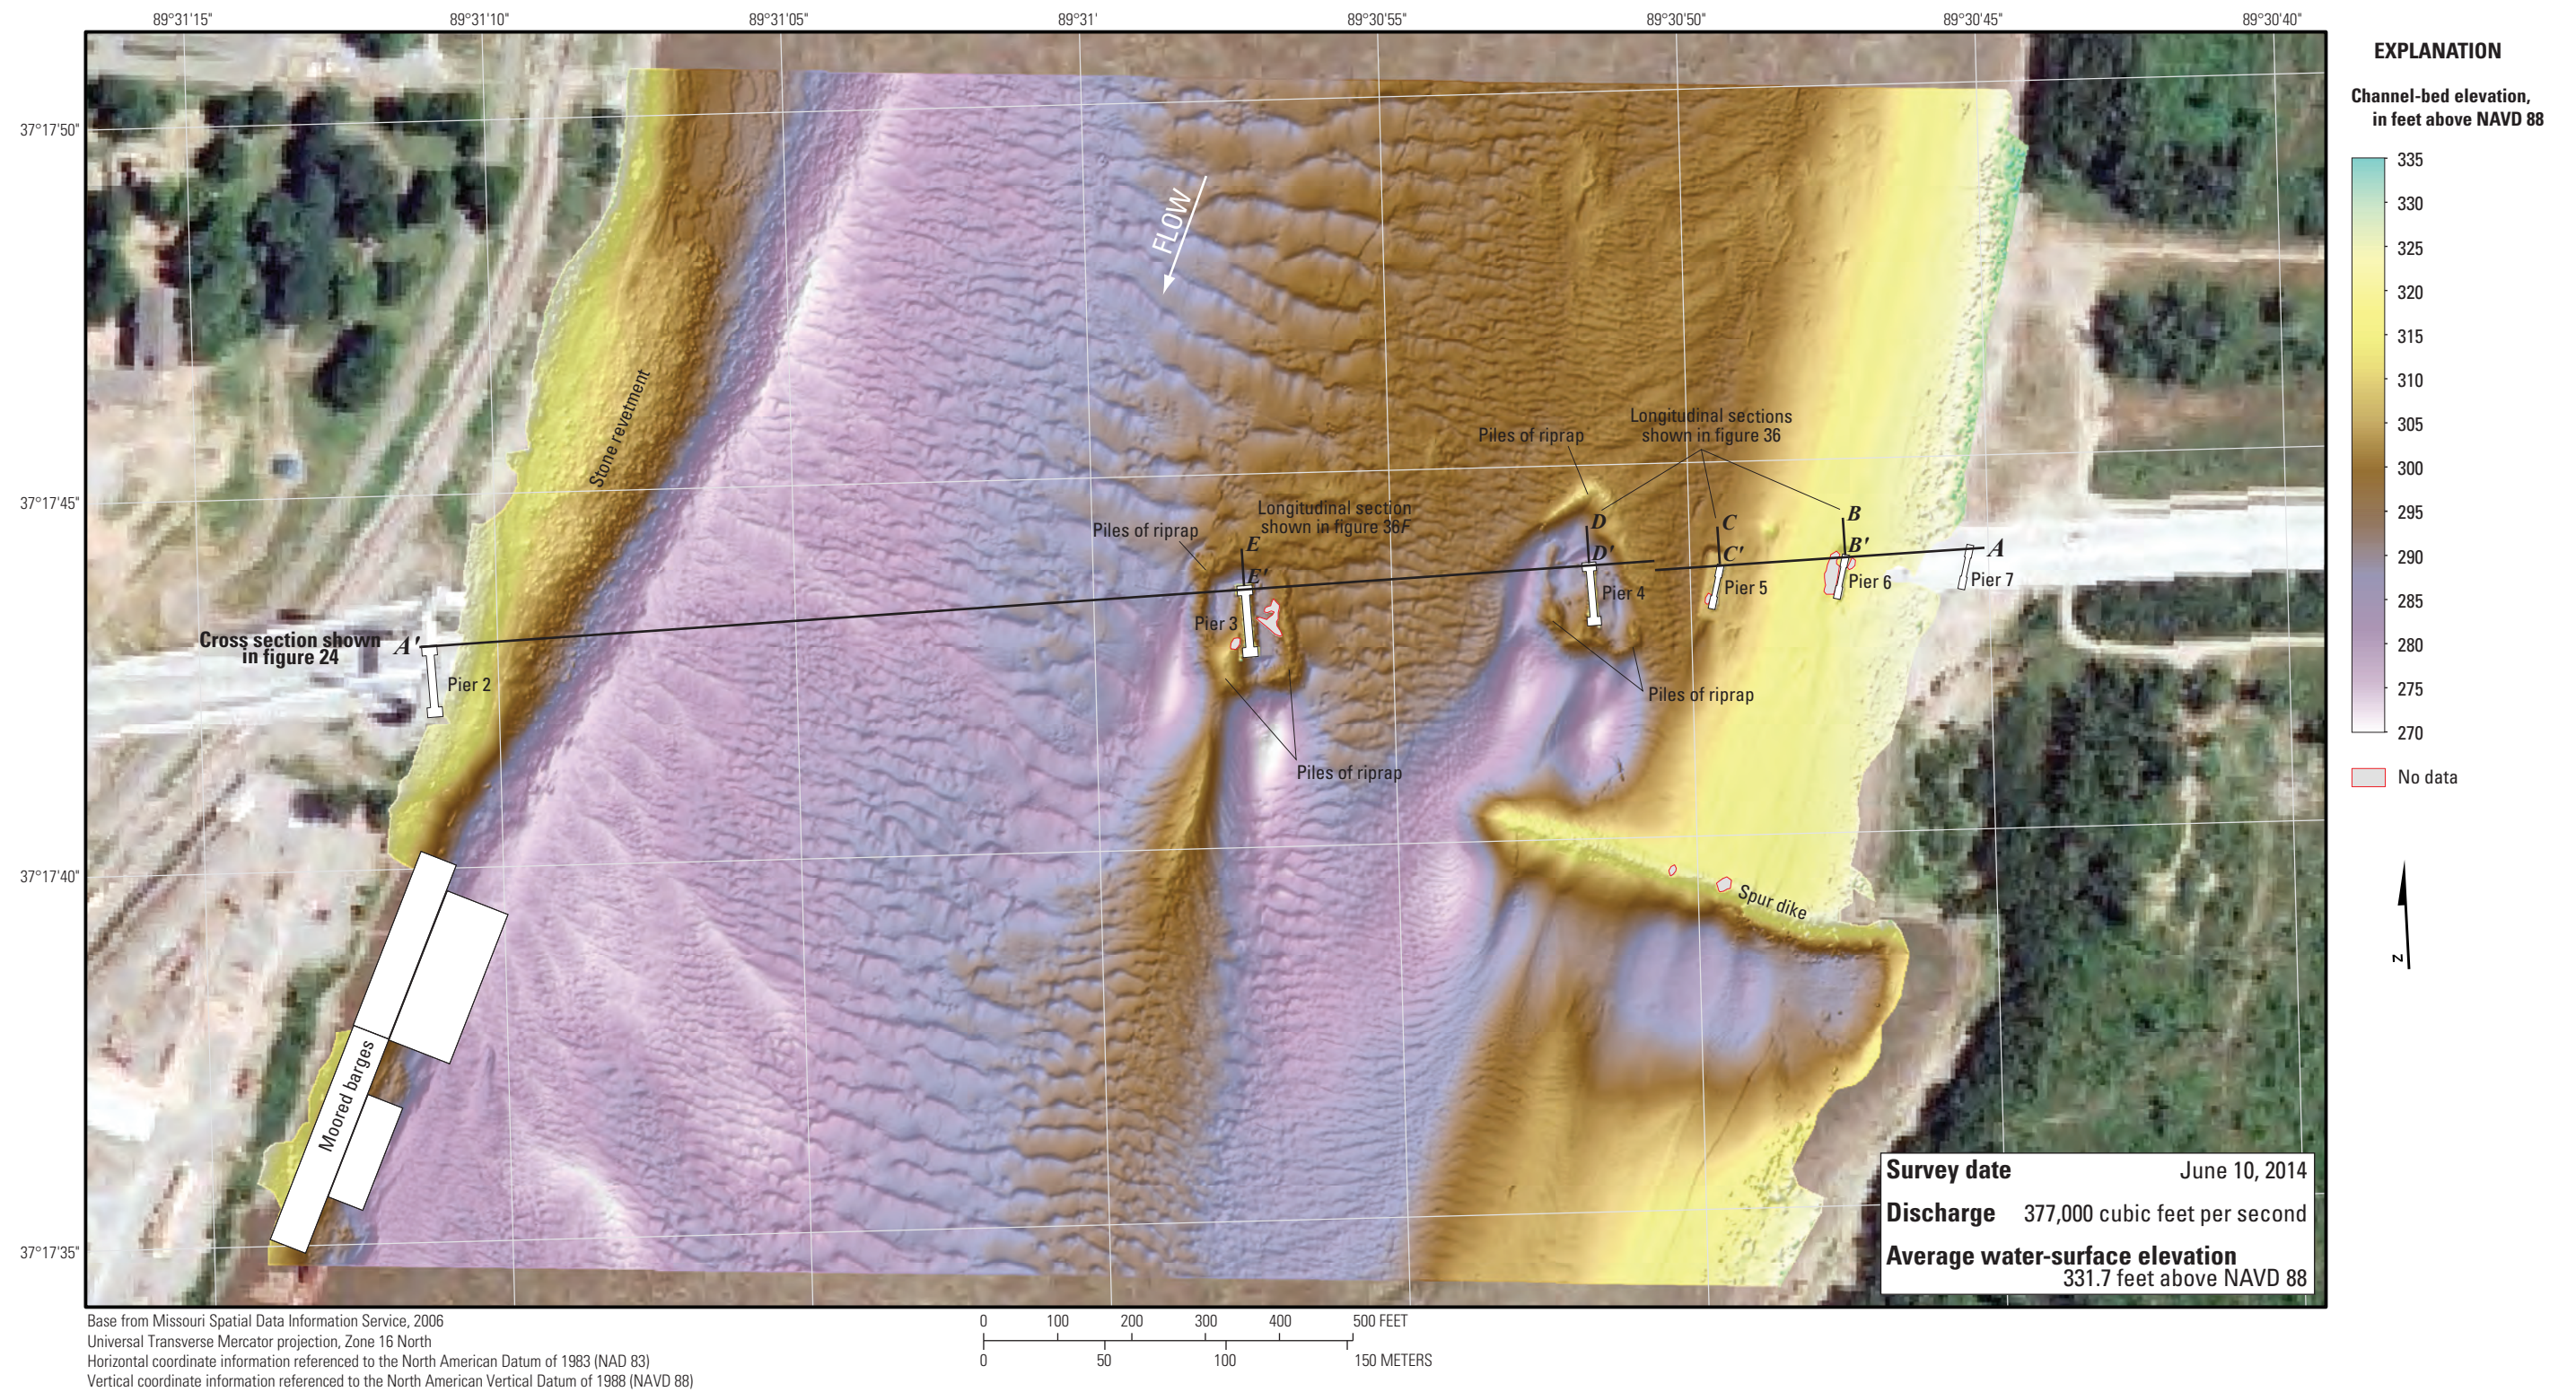
Figure 23. Bathymetric survey of the Mississippi River channel in the vicinity of structure A5076 on State Highway 34 at Cape Girardeau, Missouri.

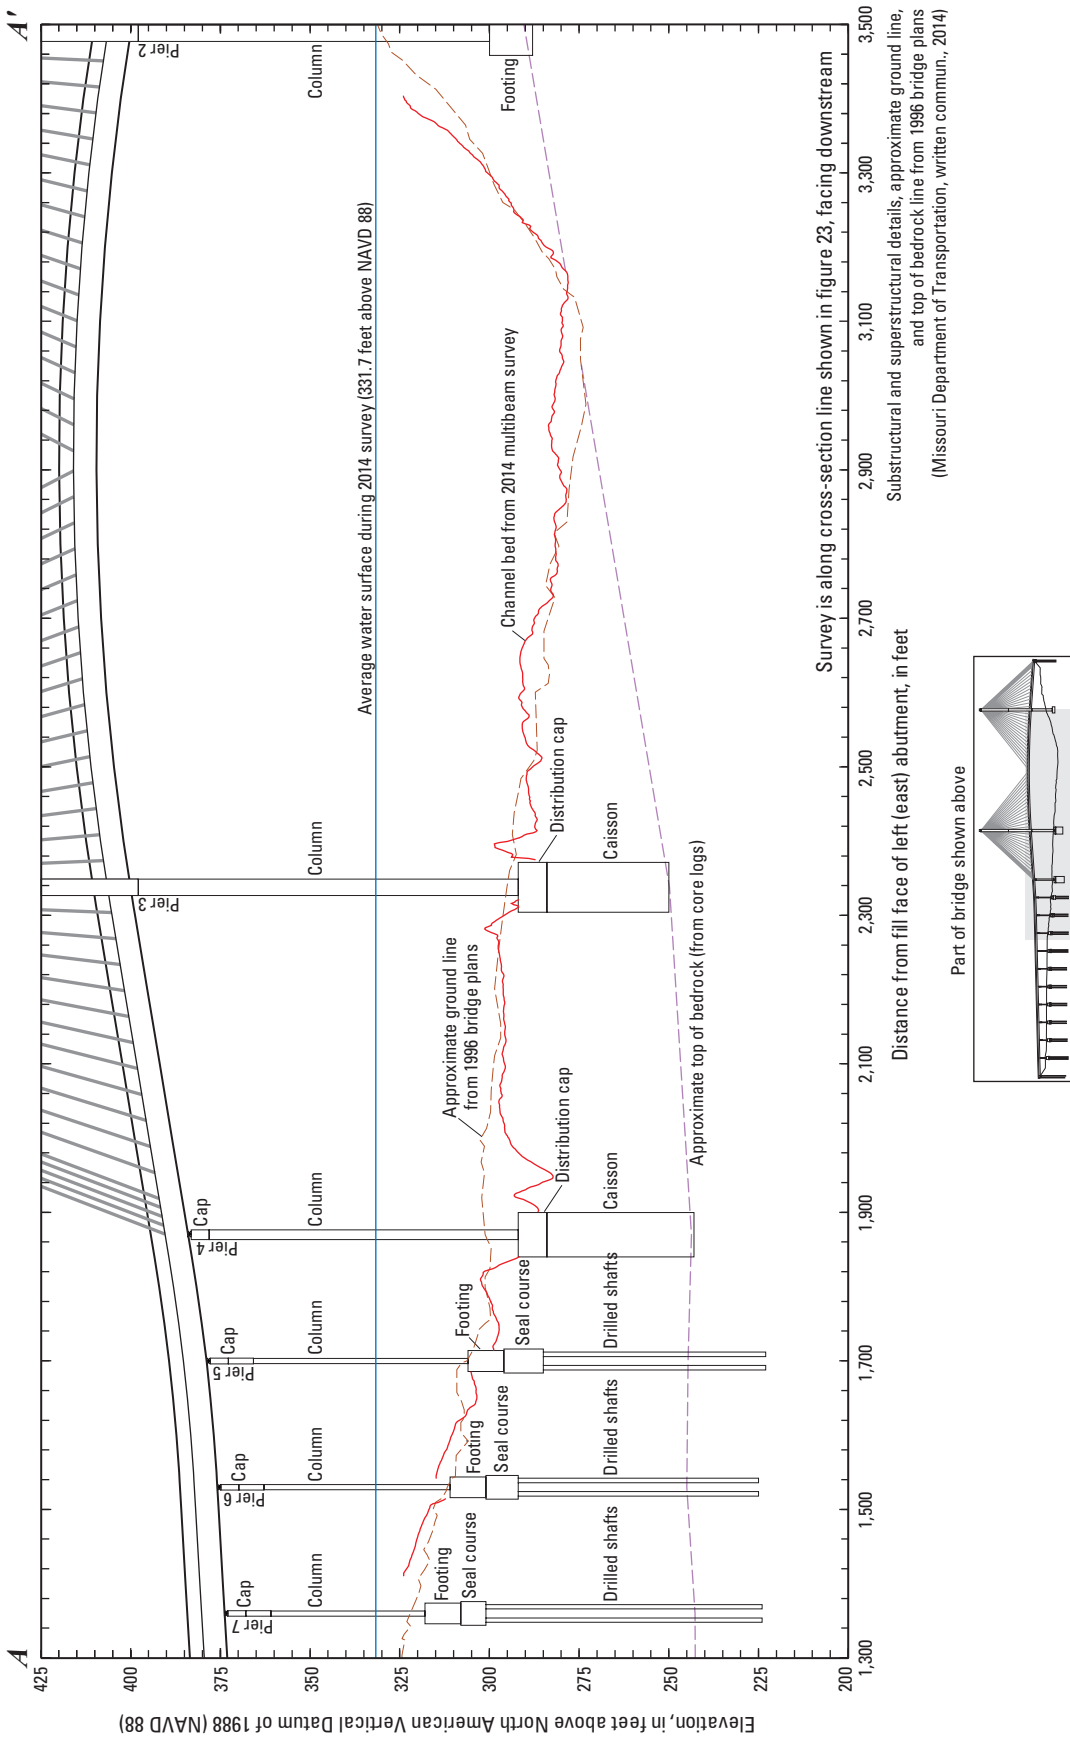
Figure 24. Key features, substructural and superstructural details, and surveyed channel bed of structure A5076 on State Highway 34 over the Mississippi River at Cape Girardeau, Missouri.

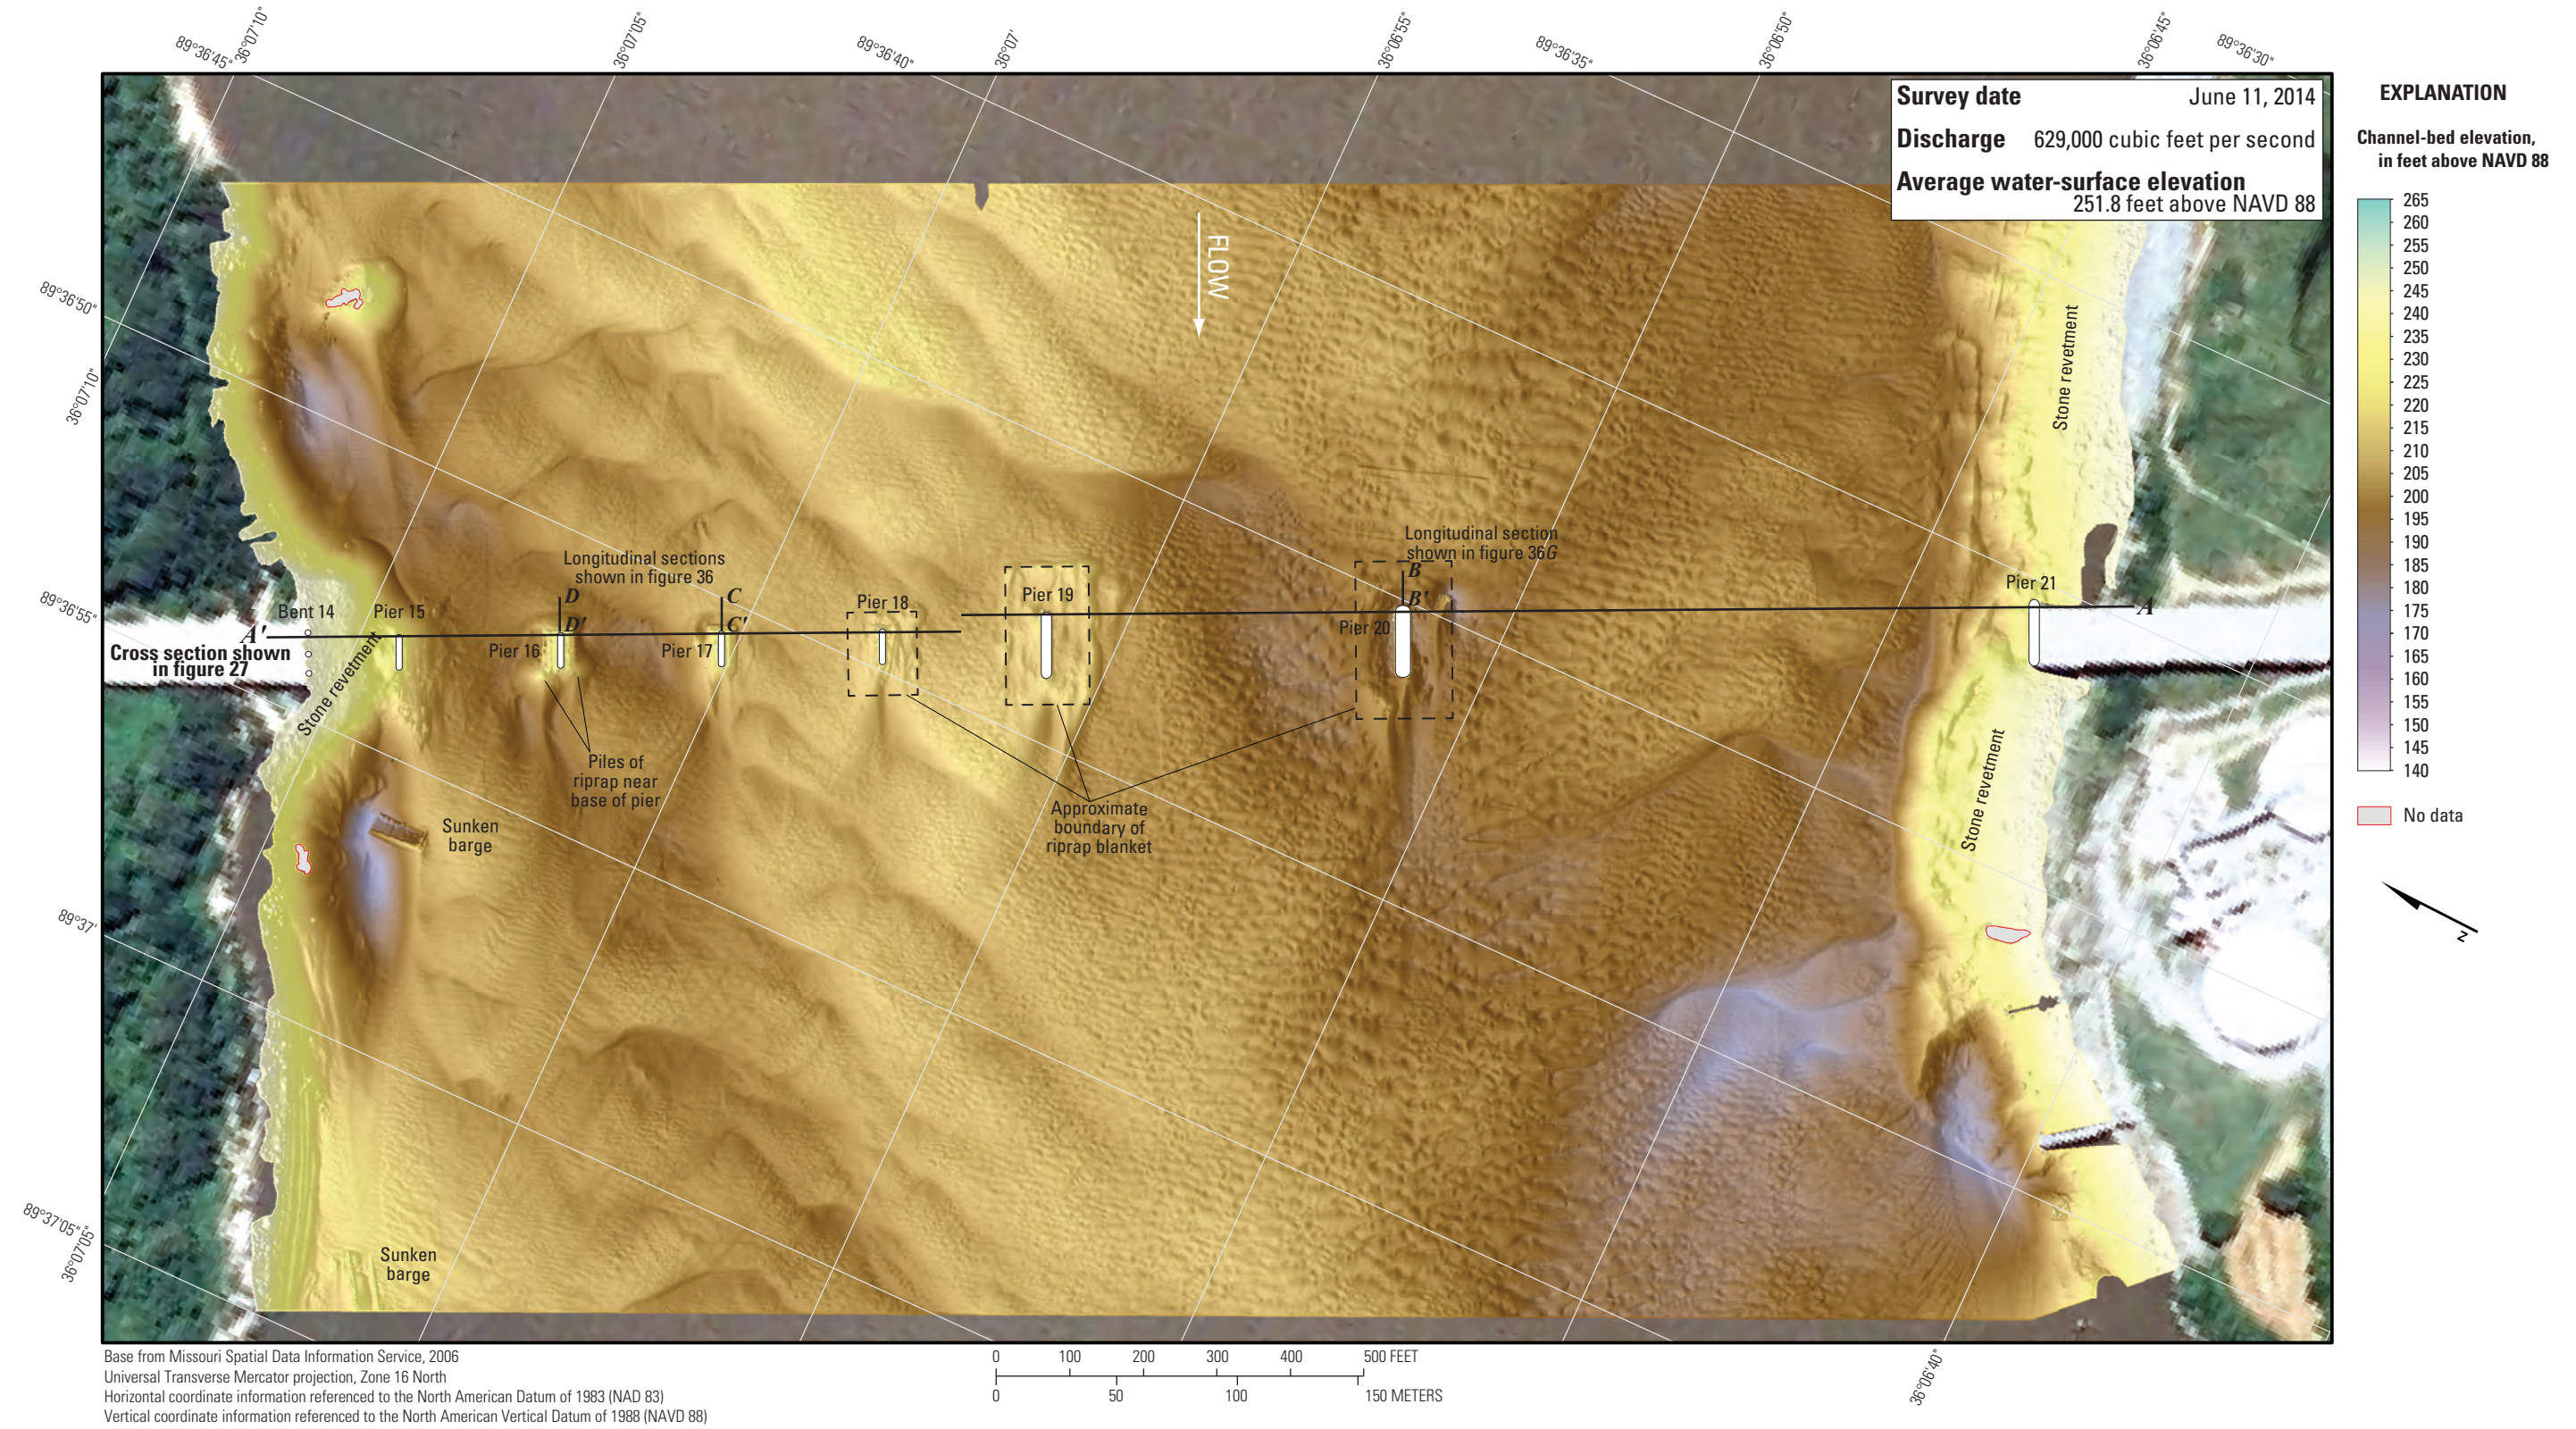
Figure 26. Bathymetric survey of the Mississippi River channel in the vicinity of structure A1700 on Interstate 155 near Caruthersville, Missouri, on June 11, 2014.

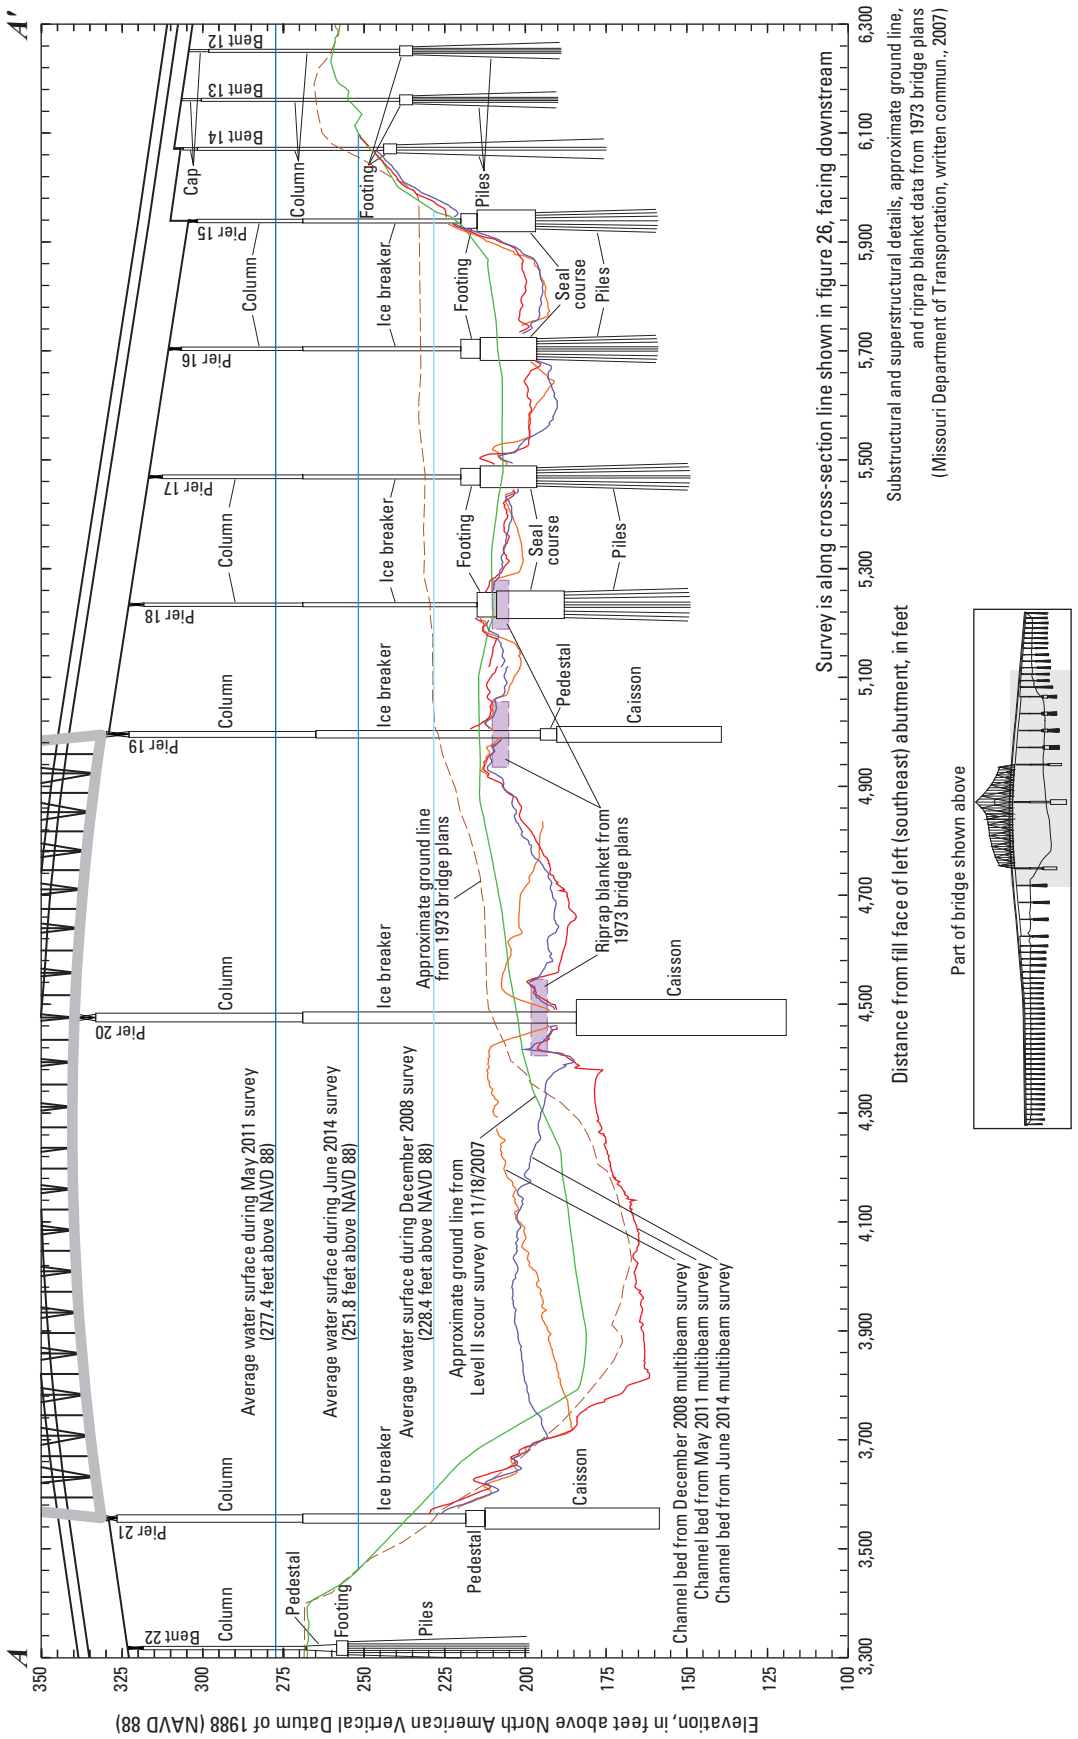
Figure 27. Key features, substructural and superstructural details, and surveyed channel bed of structure A1700 on Interstate 155 near Caruthersville, Missouri.

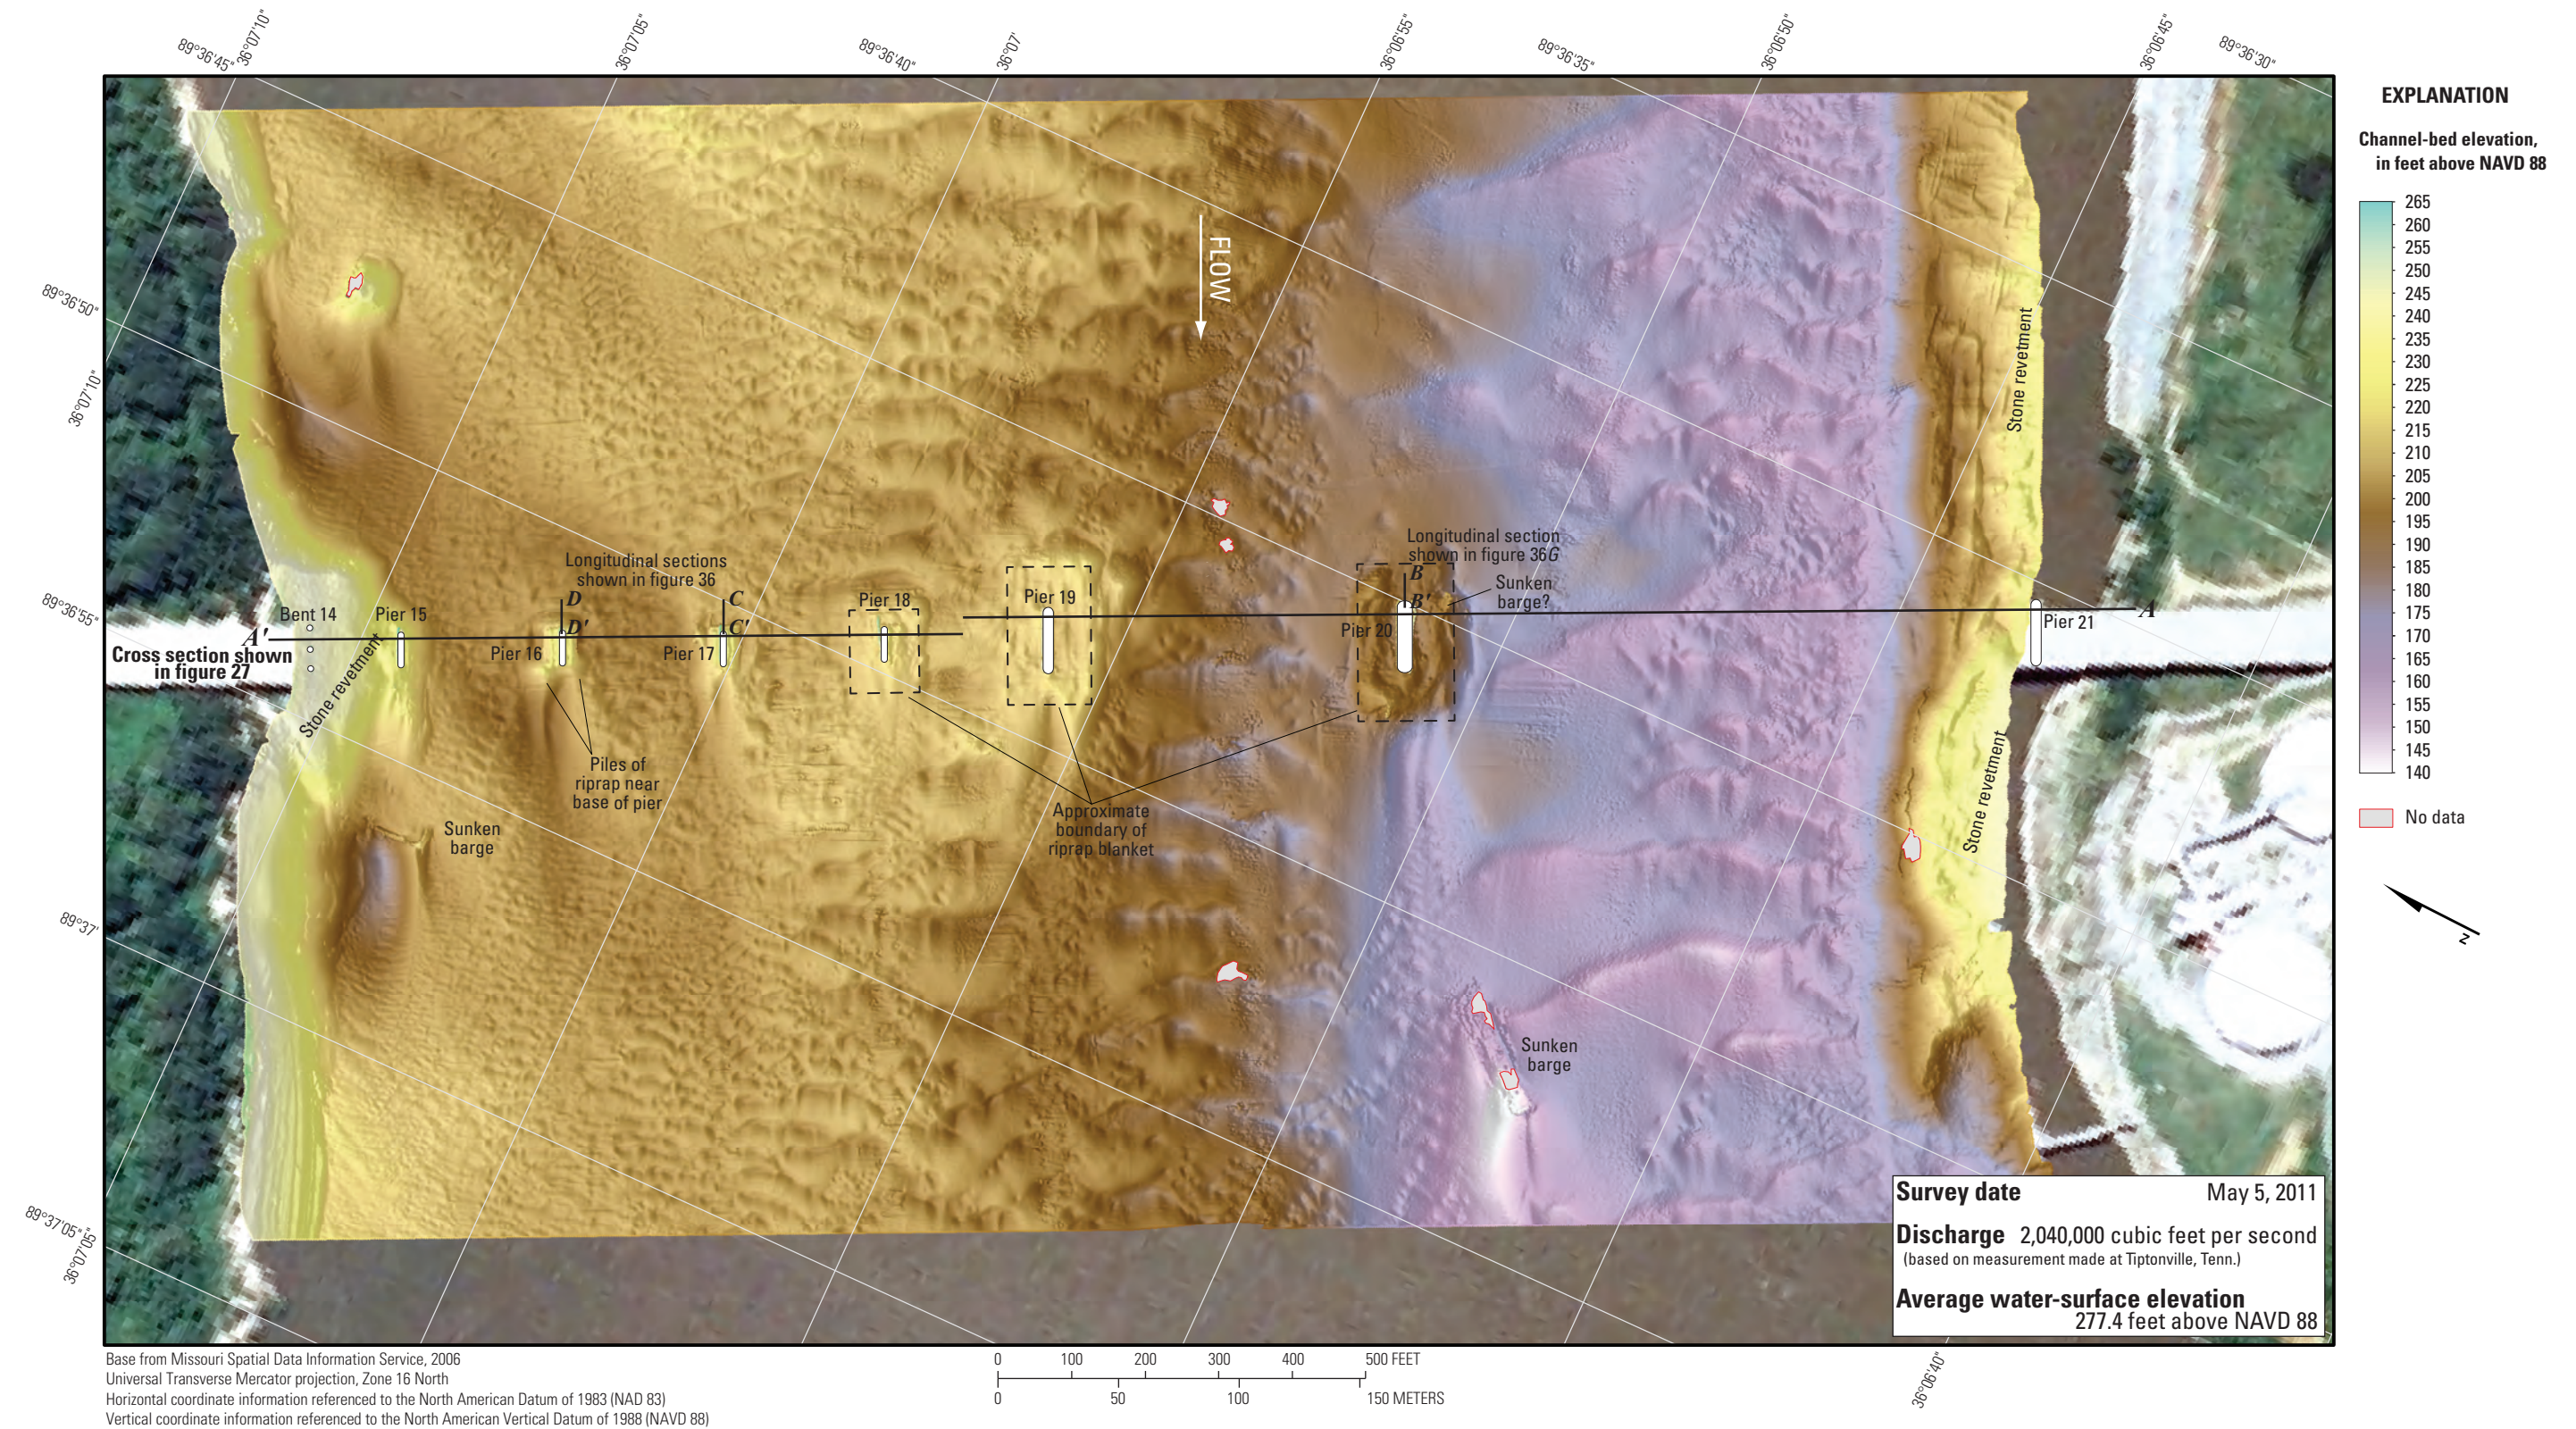
Figure 29. Bathymetric survey of the Mississippi River channel in the vicinity of structure A1700 on Interstate 155 near Caruthersville, Missouri, during flooding on May 5, 2011.

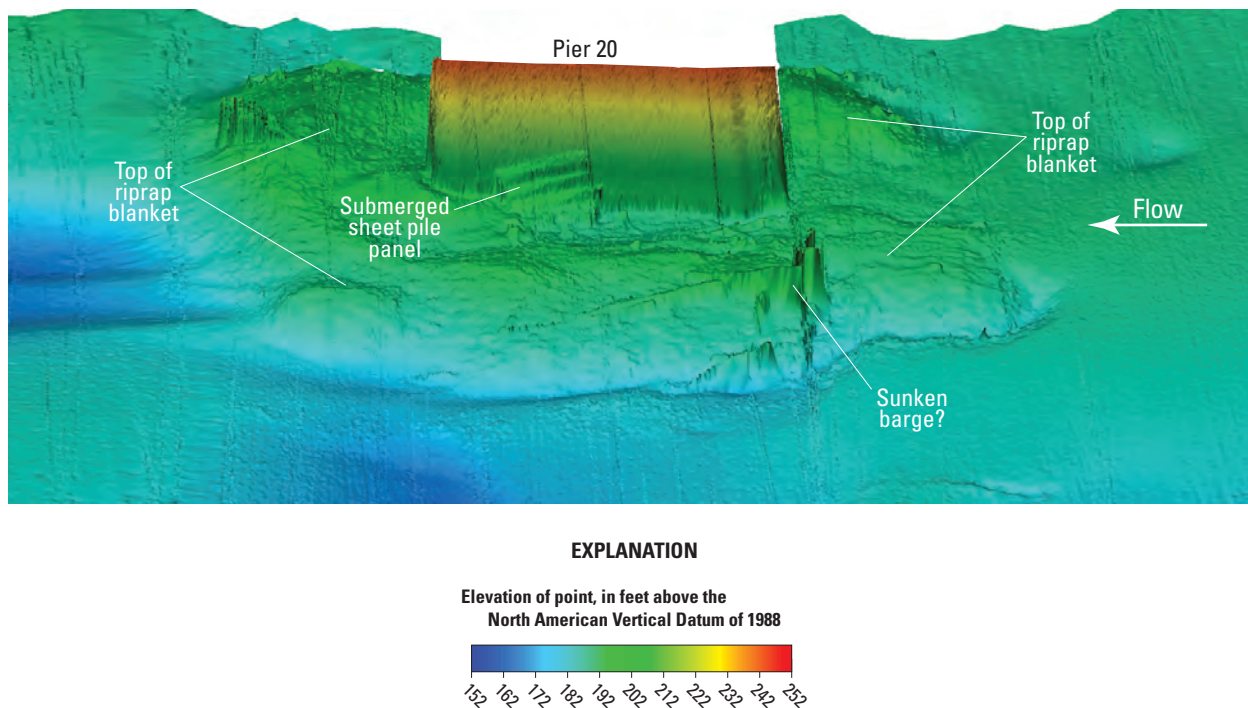
Figure 30. Shaded triangulated irregular network (TIN) visualization of the channel bed and left (southeast) side of main channel pier 20 of structure A1700 on Interstate 155 over the Mississippi River near Caruthersville, Missouri, during flooding on May 5, 2011.

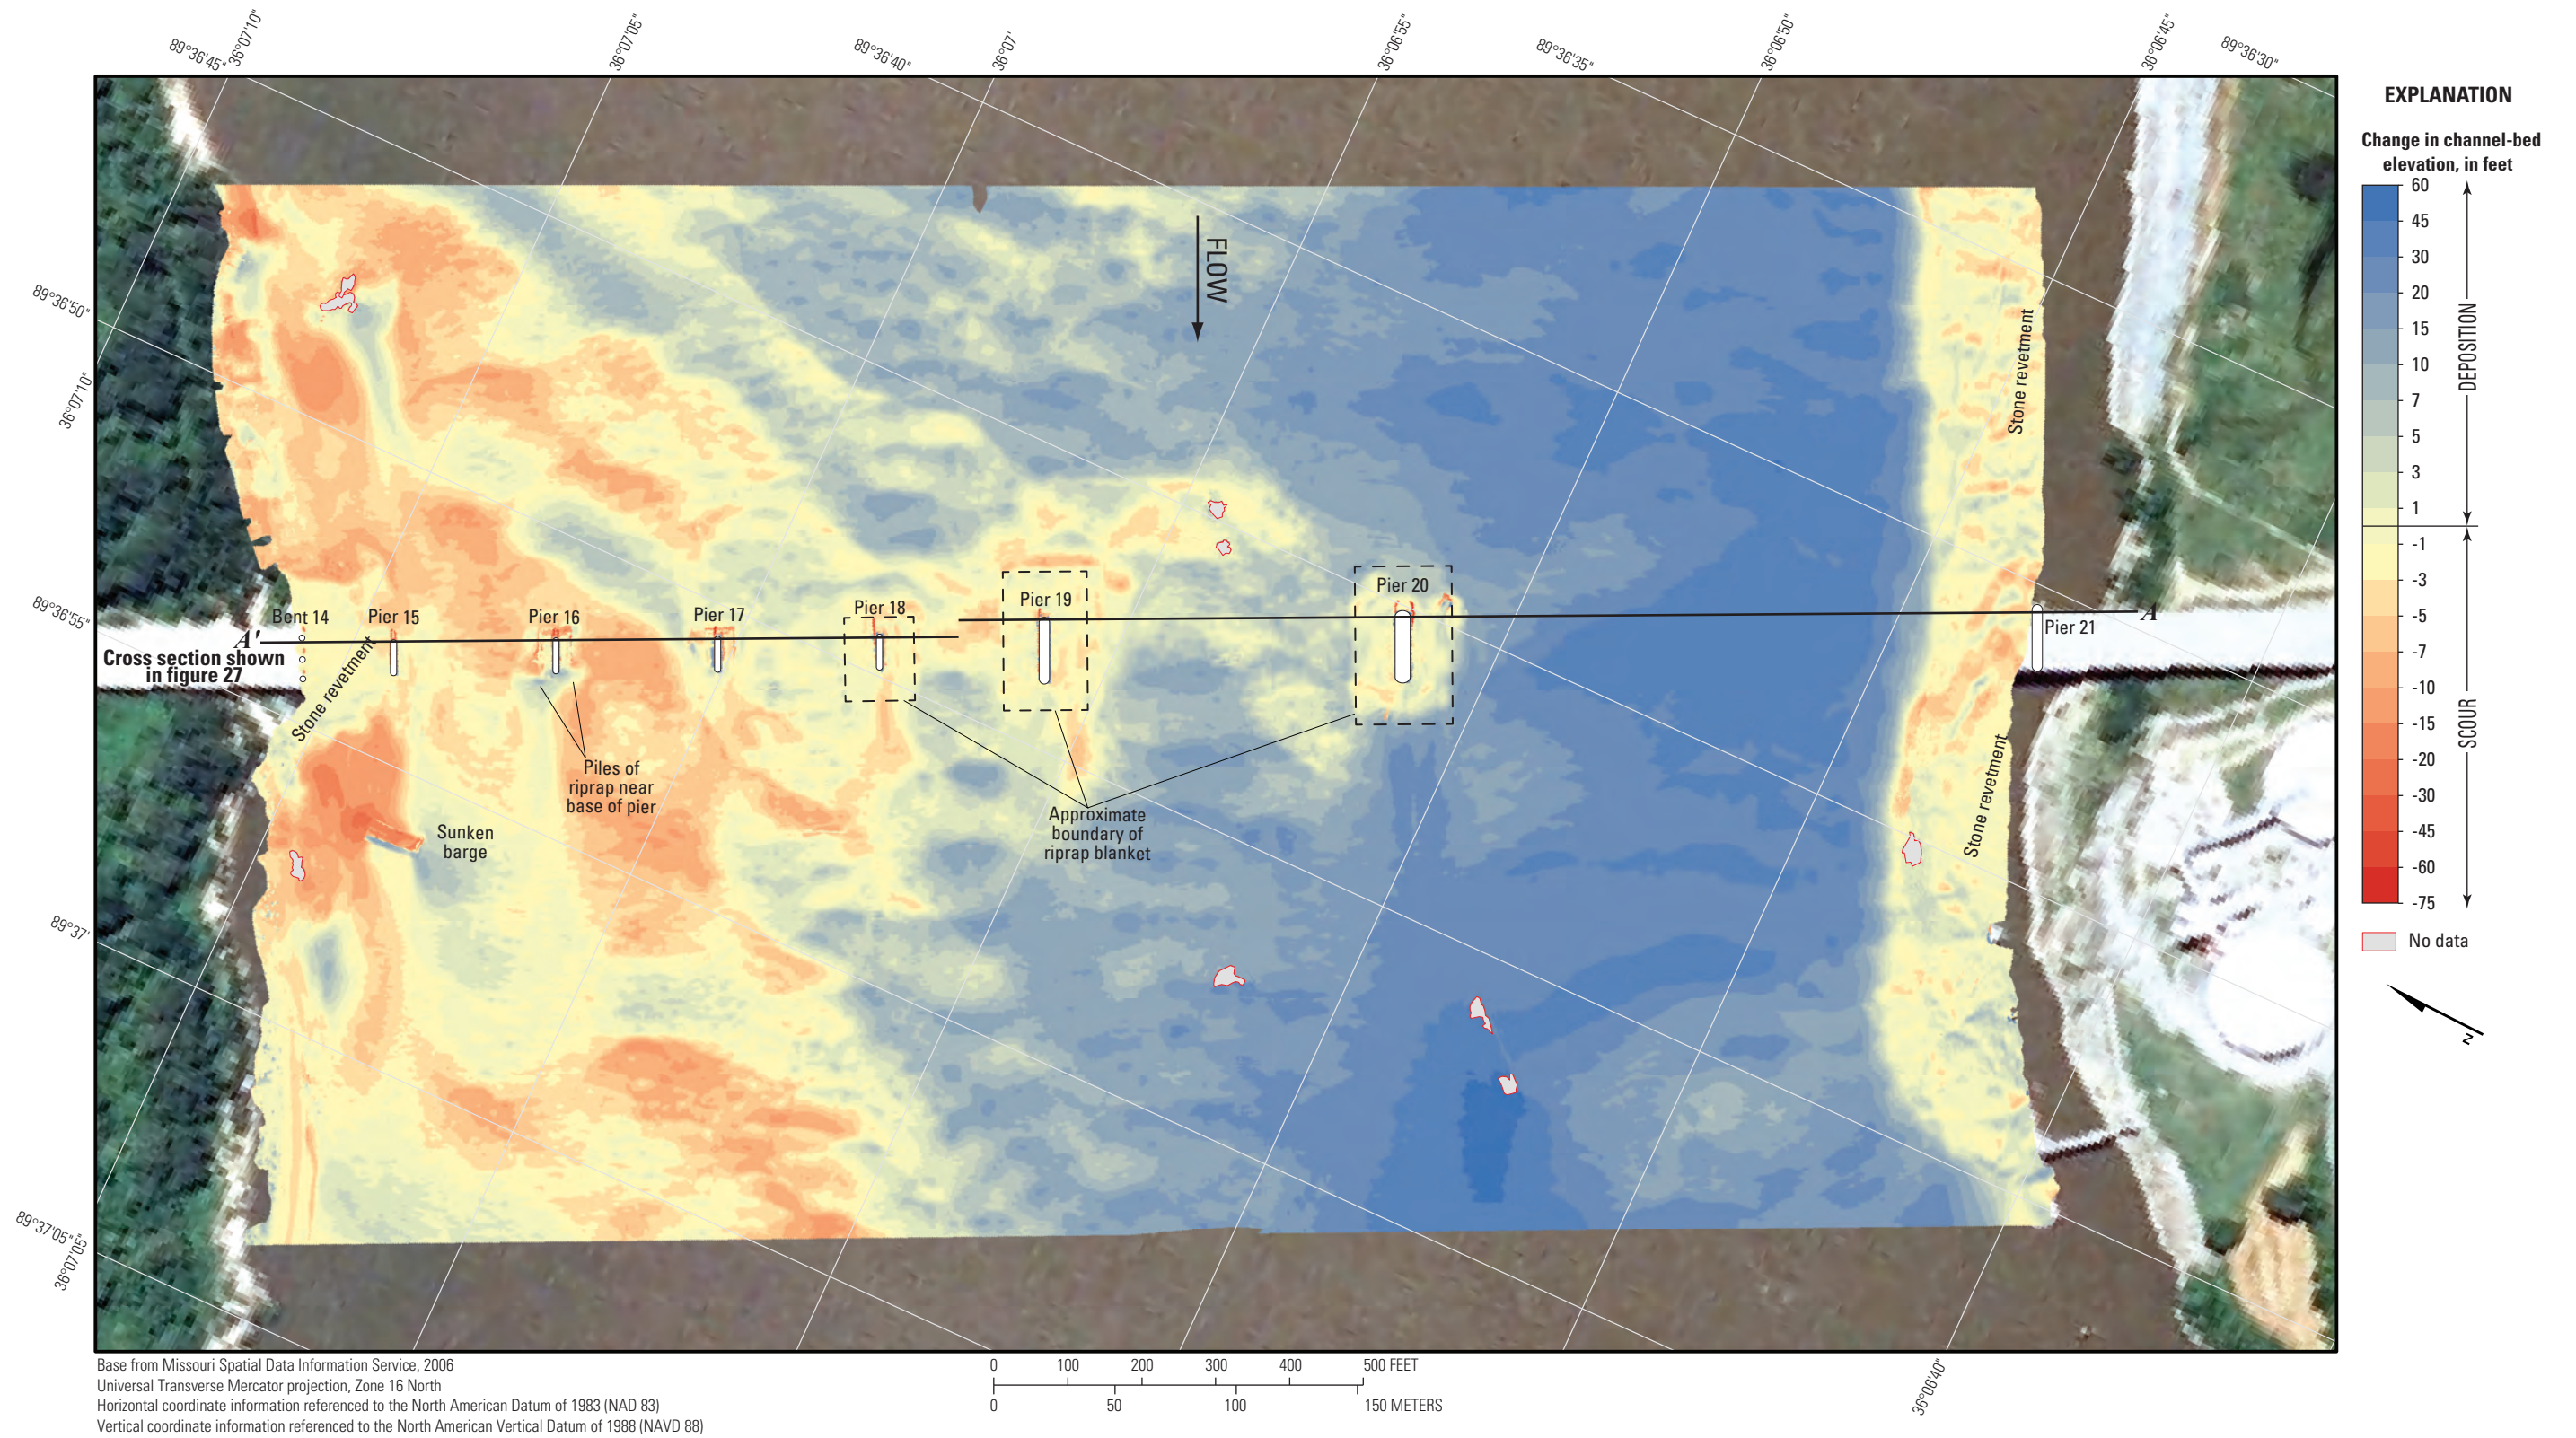
Figure 31. Difference between bathymetric surfaces created from surveys of the Mississippi River channel in the vicinity of structure A1700 on Interstate 155 near Caruthersville, Missouri, on June 11, 2014, and May 5, 2011.
