Bathymetric and Velocimetric Surveys at Highway Bridges Crossing the Missouri and Mississippi Rivers on the Periphery of Missouri, June 2014

Scientific Investigations Report 2015–5048

By Richard J. Huizinga

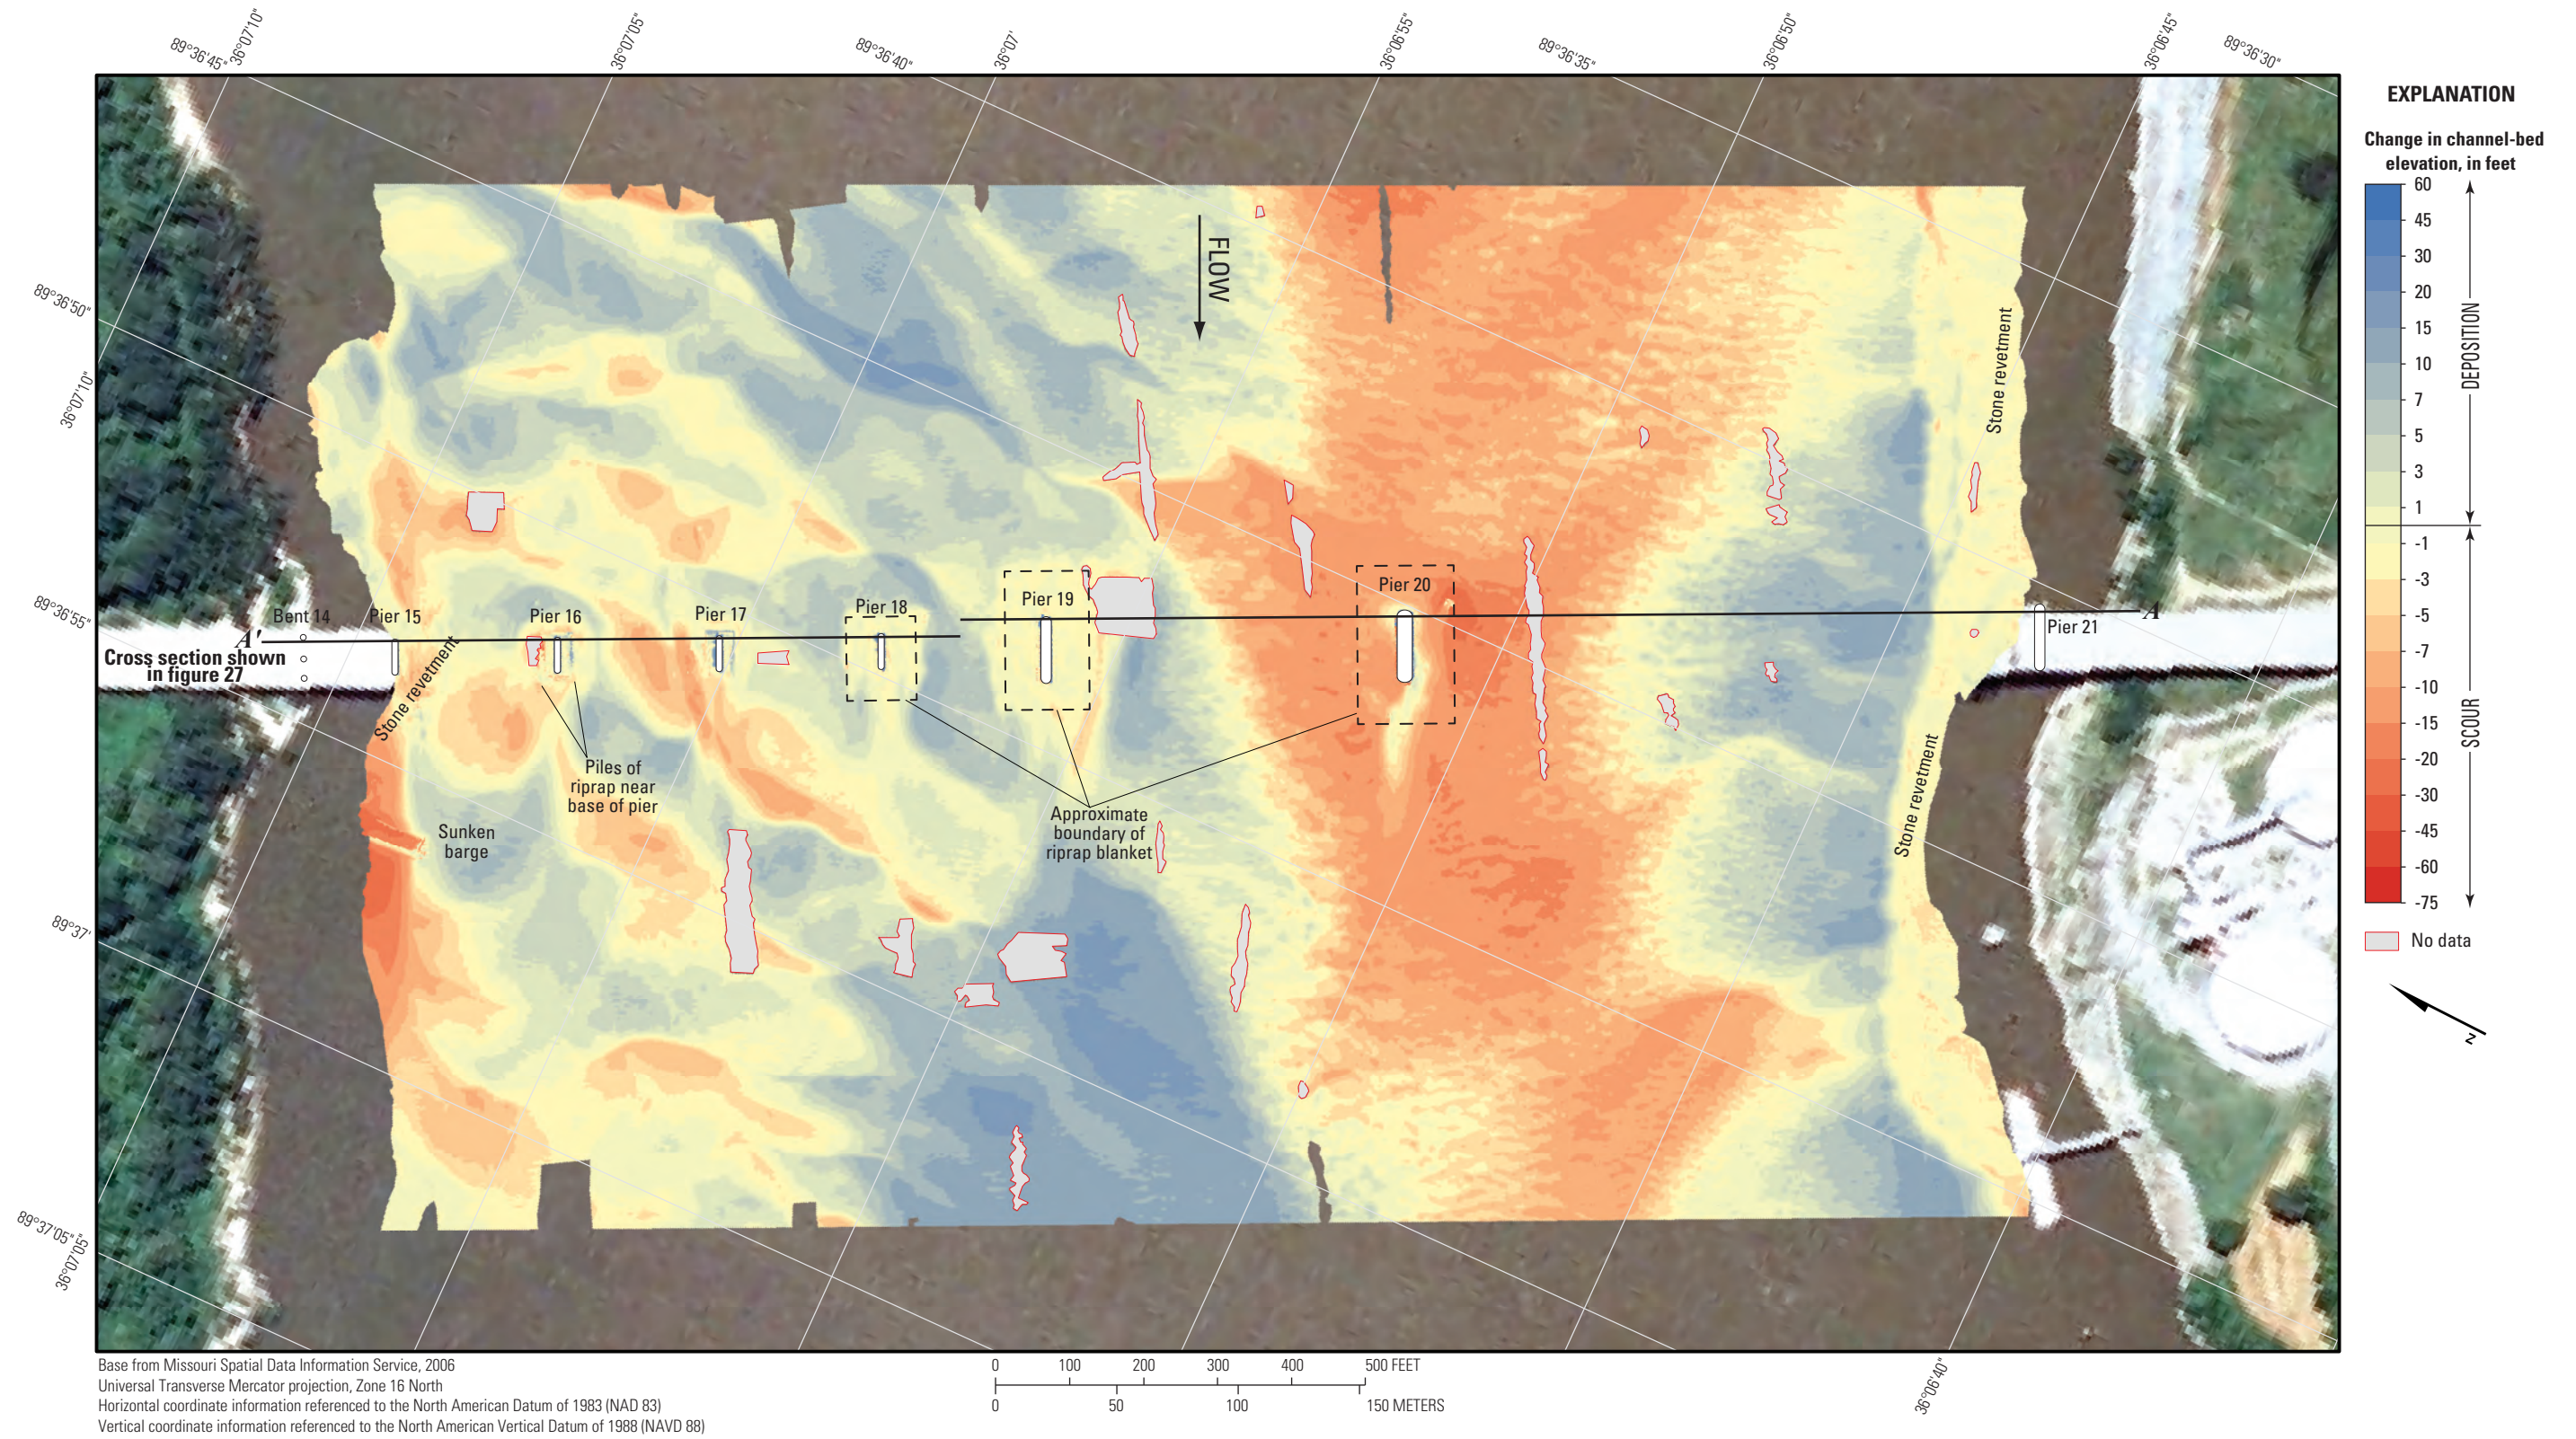
The difference between the surveys on June 11, 2014, and December 10, 2008 (fig. 32), indicates an apparent balance between areas of moderate scour and moderate deposition of up to 15 ft each; however, the 2011 flood event obviously

Figure 32. Difference between bathymetric surfaces created from surveys of the Mississippi River channel in the vicinity of structure A1700 on Interstate 155 near Caruthersville, Missouri, on June 11, 2014, and December 10, 2008.

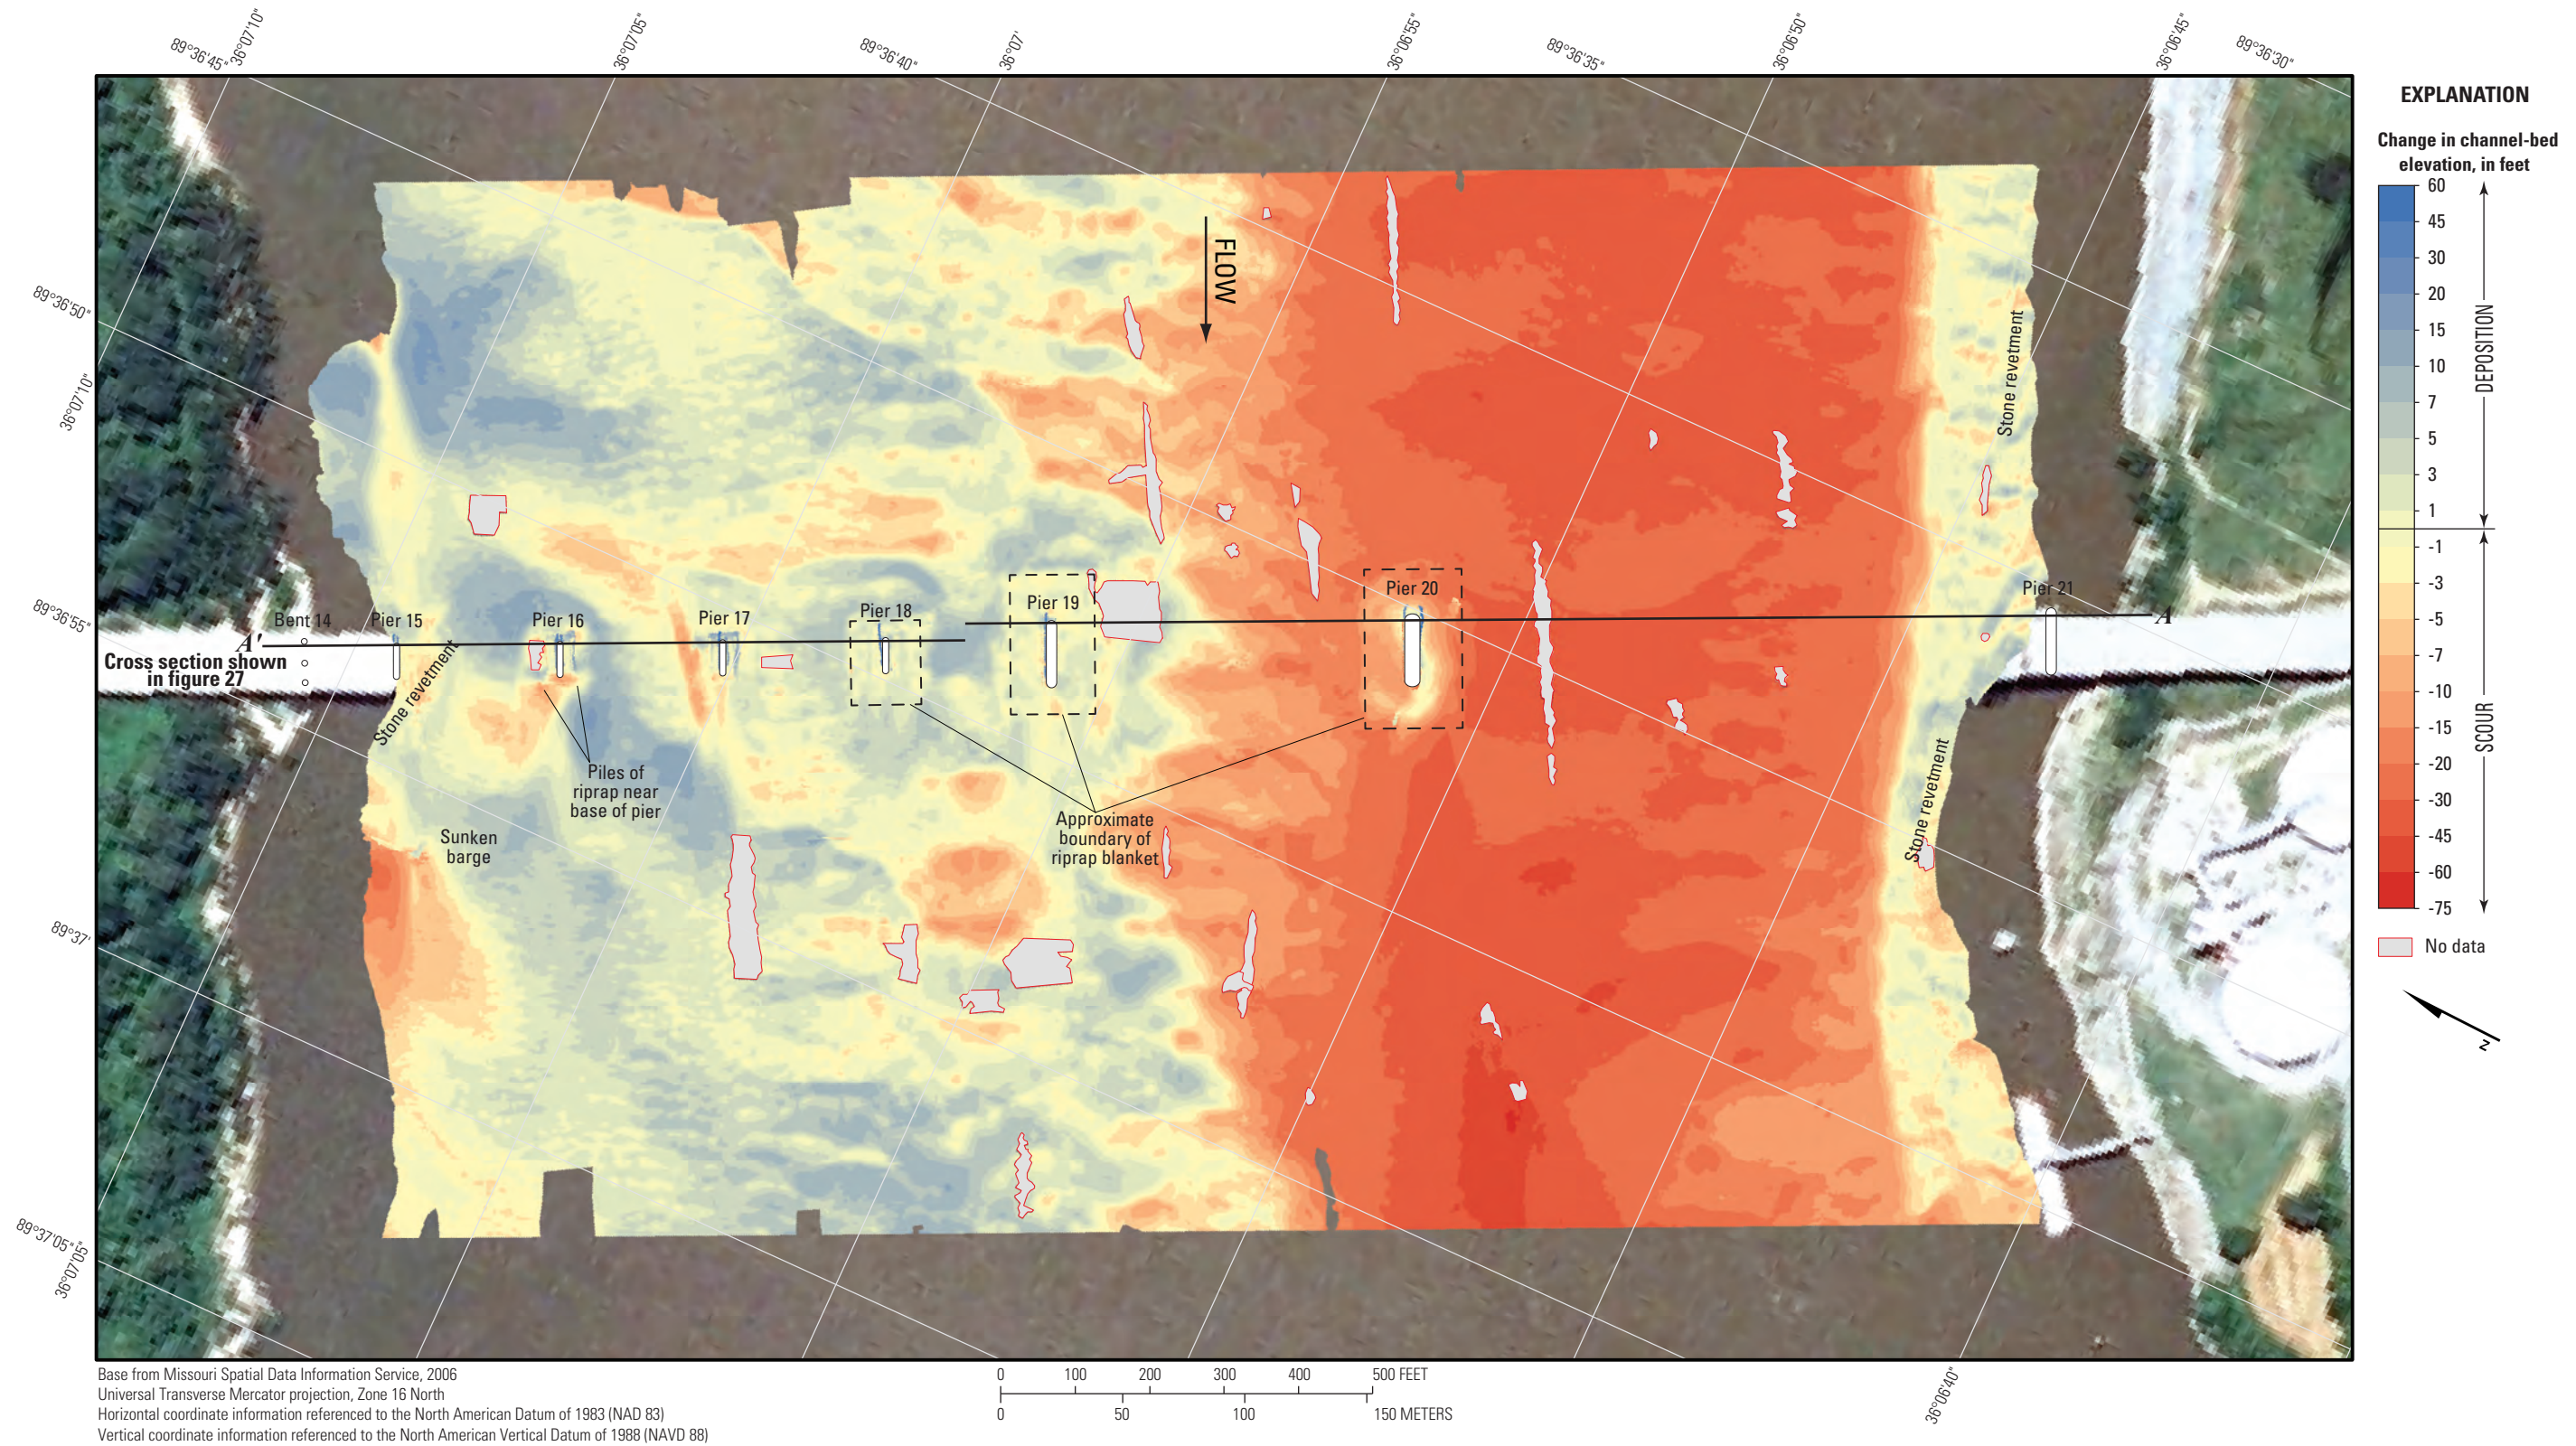
Figure 33. Difference between bathymetric surfaces created from surveys of the Mississippi River channel in the vicinity of structure A1700 on Interstate 155 near Caruthersville, Missouri, on May 5, 2011, and December 10, 2008.

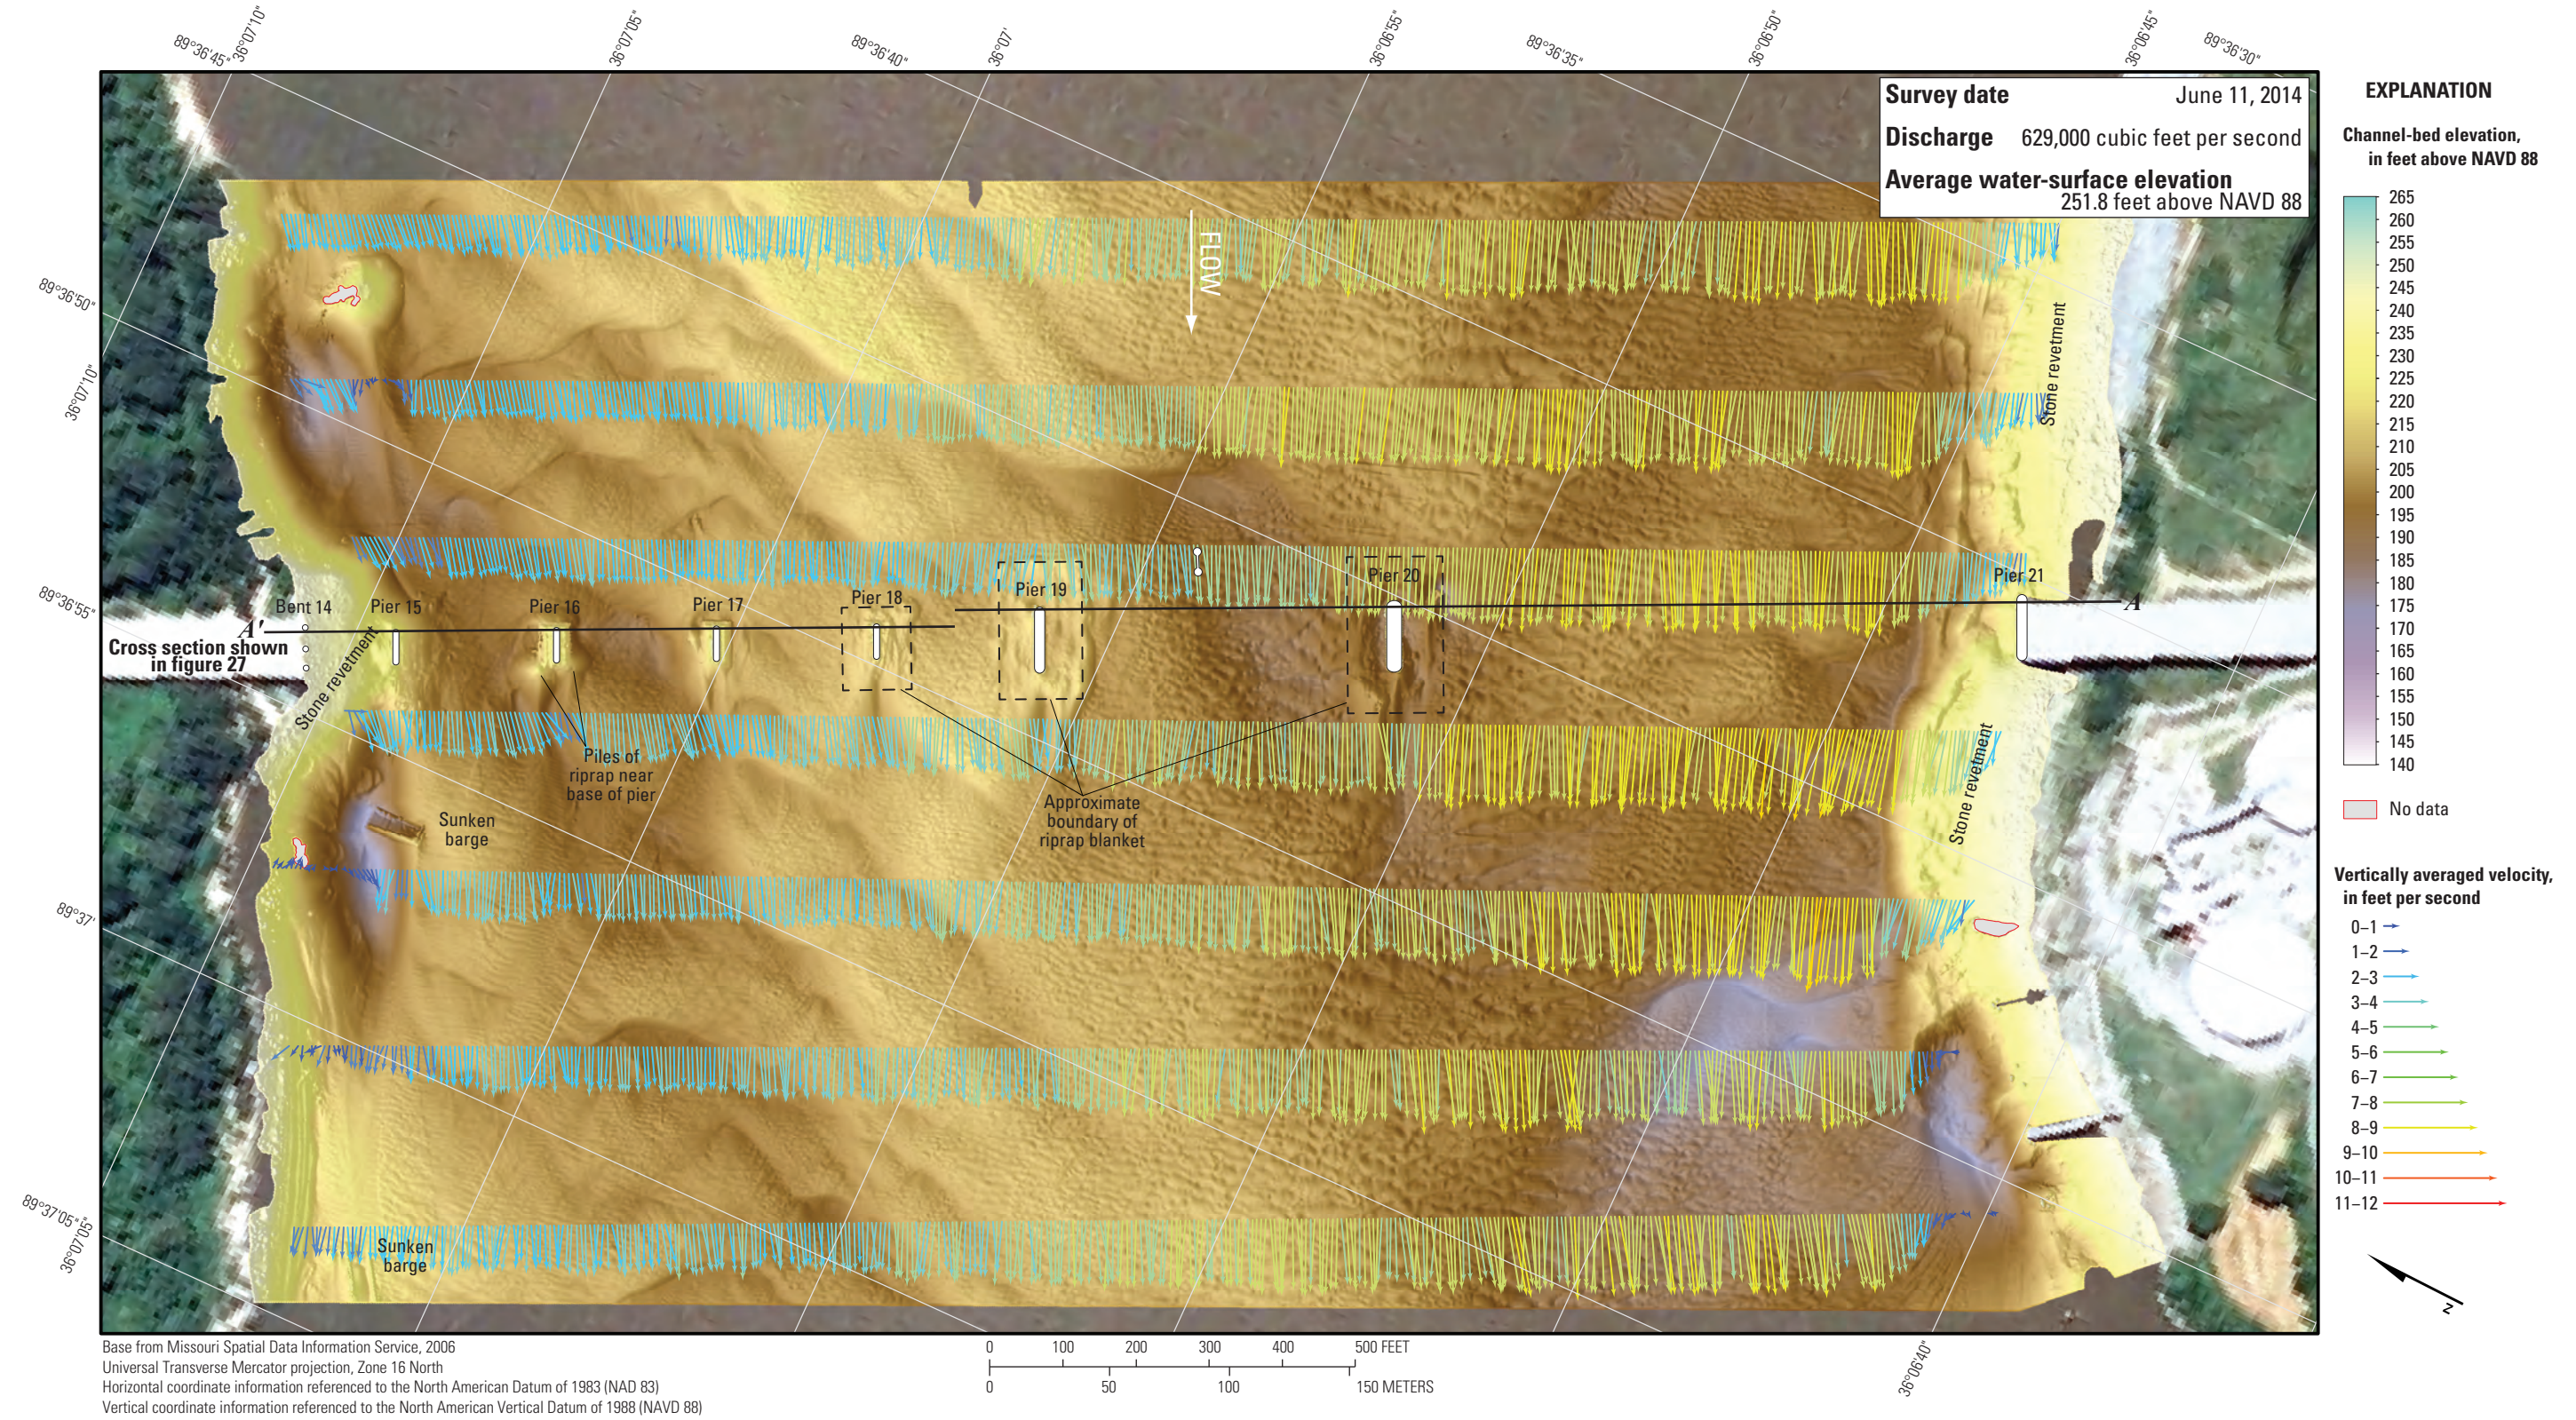
The vertically averaged velocity vectors for the 2014 survey indicate mostly uniform flow throughout a majority of the reach, with small areas of flow disturbance and shear flow, particularly along the banks near the constrictions at the bridge and downstream (fig. 34). Velocities ranged from about 6 to 10 ft/s for the left side of the channel, and from 2 to 6 ft/s for the right side of the channel, and low velocities and flow reversals were observed downstream from the bank constrictions at the bridge and the pile near the upstream end of the reach. The piers generally were aligned with flow, with minimal wake vortices observed downstream (fig. 34). Velocity data were not collected in the 2008 or 2011 surveys.

Figure 34. Bathymetry and vertically averaged velocities of the Mississippi River channel in the vicinity of structure A1700 on Interstate 155 near Caruthersville, Missouri, on June 11, 2014.

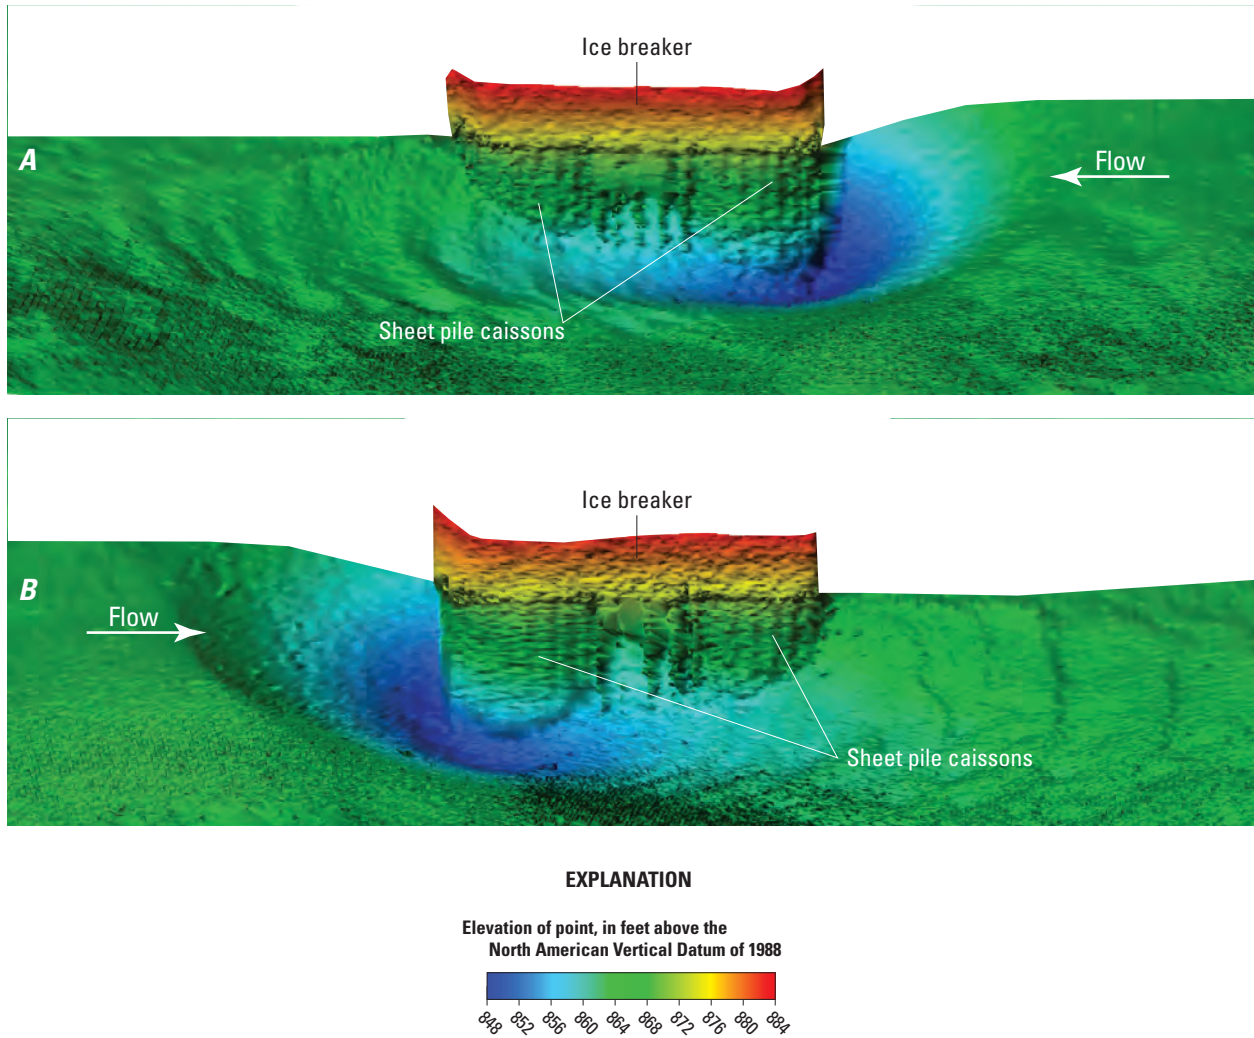
Figure 2-1. Shaded triangulated irregular network (TIN) visualization of the channel bed and A, left (northeast) side and B, right (southwest) side of main channel pier 3 of structure L0098 on U.S. Highway 136 over the Missouri River at Brownville, Nebraska.

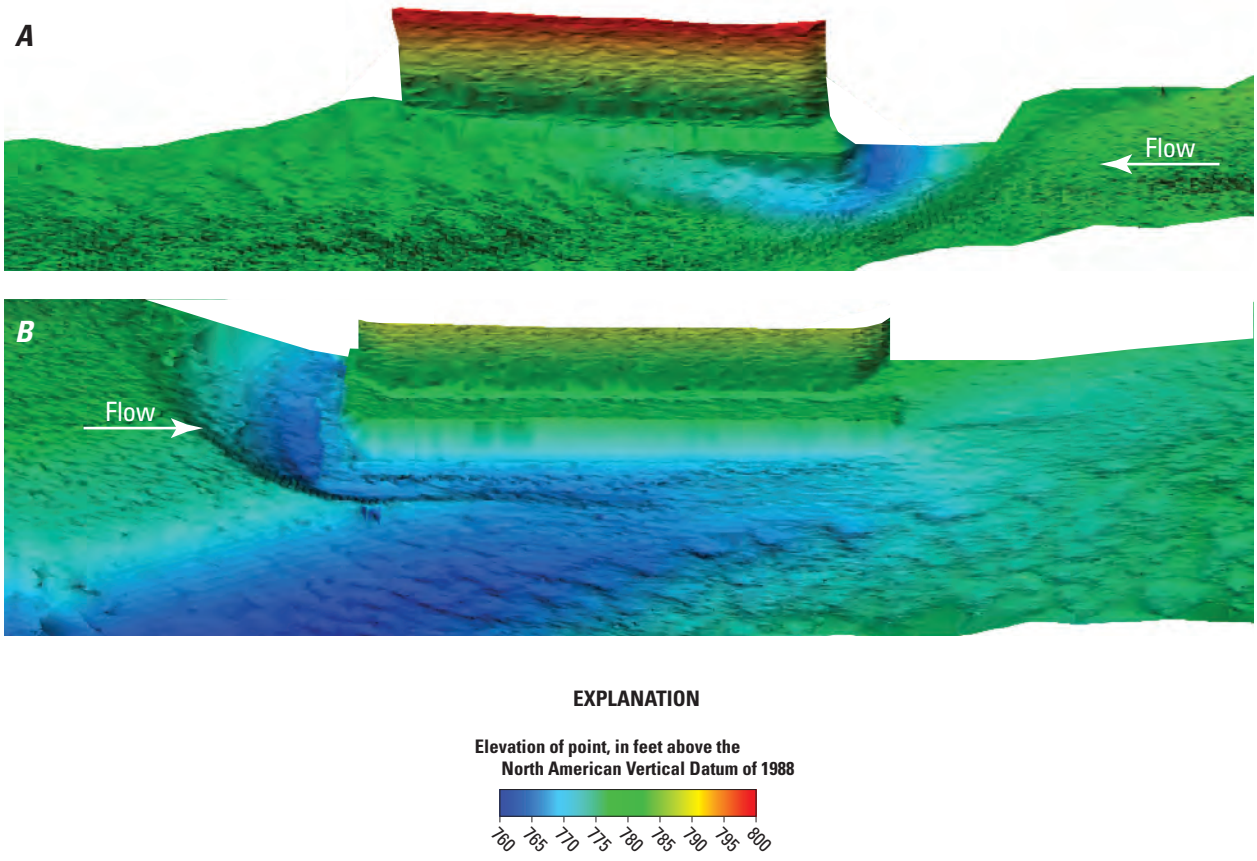
Figure 2-2. Shaded triangulated irregular network (TIN) visualization of the channel bed and *A*, left (east) side and *B*, right (west) side of main channel pier 10 of dual bridge structure A3664 on U.S. Highway 36 over the Missouri River at St. Joseph, Missouri.

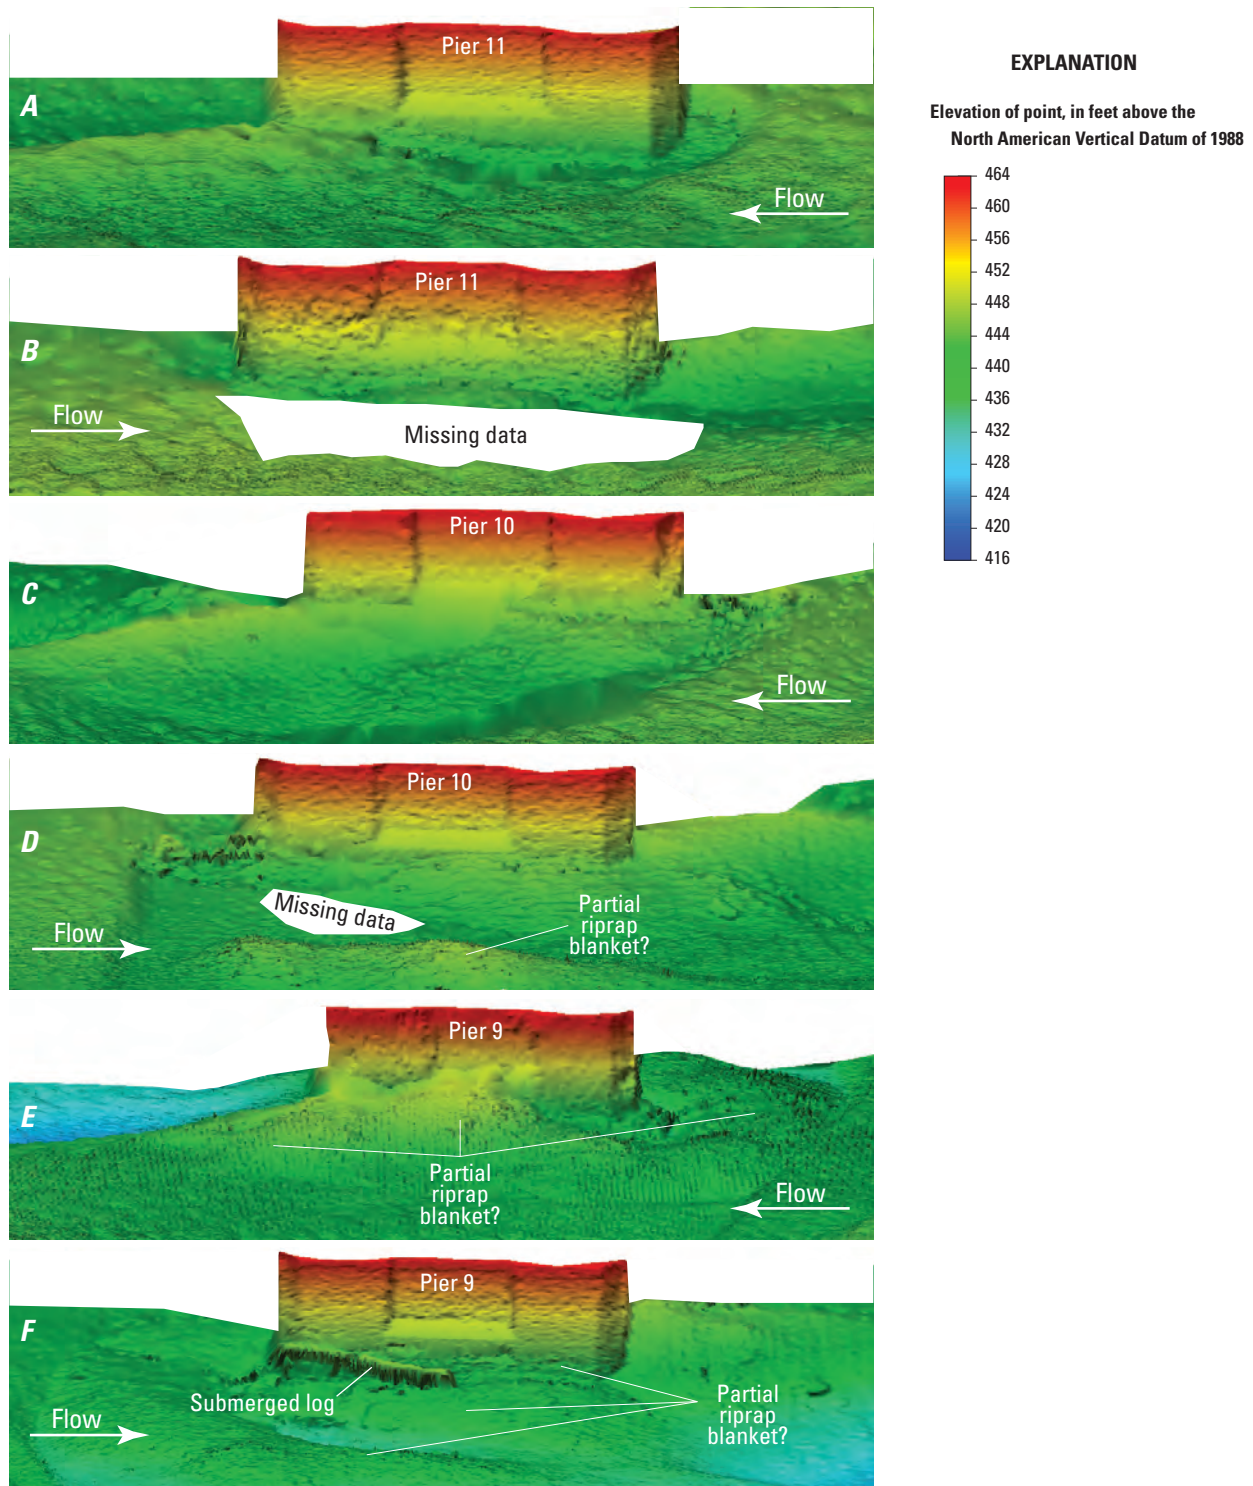
Figure 2-3. Shaded triangulated irregular network (TIN) visualization of the channel bed and *A*, left (northeast) side and *B*, right (southwest) side of main channel pier 11; *C*, left (northeast) side and *D*, right (southwest) side of main channel pier 10; and *E*, left (northeast) side and *F*, right (southwest) side of main channel pier 9 of structure A5054 on Interstate 72 over the Mississippi River at Hannibal, Missouri.

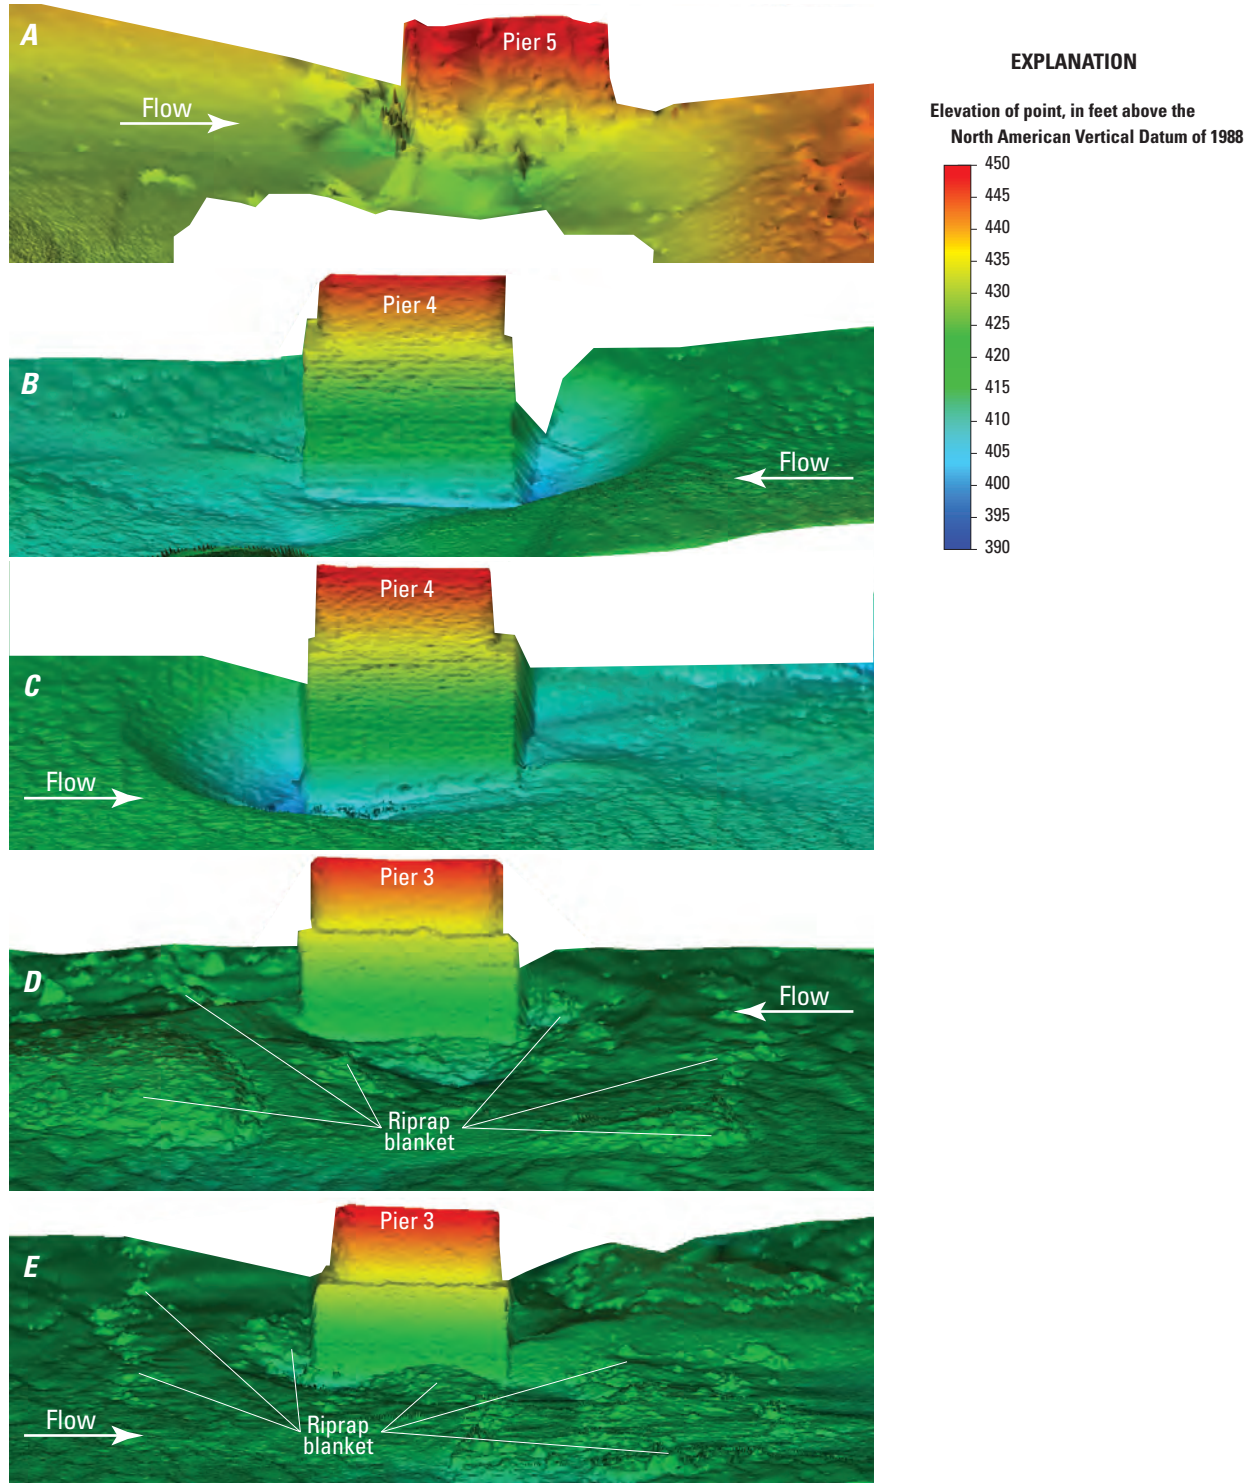
Figure 2-5. Shaded triangulated irregular network (TIN) visualization of the channel bed and A, right (southwest) side of main channel pier 5; B, left (northeast) side and C, right (southwest) side of main channel pier 4; and D, left (northeast) side and E, right (southwest) side of main channel pier 3 of structure K0932 on U.S. Highway 54 over the Mississippi River at Louisiana, Missouri.

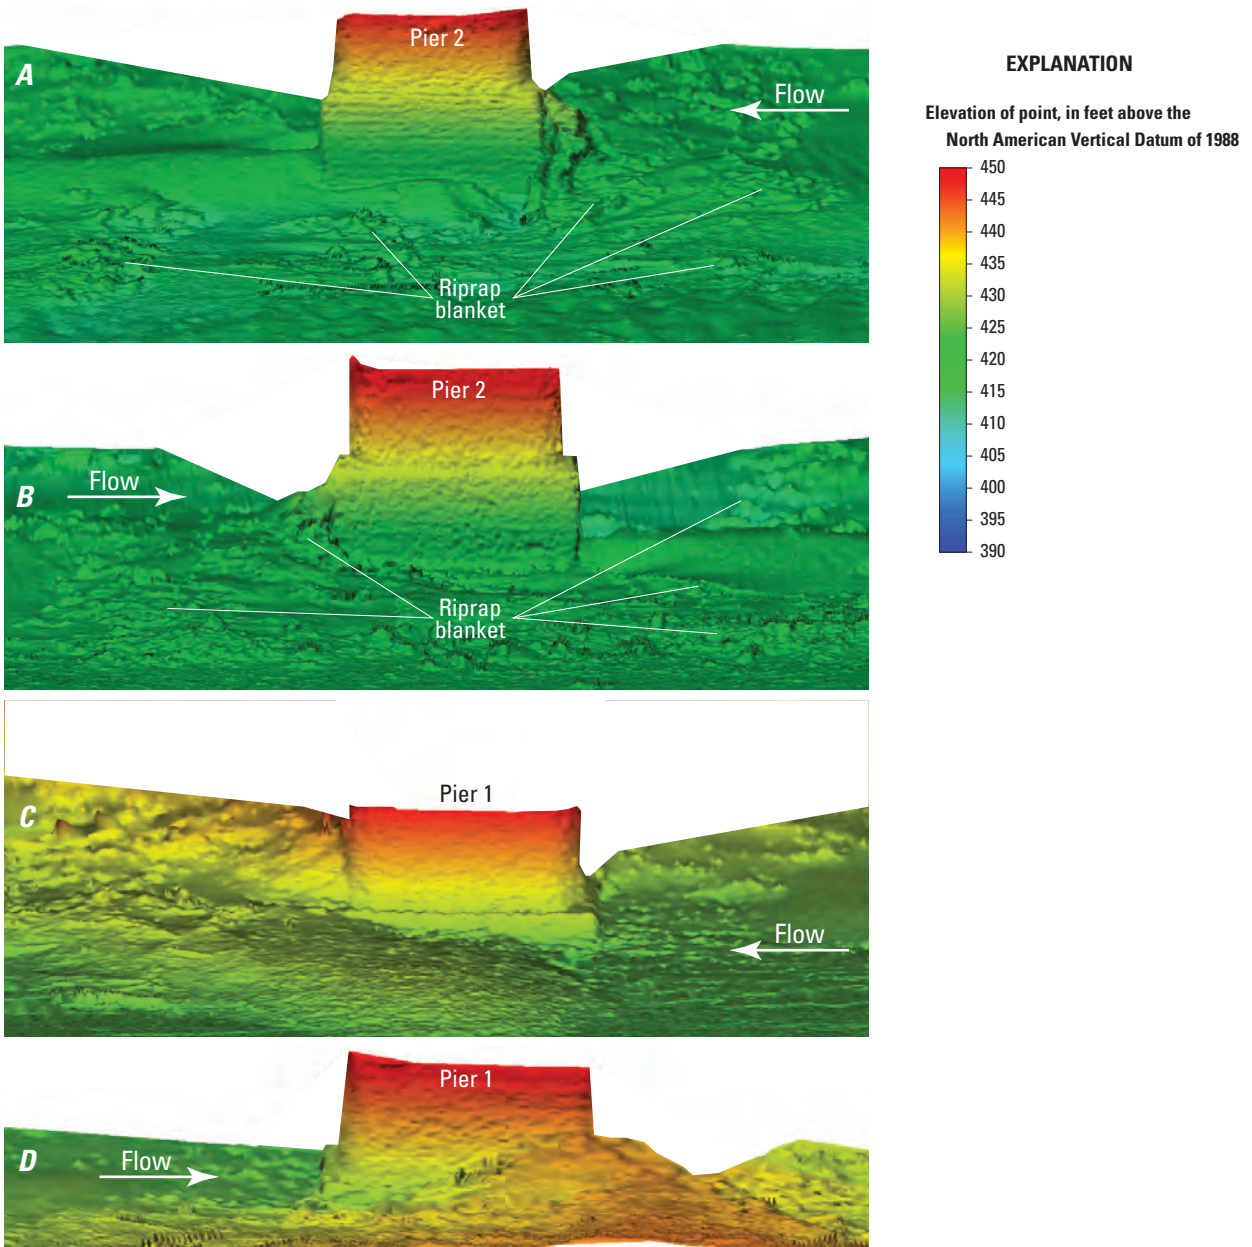
Figure 2-6. Shaded triangulated irregular network (TIN) visualization of the channel bed and *A*, left (northeast) side and *B*, right (southwest) side of main channel pier 2; and *C*, left (northeast) side and *D*, right (southwest) side of main channel pier 1 of structure K0932 on U.S. Highway 54 over the Mississippi River at Louisiana, Missouri.

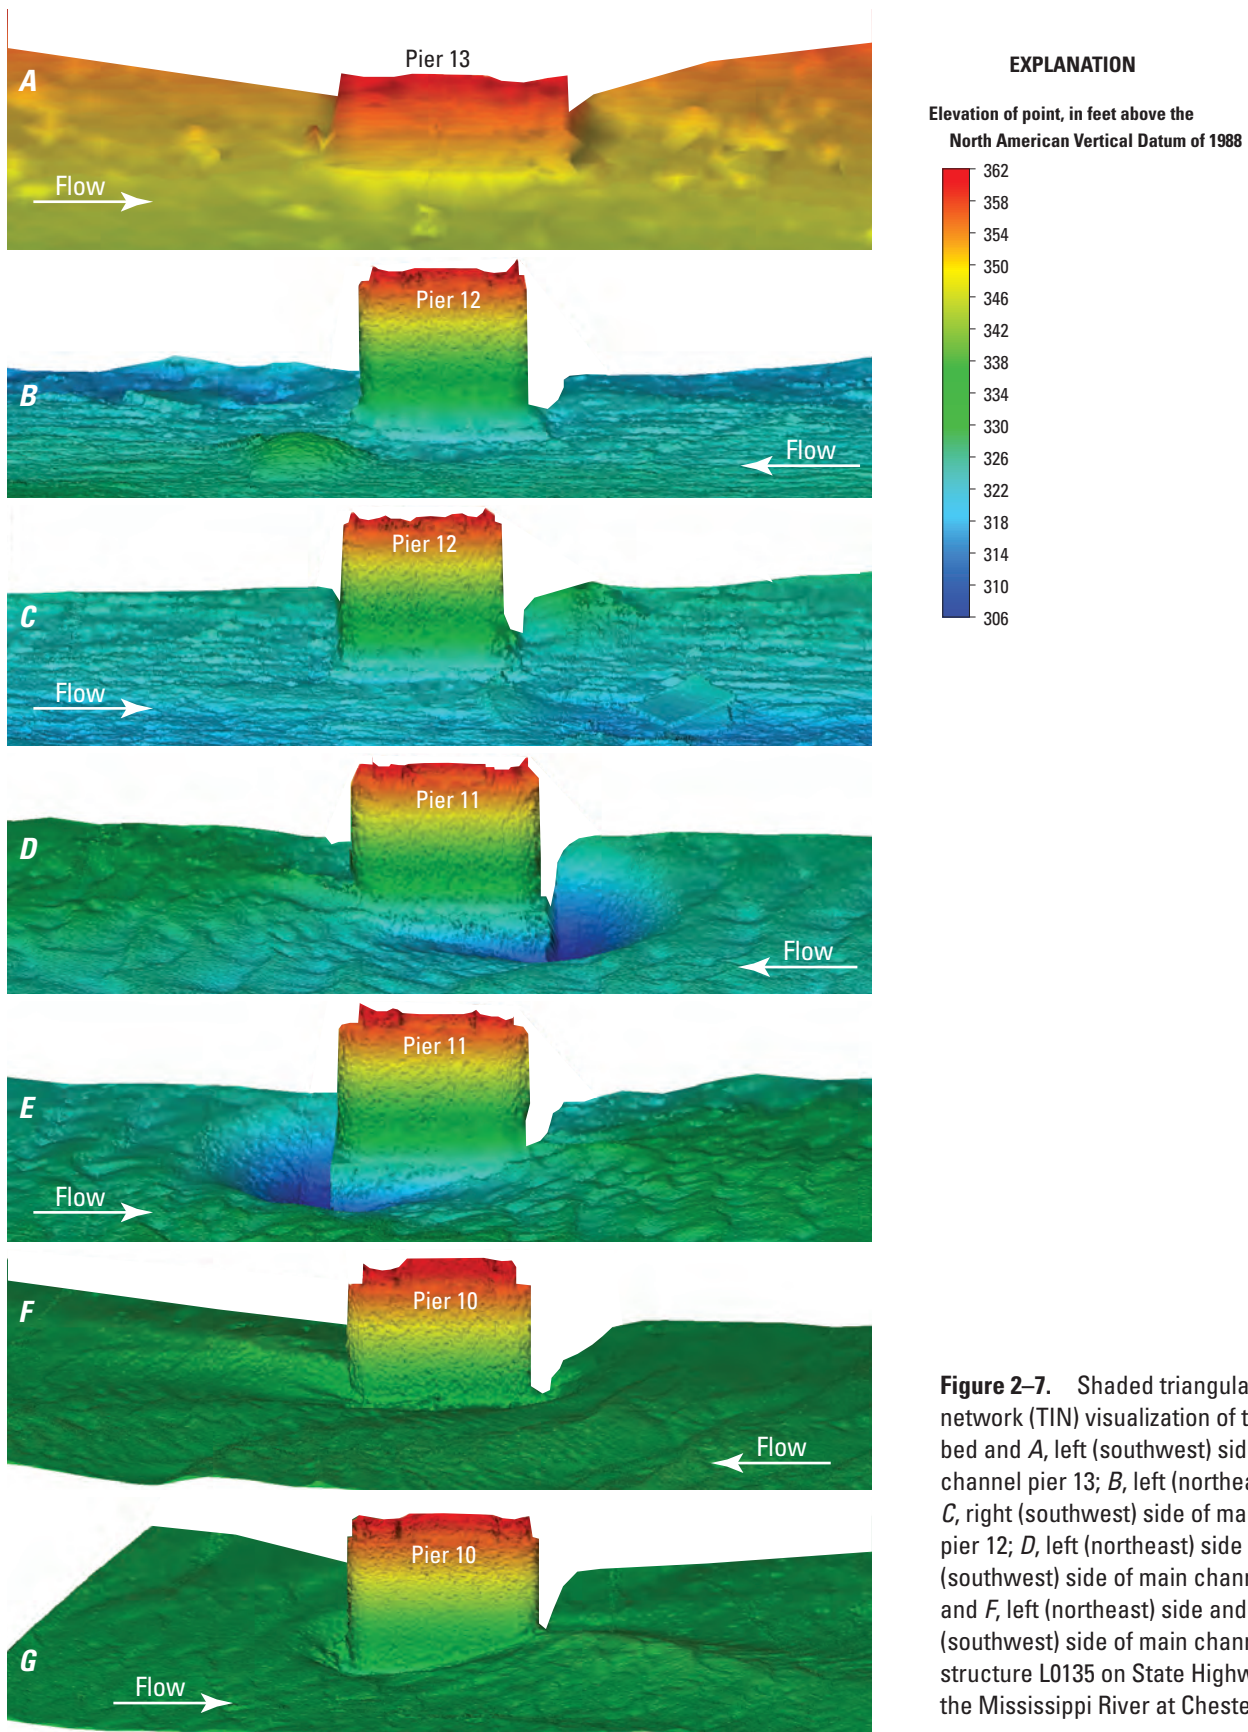
Figure 2-7. Shaded triangulated irregular network (TIN) visualization of the channel bed and A, left (southwest) side of main channel pier 13; B, left (northeast) side and C, right (southwest) side of main channel pier 12; D, left (northeast) side and E, right (southwest) side of main channel pier 11; and F, left (northeast) side and G, right (southwest) side of main channel pier 10 of structure L0135 on State Highway 51 over the Mississippi River at Chester, Illinois.
