Bathymetric and Velocimetric Surveys at Highway Bridges Crossing the Missouri and Mississippi Rivers on the Periphery of Missouri, June 2014

Scientific Investigations Report 2015–5048

By Richard J. Huizinga

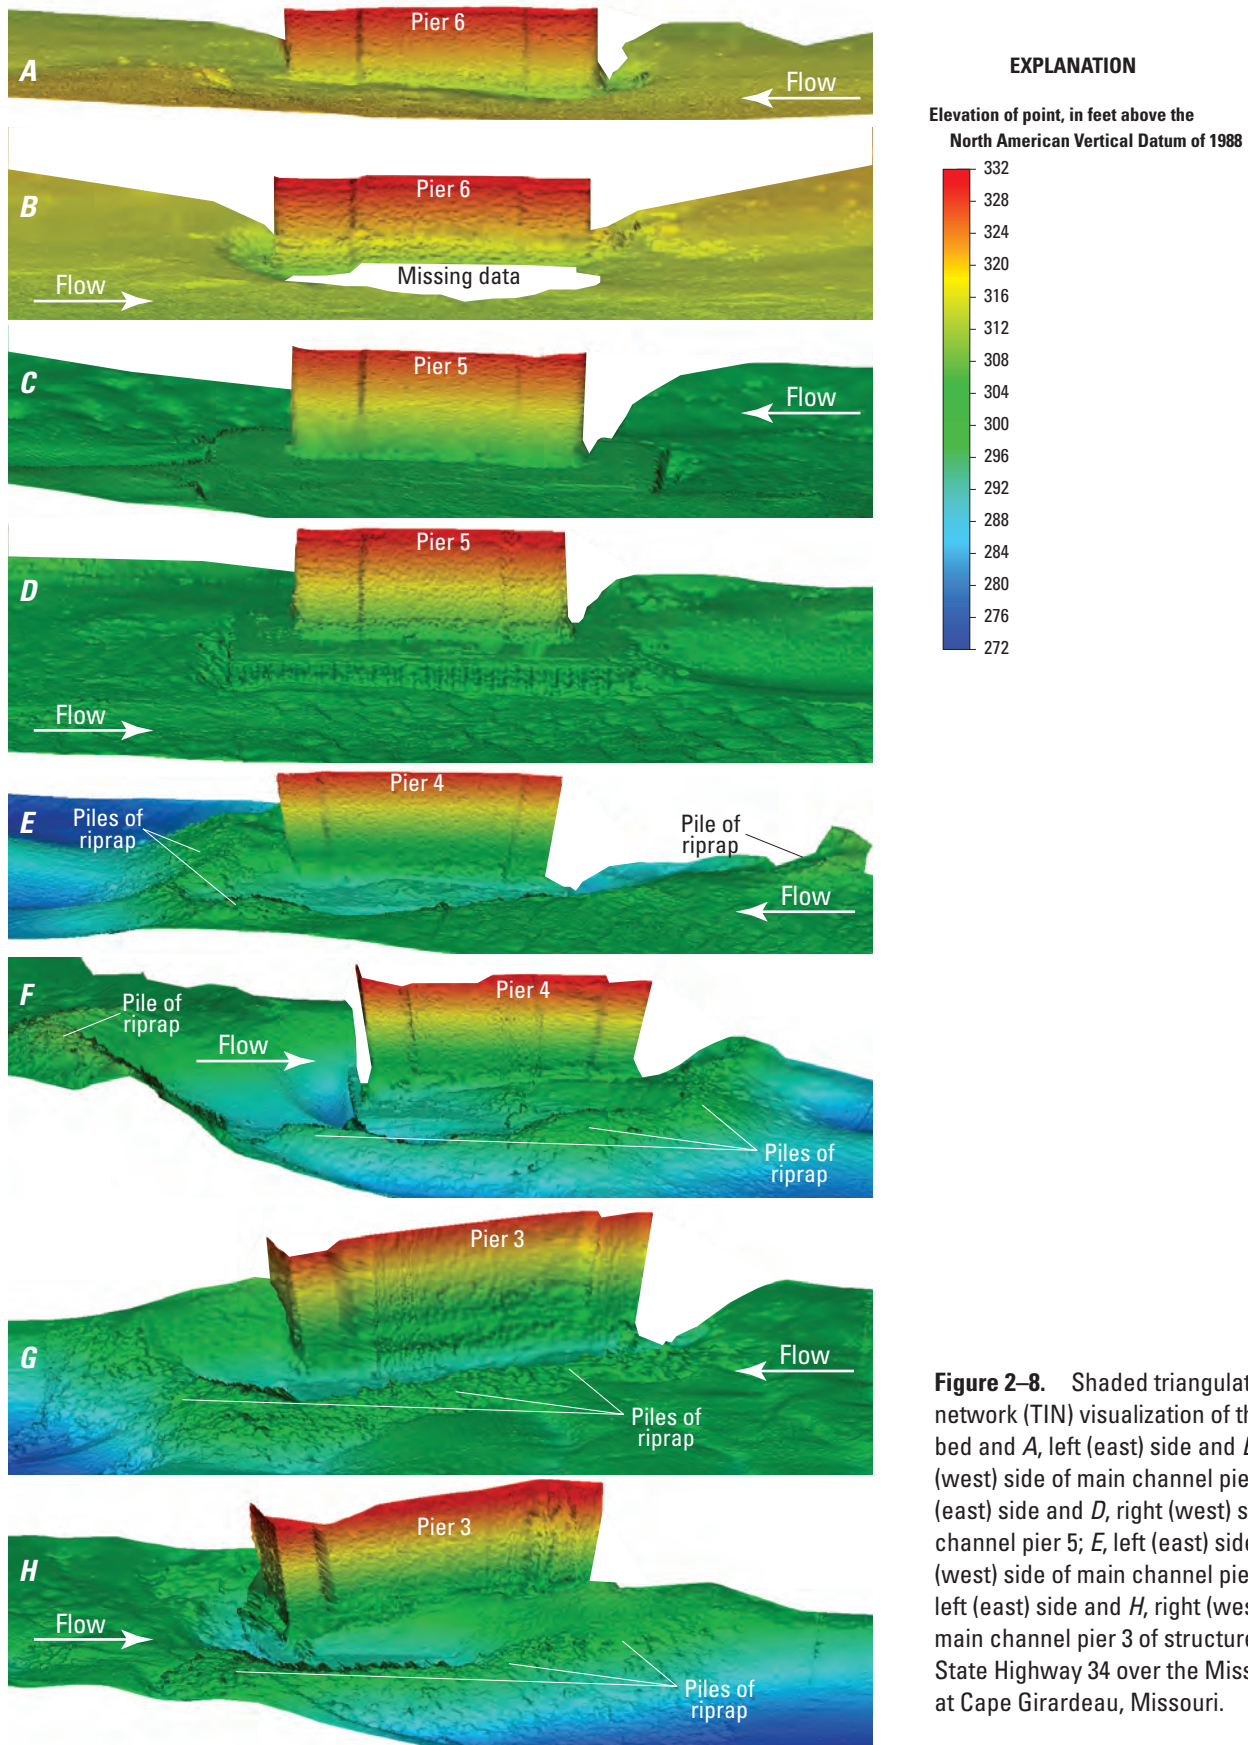
Figure 2-8. Shaded triangulated irregular network (TIN) visualization of the channel bed and A, left (east) side and B, right (west) side of main channel pier 6; C, left (east) side and D, right (west) side of main channel pier 5; E, left (east) side and F, right (west) side of main channel pier 4; and G, left (east) side and H, right (west) side of main channel pier 3 of structure A5076 on State Highway 34 over the Mississippi River at Cape Girardeau, Missouri.

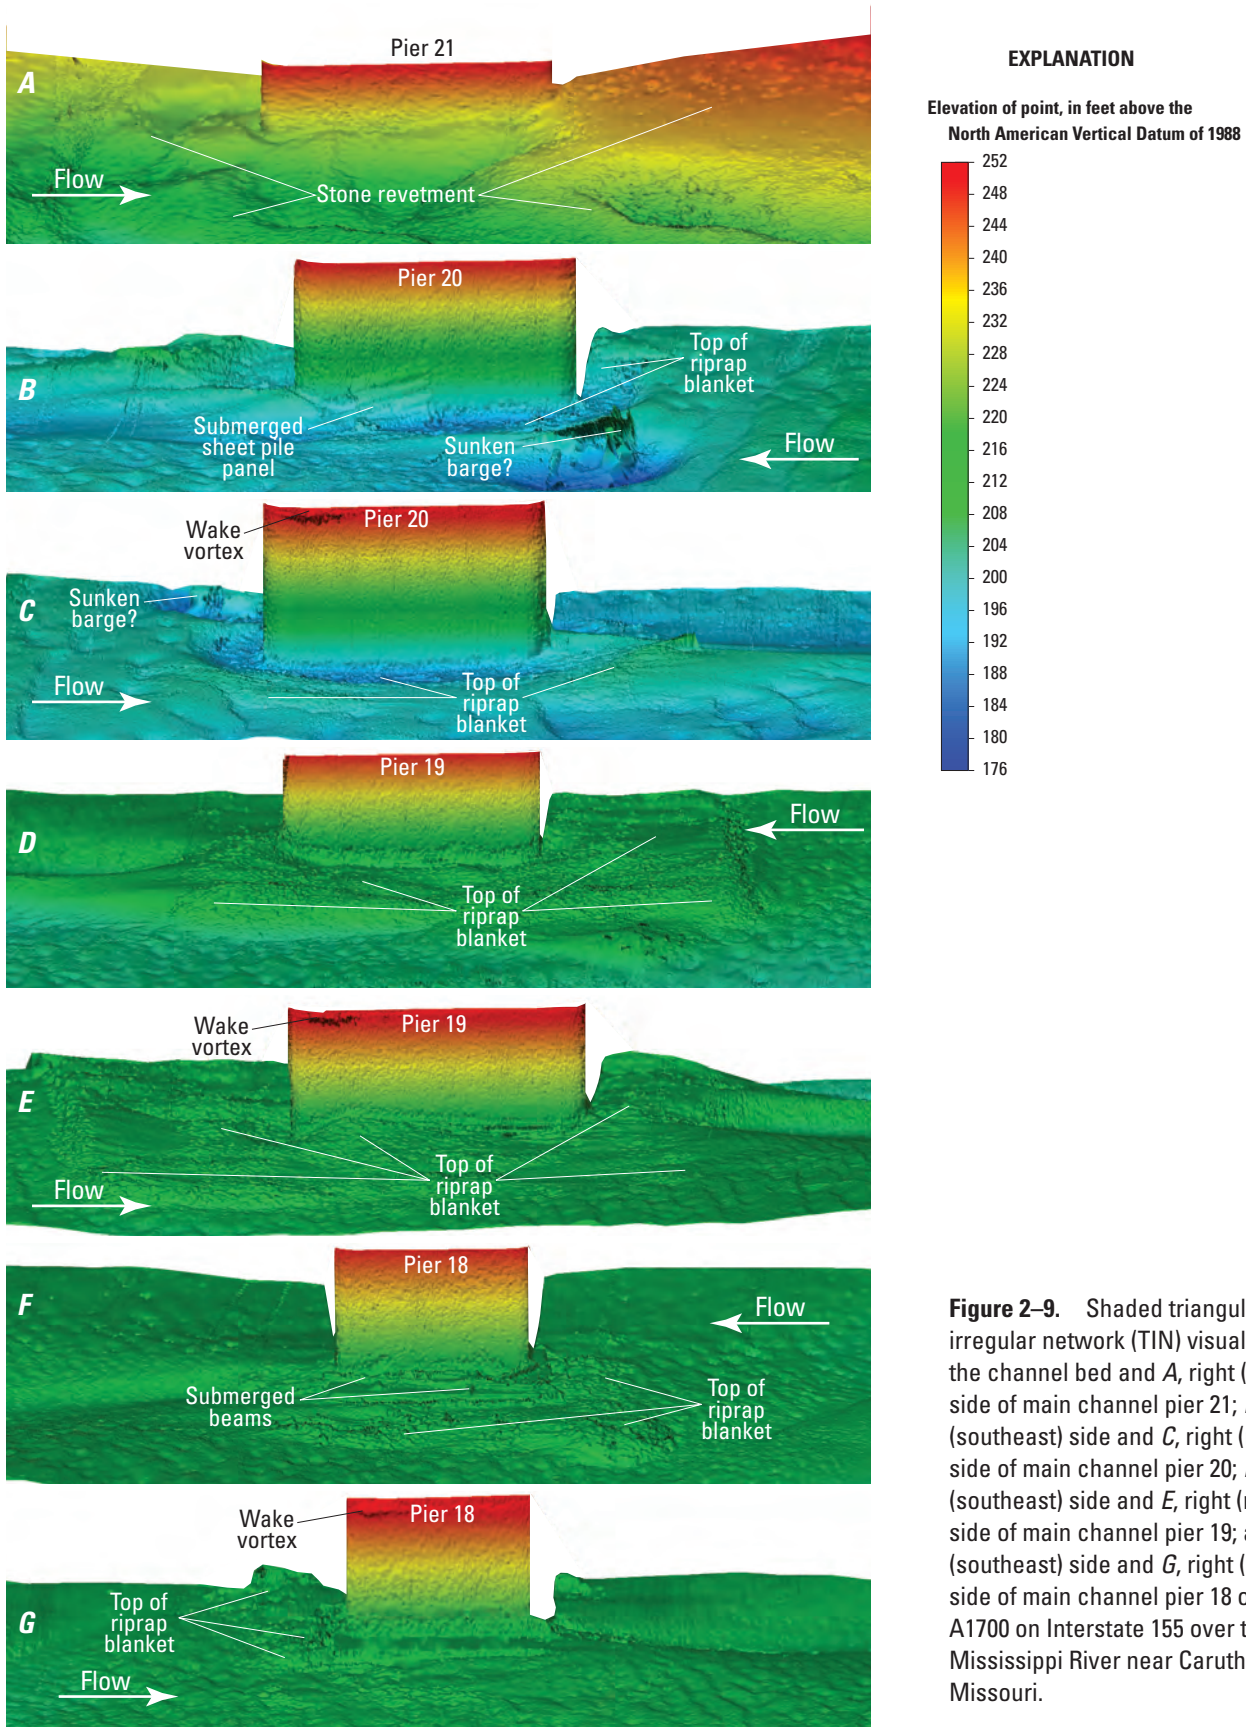
Figure 2-9. Shaded triangulated irregular network (TIN) visualization of the channel bed and A, right (northwest) side of main channel pier 21; B, left (southeast) side and C, right (northwest) side of main channel pier 20; D, left (southeast) side and E, right (northwest) side of main channel pier 19; and F, left (southeast) side and G, right (northwest) side of main channel pier 18 of structure A1700 on Interstate 155 over the Mississippi River near Caruthersville, Missouri.

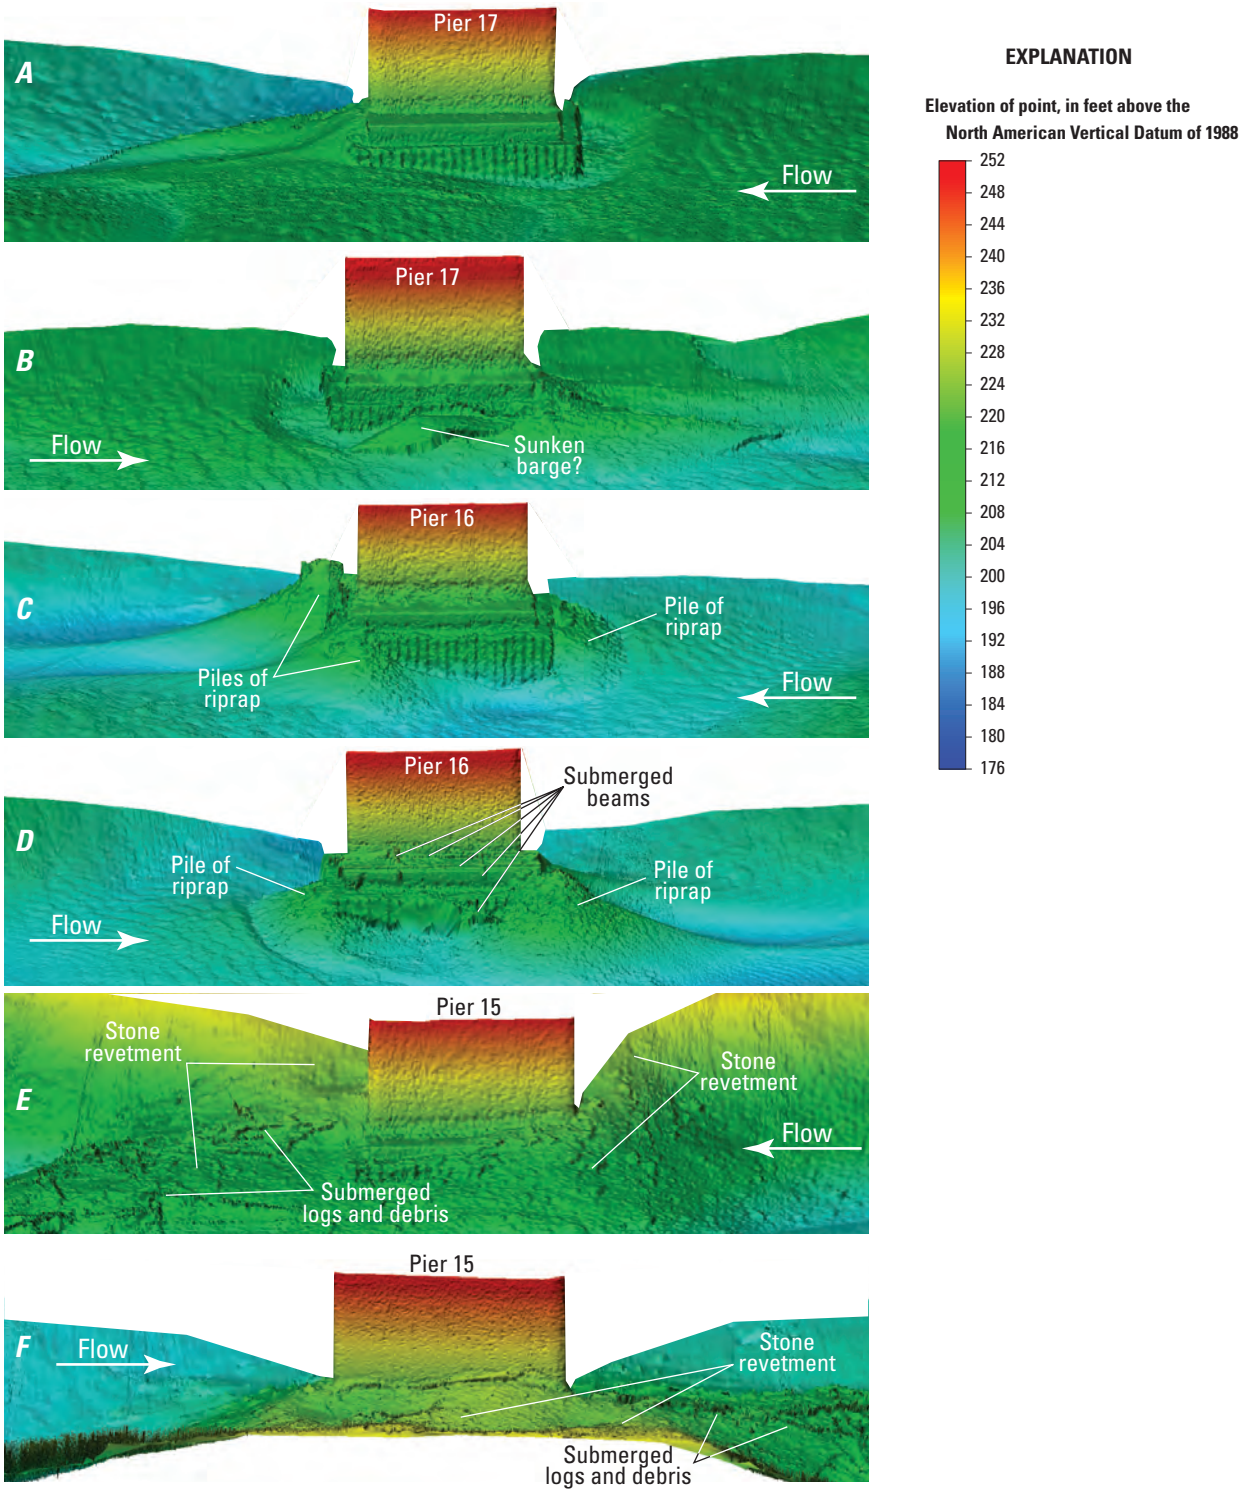
Figure 2–10. Shaded triangulated irregular network (TIN) visualization of the channel bed and *A*, left (southeast) side and *B*, right (northwest) side of main channel pier 17; *C*, left (southeast) side and *D*, right (northwest) side of main channel pier 16; and *E*, left (southeast) side and *F*, right (northwest) side of main channel pier 15 of structure A1700 on Interstate 155 over the Mississippi River near Caruthersville, Missouri.
