Results of Repeat Bathymetric and Velocimetric Surveys at the Amelia Earhart Bridge on U.S. Highway 59 Over the Missouri River at Atchison, Kansas, 2009–2013

Scientific Investigations Report 2013–5177

By Richard J. Huizinga

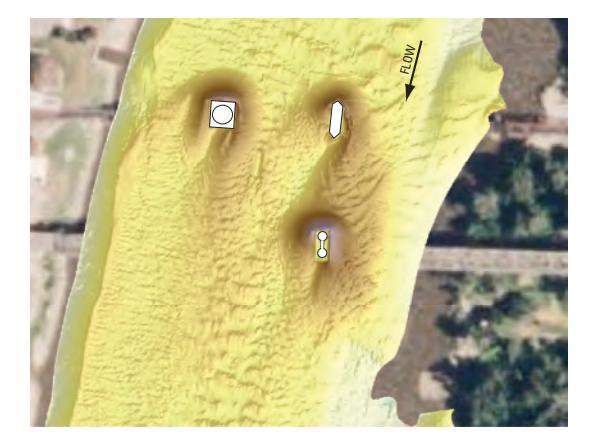
Cover. Upper Left: Bathymetric survey of the Missouri River channel near the piers of the Amelia Earhart Bridge on U.S. Highway 59 at Atchison, Kansas, on June 30, 2009, before construction of the new U.S. Highway 59 bridge.

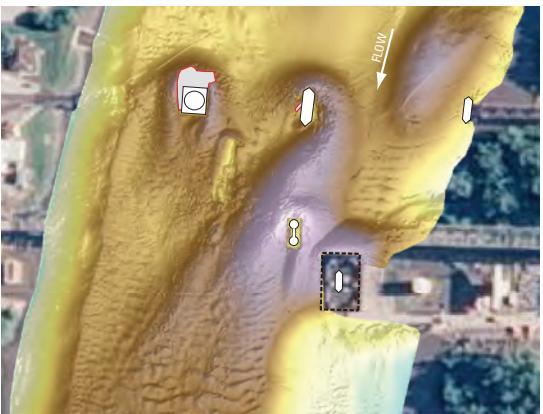
Middle: Bathymetric survey of the Missouri River channel near the piers of the Amelia Earhart Bridge on U.S. Highway 59 at Atchison, Kansas, during flooding on June 30, 2010.

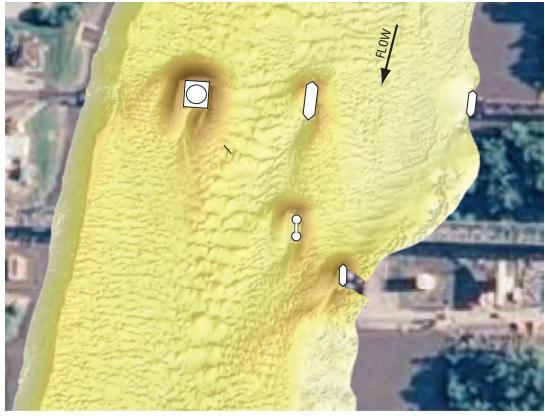
Lower Right: Bathymetric survey of the Missouri River channel near the piers of the Amelia Earhart Bridge on U.S. Highway 59 at Atchison, Kansas, on April 24, 2013, near the end of construction of the new U.S. Highway 59 bridge.
