# Post-occupancy evaluation of a recent energy efficient office building

COIN Project report 30 – 2011

This report is a post-occupancy evaluation of a recent energy efficient building. The building is located in Professor Brochs gate 2, in the city of Trondheim, the third largest Norwegian municipality. The building was erected in 2008-2009 and got partially moved in during September 2009. The building owner, KLP Eiendom, wanted to build an energy efficient office building. A target of 86 kWh/m<sup>2</sup>-yr for delivered energy (all electrical appliances included) was defined during the design stage. Among all energy efficient measures that have been taken, one consists of using fair-faced concrete ceilings instead of suspended ceilings to take advantage of the concrete's thermal inertia. The objective of the post-occupancy evaluation is to verify the energy target, to quantify the users' satisfaction rating and to get feedback on the use of fair-faced concrete ceilings.

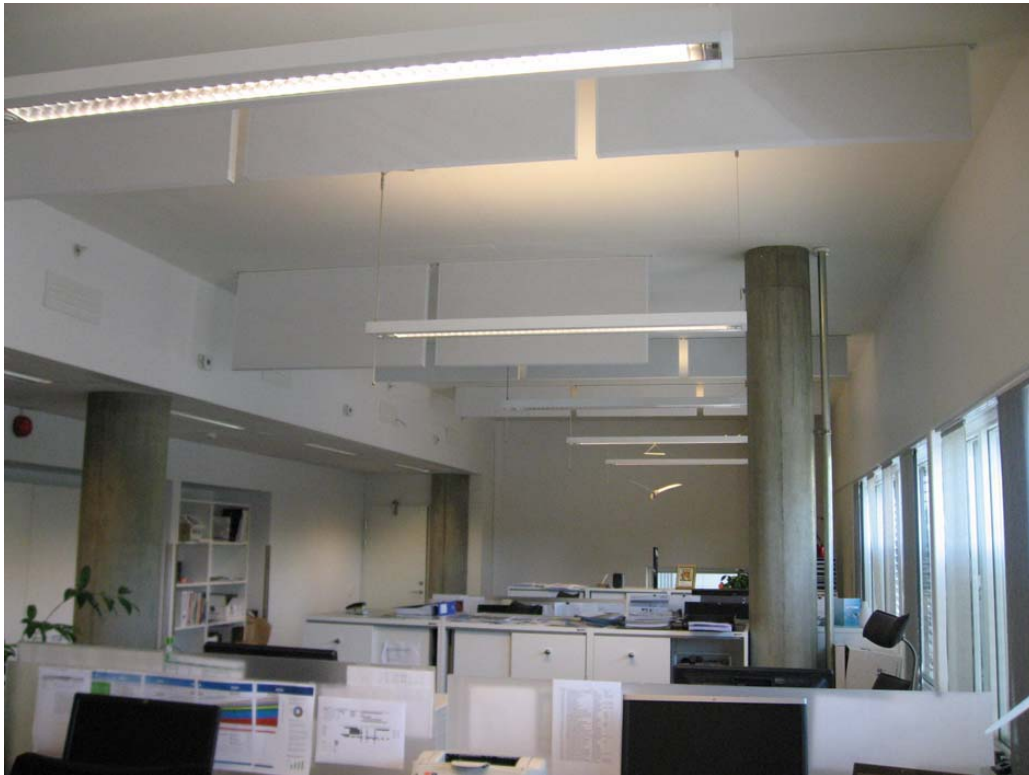
Photo 1. Office building in Prof. Brochs gt. 2 - Open space office area on the third floor, with fair-faced concrete ceilings, hanging acoustic boards and fair-faced concrete pillars (Photo: SINTEF Byggforsk)

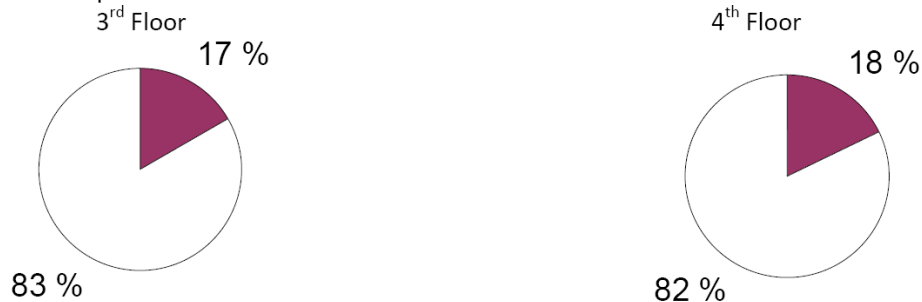
Figure 14. If you experience noise problems, is it due to poor acoustics in the room? Results for 3<sup>rd</sup> floor (left) and 4<sup>th</sup> floor (right).

If you experience noise problems, is it due to poor acoustics in the room / is the understanding of other's speech difficult?

One respondent comments "Extremely poor acoustics. When I make phone calls, people on the other side can't hear me."

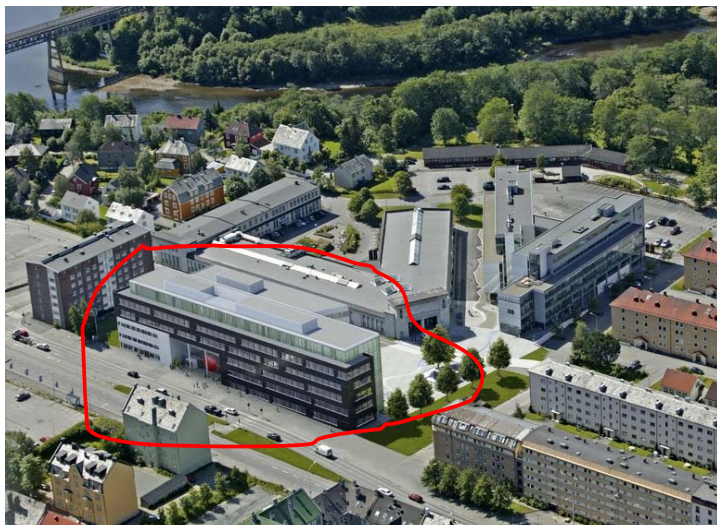
Oversikt over Teknobyen med Nidelva i bakgrunnen – Det nye kontorbygget i Professor Brochs gt.2 synes i nedre venstre hjørnet (innenfor rødt omriss). Bildet er tatt fra nord-øst. (Foto: KLP Eiendom)

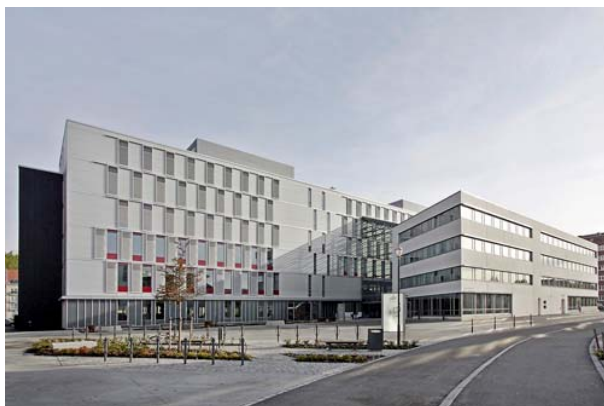
Professor Brochs gt.2 sett fra nord-vest. Den lave fløyen synes til høyre. Vestfasaden for den høye fløyen synes til venstre (Foto: KLP Eiendom)

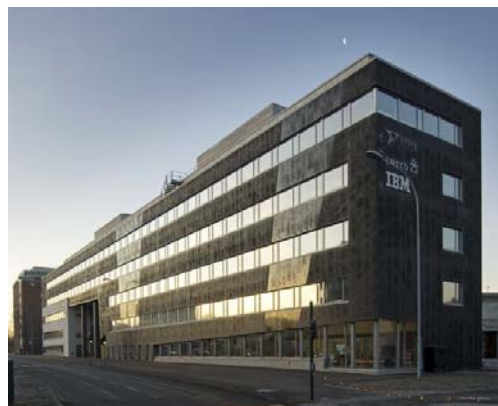
Figur 1. Oversiktbilder for Professor Brochs gate 2 i Trondheim

Professor Brochs gt.2 sett fra nord-øst. Bildet viser østfasaden for den høye fløyen (Foto: KLP Eiendom)
