DOE/NV--1480

Closure Report for
Corrective Action Unit 547:
Miscellaneous Contaminated Waste Sites,
Nevada National Security Site,
Nevada

July 2012

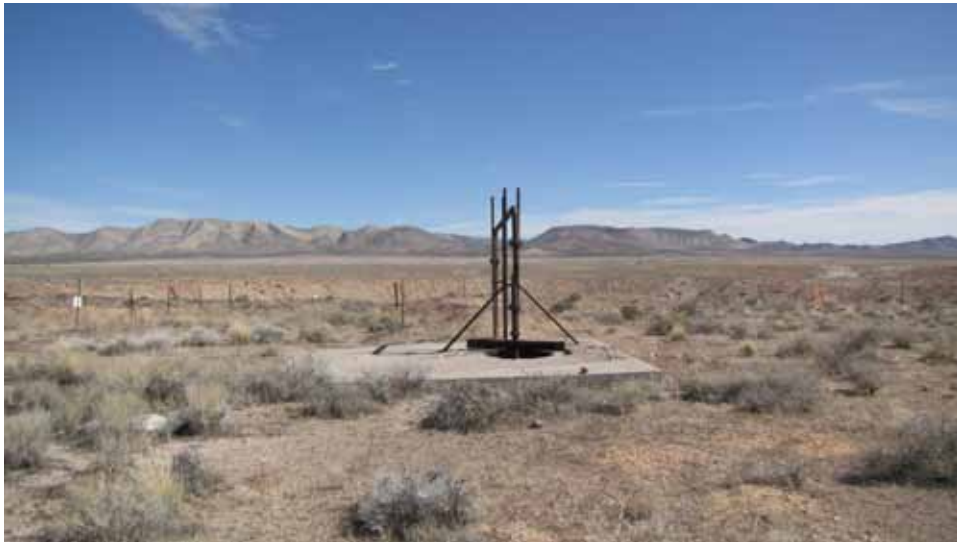
Photograph 1: CAS 02-37-02 (MULLET), Before Closure Activities,
Looking East, 03/02/2011

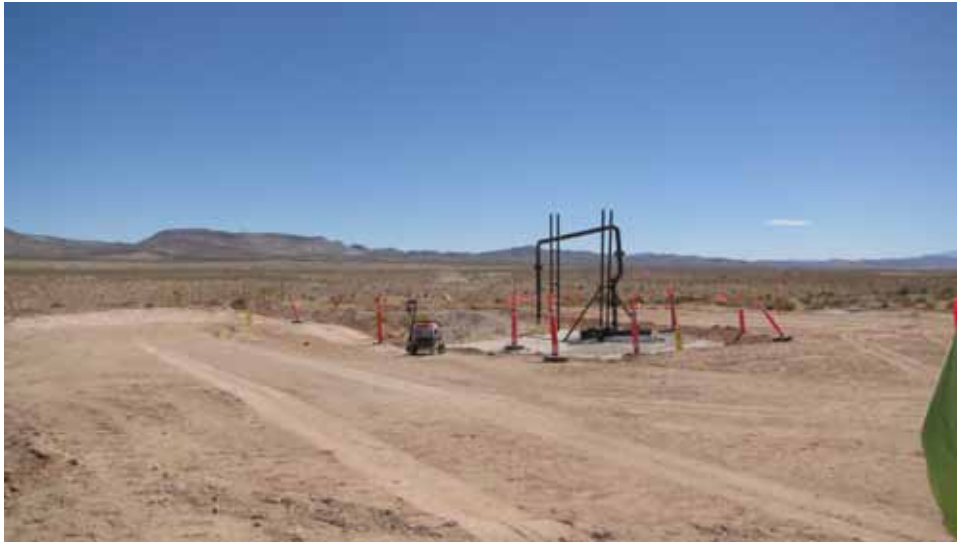
Photograph 3: CAS 02-37-02 (MULLET), Voids and Hole in Concrete Pad Filled with Concrete, Looking Southeast, 08/31/2011

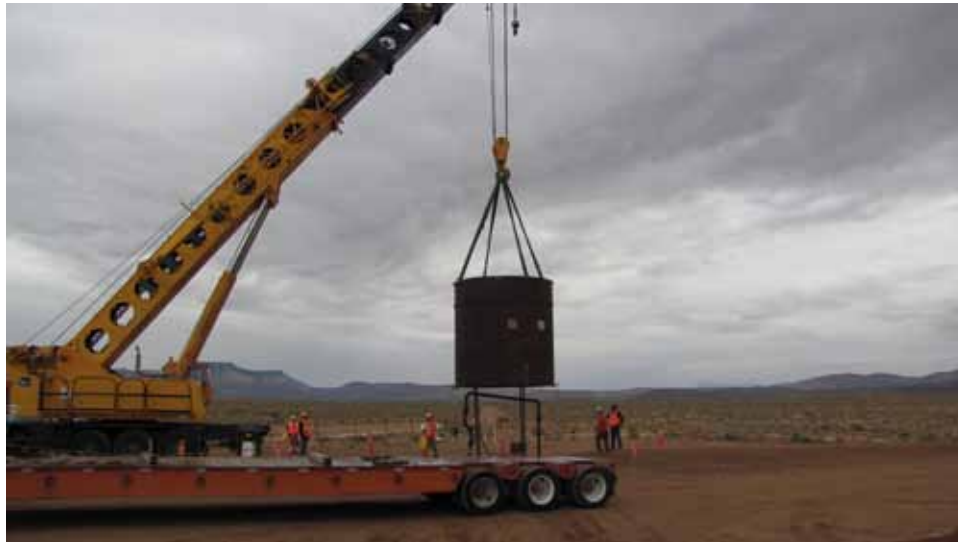
Photograph 7: CAS 02-37-02 (MULLET), Placement of Casing,
Looking Northeast, 09/14/2011

A steel casing with a lid was fabricated and placed over the vertical expansion joint at U2ag (MULLET). The casing was filled with cement, penetrations were welded closed, and “Entombed Radioactive Material” signs were welded on the casing. A 2-ft soil cover was constructed over the loose pipes and pipe run from U2ag (MULLET) to the end of the pipe assembly at the lip of the U2am (COMMODORE) crater according to the engineering design.

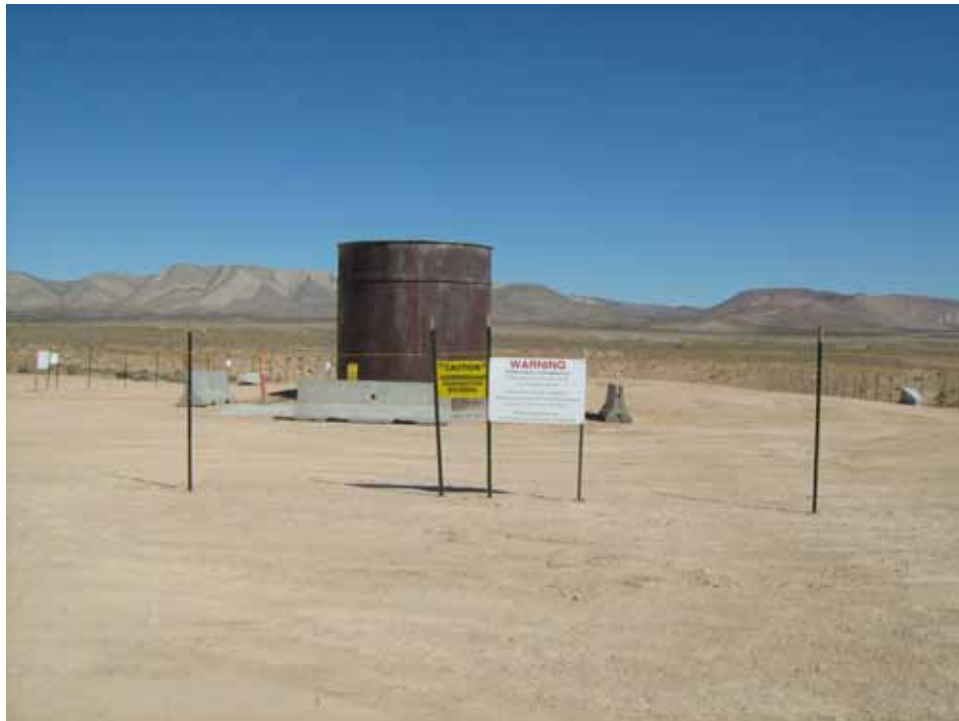
Photograph 10: CAS 02-37-02 (MULLET), Fence, Jersey Barriers, Use Restriction Warning Sign, and Radiological Posting, Looking East, 09/26/2011

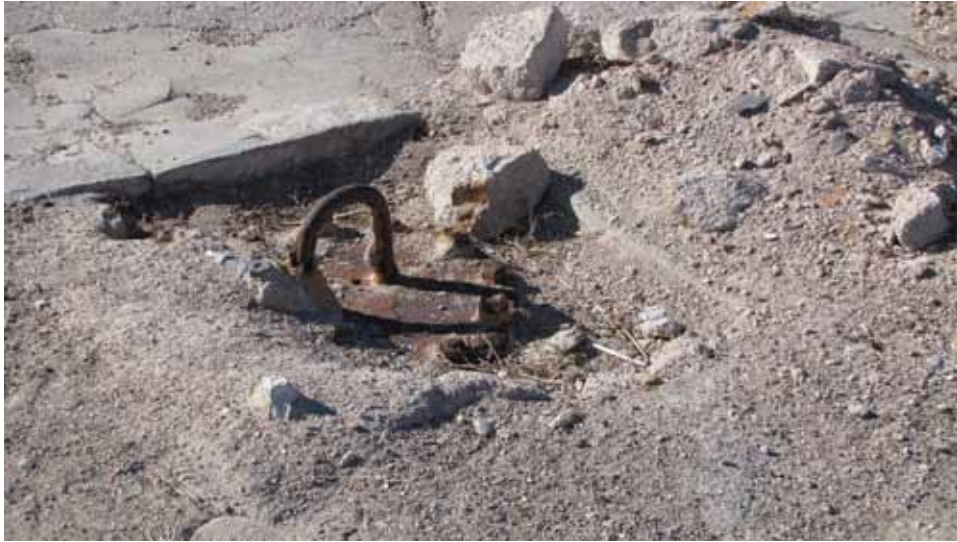
Photograph 15: CAS 03-99-19 (TEJON), Sampling Can at TEJON, 11/08/2011

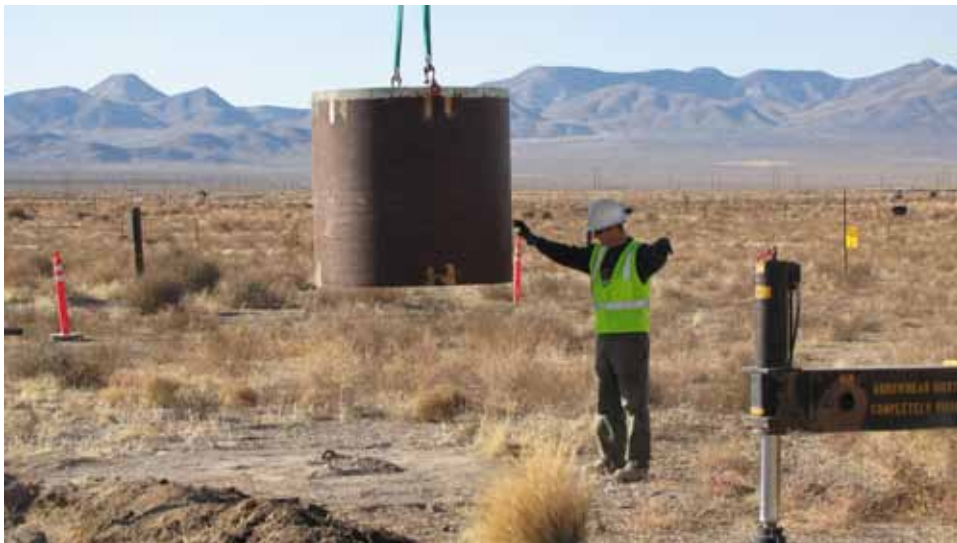
Photograph 16: CAS 03-99-19 (TEJON), Placement of Casing Over the Sampling Can at TEJON, Looking North, 11/08/2011

At CAS 03-99-19, portions of the fence that delineated the CA near U3cg (TEJON) were removed, clean fill was placed in the work area, and the work area was downposted to an URMA. The existing concrete pad at U3cg (TEJON) was repaired and leveled with concrete. The valve handles on either side of the underground sampling can near U3cg (TEJON) were cut at the ground surface, and the valve stems were grouted. A steel casing was placed over the sample can, filled with soil, and covered with a welded steel lid. A concrete apron was placed around the base of the casing.

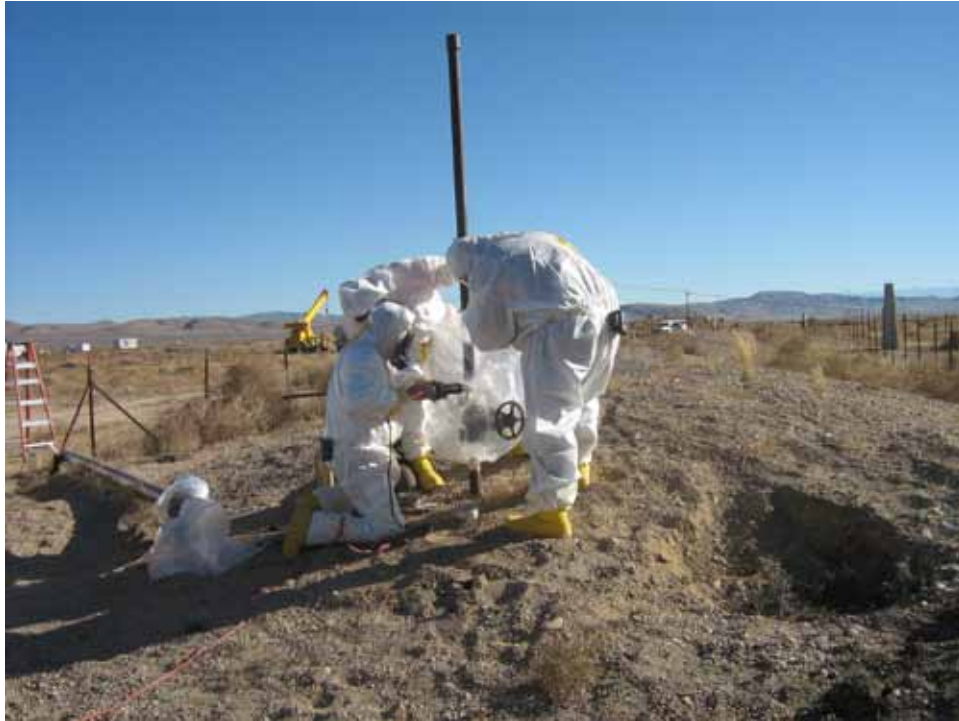
Photograph 19: CAS 03-99-19 (TEJON), Removal of the Vertical Vent Pipe at BERNALILLO, Looking South, 11/16/2011

Loose piping, a pipe collar, and vertical vent pipe near U3n (BERNALILLO) were removed and packaged as LLW. The exposed portion of the 4-inch pipe that entered the site from the east was also cut at the ground surface and capped. After removal of these items, a radiological survey was performed. The results of this survey allowed the CA near U3n (BERNALILLO) to be downposted to an RMA.

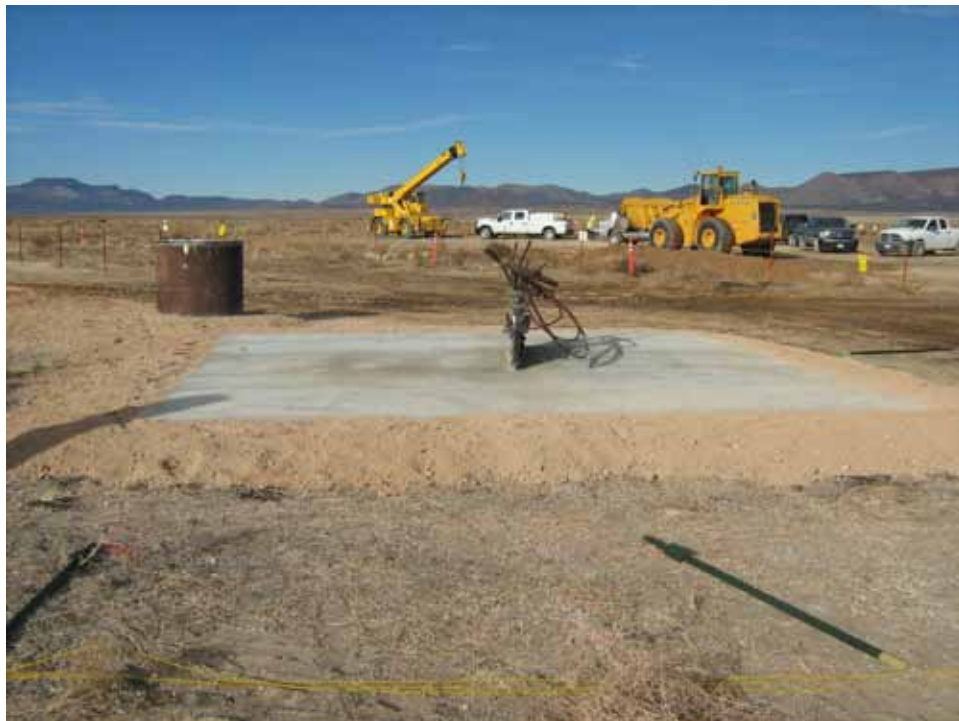
Photograph 20: CAS 03-99-19 (TEJON), Raised and Leveled Concrete Pad at TEJON, Looking Northeast, 11/17/2011

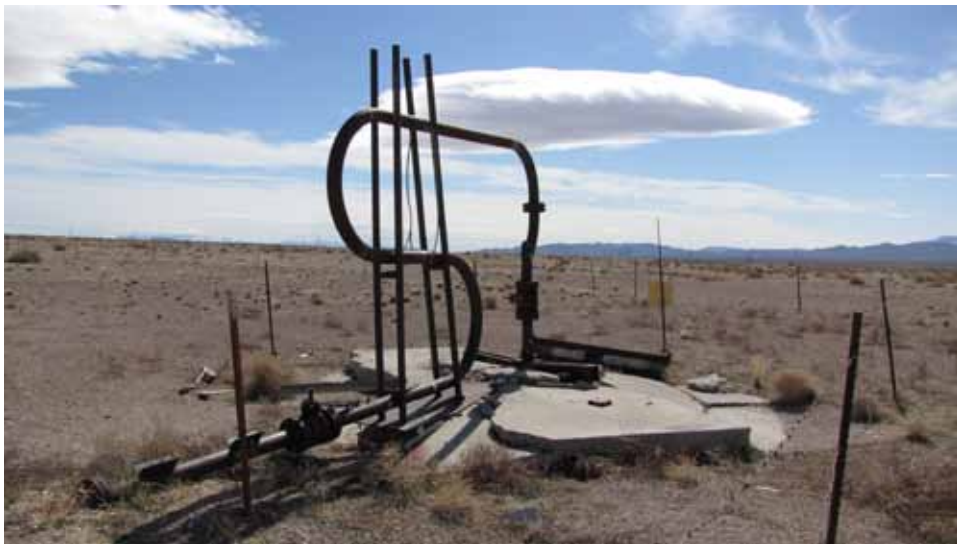
Photograph 26: CAS 09-99-06 (PLAYER), PLAYER Vertical Expansion Joint before Closure Activities, Looking South, 03/02/2011

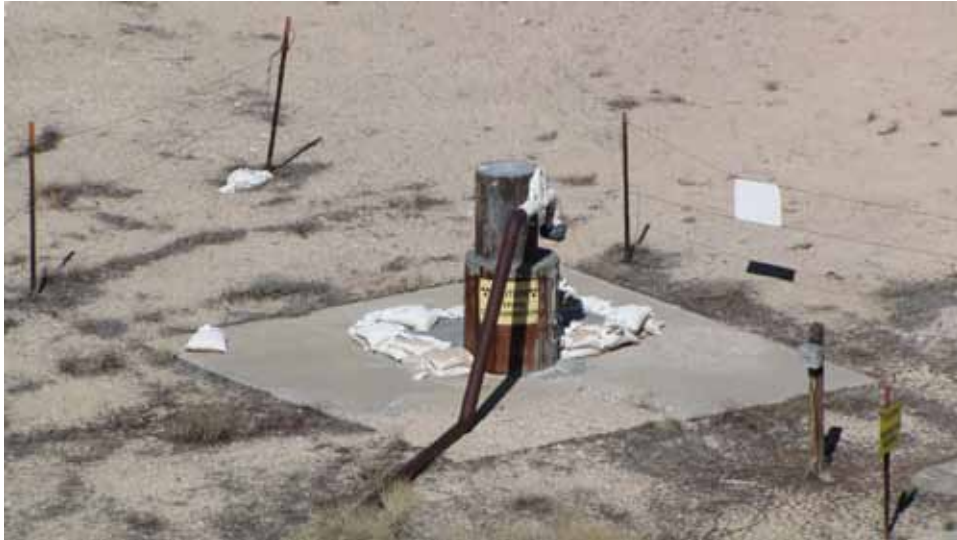
Photograph 29: CAS 09-99-06 (PLAYER), YORK Wellhead before Closure Activities, Looking North, 03/02/2011

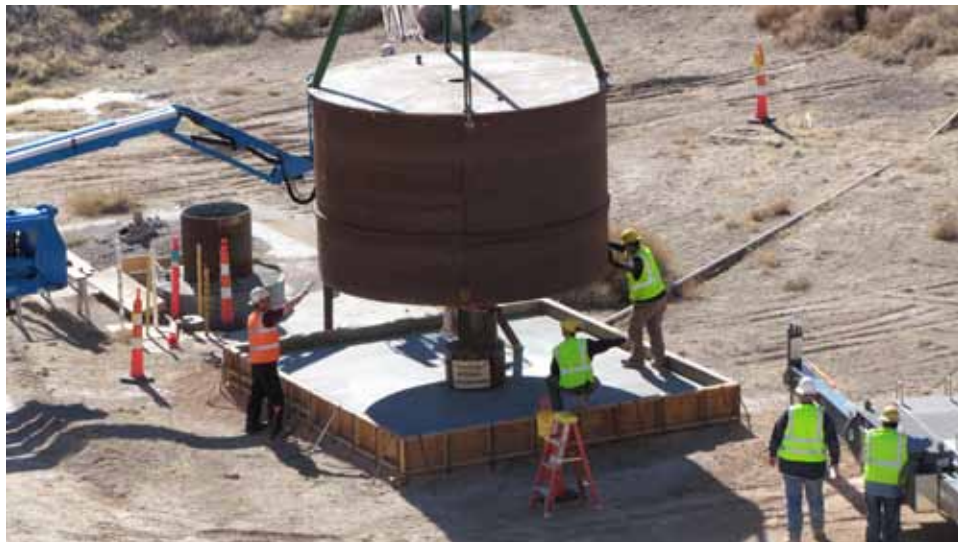
Photograph 34: CAS 09-99-06 (PLAYER), Placement of Casing Over
YORK Wellhead, Looking South, 02/08/2012

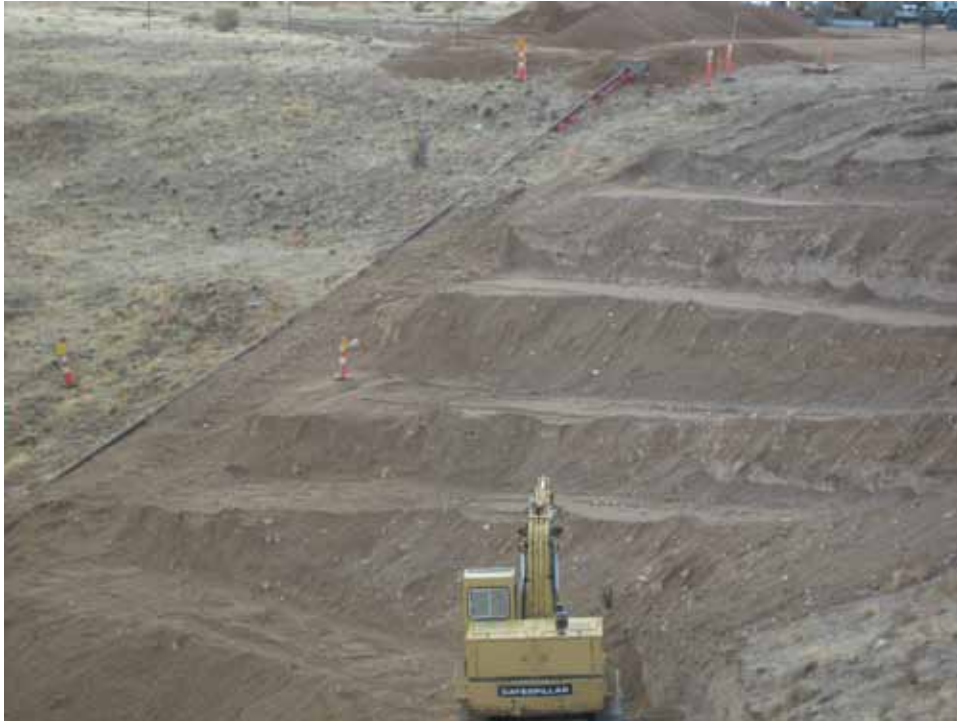
Photograph 37: CAS 09-99-06 (PLAYER), Benches on YORK Crater Slope, Looking South, 02/14/2012
