# Coastal Change from Hurricane Sandy and the 2012–13 Winter Storm Season: Fire Island, New York

By Cheryl J. Hapke, Owen Brenner, Rachel Hehre, and B.J. Reynolds

Open-File Report 2013–1231

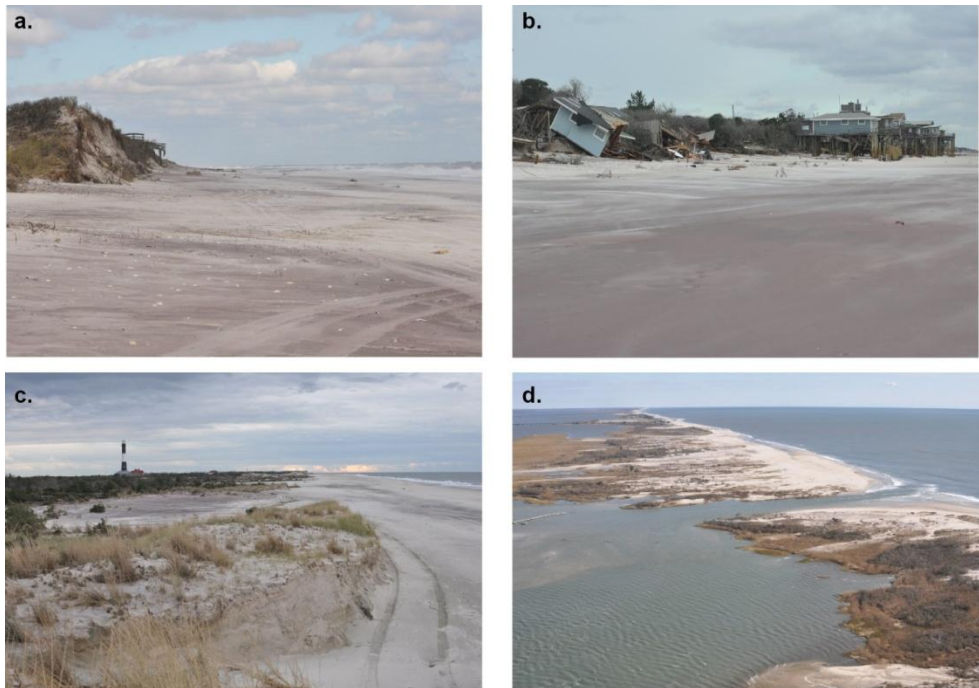
**Figure 2.** Photos of Fire Island 2 to 4 days after Sandy made landfall: a) leveled beaches and scarped dunes in central Fire Island; b) houses undermined and destroyed at Davis Park; c) leveled dunes and large overwash sheets near Fire Island lighthouse; and d) the island breach at Old Inlet.

According to the National Hurricane Center, Hurricane Sandy, at nearly 2,000 kilometers (km) in diameter, is the largest storm on historical record in the Atlantic basin. The storm, which made landfall coincident with astronomical high tides, affected an extensive area of the east coast of the United States. The highest waves and storm surge were focused along the heavily populated New York and New Jersey coasts. The storm made landfall near Atlantic City, New Jersey, the evening of October 29, 2012. At the height of the storm, a record significant wave height of 9.6 m (m) was recorded at the wave buoy offshore of Fire Island, New York (fig. 1, inset). During the storm, beaches were severely eroded and dunes extensively overwashed. Fire Island was breached in three locations, and the coastal infrastructure, including many private residences, was heavily damaged (fig. 2).

The widespread occurrence of overwash on Fire Island resulted in the leveling or removal of the dune in many places (fig. 2). Quantifying the storm impact to the upper beach and dunes becomes problematic where the dune no longer exists as part of the post-storm system.

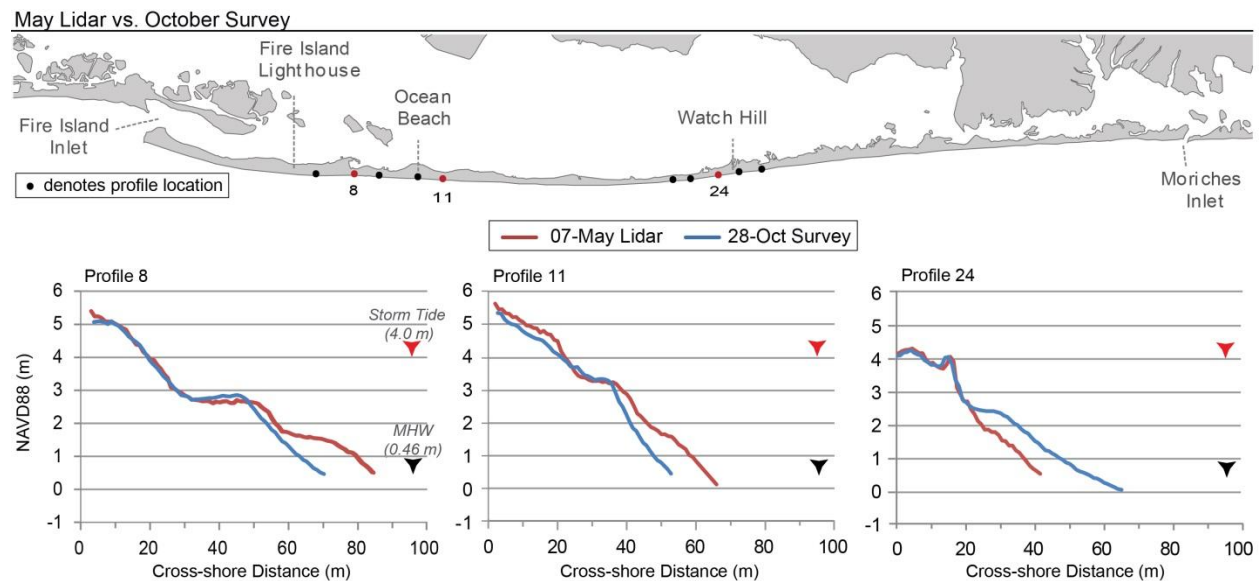
**Figure 3.** Comparisons of pre-Sandy beach profiles from lidar data (May 5, 2012) and field survey (Oct. 28, 2013) at three survey profile locations in western and central Fire Island.

Qualitative assessments were conducted to verify that the May 2012 lidar data adequately represent a “pre-storm” beach. There were relatively minor variations in profile morphology and elevation between the May 2012 and the October 28, 2012, field surveys, and the differences were primarily concentrated on the lower portion of the beach (below 2.5 m). The pre-storm (October 28) field profile tends to have a slightly higher upper beach surface and more developed berm with a steeper beachface than in May 2012, which likely developed over the 5+ summer months between surveys (fig. 3). Although the May 2012 lidar survey does not represent an immediate pre-storm dataset, differences between the field and the lidar surveys are minimal, and the assessment is included due to the value gained by the extended spatial coverage provided by the lidar dataset.

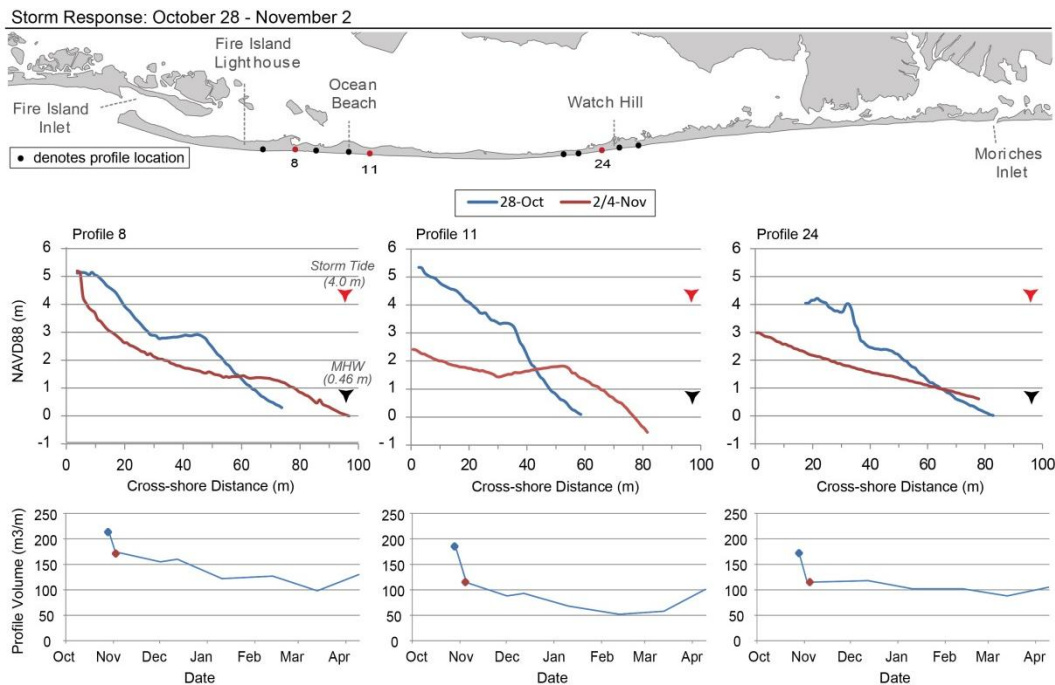
**Figure 4.** Examples of pre- and post-storm field profiles from three locations on Fire Island following Hurricane Sandy (Oct. 28–Nov. 2, 2012). Plots in lower panel show evolution of profile volume (in cubic meters per meter [m<sup>3</sup>/m]) throughout survey period. All profiles for all dates are provided in appendix 1.

The nine DGPS profile surveys collected immediately prior to (October 28) and following (November 2 and 4) Hurricane Sandy demonstrate the substantial effects of the storm (figs. 4, 5; appendix 1). All profiles show a major decline in elevation and volume. Waves and storm surge carried large quantities of sand offshore and inland by way of overwash. The resulting post-storm profiles show wide, nearly flat beaches with little or no dunes remaining. The upper portion of the beach lost 1–3 m in elevation as the profile moved from a reflective morphology with a well-defined berm crest and steeply sloped beach face to a more dissipative or nearly flat beach surface (fig. 4). The primary dunes experienced considerable erosion and were removed entirely in 4 of the 10 surveyed profiles. All of the profiles that showed complete dune loss are within the developed communities (appendix 1, profiles 8–11, 24). During the 6 days surrounding the storm, volume decline for all profiles ranged from 22 to 53 percent with an average loss of 35.4 percent (table 2). Volume loss did not differ significantly between the western (7–11) and central profiles (22–26).

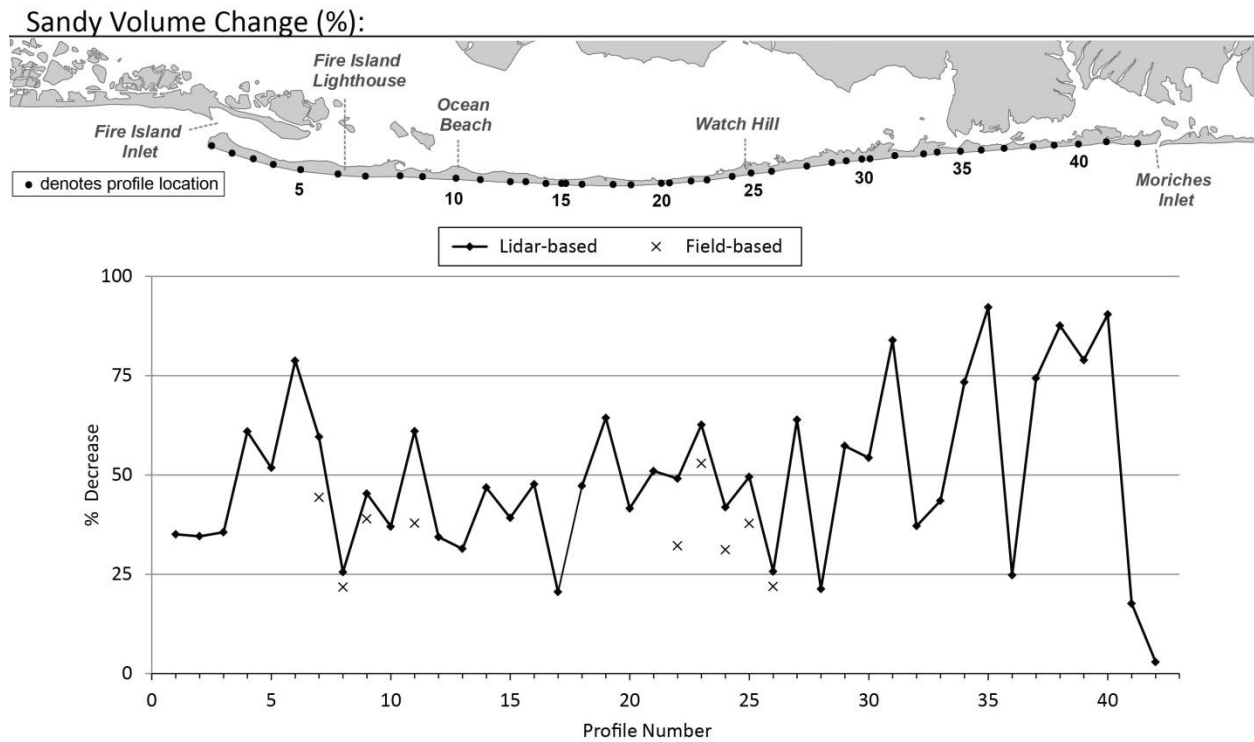
**Figure 5.** Alongshore profile volume loss values (%) derived from pre- and post-Sandy GPS (Oct. 28–Nov. 4, 2012) and lidar (May 7–Nov. 5, 2012) datasets. The lidar profile locations are shown on the map and correspond to a series of 45 along-coast profiles that were identified in a pre-Sandy study. Slightly lower volume change values in the GPS survey are due to losses that occurred between May 2012 and the October 28, 2012, field survey.

The field surveys are limited in their spatial coverage, but they provide an important pre-storm baseline of the system just before landfall. Island-wide comparisons of the May and November (2012) profile elevations from the lidar surveys demonstrate extensive losses along the length of the island. The percentage of volume change calculated from the lidar profiles indicates an average loss of 54.4 percent, whereas the volume change calculated from the field surveys indicates an average volume loss of 35.4 percent (table 2). The higher percentage of loss measured with the lidar data as compared to field profiles reflects the inclusion of the highly impacted eastern end of the island in the lidar change calculations.

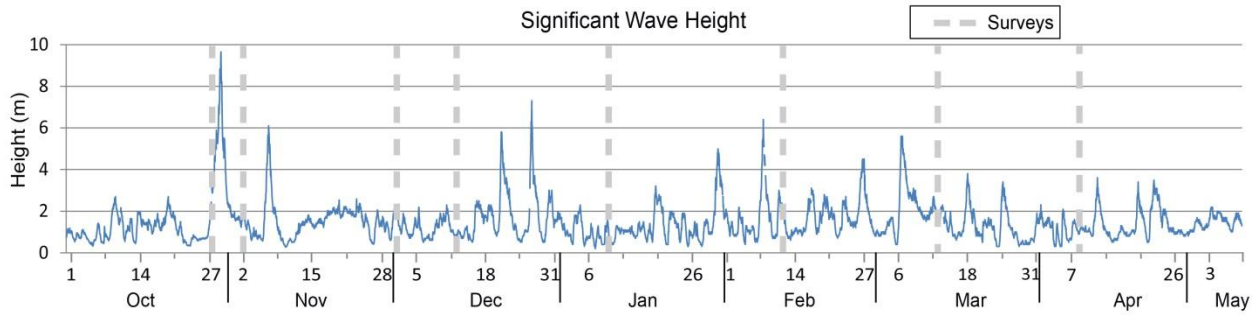
**Figure 6.** Deep water wave heights ( $H_s$ ) during hurricane Sandy (October 28–29, 2012) and seven post-Sandy winter storms (wave heights > 4 m) as recorded at wave buoy positioned approximately 30NM south of Islip, NY (National Oceanographic and Atmospheric Administration: National Data Buoy Center, Station #44025).

In the winter months following Hurricane Sandy, a series of strong nor'easter storms (particularly those with  $\geq 4$  m deep-water wave height; fig. 6) caused additional beach and dune loss on Fire Island. The changes during the 2012–13 winter season that were documented during eight post-Sandy surveys include significant and continual fluctuations in beach morphology from November to April (fig. 7; appendix 1). Predominant morphologic change patterns were examined for the 10 field survey profiles (table 4).

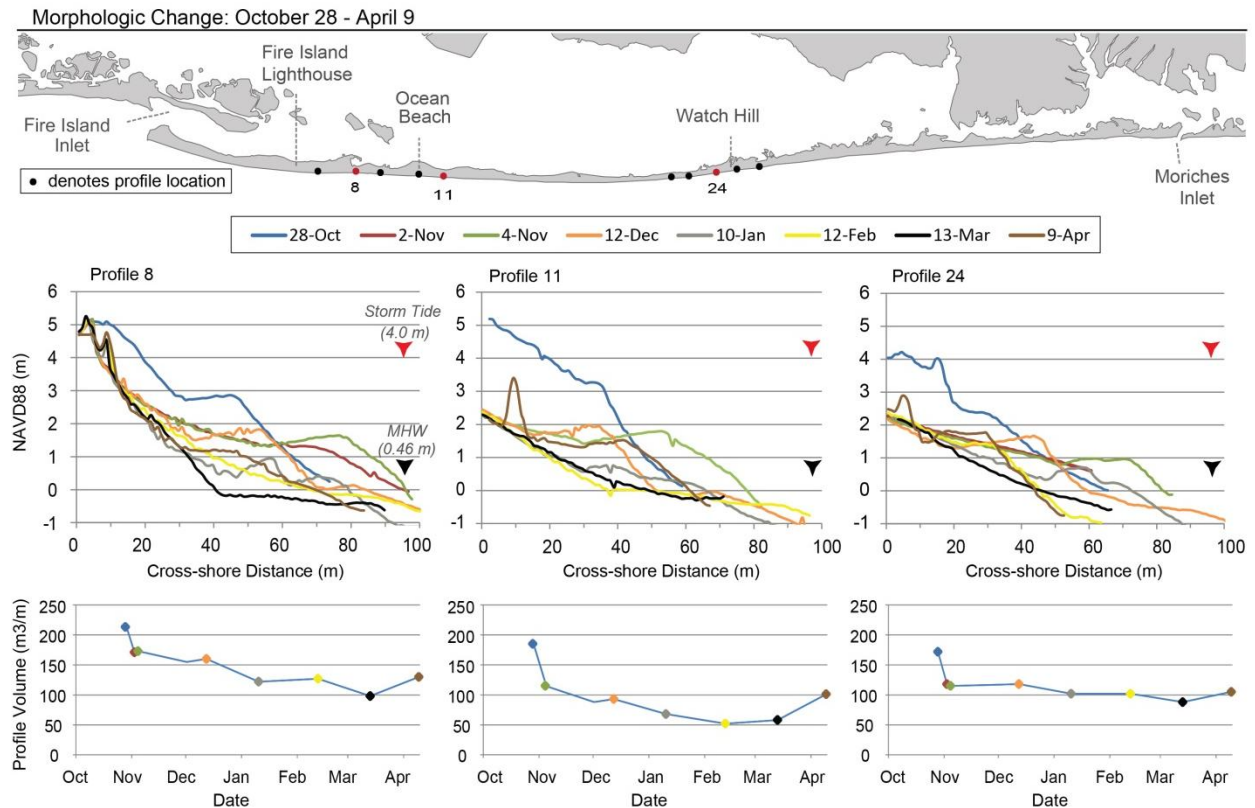
**Figure 7.** Examples of field profiles from three locations showing morphologic change from Hurricane Sandy and the winter of 2012–13 (Oct. 28, 2012–April 9, 2013). Artificial reconstruction of the dune is evident as early as the January 10, 2012 survey. All DGPS profiles for all dates are provided in appendix 1.

Following the initial post-Sandy assessment (November 2–4), calmer deep-water wave conditions (except for one stronger storm event on November 8) allowed for reformation of the lower portion of the beach, as indicated by the December 12th survey (fig. 7) which shows building of the berm and steepening of the beach face. These changes are characteristic of post-storm recovery. However, the average profile volume still decreased by 4.4 percent across all surveyed locations during the month following Hurricane Sandy. Volumetric losses appear to be related to the seaward transfer of sand from the beach and dune to the lower beachface and surf zone (fig. 7).

The subaerial portion of the beach underwent substantial change between March and April 2013 (fig. 7; table 4; appendix 1). Prolonged periods of high winter wave conditions in late February and early March led to decreases in lower beach elevation of up to 1.5 m in the March 13 survey. Beach response varied substantially with some areas (profiles 7, 11, 25, and 26) increasing in volume by as much as 26 percent and other areas (profiles 8, 9, and 24) reaching the lowest elevations and volumes of the study (figs. 7, 8; appendix 1). The beach and dunes showed measureable recovery by April 9 with beach width and elevation increasing substantially. Average volume increase of 18.9 percent occurred as the berm reformed and dune ramps began to rebuild along the upper beach. The widespread beach recovery coincides with a period of calmer wave conditions. Despite the end-of-winter recovery, however, the overall beach volume was 7 percent less than the post-Sandy measurement (November 2) and nearly 41 percent less than the pre-Sandy condition 23 weeks earlier (table 4; figs. 7, 8, 9).

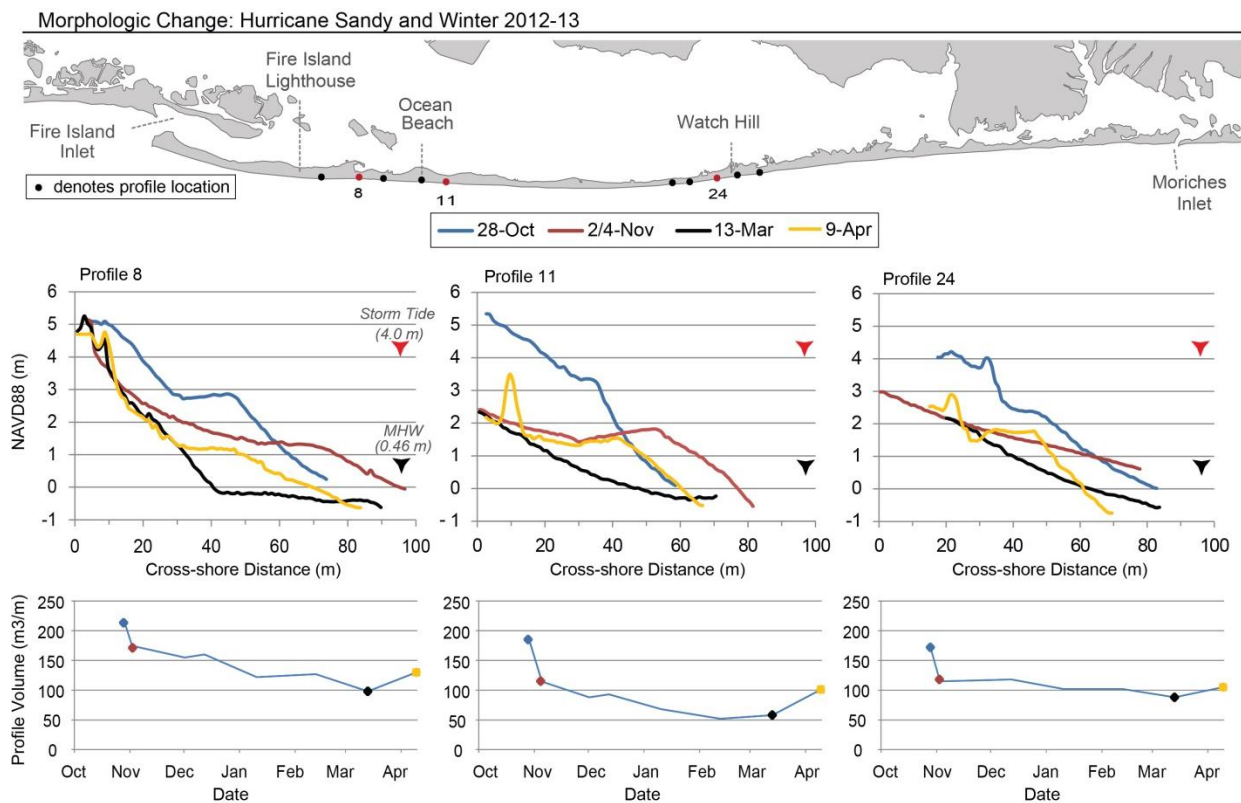
**Figure 8.** Examples of progressive changes in beach morphology from October 28, 2012, to April 9, 2013, with associated profile volumes (in cubic meters per meter [ $m^3/m$ ]) shown in lower panel. Following major Sandy loss, profiles continued to lose elevation and volume through March before experiencing slight gains in late March and early April.

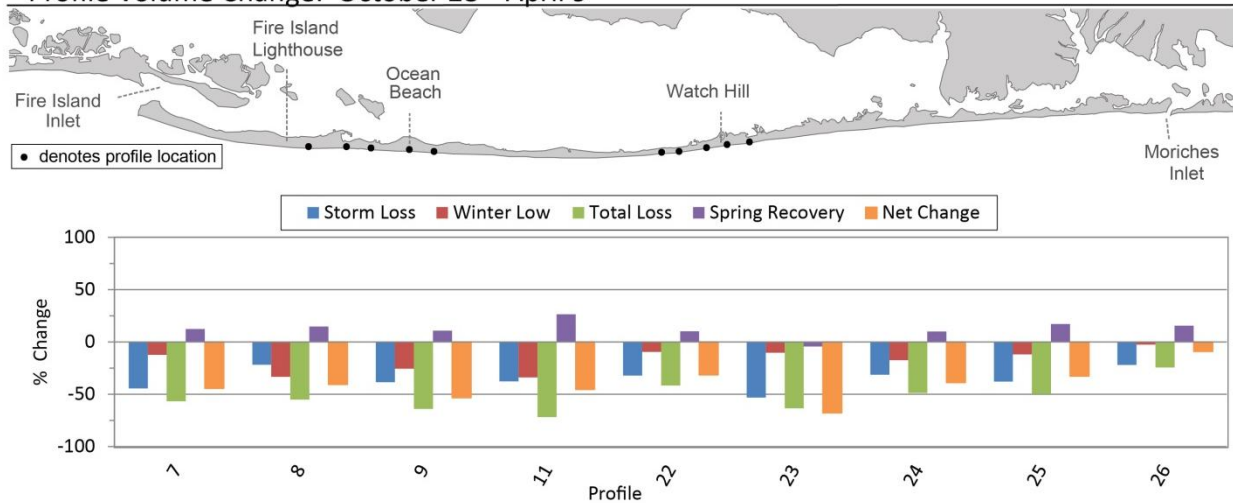
### Profile Volume Change: October 28 – April 9

**Figure 9.** Observed trends in volume change (percentage of initial pre-storm volume) at GPS profile locations: Sandy loss (Oct. 28 to Nov. 2, 2012), winter low (Nov. 2 to lowest recorded volume), total loss (Oct. 28 to lowest volume), spring recovery (lowest volume to April 9, 2013), and net volume change (Oct. 28 to Apr. 9). Despite slight increase in volume and elevation at eight of nine profiles during March and April 2013, net volume change averages -40% from large storm losses and nearly continuous decline until the March 2013 survey.

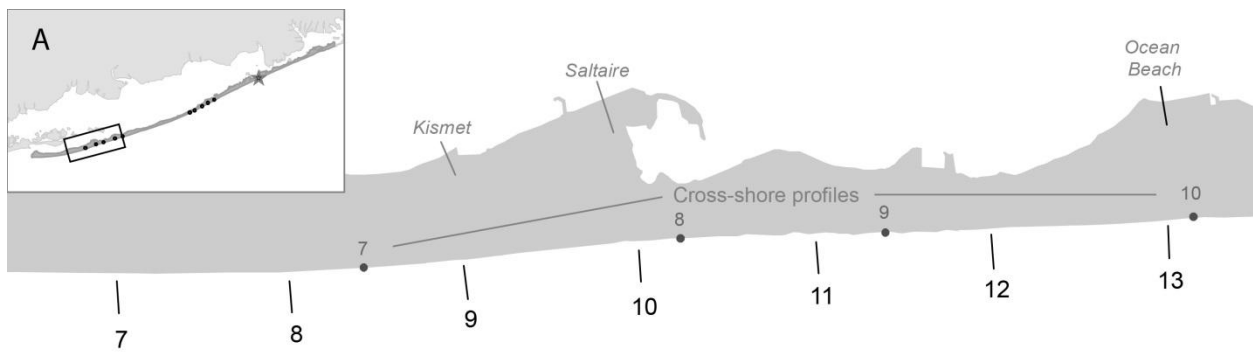
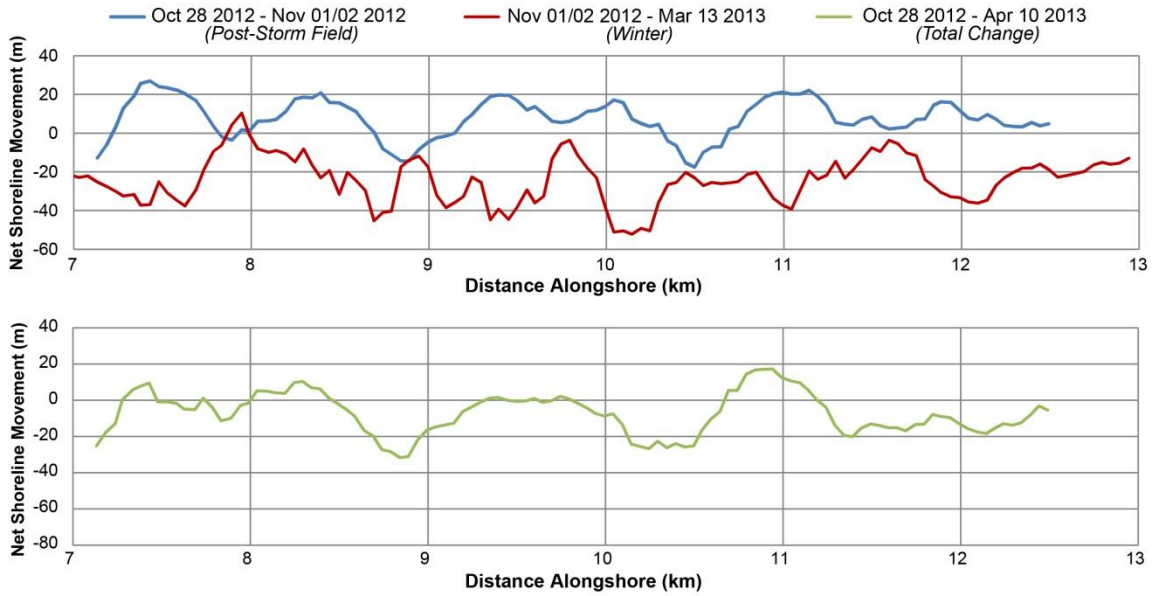
### FI Shoreline Change: Hurricane Sandy 2012

**Figure 10.** Net shoreline movement from Oct 28–Nov. 2 (blue line), Nov. 2–Mar. 13 (red line), and over the duration of the field surveys (Oct. 28–Apr. 9; green line) for (A) western Fire Island and (B) central Fire Island. See Figure 1 for survey coverage extents.

**Figure 10—Continued.** Net shoreline movement from Oct 28–Nov. 2 (blue line), Nov. 2–Mar. 13 (red line), and over the duration of the field surveys (Oct. 28–Apr. 9; green line) for (A) western Fire Island and (B) central Fire Island. See Figure 1 for survey coverage extents.

In the months following Hurricane Sandy, continued widespread and substantial erosion of the highly deflated and low-relief post-Sandy beach made the shoreline more vulnerable to the ensuing coastal storms. During the course of the winter months (November 4–March 13), the average change in the net movement of the shoreline was –21.4 m (table 5), with a maximum landward shift of nearly 60 m. Although some recovery of the shoreline was observed during the final survey period (April 7), many areas continued erode. During the 5 months of shoreline surveys (October 28–March 13) net shoreline movement averaged –8 m, with a maximum shoreline erosion value of 63.6 m (table 5). Similar to the pre- and post-Sandy surveys, net shoreline movement was variable, but with no distinct patterns of change (fig. 10).

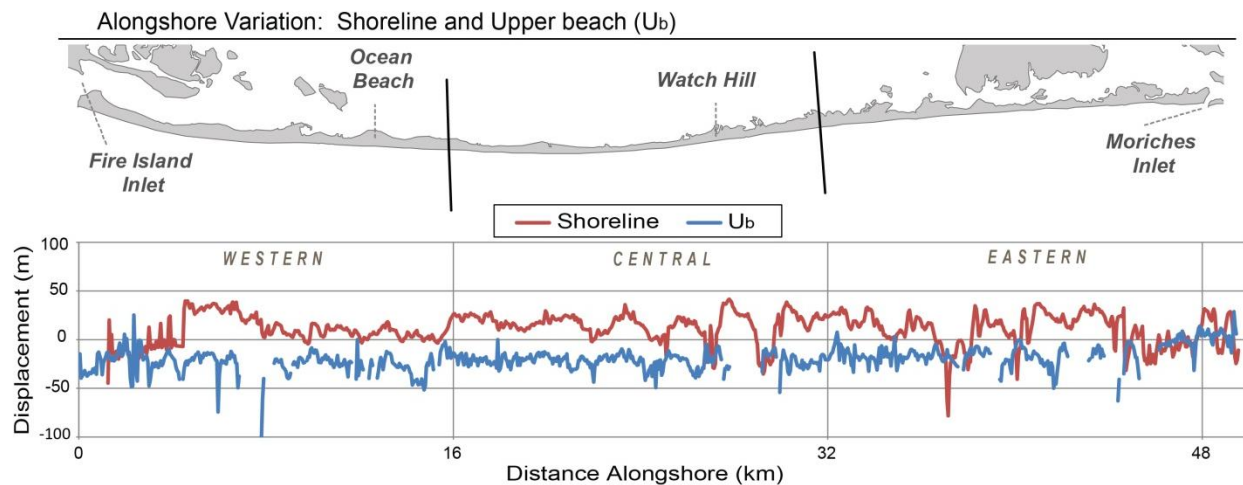
**Figure 12.** Variations in total shoreline (SL) and upper beach ( $U_b$ ) migration (in meters) caused by Hurricane Sandy calculated from pre-storm (May 7, 2012) and post-storm (November 5, 2012) lidar data. Widespread overwash and erosion reduce island topography such that shoreline position tends to move seaward while  $U_b$  migrates landward in all three subregions of Fire Island, New York. Gaps in  $U_b$  data result from erosion elimination of the  $U_b$  contour elevations along the cross-shore profile during Hurricane Sandy.

To assess the storm impacts on the upper and lower beach systems, we examined the net change associated with the shoreline and  $U_b$  along the length of the island from May to November 2012 (fig. 12). Similar to the shoreline response from the field surveys, the all-island shoreline change is predominantly progradational. Based on field observations and quantification of overwash volumes, substantial amounts of material from the beaches and dunes were carried offshore during the storm. In the days immediately following the storm, substantial amounts of material were deposited along the lower portion of the beach. Although the beach was significantly reduced in elevation (fig. 4; appendix 1), the deposition of material along the lower beach produced an overall accretional “storm” trend of the shoreline.

Areas that experienced higher amounts of landward migration of  $U_b$  (e.g. western Fire Island) appear to correspond to areas where shoreline progradation is lower. Conversely, areas where  $U_b$  experienced lesser amounts of landward migration (such as central Fire Island) have higher magnitudes of shoreline progradation. This relationship appears to be a function of the dune size—in areas with lower dunes and more prone to overwash, there was more landward transport of material, resulting in lower values for shoreline progradation. In areas with larger dunes and less prone to overwash, material eroded from the dune was deposited lower on the beach, resulting in progradation.

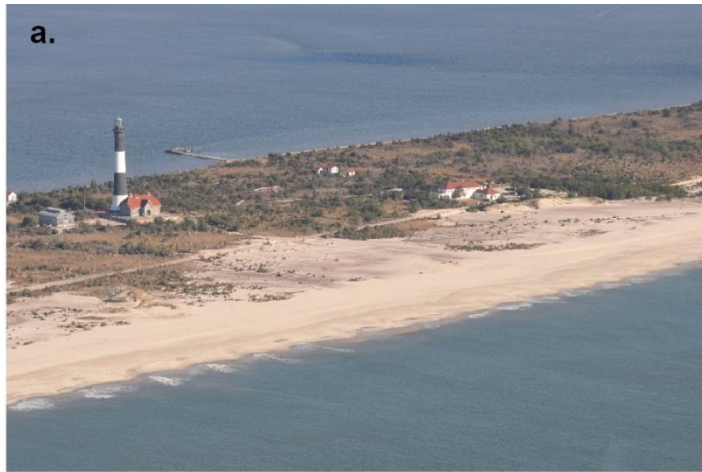
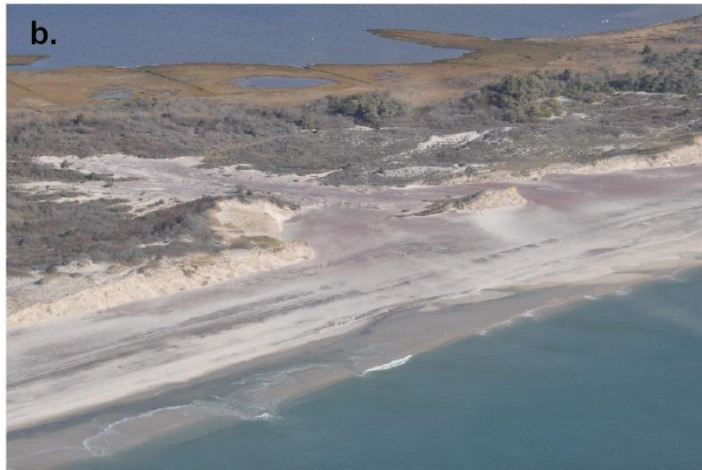
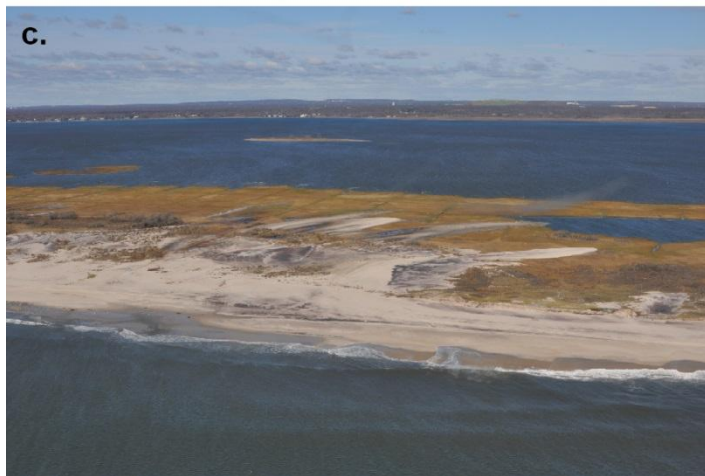
**Figure 13.** Examples of overwash styles at Fire Island, New York: (a) sheet wash in front of Fire Island Lighthouse, (b) surge channels through dunes and overwash fan along central-eastern Fire Island, and (c) tongues of overwash in eastern Fire Island.

In the central subregion of Fire Island, the occurrence of overwash is relatively low and is confined to narrow (<100 m) channels that coincide with existing cuts (vehicle access points or other lows) in the otherwise continuous dunes (figs. 13B, 14B, 15B). Volumes of overwash are also significantly lower in the central subregion (Table 7), suggesting higher overall dune and island elevations and (or) lower waves and storm surge along this segment of the island compared to adjacent areas.

Eastern Fire Island experienced the greatest amount of overwash and inundation based on areal extent and volume of overwash deposits. In areas with high pre-Sandy dunes, surge channels cut through the dunes and carried large volumes of material to the island interior, deposited as overwash fans. In lower-lying portions of this subregion, continuous overwash fans and fields of overlapping overwash tongues extend across the width of the barrier island in many locations (figs. 13C, 14C, 15C). The eastern portion of the island was breached in three locations during Hurricane Sandy.

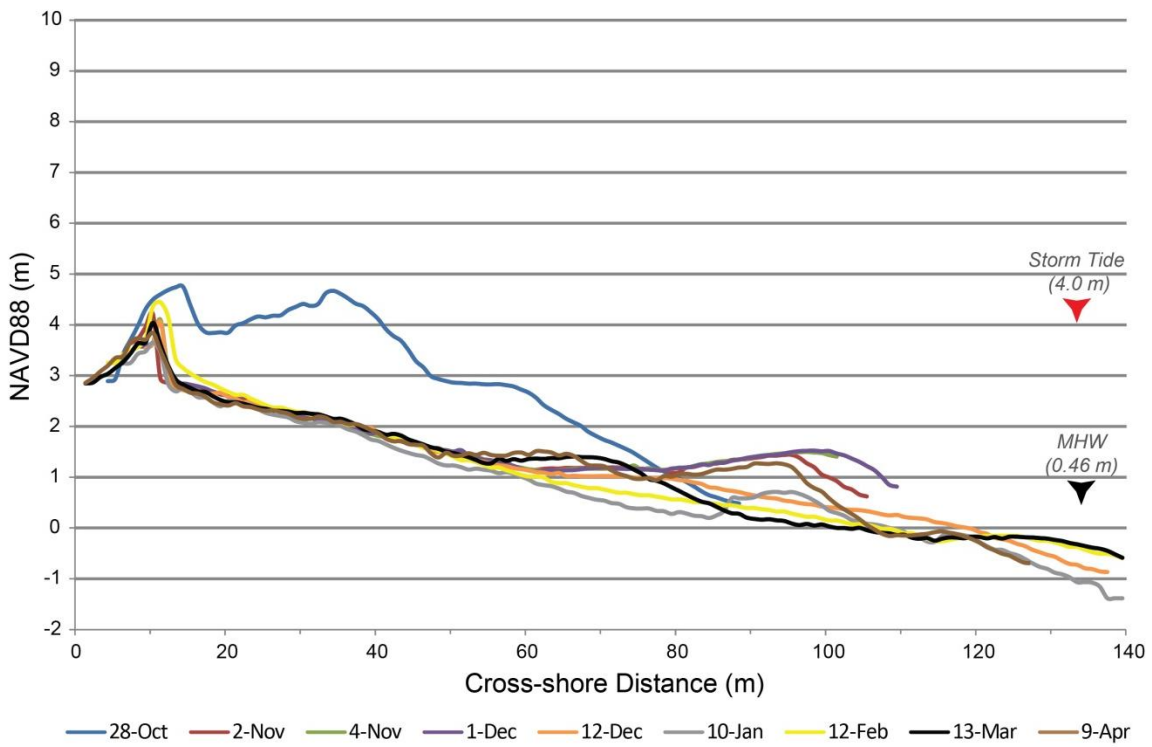
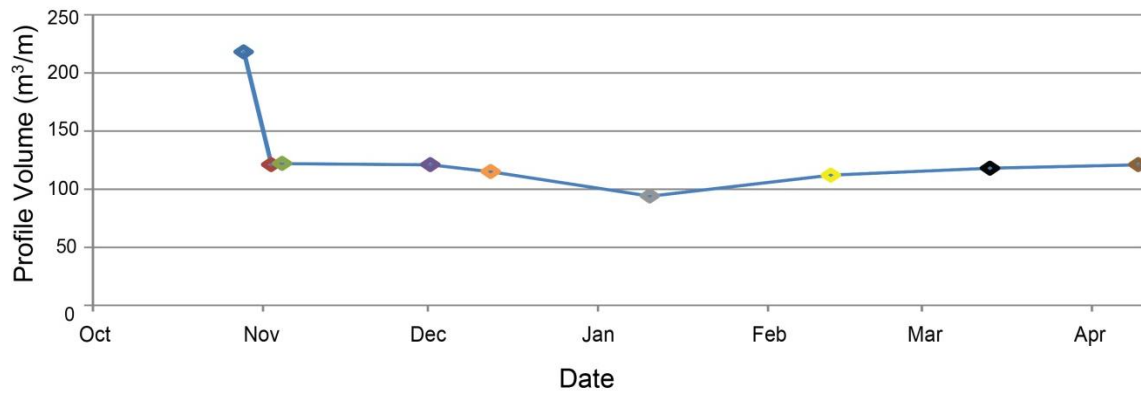
**Profile 7**

Cross-shore elevation profiles (upper panel) and associated profile volume in  $m^3/m$  (lower panel) collected during nine field surveys (October 28, 2012 to April 9, 2013) at nine DGPS profile locations along Fire Island, New York, are contained in Appendix 1.
