**Storage Capacity and Sedimentation Trends of Lago Garzas, Puerto Rico, 1996-2007**

By Soler-López, L.R.  
2012

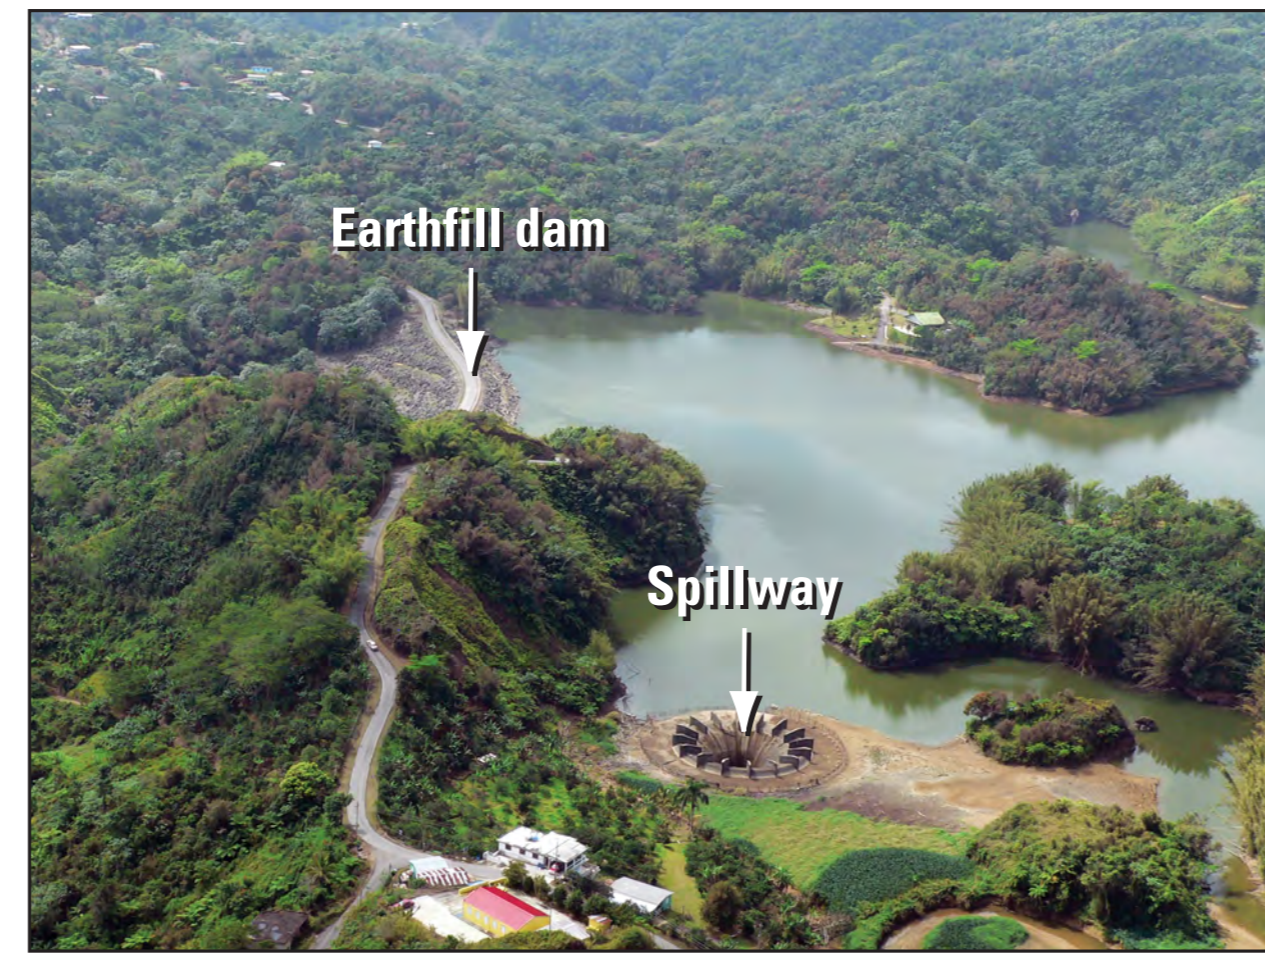
**Figure 2.** Aerial photograph of the Lago Garzas earthfill dam and spillway section, taken during a dam safety inspection in May 2006. Photograph courtesy of the Puerto Rico Electric Power Authority.

The dam is a semi-hydraulic earthfill embankment lined with boulders, and has a height of 61.57 meters, a top width of 9.14 meters, a base width of 365.76 meters, and a crest length of 227.37 meters; State Road PR-518 crosses the top of the dam. A morning-glory-type spillway is located near the west abutment of the dam at an elevation of 736.12 meters above mean sea level (Puerto Rico Water Resources Authority, 1969). Figure 2 shows an aerial photograph of the Lago Garzas earthfill dam and the morning-glory spillway section. Additional information and operational procedures are provided in Soler-López and others (1999).

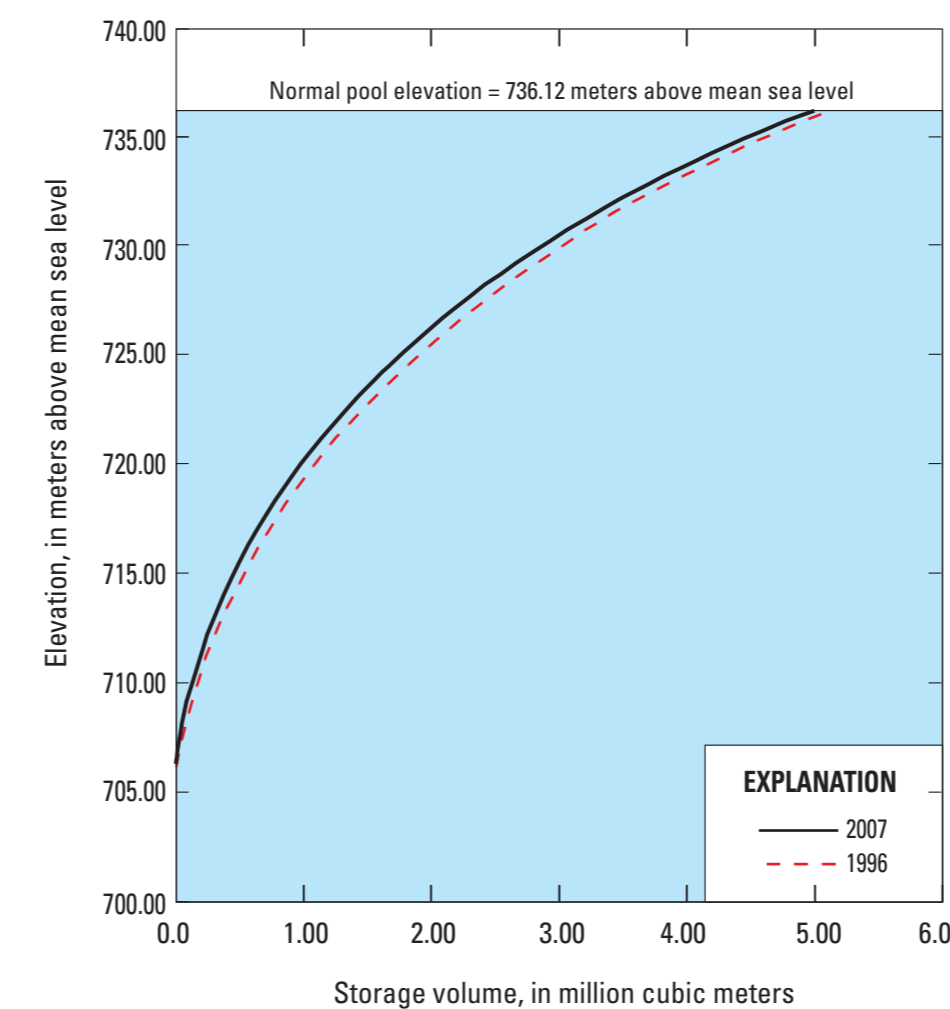
**Figure 5.** Relation between pool elevation and storage capacity of Lago Garzas for 1996 and 2007.

The storage capacity of Lago Garzas decreased from 5.11 million cubic meters in 1996 (Soler-López, 1999), to 4.99 million cubic meters by July 2007 (table 1). This decrease represents a reduction from 1996 to 2007 of 120,000 cubic meters (or 2.3 percent over 11 years), for an annual storage-capacity loss rate of about 10,909 cubic meters. The long-term sedimentation rate of Lago Garzas has decreased slightly from 13,019 cubic meters per year in 1996 to 12,656 cubic meters per year in 2007 (table 1). The nearly unchanged sedimentation rate of Lago Garzas from 1996 to 2007 (table 1) may be due to the largely undisturbed Lago Garzas drainage area (fig. 4). An actualized storage capacity table and curve were generated by calculating the TIN volume at 1-meter elevation intervals (table 2, fig. 5).

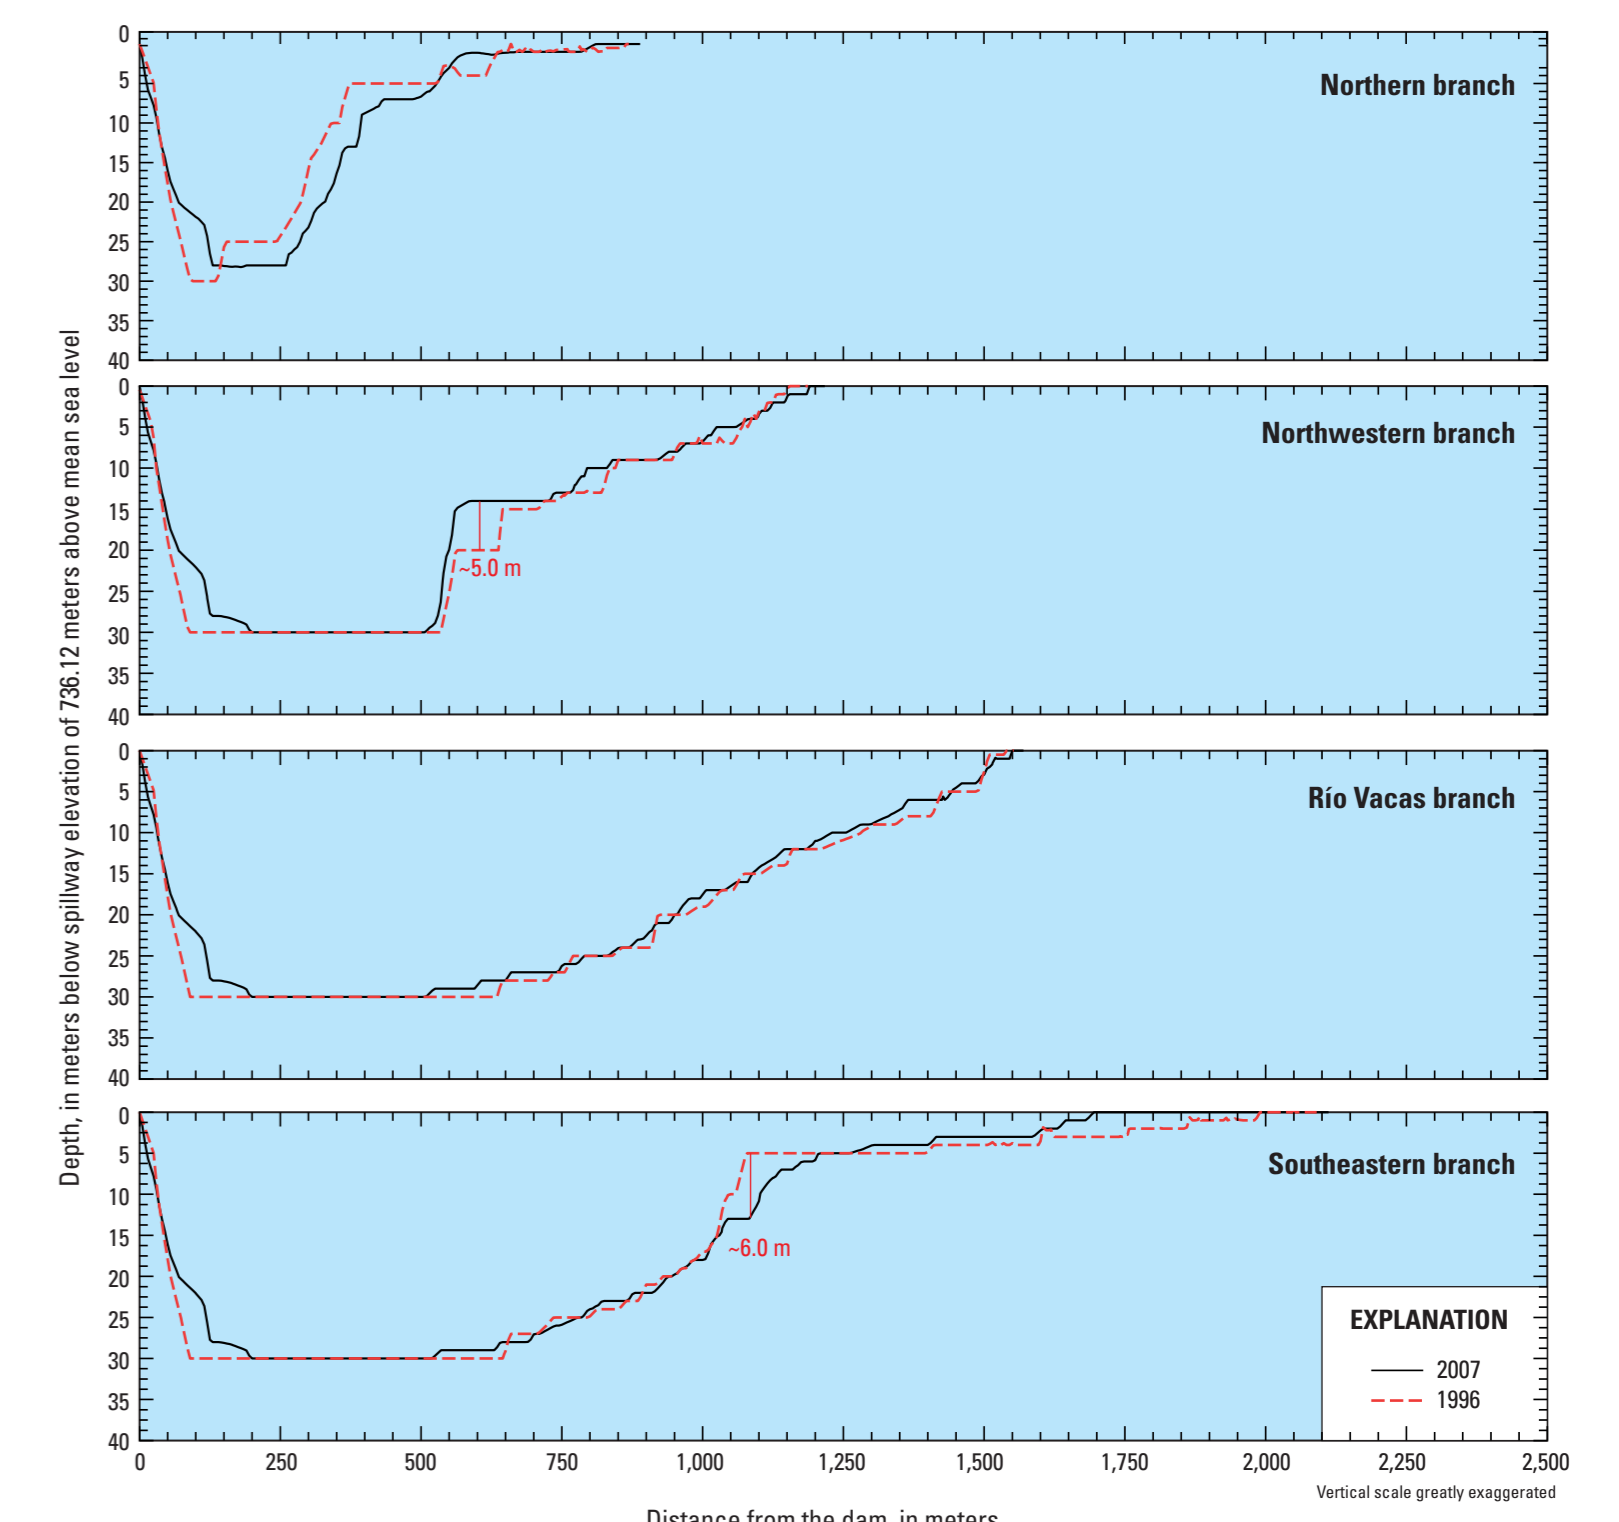
**Figure 6.** Longitudinal bottom profiles along the thalweg of Lago Garzas, within the northern, northwestern, Rio Vacas, and southeastern branches of the reservoir, for 1996 and 2007.

Sediment accumulation within the majority of Lago Garzas between 1996 and 2007 has been minimal, with the exception of one deposition area along the northwestern branch of the reservoir (fig. 6). The profiles shown in figure 6 indicate that a patch of sediment about 5 meters thick has accumulated along the northwestern branch of the reservoir between about 550 to 650 meters upstream of the dam. The Lago Garzas long-term drainage area sediment yield rate has remained relatively unchanged, decreasing slightly from 565 to 550 cubic meters per square kilometer per year from 1996 to 2007 (table 1; Soler-López and others, 1999).

Most of the storage capacity loss of Lago Garzas is distributed uniformly across the reservoir bottom; however, one area of sediment deposition is evident along the northwestern tributary branch, where an average of about 5 meters of sediment has accumulated between 1996 and 2007. The long-term Lago Garzas drainage area sediment yield has remained relatively unchanged from 1996 to 2007, decreasing slightly from 565 to 550 cubic meters per square kilometer per year.
