# Effects of Urban Best Management Practices on Streamflow and Phosphorus and Suspended-Sediment Transport on Englesby Brook in Burlington, Vermont, 2000–2010

Scientific Investigations Report 2012–5103

By Laura Medalie

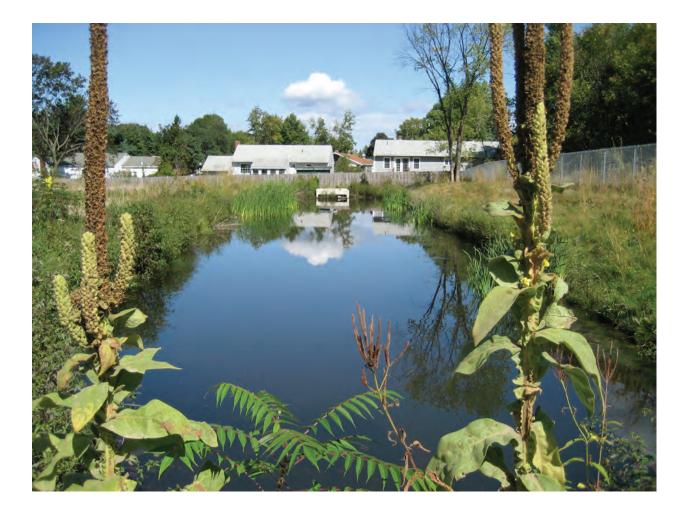
**Figure 1.** The forebay of the wet extended detention facility that is designed to trap sediment from a redirected segment of Englesby Brook in Burlington, Vermont.

Restoration included construction of four structural best management practices (BMPs) in the watershed (fig. 1, table 1). Together, these structures treat about 54 percent of runoff from the watershed. In this report, the two structures built in 2005 together are called the "wet extended detention (ED) ponds." An investigation into the effectiveness of the irrigation pond retrofit, evaluated using data through 2005 collected from Englesby Brook (Medalie, 2007), found in the post-BMP period nonsignificant decreases in phosphorus and suspended-sediment concentrations (SSC) at streamflow

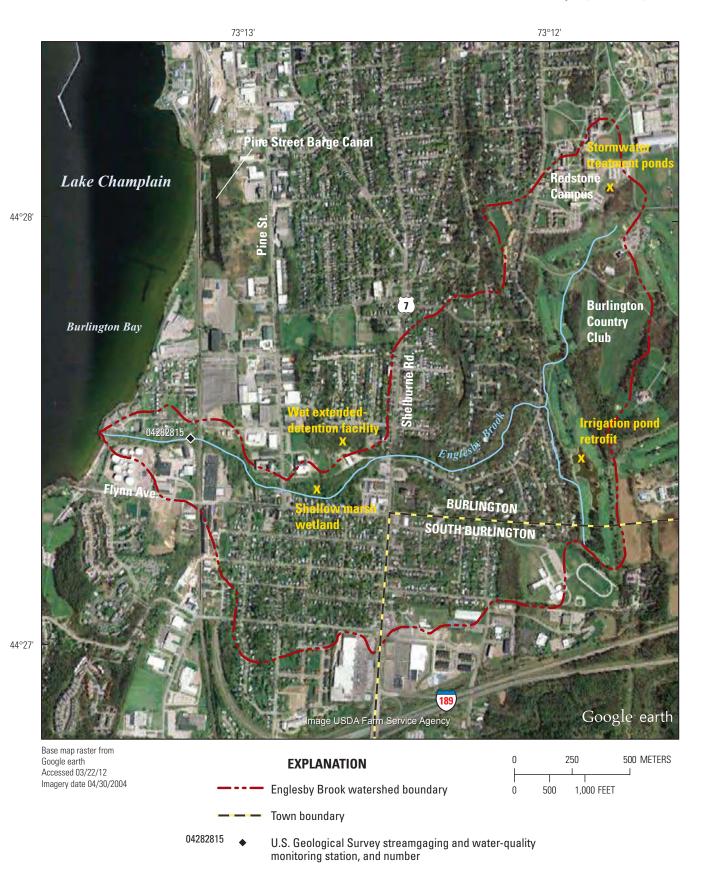
**Figure 3.** Englesby Brook in Burlington, Vermont, and its watershed. The locations of best management practices structures are indicated in yellow. The location of the U.S. Geological Survey streamgage 04282815 is shown with a black diamond.

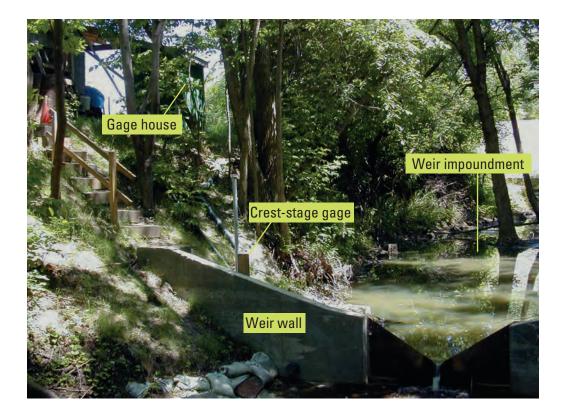
**Figure 4.** U.S. Geological Survey streamgage 04282815 on Englesby Brook in Burlington, Vermont, from below the weir, looking upstream.

The streamgage consisted of an impoundment created by a 120-degree v-notch weir with a sloping concrete wall (fig. 4). Stream stage was measured above the weir continuously at USGS streamgage 04282815 by a pressure transducer mounted on the concrete wall. Water samples were collected according to protocols from the USGS National Field Manual (U.S. Geological Survey, variously dated). Water samples were collected monthly as either manual grabs (for low streamflows when stream velocity was less than or equal to 1.5 feet per second) or using the equal-widthincrement method (for high streamflows). Water samples also were collected during many storms by an automated sampler
