Hydrologic Characteristics of Low-Impact Stormwater Control Measures at Two Sites in Northeastern Ohio, 2008–13

Scientific Investigations Report 2015–5030

By Robert A. Darner, William D. Shuster, and Denise H. Dumouchelle

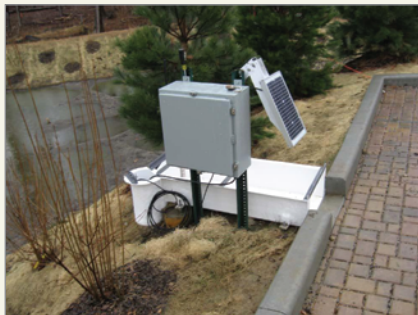
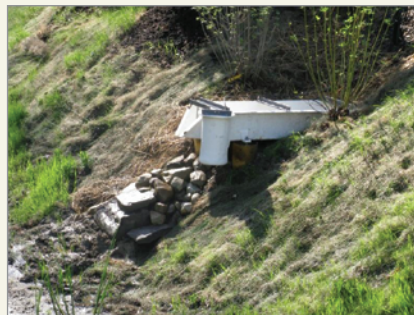
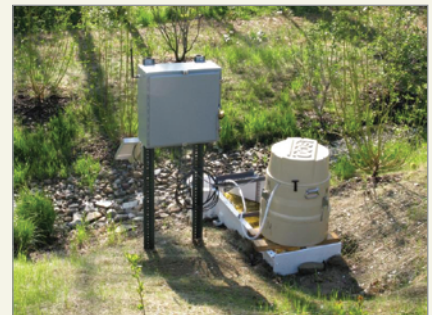
Cover. Schematic site plan for stormwater best-management practices at the Washington Street site, Geauga County, Ohio (top), and photos of three flumes (bottom, left to right). Flume 1 measures surface flow over the parking lot, flume 2 measures any overflow from the rain garden, flume 3 measures the flow from the drain line.

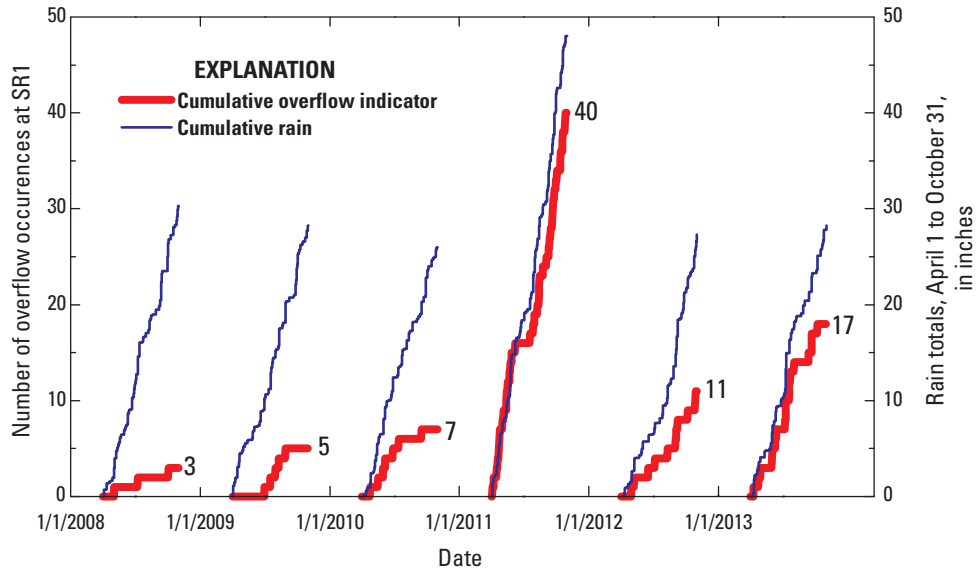
Figure 3. Cumulative overflow indicator and cumulative rain from April 1 to October 31 of each year at the Sterncrest Drive SR1 site, Cuyahoga County, Ohio.

Total rainfall measured during April 1–October 31, 2011, was much greater than in other years, which apparently drove the increase in overflow frequency (fig. 3) for that year. The relation between higher-frequency storms with greater overall seasonal depth and overflow status is illustrated in figure 3. If the data from 2011 are excluded (due to the unusual amount of rain), then the number of overflows (even with similar precipitation totals) is increasing year to year (fig. 3).

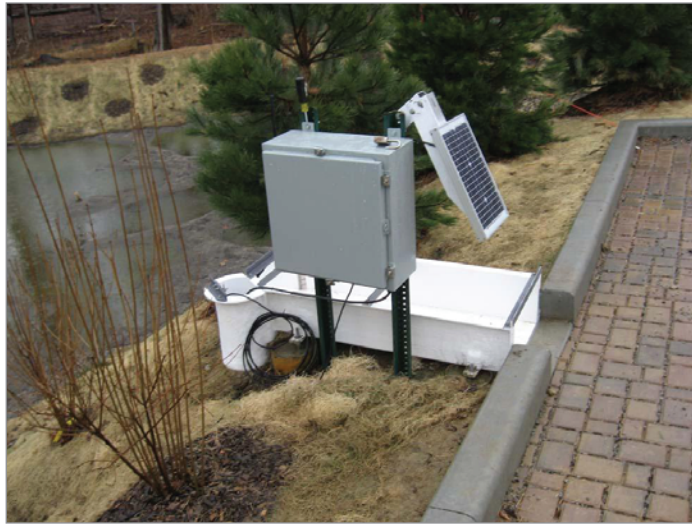
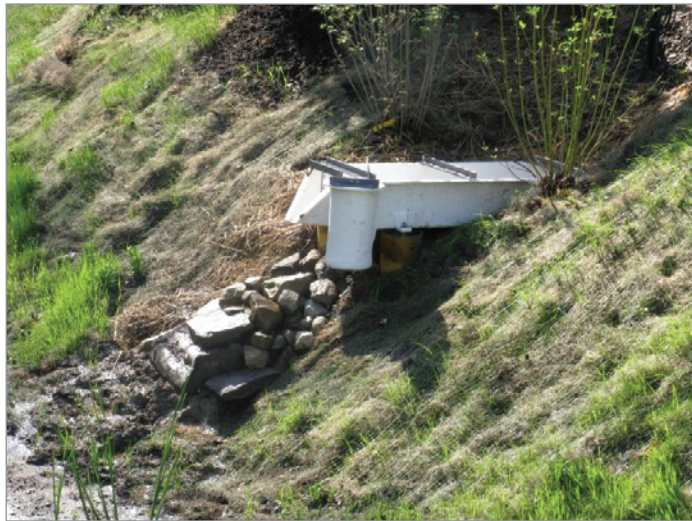
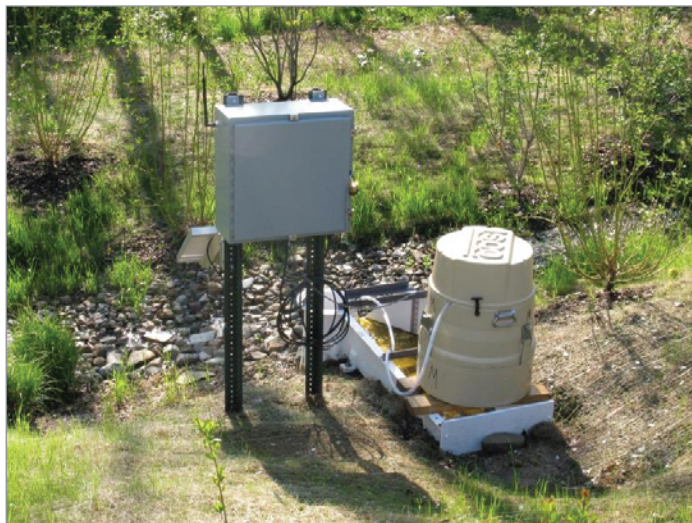
Figure 5. Three flumes at the Washington Street site, Geauga County, Ohio. A, Flume 1 measures surface flow over the parking lot. B, Flume 2 measures any overflow from the rain garden. C, Flume 3 measures the flow from the drain line.

Data from this site were analyzed for April–October 2009 and 2010 and were presented in Darner and Dumouchelle (2011). Additional data were collected from April 1, 2011 through September or October 2011. During the entire period, no measurable runoff was recorded in flume 1 (which measures surface runoff from the pervious pavers) indicating all precipitation that fell on the parking lot was either infiltrated or lost to evaporation. The runoff data from flume 2 were included with the data from flume 3 to represent the total runoff from the site.

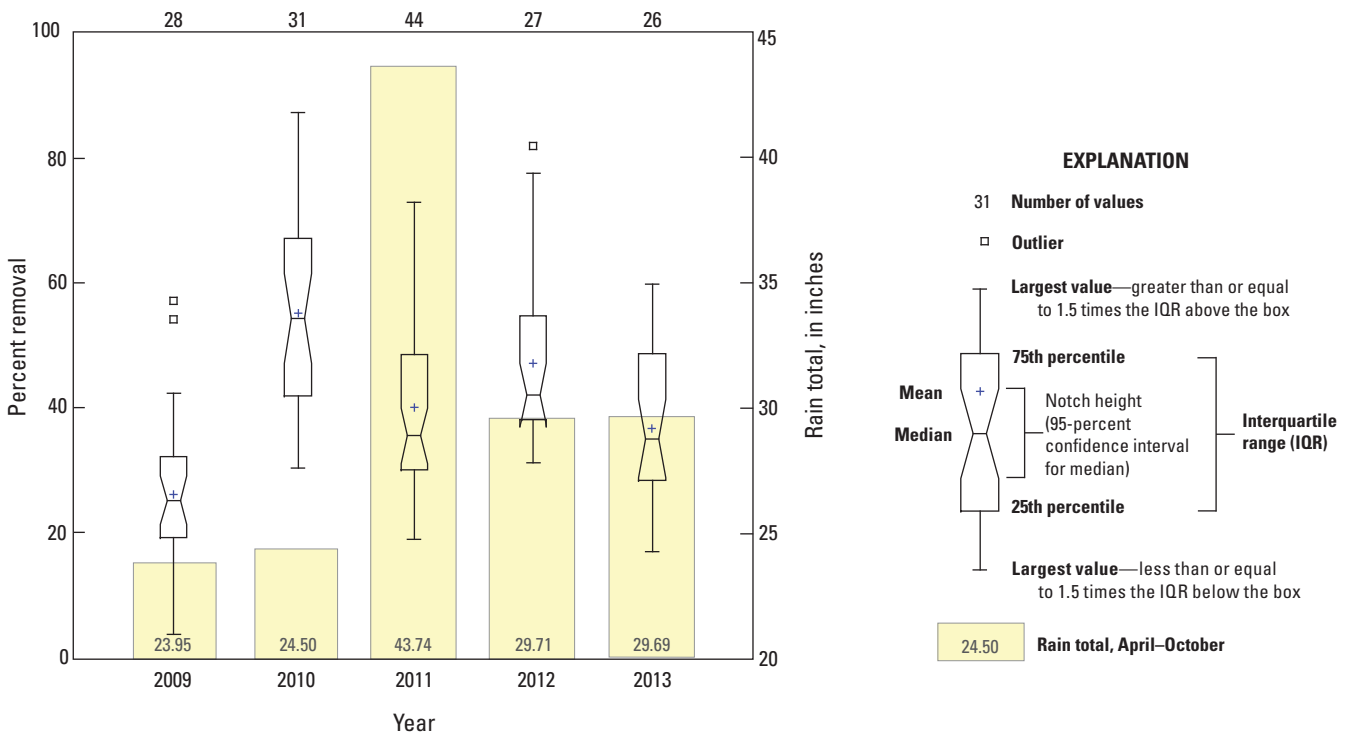
Figure 6. Percent removal and bar graph showing the depth of rain starting April 1 and ending October 31, by year, at the Washington Street site, Geauga County, Ohio.

The Washington Street SCM is intended to reduce and (or) delay the runoff from the building and parking lot. Figure 6 is a boxplot of percent removal and bar graph of Rain_{ws} by year. The mean amount of rain for the northeast region of Ohio for the months of April–October is 24.19 in. (National Oceanic and Atmospheric Administration, 2002). Rain_{ws} for 2011 was

43.74 in., an increase of nearly 45 percent over average. The amount of Rain_{ws} in 2011 was greater than in any of the other years such that the 2011 value of Rain_{ws} was 93 percent of the average annual precipitation for this area of Ohio (Midwestern Regional Climate Center, 2010). The median percent removal in 2009 was slightly less than 25 percent with two outliers indicating episodically high detention of runoff volume (fig. 6). While the Rain_{ws} in 2010 was similar to 2009, the median percent removal increased to nearly 60 percent. In 2011, the amount of Rain_{ws} was nearly twice that of 2009 and 2010. An analysis of variance shows that the mean percent removal in 2011 was different than in 2010 (results in appendix 1), and the notched intervals for 2009, 2010, and 2011 do not overlap indicating that the medians are significantly different at the 95-percent confidence level. The annual mean percent removal for 2010–13 ranged from 55 to 37 percent, with an overall mean of 45 percent. Darner and Dumouchelle (2011) stated that differences in runoff volume and lag times (discussed later) observed in 2009 as compared to 2010 might have been due to changes related to the establishment of the plants in the rain garden (overcoming the shock of transplantation, increasing root and foliage mass, and generally adapting to new environmental conditions), development of preferential flow paths, and (or) differing weather conditions.

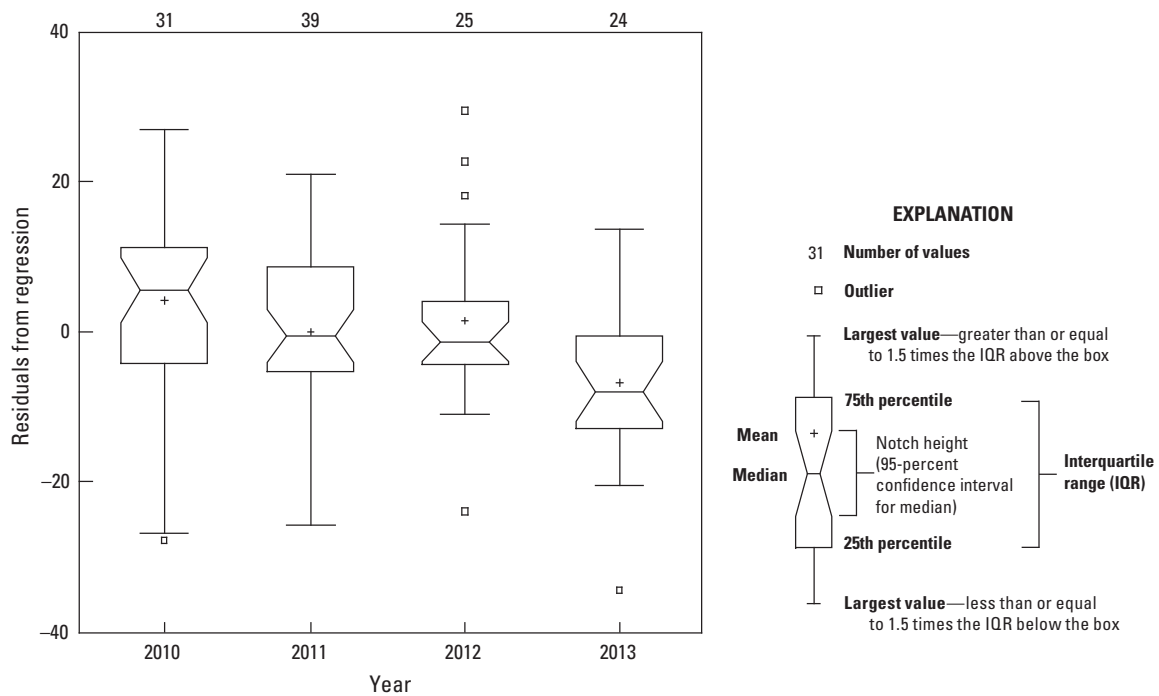
Figure 9. Percent removal residuals, by year, at the Washington Street site, Geauga County, Ohio.

regression equation $\text{Percent Removal} = -31.3 \times \log_{10}(\text{Event Rain} \times (\text{total rain April to October})) + 85.6$

To assess whether factors other than rain totals were associated with observed changes in percent removal over the 4 years, a linear regression was done to remove the variance in percent removal associated with rainfall totals (results in appendix 1, section B) and *LOG_PN* (results in appendix 1, section C). The regression with rain total, while significant, only explains about 25 percent of the variance in percent removal. The regression of *LOG_PN* only explains about 35 percent of the variance in percent removal but when other rain characteristics were added as part of a multiple linear regression (MLR), the results did not improve (results of MLR not shown). The residuals (observed minus predicted values) from the linear regression of percent removal as the dependent variable and *LOG_PN* as the independent variable represent percent removal with the effects of *LOG_PN* removed, and boxplots of the residuals by year (fig. 9) show a declining percent removal over time. Analysis of variance of the residuals indicated that there was indeed a significant decline in percent removal from 2010 to 2013 and from 2012 to 2013 (results in appendix 1, section C).

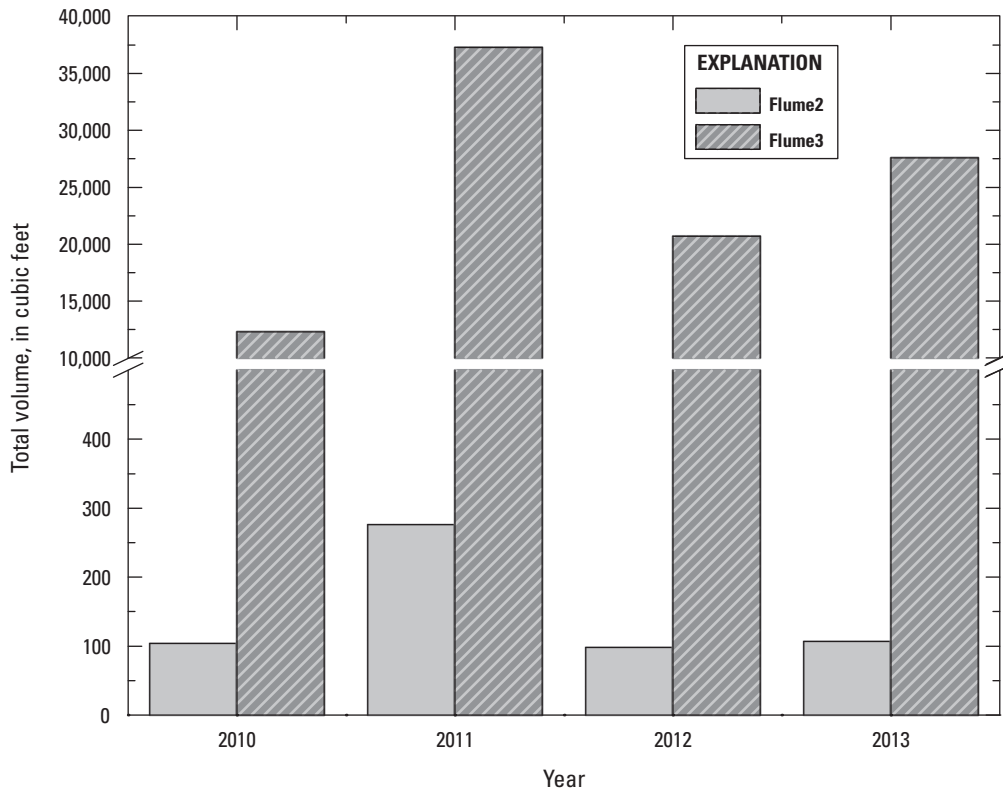
Figure 12. Total flow through flumes 2 and 3 for April–October 2010–13 at the Washington Street site, Geauga County, Ohio.

As has been discussed, the data show that the percent removal has been declining over time at the Washington Street SCM. The behavior of the rain garden and the pervious-paver system of the SCM can be investigated by examining the data from flumes 2 and 3 (fig. 4). The volume of water that overflowed the rain garden (flume 2) was similar for 2010, 2012, and 2013 but was more than 2.5 times greater in 2011 (fig. 12). The larger volume of water in flume 2 in 2011 is not extraordinary, given the greater rainfall in 2011 and the smaller demand for water by the plants (i.e., less transpiration). Likewise, volumes through flume 3 were highest in 2011; however, the

volume of water that drained from the pervious-paver system (flume 3) increased from 2010, to 2012 and 2013. Thus, the flume data indicate that the decline in the percent removal of the SCM is a function of the pervious-paver system; however, the exact cause is not known. Although the runoff increased (percent removal decreased) over time, the lag time remained fairly constant over time and therefore more water (runoff) moved through the system in roughly the same time, indicating that preferential flow paths have likely developed within the SCM.
