## Continuous Slope-Area Discharge Records in Maricopa County, Arizona, 2004–2012

Scientific Investigations Report 2015–5172

By Stephen M. Wiele, John W. Heaton, Claire E. Bunch, David E. Gardner, and  
Christopher F. Smith

Prepared in cooperation with the Flood Control District of Maricopa County

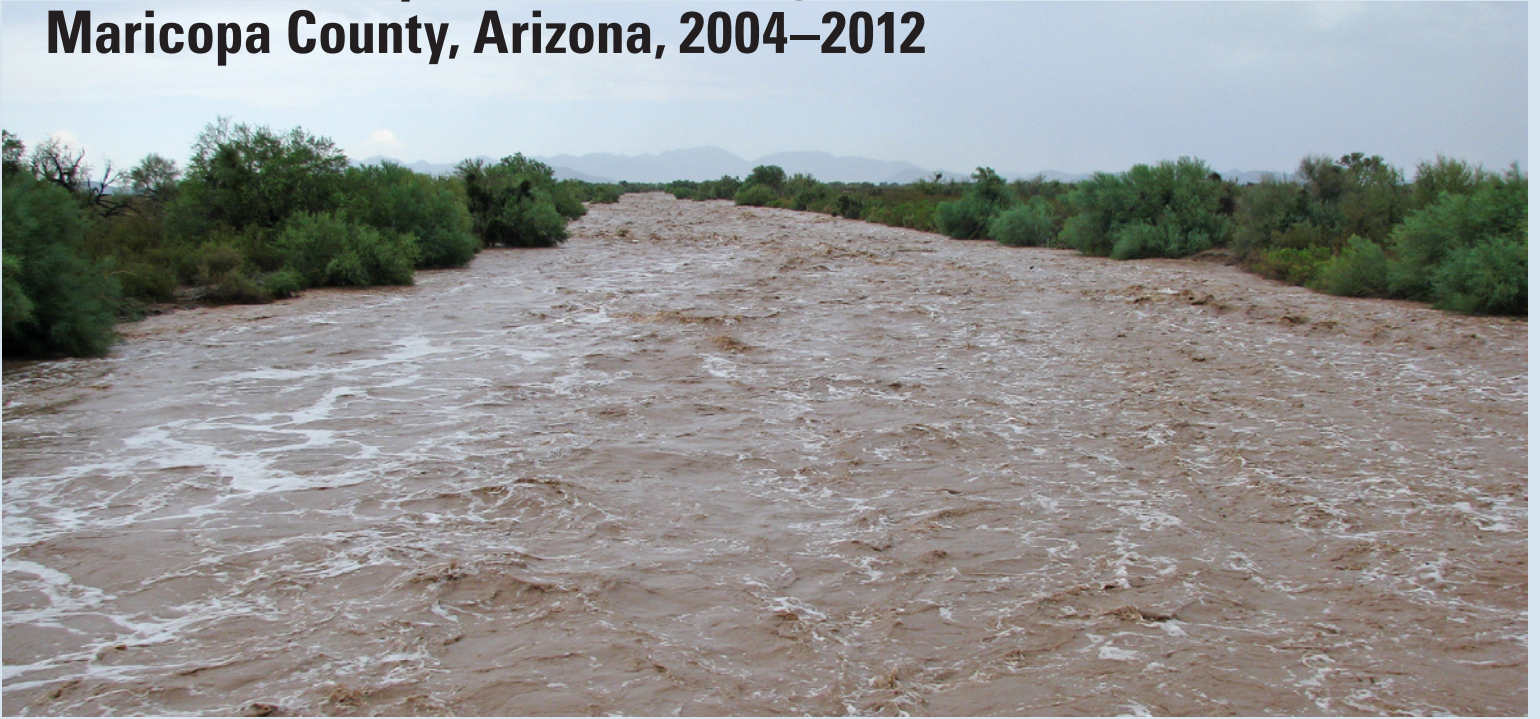
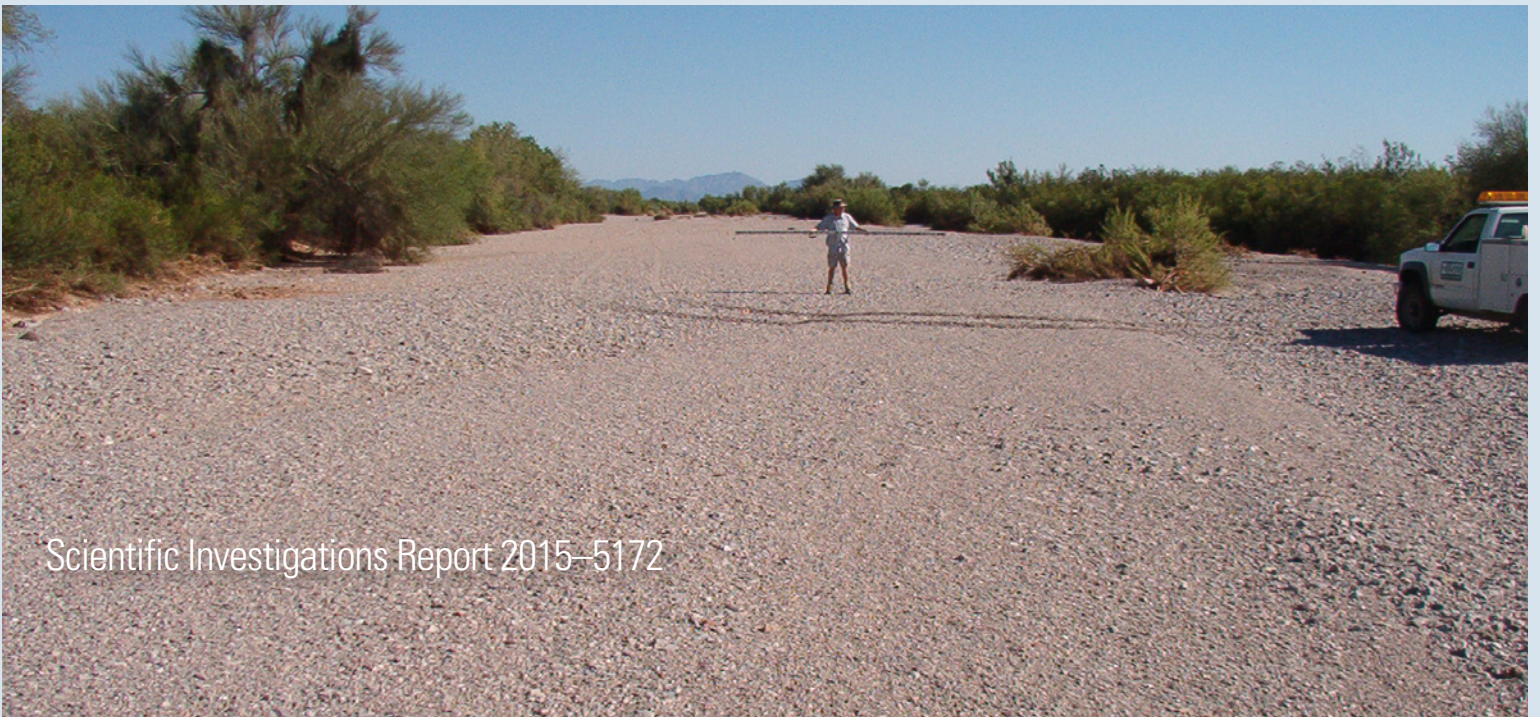
Photographs show Vekol Wash near Stanfield, Arizona, in flood (top) and at zero flow (bottom). Photographs by John W. Heaton.

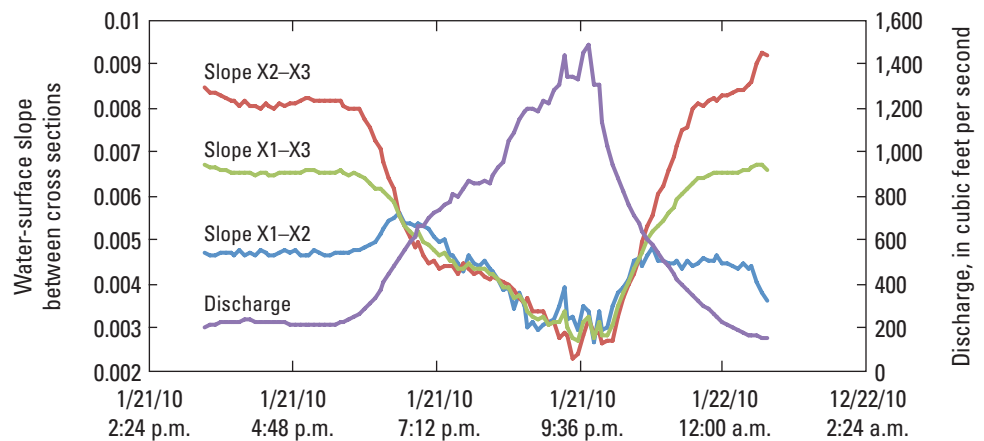
**Figure 2.** Graph showing water-surface slopes and discharge at the Deadman Wash, Arizona, continuous slope-area streamgauge during the January 21–22, 2010, flow.

through the reach. Prior to and following a flow at Deadman Wash (fig. 2), the slope derived from PT stages is only a function of the surveyed elevations of the instruments. As the stage rises, the slopes begin to converge, and at around 600 cubic feet per second ( $\text{ft}^3/\text{s}$ ), the slope is consistent through the reach. The slope steadily declines as the stage rises, then increases again as the stage falls. At around 600  $\text{ft}^3/\text{s}$ , the slopes again decouple and return to their preflow values. In this case, reliable discharge could be computed above 600  $\text{ft}^3/\text{s}$ . Plotting the slope between cross sections can be useful for identifying the lowest flow that should be calculated with the CSA streamgauge.

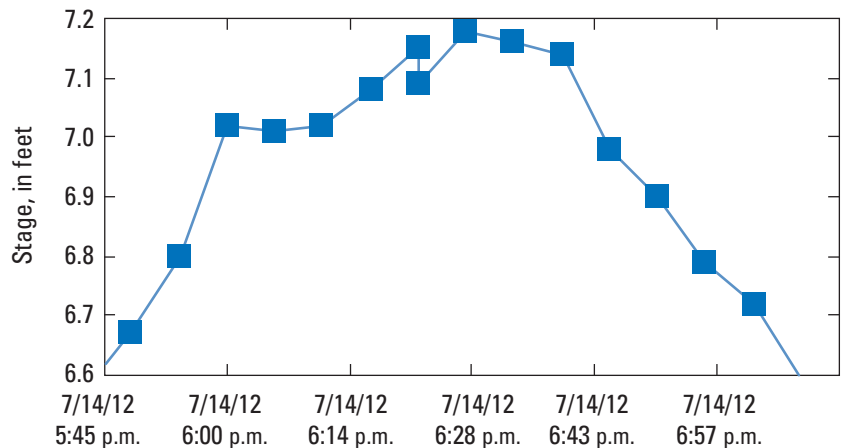
**Figure 3.** Graph showing stage record at the upstream cross section in the Tiger Wash, Arizona, continuous slope-area reach during the July 14, 2012, streamflow.

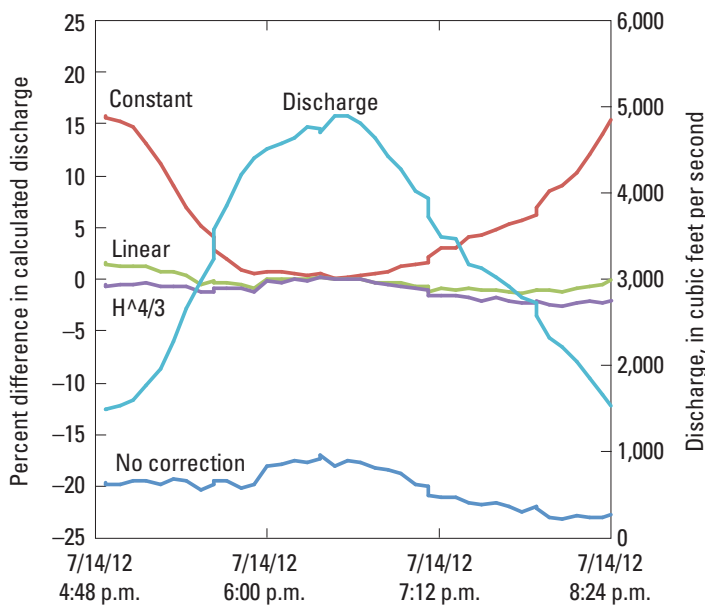
**Figure 4.** Graph showing continuous slope-area streamgage discharge record at the Tiger Wash, Arizona, streamgage. The discharge shown was computed using a drawdown correction based on  $u^2$ , where  $u$  is velocity, and is used as a reference for the differences in discharge calculated with other corrections for drawdown.

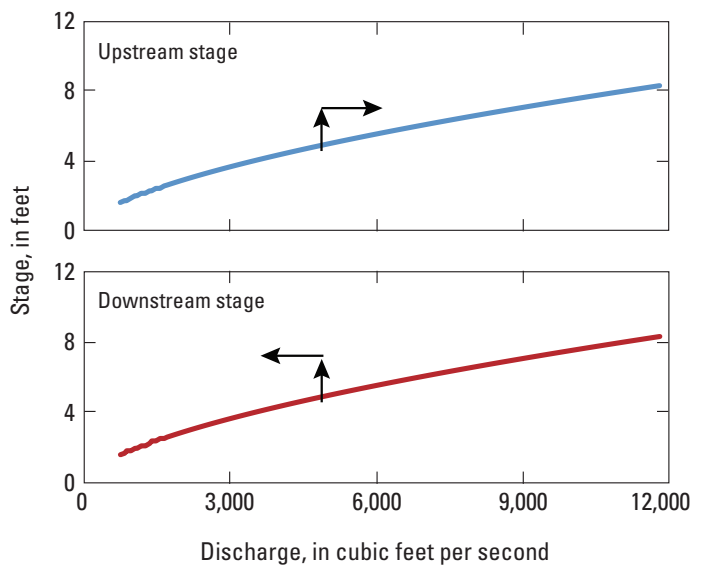
**Figure 6.** Graphs showing the difference between using the upstream pressure transducer and the downstream pressure transducer in developing rating curves. An upward fluctuation in stage increases the slope used to compute discharge. This increases the computed discharge and tends to move the stage-discharge pair towards the rating line (top). With an upward fluctuation in stage at the downstream gage, the opposite occurs. The slope used to compute discharge is lower, leading to a lower computed discharge. The stage-discharge pair moves away from the rating line (bottom).

at the upstream end is trending in the same direction as the stage (both are increasing), whereas at the downstream end, they are moving in opposite directions (fig. 6). As a result, the downstream PT will produce more scatter in the stage-discharge relation.

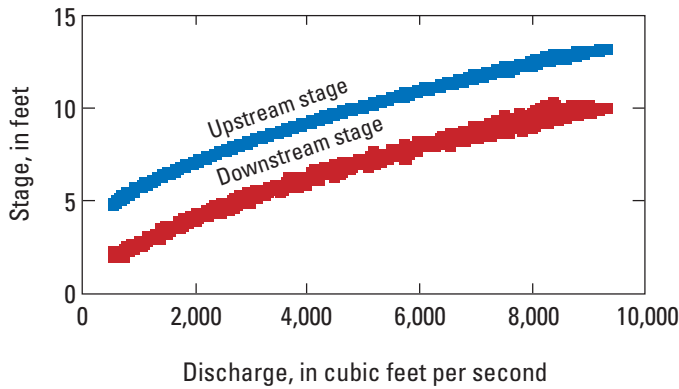
**Figure 8.** Stage-discharge plots using values from the hydrograph in figure 7. The plot using the upstream stage pressure transducer (blue) shows less scatter than with the downstream pressure transducer (red).

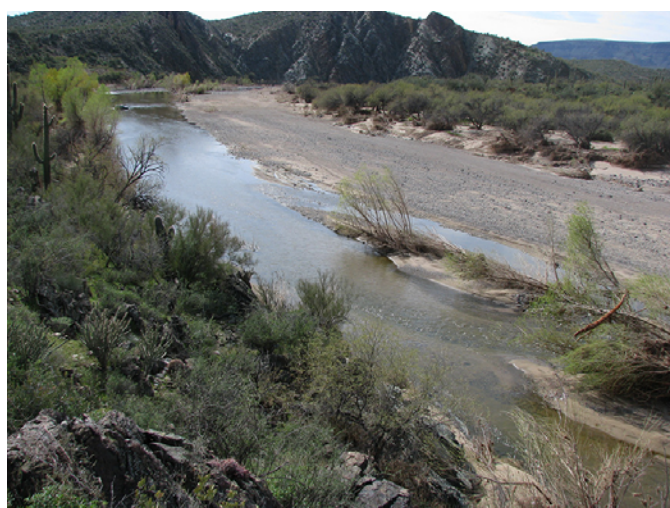
**Figure 12.** Cross section 1 in the Agua Fria near Rock Springs, Arizona, continuous slope-area reach, February 4, 2010.

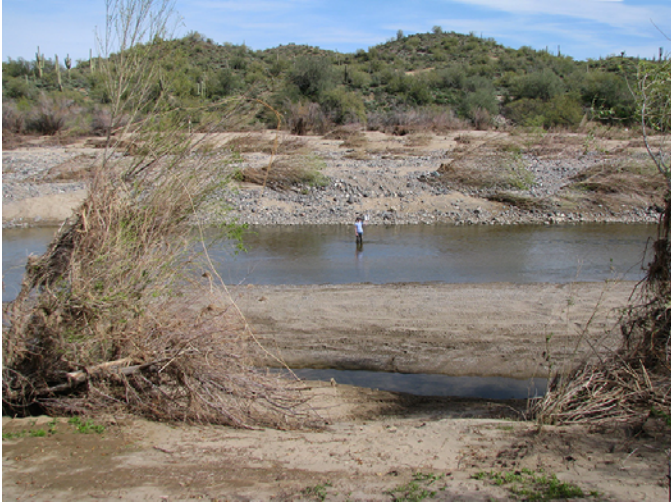
**Figure 14.** Cross section 3 in the Agua Fria near Rock Springs, Arizona, continuous slope-area reach, February 4, 2010.

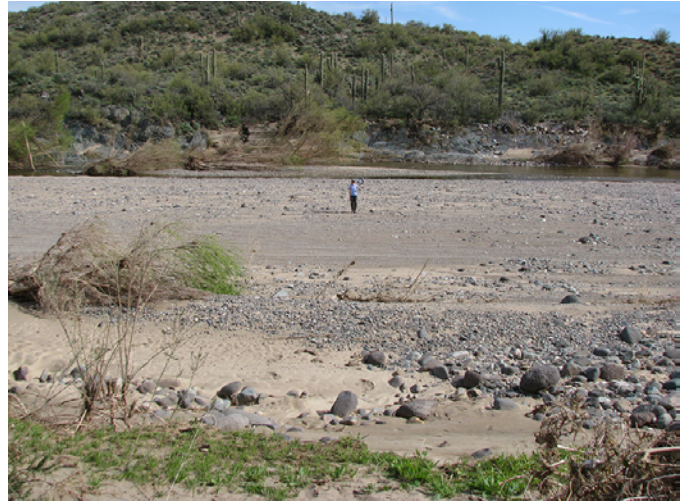
**Figure 13.** Cross section 2 in the Agua Fria near Rock Springs, Arizona, continuous slope-area reach, February 4, 2010.

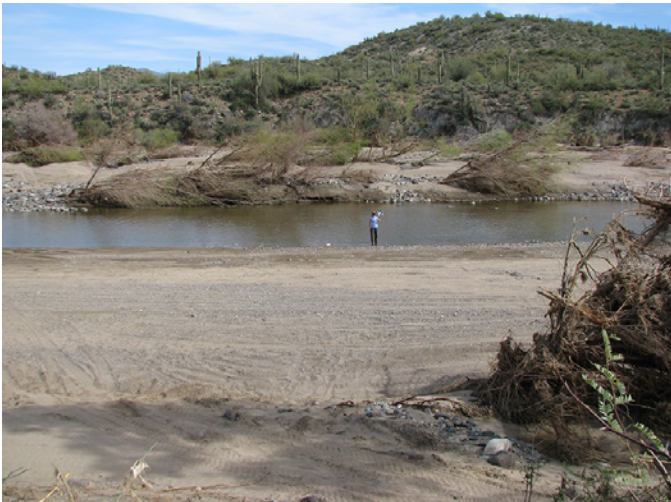
**Figure 15.** Cross section 4 in the Agua Fria near Rock Springs, Arizona, continuous slope-area reach, February 4, 2010.

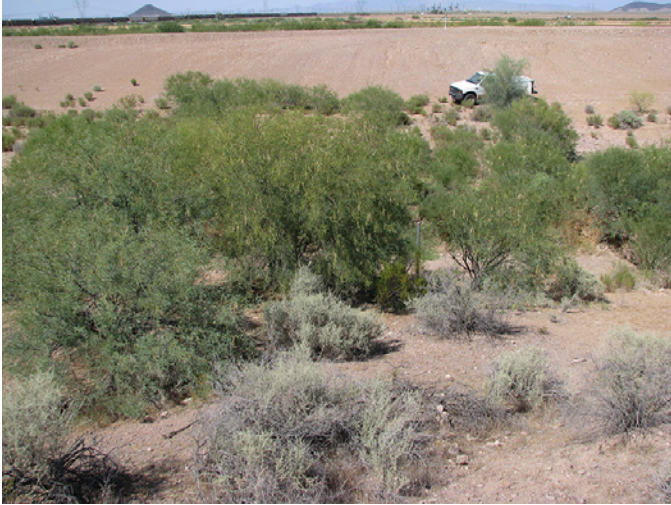
**Figure 17.** Cross section 1 in the Centennial Wash at Southern Pacific Railroad Bridge near Arlington, Arizona, July 1, 2009.

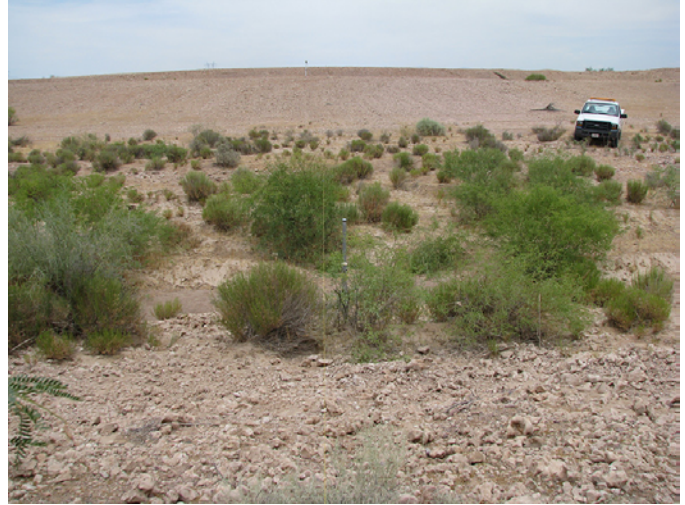
**Figure 18.** Cross section 2 in the Centennial Wash at Southern Pacific Railroad Bridge near Arlington, Arizona, July 1, 2009.

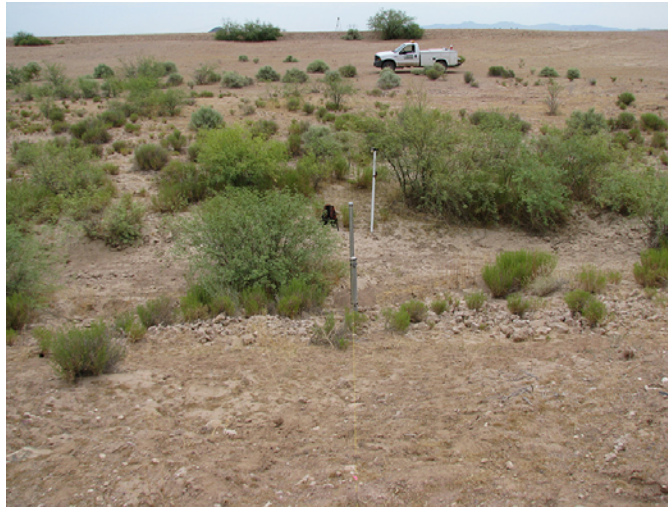
**Figure 19.** Cross section 3 in the Centennial Wash at Southern Pacific Railroad Bridge near Arlington, Arizona, July 1, 2009.

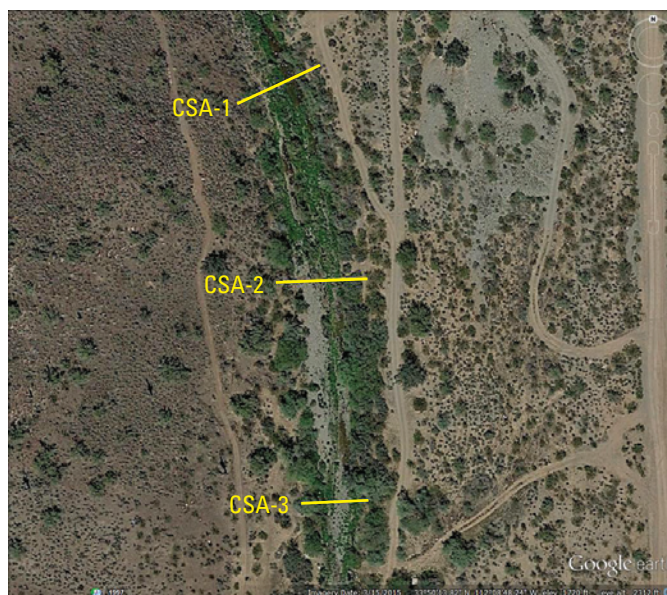
**Figure 20.** Aerial view of the Deadman Wash near New River, Arizona, continuous slope-area (CSA) reach. Cross sections are shown in yellow. Flow is from top to bottom. Image is from Google Earth and was taken March 15, 2015.

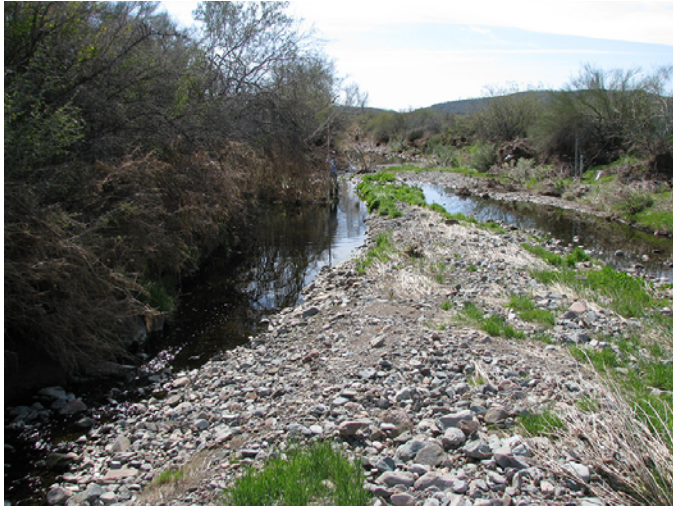
**Figure 21.** Overview of Deadman Wash near New River, Arizona, continuous slope-area reach, February 17, 2010.

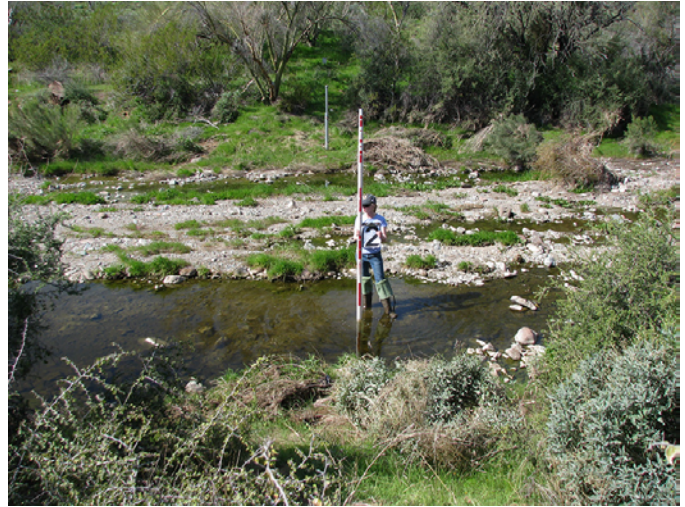
**Figure 23.** Cross section 2 in the Deadman Wash near New River, Arizona, continuous slope-area reach, February 17, 2010.

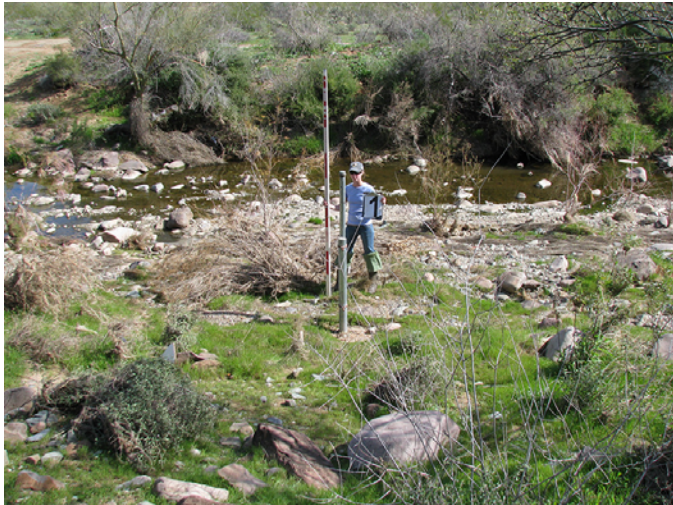
**Figure 22.** Cross section 1 in the Deadman Wash near New River, Arizona, continuous slope-area reach, February 17, 2010.

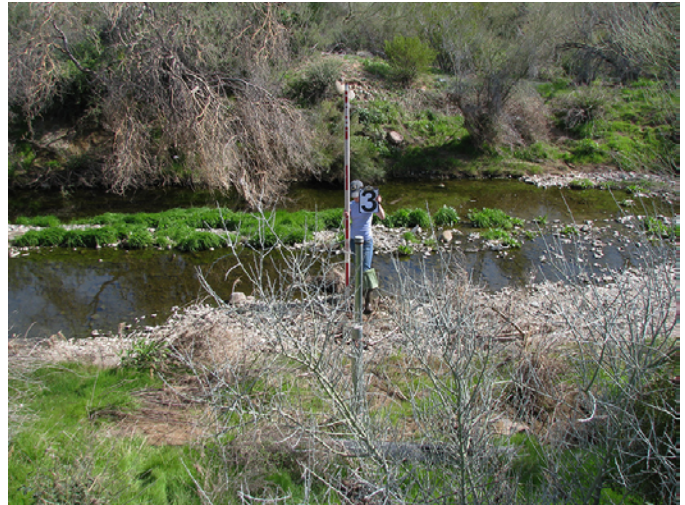
**Figure 24.** Cross section 3 in the Deadman Wash near New River, Arizona, continuous slope-area reach, February 17, 2010.

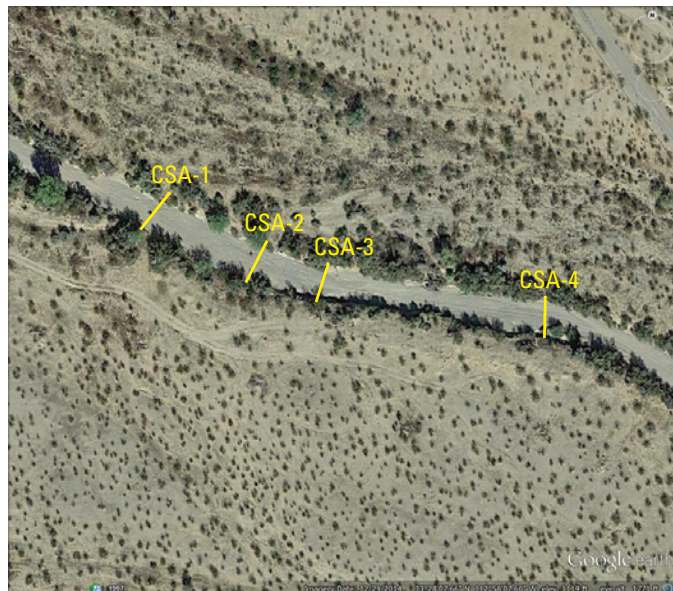
**Figure 25.** Aerial view of the Delaney Wash, Arizona, continuous slope-area (CSA) reach. The cross sections are shown in yellow. Flow is from left to right. Image is from Google Earth and was taken December 29, 2014.

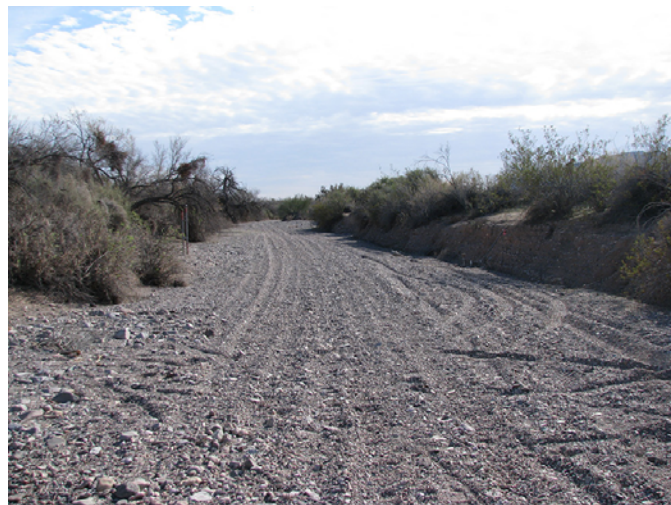
**Figure 27.** Looking downstream in the Delaney Wash, Arizona, continuous slope-area reach upstream of cross section 3. The USGS crest-stage gage and stage pressure transducer are on the left bank, and the Flood Control District of Maricopa County stage sensor is on the right bank.

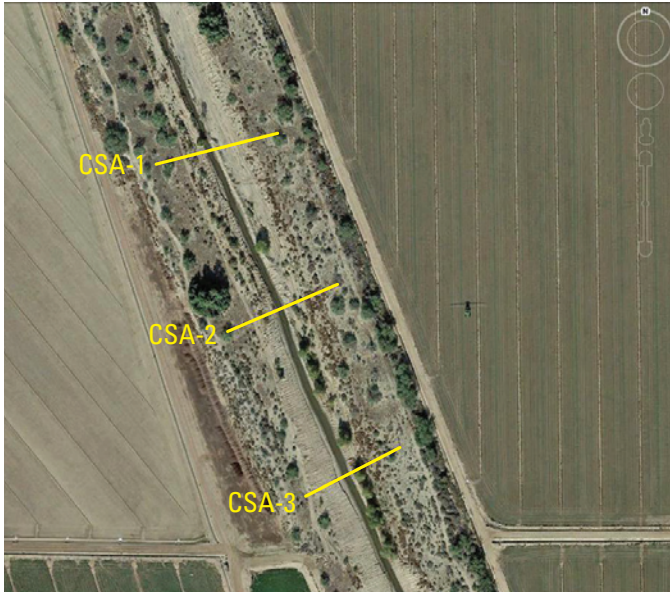
**Figure 28.** Aerial view of the Hassayampa River near Arlington, Arizona, continuous slope-area (CSA) reach. Cross sections are shown in yellow. Flow is from upper left to lower right. Image is from Google Earth and was taken December 29, 2014.

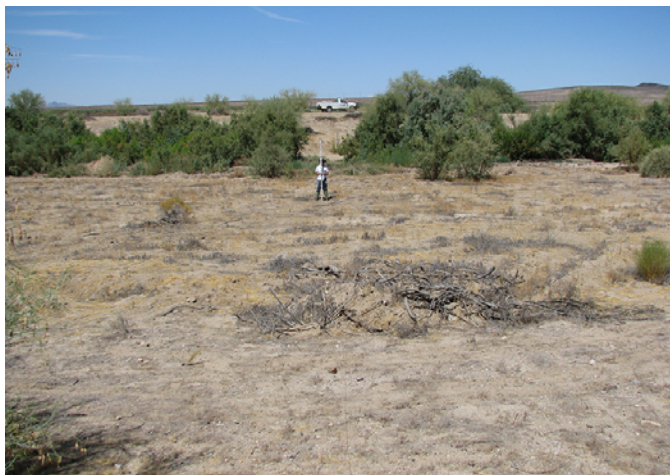
**Figure 29.** Cross section 1 in the Hassayampa River near Arlington, Arizona, continuous slope-area reach, July 9, 2009.

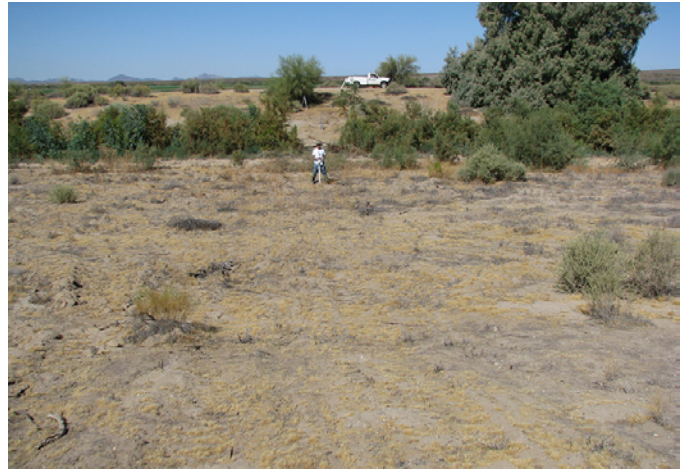
**Figure 30.** Cross section 2 in the Hassayampa River near Arlington, Arizona, continuous slope-area reach, July 9, 2009.

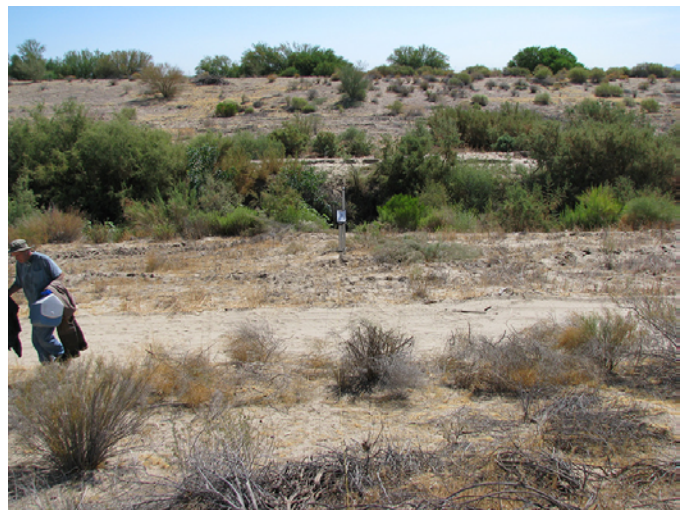
**Figure 31.** Cross section 3 in the Hassayampa River near Arlington, Arizona, continuous slope-area reach, July 9, 2009.

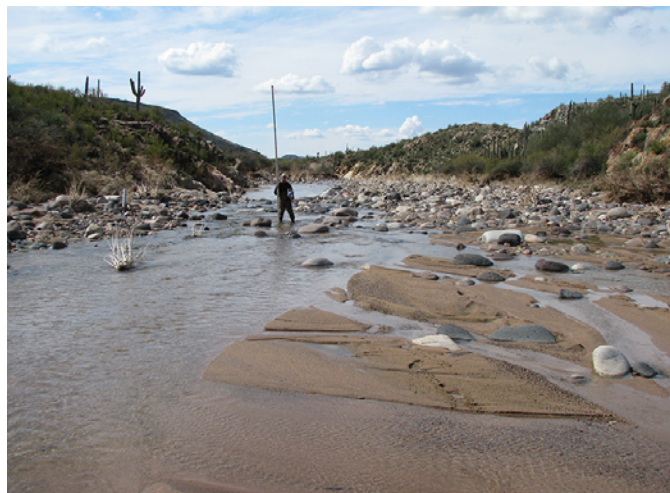
**Figure 35.** Cross section 2 in the New River near Rock Springs, Arizona, continuous slope-area reach, February 9, 2010.

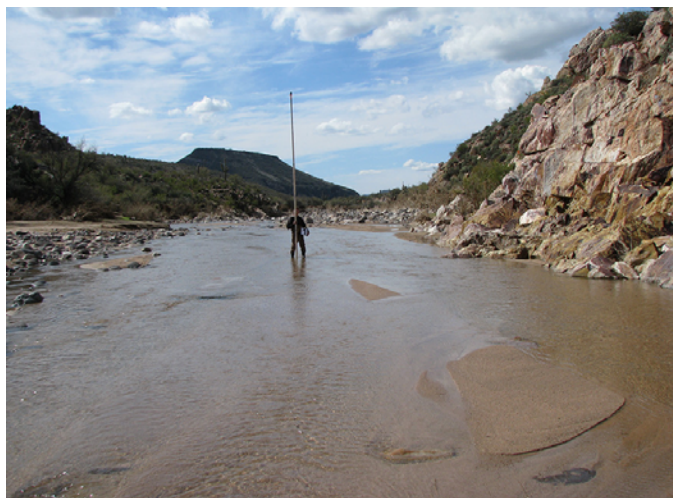
**Figure 34.** Cross section 1 in the New River near Rock Springs, Arizona, continuous slope-area reach, February 9, 2010.

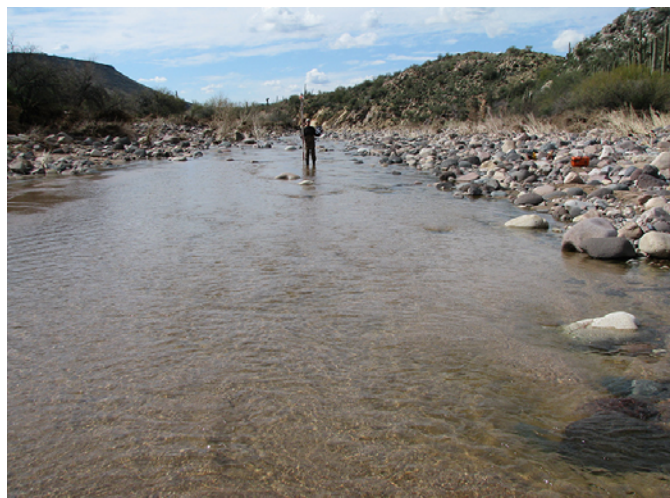
**Figure 36.** Cross section 3 in the New River near Rock Springs, Arizona, continuous slope-area reach, February 9, 2010.

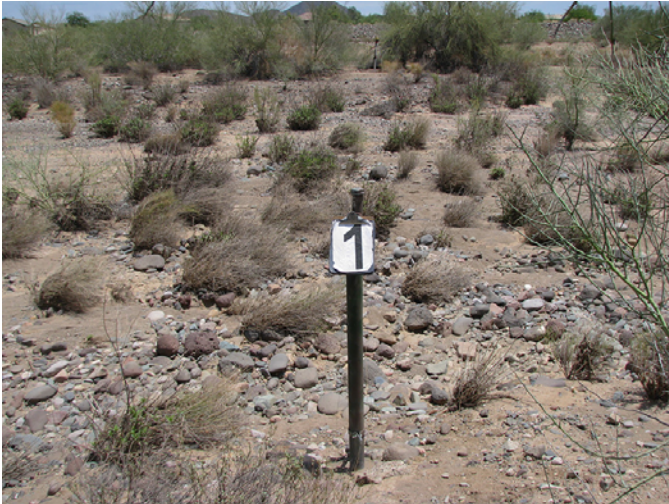
**Figure 38.** Cross section 1 in the Skunk Creek near Phoenix, Arizona, continuous slope-area reach, July 27, 2012.

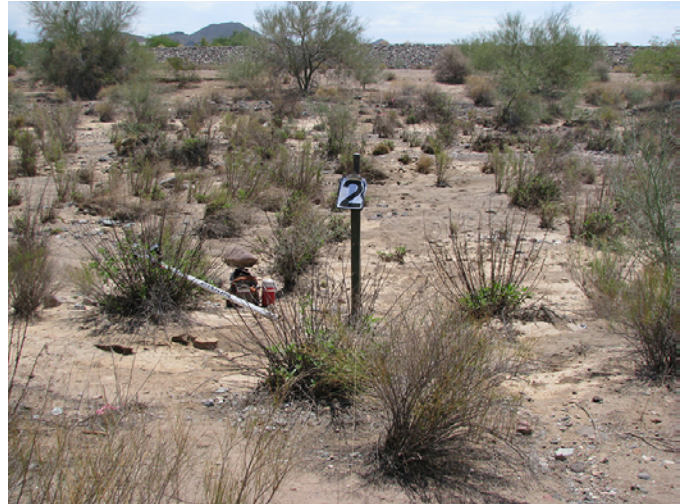
**Figure 39.** Cross section 2 in the Skunk Creek near Phoenix, Arizona, continuous slope-area reach, July 27, 2012.

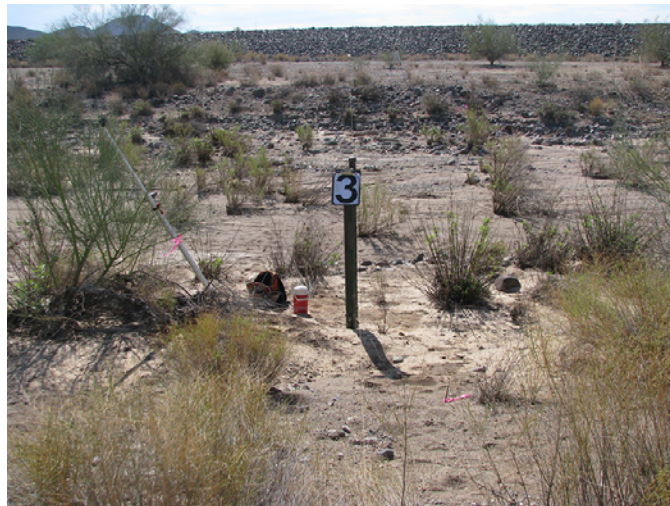
**Figure 40.** Cross section 3 in the Skunk Creek near Phoenix, Arizona, continuous slope-area reach, July 27, 2012.

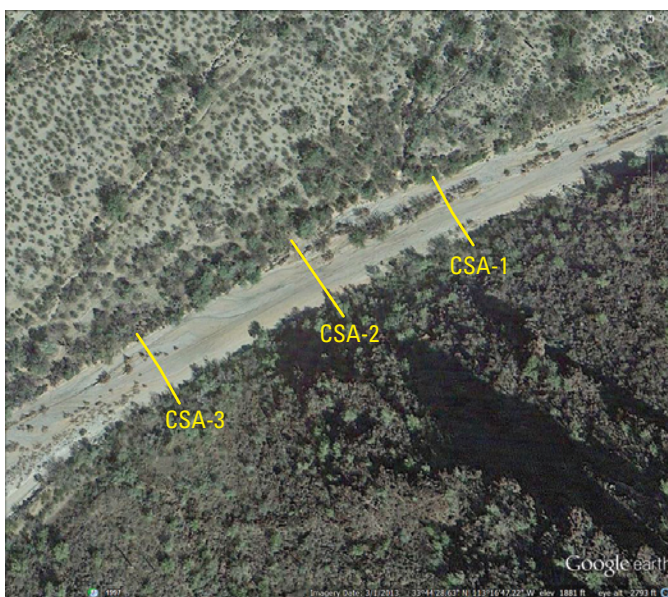
**Figure 41.** Aerial view of the Tiger Wash near Aguila, Arizona, continuous slope-area (CSA) reach. Cross sections are shown in yellow. Flow is from right to left. Image is from Google Earth and was taken March 1, 2013.

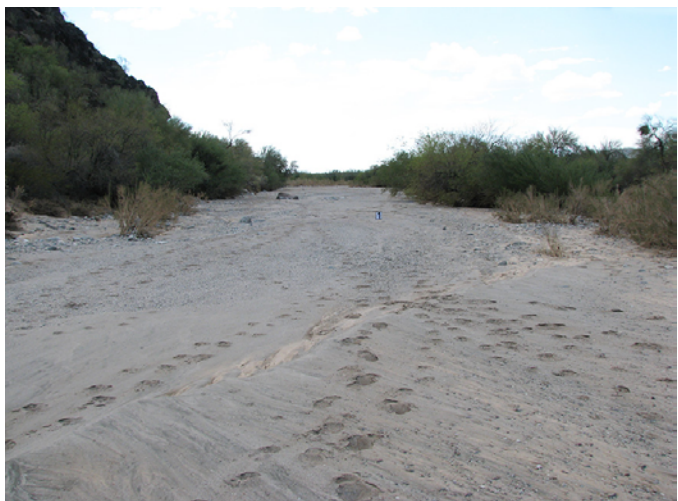
**Figure 42.** Continuous slope-area reach in Tiger Wash near Aguila, Arizona, September 10, 2009. View is looking downstream.

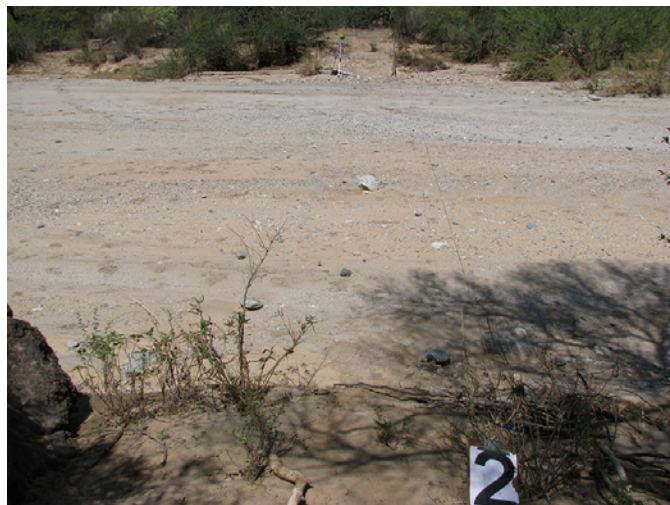
**Figure 44.** Cross section 2 in the Tiger Wash near Aguila, Arizona, continuous slope-area reach, September 10, 2009.

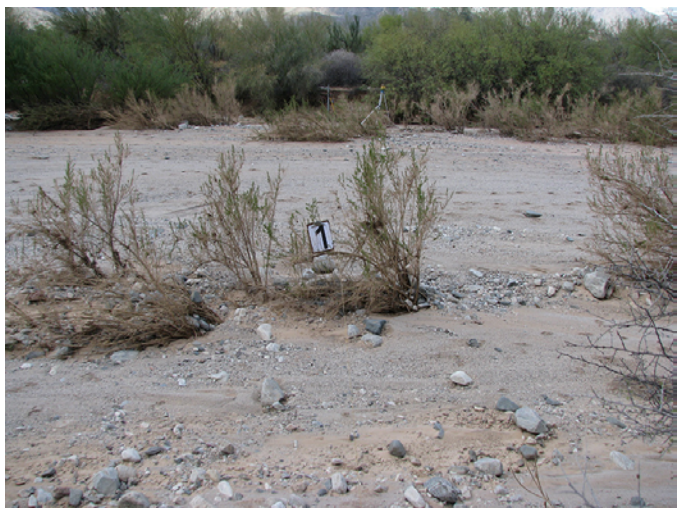
**Figure 43.** Cross section 1 in the Tiger Wash near Aguila, Arizona, continuous slope-area reach, September 10, 2009.

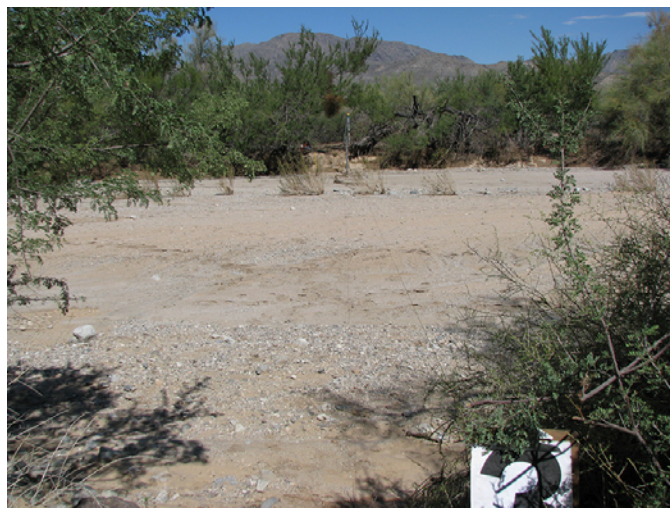
**Figure 45.** Cross section 3 in the Tiger Wash near Aguila, Arizona, continuous slope-area reach, September 10, 2009.

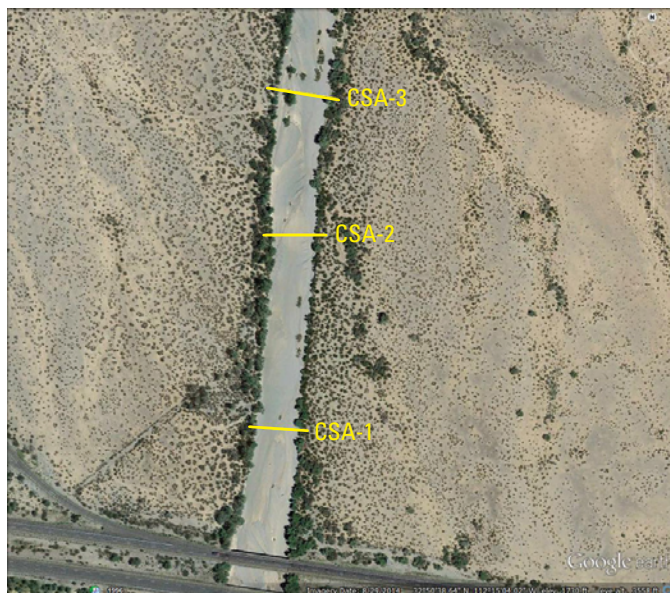
**Figure 46.** Aerial view of the Vekol Wash near Stanfield, Arizona, continuous slope-area (CSA) reach. Cross sections are shown in yellow. Flow is from bottom to top. Image is from Google Earth and was taken August 29, 2014.

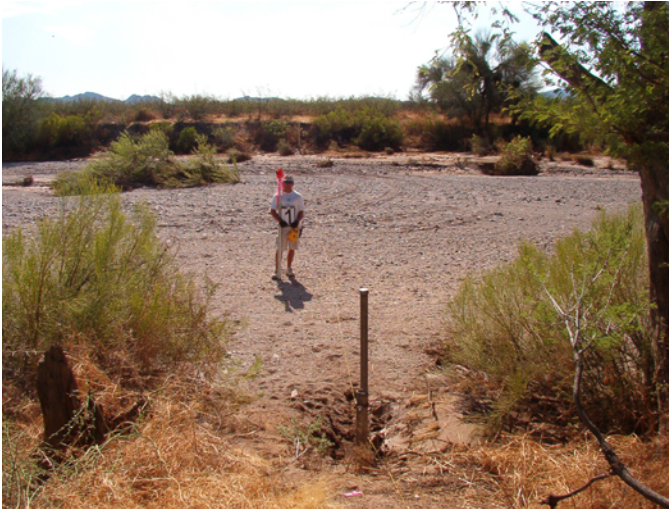
**Figure 47.** Cross section 1 in the Vekol Wash near Stanfield, Arizona, continuous slope-area reach, July 26, 2005.

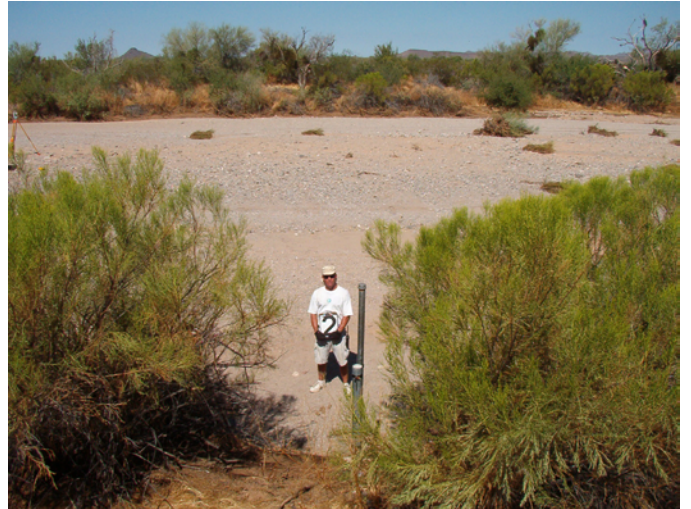
**Figure 48.** Cross section 2 in the Vekol Wash near Stanfield, Arizona, continuous slope-area reach, July 26, 2005.

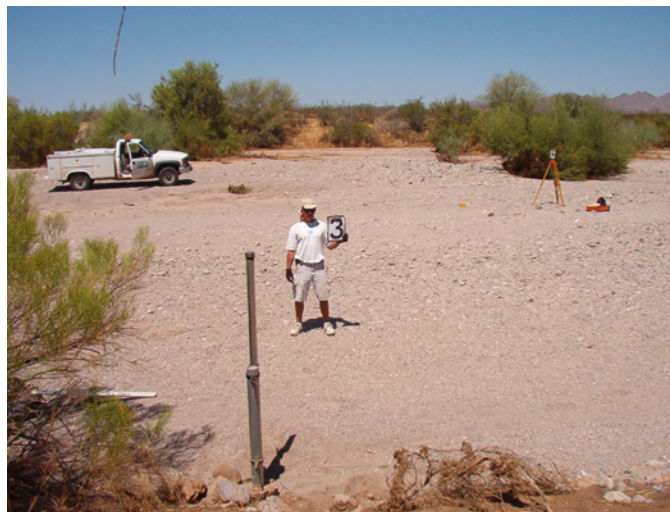
**Figure 49.** Cross section 3 in the Vekol Wash near Stanfield, Arizona, continuous slope-area reach, July 26, 2005.
