DOE/NV--1473

# Post-Closure Inspection Report for the Tonopah Test Range, Nevada

## For Calendar Year 2011

U.S. Department of Energy  
National Nuclear Security Administration  
Nevada Site Office

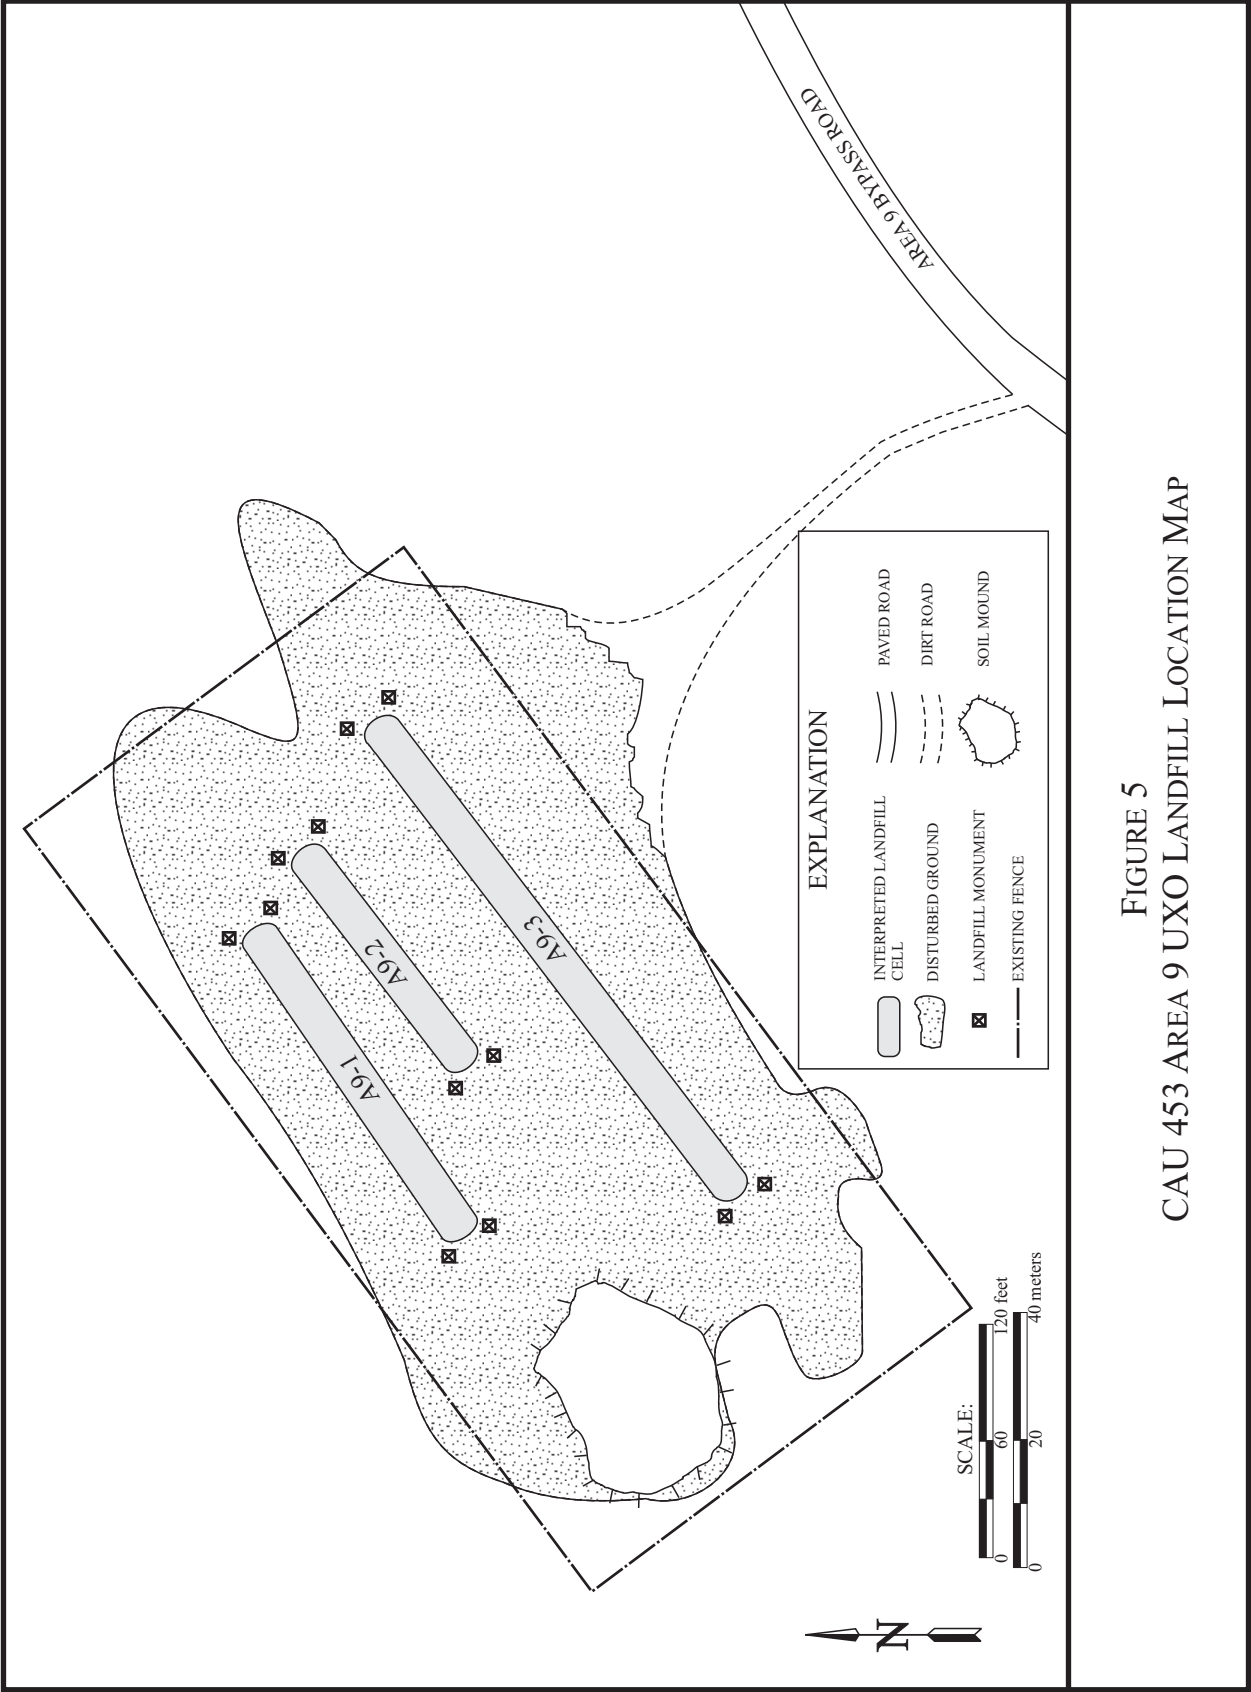
FIGURE 5  
CAU 453 AREA 9 UXO LANDFILL LOCATION MAP

The site is shown in Figure 5 of Appendix A. The annual inspection was conducted on May 4, 2011. The fence, signs, and monuments were in good condition. There was evidence of animal burrowing. Animal burrows were backfilled on July 13, 2011. Inspections should continue as scheduled.
