Bathymetric and Velocimetric Surveys at Highway Bridges Crossing the Missouri River in and into Missouri during Summer Flooding, July–August 2011

Scientific Investigations Report 2012–5204

By Richard J. Huizinga

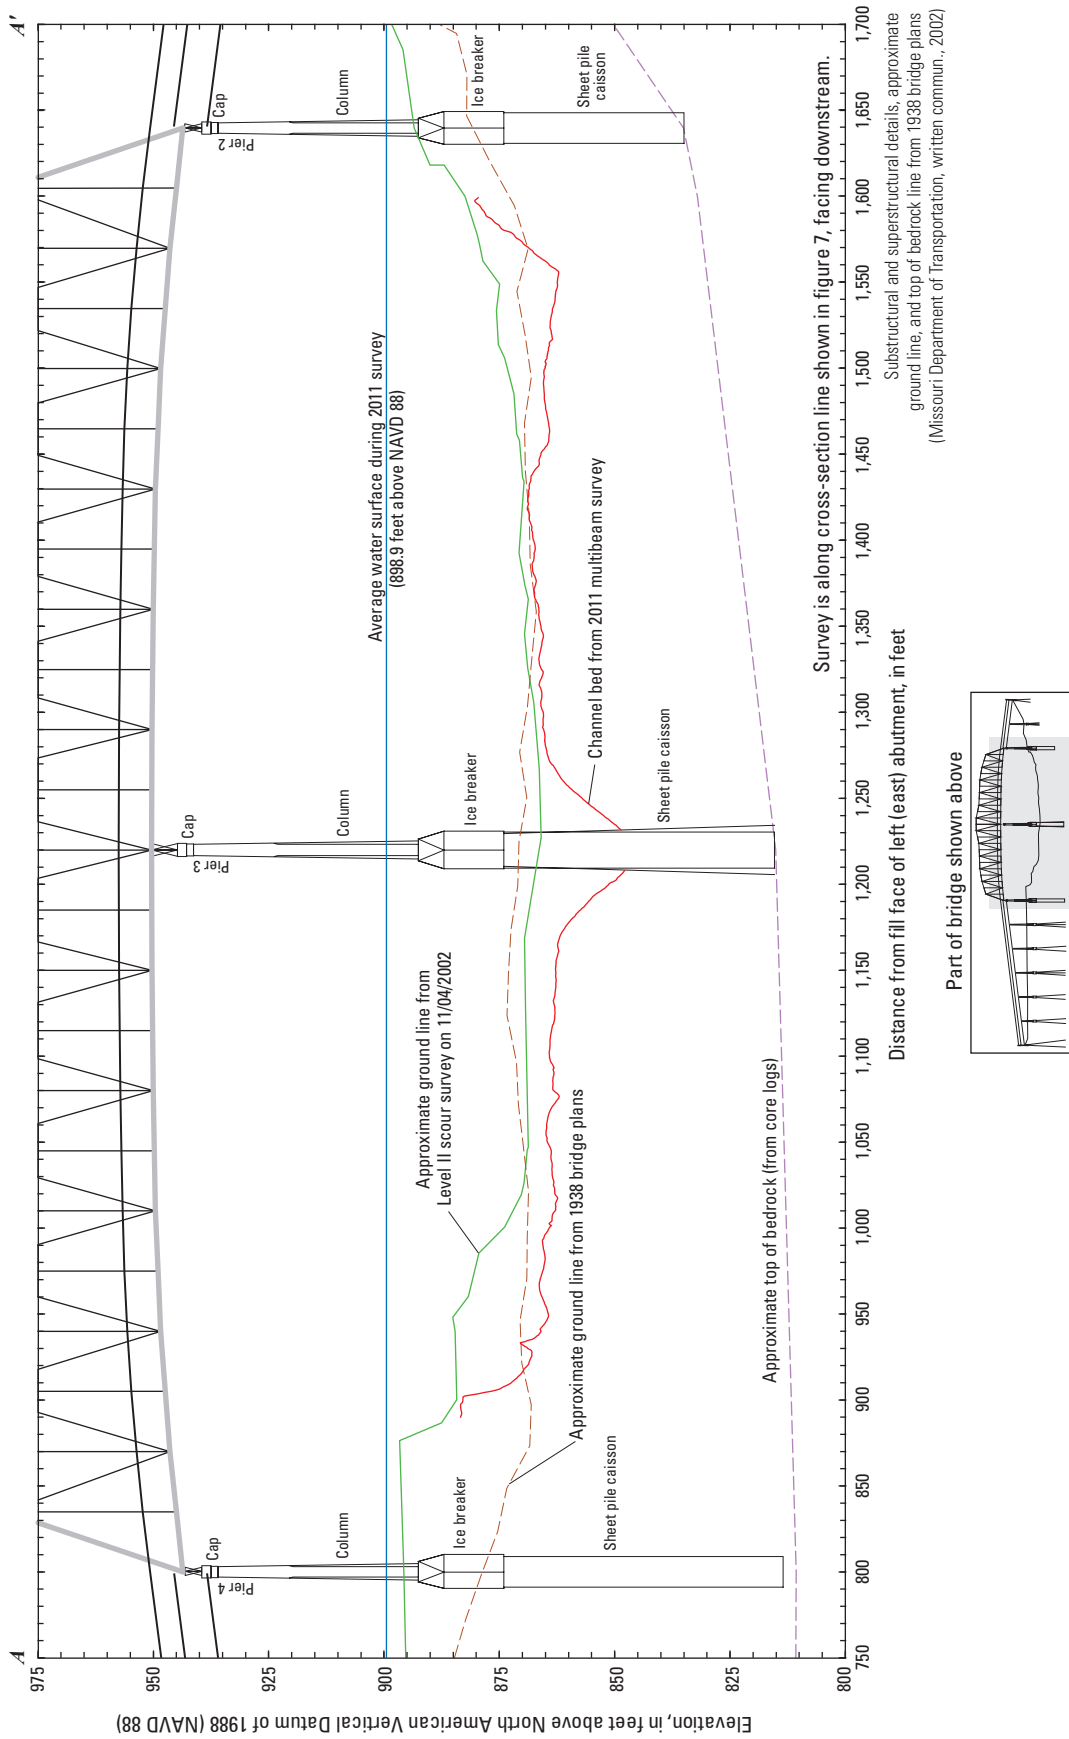
In the vicinity of main channel pier 3, a local scour hole had a minimum channel-bed elevation of approximately 846.0 ft (table 6), about 17 ft below the average channel bed immediately upstream from the pier (fig. 7). Information from bridge plans indicates that pier 3 is founded on sheet piling caissons on bedrock, with about 31 ft of bed material between the bottom of the scour hole and bedrock at the upstream face of the pier (fig. 8; table 6). The unique configuration of the sheet pile caissons and ice breaker of the pier are clearly seen in a point cloud visualization of the multibeam depth points obtained during the survey (fig. 9).

A Level II scour assessment was performed at this site in November 2002 (Huizinga and Rydlund, 2004), and the surveyed channel bed from the multibeam scan was 5 to 10 ft lower than the channel bed from the Level II scour survey for part of the channel to the left of pier 3, and similar to the channel bed from the Level II scour survey for part of the channel to the right of pier 3 (fig. 8); however, the channel bed from the multibeam scan was substantially lower than the Level II scour survey at both banks, and generally was 5 or more feet lower than the approximate ground line from bridge plans when the bridge was built in 1938, except for part to the right of the main channel pier (fig. 8).

Figure 8. Key features, substructural and superstructural details, and surveyed channel bed of structure L0098 on U.S. Highway 136 over the Missouri River at Brownville, Nebraska.

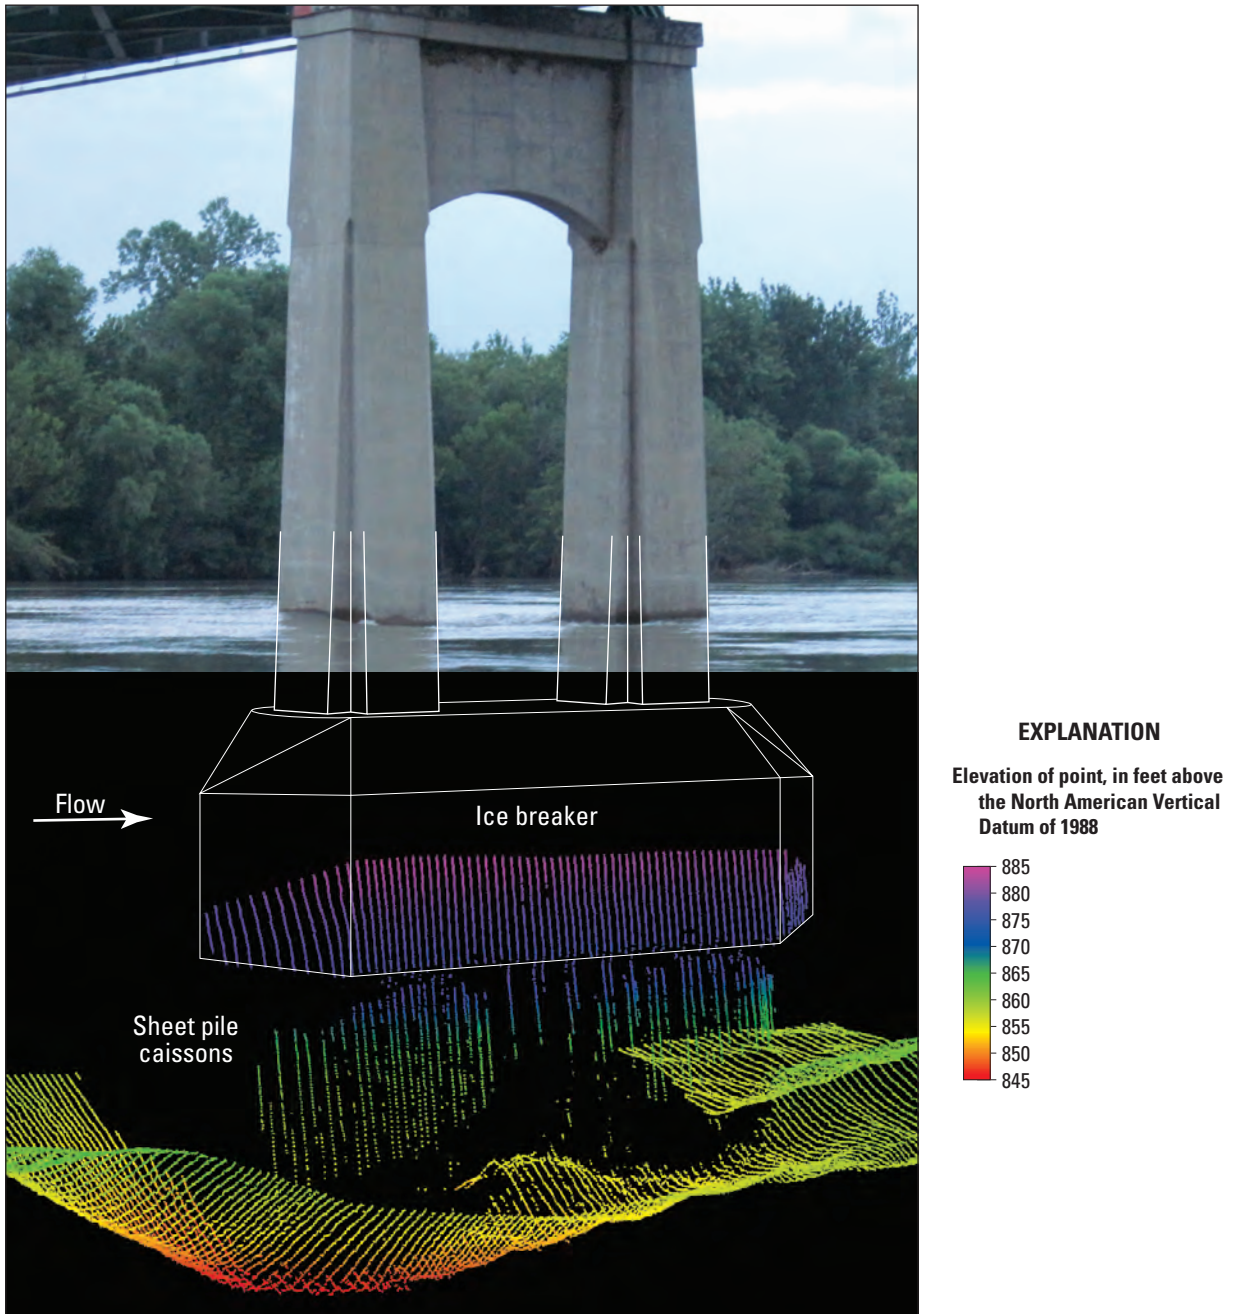
Figure 9. Point cloud visualization of the channel bed and right (west) side of pier 3 of structure L0098 on U.S. Highway 136 over the Missouri River at Brownville, Nebraska.

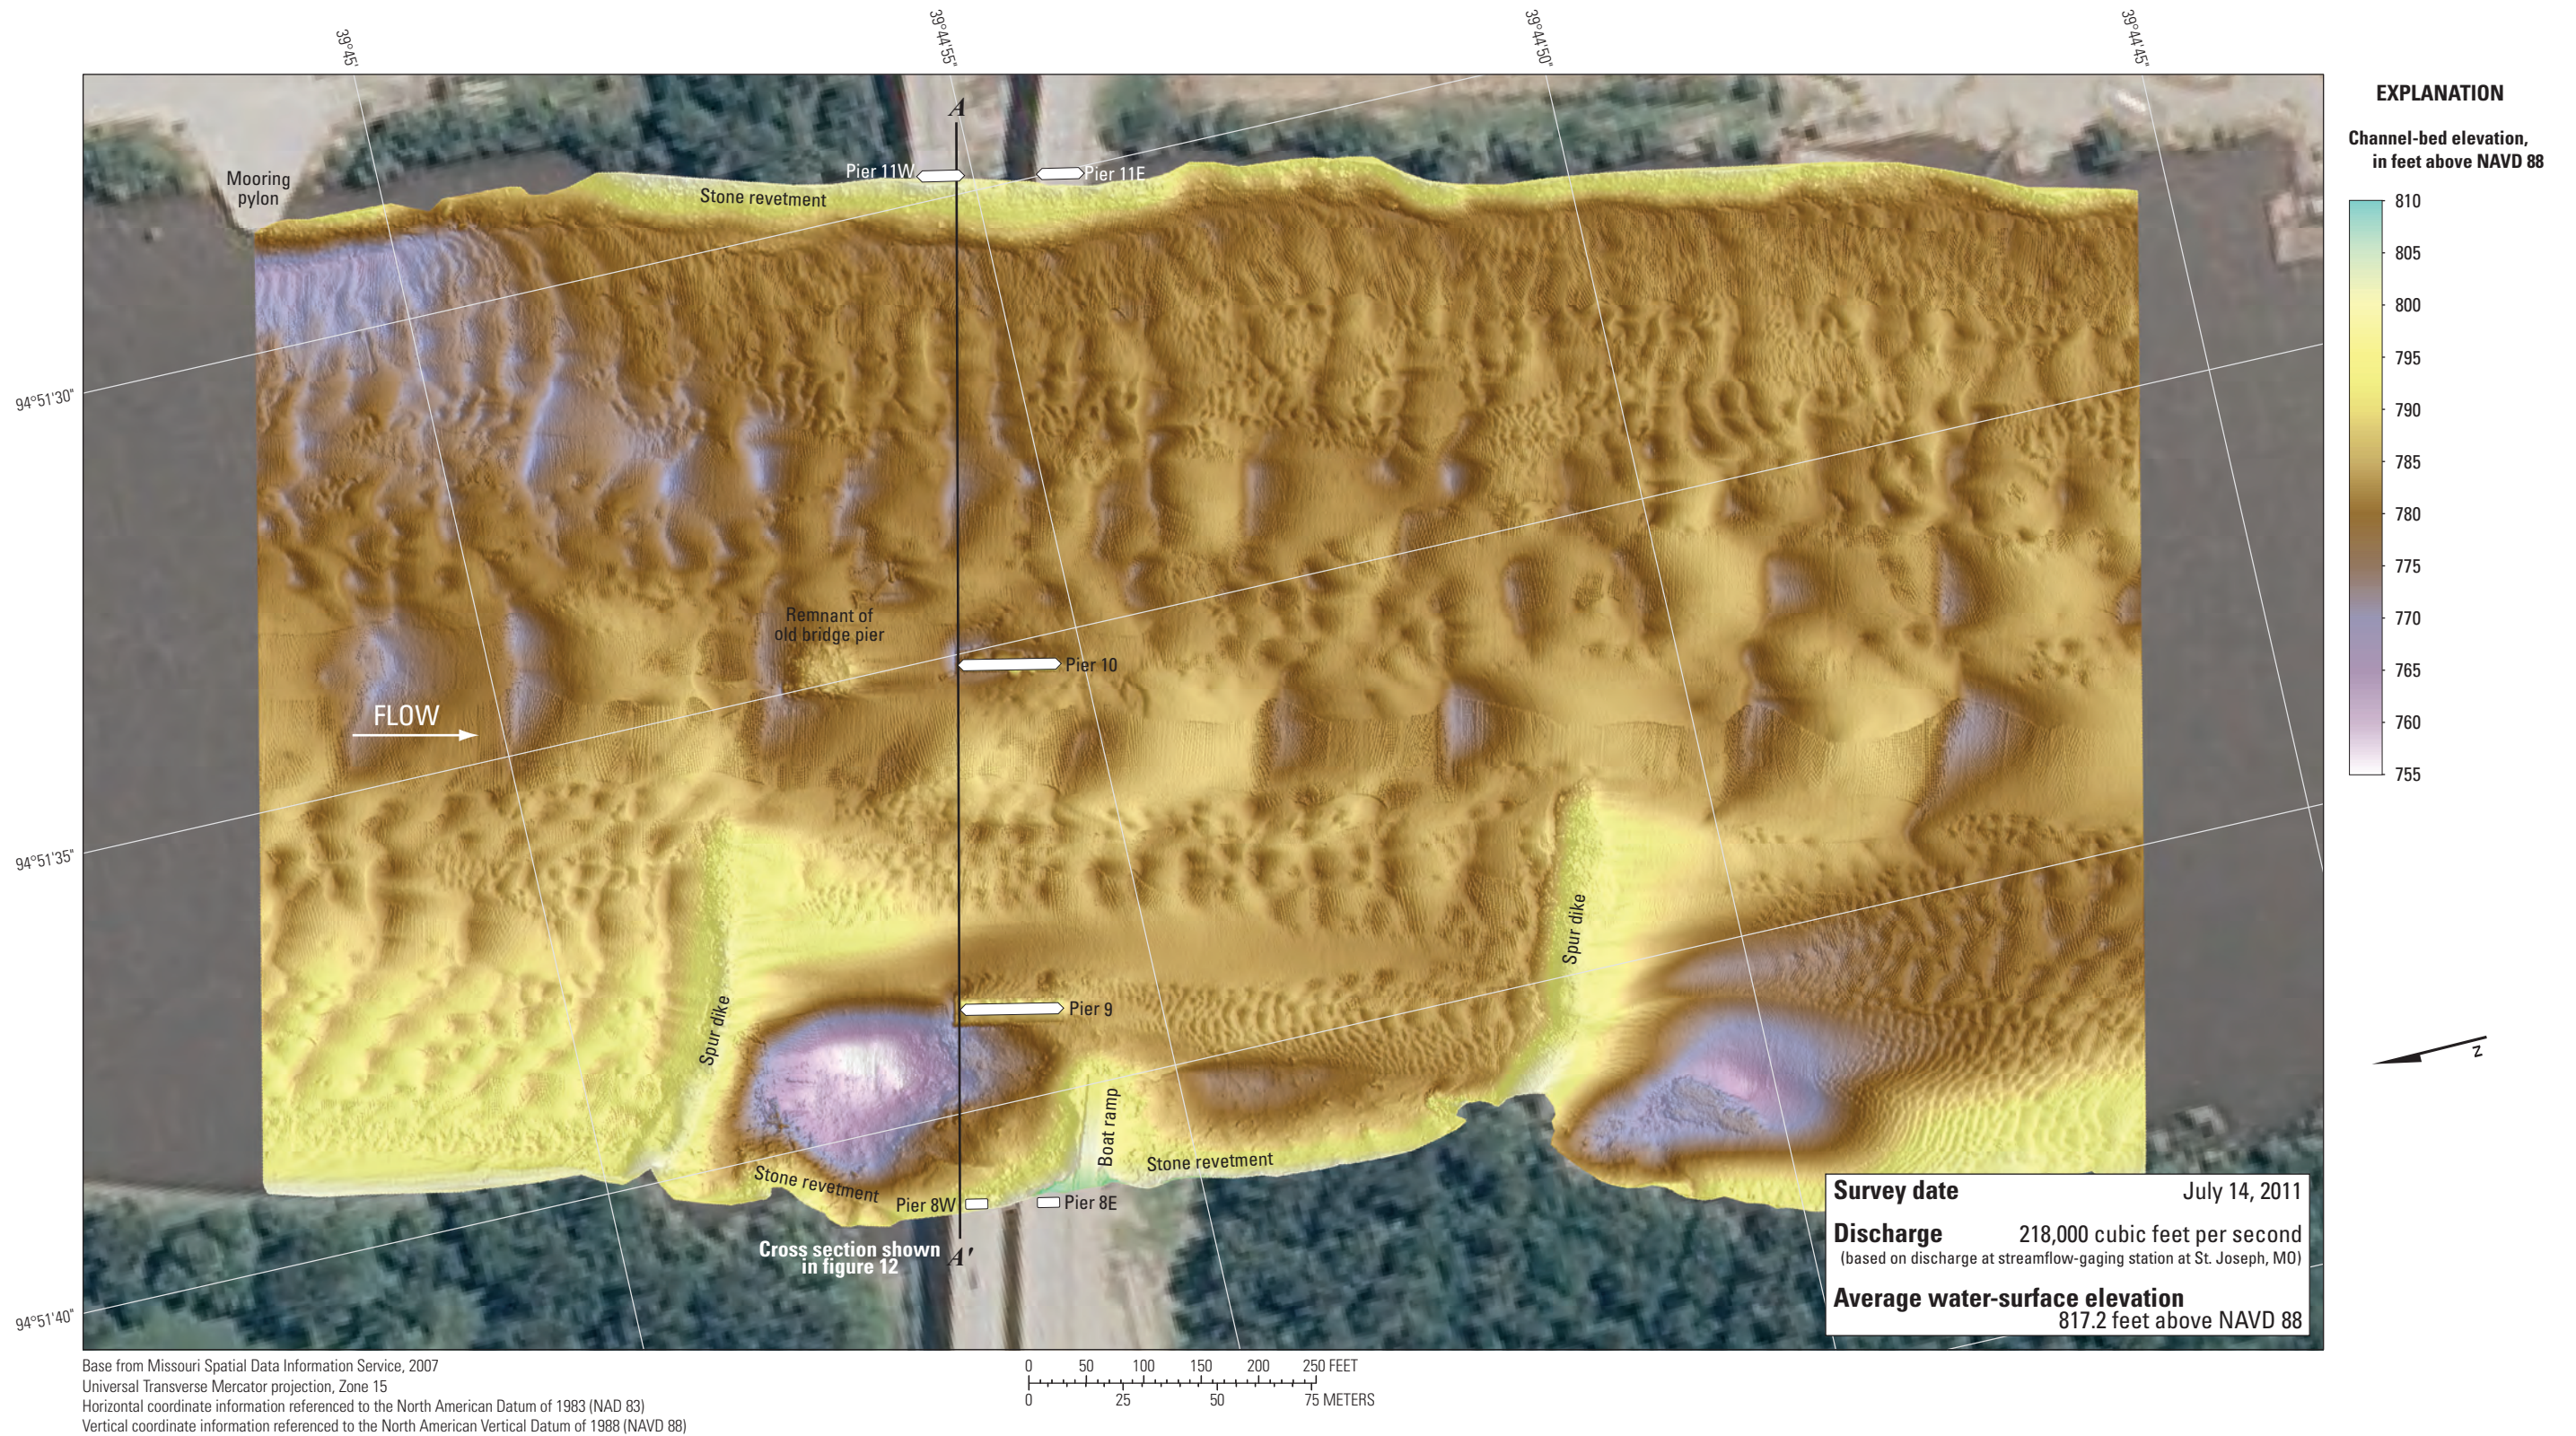
The survey area was about 1,640 ft long and about 870 ft wide, extending across the active channel from bank to bank (fig. 11). The upstream end of the survey area was about 655 ft upstream from the centerline of structure A3664 (fig 11). The channel-bed elevations ranged from about 773 to 791 ft for most of the surveyed area (5 to 95 percentile range of the bathymetric data), except on the downstream sides of the two spur dikes on the right (west) bank, and near a mooring pylon at the upstream left (east) corner of the reach (fig. 11). The overall minimum channel-bed elevation of 756.5 ft was in a hole downstream from the upstream spur dike on the right (west) bank, and the minimum channel-bed elevation near the mooring pylon at the upstream left (east) corner of the reach was 767.1 ft (fig. 11). The center of the channel had numerous large dunes, and the remainder of the channel bed was covered with medium and small dunes and ripples (fig. 11). Stone revetment was present on the left (east) bank throughout the reach, and on the right (west) bank between the spur dikes and near the bridge and boat ramp (fig. 11).

difficult to differentiate from the large dunes in the middle of the channel (fig. 11). The large local scour hole downstream from the upstream spur dike resulted in a channel-bed elevation of 770.1 ft at the upstream right corner of main channel pier 9 and a steeply sloping channel bed on the upstream left side of pier 8 on the right bank (figs. 11, 12). Information from bridge plans indicates that piers 9 and 10 are founded on shafts drilled into bedrock, with about 26 ft of bed material between the bottom of the scour hole and bedrock at the upstream face of pier 10 (fig. 12; table 6); however, the local scour hole caused by the upstream spur dike results in substantially less material between the bottom of the scour hole and bedrock, and contributes to the scour observed at piers 8 and 9 (fig. 12; table 6). The stone revetment present on the right bank may provide some resistance to scour at pier 8.

Figure 11. Bathymetric survey of the Missouri River channel in the vicinity of dual bridge structure A3664 on U.S. Highway 36 at St. Joseph, Missouri.

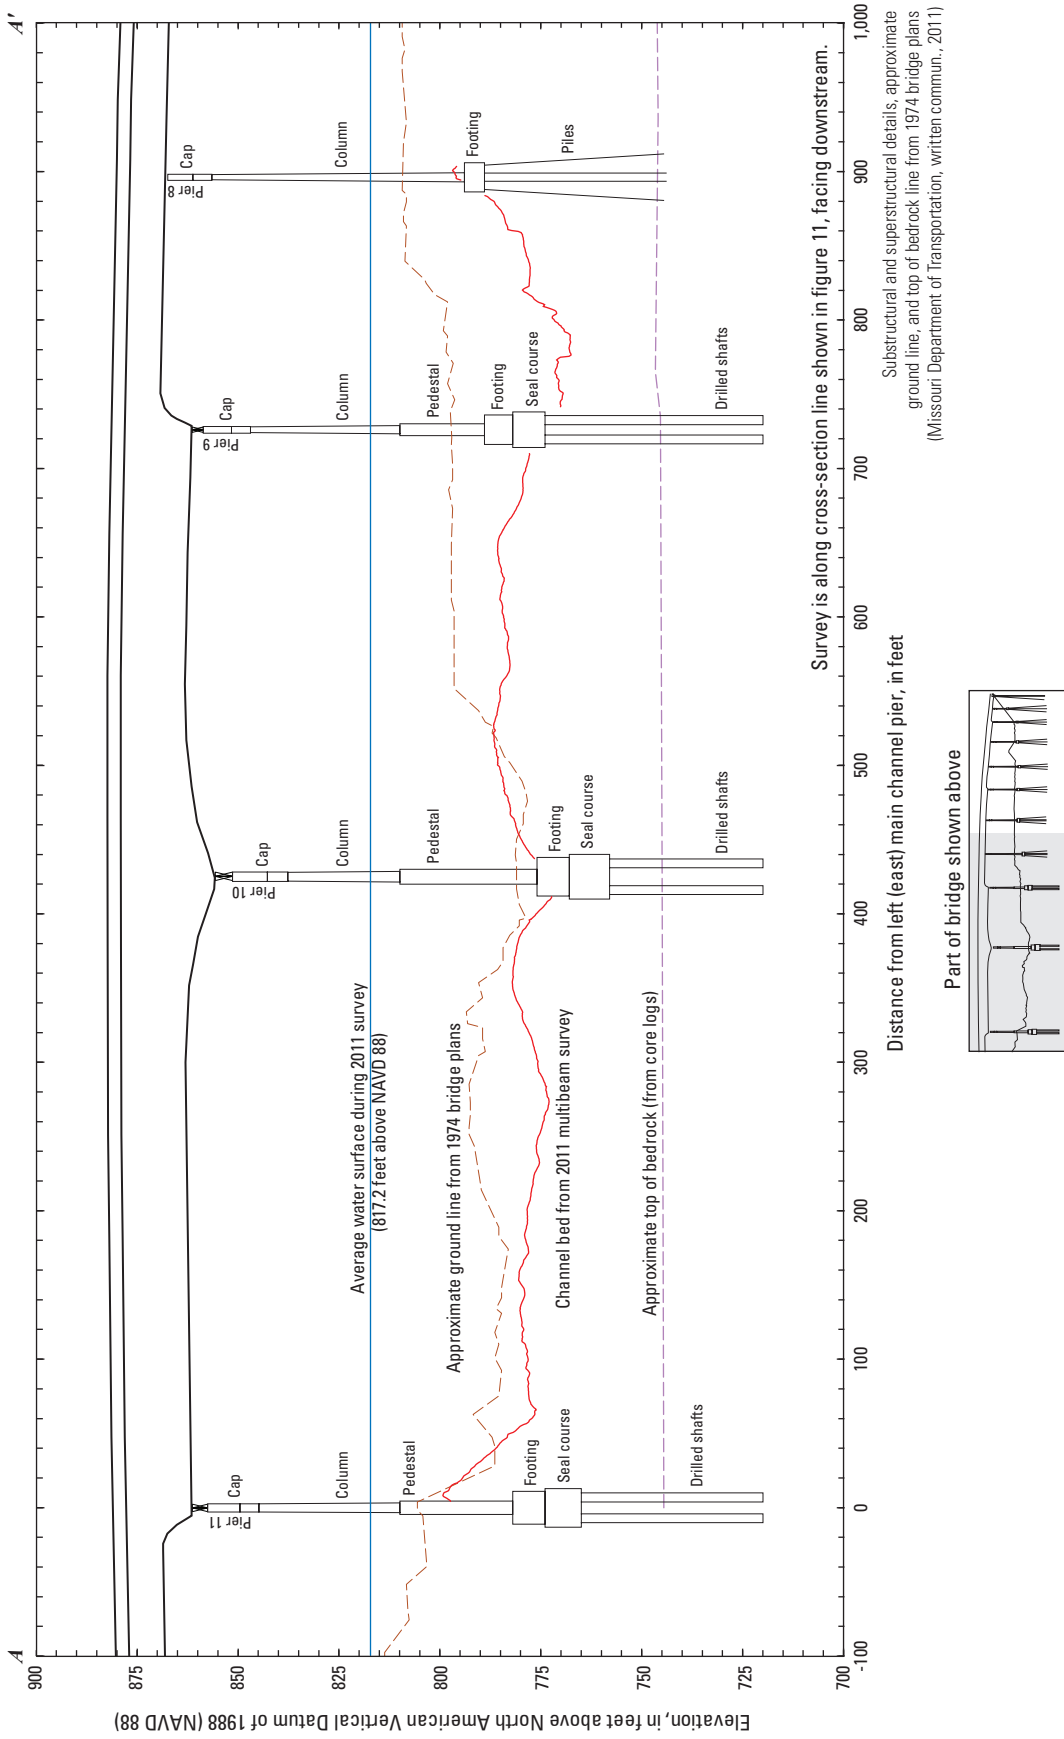
The surveyed bed generally was lower than the original ground line from bridge plans at the time of construction (1974) at dual bridge structure A3664, ranging from slightly higher than to as much as 30 ft lower than the original ground line (fig. 12). For most of the channel cross section shown in figure 12, the surveyed bed was approximately 20 ft lower than the original ground line from bridge plans at construction (1974).

Figure 12. Key features, substructural and superstructural details, and surveyed channel bed of dual bridge structure A3664 on U.S. Highway 36 over the Missouri River at St. Joseph, Missouri.

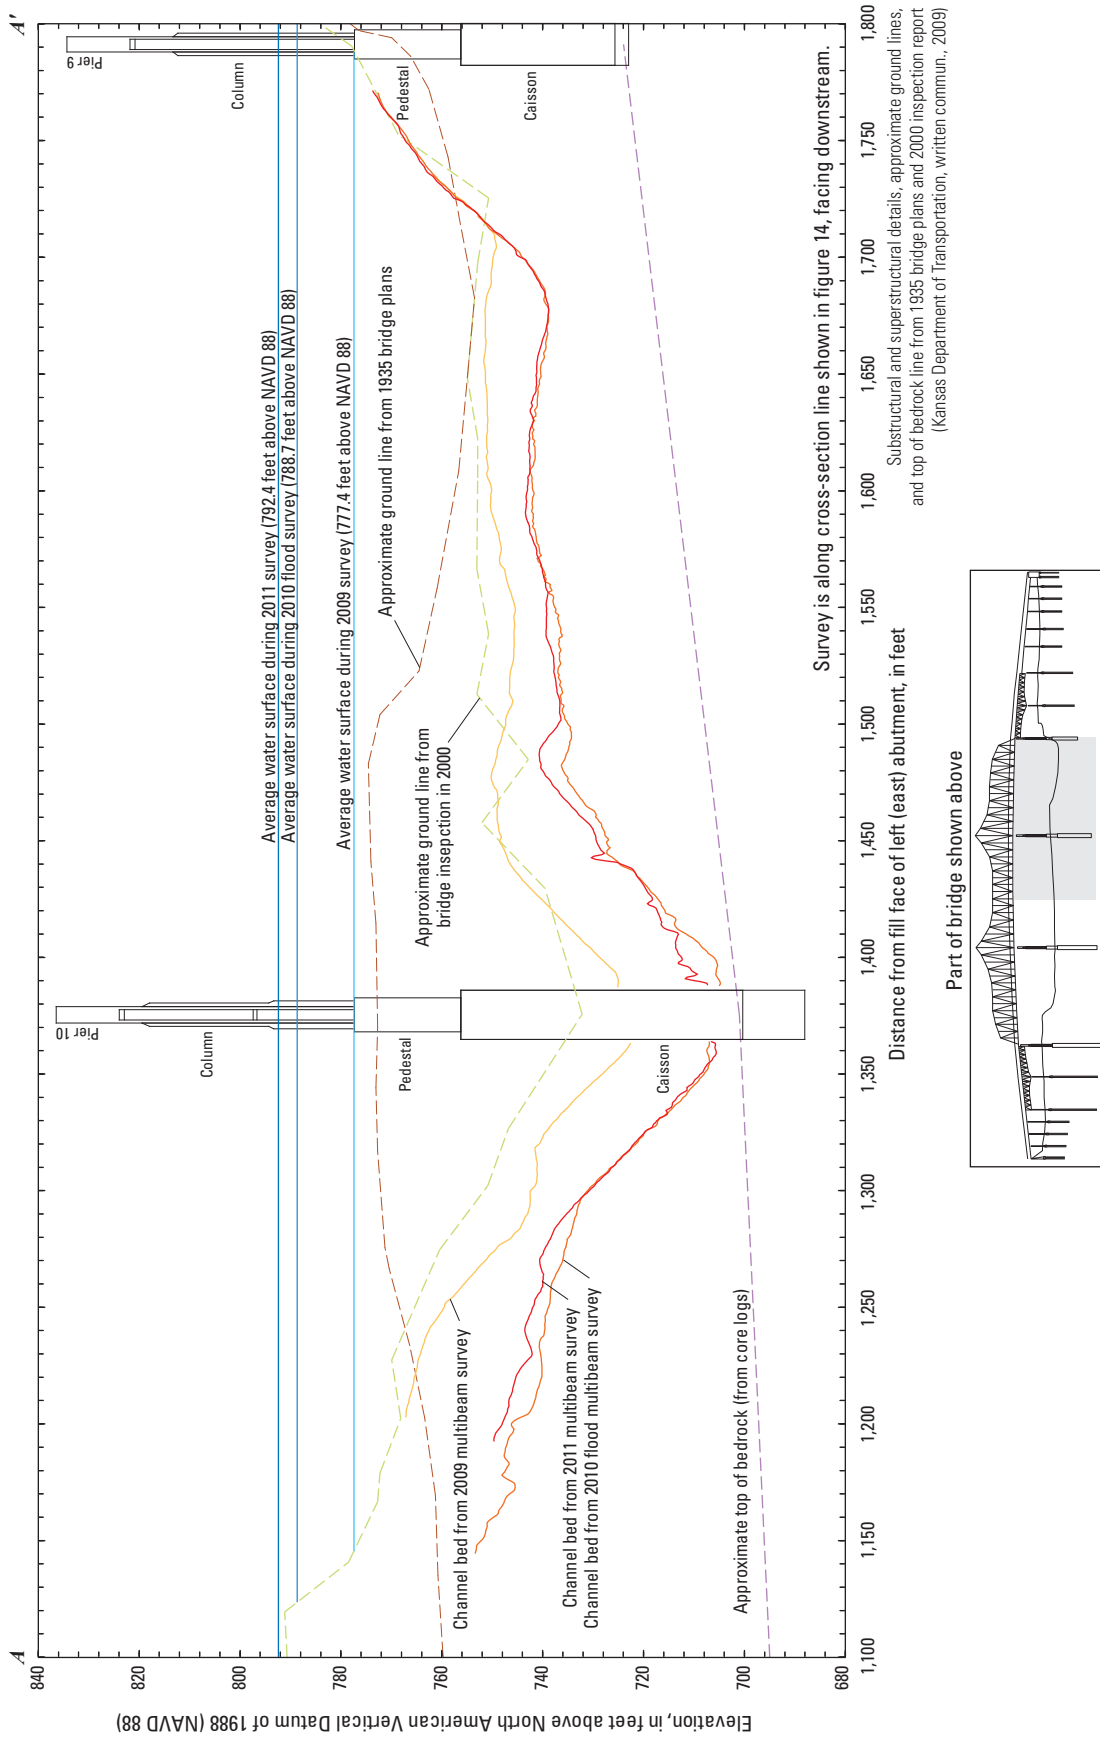
The surveyed bed from 2011 was a nearly uniform 20–25 ft lower than the surveyed bed from 2009 before construction of the new U.S. Highway 59 bridge began (fig. 15); however, the surveyed bed from 2011 was about 1–4 ft higher than the surveyed bed from 2010 near the 2010 flood peak, despite the fact that the 2011 flood had a higher flow rate and water-surface elevation than 2010.

Figure 15. Key features, substructural and superstructural details, and surveyed channel bed of structure 59-3-16.38 (013) on U.S. Highway 59 over the Missouri River at Atchison, Kansas.

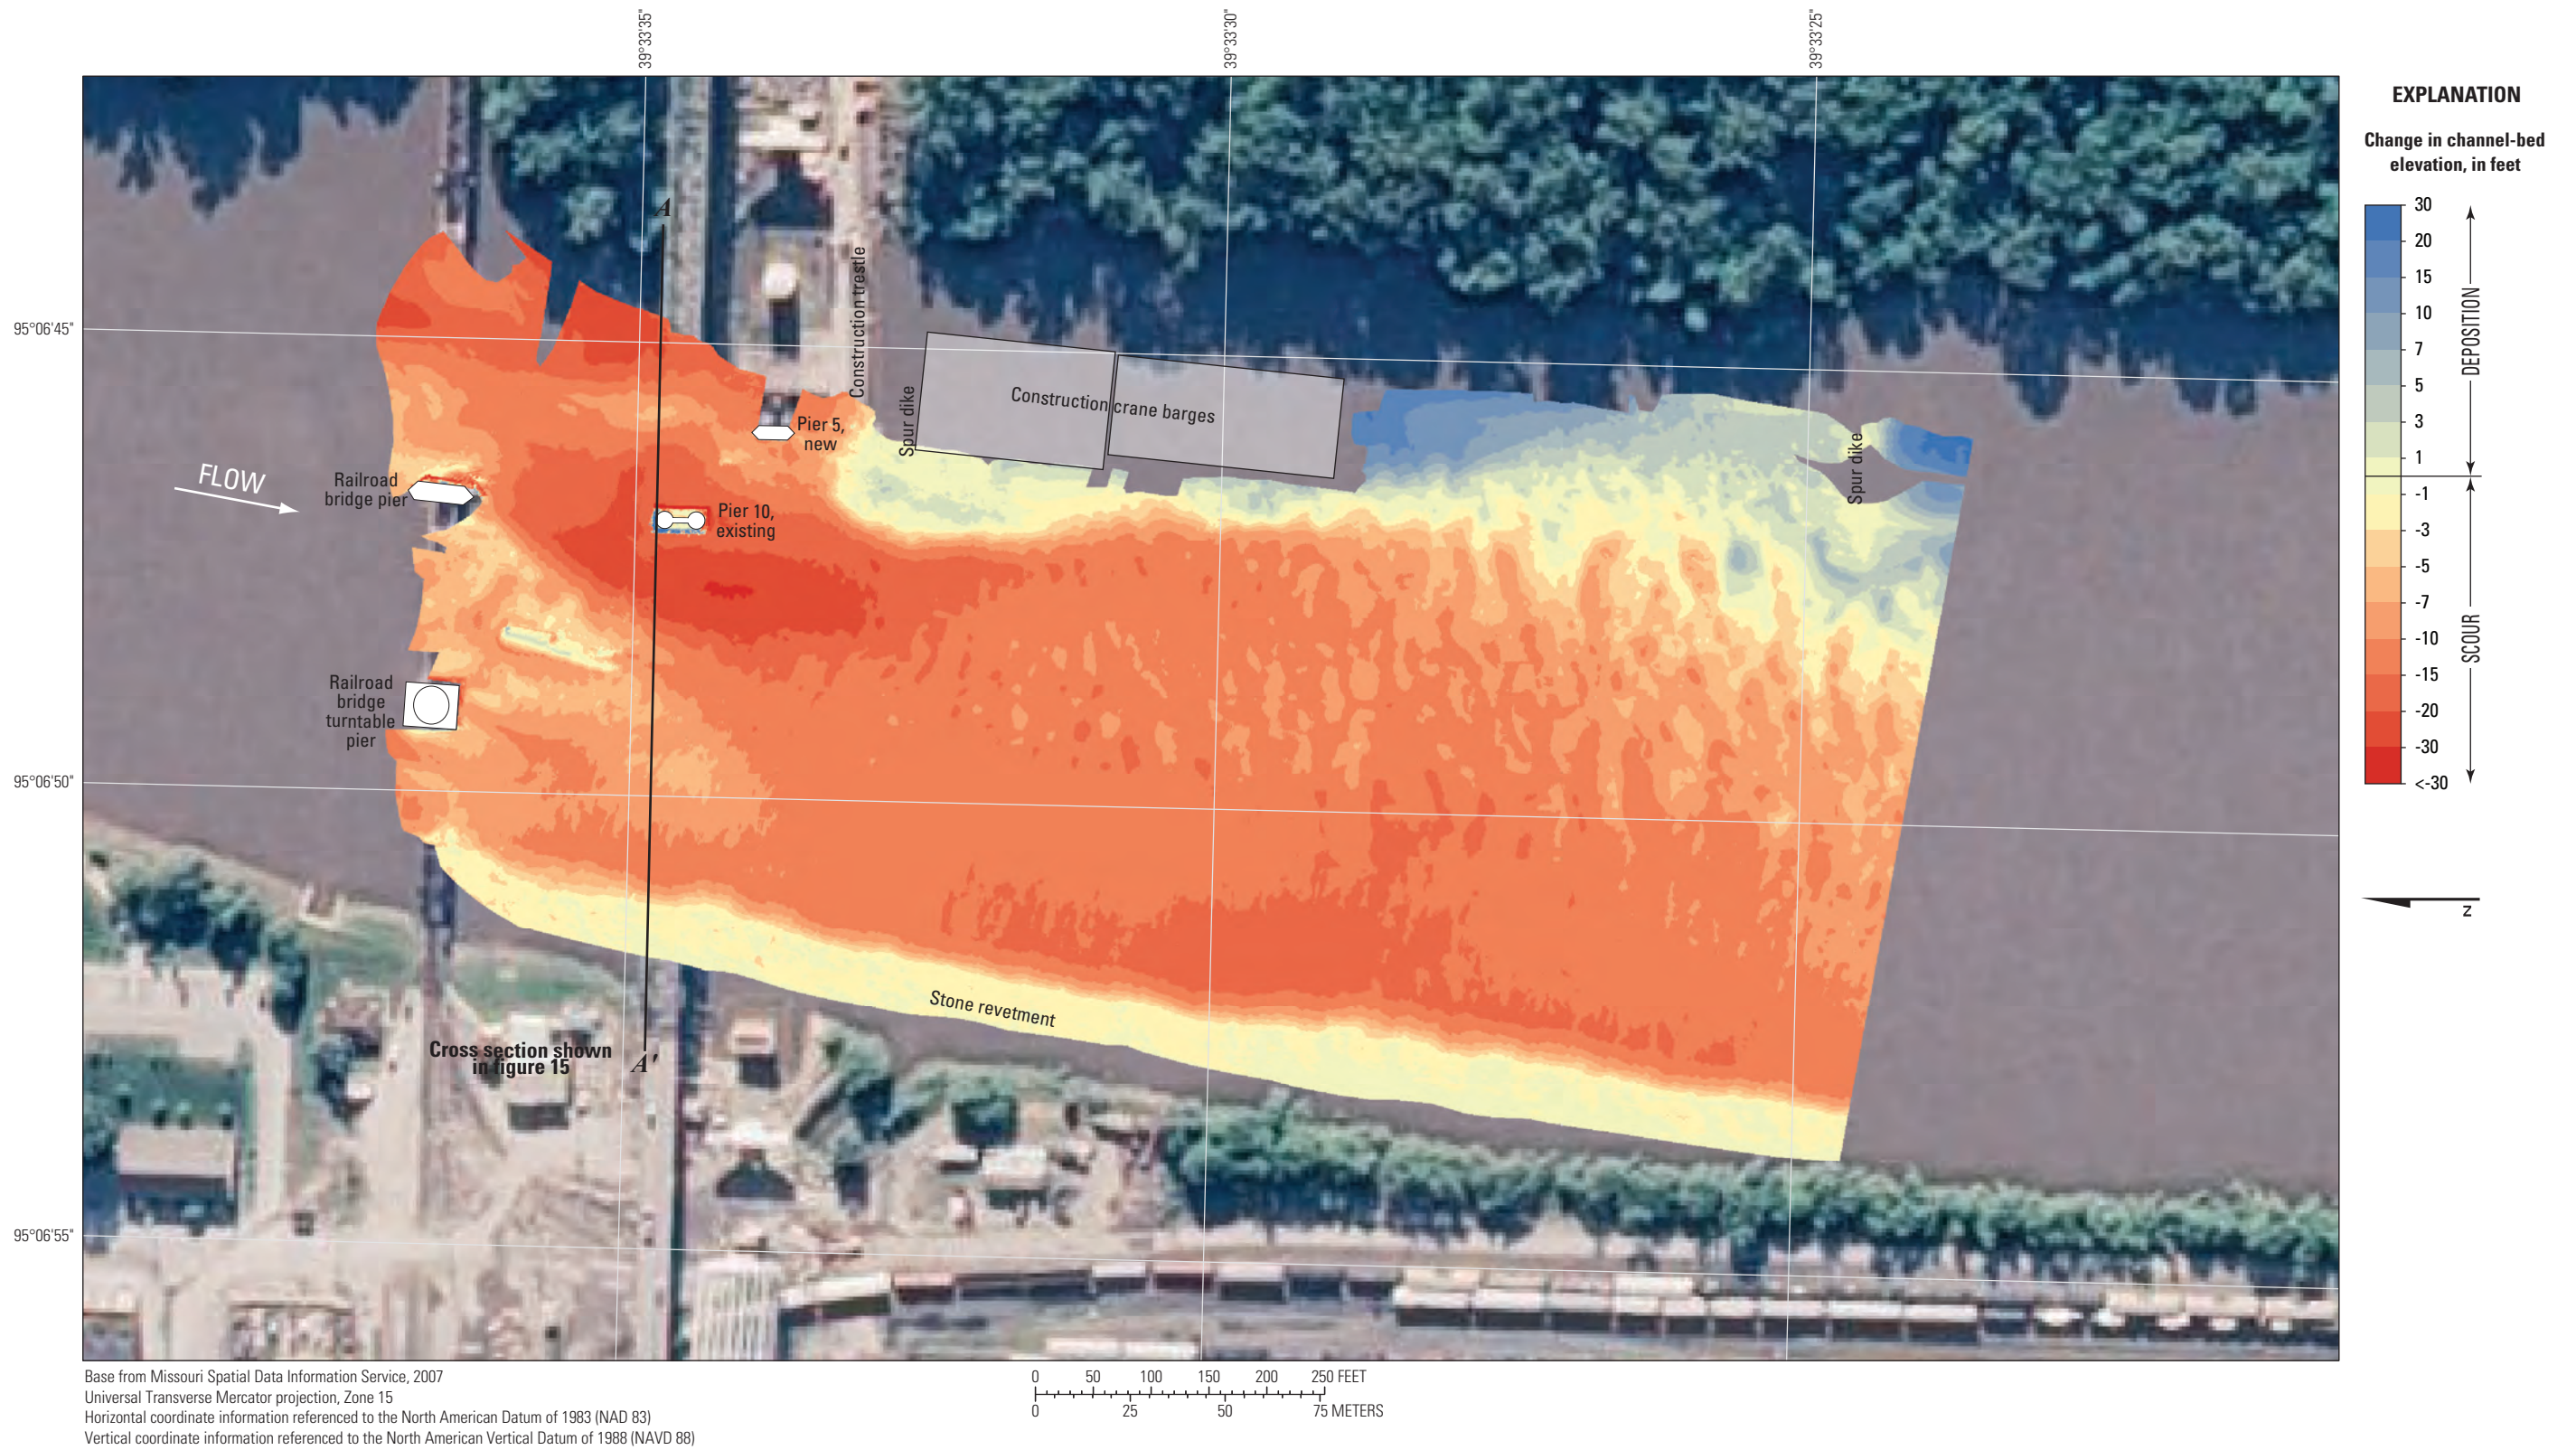
In the vicinity of main channel pier 10, the scour hole had a minimum channel-bed elevation of approximately 705 ft (table 6), about 34 ft below the average channel bed to either side of the pier (fig. 14). This scour hole was substantially affected by local scour caused by the railroad bridge pier upstream (fig. 14). Information from bridge plans indicates that pier 10 is founded on a caisson on bedrock, with only about 4 ft of bed material between the bottom of the scour hole and bedrock at the upstream face of pier 10 (fig. 15; table 6). In modern construction, bridge substructural elements usually are pinned or socketed to bedrock (American Association of State Highway Transportation Officials, 2012; Brown and others, 2010), but full exposure of usually buried substructural elements warrants special consideration and observation, particularly at an older bridge such as structure 59-3-16.38 (013).

Figure 16. Difference between surfaces created from bathymetric surveys of the Missouri River channel in the vicinity of structure 59-3-16.38 (013) on U.S. Highway 59 at Atchison, Kansas, on June 30, 2009, and July 15, 2011.

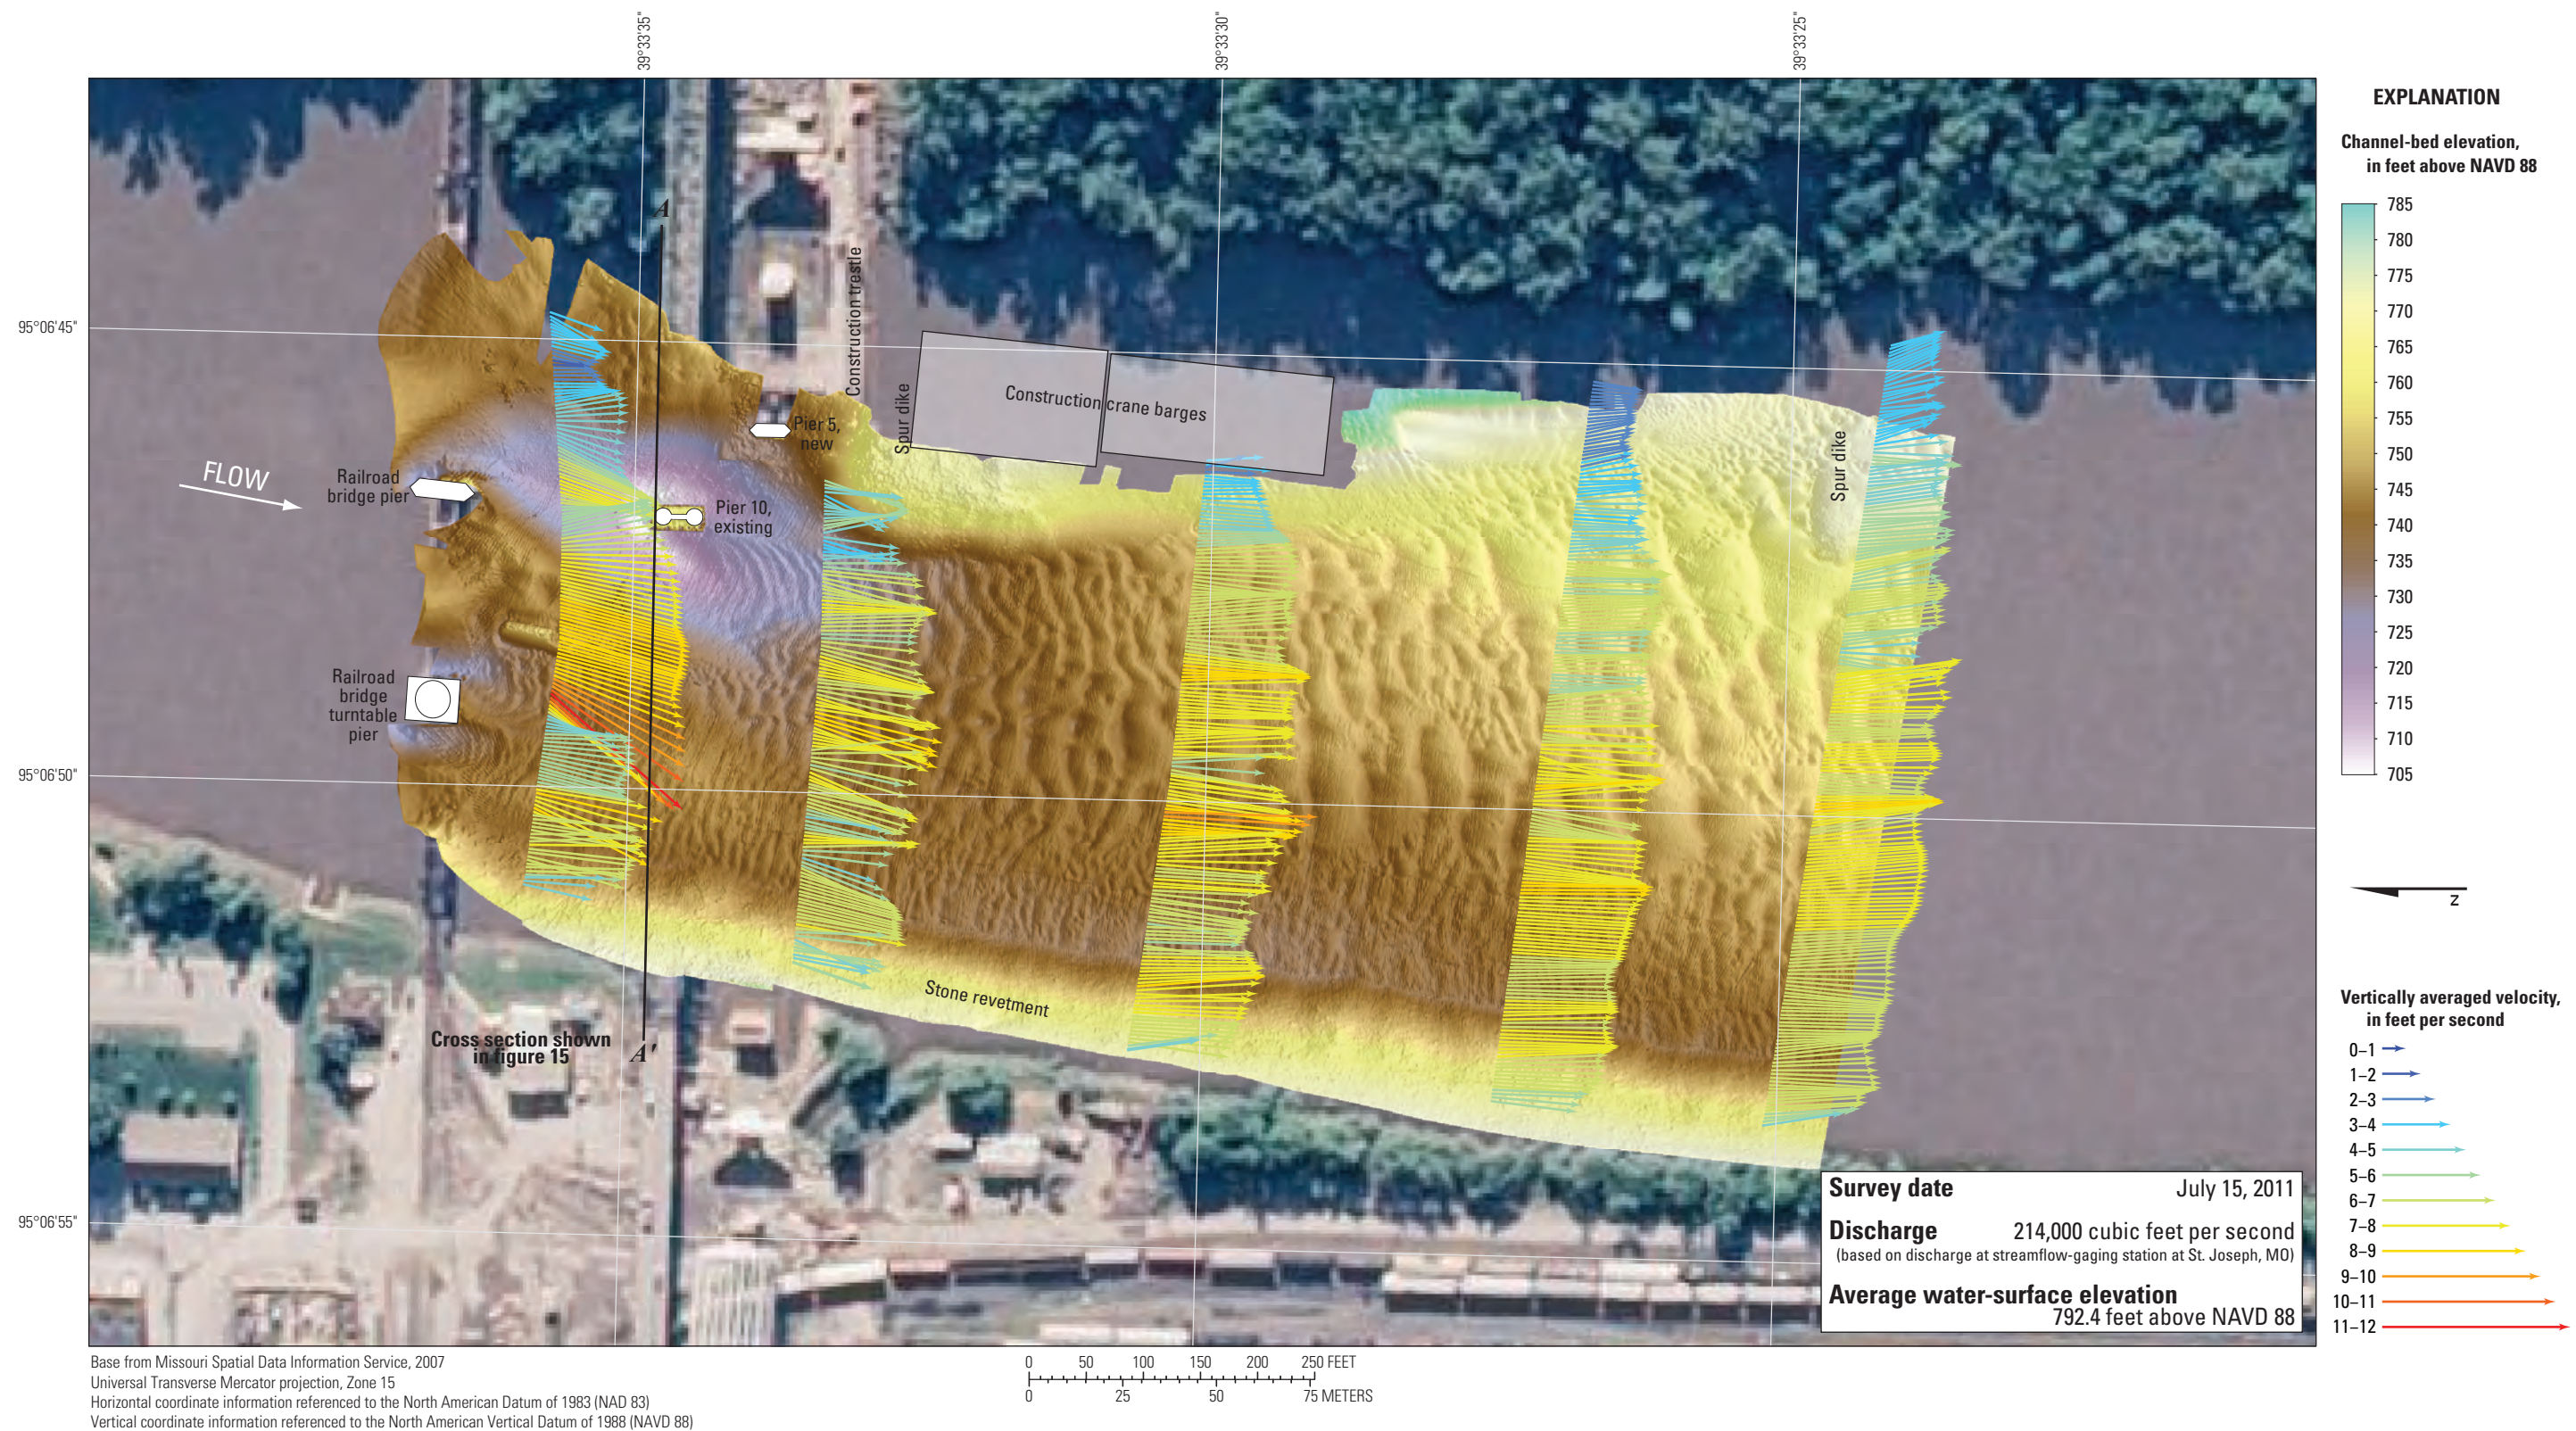
The vertically averaged velocity vectors indicated substantial turbulence in the vicinity of the railroad and U.S. Highway 59 bridges. Downstream from the railroad bridge turntable pier, the velocity reached a local maximum of nearly 12 ft/s, but also dropped to about 5 ft/s about 20 ft to the right, downstream from the railroad bridge turntable pier (fig. 18). Most of the turbulence and local high velocity values abated in the downstream part of the reach, with average velocities between 6 and 9 ft/s in the channel and between 3 and 5 ft/s along the left bank. There also was substantial turbulence downstream from pier 10 of the existing bridge and pier 5 of the new bridge (fig. 18).

Figure 18. Bathymetry and vertically averaged velocities of the Missouri River channel in the vicinity of structure 59-3-16.38 (013) on U.S. Highway 59 at Atchison, Kansas.
