Bathymetric and Velocimetric Surveys at Highway Bridges Crossing the Missouri River in and into Missouri during Summer Flooding, July–August 2011

Scientific Investigations Report 2012–5204

By Richard J. Huizinga

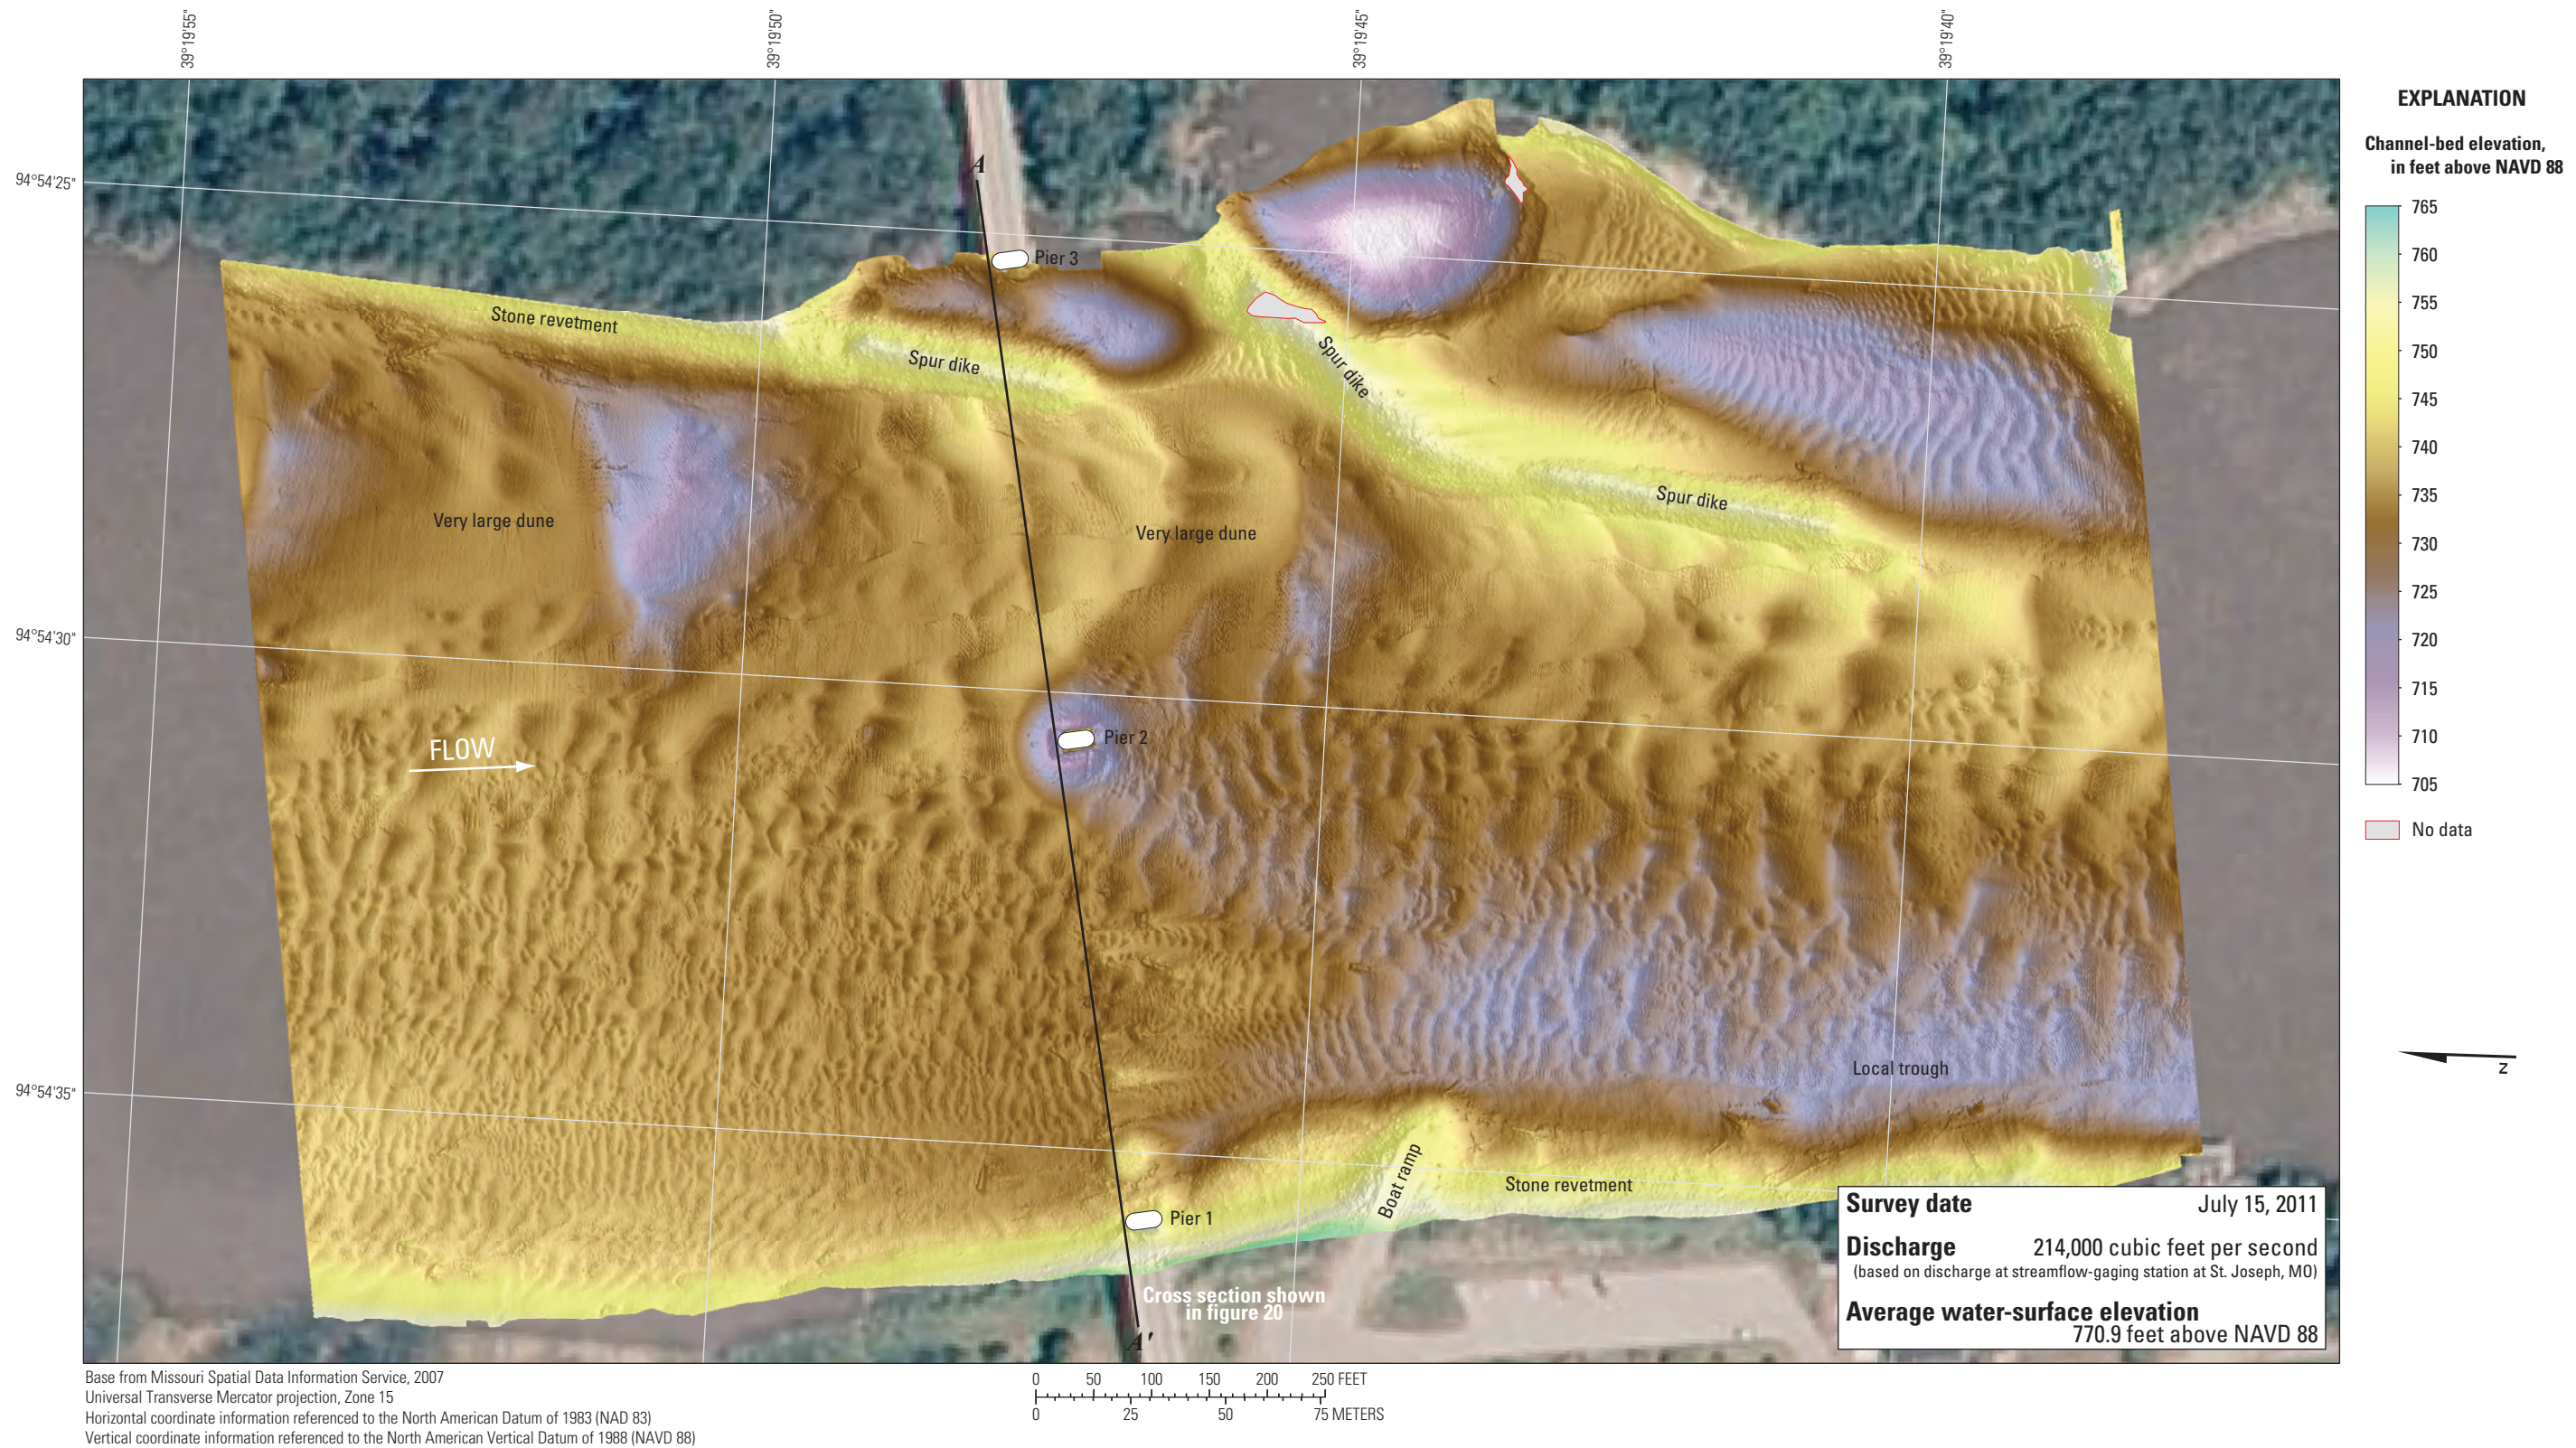
In the vicinity of main channel pier 2, a local scour hole had a minimum channel-bed elevation of about 716 ft (table 6), about 17 ft below the average channel bed immediately upstream from the pier (fig. 19). Information from bridge plans indicates that pier 2 is founded on footings on bedrock, with about 12 ft of bed material between the bottom of the scour hole and bedrock at the upstream face of the pier (fig. 20; table 6). In the vicinity of main channel pier 3, a local scour hole caused in part by the adjacent spur dike had a minimum channel-bed elevation of about 720 ft (table 6), but the deepest part of the hole was located downstream from and 40 ft to the right of pier 3 (figs. 19, 20). There was no observable scour hole near pier 3 that could be directly attributed to the pier (figs. 19, 20). There also was no observable scour hole near pier 1 on the right bank (figs. 19, 20). The surveyed bed generally was lower than the original ground line from bridge plans at the time of construction (1952) at this site, and the surveyed channel appeared to be more narrow than the channel at the time of construction, especially on the right (west) bank (fig. 20).

Figure 19. Bathymetric survey of the Missouri River channel in the vicinity of structure 92-52-18.48 (026) on State Highway 92 at Leavenworth, Kansas.

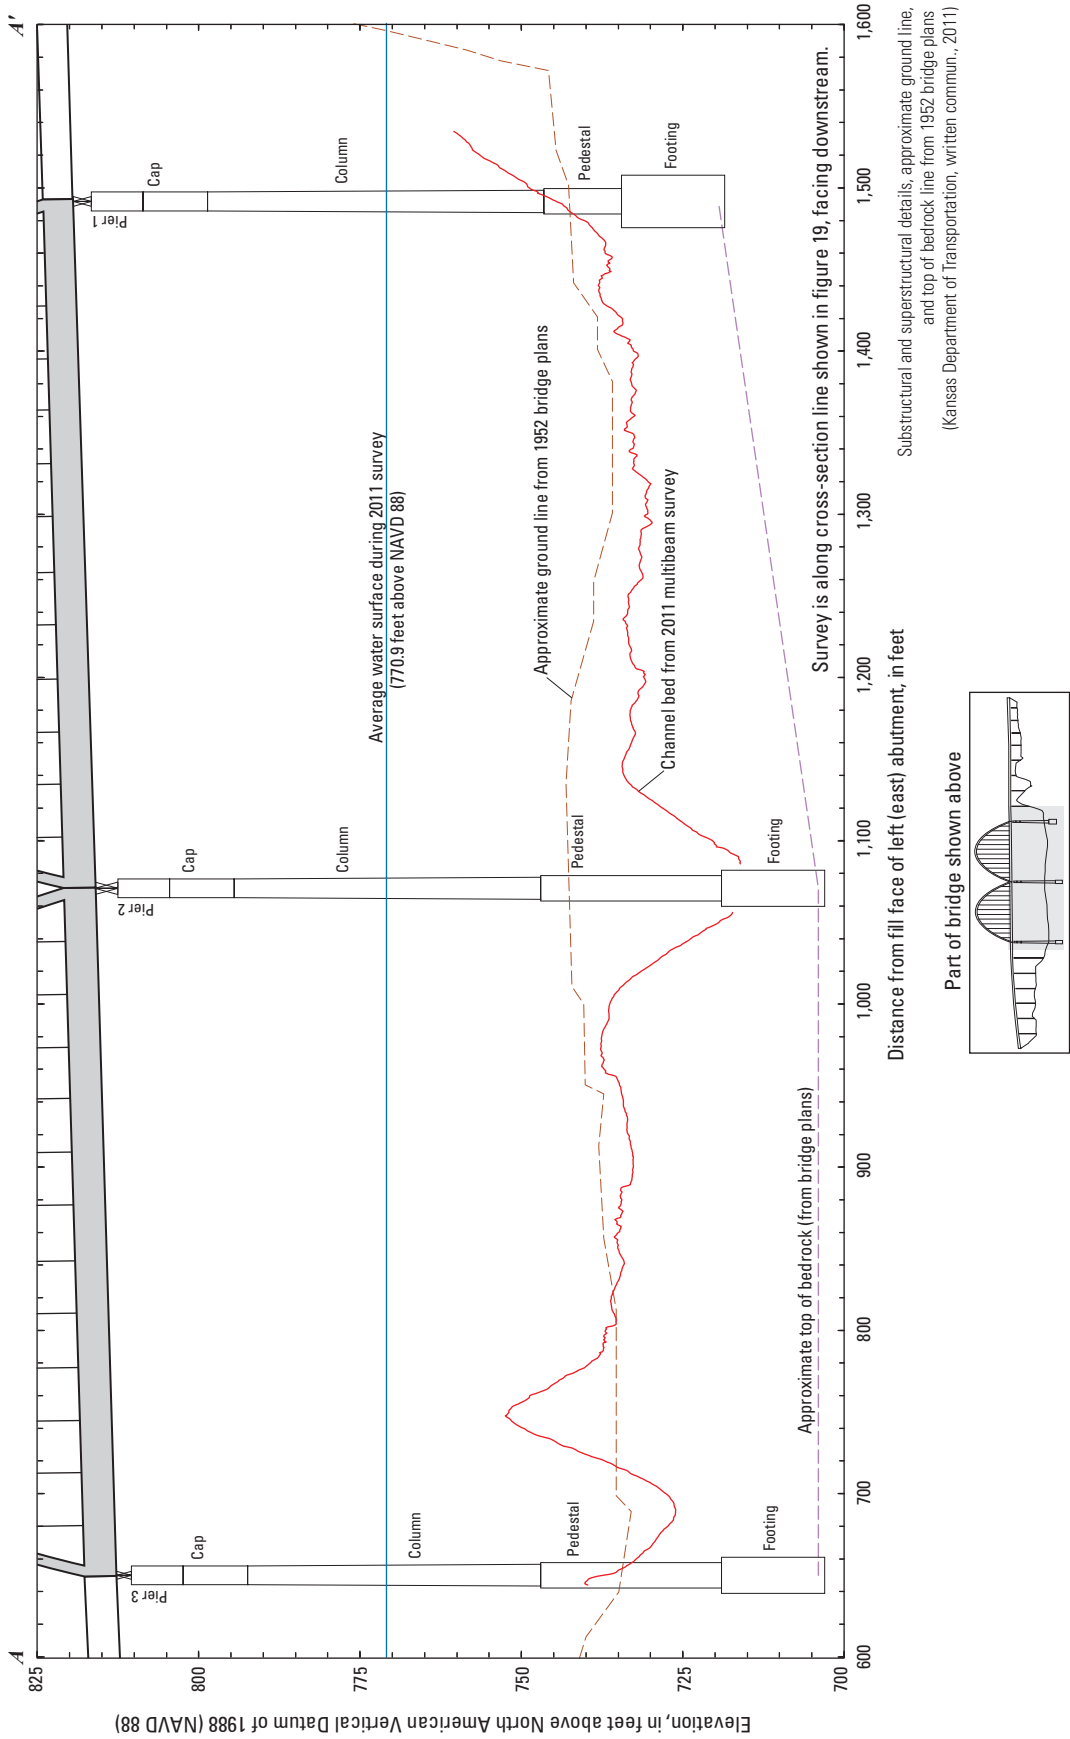
Figure 20. Key features, substructural and superstructural details, and surveyed channel bed of structure 92-52-18.48 (026) on State Highway 92 over the Missouri River at Leavenworth, Kansas.

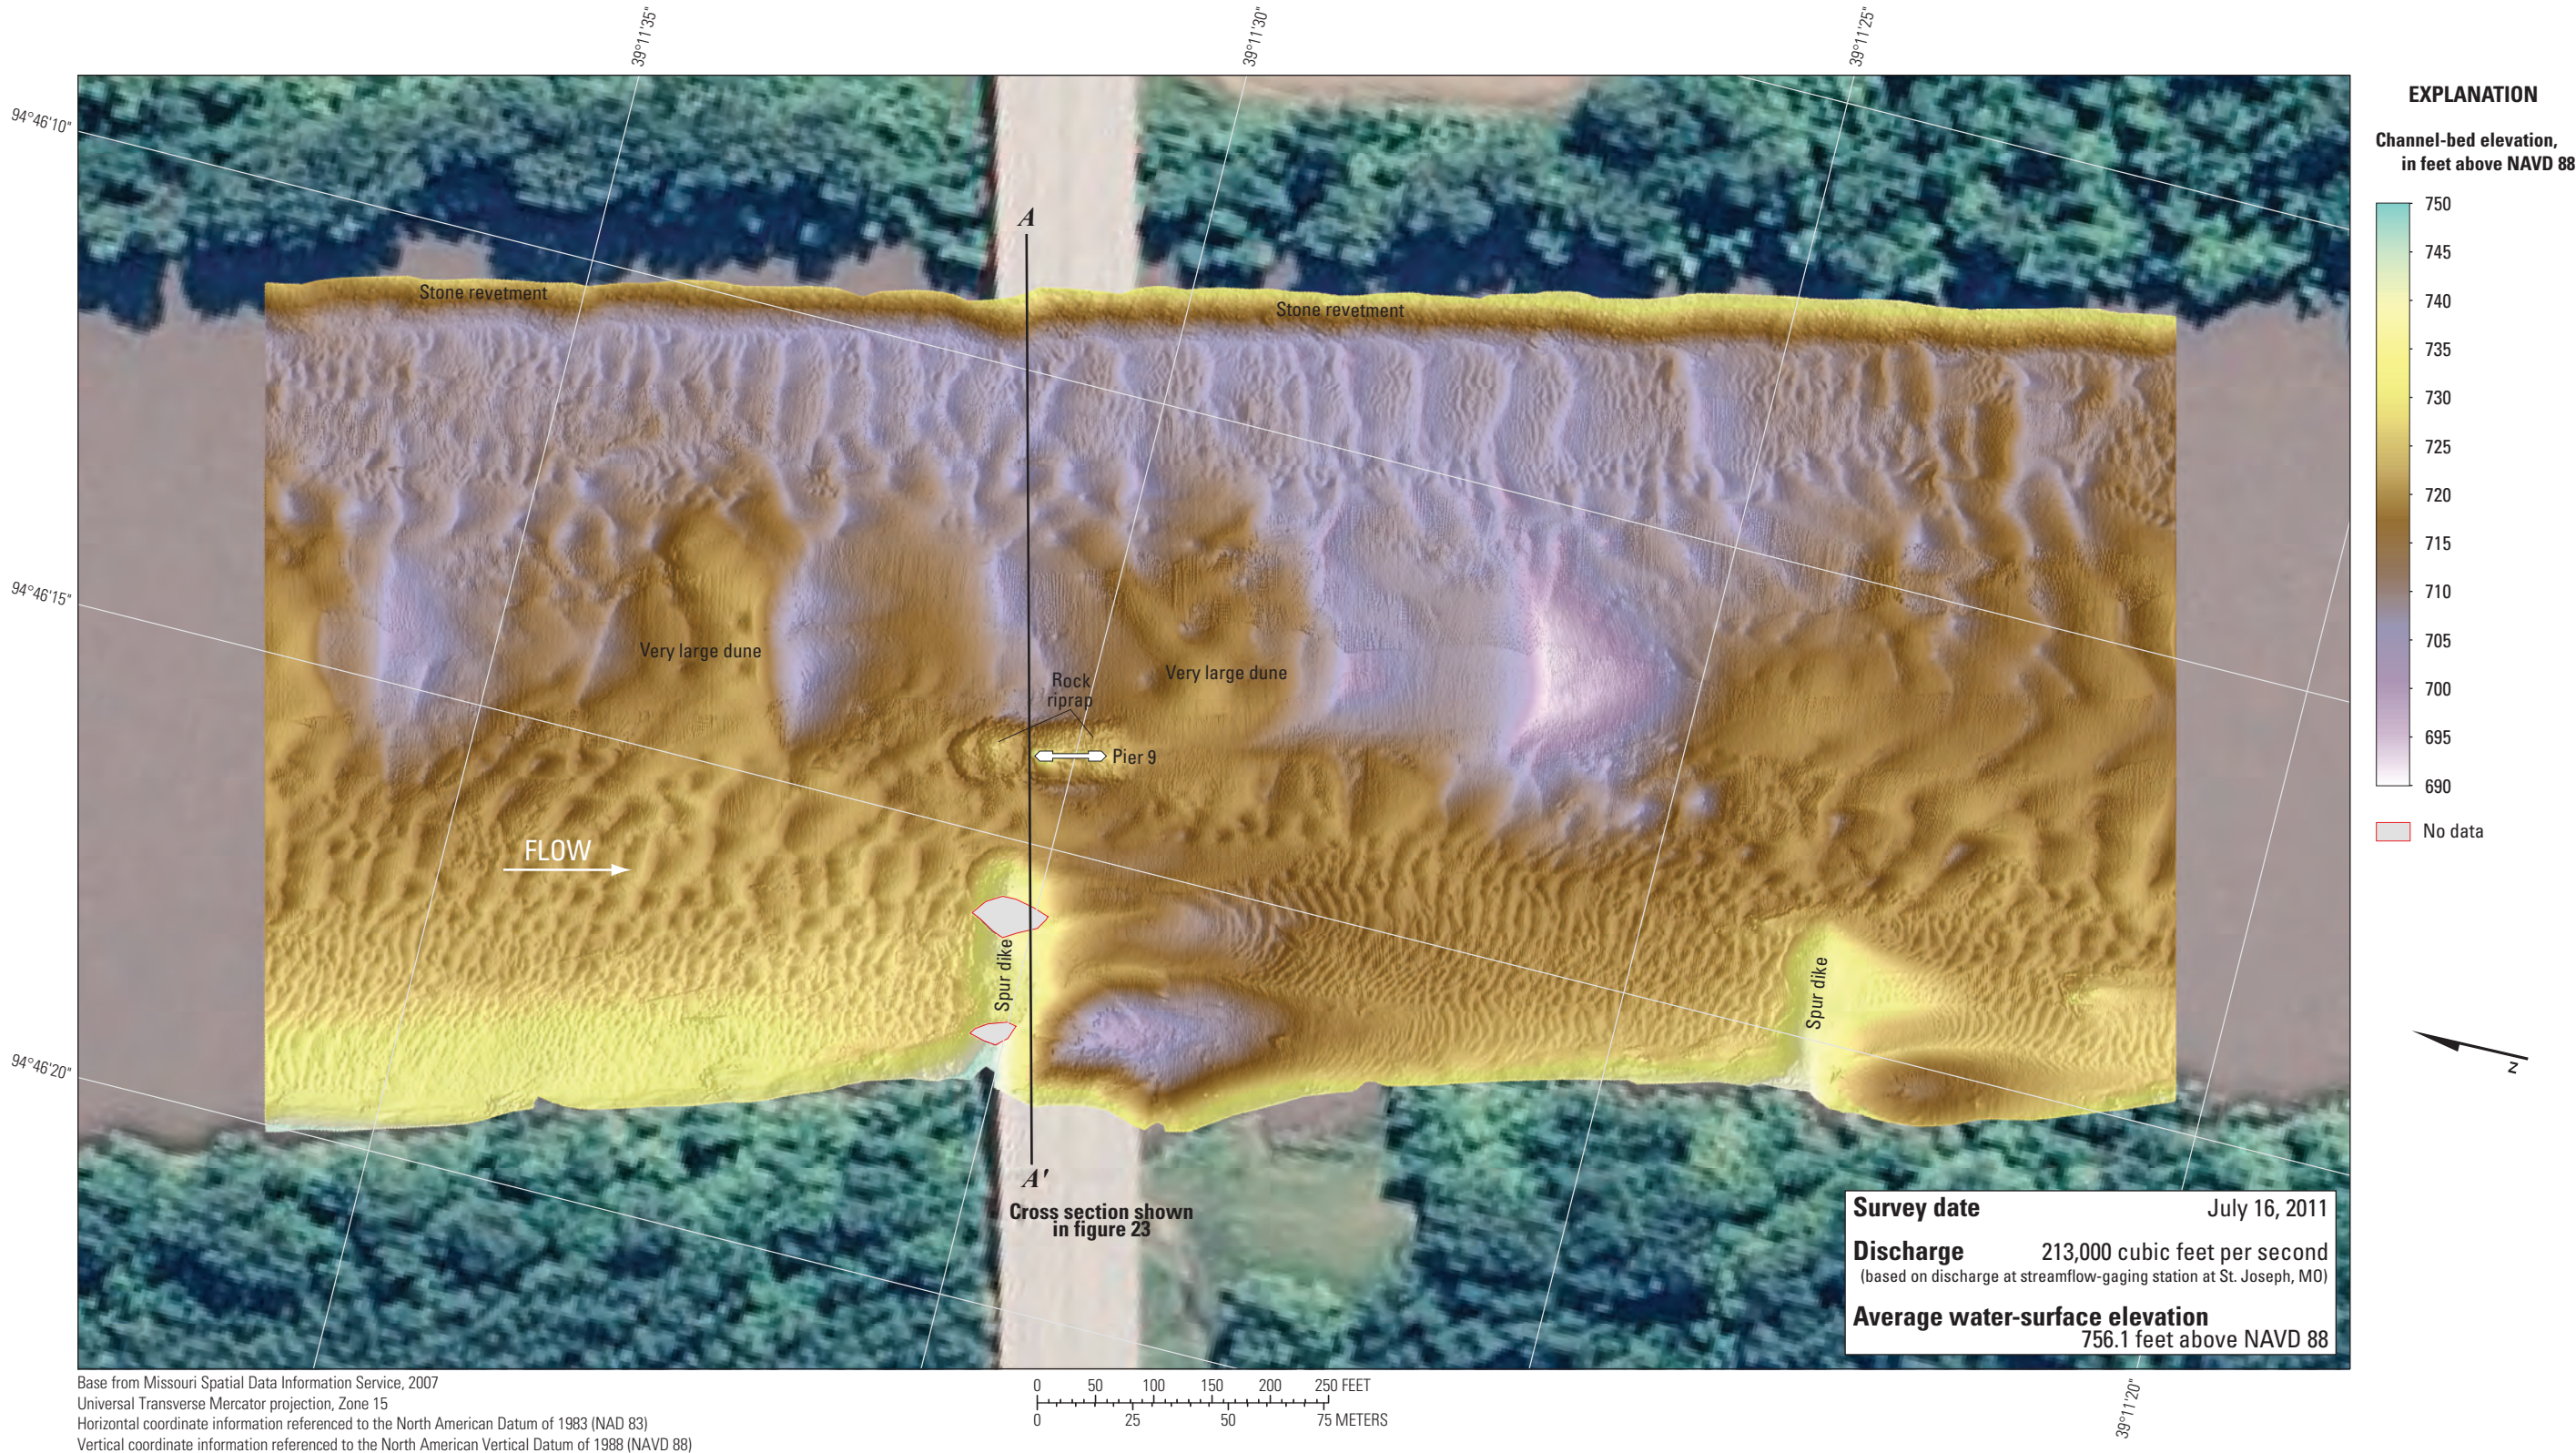
Figure 22. Bathymetric survey of the Missouri River channel in the vicinity of structures 435-105-11.97 (235) and 435-105-11.98 (240) on Interstate 435 near Kansas City, Missouri.

Main channel pier 9 appeared to be surrounded by a mound of rock riprap, with a local minimum channel-bed elevation of about 709 ft to the left of the pier and riprap (figs. 22, 23; table 6). The top of the rock riprap around the upstream face of the pier was at an elevation of about 719 ft, which is equal to or slightly above the average channel bed immediately upstream from the pier (figs. 22, 23); another pile of rock riprap was present upstream from the pier (fig. 22). Information from bridge plans indicates that pier 9 is founded on shafts drilled about 4 ft into bedrock, with about 49 ft of bed material between the bottom of the scour hole and bedrock (fig. 23; table 6). The surveyed bed generally was 5 to 10 ft lower than the original ground line from bridge plans at the time of construction (1974) in the channel to the left of pier 9, but was substantially higher than the original ground line in the channel to the right of pier 9 (fig. 23).

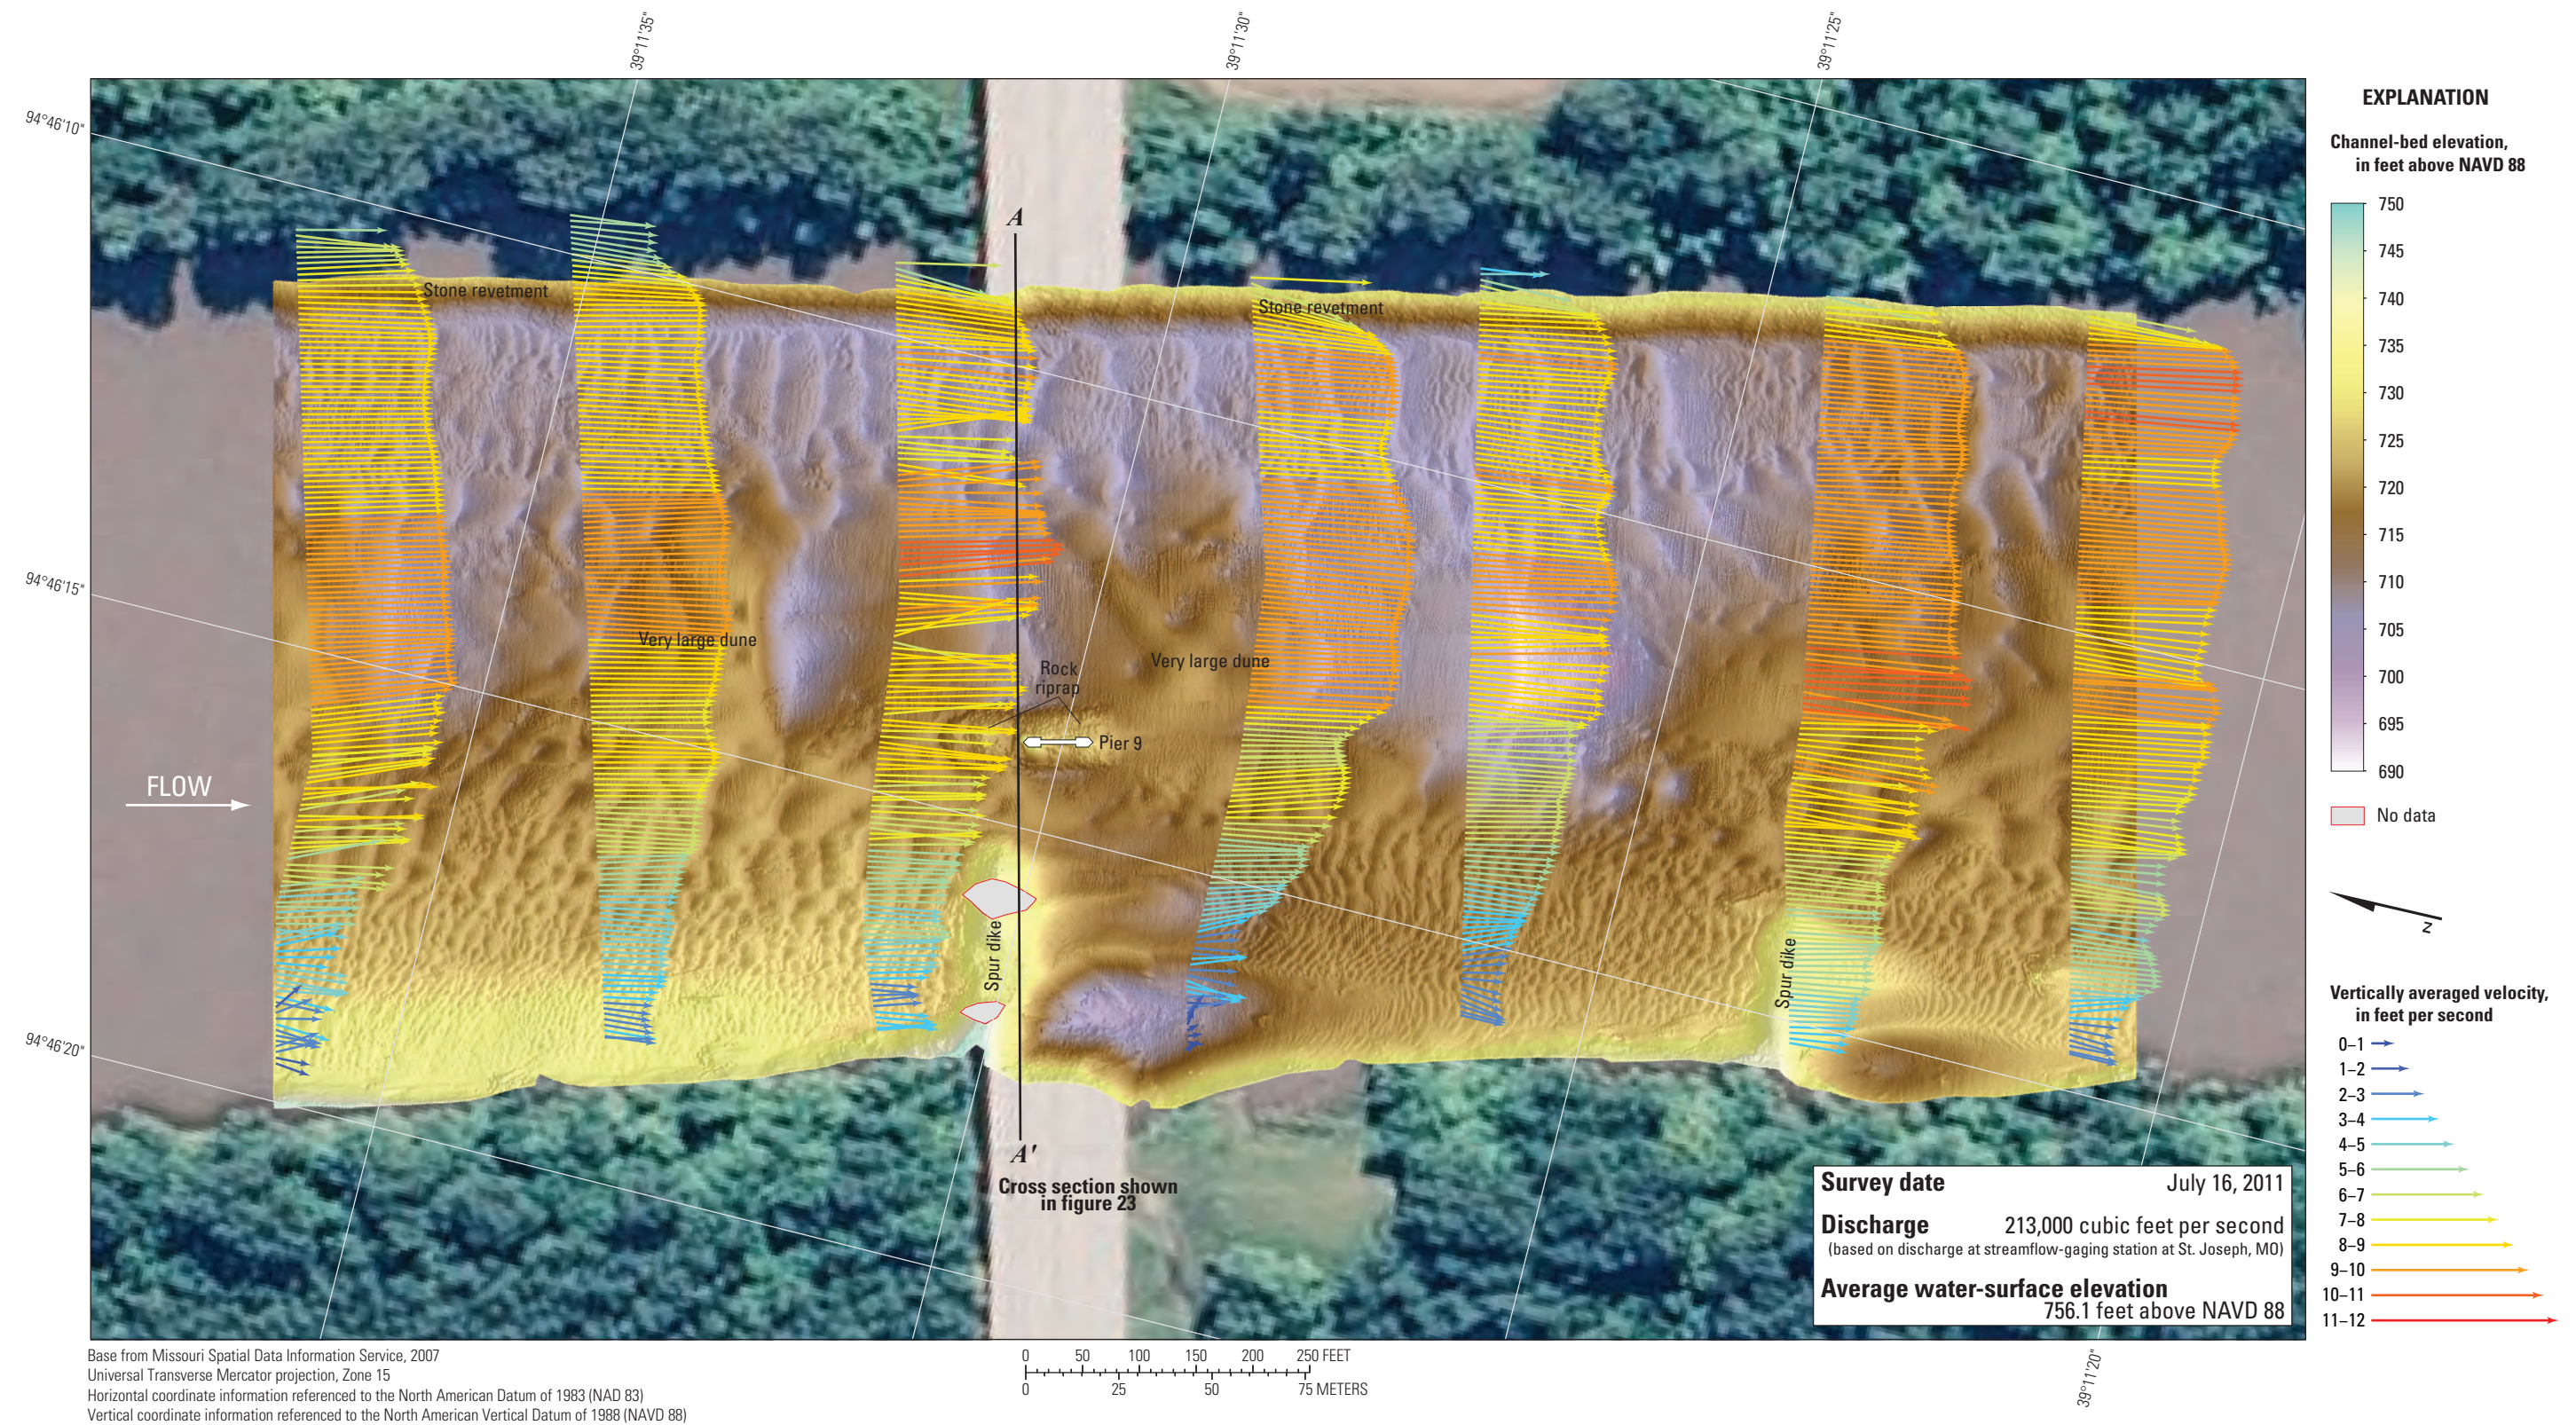
Figure 24. Bathymetry and vertically averaged velocities of the Missouri River channel in the vicinity of structures 435-105-11.97 (235) and 435-105-11.98 (240) on Interstate 435 near Kansas City, Missouri.

The vertically averaged velocity vectors indicate mostly uniform flow at between 8 and 10 ft/s in the main channel, with a few local velocities reaching 11 ft/s, and lower values along the banks, particularly along the right (west) bank and downstream from the spur dikes (fig. 24). Pier 9 is aligned with the flow, and there was more turbulence in the upstream reach and immediately upstream from the bridge than downstream from the pier (fig. 24).

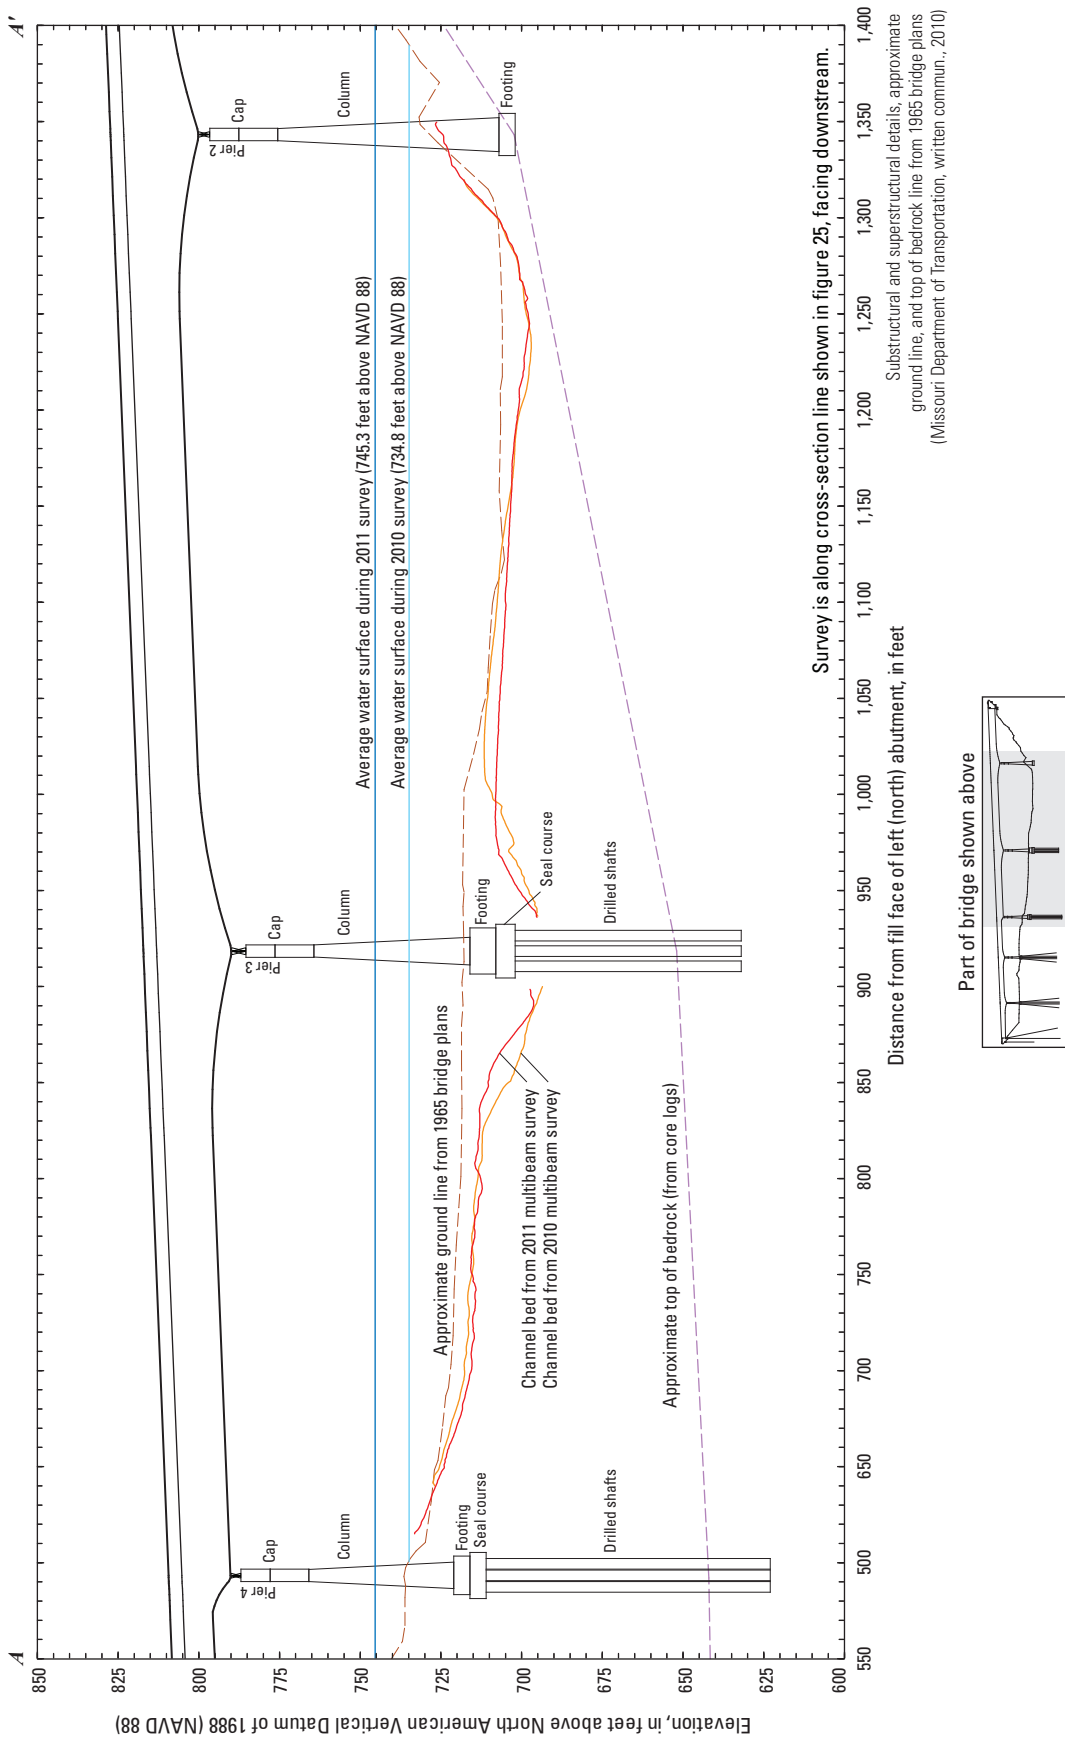
Figure 26. Key features, substructural and superstructural details, and surveyed channel bed structure A1800 on Interstate 635 over the Missouri River in Kansas City, Missouri.

In the vicinity of main channel pier 3, the scour hole had a minimum channel-bed elevation of about 693 ft (table 6), about 18 ft below the average channel bed immediately upstream from the pier (fig. 26), and approximately 9 ft below the elevation of the bottom of the pier seal course of 702.28 ft (fig. 26; table 6). Information from bridge plans indicates that pier 3 is founded on shafts drilled 20 ft into bedrock, with about 41 ft of bed material between the bottom of the scour hole and bedrock at the upstream face of pier 3 (fig. 26; table 6).

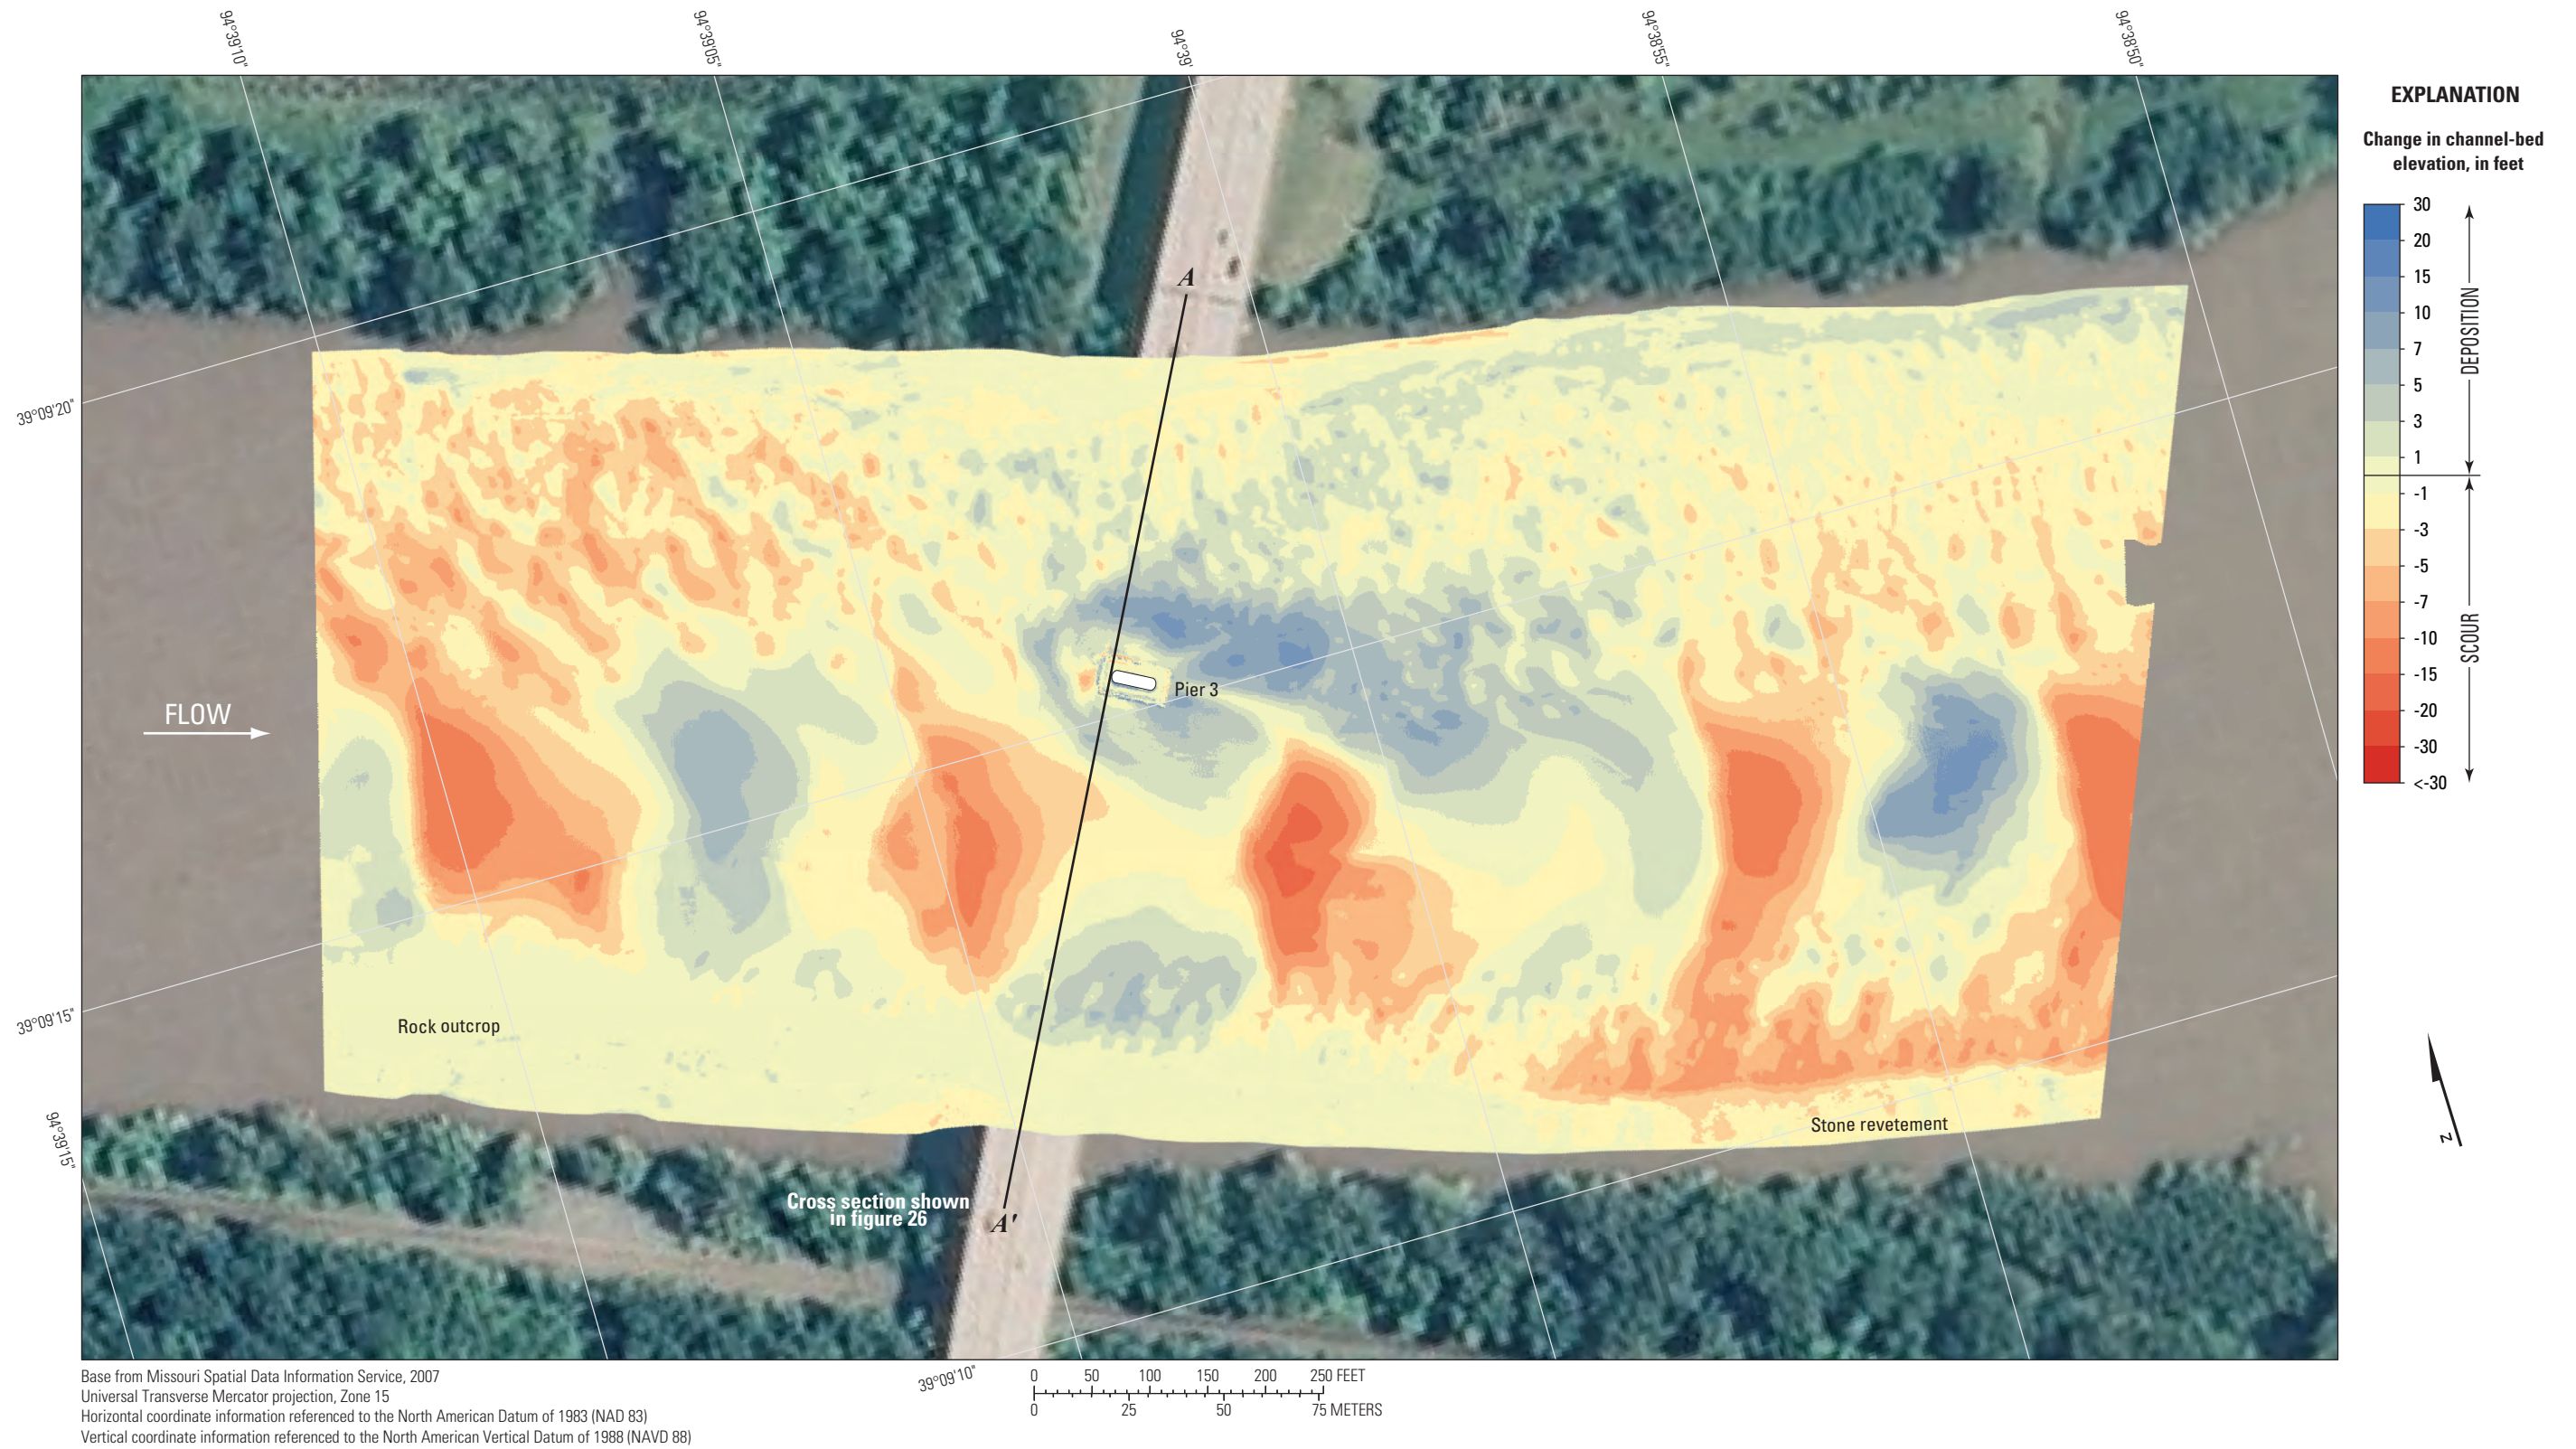
Figure 27. Difference between surfaces created from bathymetric surveys of the Missouri River channel in the vicinity of structure A1800 on Interstate 635 in Kansas City, Missouri, on March 15, 2010, and July 16, 2011.

The difference between the survey on July 16, 2011, and the previous survey on March 15, 2010 (fig. 27) indicates substantial variation from 2010 to 2011, particularly near the large dune features from the 2011 survey (fig. 25). Large dune features also were present in the 2010 survey (Huizinga, 2010), but their position was out-of-phase with the features from the 2011 survey. There appeared to be an area of net scour on the left (north) side in the upstream and downstream reaches, with an area of net deposition on the left side immediately downstream from the bridge (fig. 27). The average difference between the bathymetric surfaces was -1.26 ft (table 7), indicating overall scour occurred between the 2010 and 2011 surveys. The cross sections from the two surveys are not substantially different from one another (fig. 26), despite a water-surface elevation difference of more than 10 ft and a flow difference of 84,000 ft³/s (table 7). The scour hole near pier 3 was slightly narrower and deeper in 2011 than in 2010 (fig. 26), as evidenced by the small area of scour at the upstream face and the overall pattern of deposition in a horseshoe shape around the pier (fig. 27). The rock outcrop on the upstream right (south) bank appeared to experience no change, as would be expected (fig. 27)—although rock ultimately is an erodible material, its rate of erosion is substantially slower than that of sand and silt (Richardson and Davis, 2001); however, the stone revetment on the downstream right (south) bank appeared to have degraded in some areas, likely from localized slumping (fig. 27). As with difference maps presented earlier in this report, the appearance of substantial deposition or scour at the faces of the pier result from minor horizontal positional variances between the surveys.
