Bathymetric and Velocimetric Surveys at Highway Bridges Crossing the Missouri River in and into Missouri during Summer Flooding, July–August 2011

Scientific Investigations Report 2012–5204

By Richard J. Huizinga

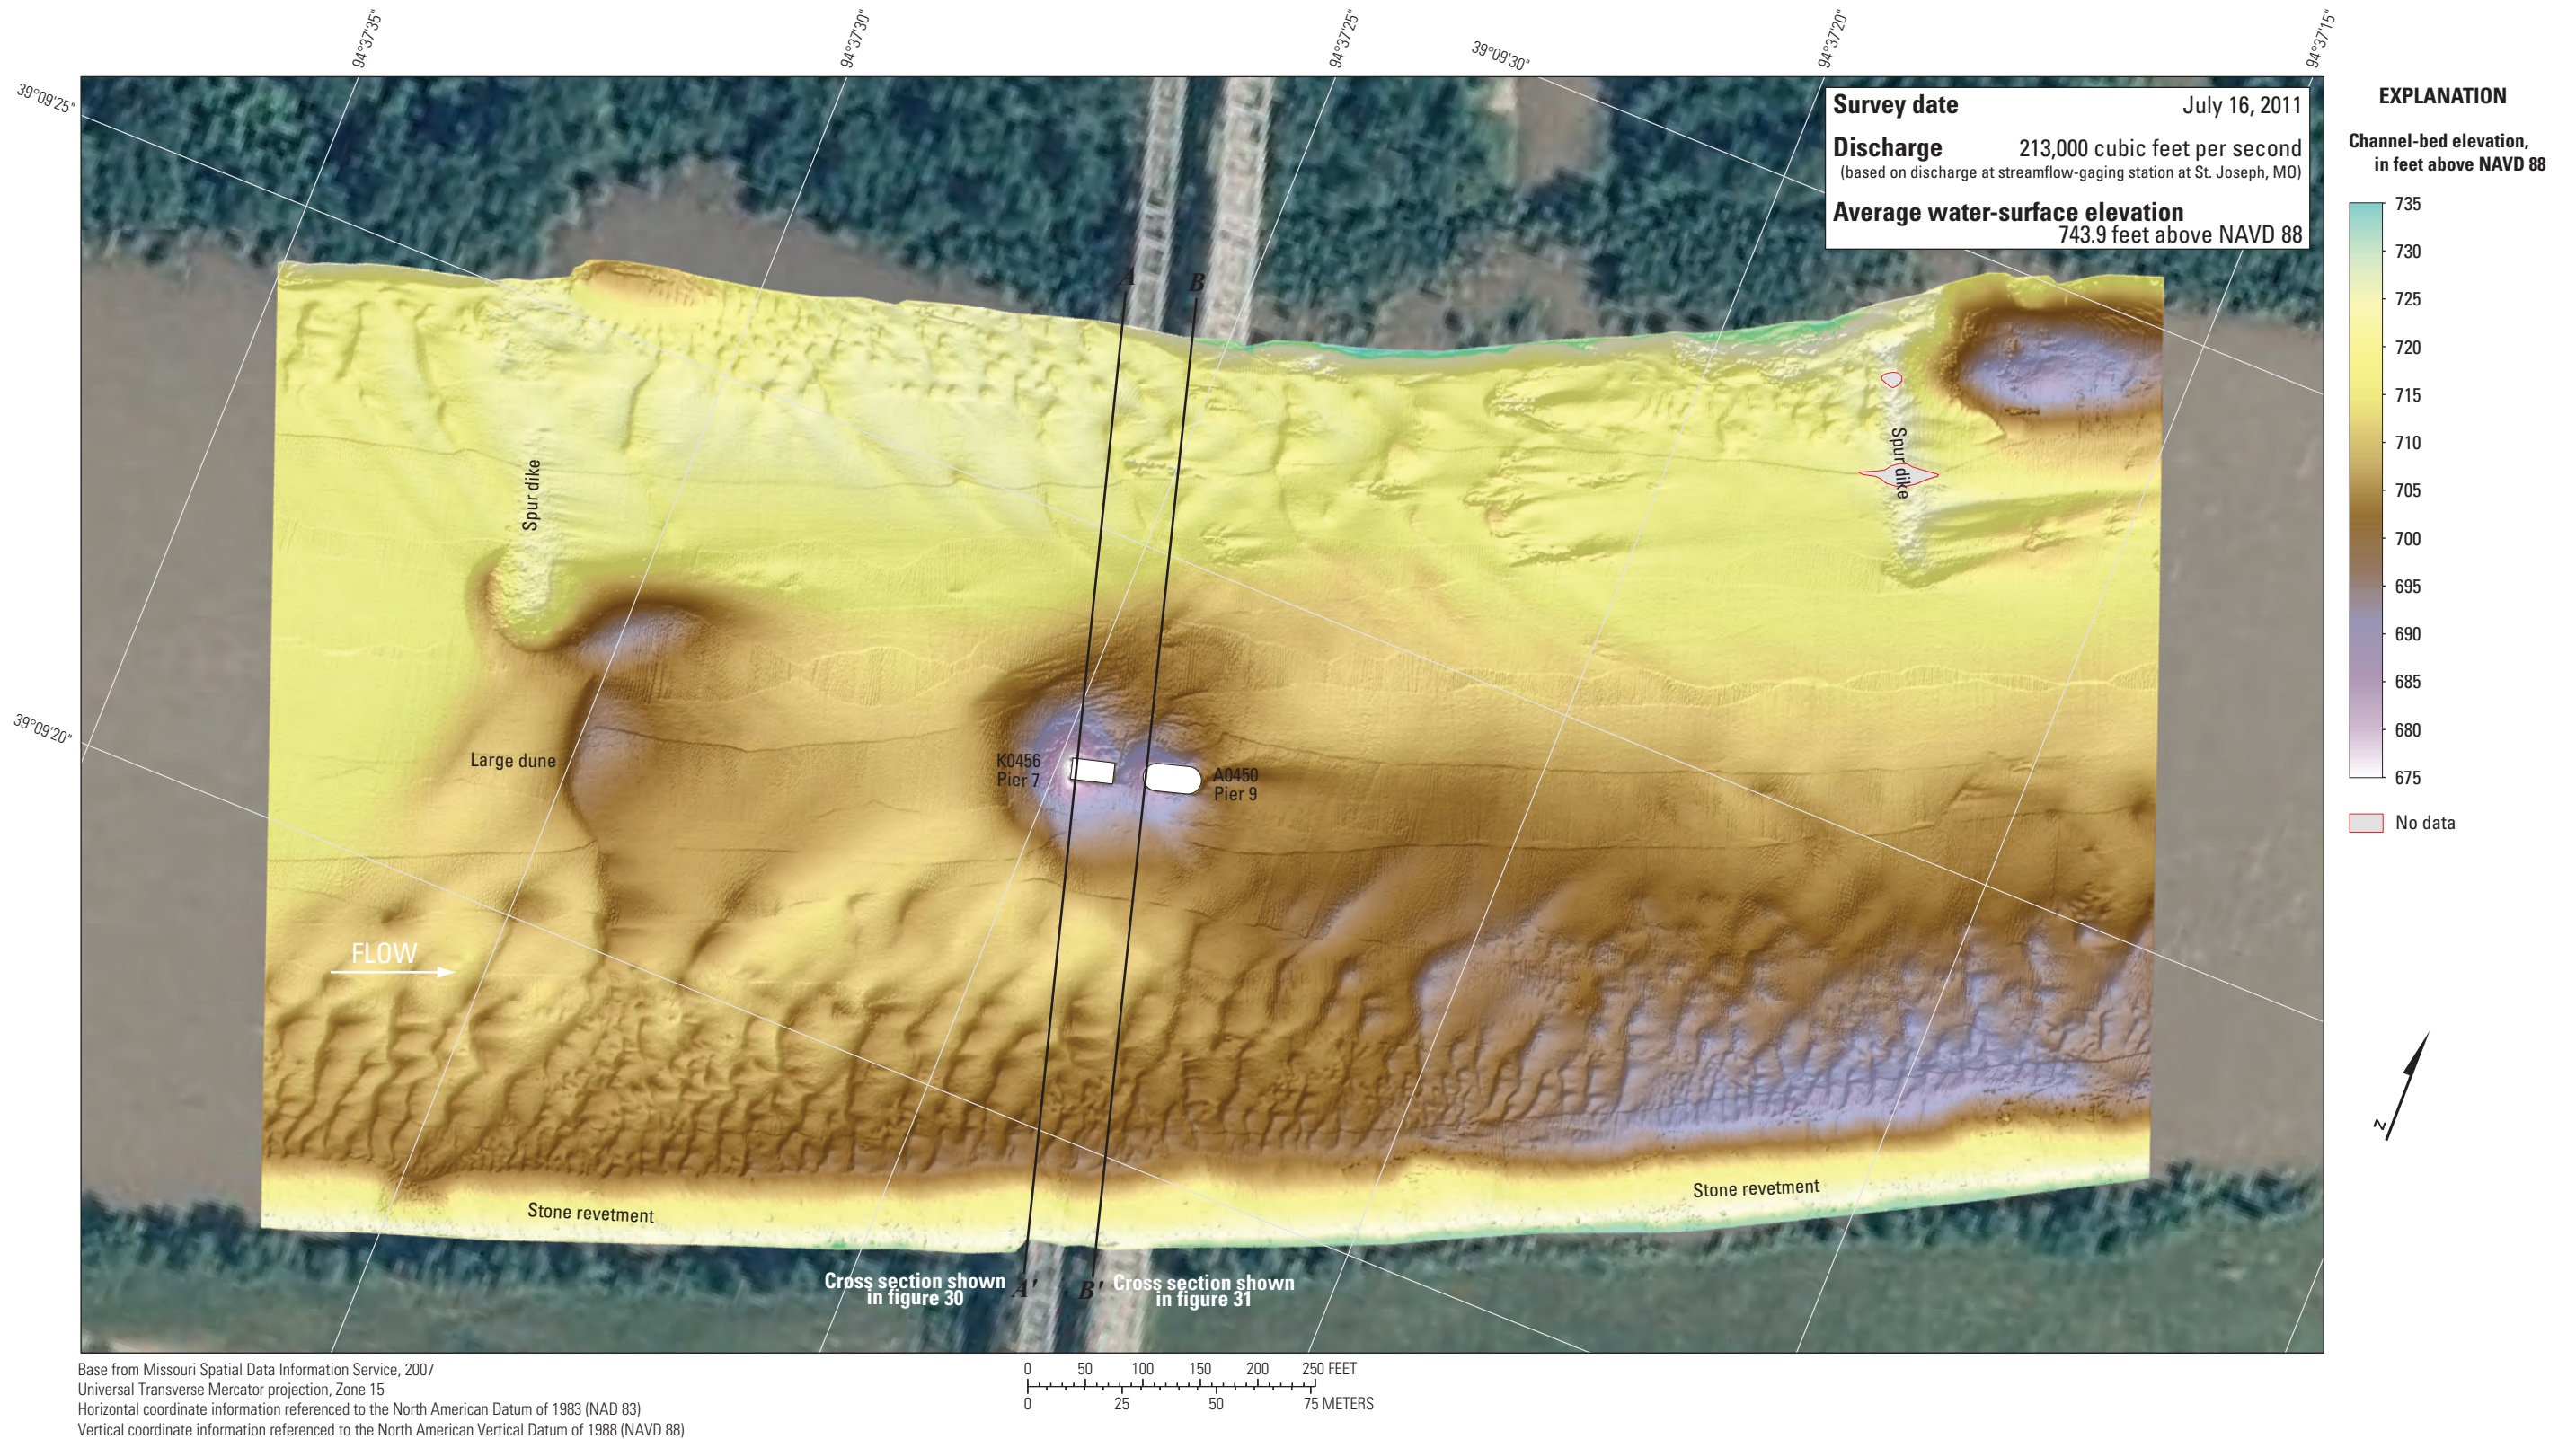
Figure 29. Bathymetric survey of the Missouri River channel in the vicinity of structures K0456 and A0450 on U.S. Highway 69 in Kansas City, Missouri.

The survey area was about 1,640 ft long and about 790 ft wide, extending from bank to bank in the main channel (fig. 29). The upstream end of the survey area was about 755 ft upstream from the centerline between structures K0456 and A0450 (fig. 29). The channel-bed elevations ranged from about 695 to 722 ft for most of the surveyed area (5 to 95 percentile range of the bathymetric data; fig. 29). A narrow thalweg along the outside of the channel bend on the right (south) bank ranged from 8 to 20 ft deeper than the channel bed on the inside of the bend on the left (north) bank (fig. 29). One large dune feature was detected in the middle of the upstream channel; otherwise, the channel bed was smooth with numerous smaller dunes and ripples along the banks (fig. 29). Because the channel bed was smooth, minor variations in the sonar head (believed to be caused by pole flexure) were exacerbated, resulting in discrepancies between the swathes that appear as longitudinal stripes in the survey (fig. 29). Stone revetment was present on the right (south) bank throughout the reach (fig. 29).

In the vicinity of main channel pier 7 of upstream structure K0456 (fig. 29), a scour hole had a minimum channel-bed elevation of about 677 ft (table 6), about 32 ft below the average channel bed immediately upstream from the pier. The scour hole upstream from pier 7 of upstream structure K0456

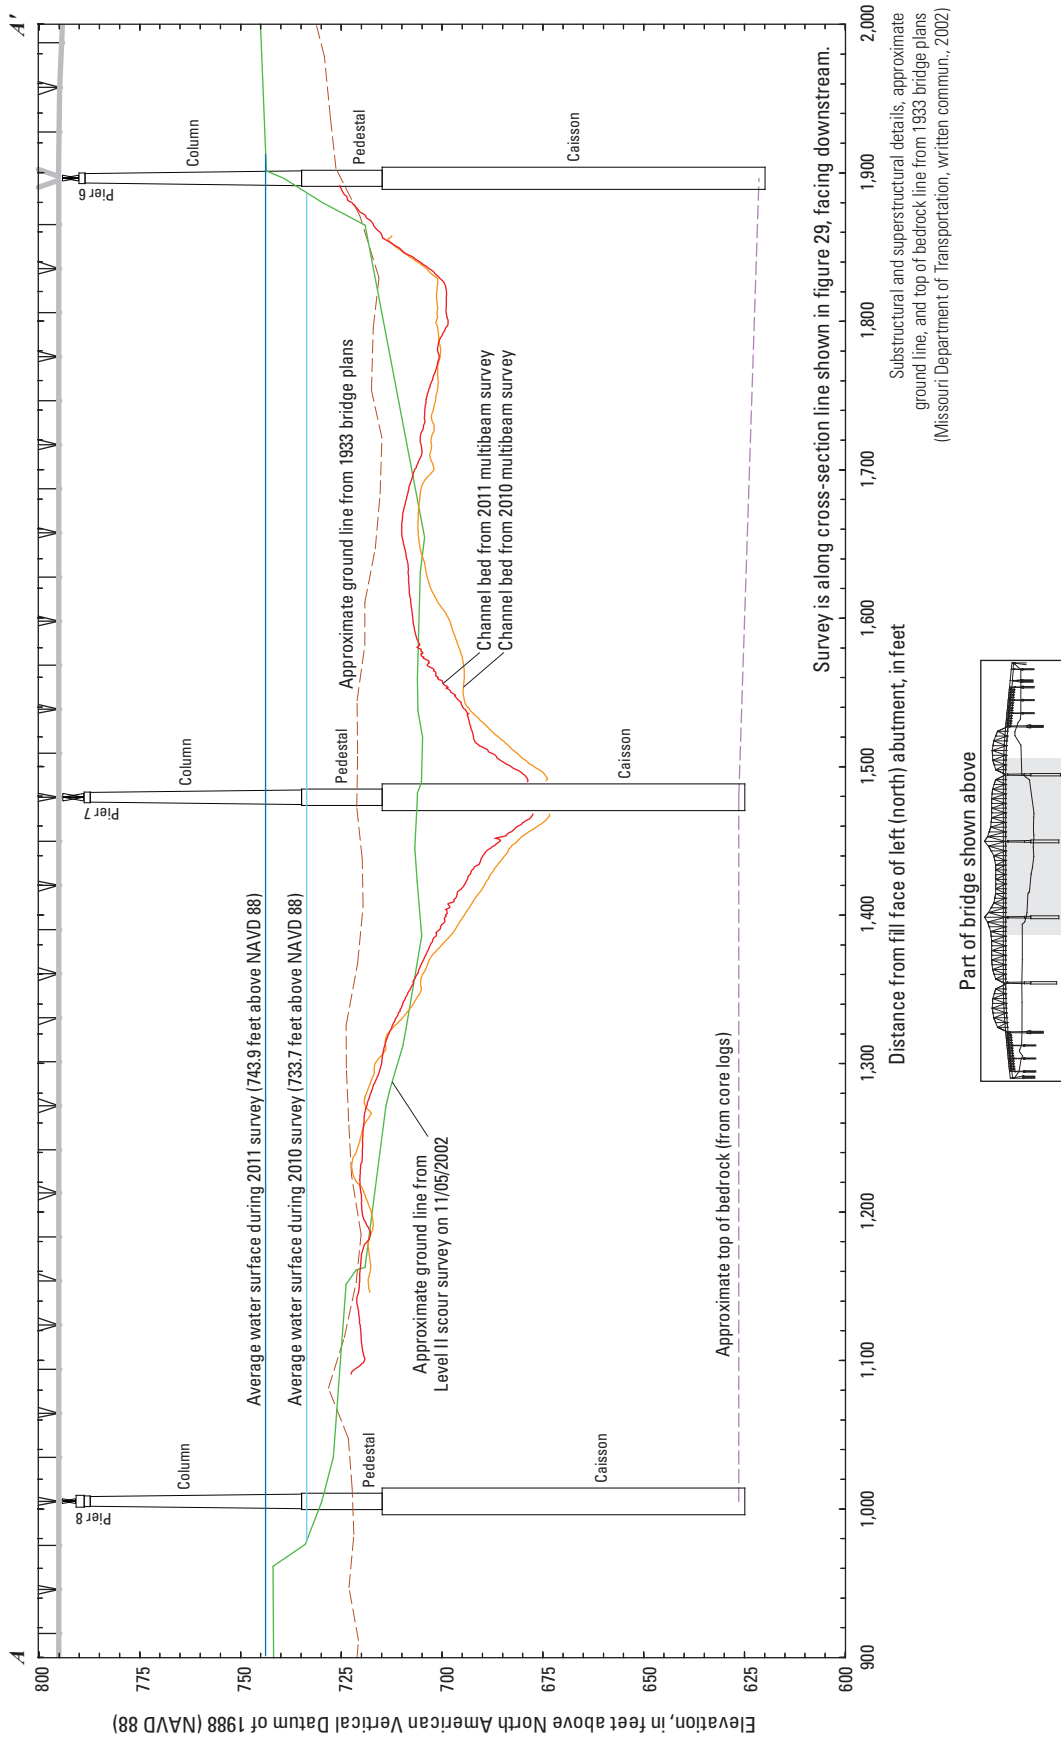
Figure 30. Key features, substructural and superstructural details, and surveyed channel bed of structure K0456 on U.S. Highway 69 over the Missouri River in Kansas City, Missouri.

was about 8 ft deeper than the scour hole upstream from pier 9 of downstream structure A0450 (table 6). Information from bridge plans indicates that the main channel piers of both structures K0456 and A0450 are caissons on bedrock (figs. 30, 31). About 50 ft of bed material was between the bottom of the deeper scour hole at structure K0456 and the bottom of the caissons (fig. 30; table 6).

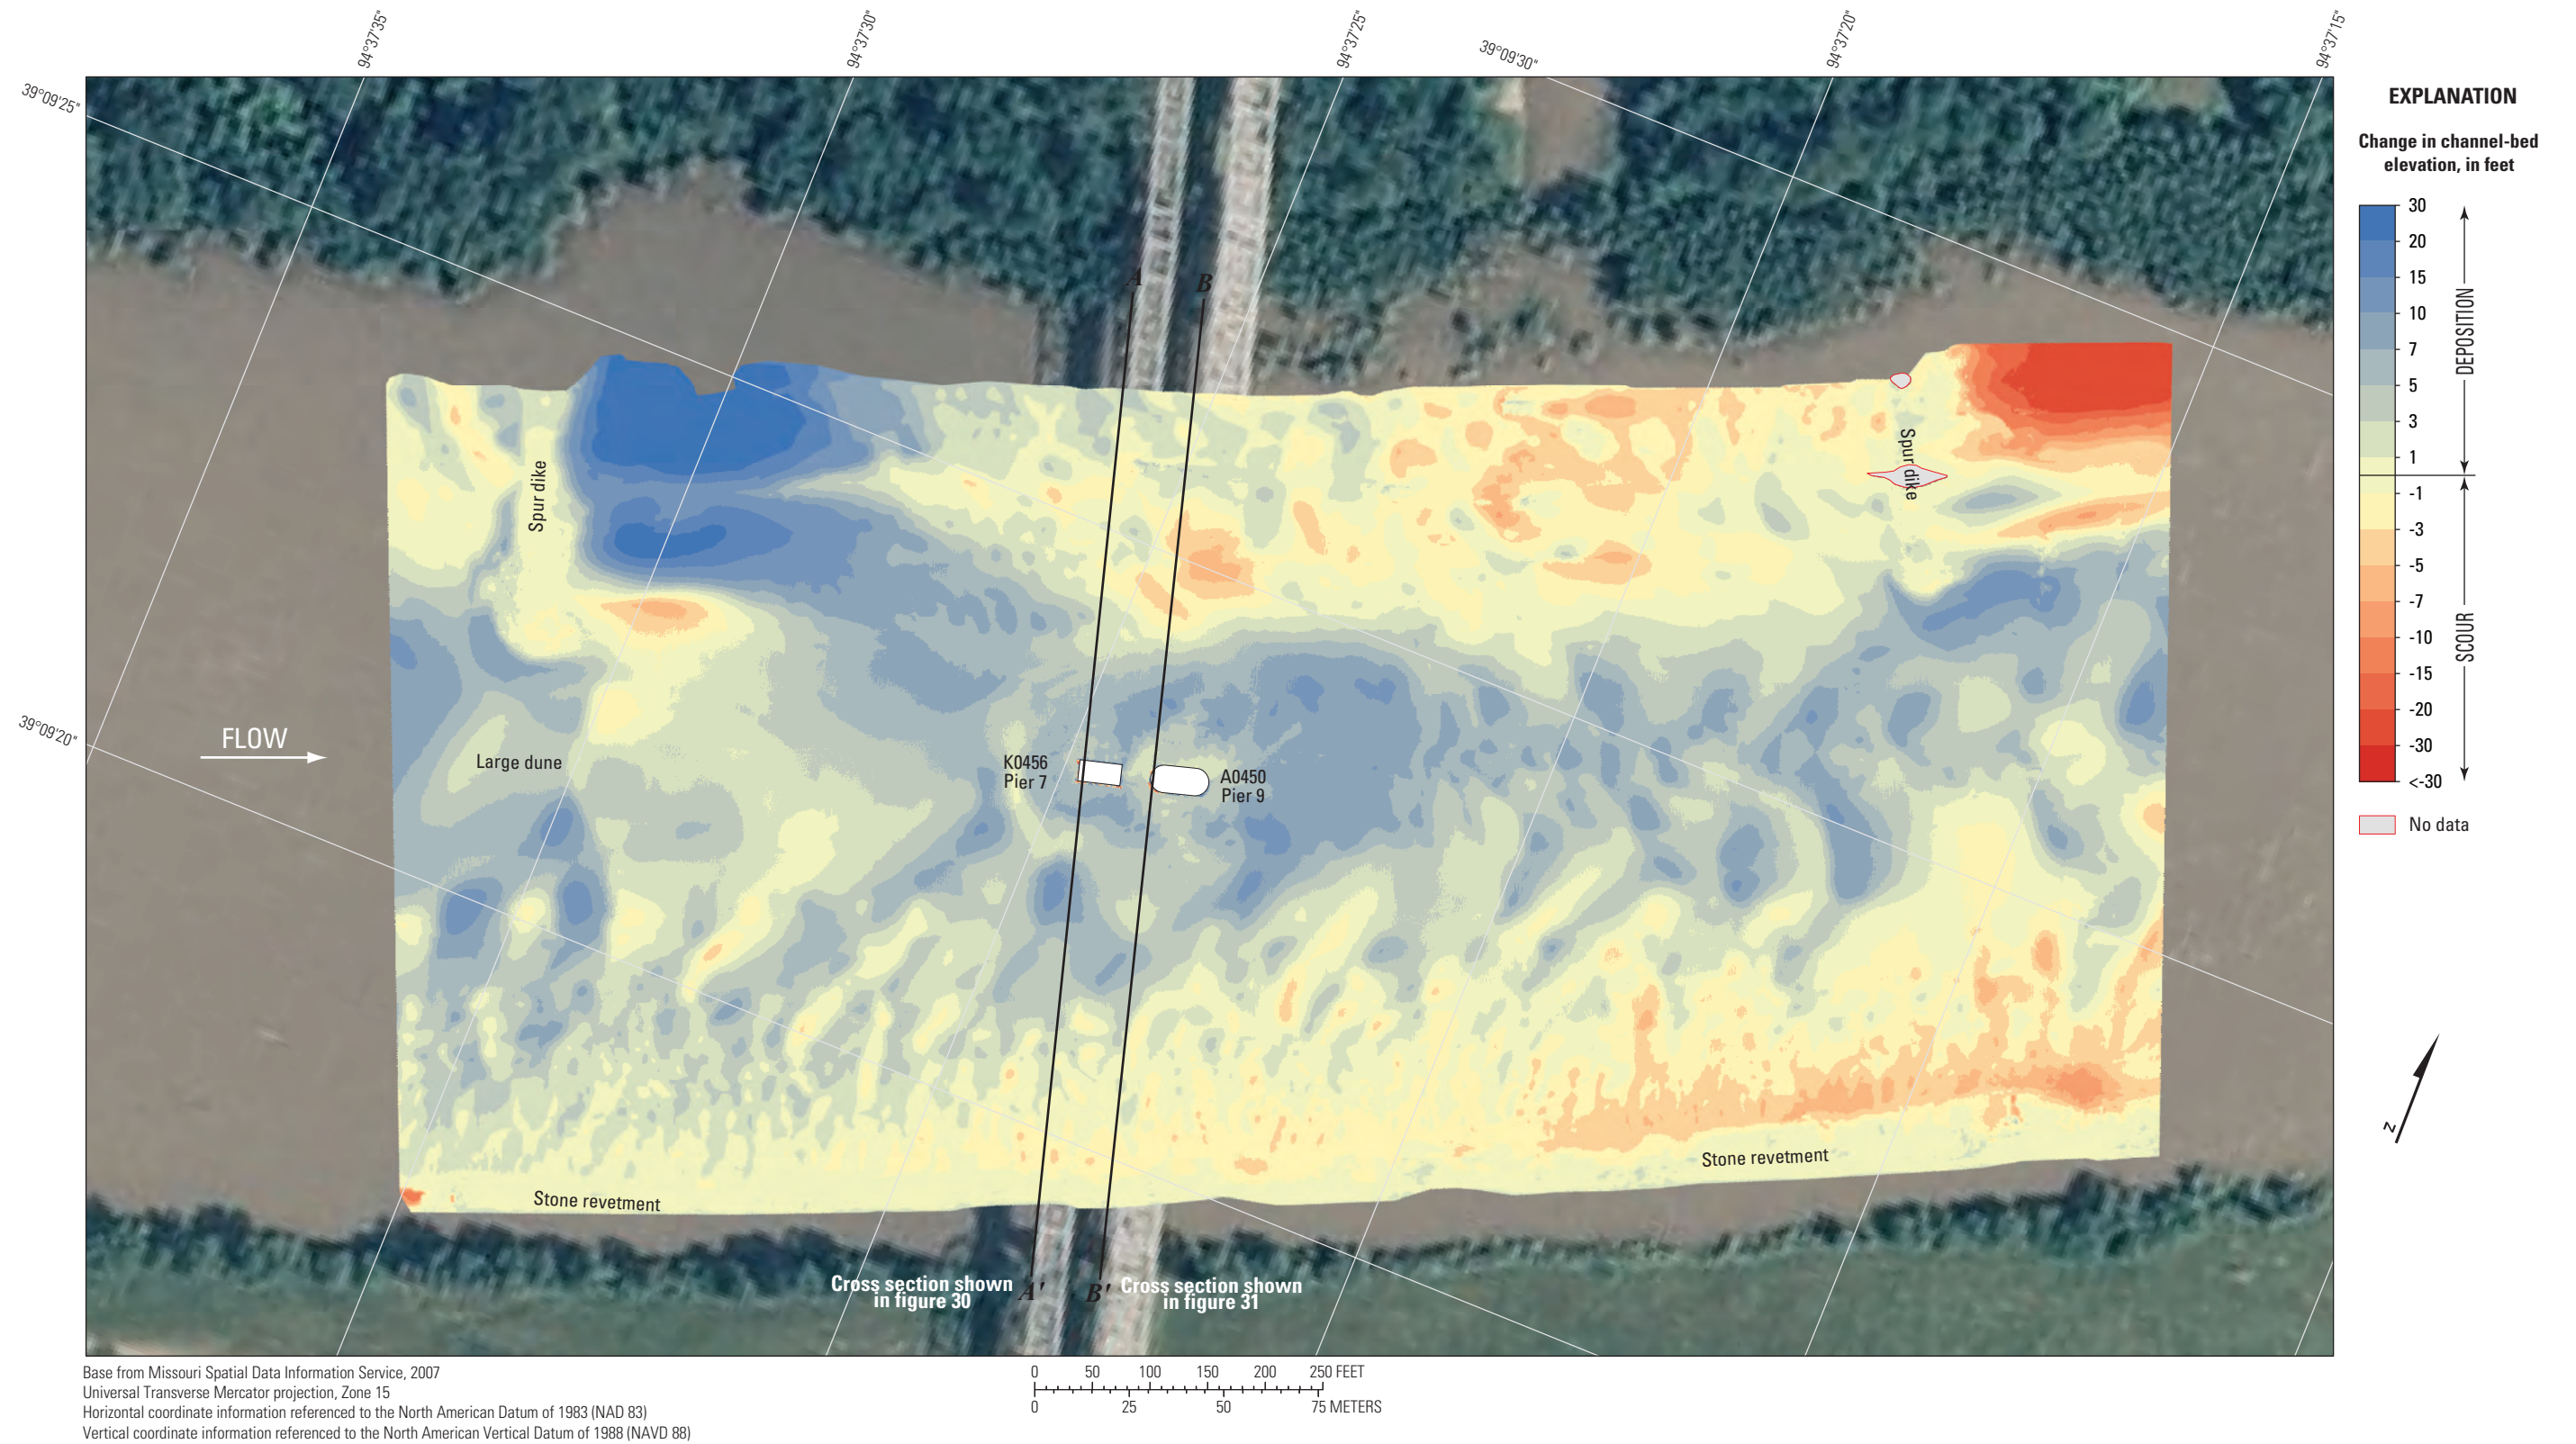
Figure 32. Difference between surfaces created from bathymetric surveys of the Missouri River channel in the vicinity of structures K0456 and A0450 on U.S. Highway 69 in Kansas City, Missouri, on March 15, 2010, and July 16, 2011.

The difference between the survey on July 16, 2011, and the previous survey on March 15, 2010 (fig. 32) indicates substantial deposition from 2010 to 2011, particularly downstream from the upstream spur dike. The average difference between the bathymetric surfaces was +2.45 ft (table 7). However, there was substantial scour downstream from the downstream spur dike (fig. 32), and there appeared to be an area of net scour on the left (north) side and the thalweg in the downstream reach, with an area of net deposition between them (fig. 32). The cross sections along the upstream bridge faces from the two surveys are similar to one another in shape with the 2011 survey generally higher than the 2010 survey (figs. 30, 31), despite a water-surface elevation difference of more than 10 ft and a flow difference of 84,000 ft³/s (table 7). As was observed at structure A1800 upstream, the scour holes near the main channel piers were narrower in 2011 than in 2010 (figs. 30, 31), as evidenced by the overall pattern of deposition in a horseshoe shape around the piers (fig. 32). The stone revetment on the right (south) bank appeared to have experienced a mix of scour and deposition (fig. 32).

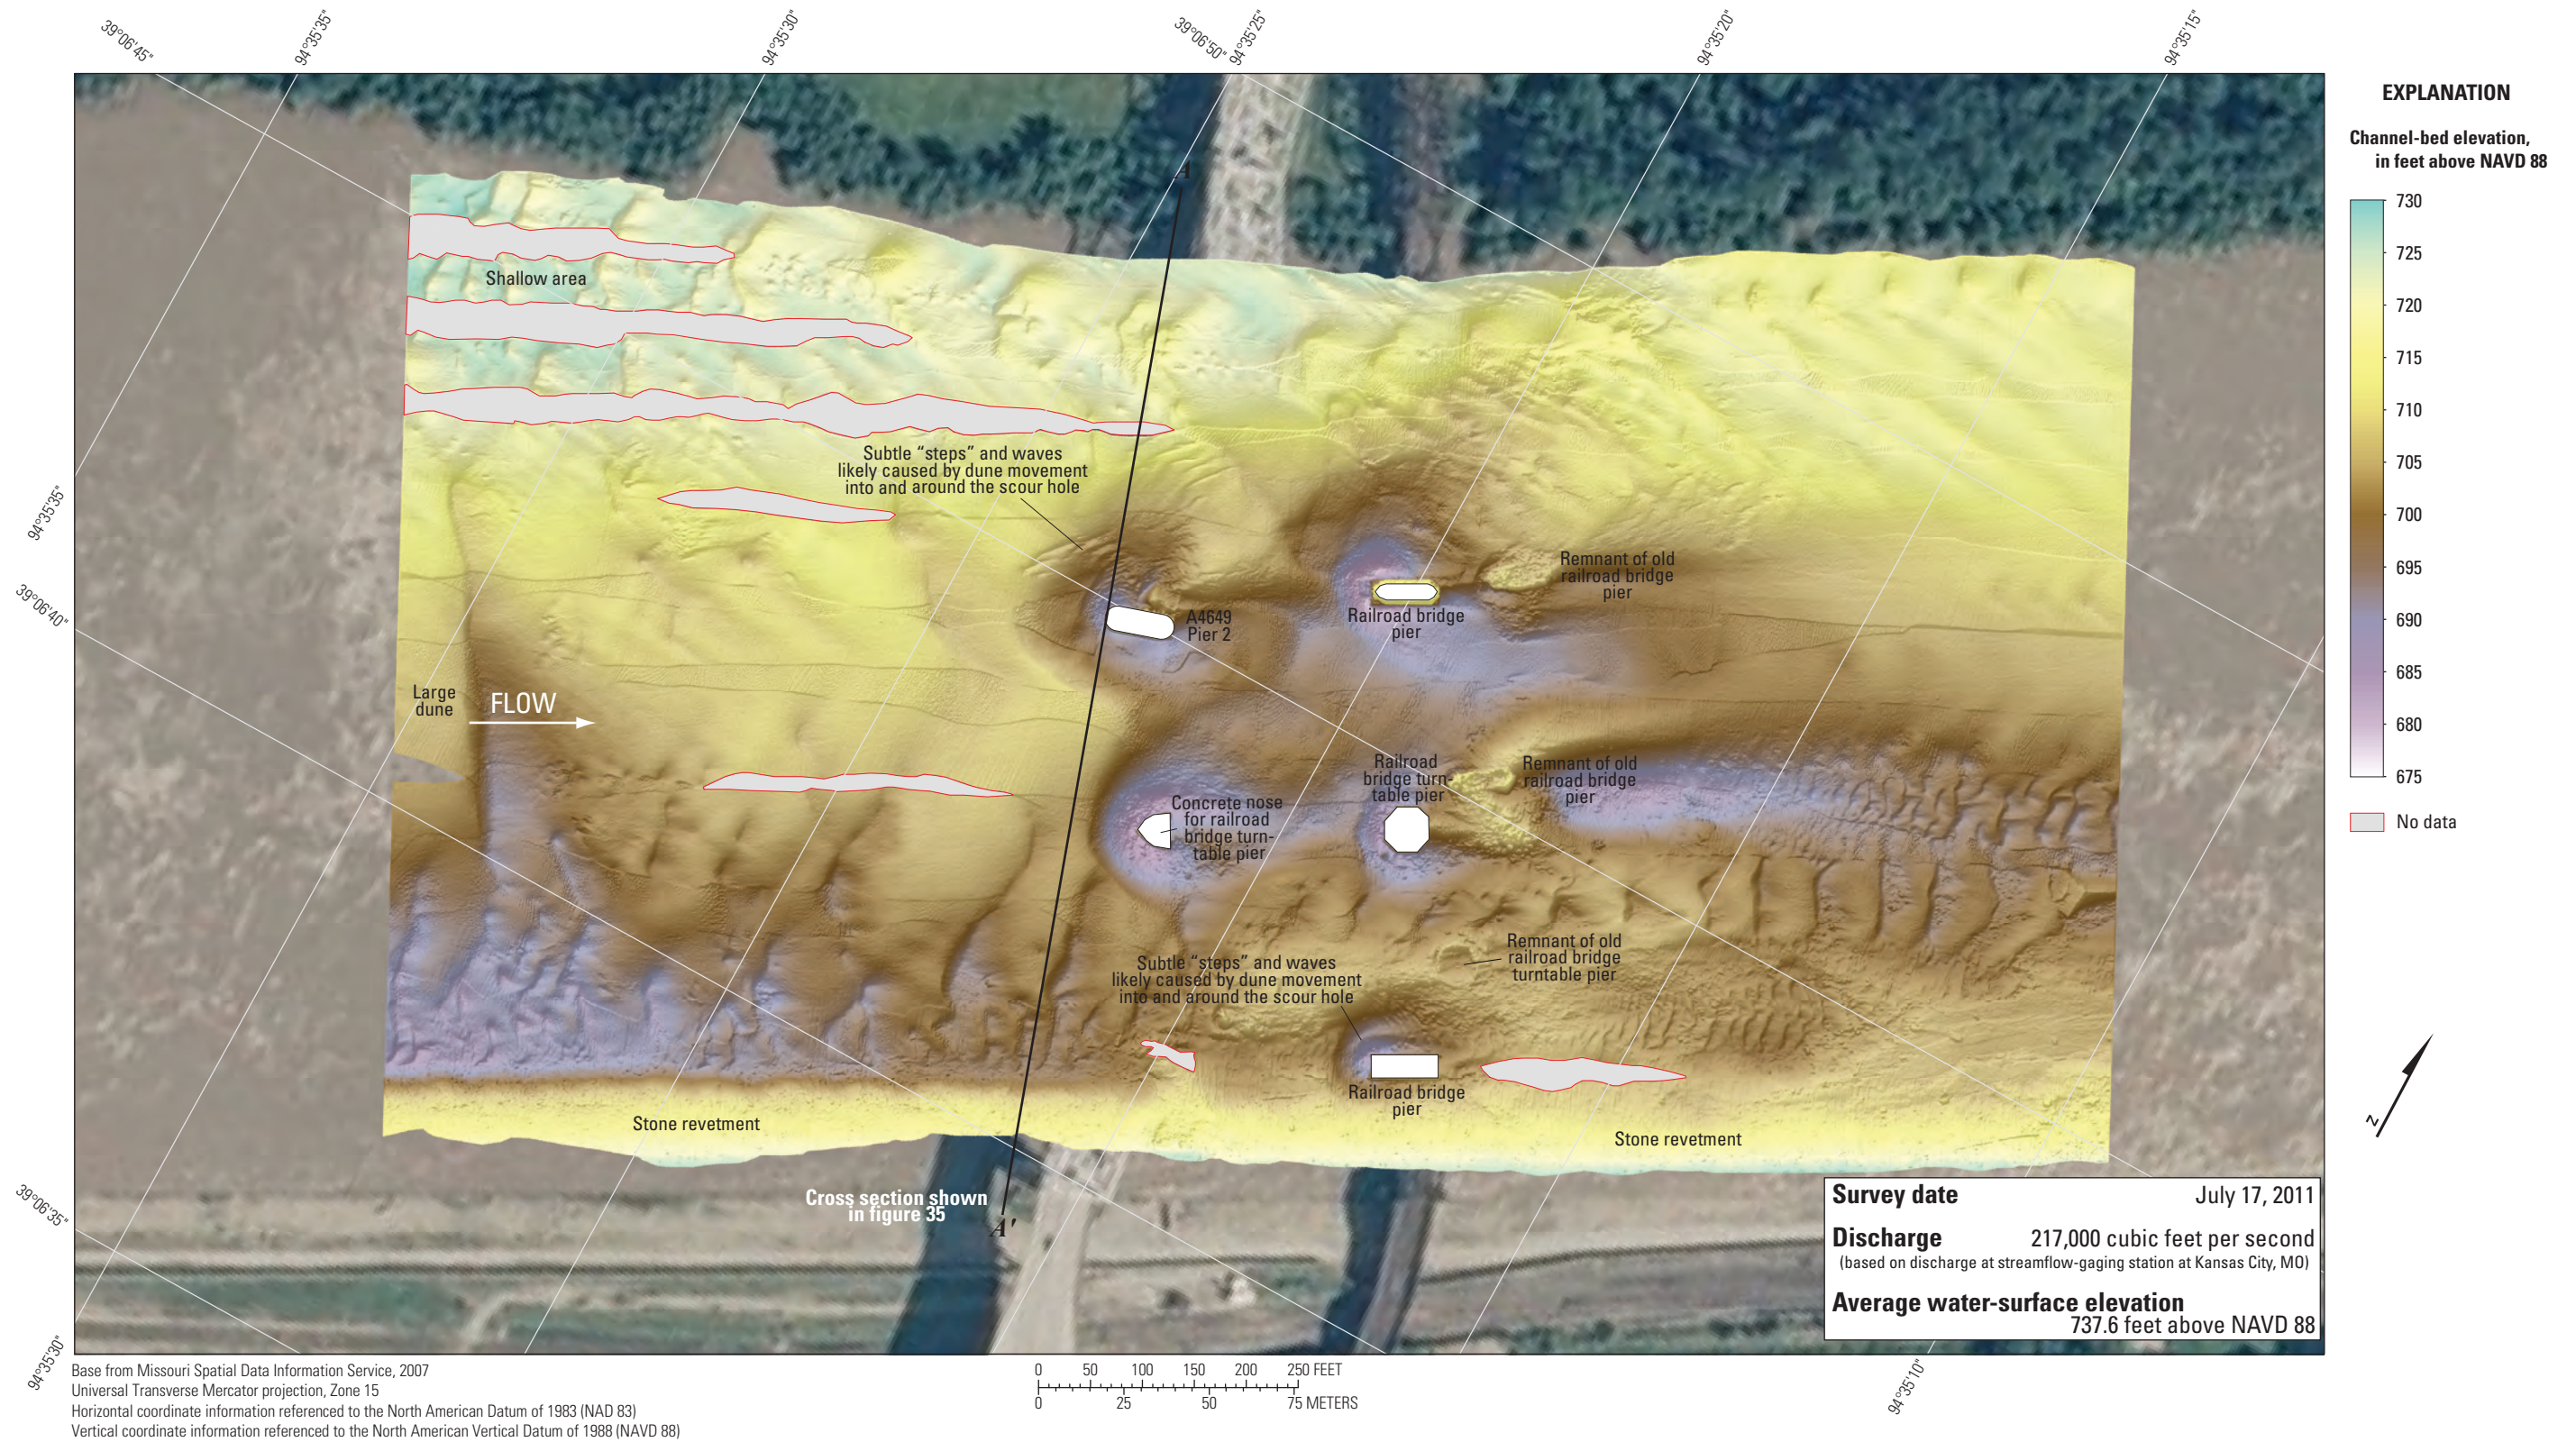
Figure 34. Bathymetric survey of the Missouri River channel in the vicinity of structure A4649 on U.S. Highway 169 in Kansas City, Missouri.

The survey area was about 1,660 ft long and about 885 ft wide, extending from bank to bank in the main channel (fig. 34). The upstream end of the survey area was about 720 ft upstream from the centerline of structure A4649 at pier 2 (fig. 34). The channel-bed elevations ranged from about 692 to 722 ft for most of the surveyed area (5 to 95 percentile range of the bathymetric data), except near pier 2 of structure A4649, the various railroad bridge piers, and the concrete nose upstream from the railroad bridge turntable pier (fig. 34). A deep thalweg on the right (south) bank on the upstream end of the surveyed area was about 25 ft deeper than the channel bed in the middle of the channel (fig. 34). The thalweg became shallower and shifted to the left at the bridges and downstream (fig. 34). Remnants of piers from an old bridge were evident downstream from the existing railroad bridge (fig. 34). One large dune feature was detected in the upstream channel at this site, and numerous medium and small dunes and ripples were detected throughout the channel, particularly in the channel thalweg upstream from structure A4649 and downstream from the railroad bridge (fig. 34). The various bed features were dynamic between survey passes, and there likely were minor variations in the sonar mount (caused by pole flexure), resulting in discrepancies between the swathes that appear as longitudinal stripes in the survey (fig. 34). The shallow area in the upstream left part of the channel was not extensively surveyed because of the increased risk of damage to the sonar head and the inordinate time required to adequately survey the area, resulting in several long patches of no data between swathes in this area (fig. 34). Stone revetment was present on the right (south) bank throughout the reach (fig. 34).

In the vicinity of main channel pier 2 (fig. 34), a scour hole had a minimum channel-bed elevation of about 687 ft (table 6), about 22 ft below the average channel bed immediately upstream from the pier (table 6). The scour hole extended further around the right side of the pier, with a submerged remnant of a structure near the left downstream side of the pier (fig. 34), presumably a nose for the railroad bridge downstream similar to the concrete nose upstream from the railroad bridge turntable pier. As in the previous survey at this site (Huizinga, 2010), the remnants of the old bridge piers were clearly defined, as were the piles of particulate rock debris

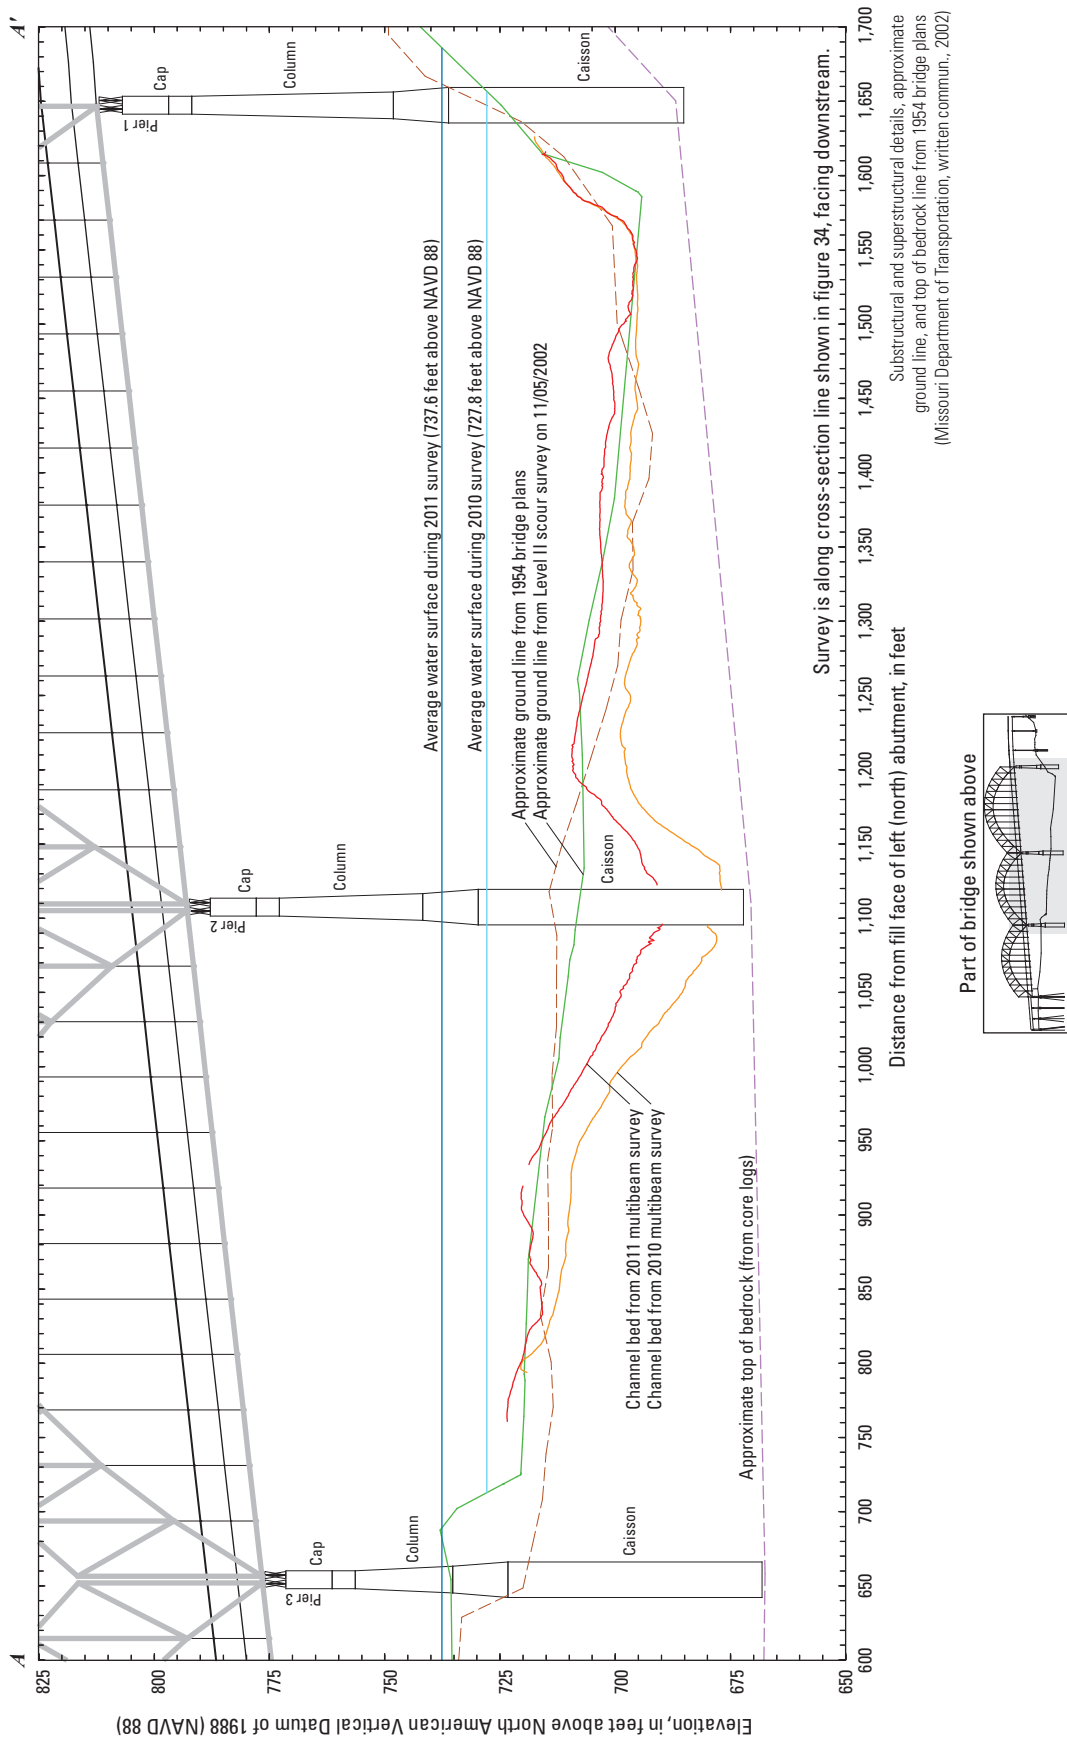
Figure 35. Key features, substructural and superstructural details, and surveyed channel bed of structure A4649 on U.S. Highway 169 over the Missouri River in Kansas City, Missouri.

around them. The remnant downstream from the existing railroad bridge turntable pier had a maximum elevation greater than 710 ft, which is about 13 ft above the channel bed immediately upstream from it. Avoiding this pier remnant would be difficult in lower flow conditions than those on the day of the survey. The overall minimum channel-bed elevation was 678.5 ft, and occurred upstream from the left railroad bridge pier. Information from bridge plans indicate that main channel pier 2 of structure A4649 is a caisson on bedrock, with about 17 ft of bed material between the bottom of the scour hole and the bottom of the caissons (fig. 35; table 6).

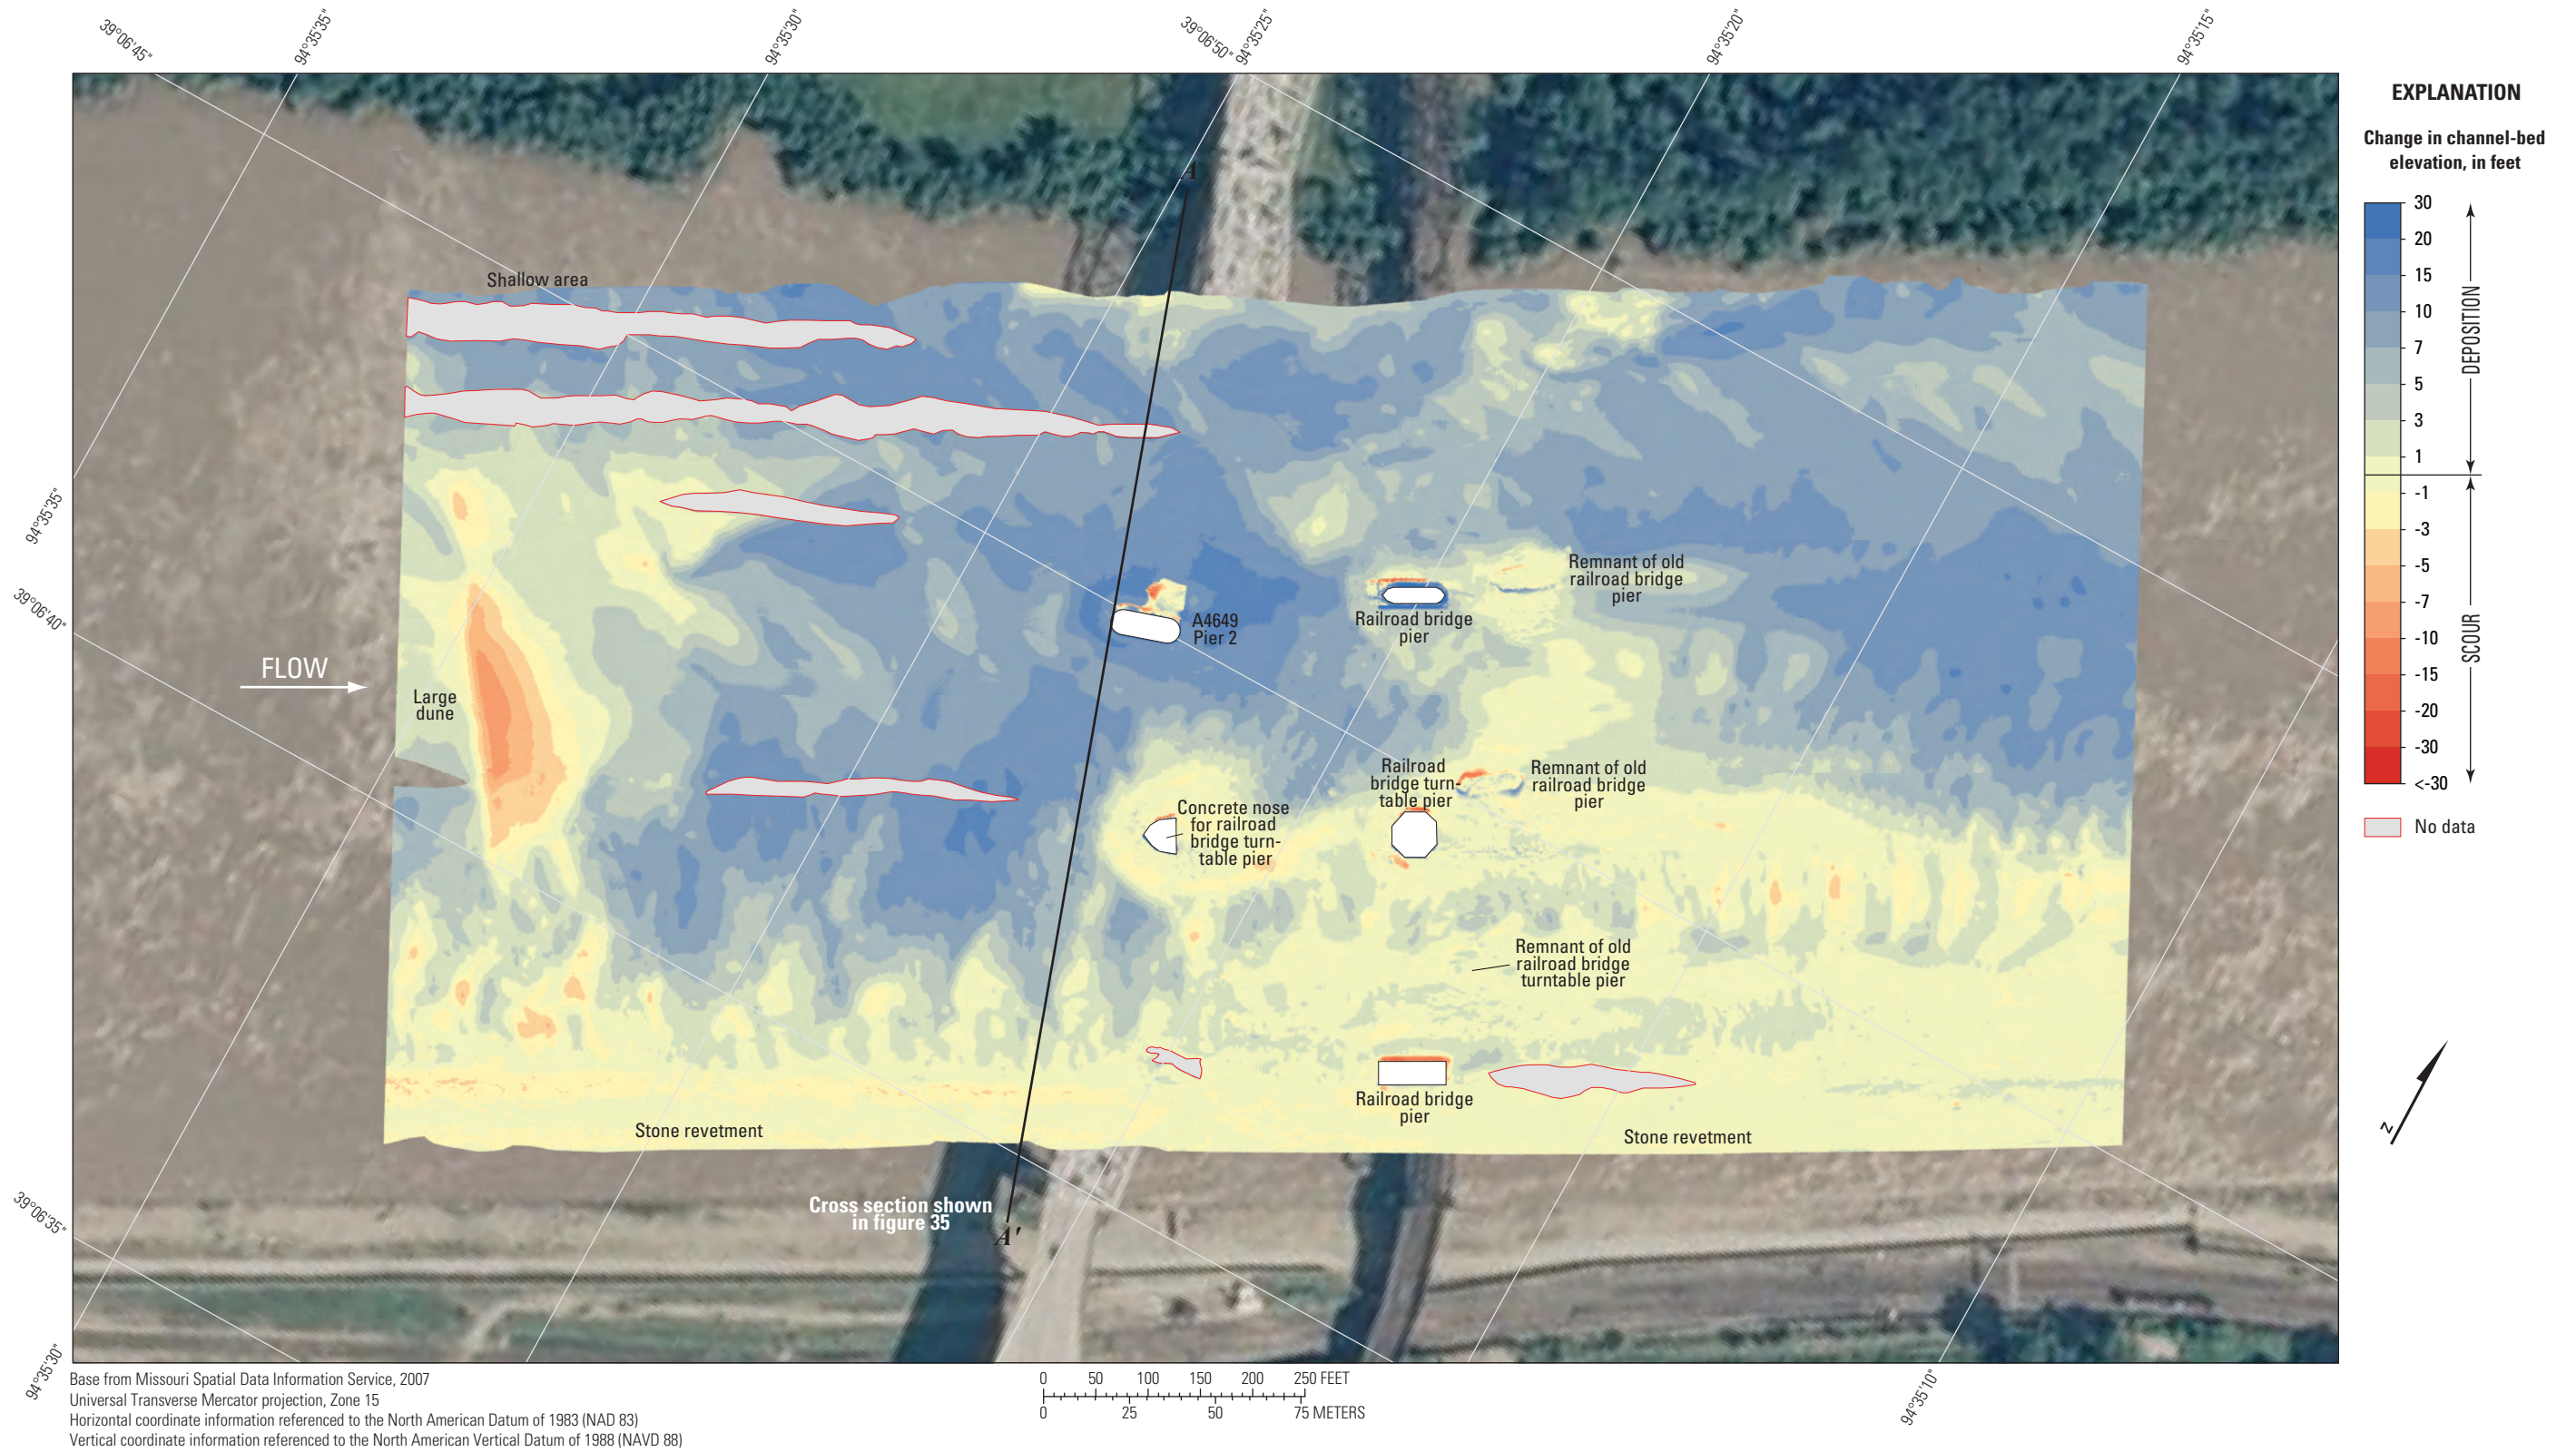
Figure 36. Difference between surfaces created from bathymetric surveys of the Missouri River channel in the vicinity of structure A4649 on U.S. Highway 169 in Kansas City, Missouri, on March 16, 2010, and July 17, 2011.

The difference between the survey on July 17, 2011, and the previous survey on March 16, 2010 (fig. 36) indicates substantial deposition throughout the reach from the 2010 to 2011 surveys, with an average difference of +4.68 ft between the bathymetric surfaces (table 7). There was one area of substantial scour downstream from the large dune feature in the 2011 survey, and about 3 to 5 ft of scour along the bottom of the right (south) bank (fig. 36). The cross sections from the two surveys also were substantially different from one another (fig. 35), with the 2011 section 10 to 15 ft higher than in 2010, despite a water-surface elevation difference of nearly 10 ft and a flow difference of 90,000 ft³/s (table 7). The scour hole near main channel pier 2 in 2011 was of a similar shape to that in 2010, albeit much shallower (figs. 35, 36); however, near the railroad bridge piers and concrete nose, the scour holes are approximately the same between the two surveys (fig. 36). As with several difference maps earlier in this report, the appearance of substantial deposition or scour at the faces of the piers result from minor horizontal positional variances between the surveys.
