Bathymetric and Velocimetric Surveys at Highway Bridges Crossing the Missouri River in and into Missouri during Summer Flooding, July–August 2011

Scientific Investigations Report 2012–5204

By Richard J. Huizinga

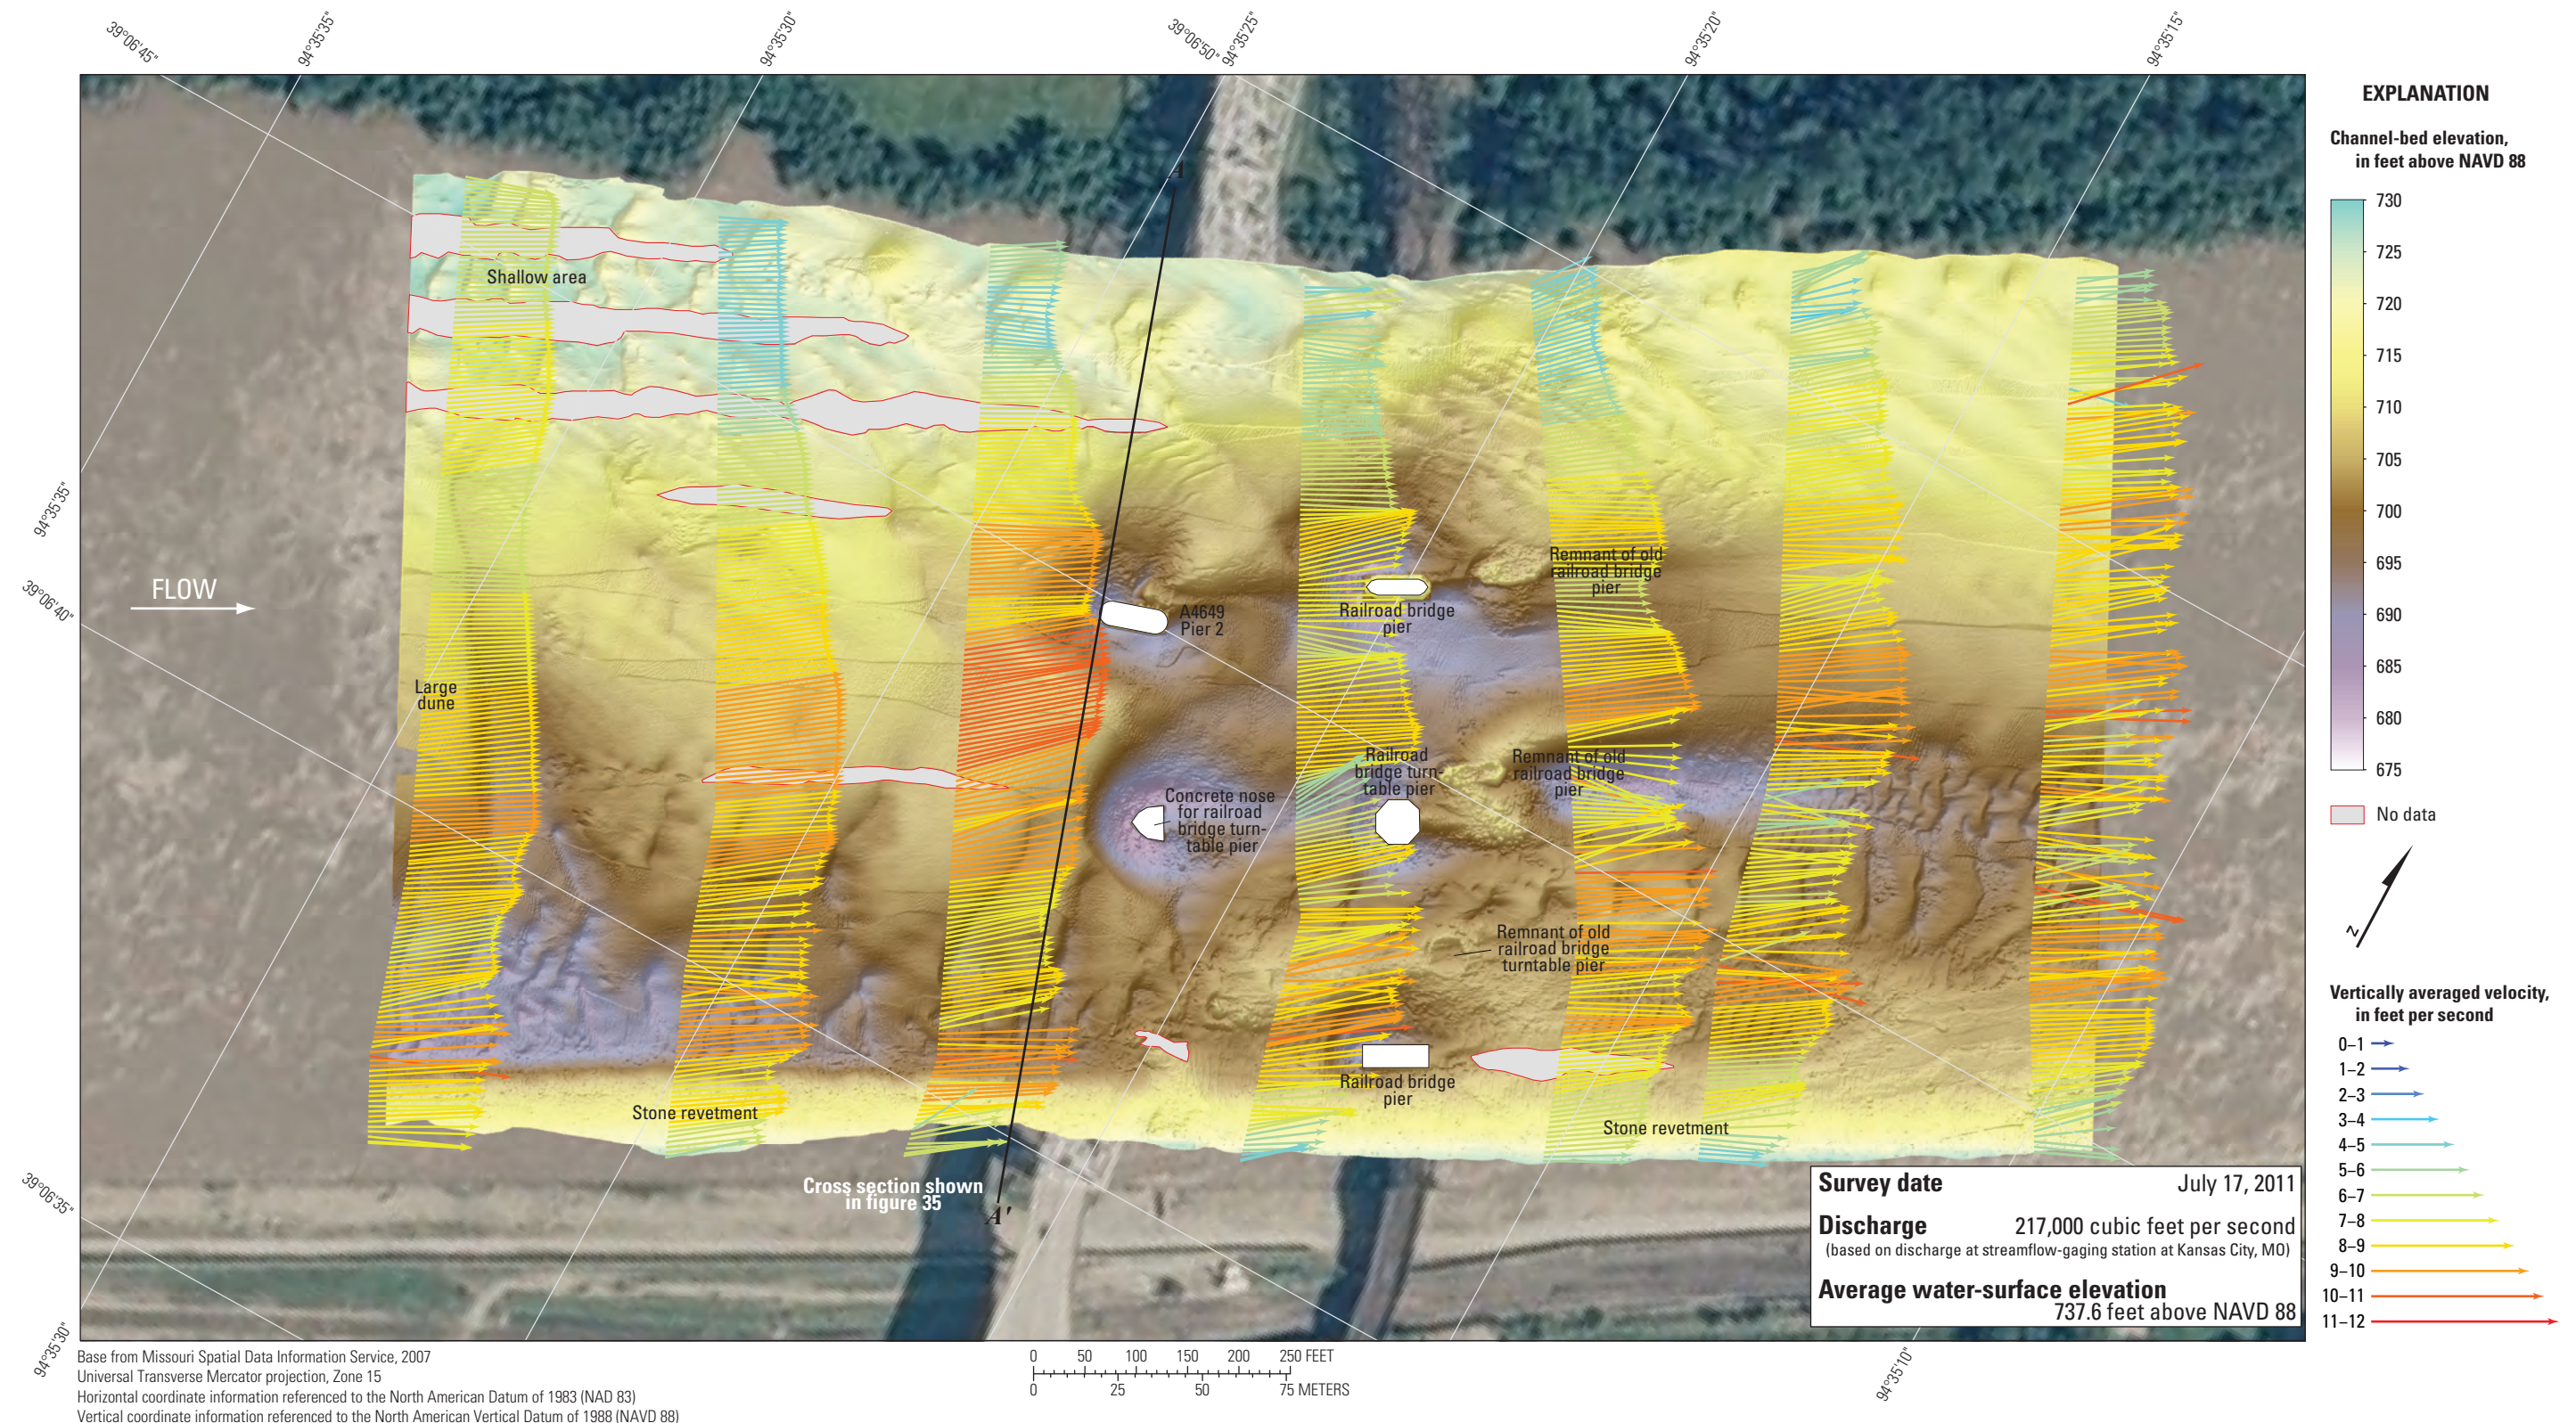
Figure 37. Bathymetry and vertically averaged velocities of the Missouri River channel in the vicinity of structure A4649 on U.S. Highway 169 in Kansas City, Missouri.

The vertically averaged velocity vectors indicate mostly uniform flow upstream from the structure A4649 ranging from about 4 to 11 ft/s (fig. 37). Flow appeared to be diagonal across the channel immediately upstream of structure A4649 (fig. 37). Substantial turbulence was observed between structure A4649 and the railroad bridge and in the downstream part of the reach at this site (fig. 37).

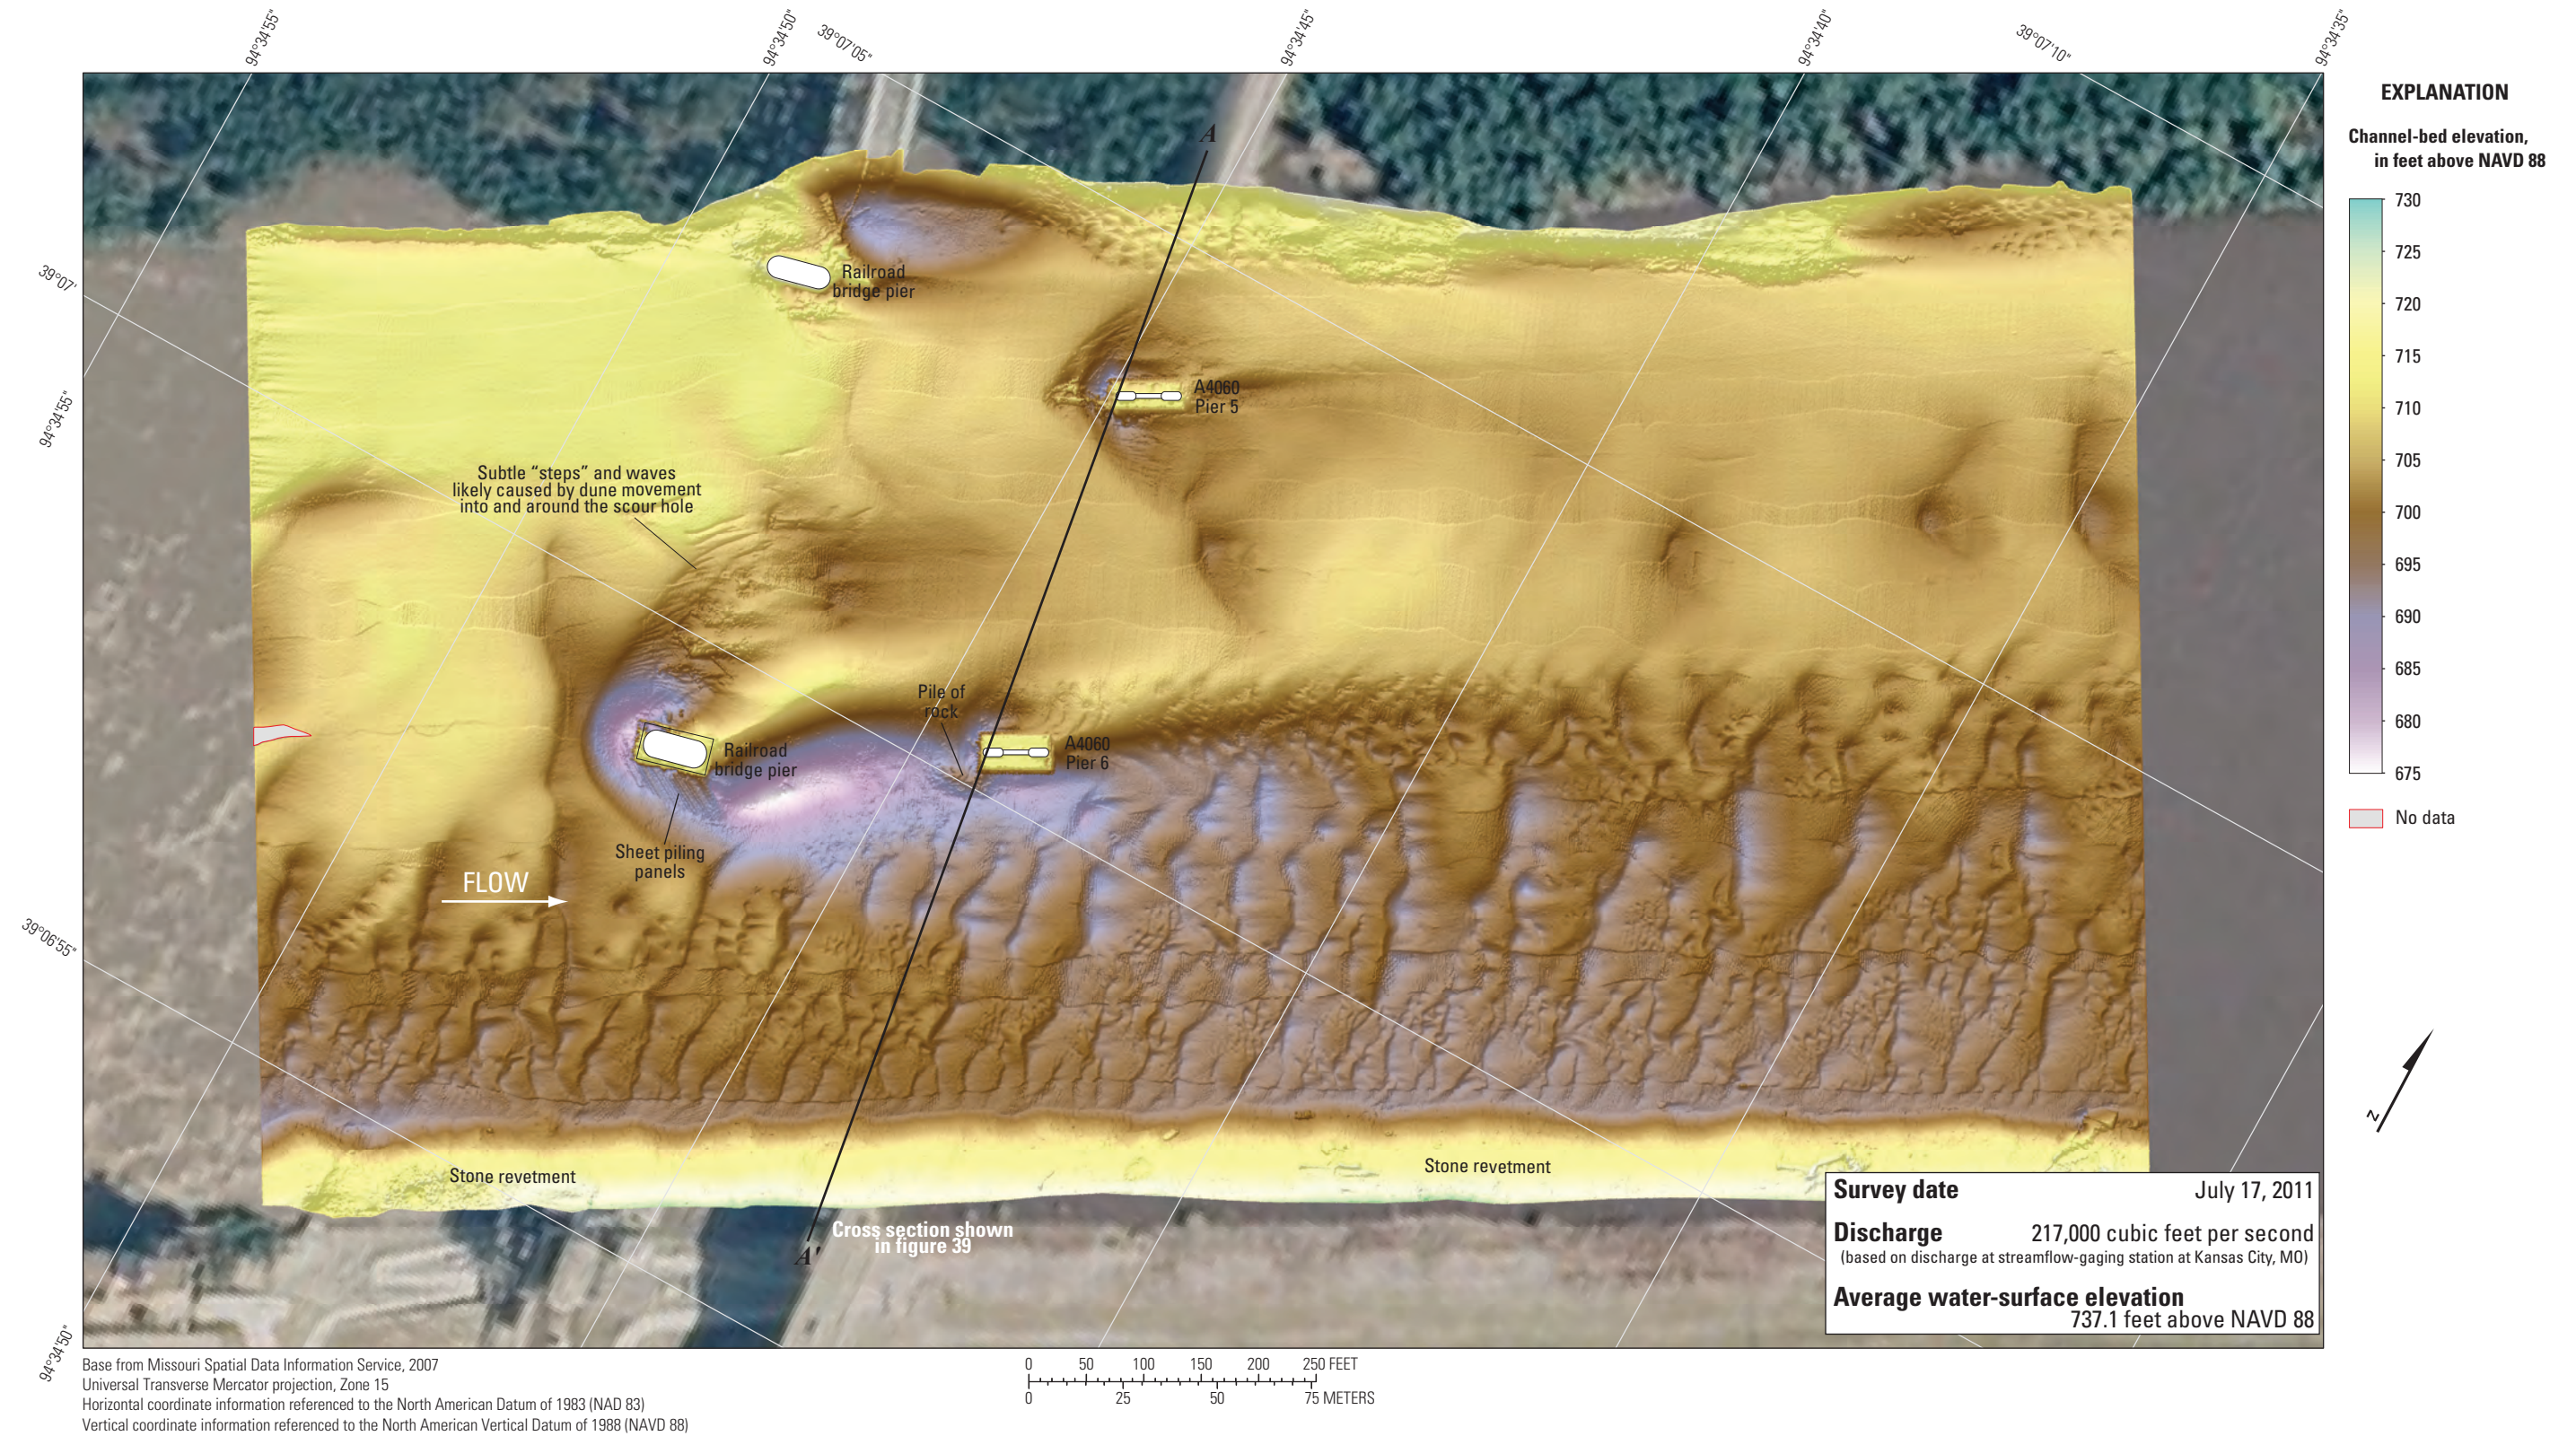
Figure 38. Bathymetric survey of the Missouri River channel in the vicinity of structure A4060 on State Highway 9 in Kansas City, Missouri.

The survey area was about 1,640 ft long and about 850 ft wide, extending from bank to bank in the main channel (fig. 38). Piers 5 and 6 were in the water and away from the banks, and the upstream end of the survey area was about 665 ft upstream from the centerline of structure A4060 at pier 6 (fig. 38). The channel-bed elevations ranged from about 693 to 713 ft for most of the surveyed area (5 to 95 percentile range of the bathymetric data), except near the railroad bridge pier upstream from pier 6 of structure A4060 (fig. 38). A thalweg along the right (south) bank throughout the surveyed area was about 15 ft deeper than the channel bed in the middle of the channel (fig. 38). A few medium dune features were detected in the middle of the channel upstream from the bridges, and numerous smaller dunes and ripples were present along the channel thalweg on the right (south) side (fig. 38). Downstream from structure A4060, the elevations in the middle of the channel were 4 to 7 ft lower than elevations upstream from the bridges (fig. 38). Stone revetment was present on the right (south) bank throughout the reach (fig. 38).

In the immediate vicinity of left (north) main channel pier 5 (fig. 38), a scour hole had a minimum channel-bed elevation of about 689 ft (table 6), about 7 ft below the elevation of the bottom of the pier seal course of 696.26 ft (fig. 39; table 6). Several beams or piles were protruding from the channel bed immediately upstream from pier 5 (fig. 38). Near the right (south) main channel pier 6 (fig. 38), a poorly defined scour hole had a minimum channel-bed elevation of about 686 ft; however, a substantial scour hole immediately upstream from the pier had a minimum channel-bed elevation of about 676 ft. This deeper hole likely was the result of flow over large sheet piling panels that were lying on the channel bottom on the right (south) side of the upstream railroad bridge pier (fig. 38) observed in the previous survey (Huizinga, 2010). A pile of particulate rock material immediately upstream from pier 6 of structure A4060 extended around the right (south) side (fig. 38), but the highest point on this pile was about 1 ft below the elevation of the bottom of the pier seal course of 696.26 ft (fig. 38; table 6). The minimum channel-bed elevation in the

vicinity of pier 6 was about 10 ft below the elevation of the bottom of the pier seal course (fig. 38; table 6). Information from bridge plans indicates that piers 5 and 6 are founded on shafts drilled 20 ft into bedrock, with about 22 ft of bed material between the bottom of the scour hole and bedrock at pier 5 and 16 ft of material at pier 6 (fig. 39; table 6).

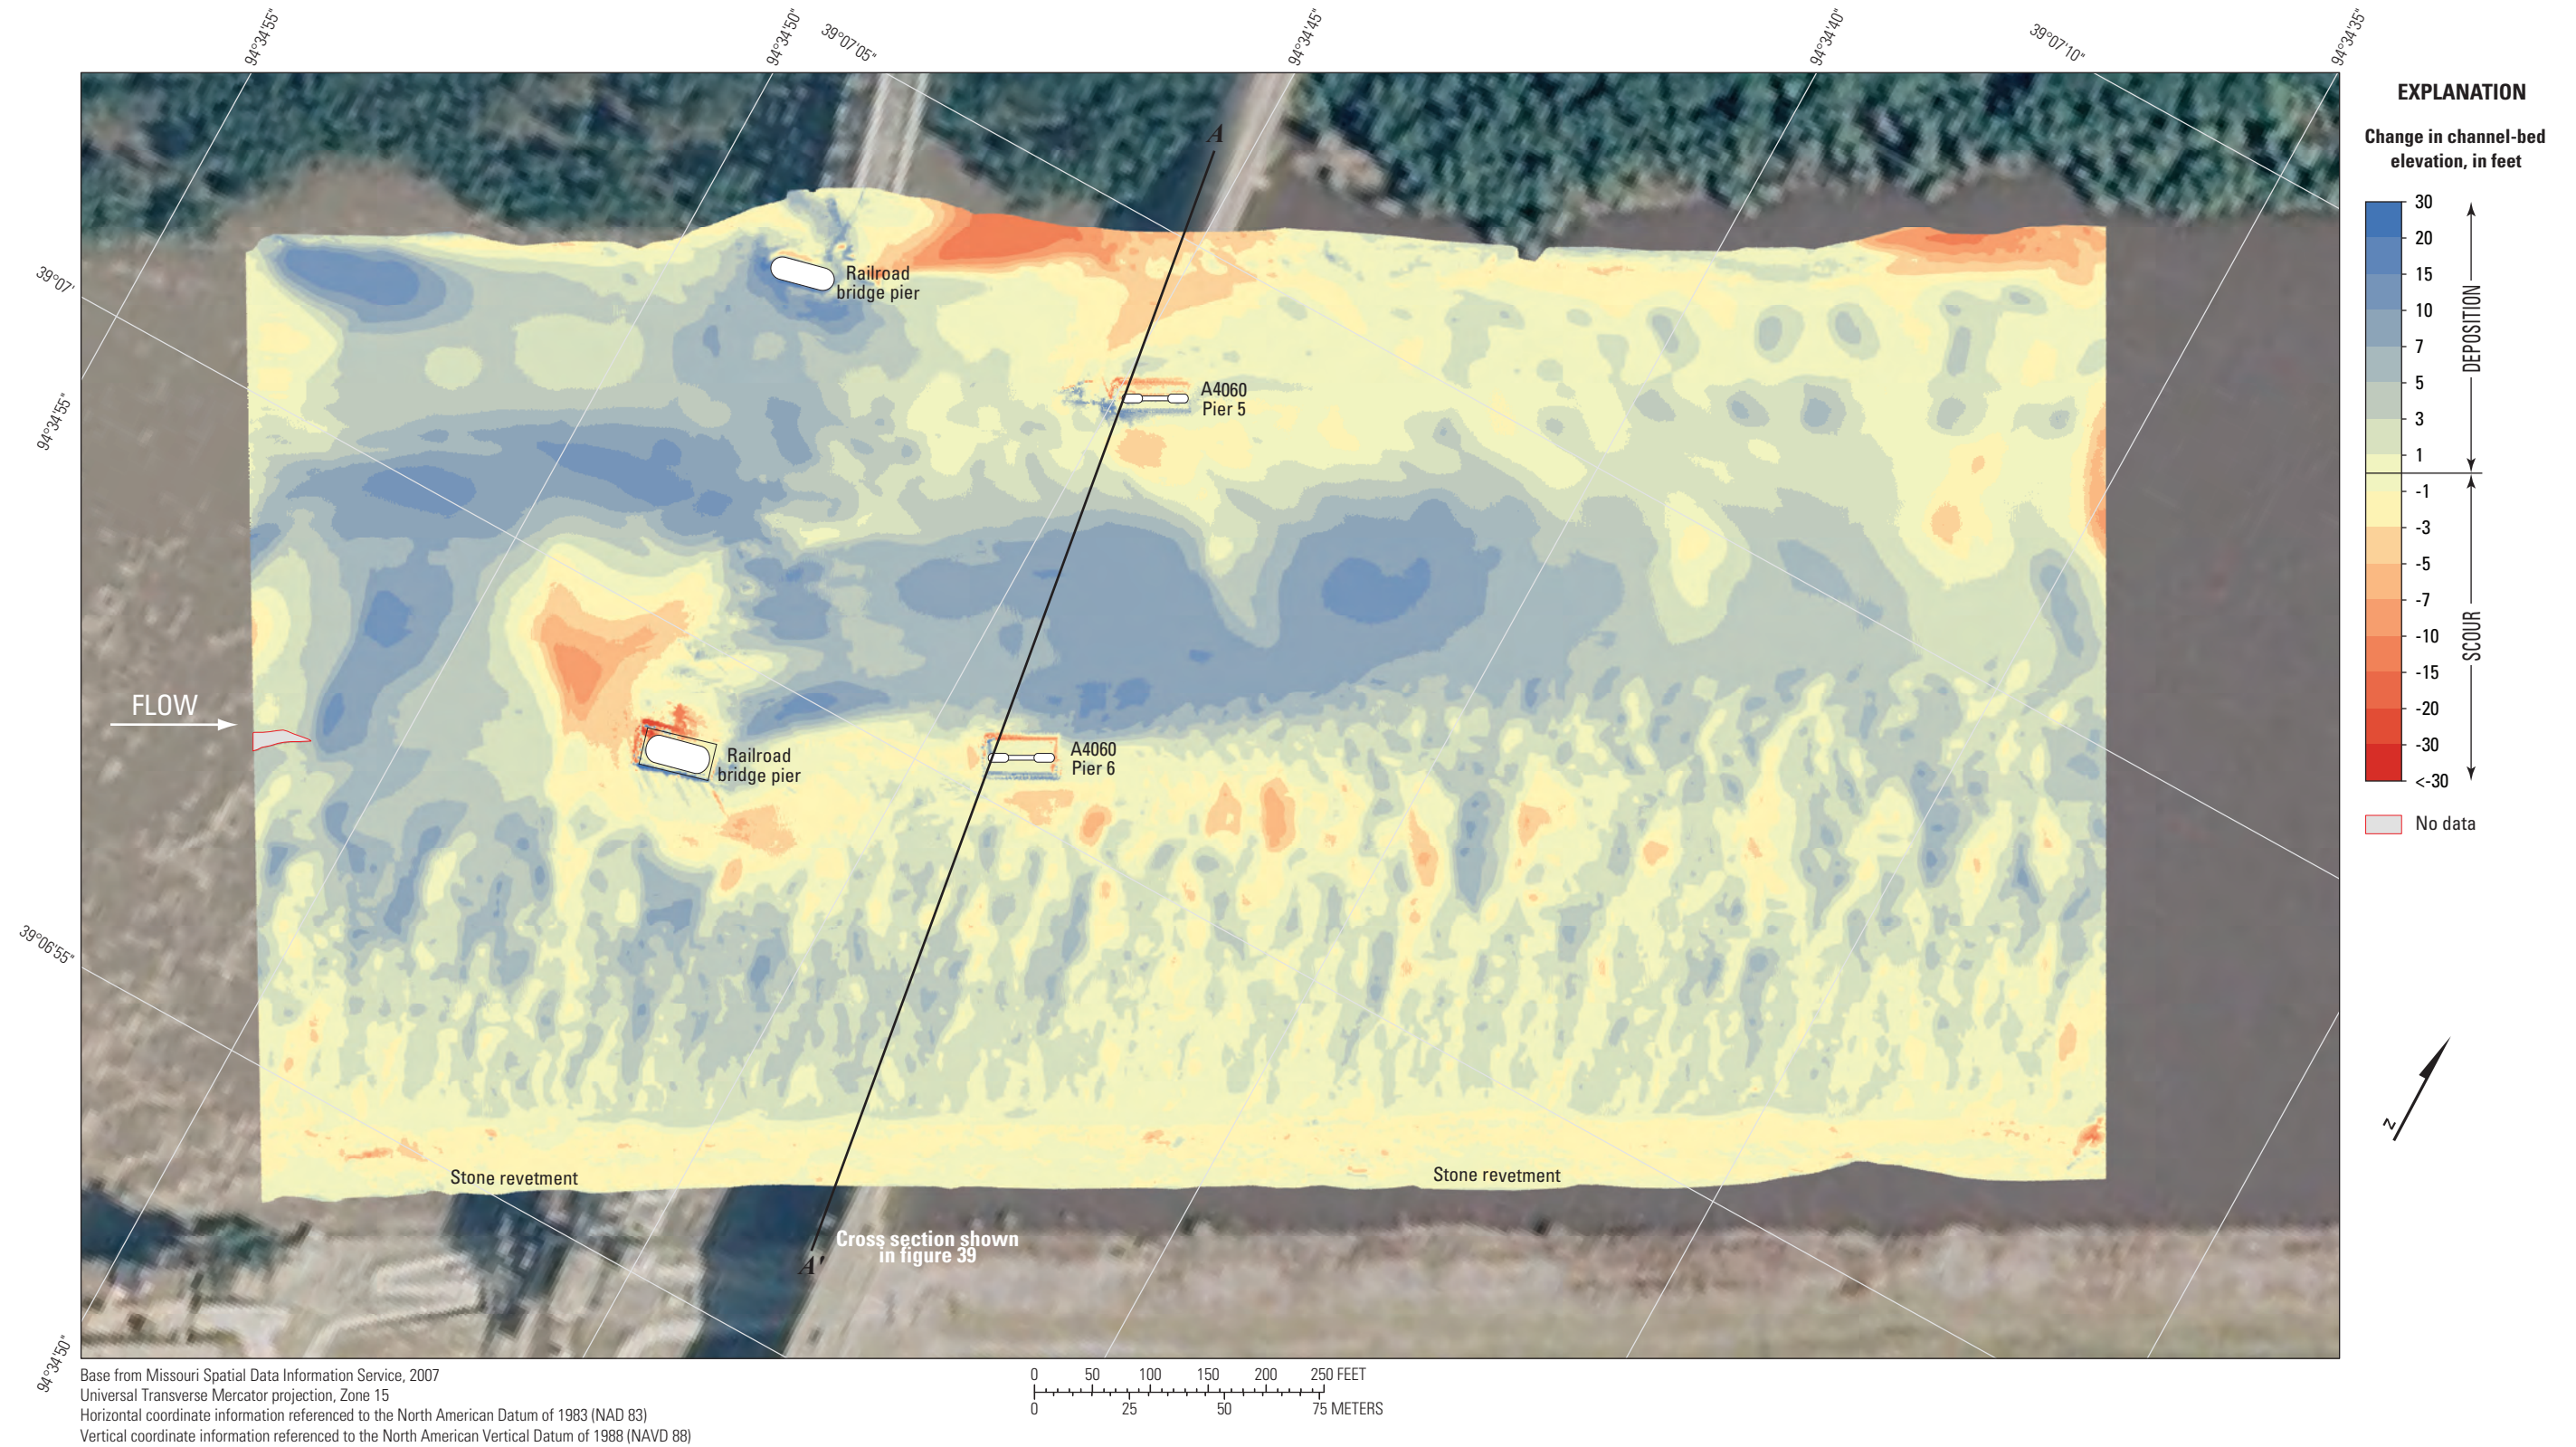
Figure 40. Difference between surfaces created from bathymetric surveys of the Missouri River channel in the vicinity of structure A4060 on State Highway 9 in Kansas City, Missouri, on March 16, 2010, and July 17, 2011.

The difference between the survey on July 17, 2011, and the previous survey on March 16, 2010 (fig. 40) indicates substantial deposition throughout the reach from 2010 to 2011, with an average difference of +2.03 ft between the bathymetric surfaces (table 7). There were a few areas of substantial scour: one along the left bank downstream from the left (north) railroad bridge pier, one at the downstream end of the reach, and one upstream from the right (south) railroad bridge pier (fig. 40). There also were a few areas of minor scour among the medium and small dunes and ripples in the thalweg (fig. 40). The cross sections from the two surveys were similar to one another in the thalweg on the right side of the channel (fig. 39), despite a water-surface elevation difference of more than 10 ft and a flow difference of 91,000 ft³/s (table 7); however, the sections were substantially different from one another in the left part of the channel (fig. 39). The scour hole near main channel pier 5 in 2011 was of a similar shape to that in 2010, albeit shallower on one side and deeper on the other (figs. 39, 40). As with several difference maps earlier in this report, the appearance of substantial deposition or scour at the faces of the piers result from minor horizontal positional variances between the surveys. The stone revetment on the right (south) bank appeared to have several areas of localized scour (fig. 40).

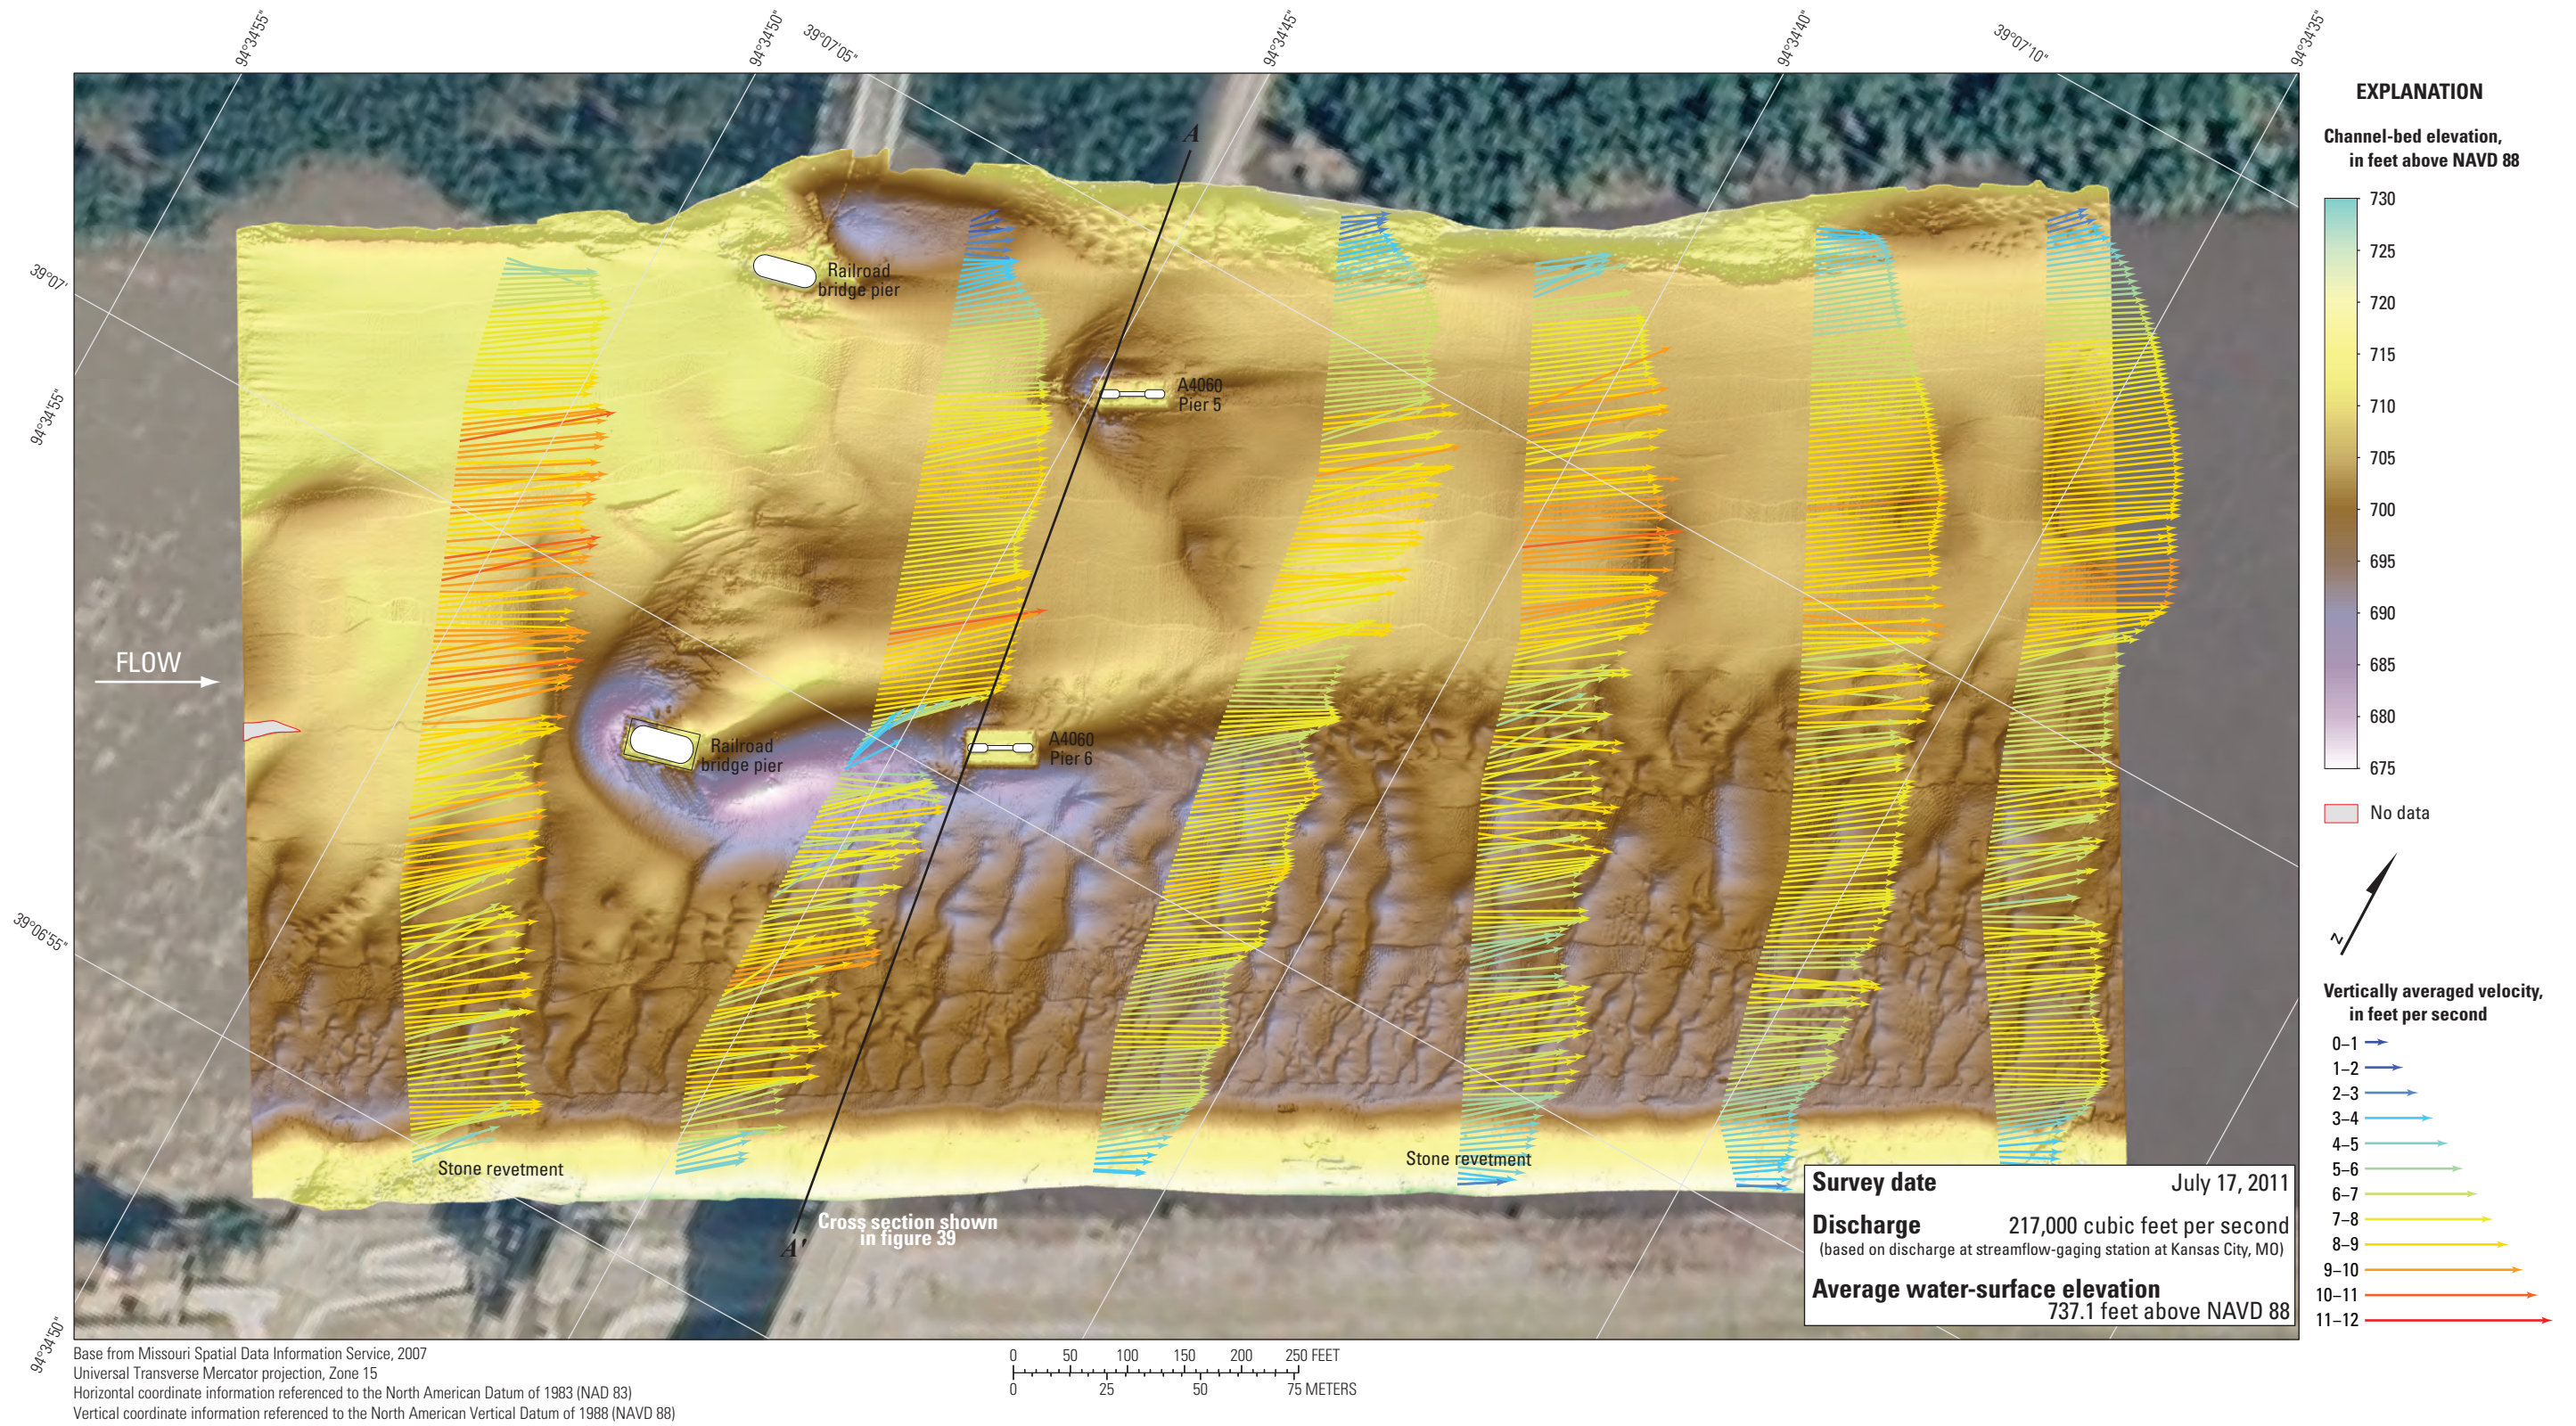
Figure 41. Bathymetry and vertically averaged velocities of the Missouri River channel in the vicinity of structure A4060 on State Highway 9 in Kansas City, Missouri.

The vertically averaged velocity vectors indicate mostly uniform flow in the shallow part of the channel on the left (north) side, ranging from about 6 to 11 ft/s (fig. 41). In the deeper thalweg, flow was slightly slower and more turbulent (fig. 41). Substantial turbulence was observed between the right (south) piers of the railroad bridge and structure A4060 (fig. 41).

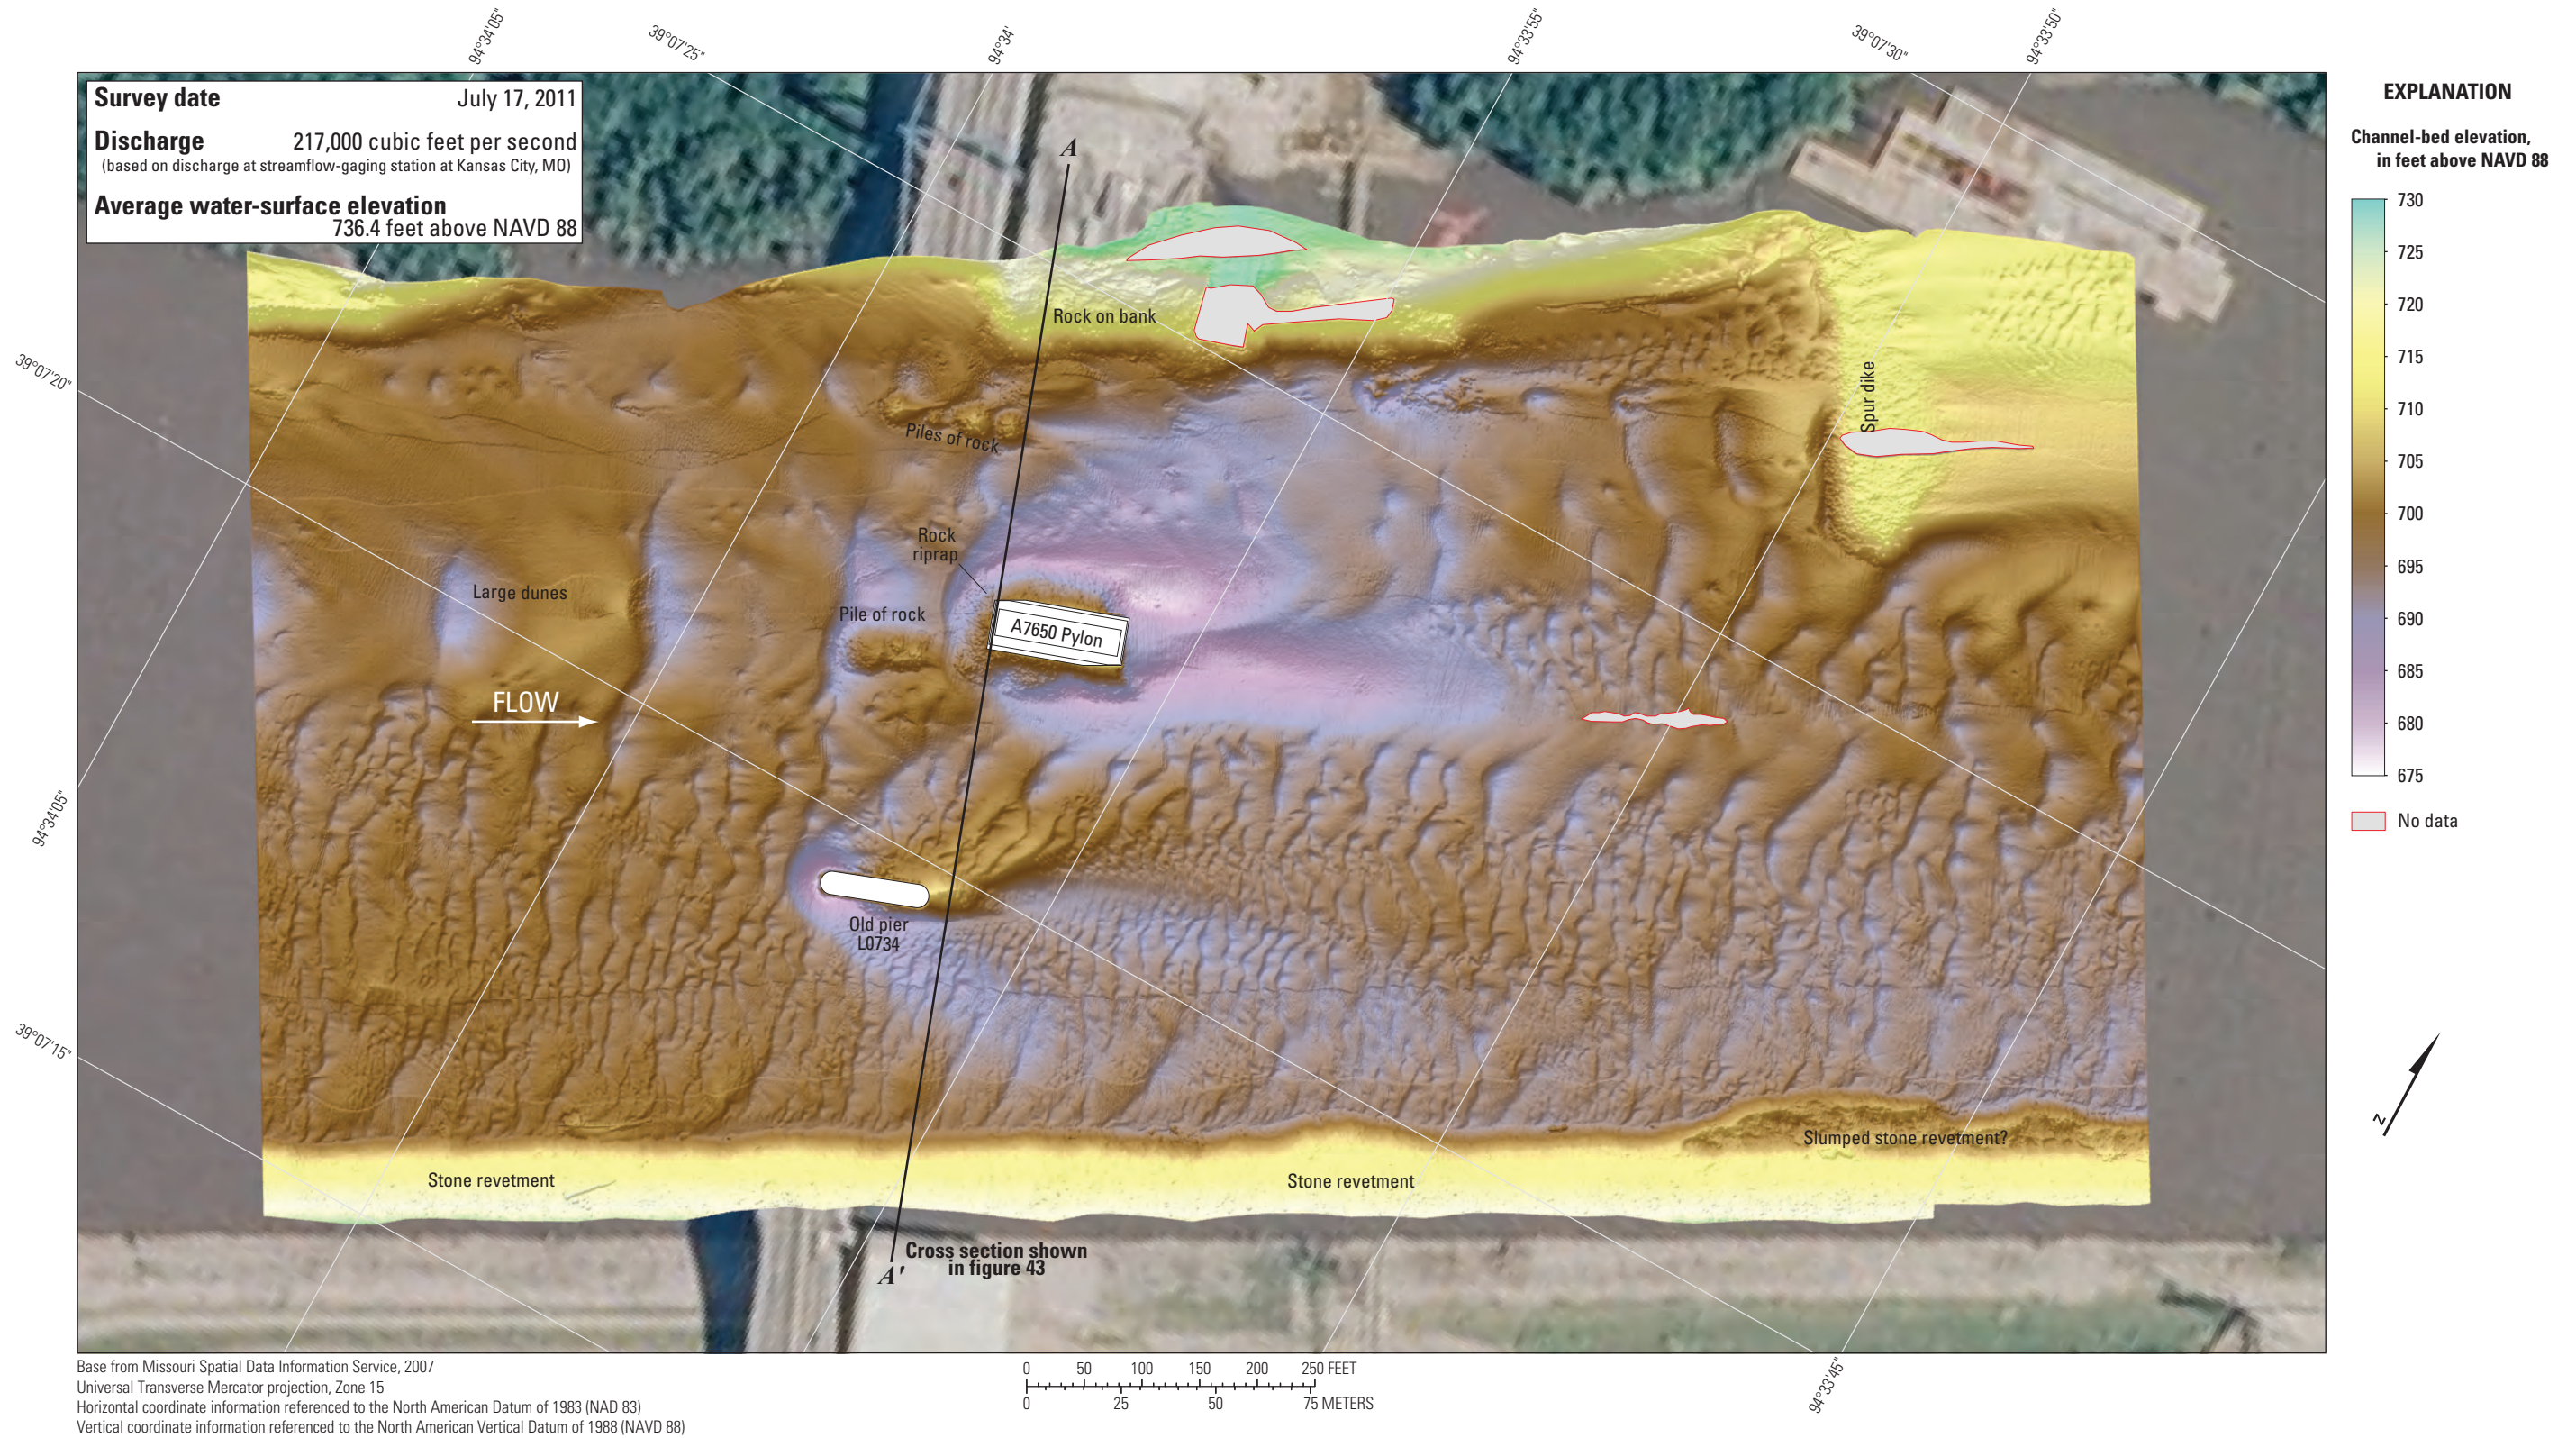
Figure 42. Bathymetric survey of the Missouri River channel in the vicinity of structure A7650 on Interstate 35 in Kansas City, Missouri.

The survey area was about 1,640 ft long and about 850 ft wide, extending from bank to bank in the main channel (fig. 42). The upstream end of the survey area was about 700 ft upstream from the centerline of structure A7650 at the pylon (fig. 42). The channel-bed elevations ranged from about 690 to 718 ft for most of the surveyed area (5 to 95 percentile range of the bathymetric data), except in the vicinity of the pylon and the old pier of structure L0734 upstream from structure A7650 (fig. 42). Unlike upstream structures A4649 and A4060, there was no definitive thalweg along either side of the channel (fig. 42). A few large dune features were detected on the left (north) side of the channel upstream from the bridge, and numerous medium and small dunes and ripples were present throughout the rest of the channel (fig. 42). Downstream from the spur dike on the left (north) side of the downstream reach, the elevations were 12 to 17 ft higher than elevations on the right side (fig. 42). Stone revetment was present on the right (south) bank throughout the reach (fig. 42), and appeared to have an area where it had slumped near the downstream end of the reach.

The main channel pylon appeared to be surrounded by a mound of rock riprap, with a local minimum channel-bed elevation of about 678 ft near the downstream left (north) corner (figs. 42, 43; table 6). The top of the riprap around the upstream face of the pylon were at an elevation of about 699 ft, which is slightly below the elevation of the bottom of the pylon seal course of 699.50 ft (table 6); the top of the riprap along the sides of the pylon is lower than at the upstream face (fig. 43). Several piles of particulate rock were observed in the channel near structure A7650. The minimum channel-bed elevation in the vicinity of the pylon was about 21 ft below the elevation of the bottom of the pylon seal course (fig. 43; table 6). Information from bridge plans indicates that the pylon is founded on shafts drilled 32 ft into bedrock, with about 31 ft of bed material between the bottom of the scour hole and bedrock (fig. 43; table 6). A scour hole with a minimum channel-bed elevation of 679 ft was observed near the old pier of structure L0734 upstream from structure A7650, but this pier was in the process of being demolished at the time of the survey. The surveyed bed generally was similar to the original ground line from bridge plans (2008), with an area of 15 to 20 ft of scour to the left of the pylon and an area of 15 to 20 ft of deposition downstream from the old pier of structure L0734 (fig. 43).
