Bathymetric and Velocimetric Surveys at Highway Bridges Crossing the Missouri River in and into Missouri during Summer Flooding, July–August 2011

Scientific Investigations Report 2012–5204

By Richard J. Huizinga

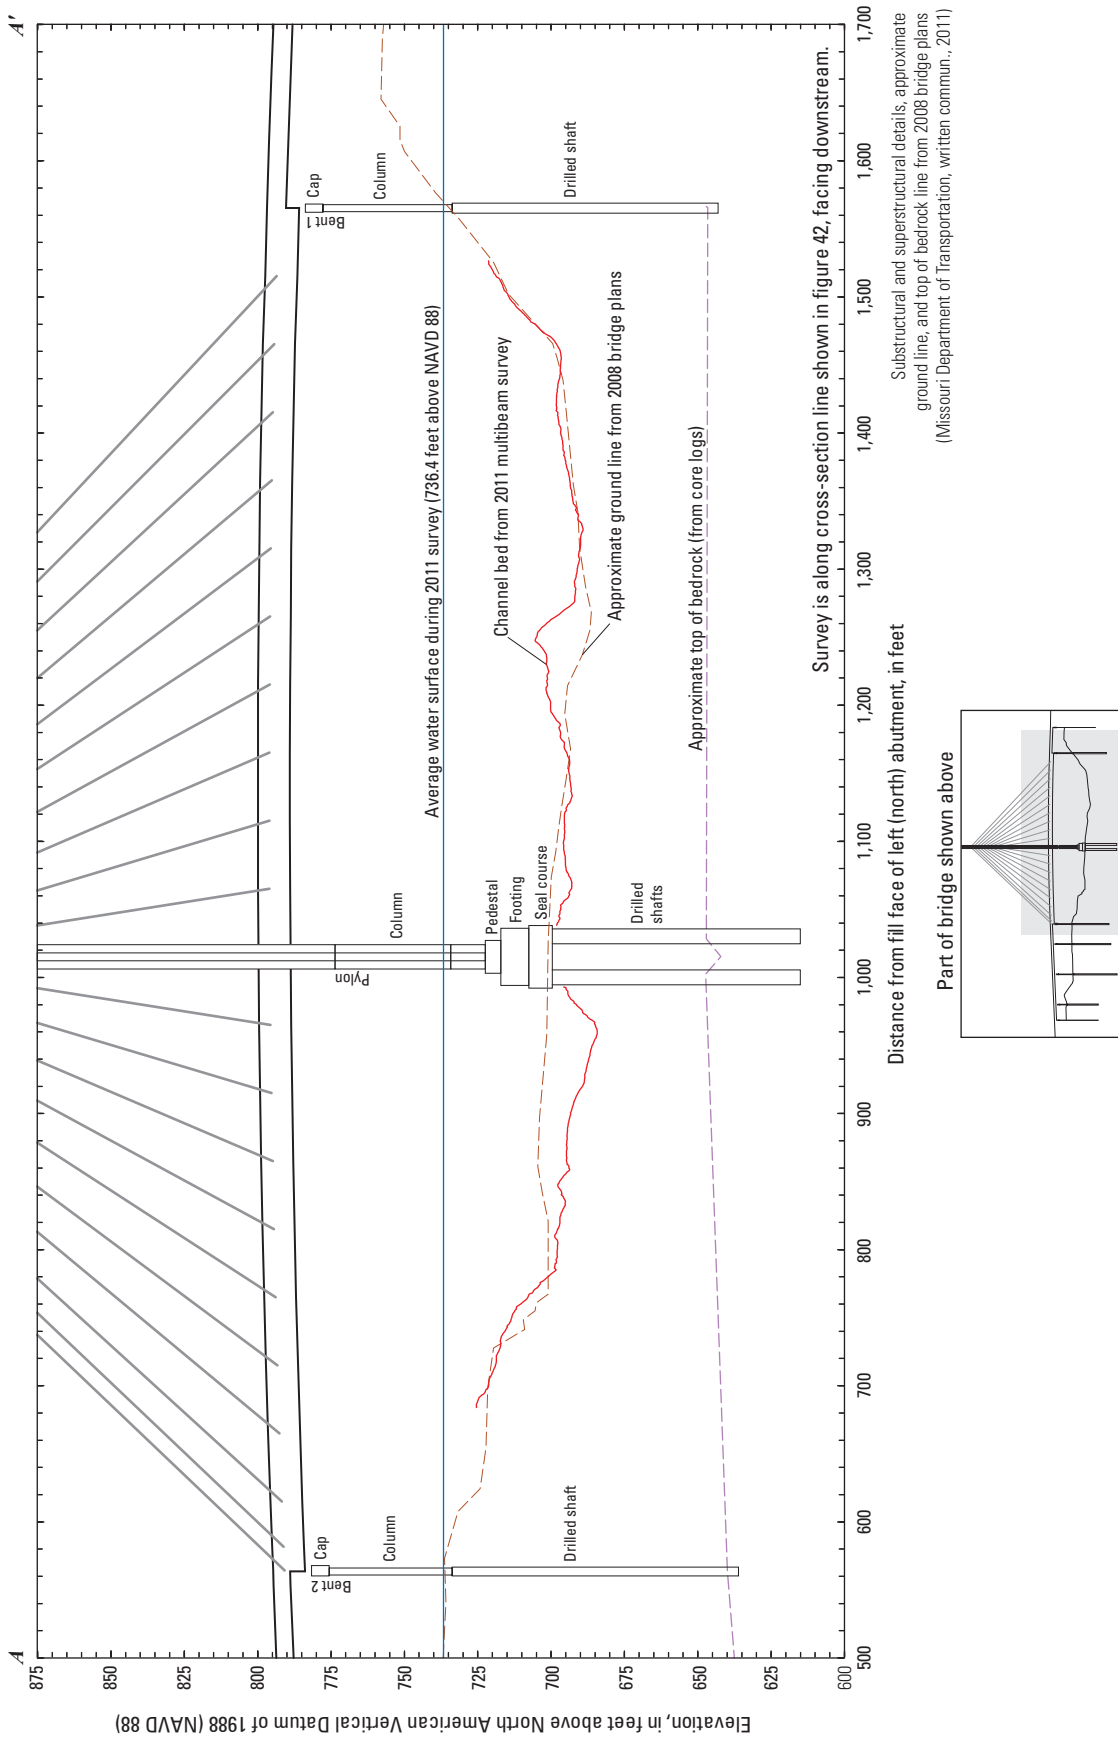
Figure 43. Key features, substructural and superstructural details, and surveyed channel bed of structure A7650 on Interstate 35 over the Missouri River in Kansas City, Missouri.

The main channel pylon appeared to be surrounded by a mound of rock riprap, with a local minimum channel-bed elevation of about 678 ft near the downstream left (north) corner (figs. 42, 43; table 6). The top of the riprap around the upstream face of the pylon were at an elevation of about 699 ft, which is slightly below the elevation of the bottom of the pylon seal course of 699.50 ft (table 6); the top of the riprap along the sides of the pylon is lower than at the upstream face (fig. 43). Several piles of particulate rock were observed in the channel near structure A7650. The minimum channel-bed elevation in the vicinity of the pylon was about 21 ft below the elevation of the bottom of the pylon seal course (fig. 43; table 6). Information from bridge plans indicates that the pylon is founded on shafts drilled 32 ft into bedrock, with about 31 ft of bed material between the bottom of the scour hole and bedrock (fig. 43; table 6). A scour hole with a minimum channel-bed elevation of 679 ft was observed near the old pier of structure L0734 upstream from structure A7650, but this pier was in the process of being demolished at the time of the survey. The surveyed bed generally was similar to the original ground line from bridge plans (2008), with an area of 15 to 20 ft of scour to the left of the pylon and an area of 15 to 20 ft of deposition downstream from the old pier of structure L0734 (fig. 43).

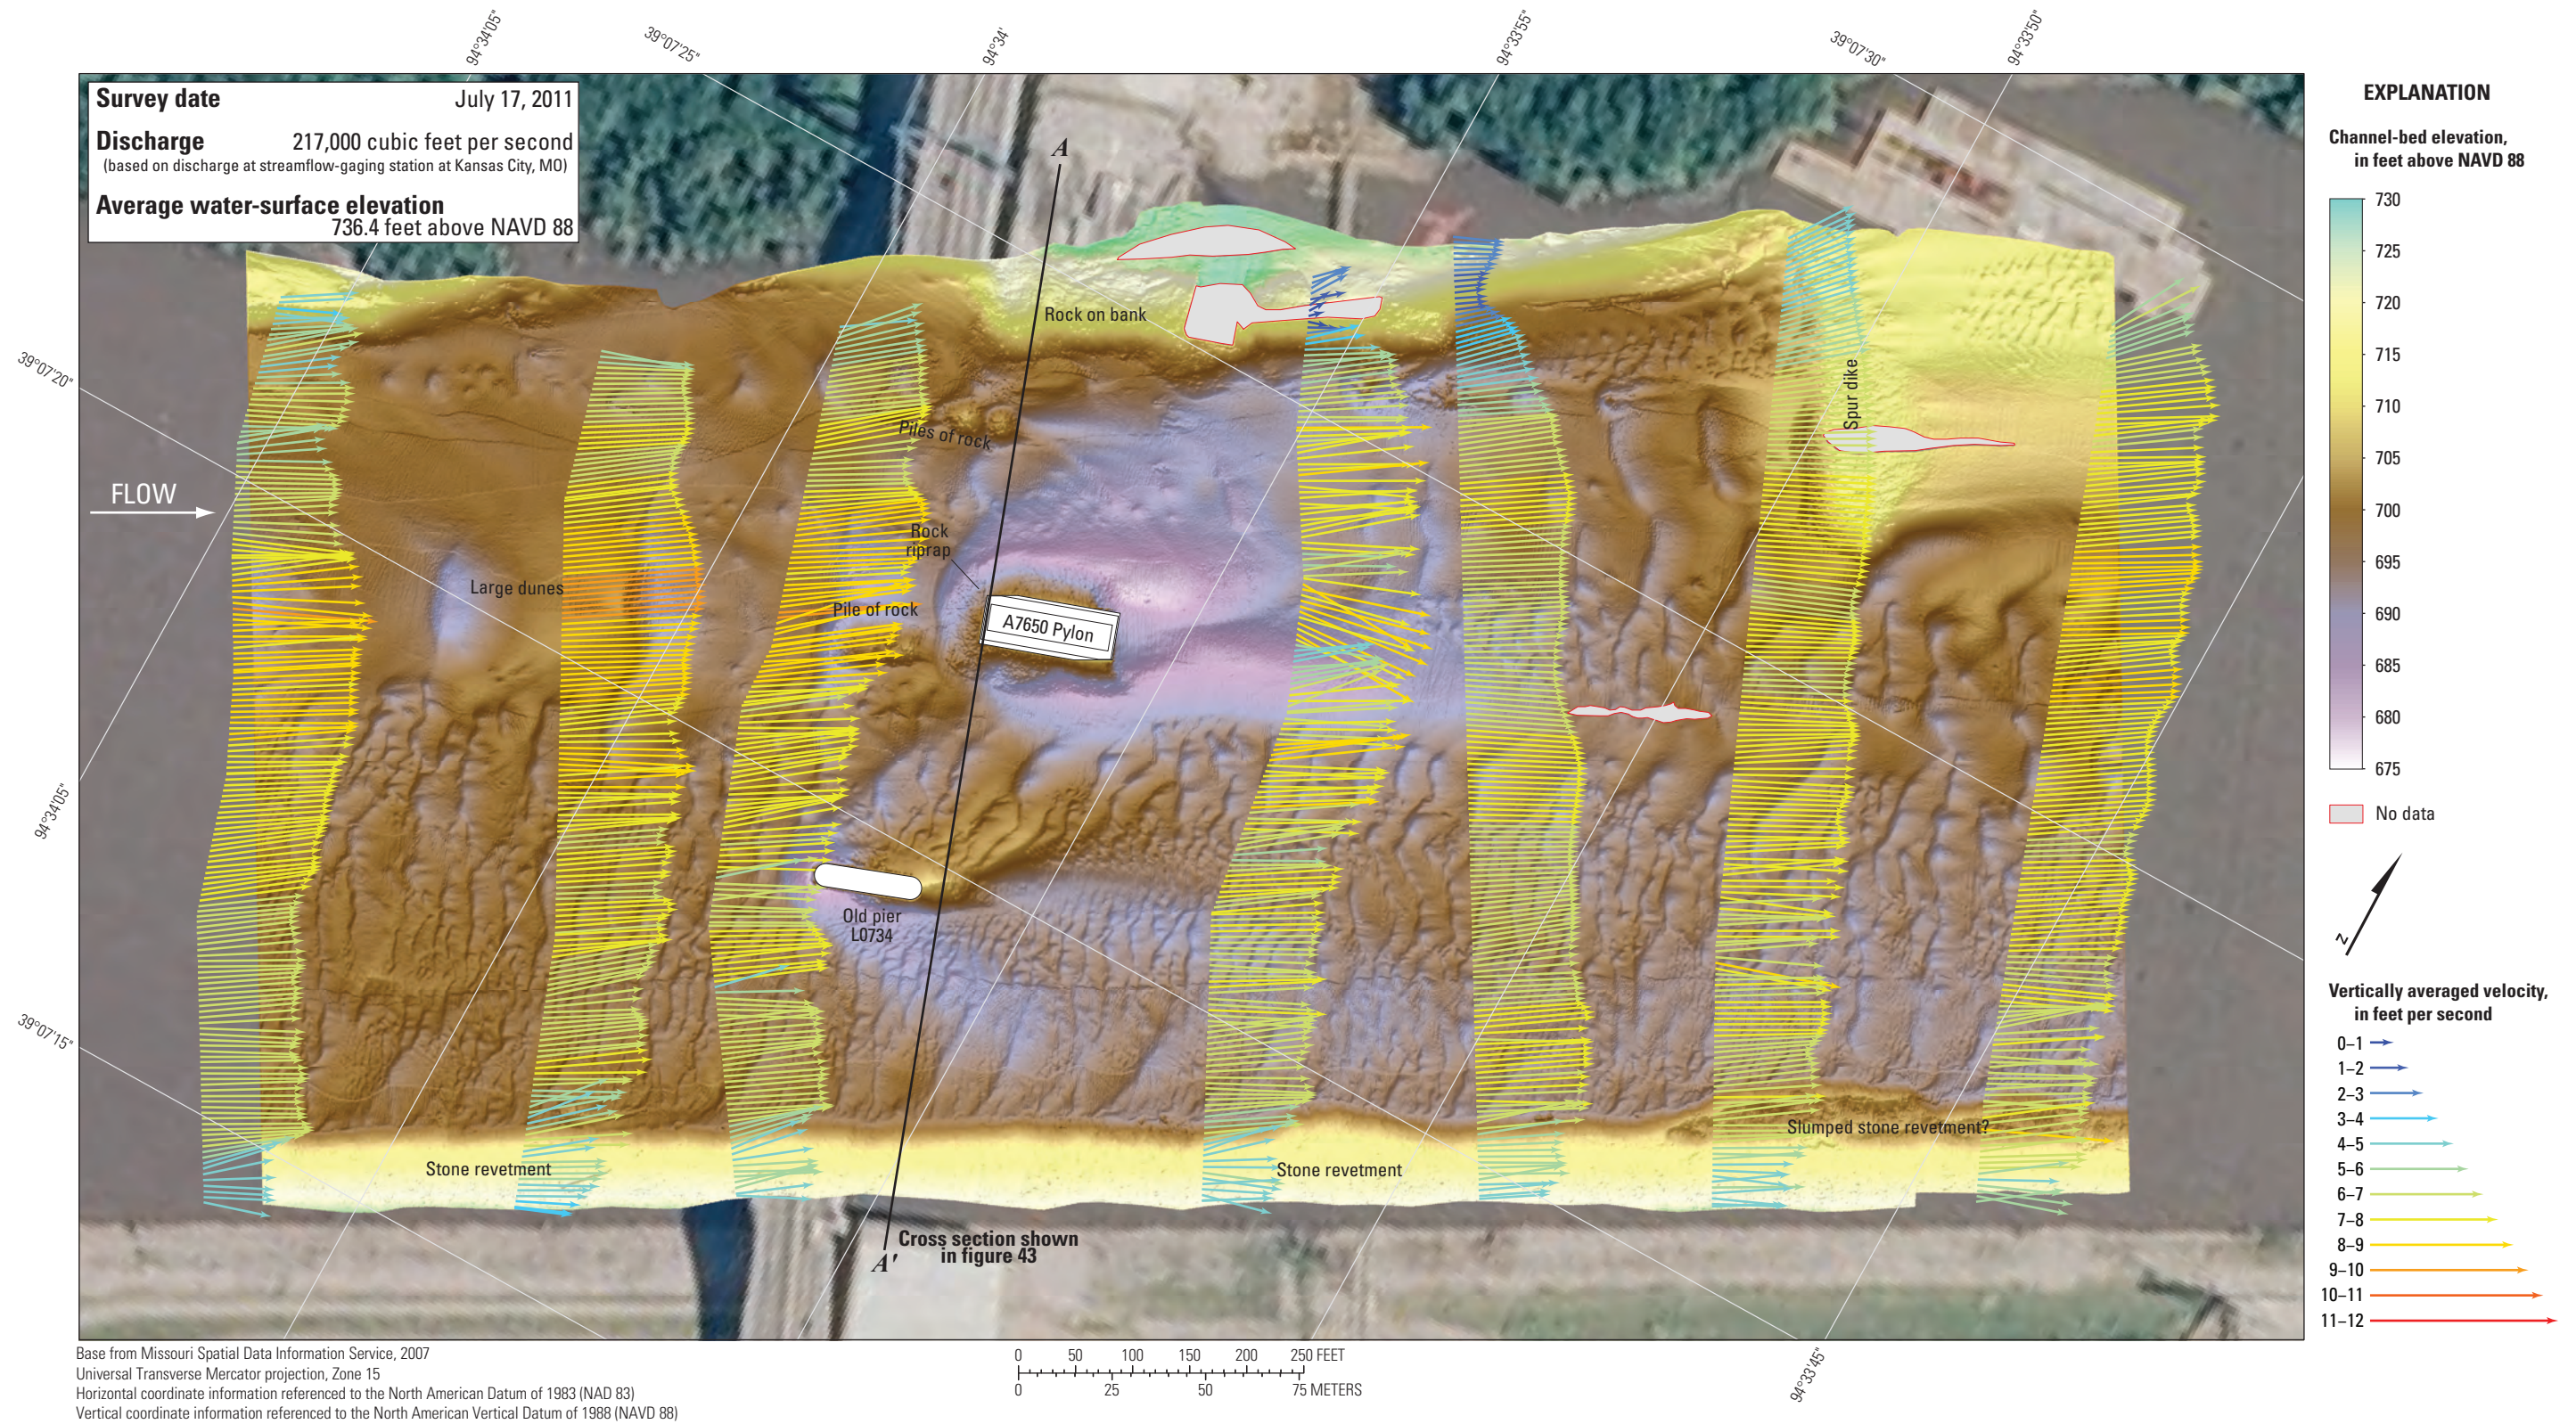
Figure 44. Bathymetry and vertically averaged velocities of the Missouri River channel in the vicinity of structure A7650 on Interstate 35 in Kansas City, Missouri.

The vertically averaged velocity vectors indicate mostly uniform flow throughout most of the channel, with velocities ranging from about 5 to 10 ft/s (fig. 44), except downstream from the rocky left (north) bank near the bridge. Substantial turbulence was observed downstream from the main channel pylon (fig. 44), likely as a result of the pylon being skewed to flow.

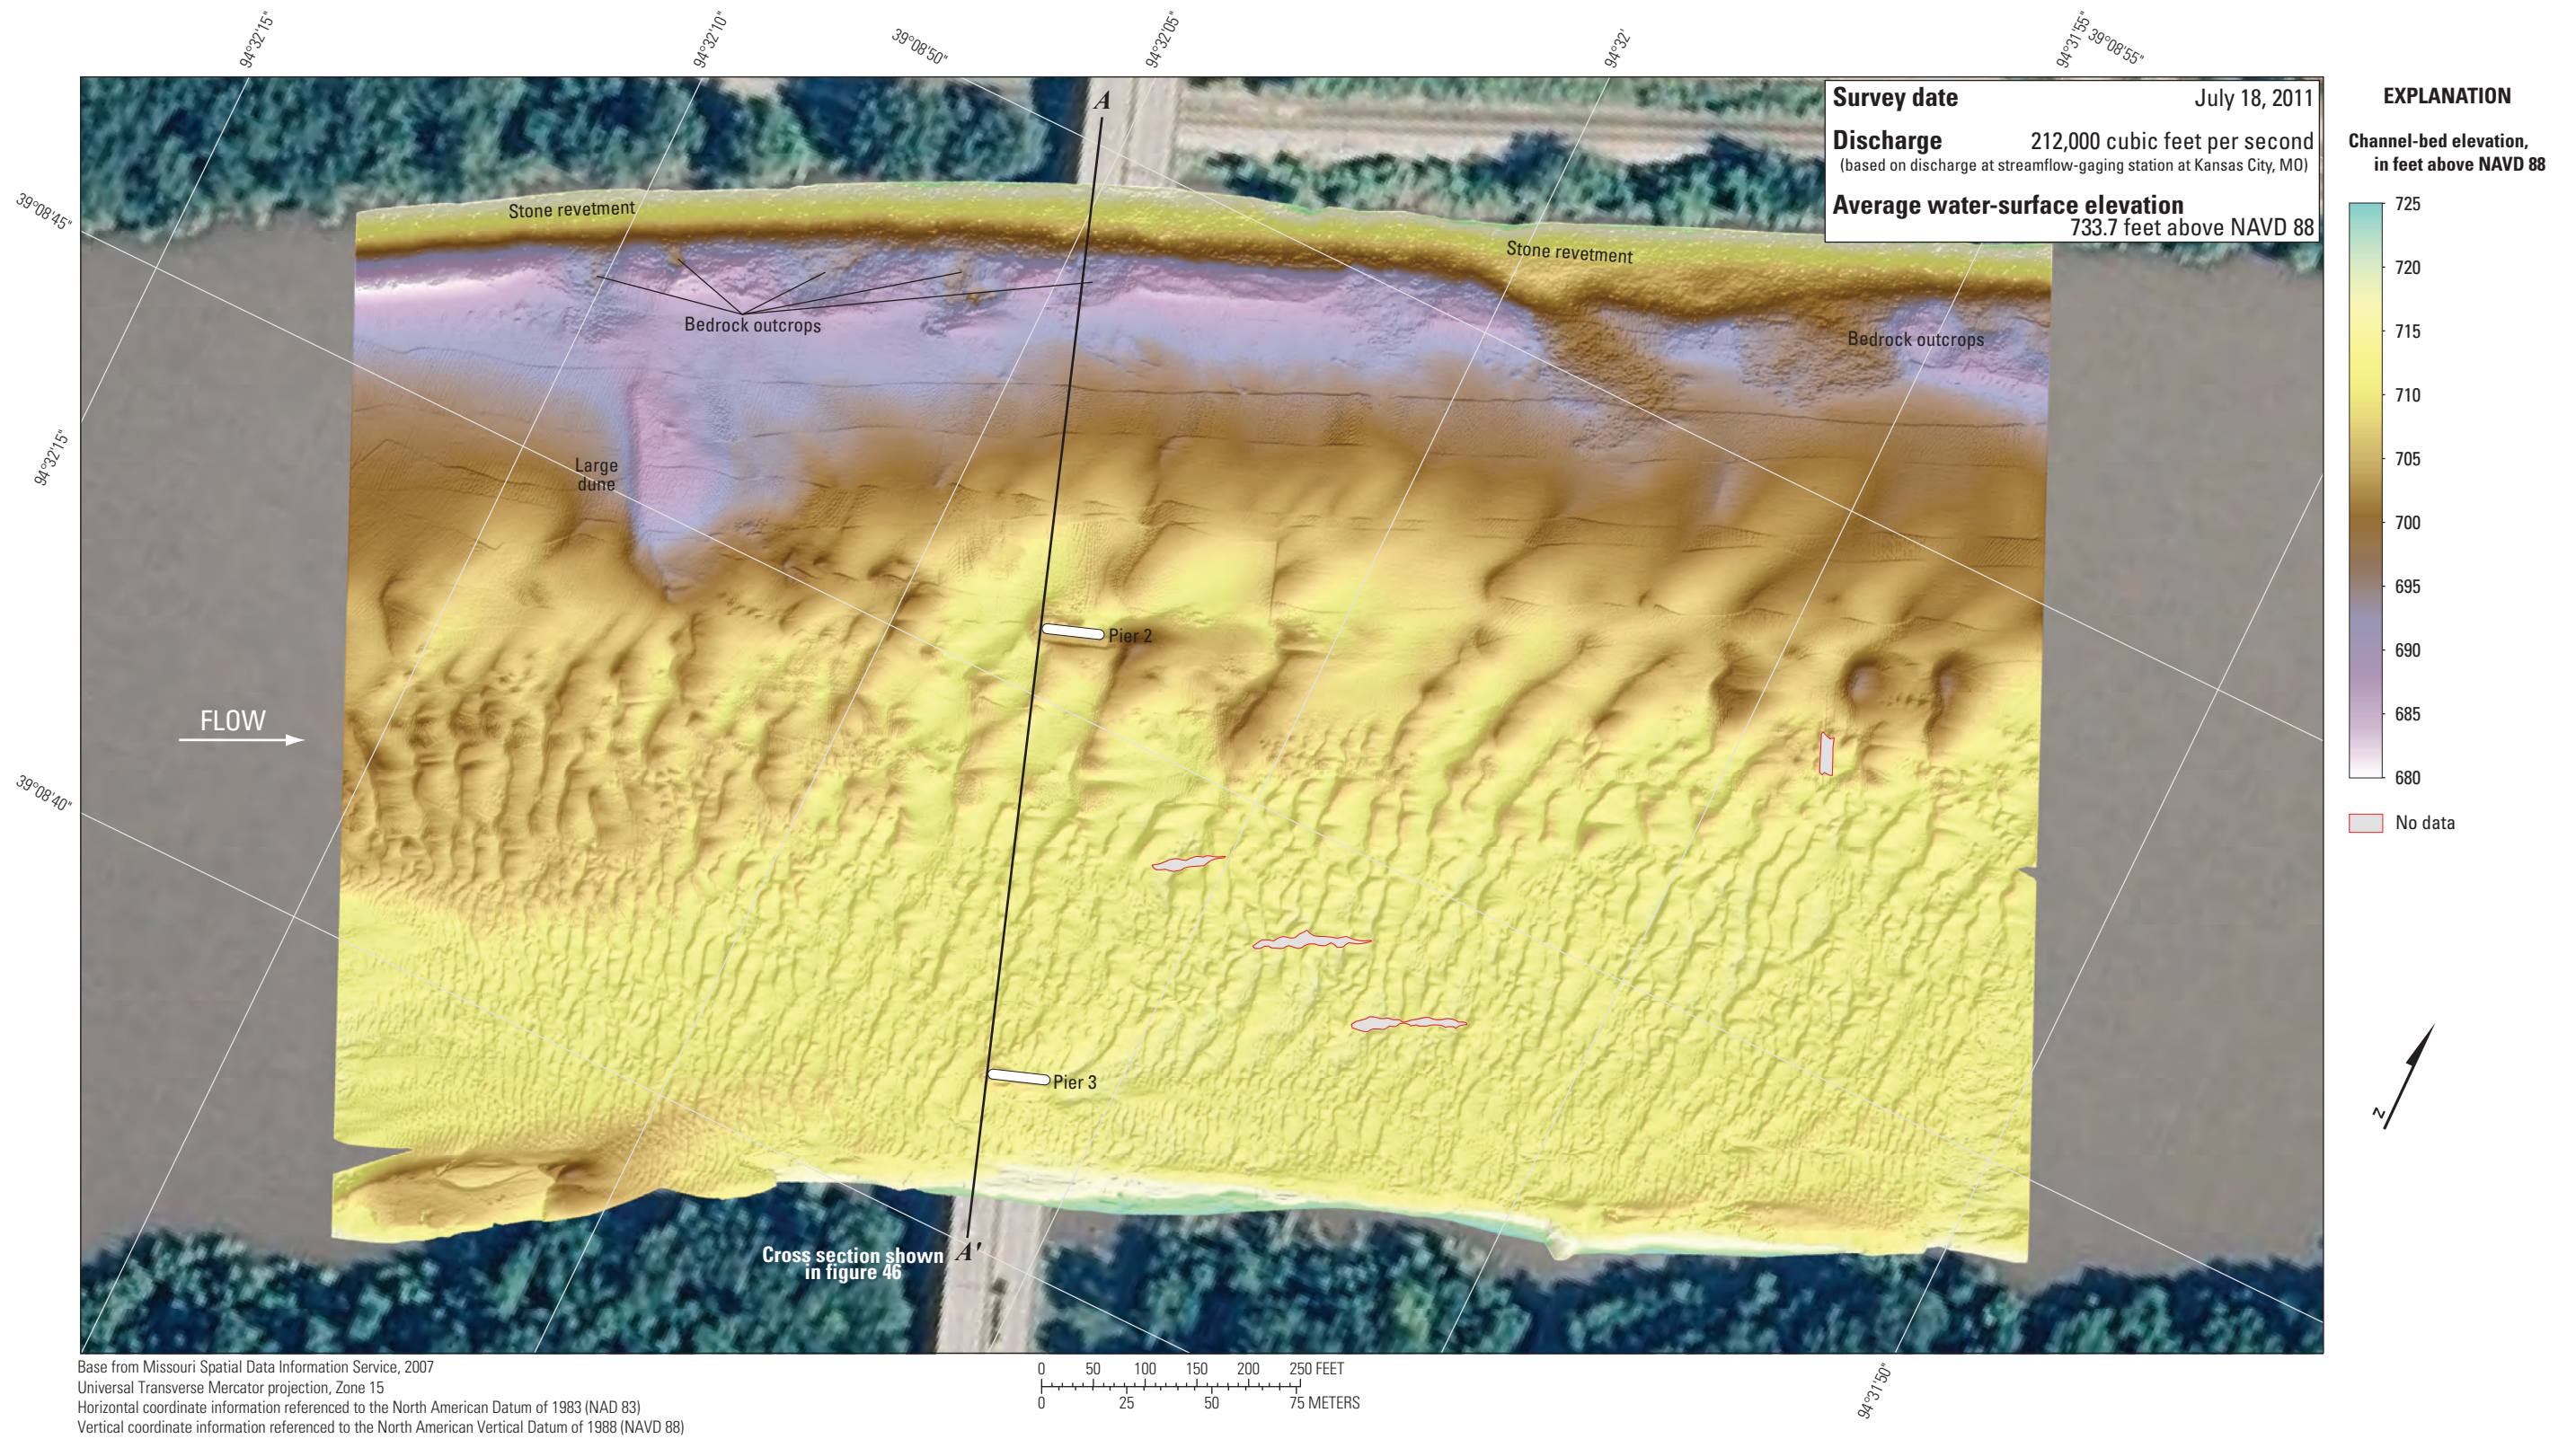
Figure 45. Bathymetric survey of the Missouri River channel in the vicinity of structure A5817 on State Highway 269 in Kansas City, Missouri.

In the vicinity of main channel pier 2 (fig. 45), a minor scour hole had a minimum channel-bed elevation of about 702 ft (table 6), about 14 ft above the elevation of the bottom

of the pier seal course of 687.26 ft (fig. 46; table 6). The top of the pier footing was evident along the right (south) side of the pier during the survey (fig. 45). The minor scour hole near pier 3 was difficult to discern from nearby small dunes and ripples (fig. 45). Information from bridge plans indicates that piers 2 and 3 of structure A5817 are founded on shafts drilled 20 ft into bedrock, with about 25 ft of bed material between the bottom of the scour hole and bedrock at pier 2 and about 48 ft of material at pier 3 (fig. 46; table 6).

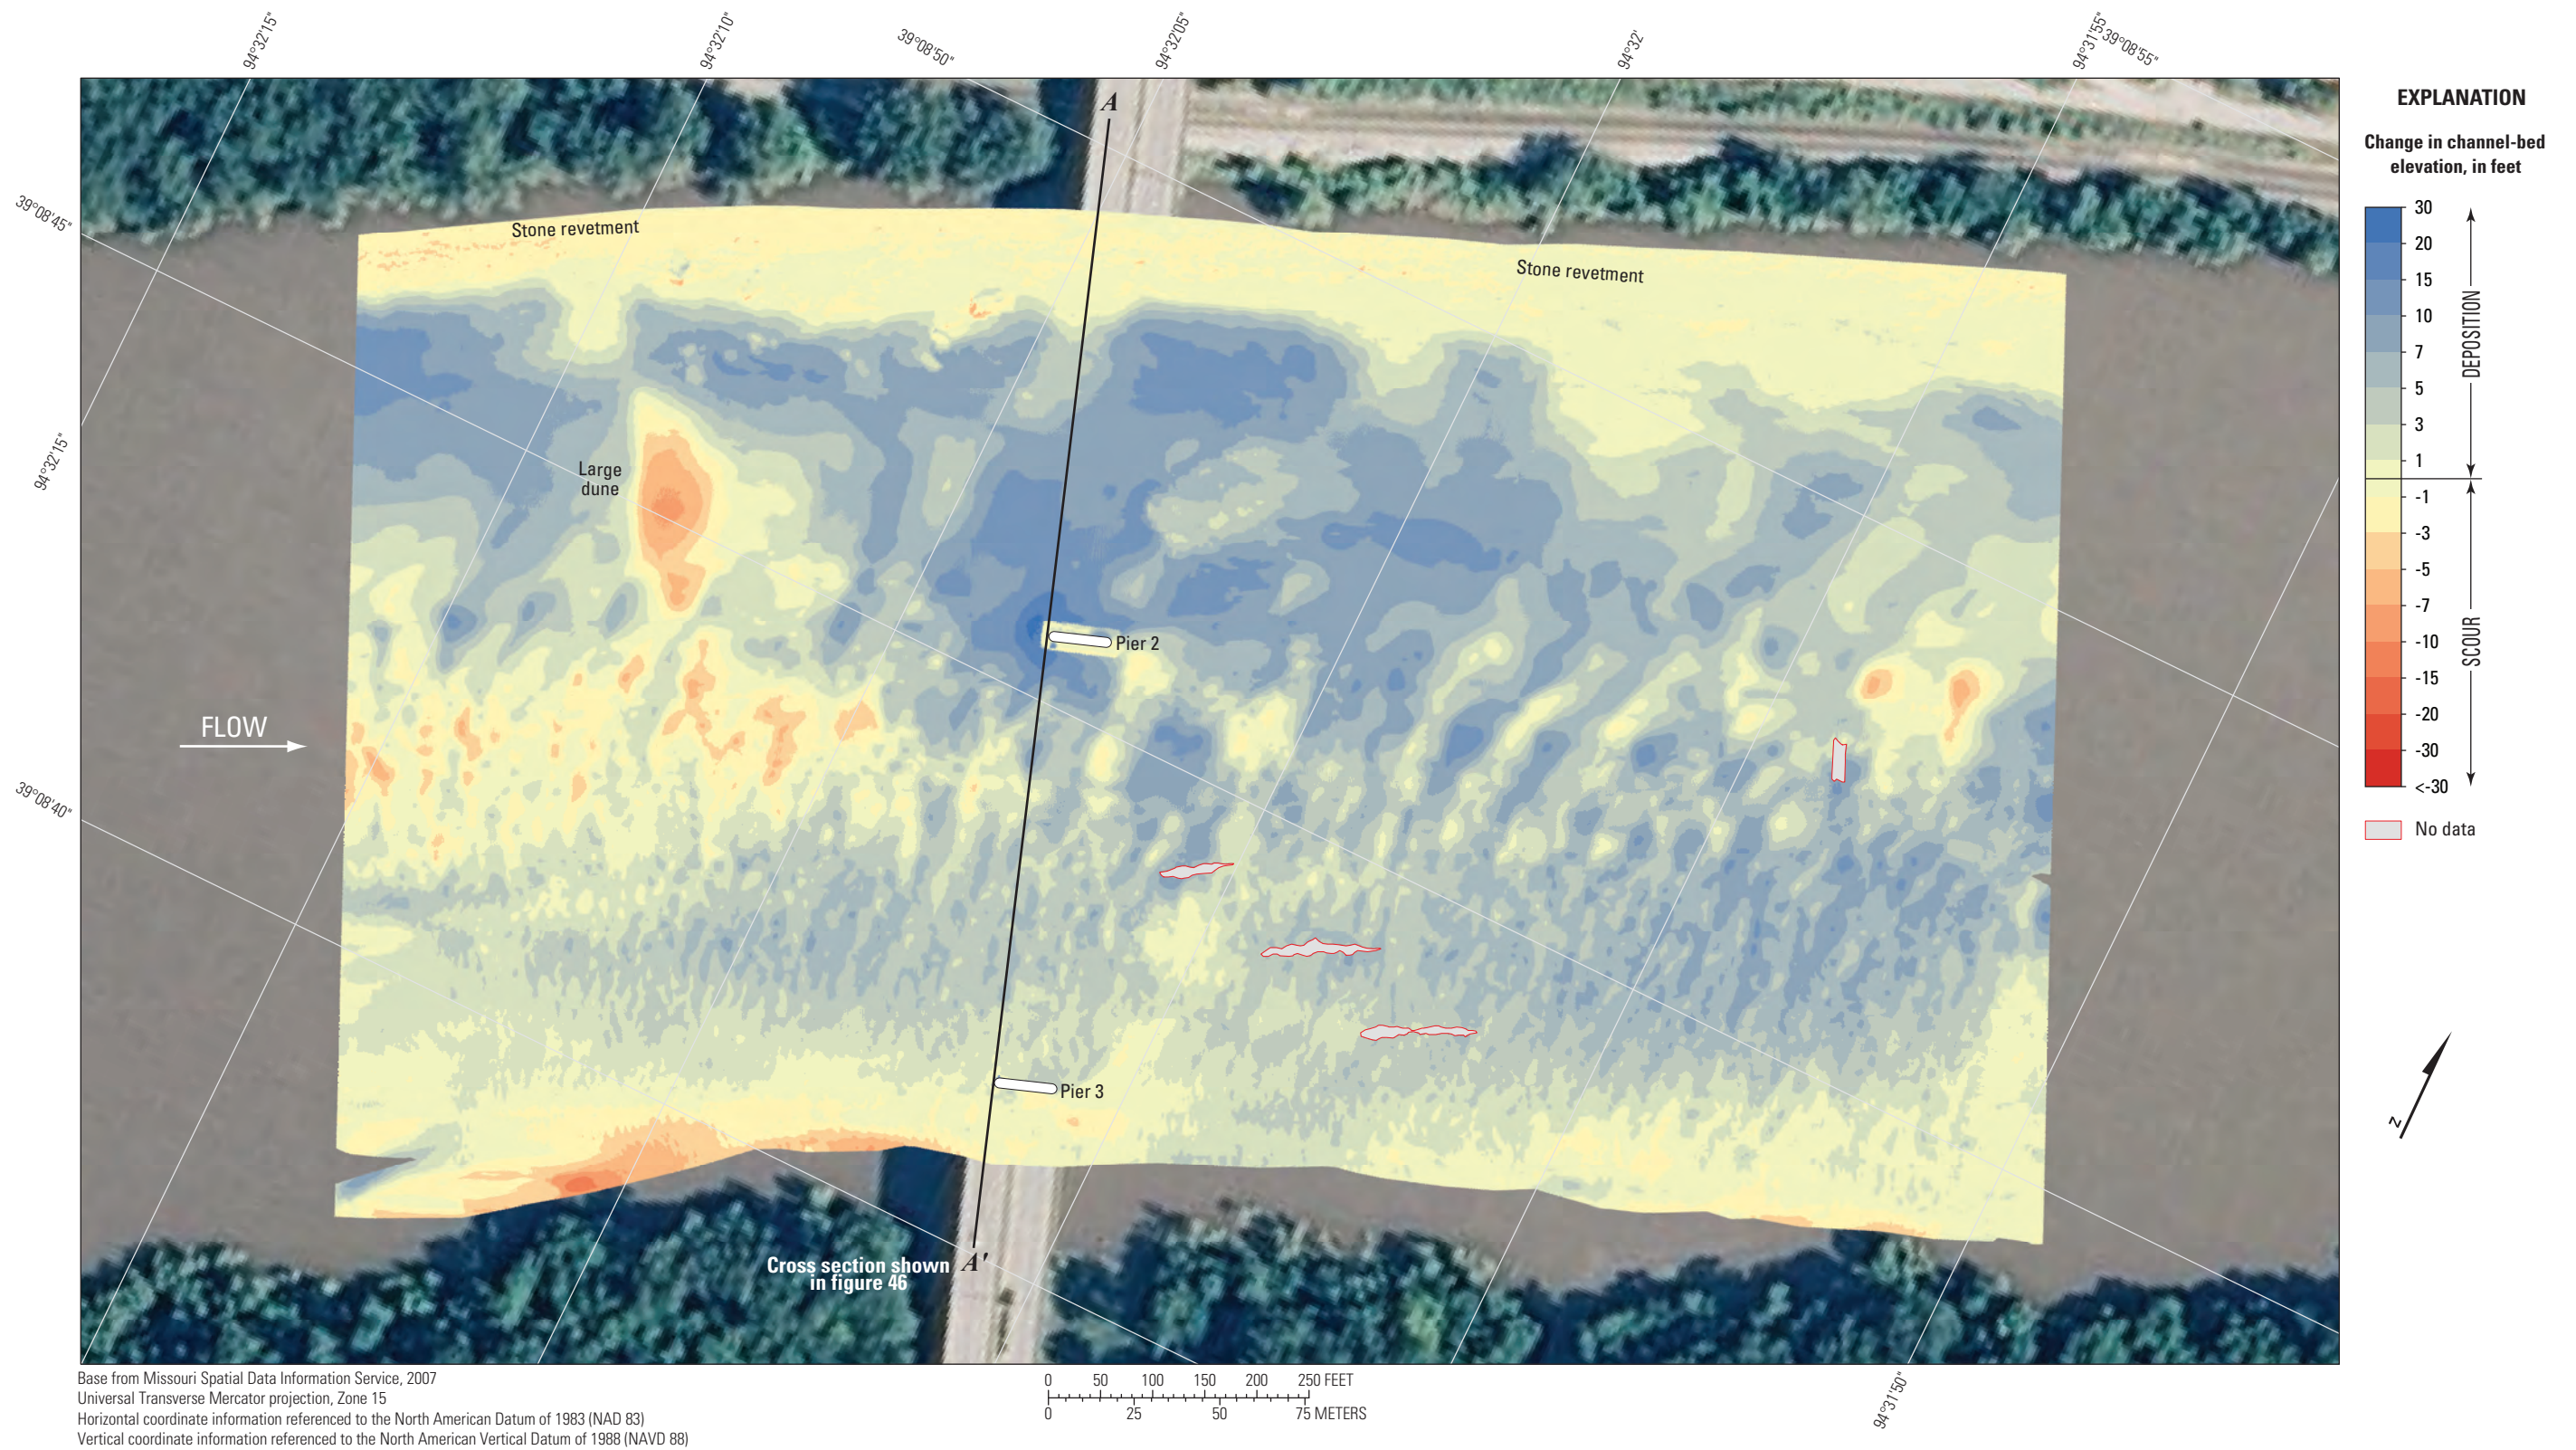
Figure 47. Difference between surfaces created from bathymetric surveys of the Missouri River channel in the vicinity of structure A5817 on State Highway 269 in Kansas City, Missouri, on March 17, 2010, and July 18, 2011.

The difference between the survey on July 18, 2011, and the previous survey on March 17, 2010 (fig. 47) indicates substantial deposition throughout the reach from 2010 to 2011, with an average difference +3.30 ft between the bathymetric surfaces (table 7). There were a few areas of scour from 2010 to 2011, predominantly in the upstream reach: near the large dune feature and the various smaller dunes and ripples in the middle of the channel, and along the right (south) bank (fig. 47). The cross sections from the two surveys also indicate substantial deposition throughout (fig. 46), despite a water-surface elevation difference of nearly 10 ft and a flow difference of 88,000 ft³/s (table 7). Whereas the scour hole near main channel pier 2 was below the seal course in 2010, in 2011 it was at the top of the footing (fig. 46). The stone revetment on the left (north) bank appeared to have several areas of localized scour in the upstream reach (fig. 47).

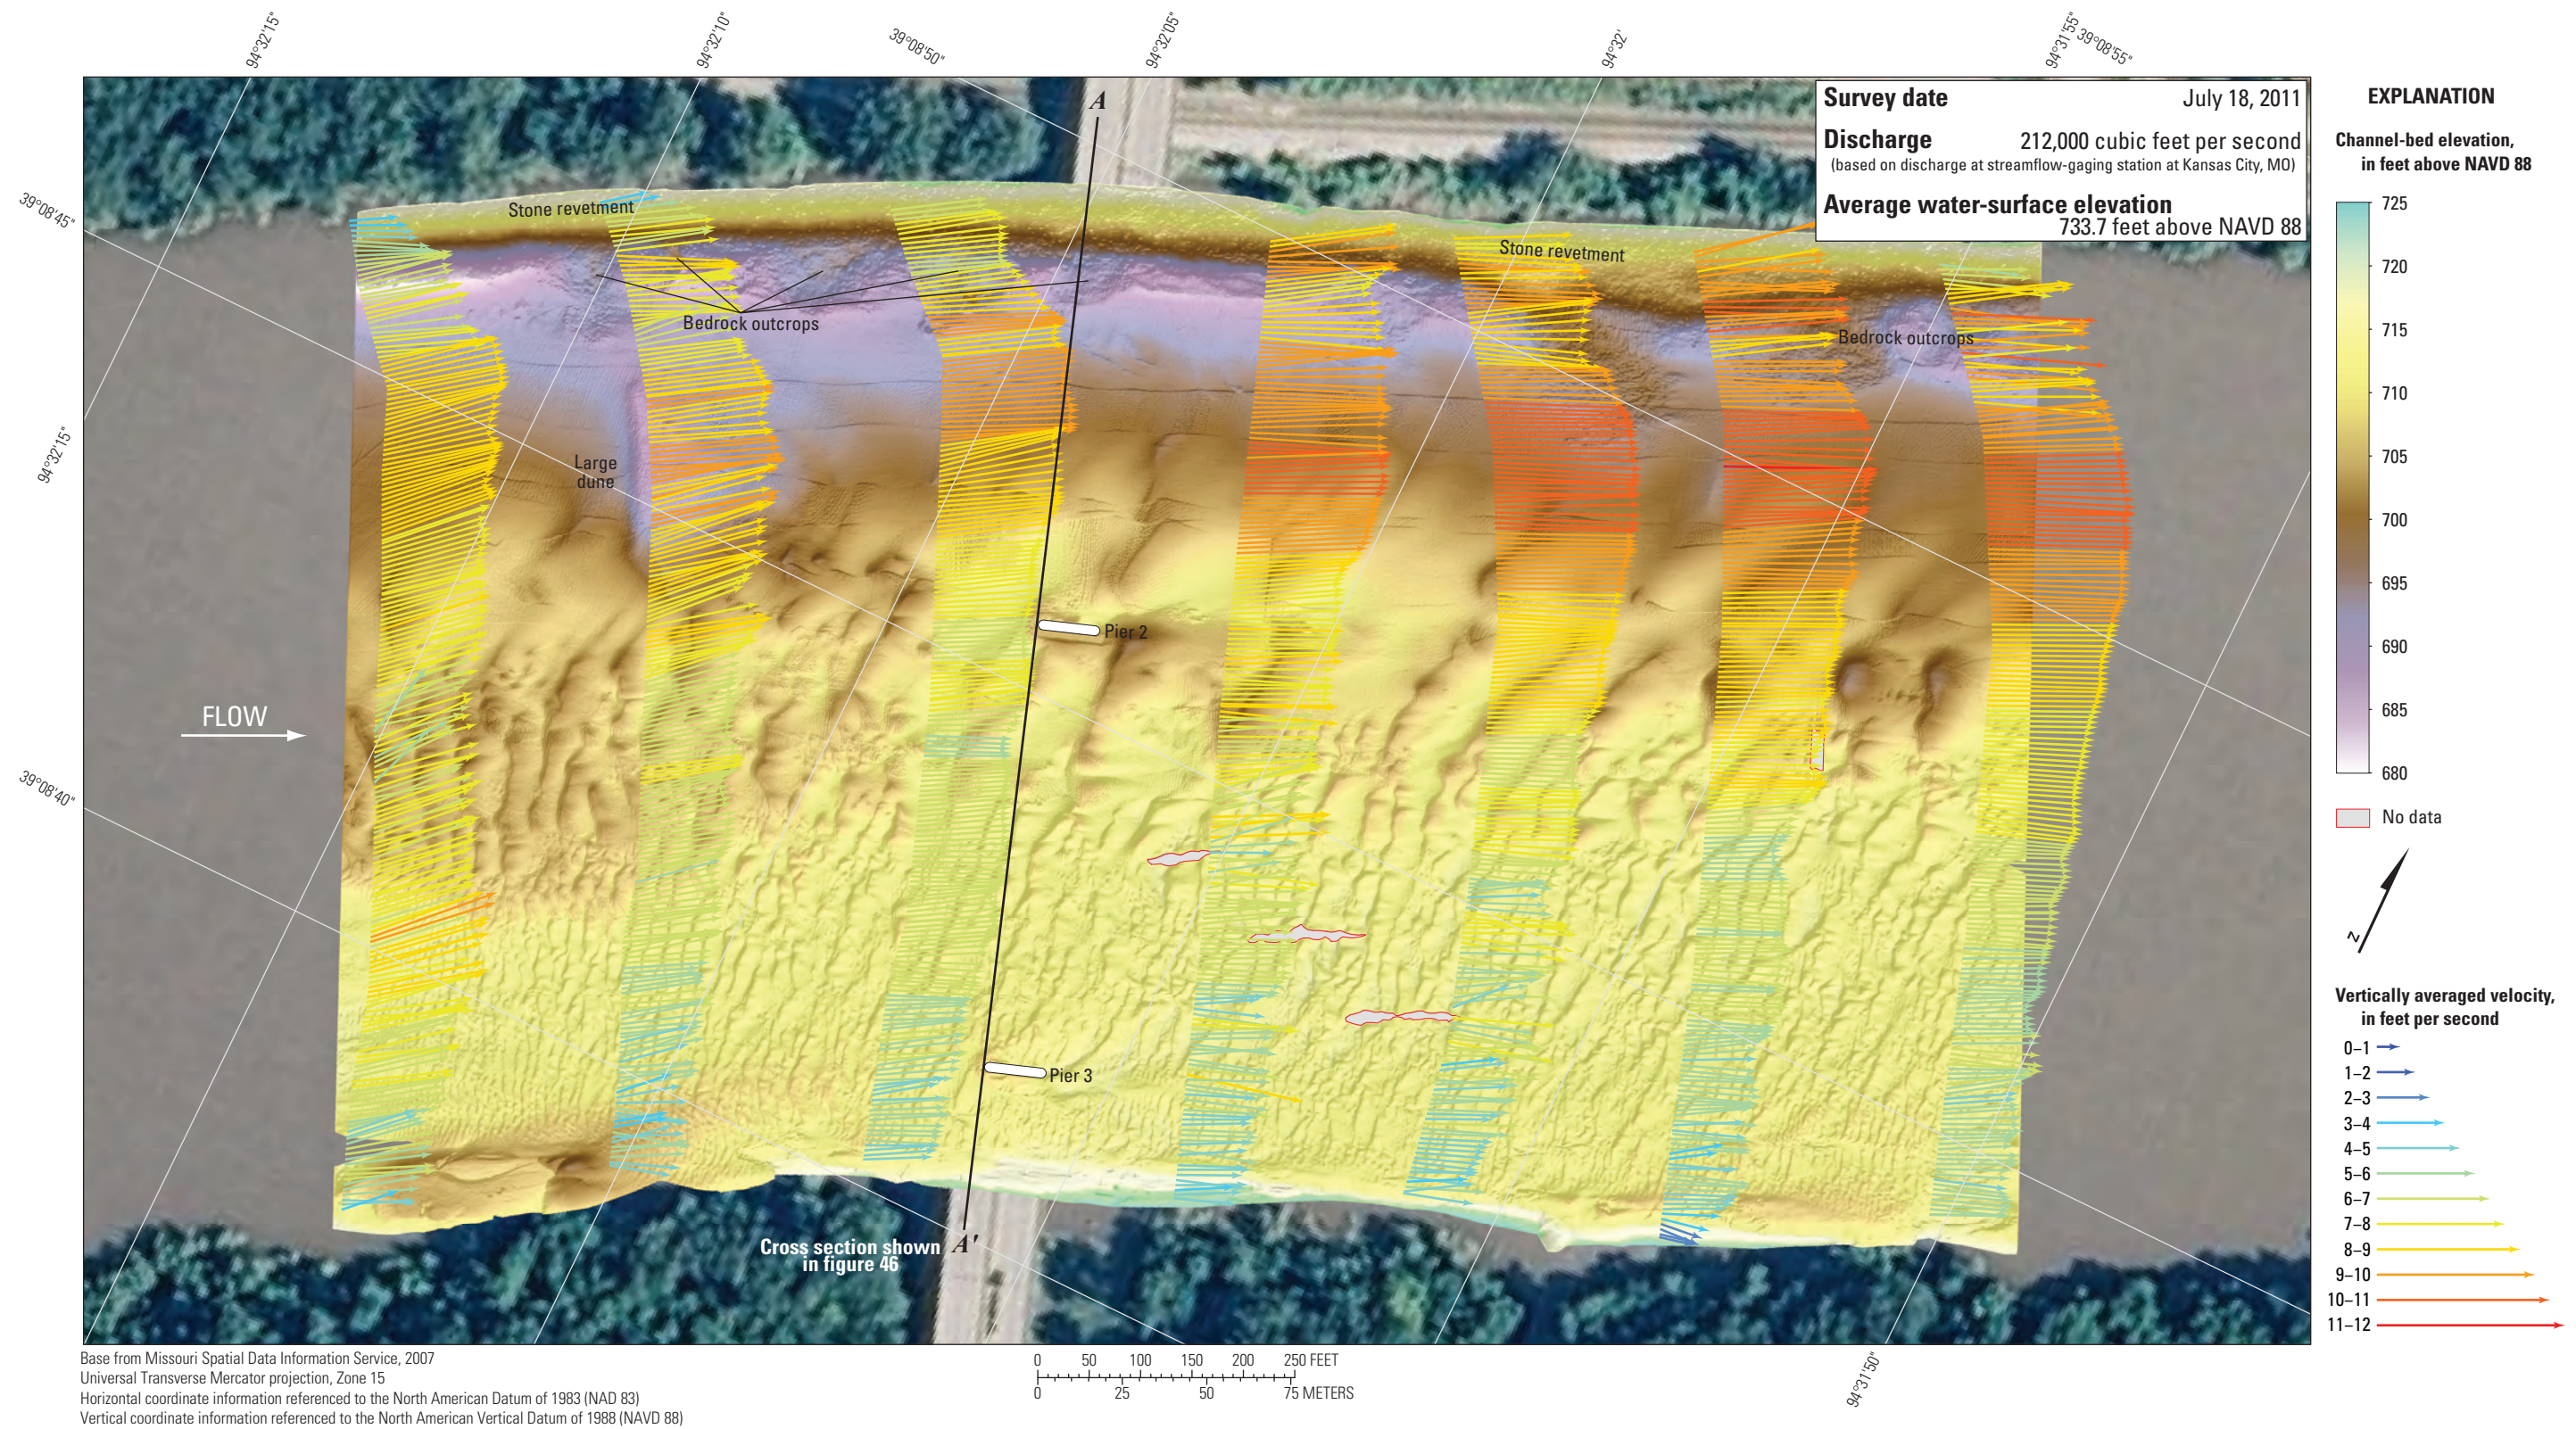
Figure 48. Bathymetry and vertically averaged velocities of the Missouri River channel in the vicinity of structure A5817 on State Highway 269 in Kansas City, Missouri.

The vertically averaged velocity vectors indicate mostly uniform flow throughout the reach, ranging from about 4 ft/s along the inside of the bend on the right (south) bank to 12 ft/s near the downstream thalweg (fig. 48). Flow was angled to the left (north) in the upstream part of the reach because of the bend in the channel (fig. 48). Moderate to substantial turbulence was observed along the thalweg near bedrock outcrops, and along the inside of the bend along the right (south) bank (fig. 48).

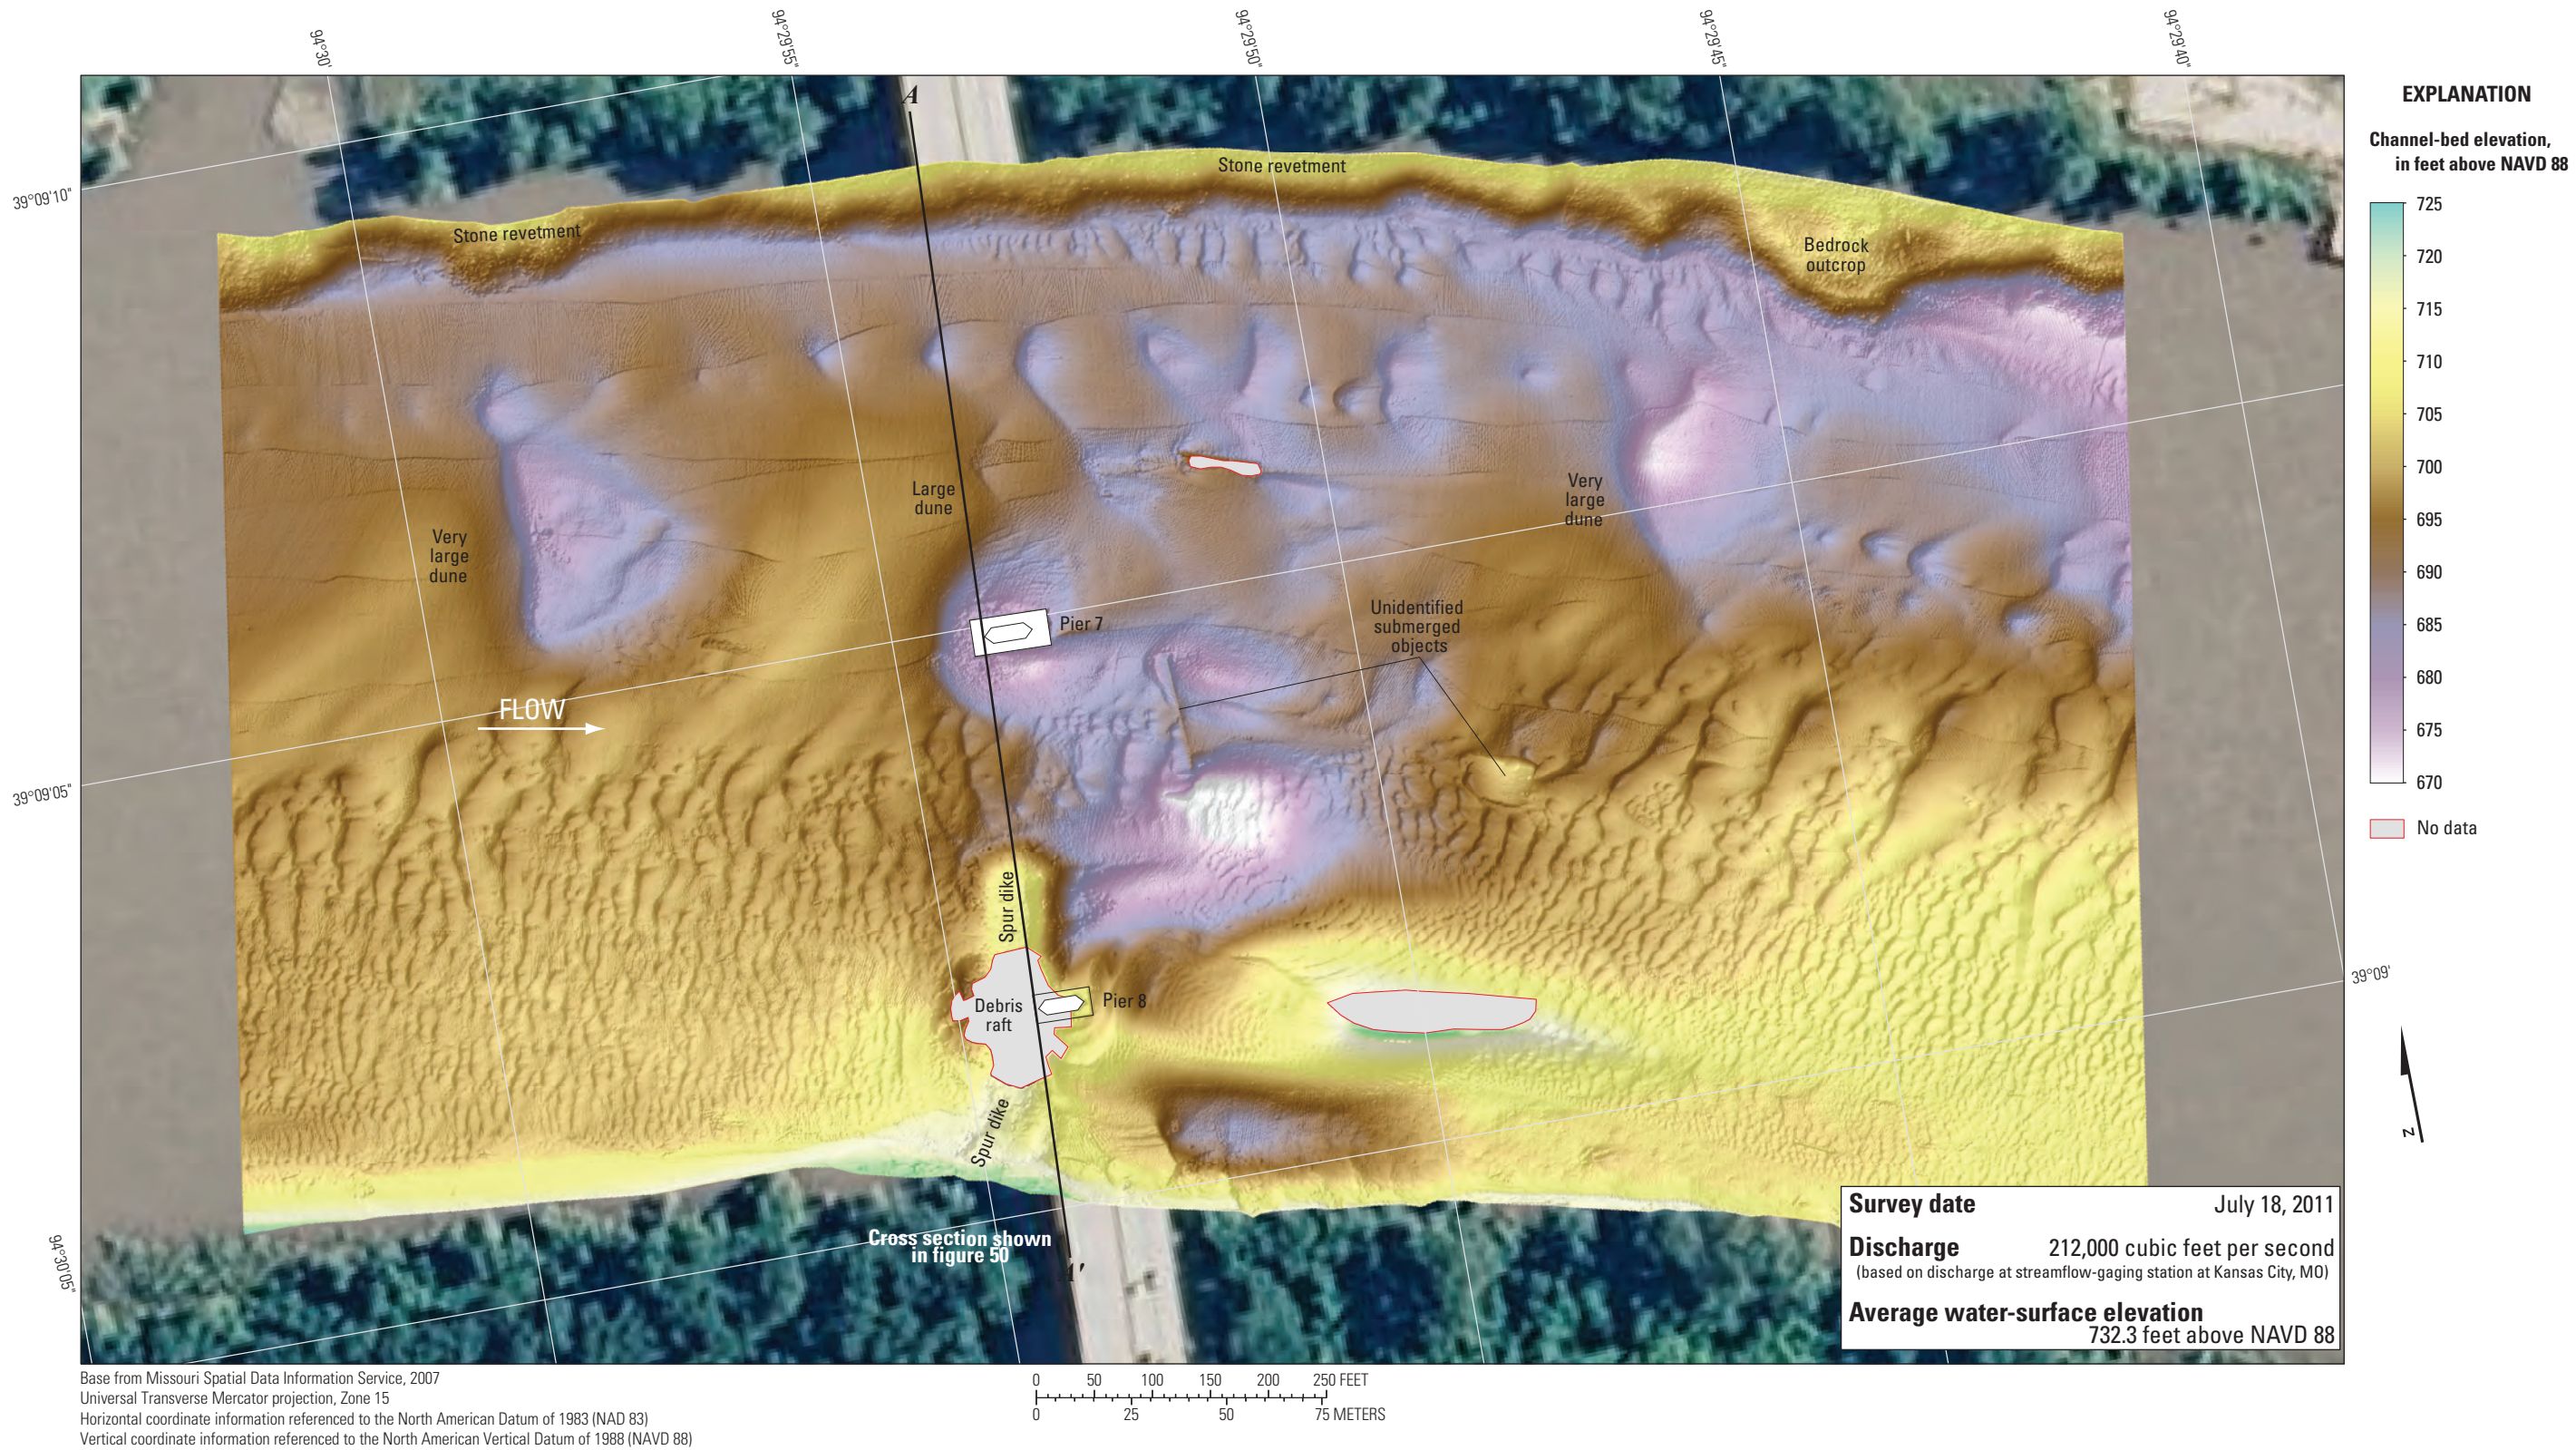
Figure 49. Bathymetric survey of the Missouri River channel in the vicinity of structure A0767 on Interstate 435 in Kansas City, Missouri.

and could not be surveyed because of a substantial debris raft (fig. 49). The top of the footing on the downstream end of the pier was visible (fig. 49), but the minimum channel elevation was 700 ft, nearly 11 ft higher than the bottom of the seal course elevation of 689.26 ft (fig. 49; table 6). Information from bridge plans indicates that piers 7 and 8 are founded on shafts drilled 20 ft into bedrock, with about 14 ft of bed material between the bottom of the scour hole and bedrock at pier 7 and about 52 ft of material at pier 8 (fig. 50; table 6). A point cloud visualization of the multibeam depth points obtained during the survey at pier 7 indicates the bottom of the seal course as a sonic “shadow,” with the sides of drilled shafts appearing as points in the shadow (fig. 51).
