Bathymetric and Velocimetric Surveys at Highway Bridges Crossing the Missouri River in and into Missouri during Summer Flooding, July–August 2011

Scientific Investigations Report 2012–5204

By Richard J. Huizinga

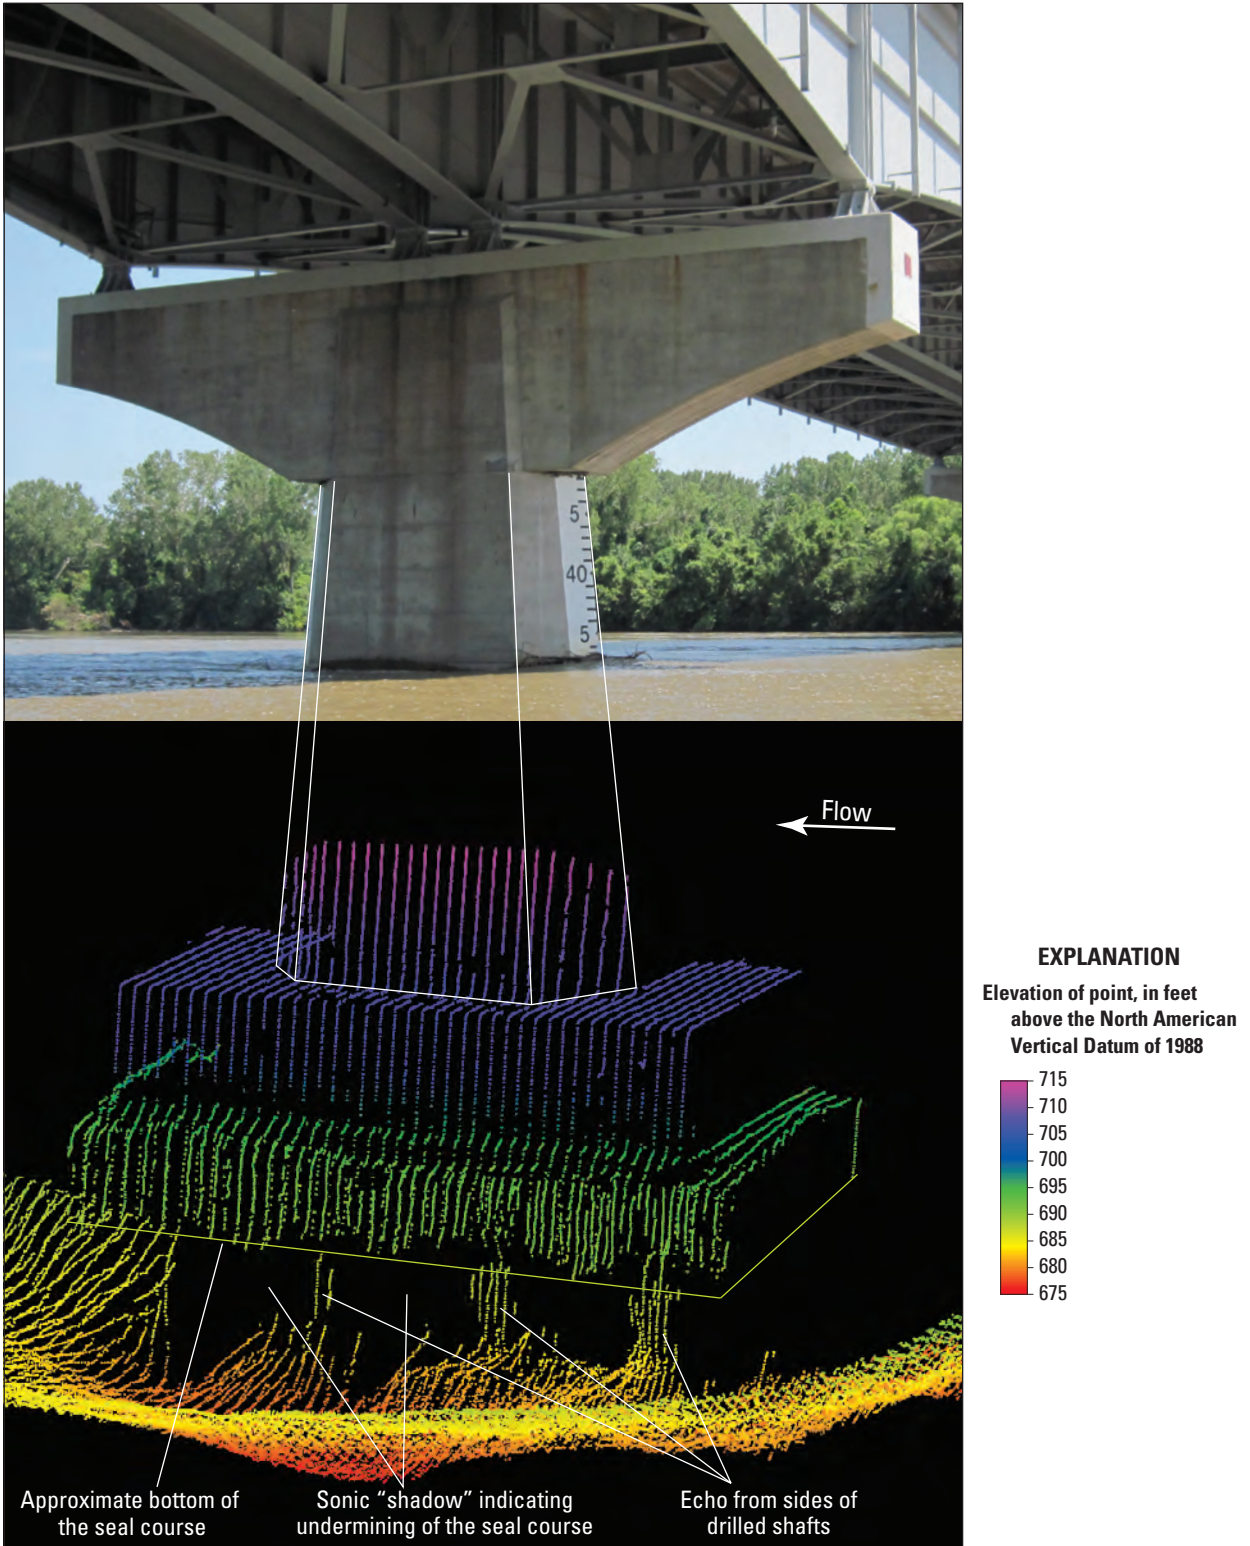
Figure 51. Point cloud visualization of the channel bed and left (north) side of main channel pier 7 of structure A0767 on Interstate 435 over the Missouri River in Kansas City, Missouri.

and could not be surveyed because of a substantial debris raft (fig. 49). The top of the footing on the downstream end of the pier was visible (fig. 49), but the minimum channel elevation was 700 ft, nearly 11 ft higher than the bottom of the seal course elevation of 689.26 ft (fig. 49; table 6). Information from bridge plans indicates that piers 7 and 8 are founded on shafts drilled 20 ft into bedrock, with about 14 ft of bed material between the bottom of the scour hole and bedrock at pier 7 and about 52 ft of material at pier 8 (fig. 50; table 6). A point cloud visualization of the multibeam depth points obtained during the survey at pier 7 indicates the bottom of the seal course as a sonic “shadow,” with the sides of drilled shafts appearing as points in the shadow (fig. 51).

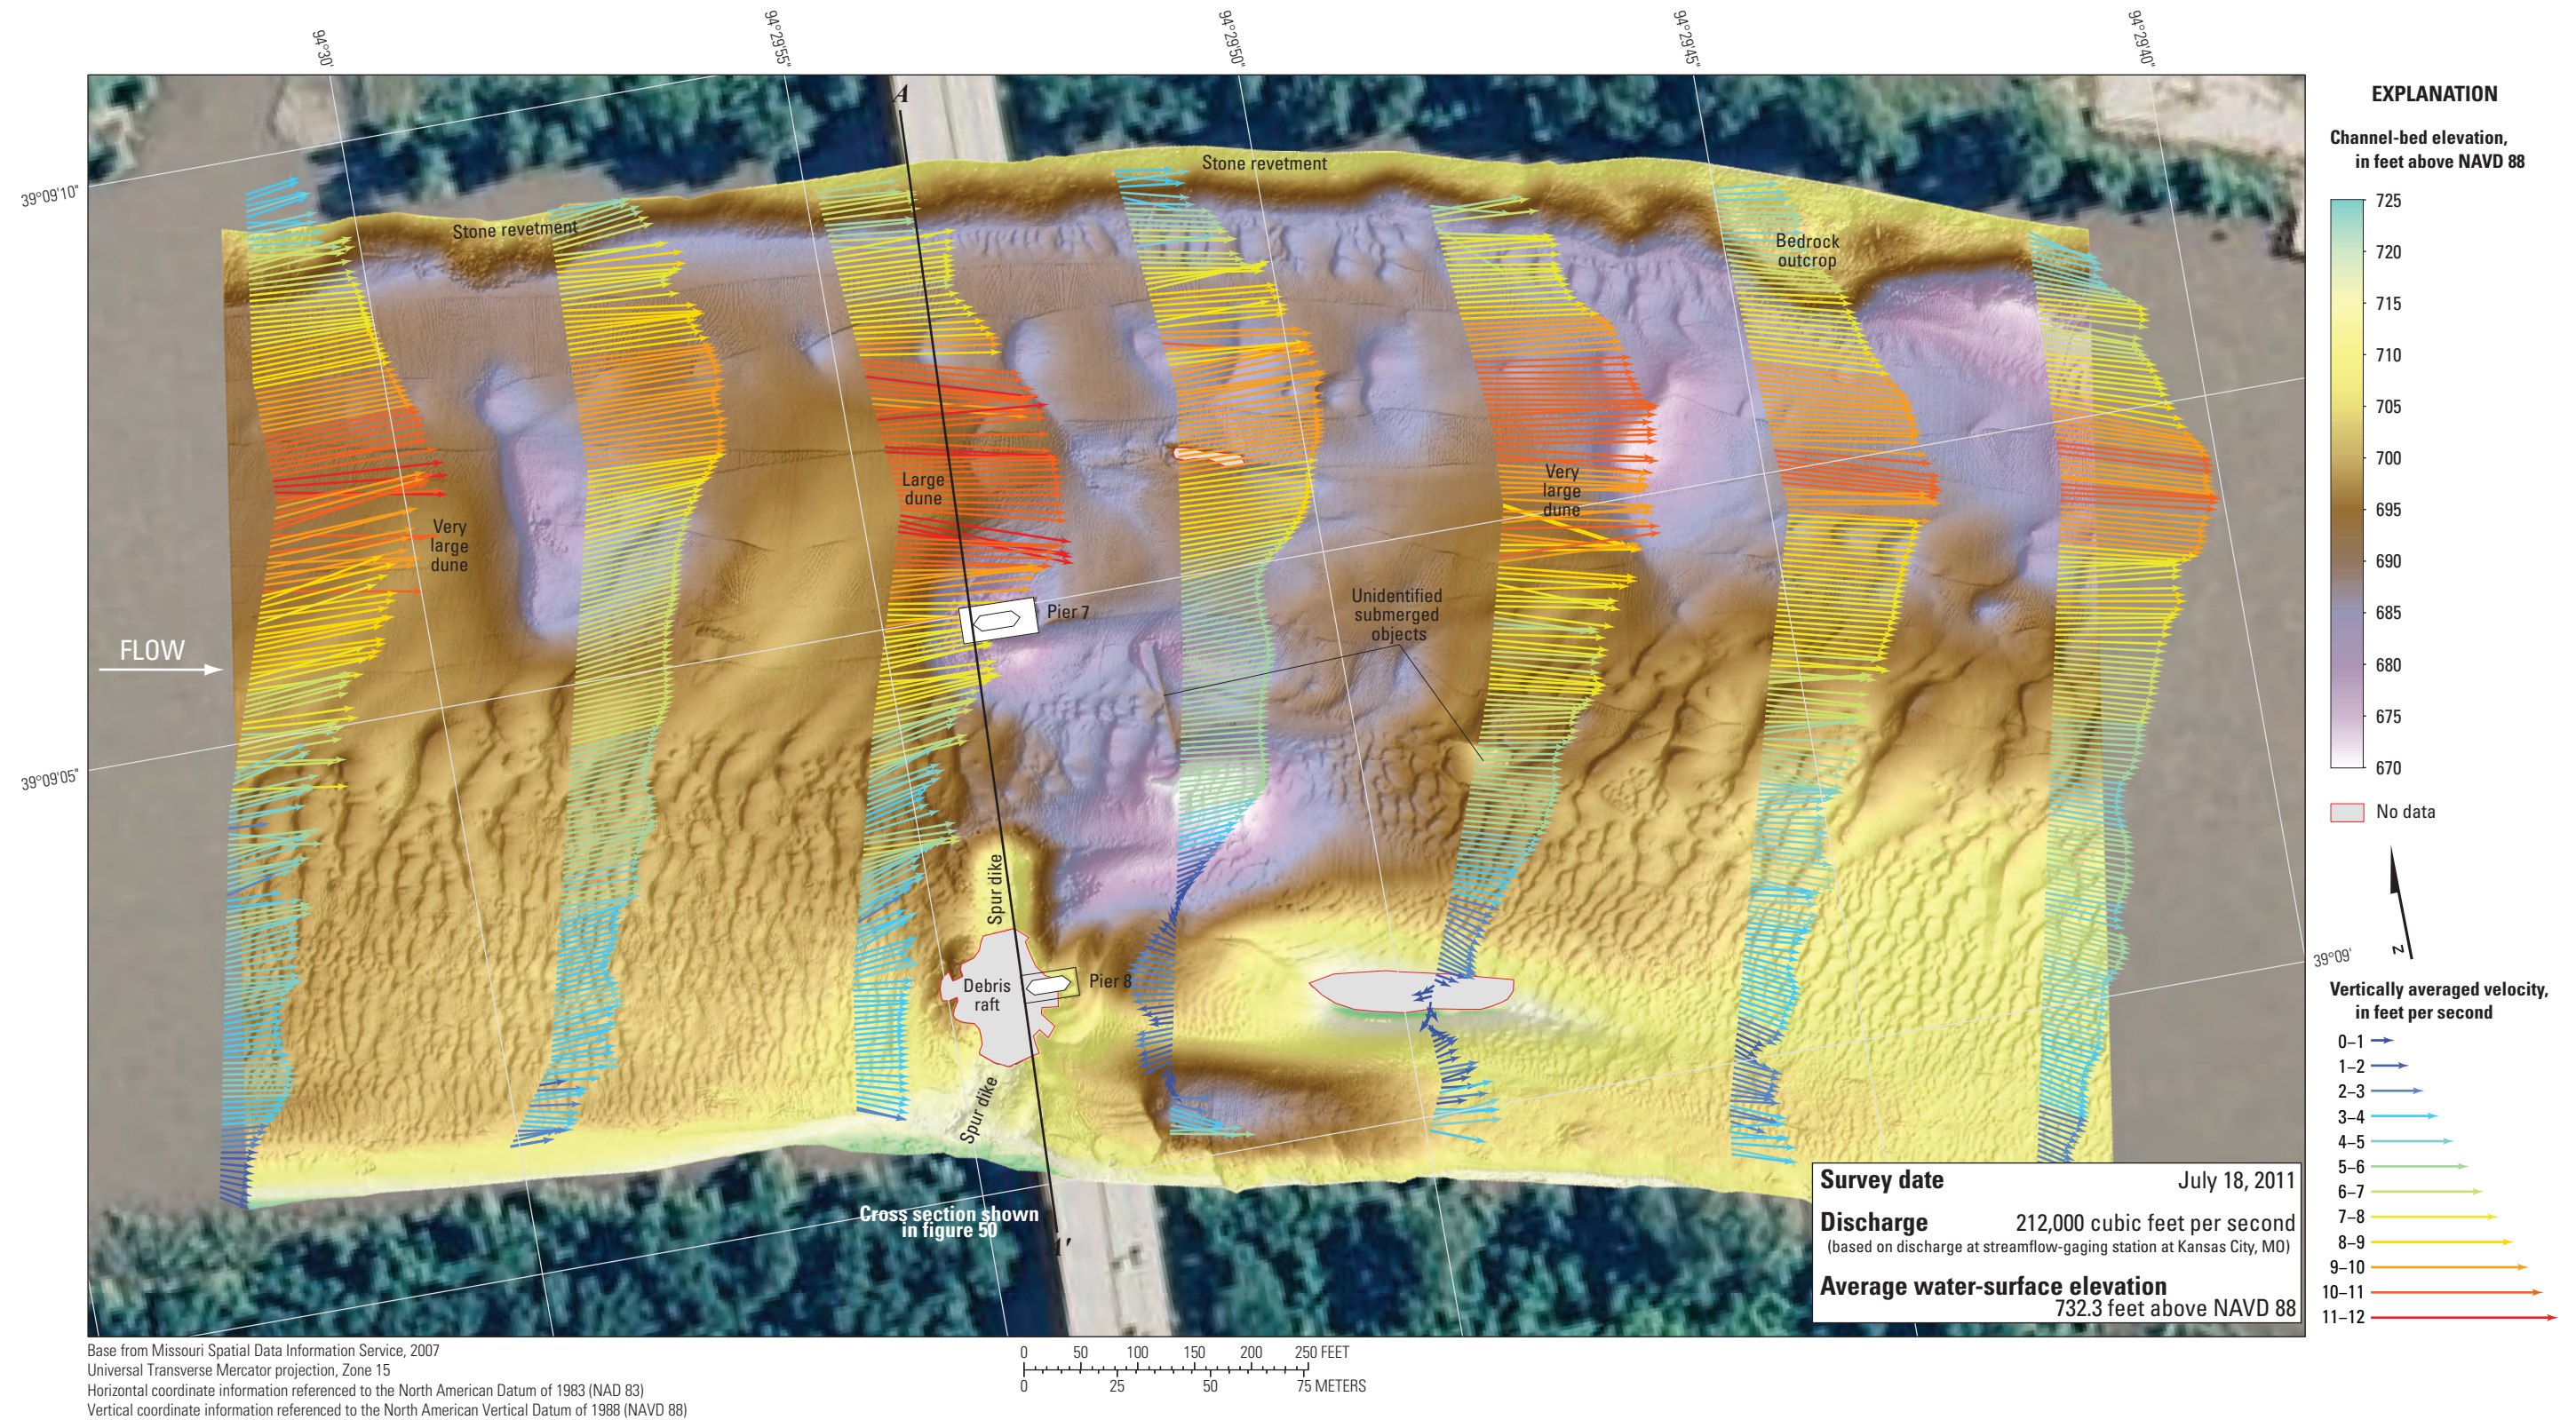
Figure 53. Bathymetry and vertically averaged velocities of the Missouri River channel in the vicinity of structure A0767 on Interstate 435 in Kansas City, Missouri.

The vertically averaged velocity vectors indicate mostly uniform flow throughout the reach, ranging from about 3 ft/s along the inside of the bend on the right (south) bank to 12 ft/s in the thalweg (fig. 53). Flow was angled to the right (south) near the upstream face of the bridge, and there was flow reversal downstream from the spur dike, debris raft, and pier 8 (fig. 53). Moderate to substantial turbulence was observed in several transects (fig. 53).

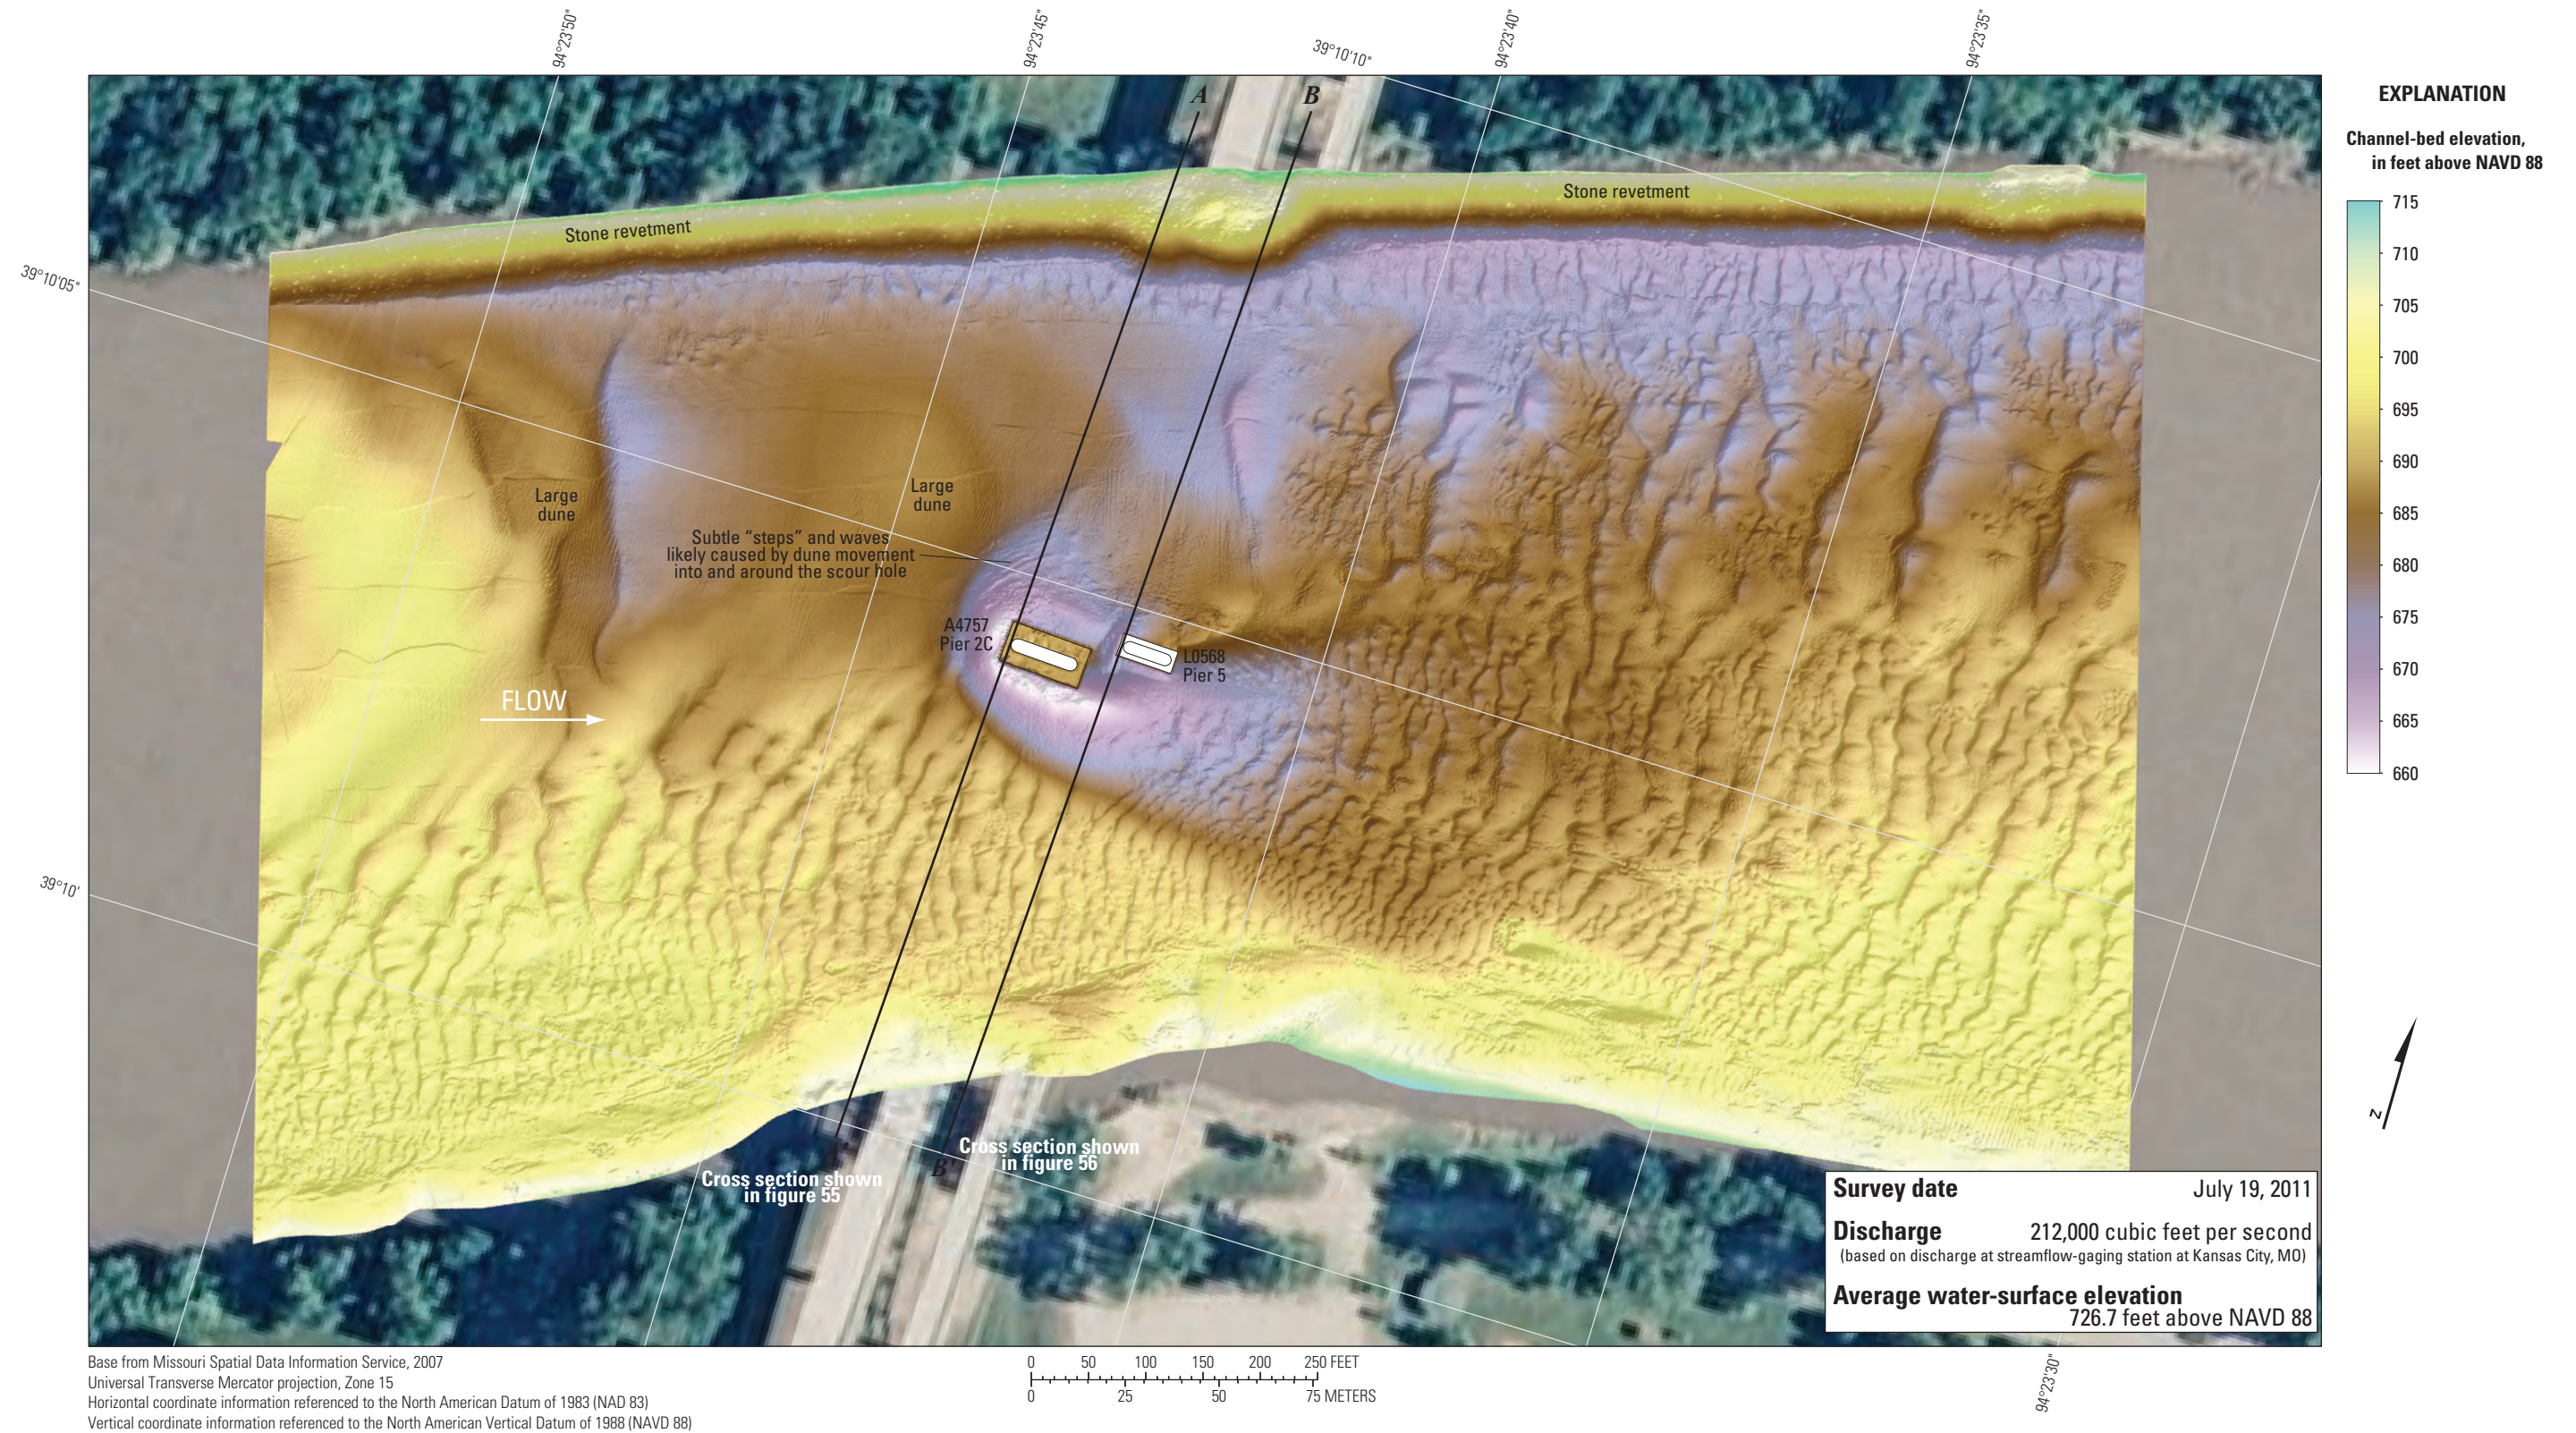
Figure 54. Bathymetric survey of the Missouri River channel in the vicinity of structures A4757 and L0568 on State Highway 291 in Kansas City, Missouri.

In the vicinity of the main channel piers (fig. 54), a large scour hole encompassing both piers had a minimum channel-bed elevation of about 662 ft (table 6). The main channel piers were skewed to the approaching flow, which caused a wide scour hole with somewhat unique characteristics as compared to scour holes at the other surveyed bridges. Pier 5 of structure L0568 was in the wake of pier 2C of structure A4757, and, therefore, had no well-defined scour hole specific to it. The point of overall minimum channel-bed elevation in the reach occurred on the right (south) side of pier 2C of structure A4757 (fig. 54). At the upstream end of pier 2C of structure A4757, the minimum channel-bed elevation was about 666 ft, and at the upstream end of pier 5 of structure L0568, the minimum channel-bed elevation was about 669 ft (fig. 54; table 6). Information from bridge plans indicates that the main channel pier of structure A4757 is founded on shafts drilled 20 ft into bedrock (fig. 55), with about 43 ft of bed material between the bottom of the scour hole and bedrock at the point of minimum elevation of the scour hole (table 6), and about 47 ft of material near the upstream pier face (fig. 55). At the point of minimum elevation, the surveyed channel bed was about 4 ft lower than the bottom of the seal course elevation of 666.26 ft (table 6). Information from bridge plans indicate that the main channel pier of structure L0568 is a caisson on bedrock (fig. 56), with about 44 ft of bed material between the bottom

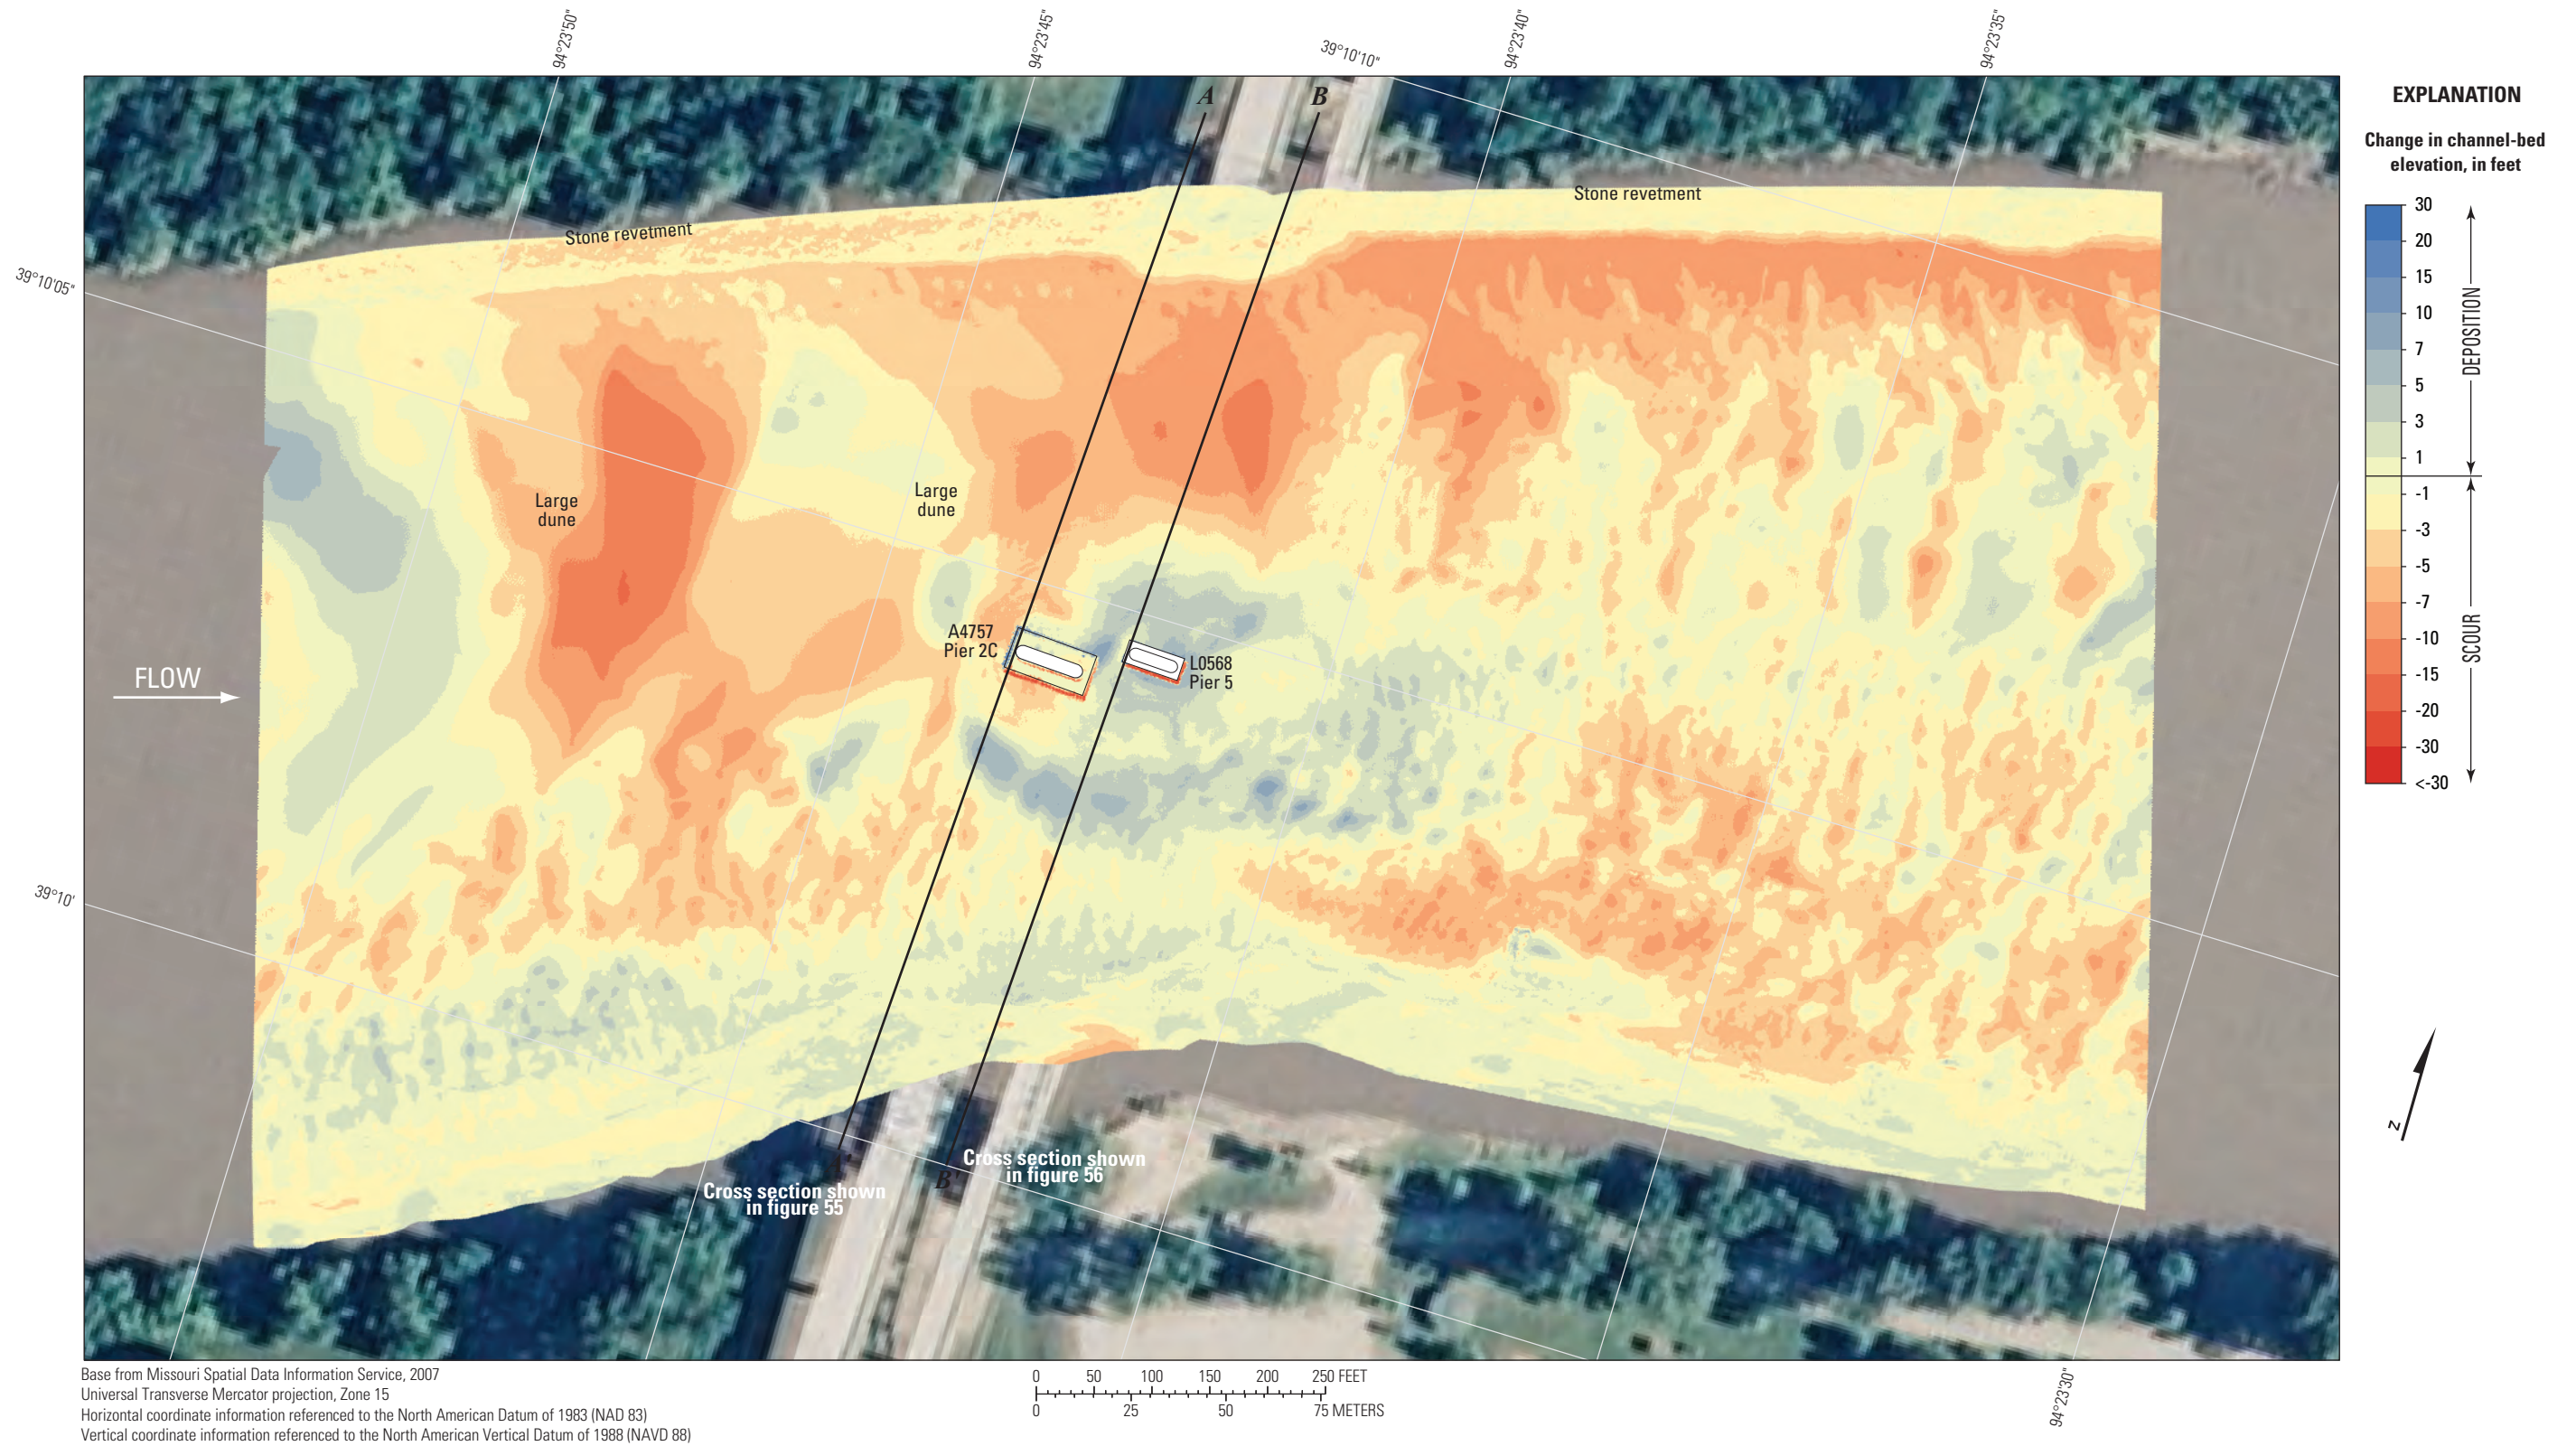
Figure 57. Difference between surfaces created from bathymetric surveys of the Missouri River channel in the vicinity of structures A4757 and L0568 on State Highway 291 in Kansas City, Missouri, on March 18, 2010, and July 19, 2011.

The difference between the survey on July 19, 2011, and the previous survey on March 18, 2010 (fig. 57) indicates moderate scour throughout the reach from 2010 to 2011, with an average difference of -2.32 ft between the bathymetric surfaces (table 7). There were a few areas of deposition, predominantly in the upstream reach and around main channel pier 5 of downstream structure L0568 (fig. 57); however, additional scour of as much as 7 ft had occurred around main channel pier 2C of upstream structure A4757. The cross sections from the 2011 survey are similar to but lower than the 2010 survey at both bridges (figs. 55, 56), likely as a result of the water-surface elevation difference of more than 9 ft and a flow difference of 92,000 ft³/s (table 7). The scour hole near pier 2C of structure A4757 was slightly narrower at the top and deeper in 2011 than in 2010 (figs. 55, 57), whereas the scour hole near pier 5 of structure L0568 was of a similar shape but shallower in 2011 than in 2010 (figs. 56, 57). As with several difference maps presented earlier in this report, the appearance of substantial deposition or scour at the faces of the piers results from minor horizontal positional variances between the surveys. The stone revetment on the upstream left (north) bank appeared to have experienced general scour, whereas the right (south) bank near the bridges and downstream appeared to have experienced deposition with localized scour downstream from structure L0568 (fig. 57).

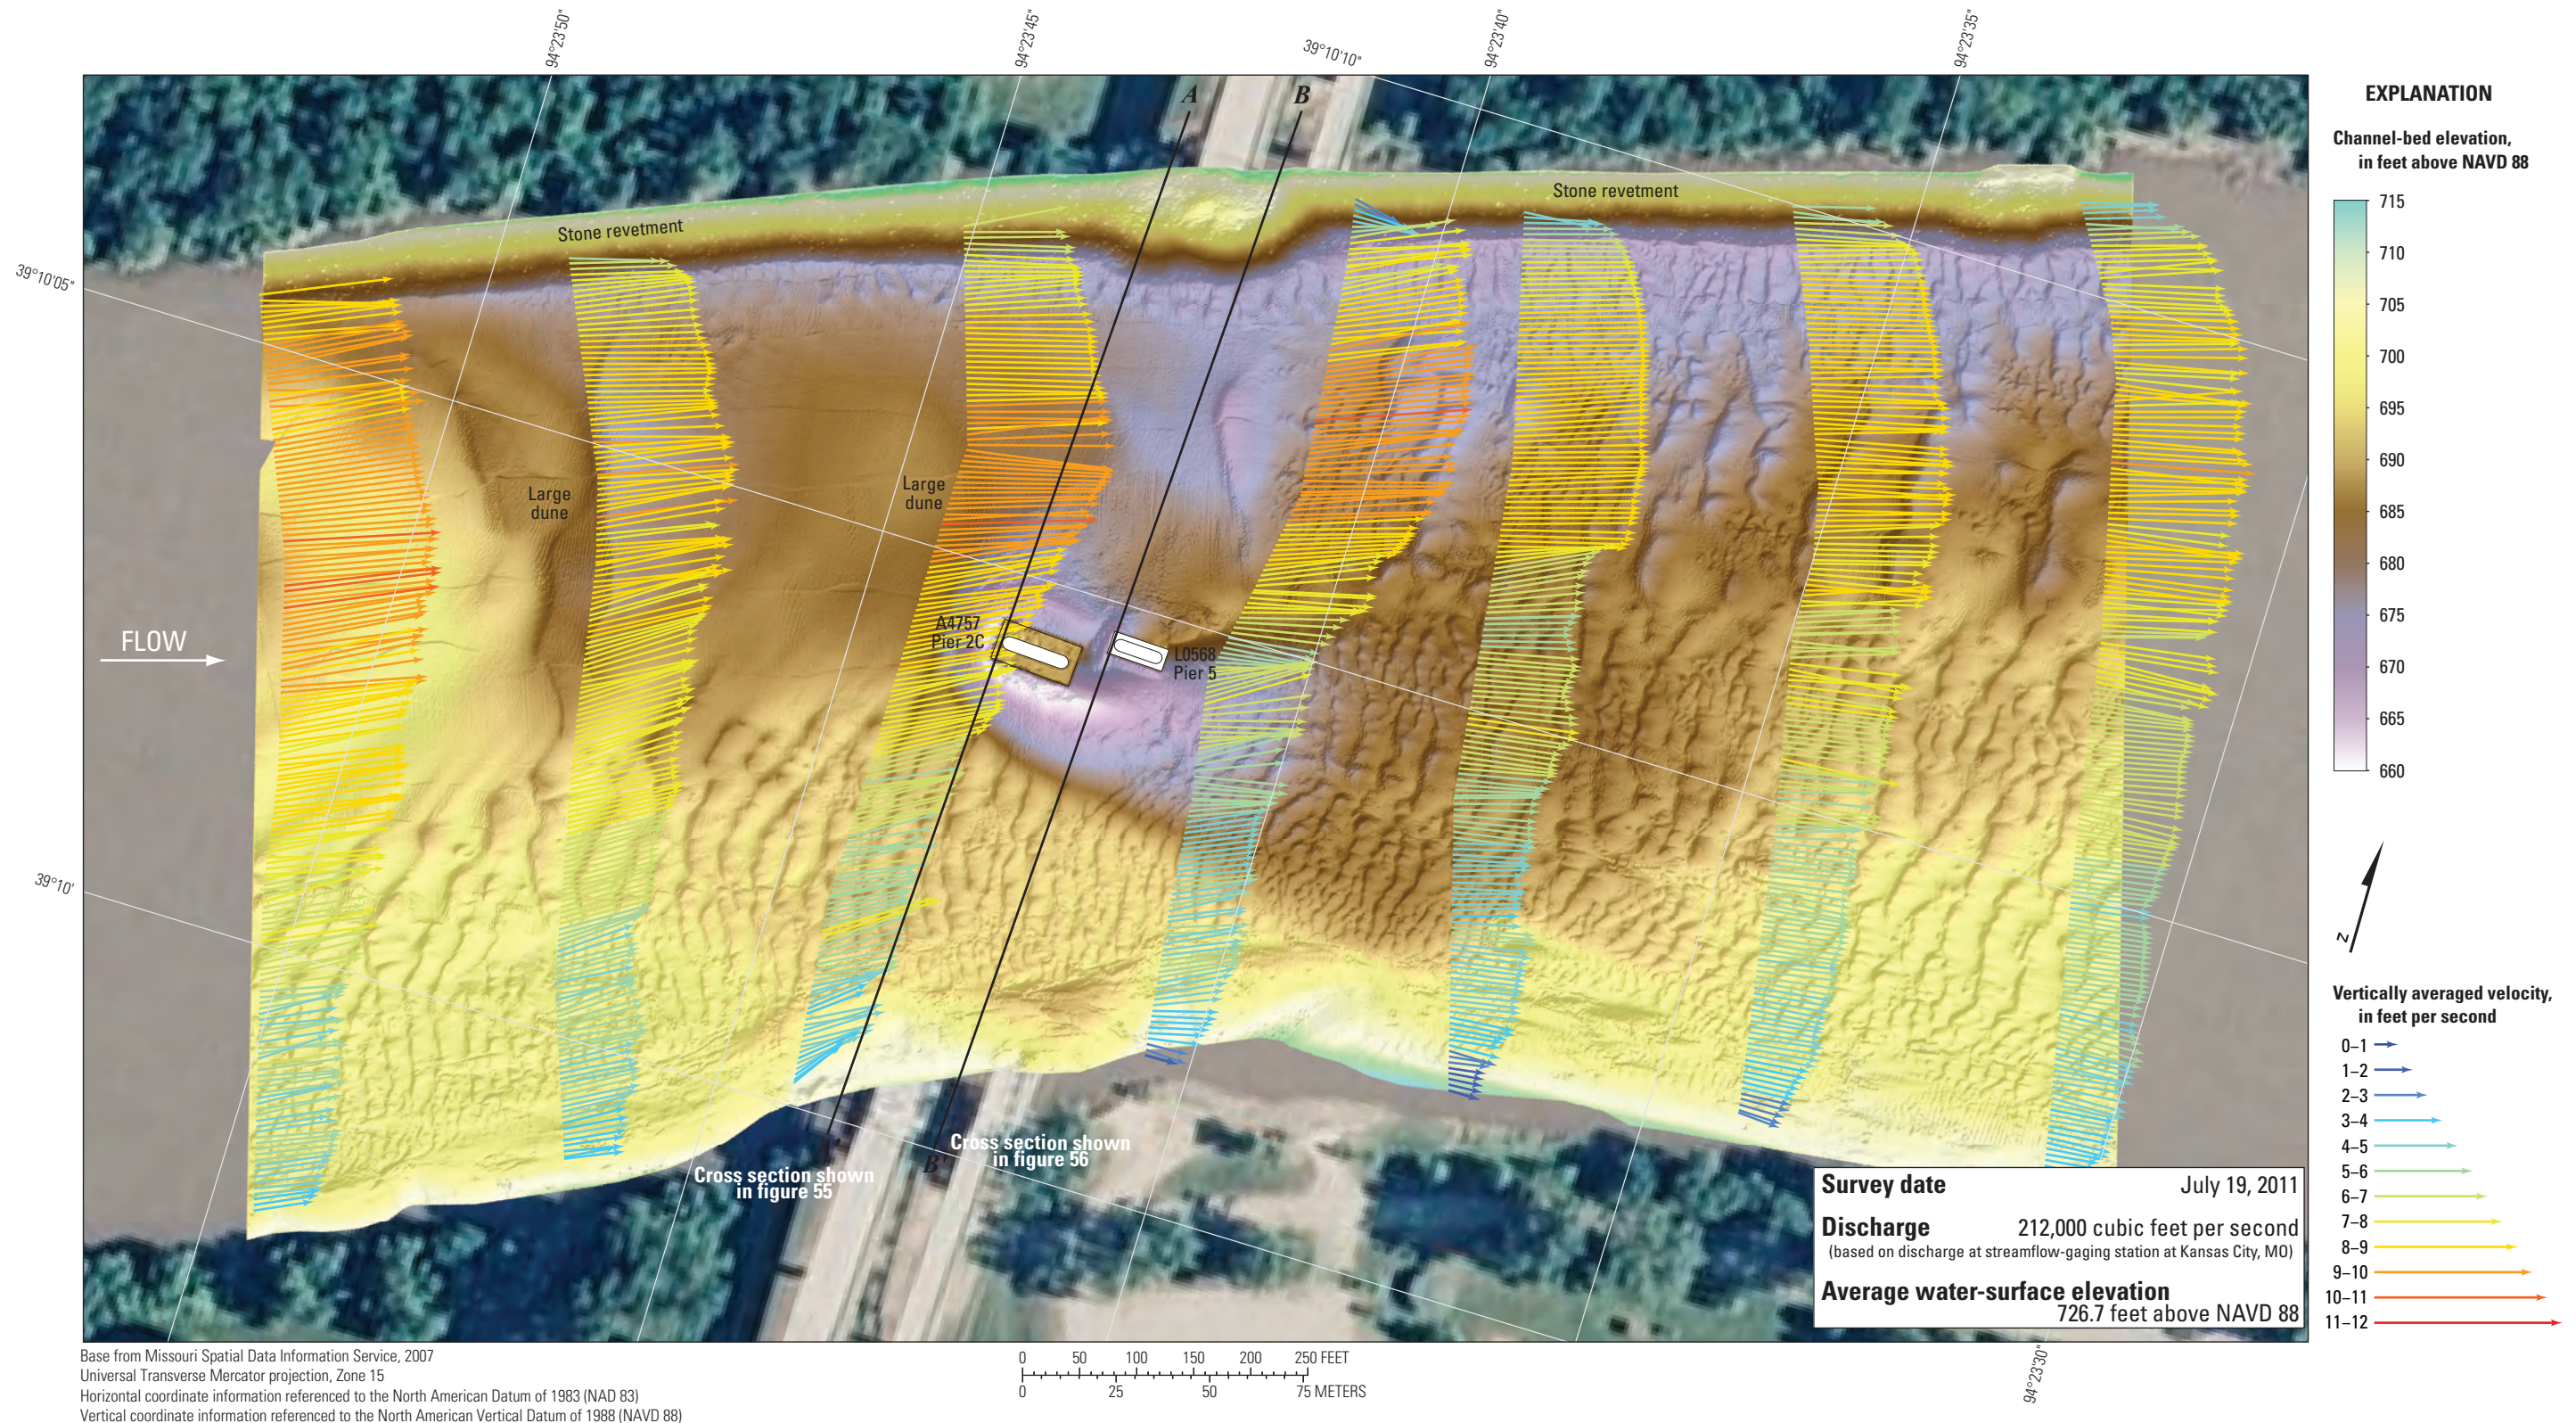
Figure 58. Bathymetry and vertically averaged velocities of the Missouri River channel in the vicinity of structures A4757 and L0568 on State Highway 291 in Kansas City, Missouri.

The vertically averaged velocity vectors indicate mostly uniform flow throughout the reach, ranging from about 3 ft/s along the inside of the bend on the right (south) bank to nearly 12 ft/s in the thalweg (fig. 58). Flow was angled to the left (north) near the upstream and downstream faces of the bridges (fig. 58). Moderate turbulence was observed in several transects, particularly near the bank protrusions near the bridges and downstream from the main channel piers (fig. 58). Velocities were slightly lower downstream from the bridges, likely caused by the flow expansion downstream from the constriction at the bridges (fig. 58).

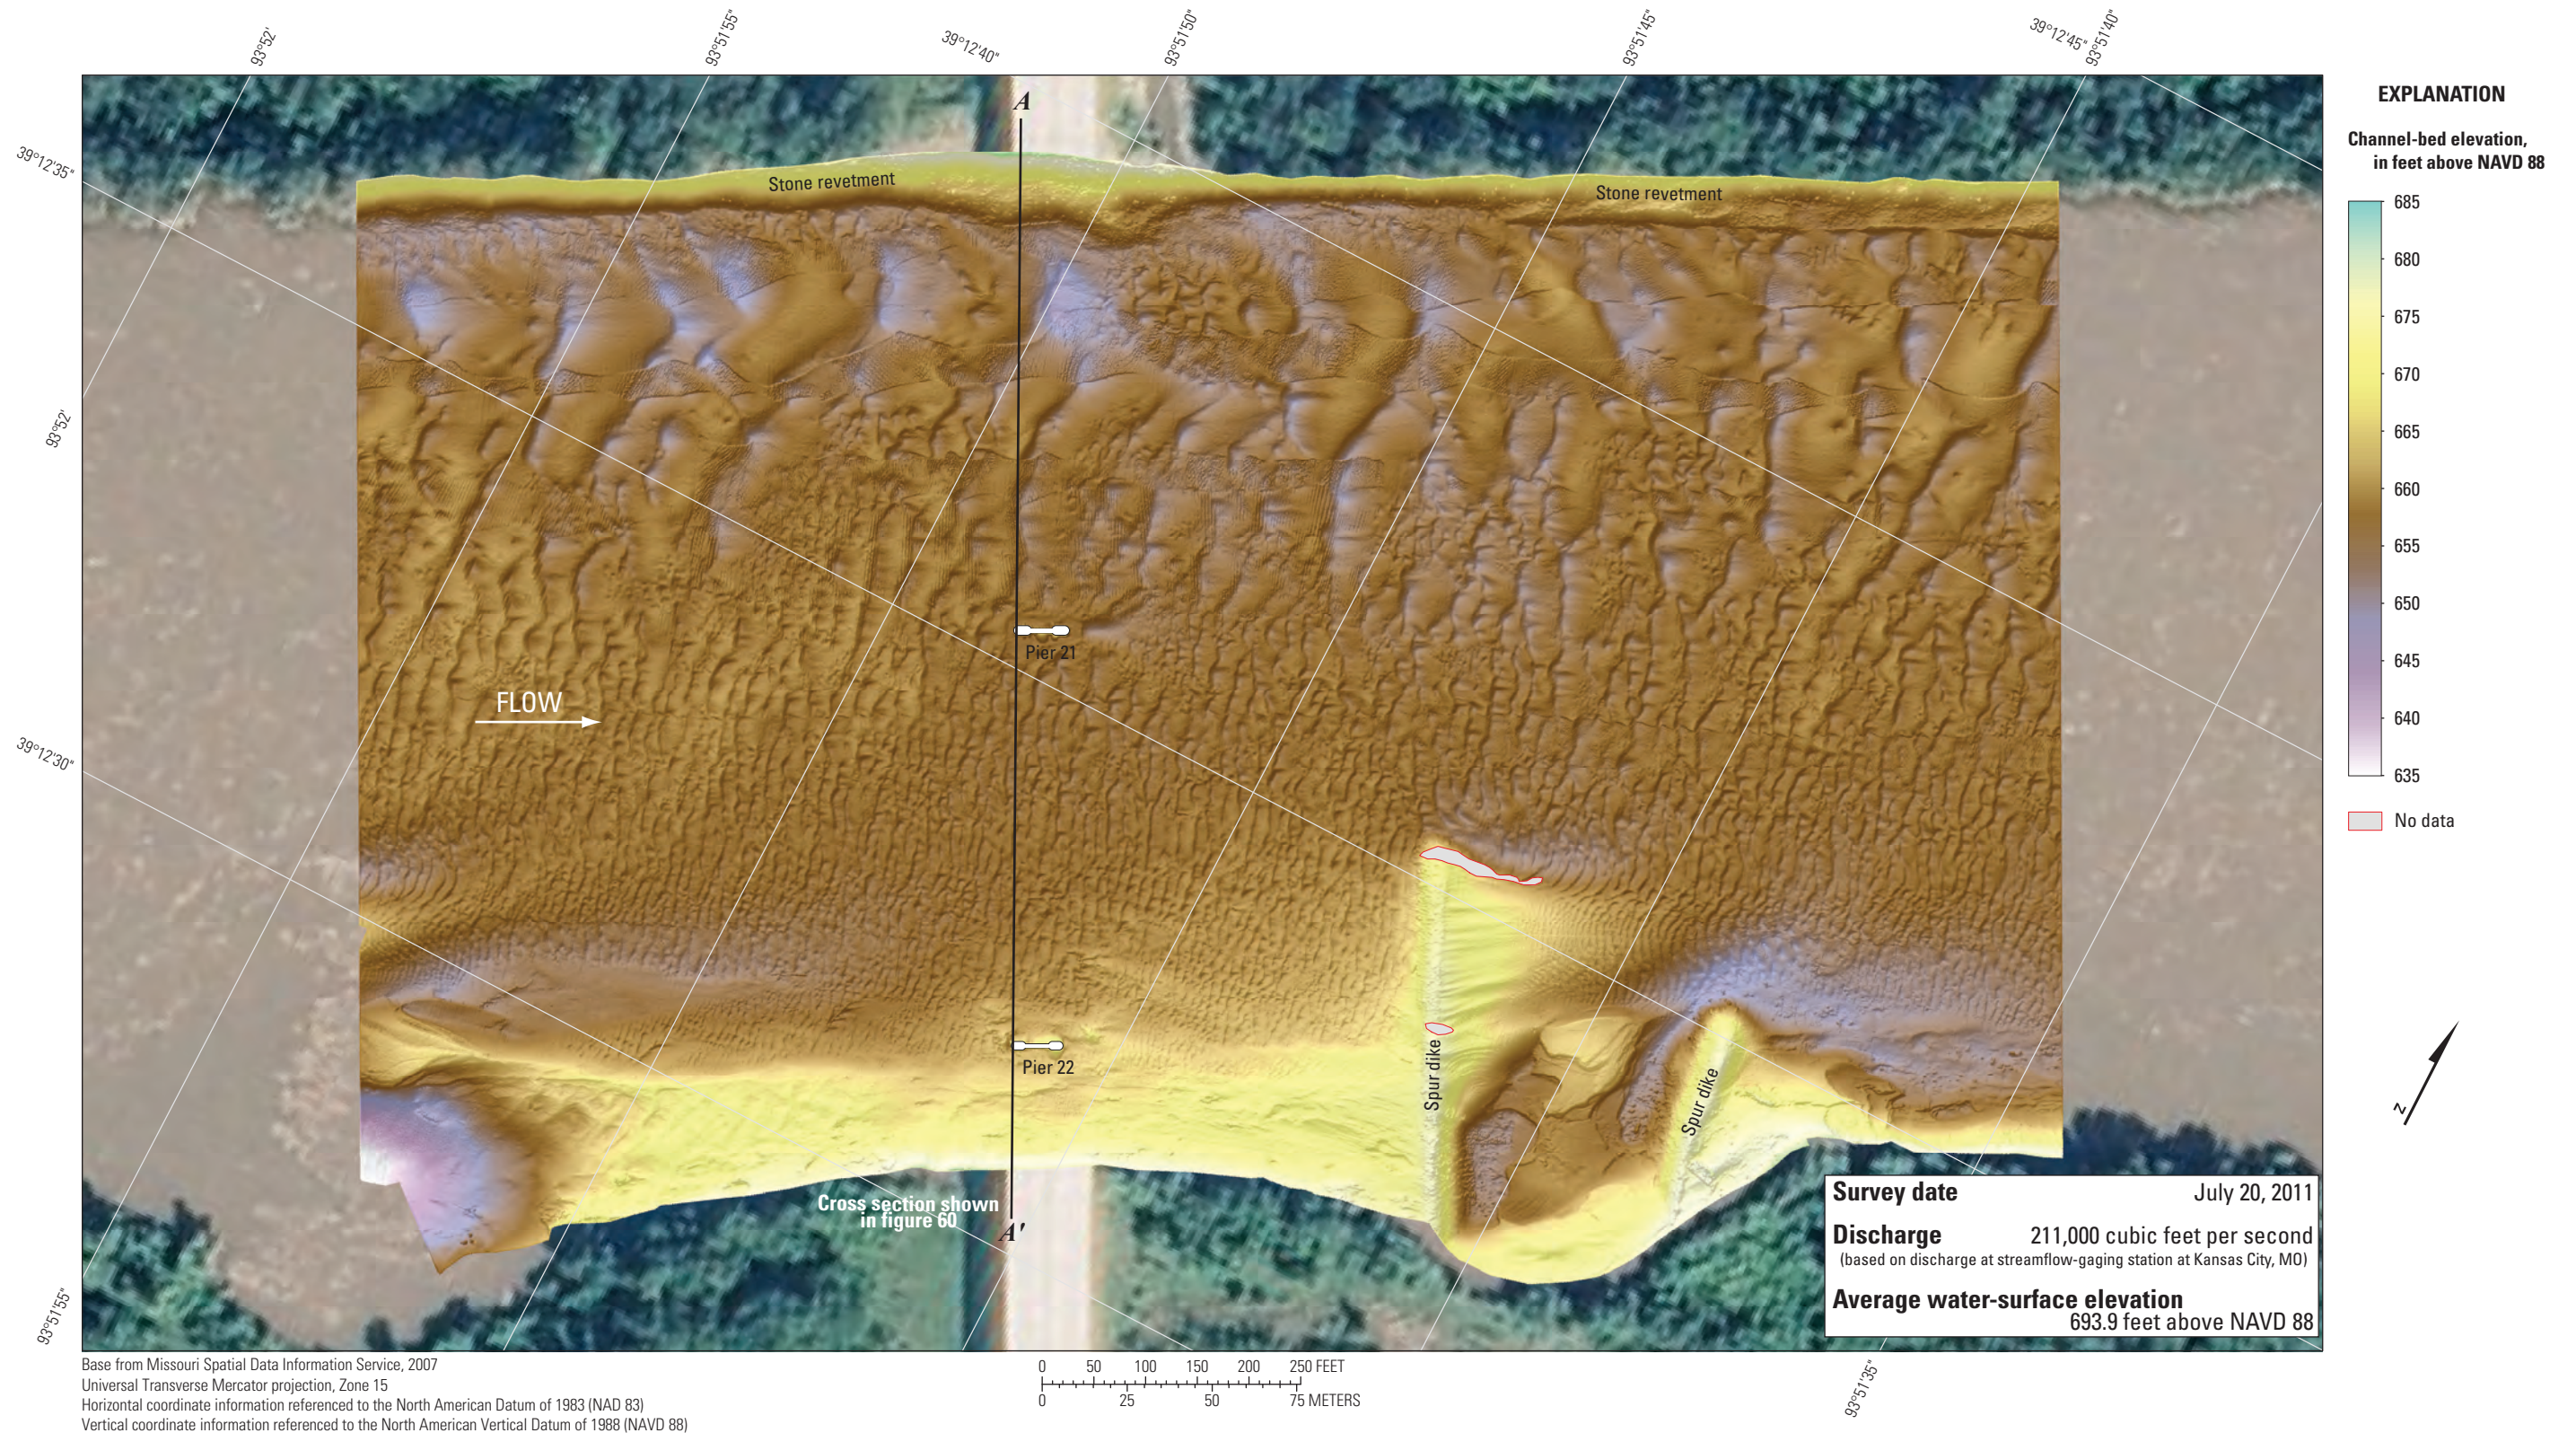
Figure 59. Bathymetric survey of the Missouri River channel in the vicinity of structure A5664 on State Highway 13 at Lexington, Missouri

The minor scour holes in the vicinity of both main channel piers 21 and 22 were difficult to discern from nearby dunes and ripples (fig. 59). The top of the footing for pier 21 was evident at the downstream end of the pier (fig. 59). Information from bridge plans indicates that piers 21 and 22 are founded on shafts drilled 28 to 50 ft into bedrock, with about 49 ft of bed material between the channel bottom and bedrock at pier 21 and about 27 ft of material at pier 22 (fig. 60; table 8). The surveyed bed generally was similar to the original ground line from bridge plans (1999), with an area of 5 to 10 ft of deposition near pier 22 (fig. 60).
