Bathymetric and Velocimetric Surveys at Highway Bridges Crossing the Missouri River in and into Missouri during Summer Flooding, July–August 2011

Scientific Investigations Report 2012–5204

By Richard J. Huizinga

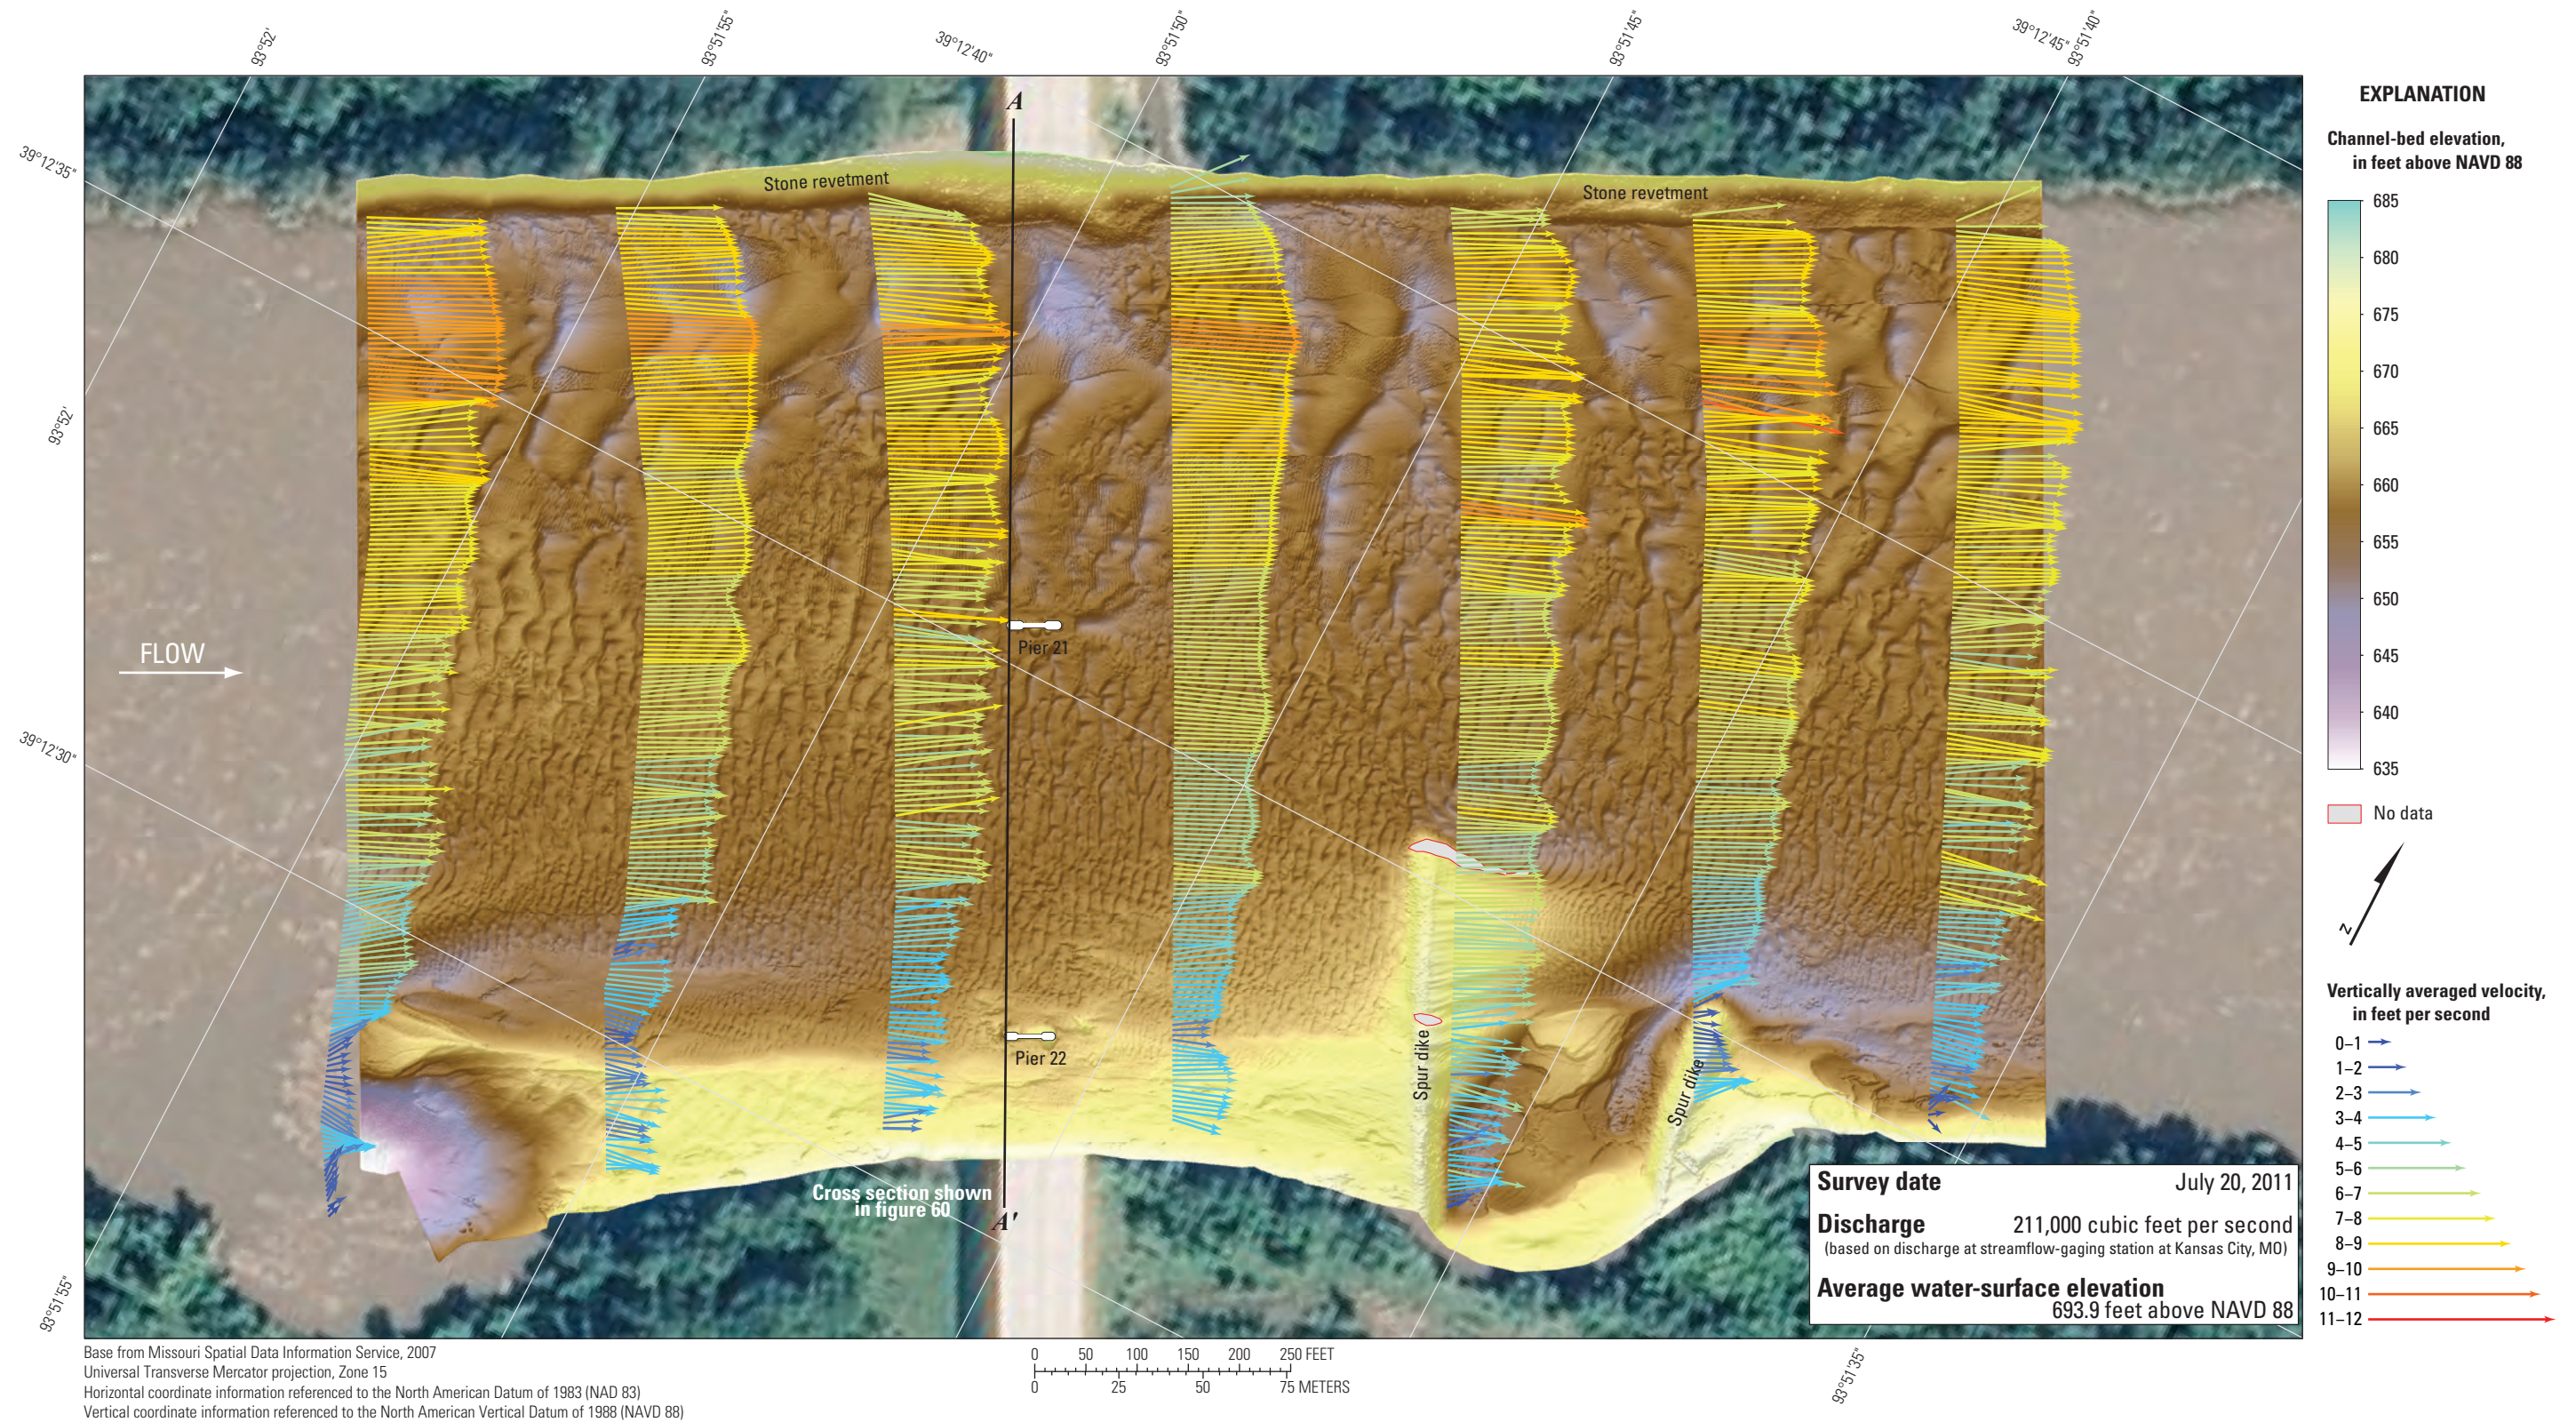
Figure 61. Bathymetry and vertically averaged velocities of the Missouri River channel in the vicinity of structure A5664 on State Highway 13 at Lexington, Missouri.

The vertically averaged velocity vectors indicate mostly uniform flow throughout most of the channel, ranging from about 4 to 10 ft/s (fig. 61), except downstream from the spur dikes on the right (south) bank. Moderate turbulence was observed at several transects (fig. 61), likely as a result of flow disturbances caused by the spur dikes. The bridge piers were aligned with flow, with no evident turbulence downstream from either (fig. 61).

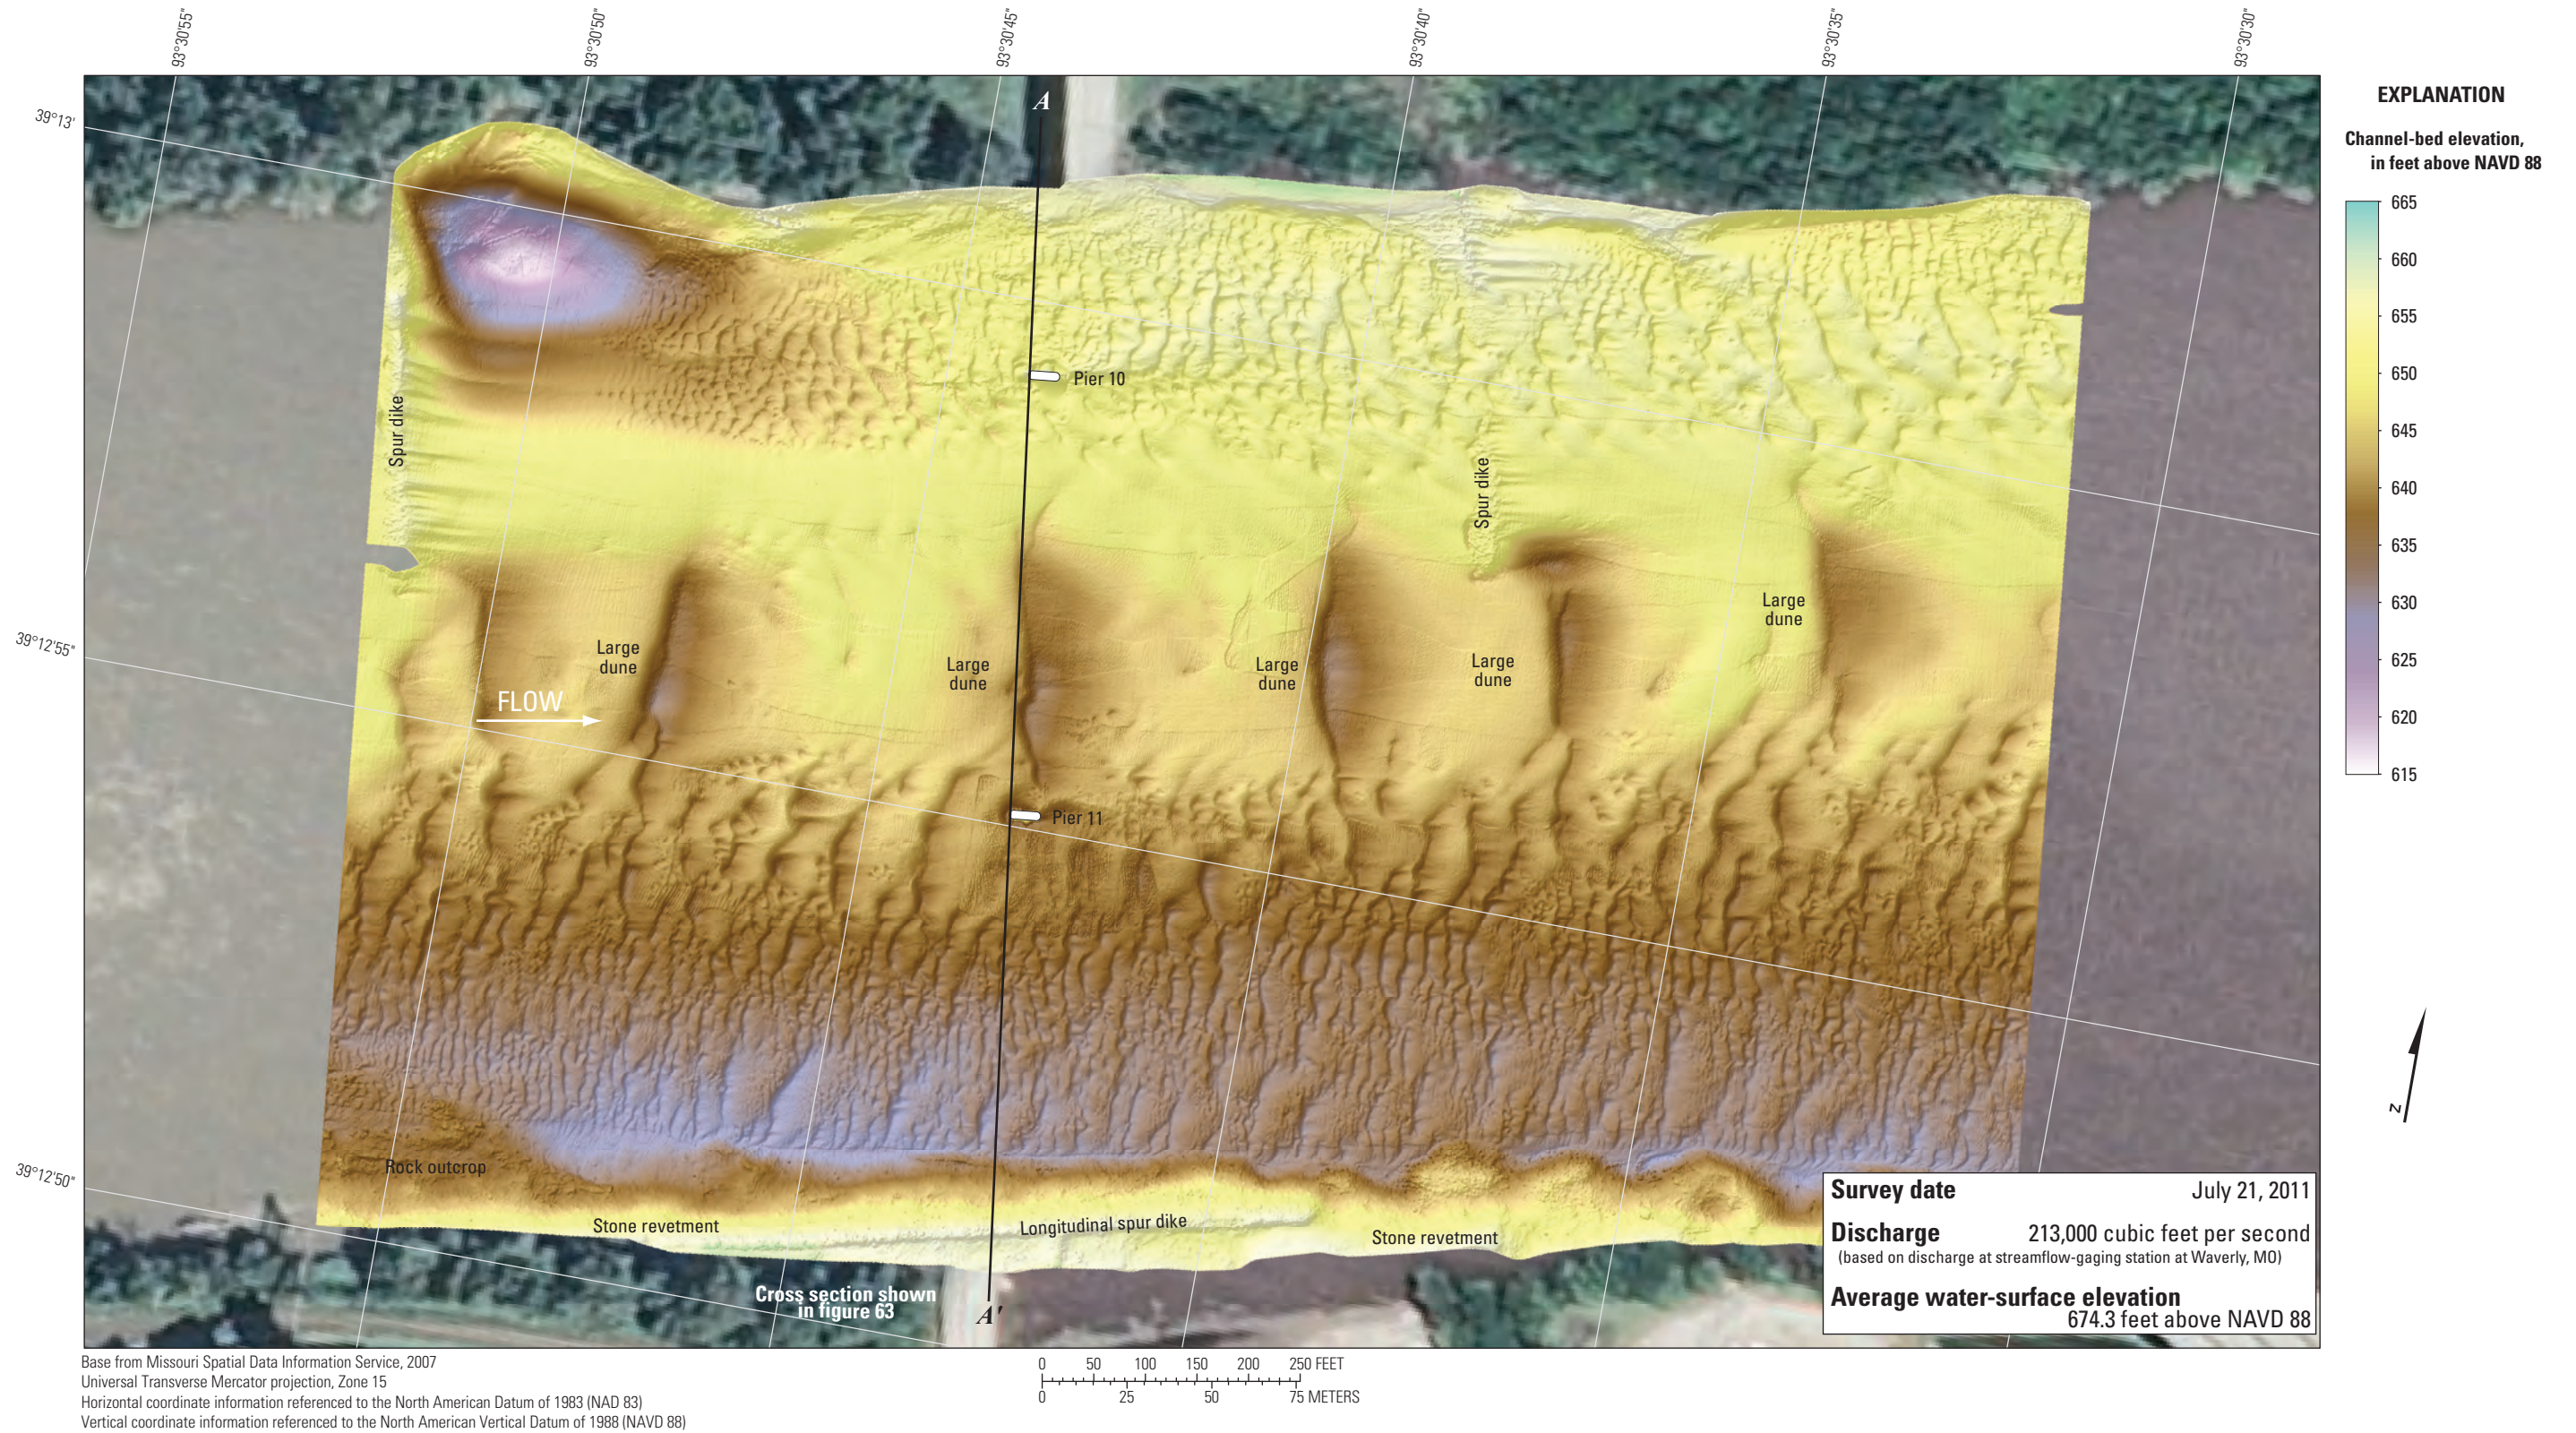
Figure 62. Bathymetric survey of the Missouri River channel in the vicinity of structure A5910 on U.S. Highway 24 at Waverly, Missouri.

The survey area was about 1,640 ft long and about 1,020 ft wide, extending from bank to bank in the main channel (fig. 62). The upstream end of the survey area was about 650 ft upstream from the centerline of structure A5910 (fig. 62), and piers 10 and 11 were in the water and away from the banks. The channel-bed elevations ranged from about 632 to 653 ft for most of the surveyed area (5 to 95 percentile range of the bathymetric data), except in the vicinity of the upstream spur dike on the left (north) bank (fig. 62). A deep thalweg on the right (south) bank on the upstream end of the surveyed area was about 20 ft deeper than the channel bed in the middle of the channel (fig. 62). A series of large dune features were detected in the middle of the channel, and numerous medium and small dunes and ripples were present throughout the rest of the channel (fig. 62). Around the downstream spur dike on the left (north) side, the elevations were 20 to 25 ft higher than elevations in the thalweg on

the right side (fig. 62). Rock outcrops, stone revetment, and longitudinal spur dikes were present on the right (south) bank throughout the reach (fig. 62).

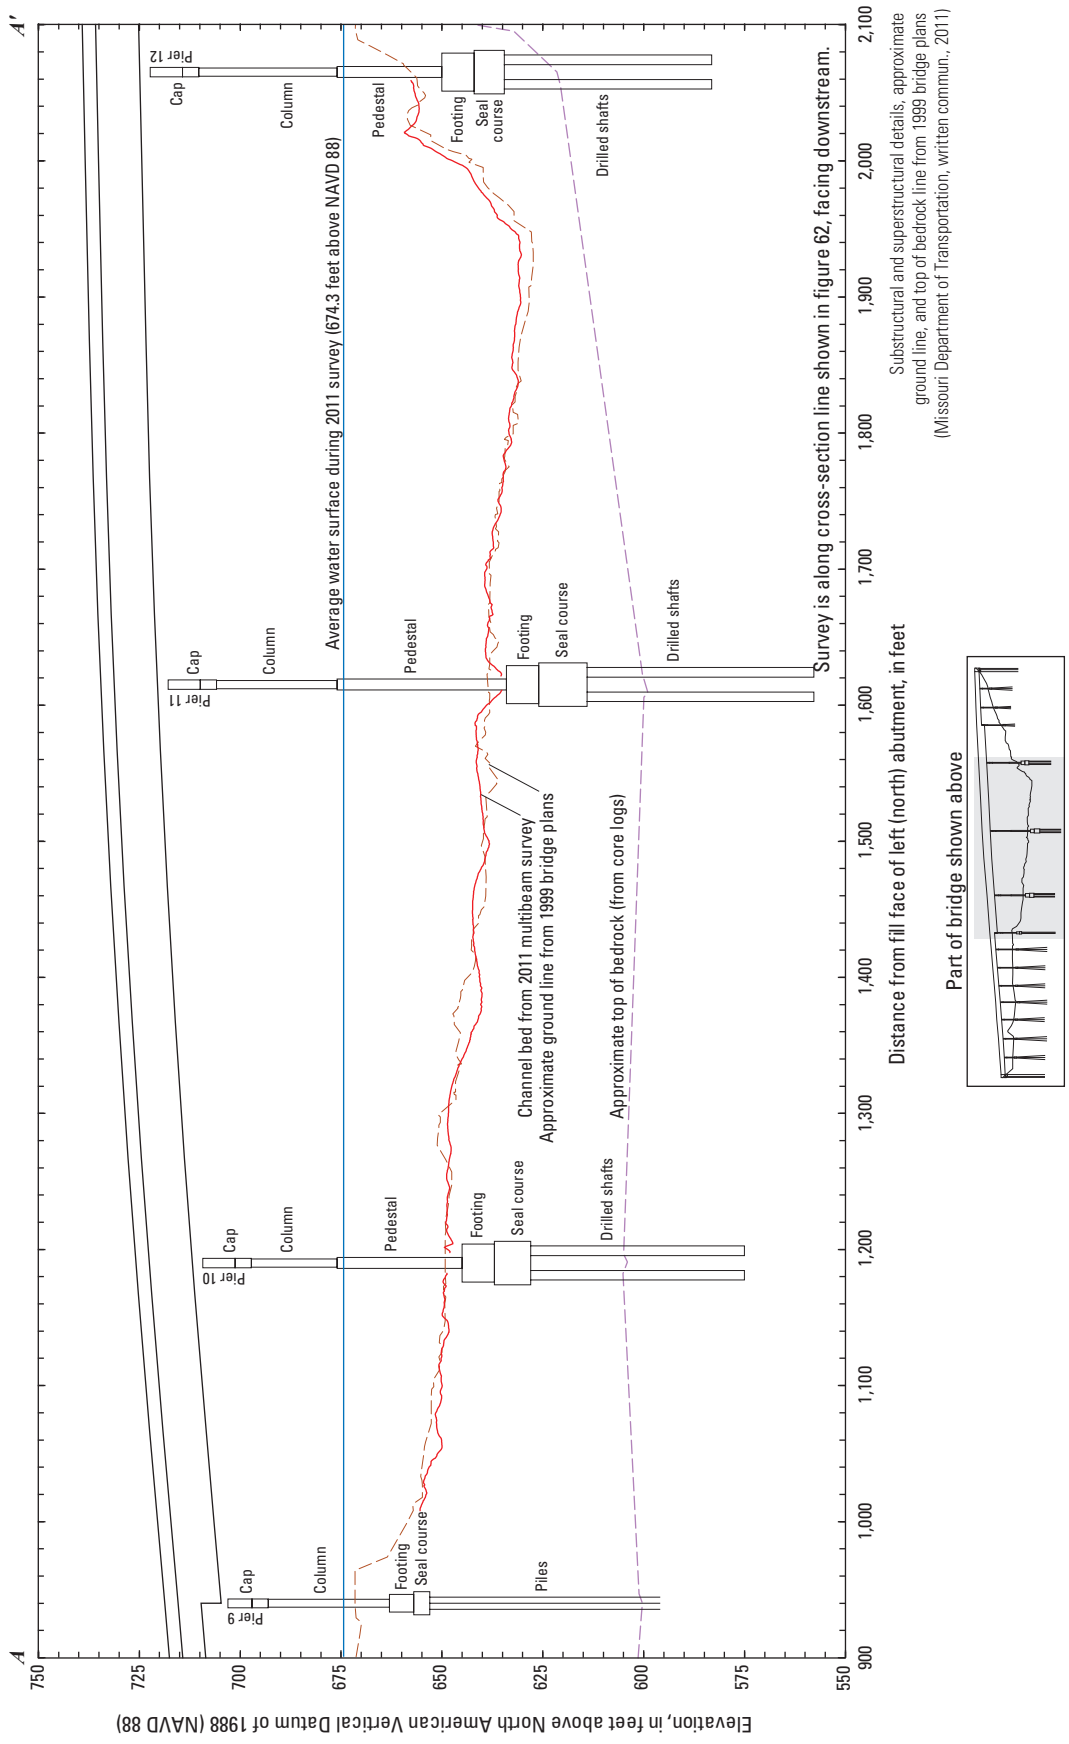
Figure 63. Key features, substructural and superstructural details, and surveyed channel bed of structure A5910 on U.S. Highway 24 over the Missouri River at Waverly, Missouri.

Minor scour holes were observed near the two piers in water. In the vicinity of main channel pier 11 (fig. 62), a minor scour hole had a minimum channel-bed elevation of about 635 ft (table 8), about 21 ft above the elevation of the bottom of the pier seal course of 614.00 ft (fig. 63; table 8). The minor scour hole near pier 10 was difficult to discern from nearby small dunes and ripples (figs. 62, 63). Information from bridge plans indicates that piers 10 and 11 are founded on shafts drilled 30 to 42 ft into bedrock, with about 42 ft of bed material between the bottom of the scour hole and bedrock at pier 10 and about 35 ft of material at pier 11 (fig. 63; table 8). The surveyed bed generally was similar to the original ground line from bridge plans (1999), with localized areas of scour and deposition across the section (fig. 63).

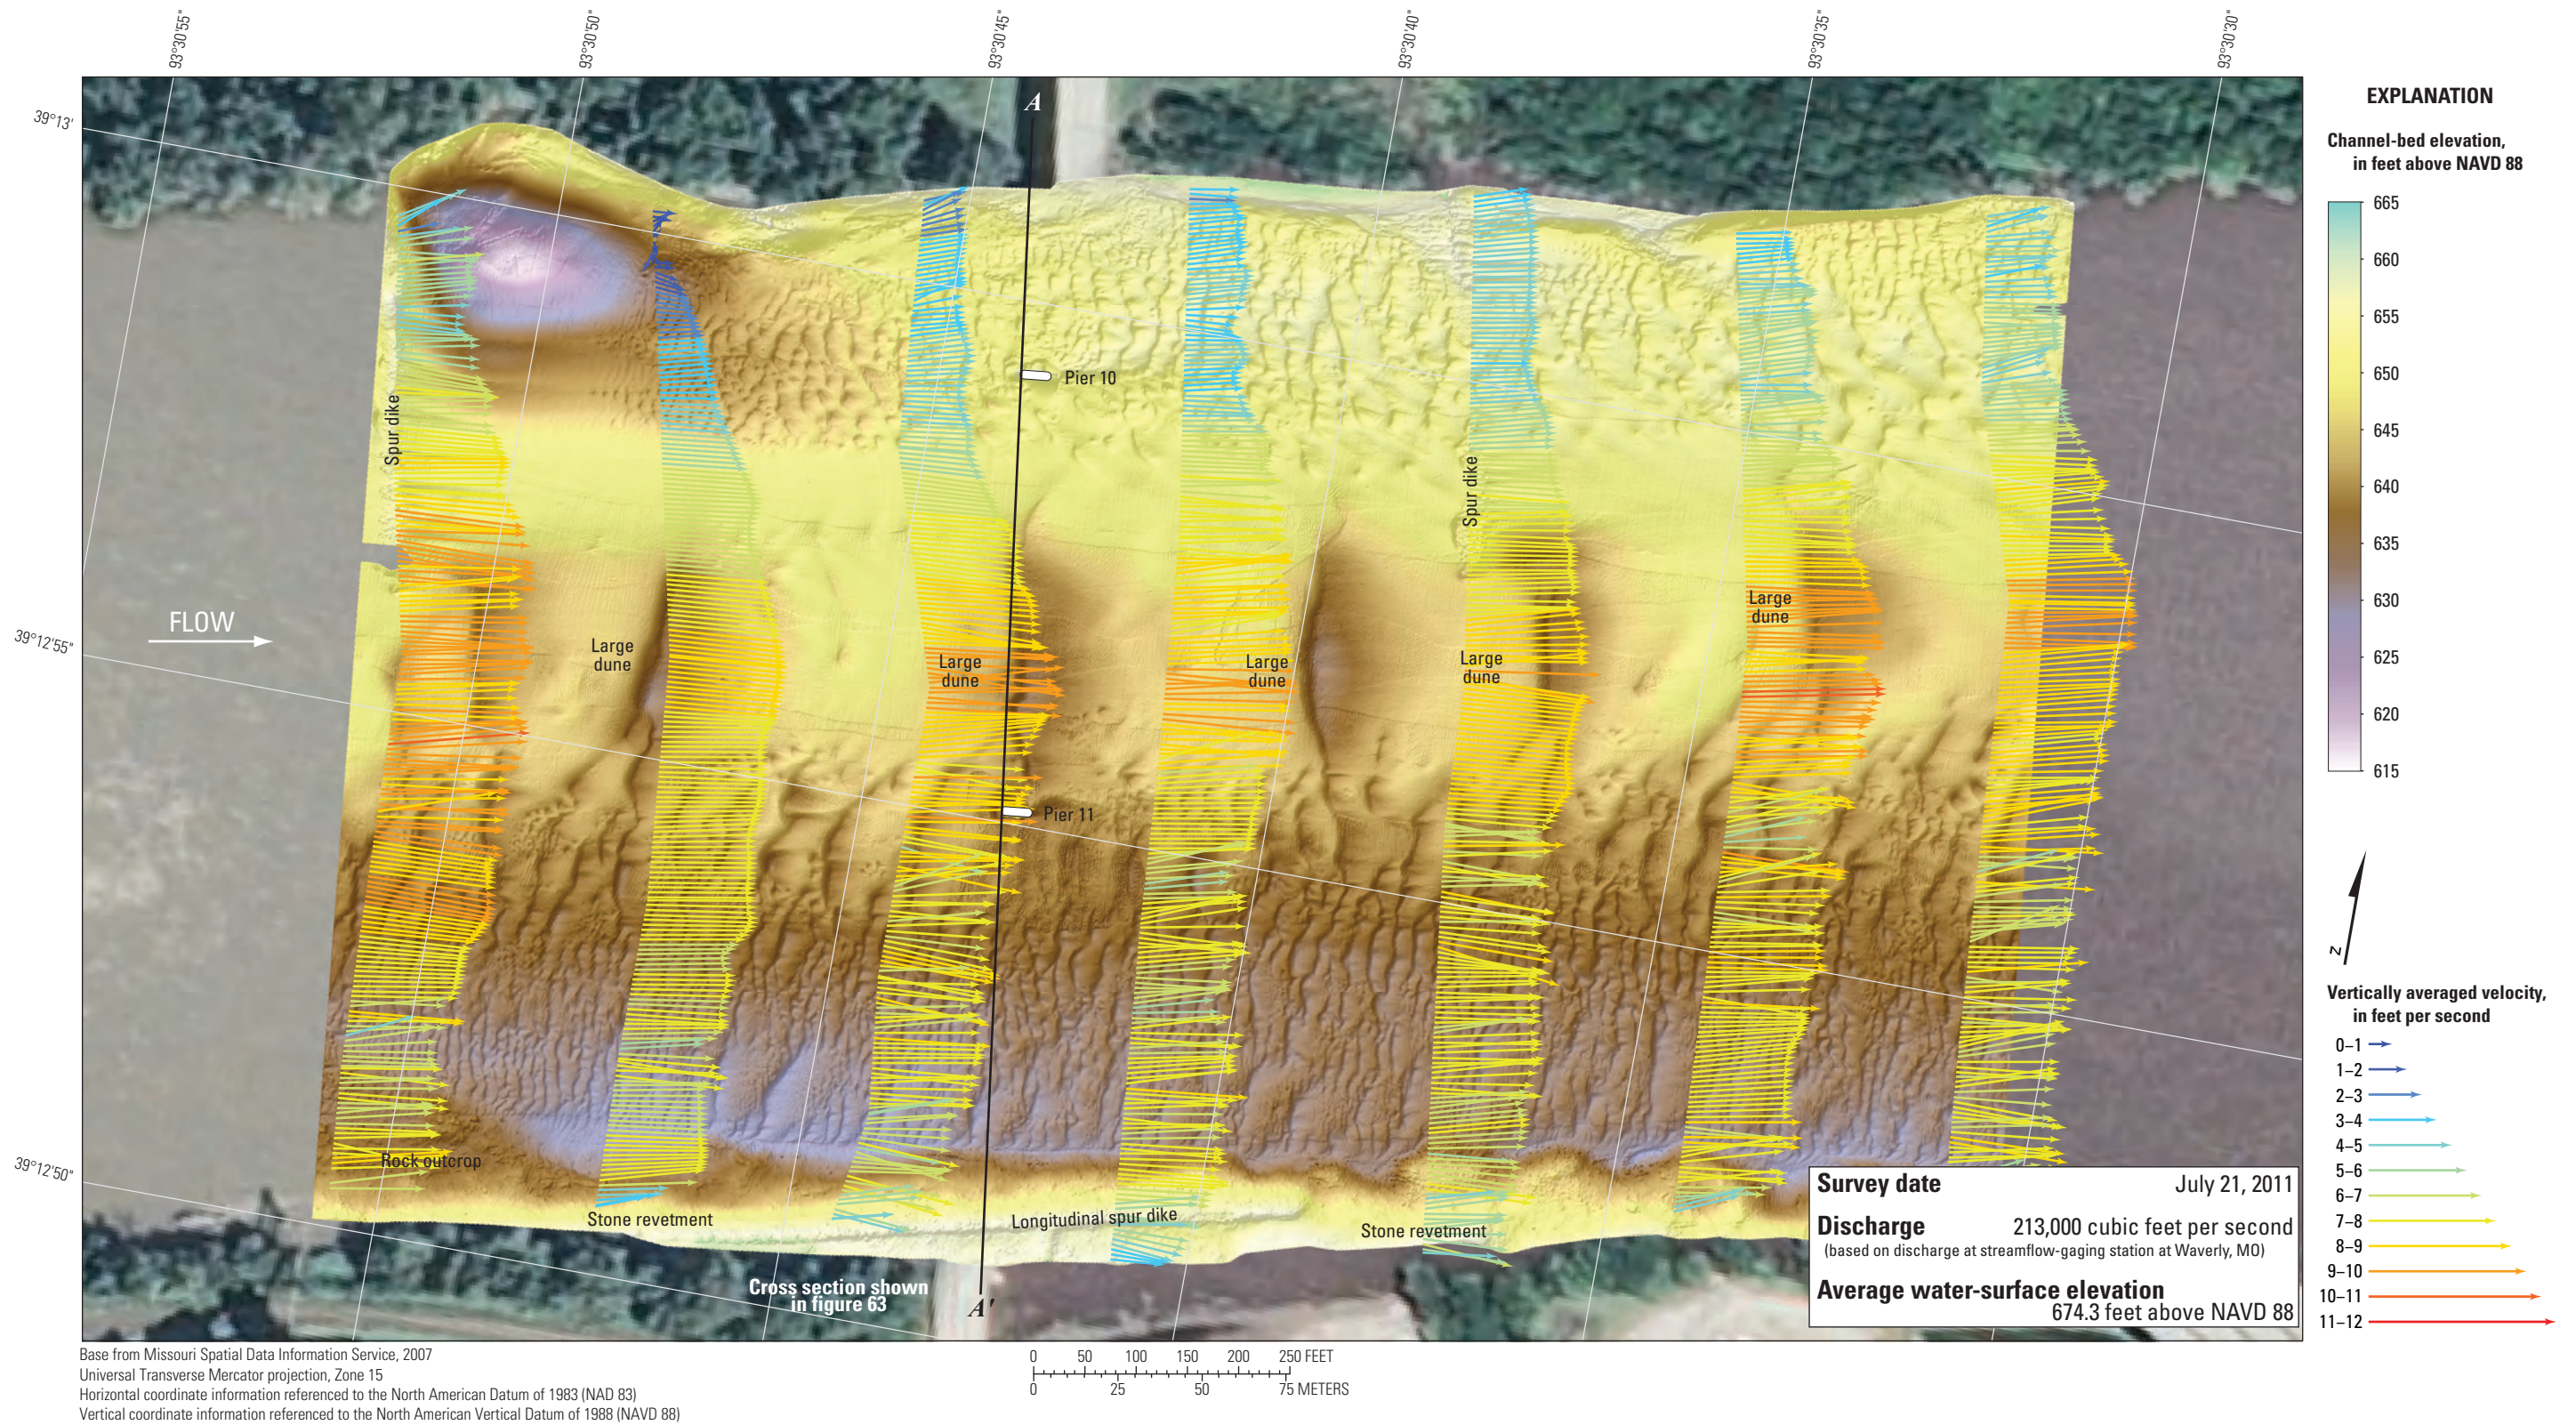
Figure 64. Bathymetry and vertically averaged velocities of the Missouri River channel in the vicinity of structure A5910 on U.S. Highway 24 at Waverly, Missouri.

The vertically averaged velocity vectors indicate mostly uniform flow throughout most of the channel, with velocities ranging from about 4 to 11 ft/s (fig. 64), except downstream from the upstream spur dike on the left (north) bank. Moderate turbulence was observed in the channel thalweg at and downstream from the bridge (fig. 64), and local flow reversal was observed downstream from the upstream spur dike on the left (north) bank (fig. 64). The bridge piers were aligned with flow, with no evident turbulence downstream from either pier (fig. 64).

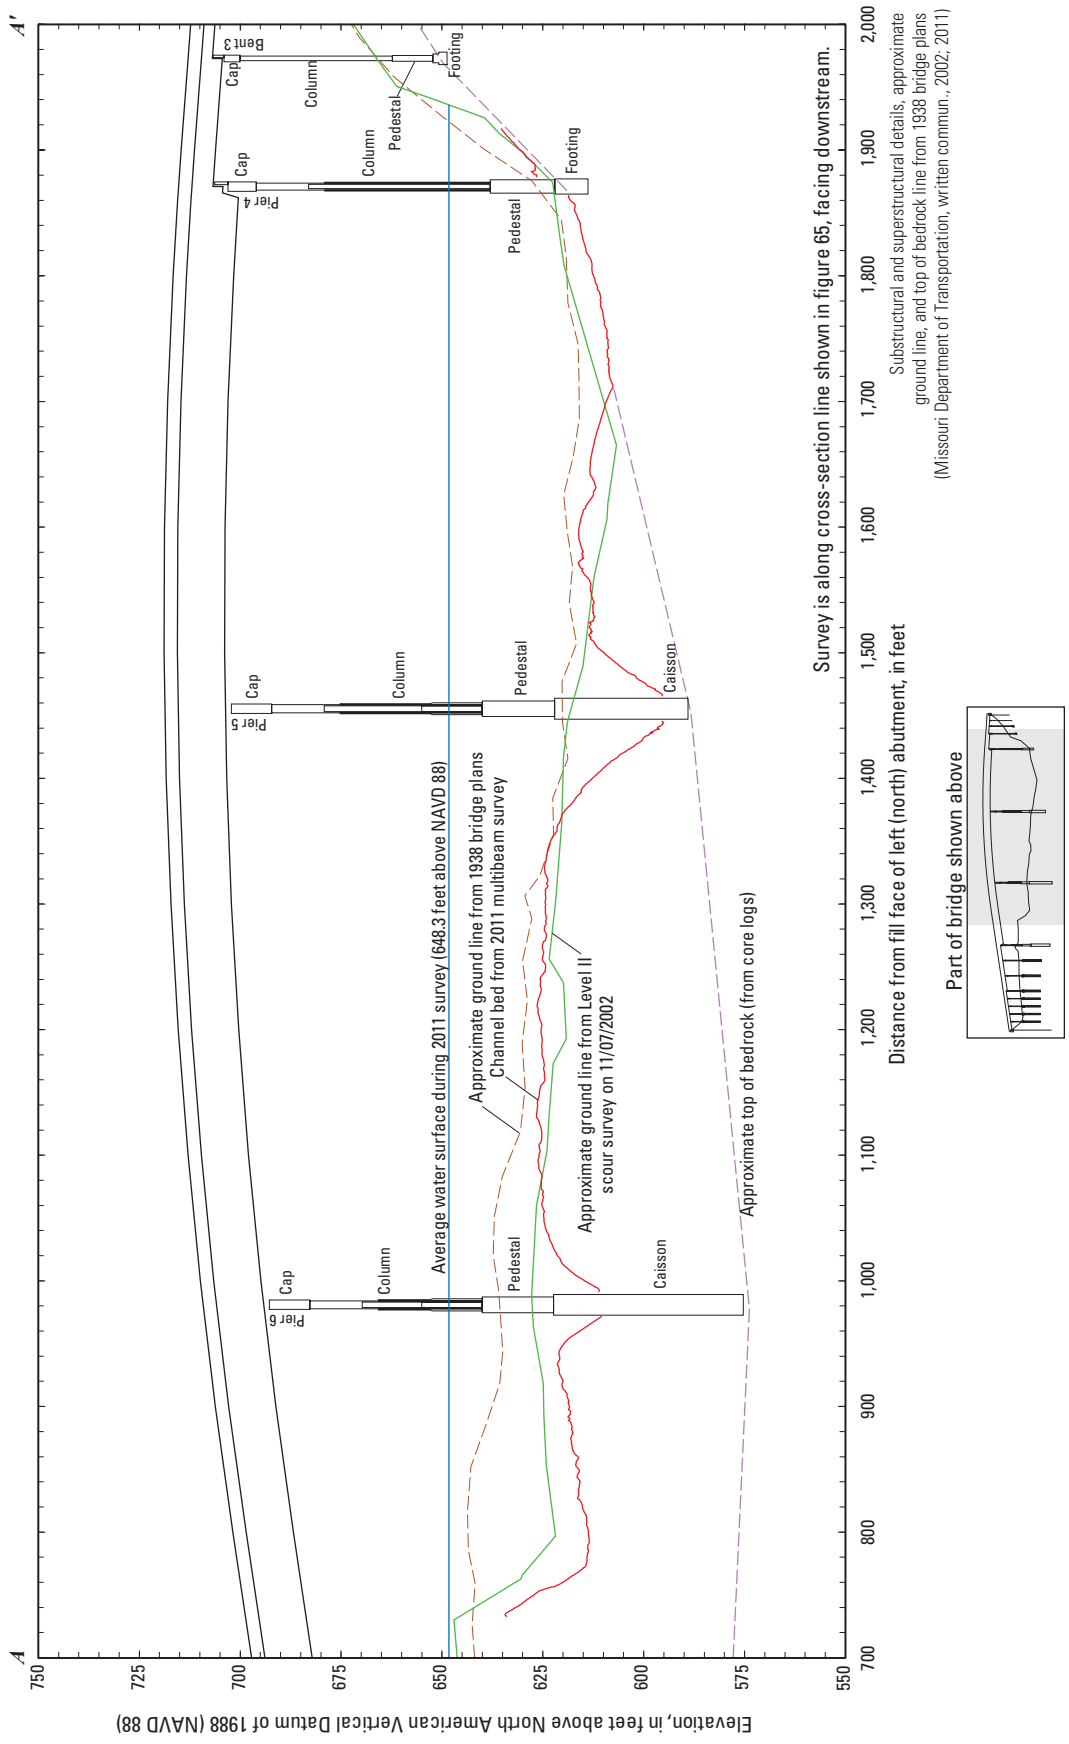
Figure 66. Key features, substructural and superstructural details, and surveyed channel bed of structure K0999 on State Highway 41 over the Missouri River at Miami, Missouri.

Scour holes were observed near two of the three piers in water. In the vicinity of pier 6 (fig. 65), a moderate scour hole had a minimum channel-bed elevation of about 609 ft (table 8), about 14 ft below the average channel bed upstream

from the pier (figs. 65, 66; table 8). A substantial scour hole was observed in the vicinity of pier 5, with a minimum channel-bed elevation of about 593 ft (figs. 65, 66; table 8). Information from bridge plans indicates that piers 5 and 6 are caissons founded on bedrock, with about 35 ft of bed material between the bottom of the scour hole and bedrock at pier 6, but only about 5 ft of material at pier 5 (fig. 66; table 8). No scour hole was observed near pier 4 (fig. 65), which is founded on a footing on bedrock according to bridge plans (fig. 66; table 8). The surveyed bed generally was similar to the ground line from the Level II bridge scour assessment in 2002 except near the piers, with about 5 to 10 ft of deposition between piers 5 and 6 and between pier 5 and the channel thalweg, and about 15 ft of scour near the left bank (fig. 66). The approximate top of bedrock line from bridge plans confirms that the fluvial material near the right bank has washed away, exposing the bedrock along the thalweg (fig. 66). In modern construction, bridge substructural elements usually are pinned or socketed to bedrock (American Association of State Highway Transportation Officials, 2012; Brown and others, 2010), but full exposure of usually buried substructural elements warrants special consideration and observation.

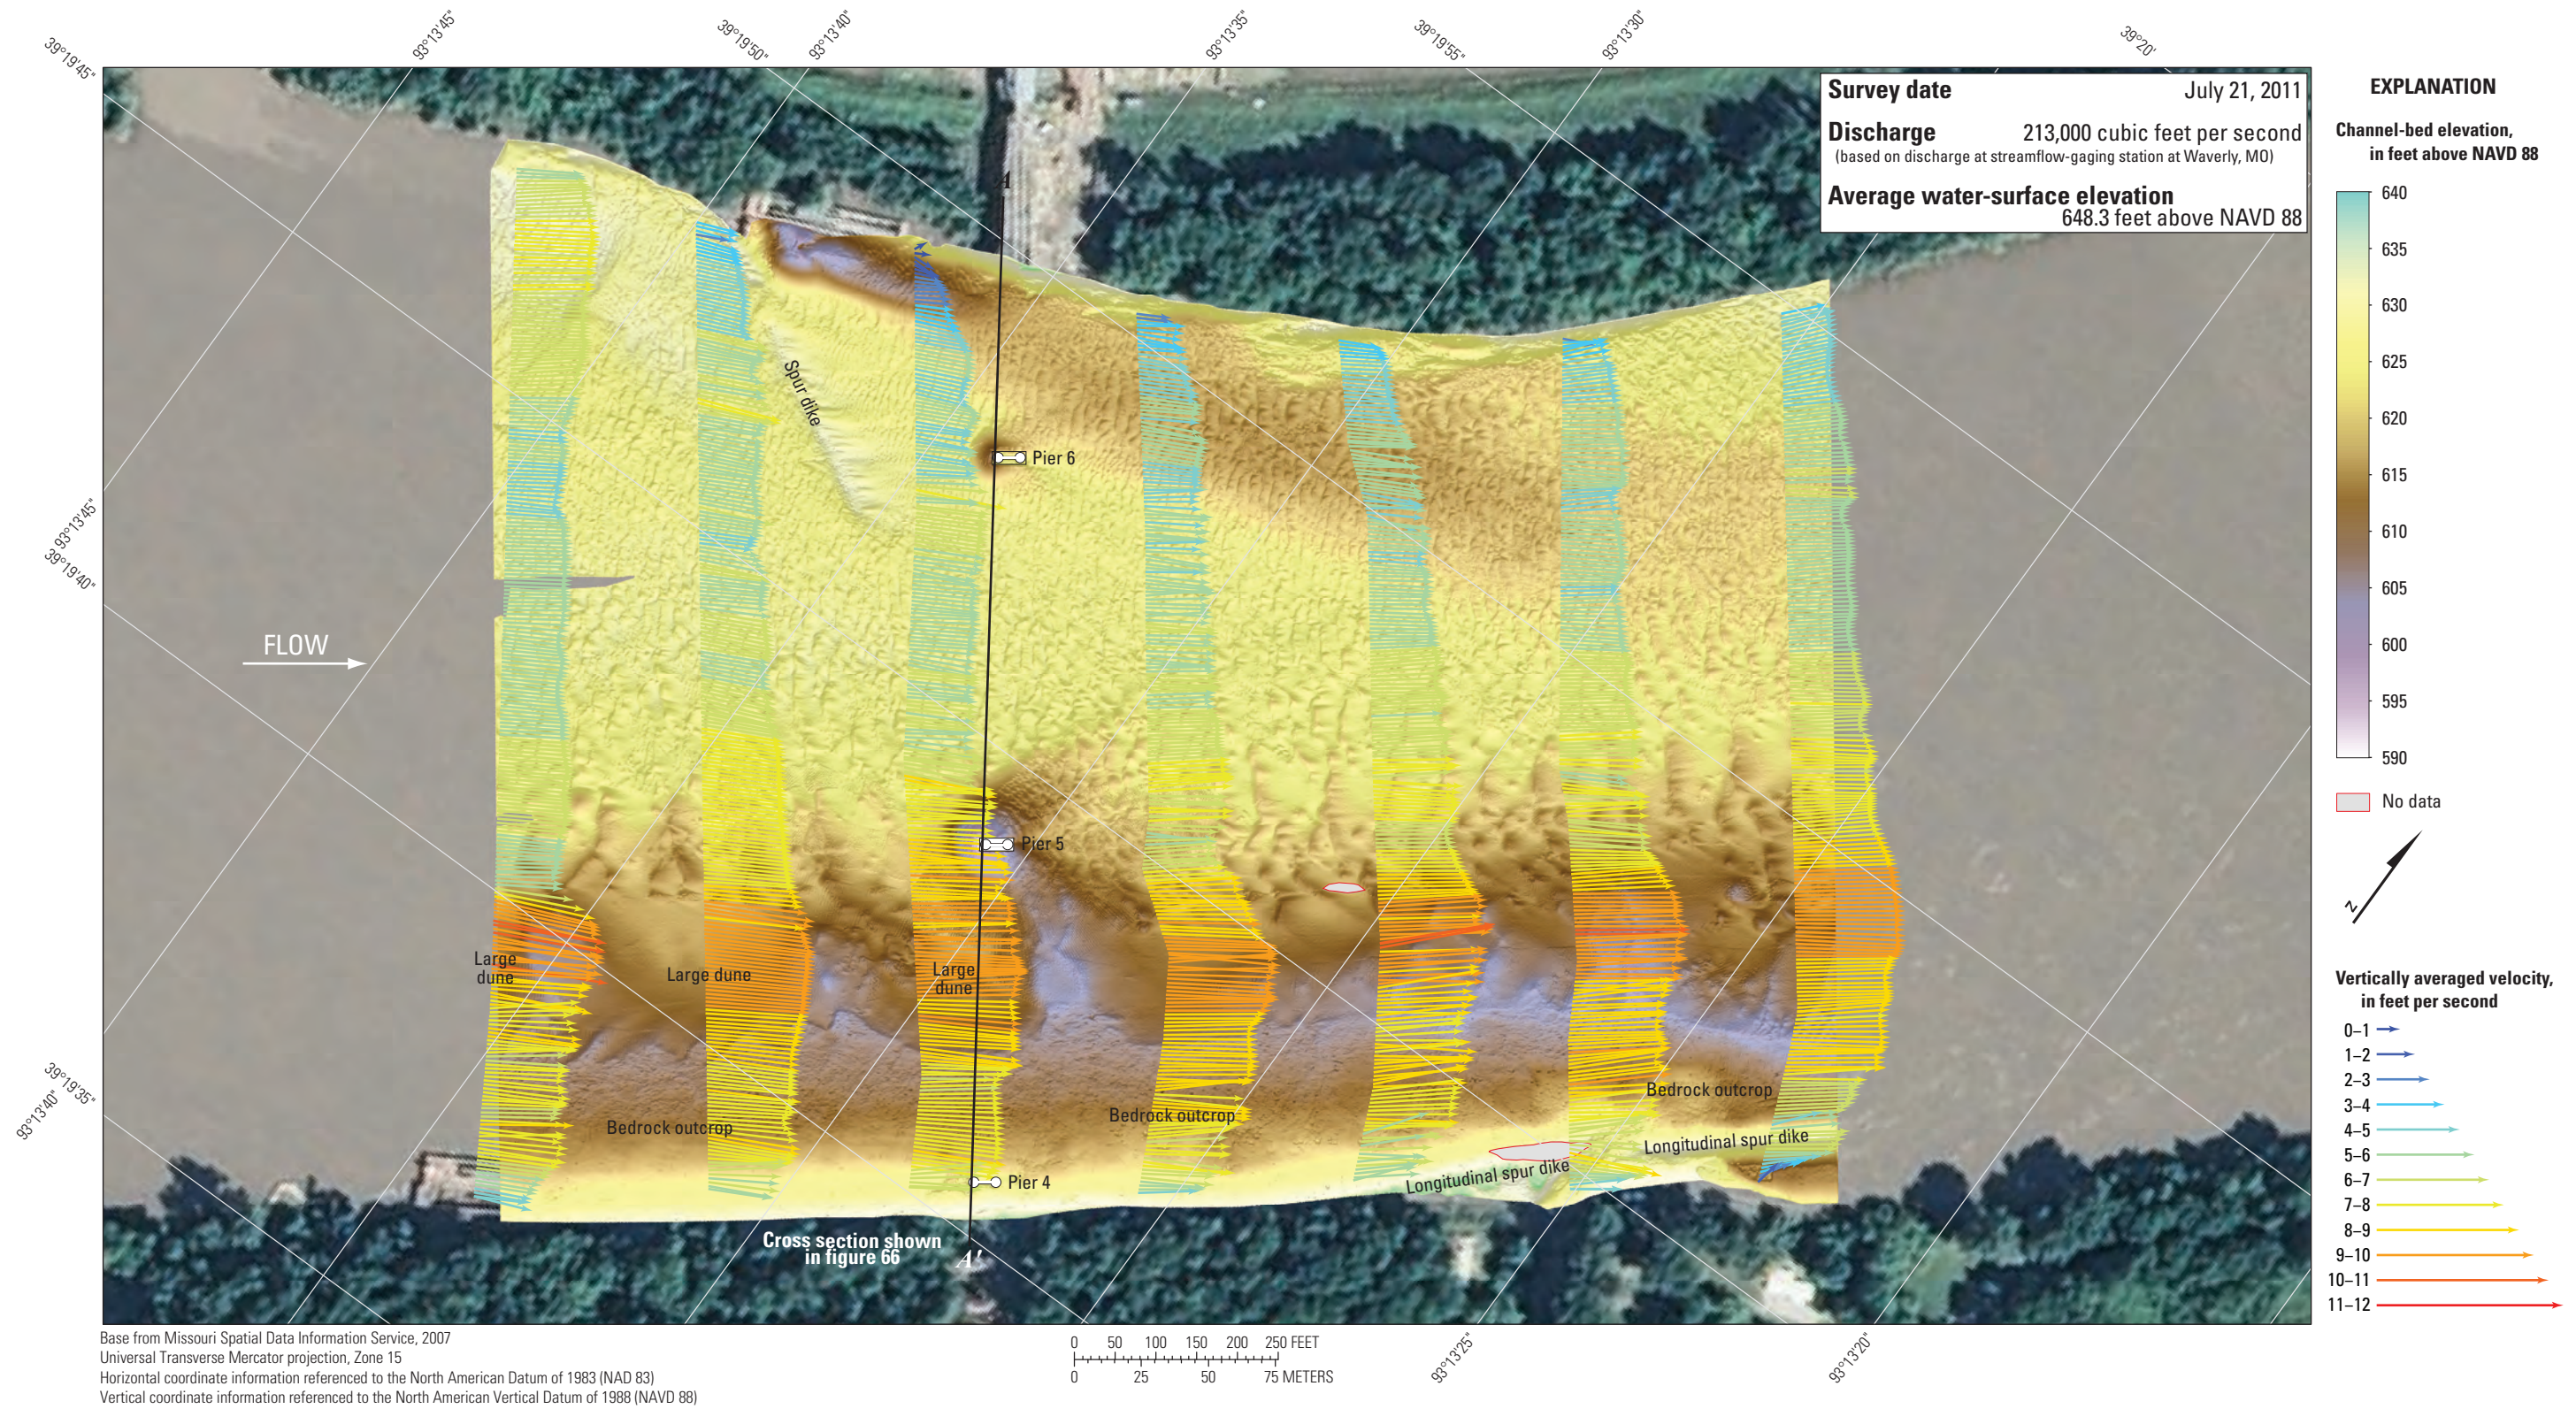
Figure 67. Bathymetry and vertically averaged velocities of the Missouri River channel in the vicinity of structure K0999 on State Highway 41 at Miami, Missouri.

The vertically averaged velocity vectors indicate mostly uniform flow throughout most of the channel, with velocities ranging from about 4 to 10 ft/s (fig. 67). Velocities were higher in the thalweg, and lower in the shallow area on the left (north) side of the channel (fig. 67). Moderate turbulence was observed at various locations in the channel thalweg (fig. 67), and local velocity minima were observed downstream from the spur dike on the left (north) bank and behind the longitudinal spur dike on the right (south) bank (fig. 67). The bridge piers were aligned with flow, with no evident turbulence downstream from any pier (fig. 67).
