Bathymetric and Velocimetric Surveys at Highway Bridges Crossing the Missouri River in and into Missouri during Summer Flooding, July–August 2011

Scientific Investigations Report 2012–5204

By Richard J. Huizinga

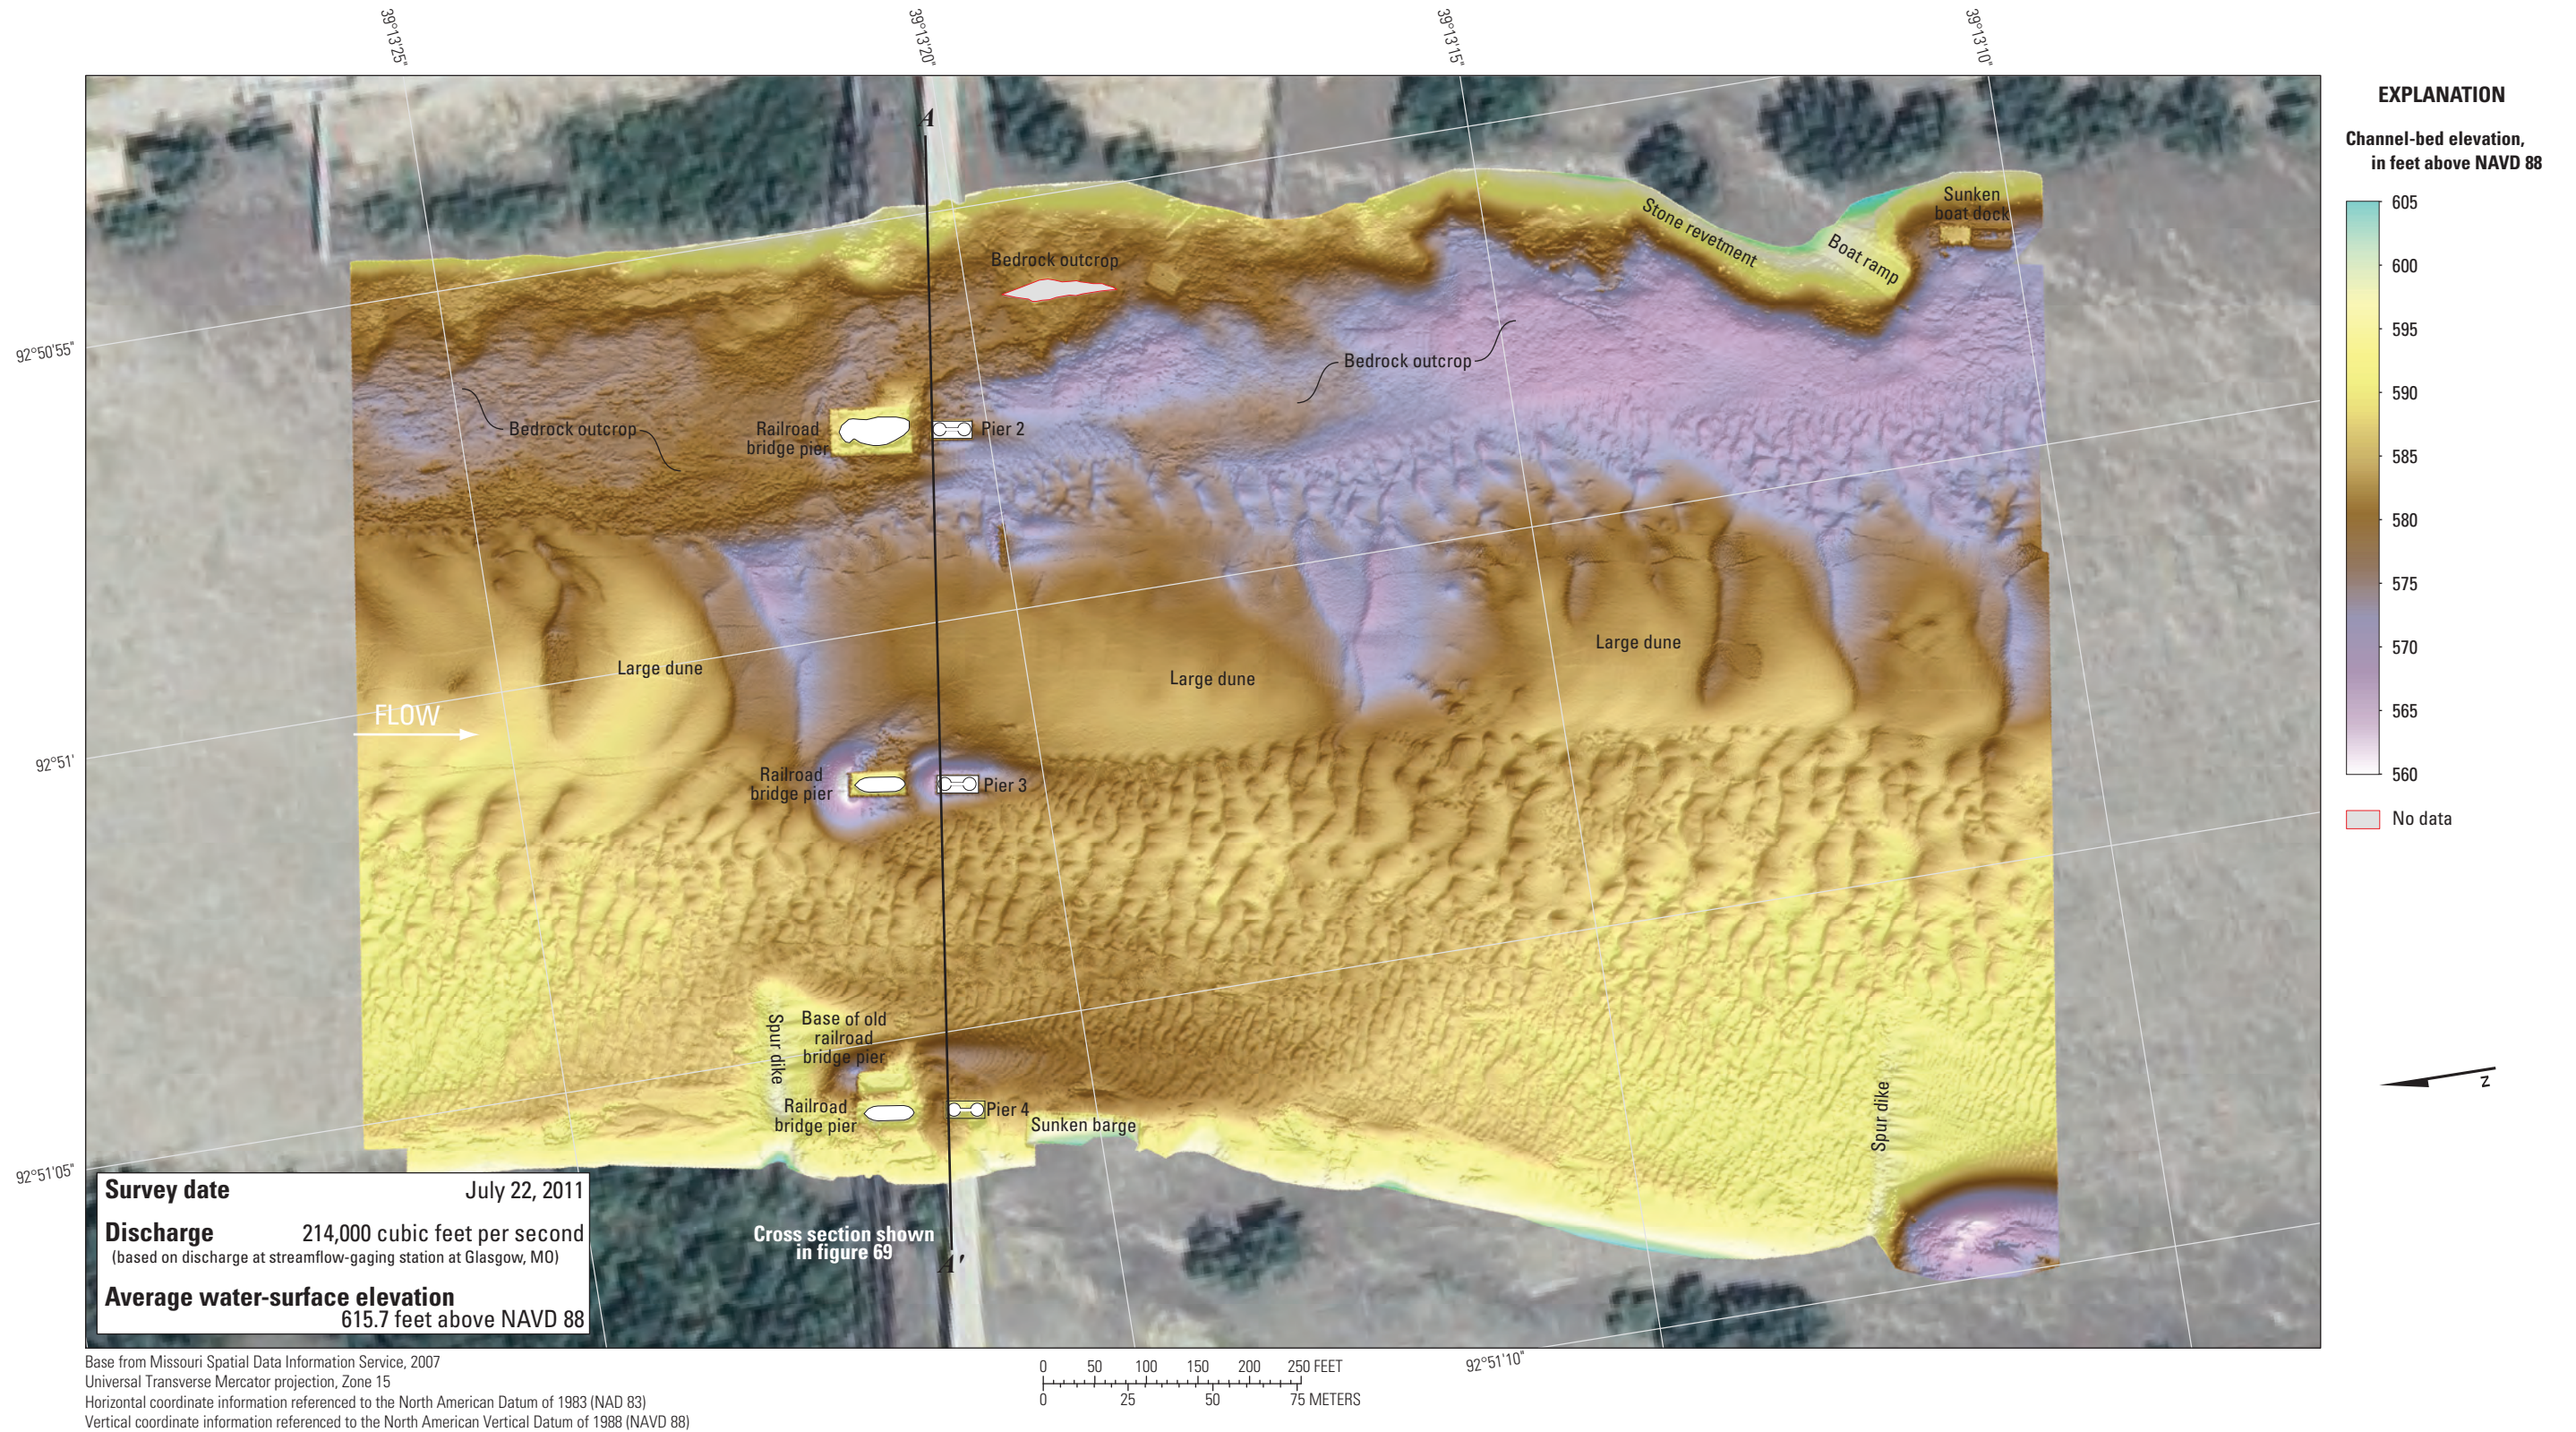
Figure 68. Bathymetric survey of the Missouri River channel in the vicinity of structure G0069 on State Highway 240 at Glasgow, Missouri.

The survey area was about 1,640 ft long, and varied from about 885 ft wide at the upstream end to about 1,060 ft wide near the downstream end, extending from bank to bank in the main channel (fig. 68). The upstream end of the survey area was about 590 ft upstream from the centerline of structure G0069, and piers 2, 3, and 4 were in the water and away from the banks (fig. 68). Structure G0069 is immediately downstream from a railroad bridge (fig. 68). The channel-bed elevations ranged from about 570 to 591 ft for most of the surveyed area (5 to 95 percentile range of the bathymetric data), except near the piers and the left (east) bank in the downstream reach (fig. 68; table 5). A poorly defined thalweg along the left (east) bank was constrained by a substantial area of exposed bedrock in the upstream reach, but was about 20 to 25 ft deeper than the channel bed on the right (west) side in the downstream reach (fig. 68). Several small spur dikes were present on the right (west) bank, along with a sunken barge (fig. 68). A few large dune features were detected in the middle of the channel, near the interface of the thalweg with the exposed bedrock, and numerous medium and small dunes and ripples were present throughout the rest of the channel (fig. 68).

No scour hole was observed near pier 2 (fig. 68), which is founded on a footing on bedrock according to bridge plans (fig. 69; table 8); however, a point cloud visualization of the multibeam depth points obtained during the survey near pier 2 indicates the magnitude of the exposure of the bridge and railroad bridge piers (fig. 70). It was difficult to determine from the multibeam depth points if the footing of pier 2 was undermined, because of sonic “ringing” that occurs near perpendicular faces such as that of the bedrock and the side of the footing. The ground line from the bathymetric survey indicated

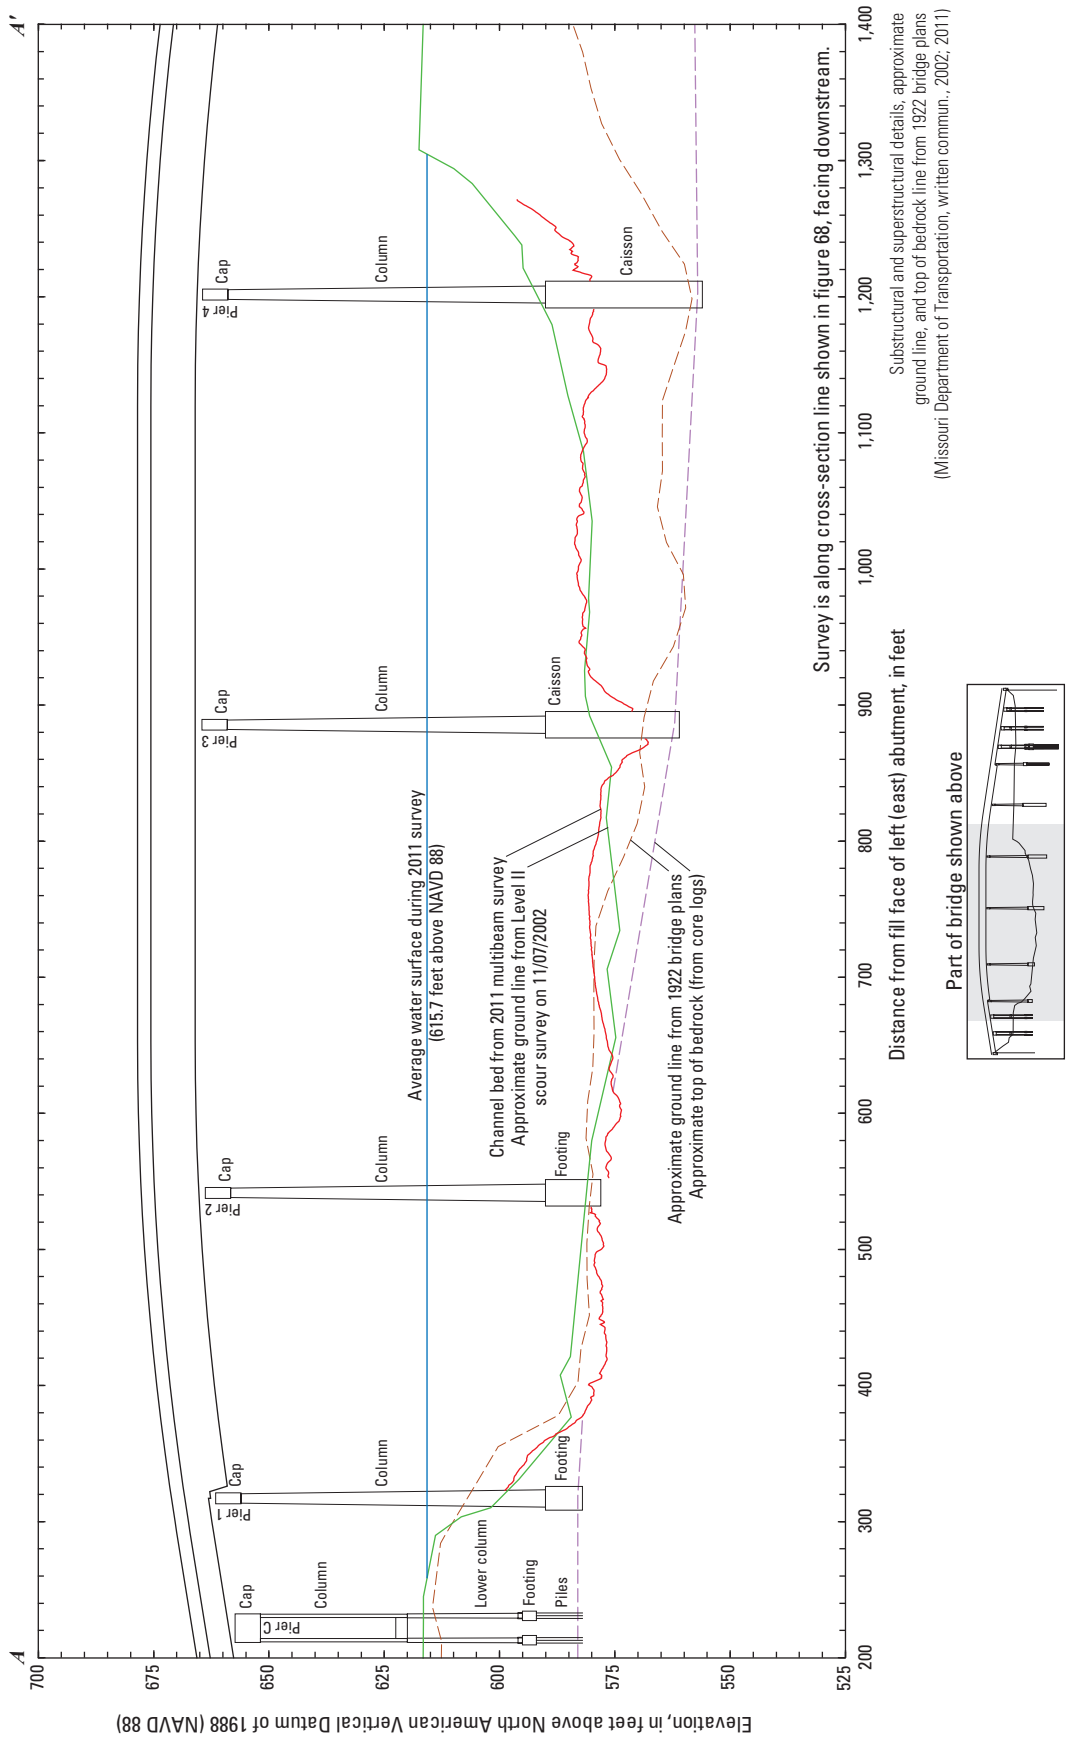
Figure 69. Key features, substructural and superstructural details, and surveyed channel bed of structure G0069 on State Highway 240 over the Missouri River at Glasgow, Missouri.

that the right (west) side of the footing may indeed be undermined, but the details of the foundation of the footing of pier 2 in the bridge plans for structure G0069 are not sufficient to tell if it was entrenched in the bedrock in any way, particularly if the top of the bedrock was not level (figs. 68, 69). In modern construction, bridge substructural elements usually are pinned or socketed to bedrock (American Association of State Highway Transportation Officials, 2012; Brown and others, 2010), but full exposure of usually buried substructural elements warrants special consideration and observation, particularly at an older bridge such as structure G0069.

Scour holes were observed near main channel piers 3 and 4. In the vicinity of main channel pier 3 (fig. 68), a substantial scour hole had a minimum channel-bed elevation of about 566 ft (table 8), about 11 ft below the average channel bed immediately upstream from the pier (figs. 68, 69; table 8). A moderate scour hole was observed in the vicinity of main channel pier 4, with a minimum channel-bed elevation of about 578 ft (figs. 68, 69; table 8). Information from bridge plans indicates that piers 3 and 4 are caissons founded on bedrock, with only about 4 ft of bed material between the bottom of the scour hole and bedrock at pier 3, and about 21 ft of material at pier 4 (fig. 69; table 8). The scour observed near all of the highway bridge piers was substantially affected by the upstream railroad bridge piers. The surveyed bed generally was similar to the ground line from the Level II bridge scour assessment in 2002, with about 5 to 10 ft of scour near pier 2, and about 5 to 10 ft of deposition between piers 2 and 3 and between piers 3 and 4 (fig. 69). The approximate top of bedrock line from bridge plans confirms that the fluvial material near the left bank has washed away, exposing the bedrock along the thalweg (fig. 69).

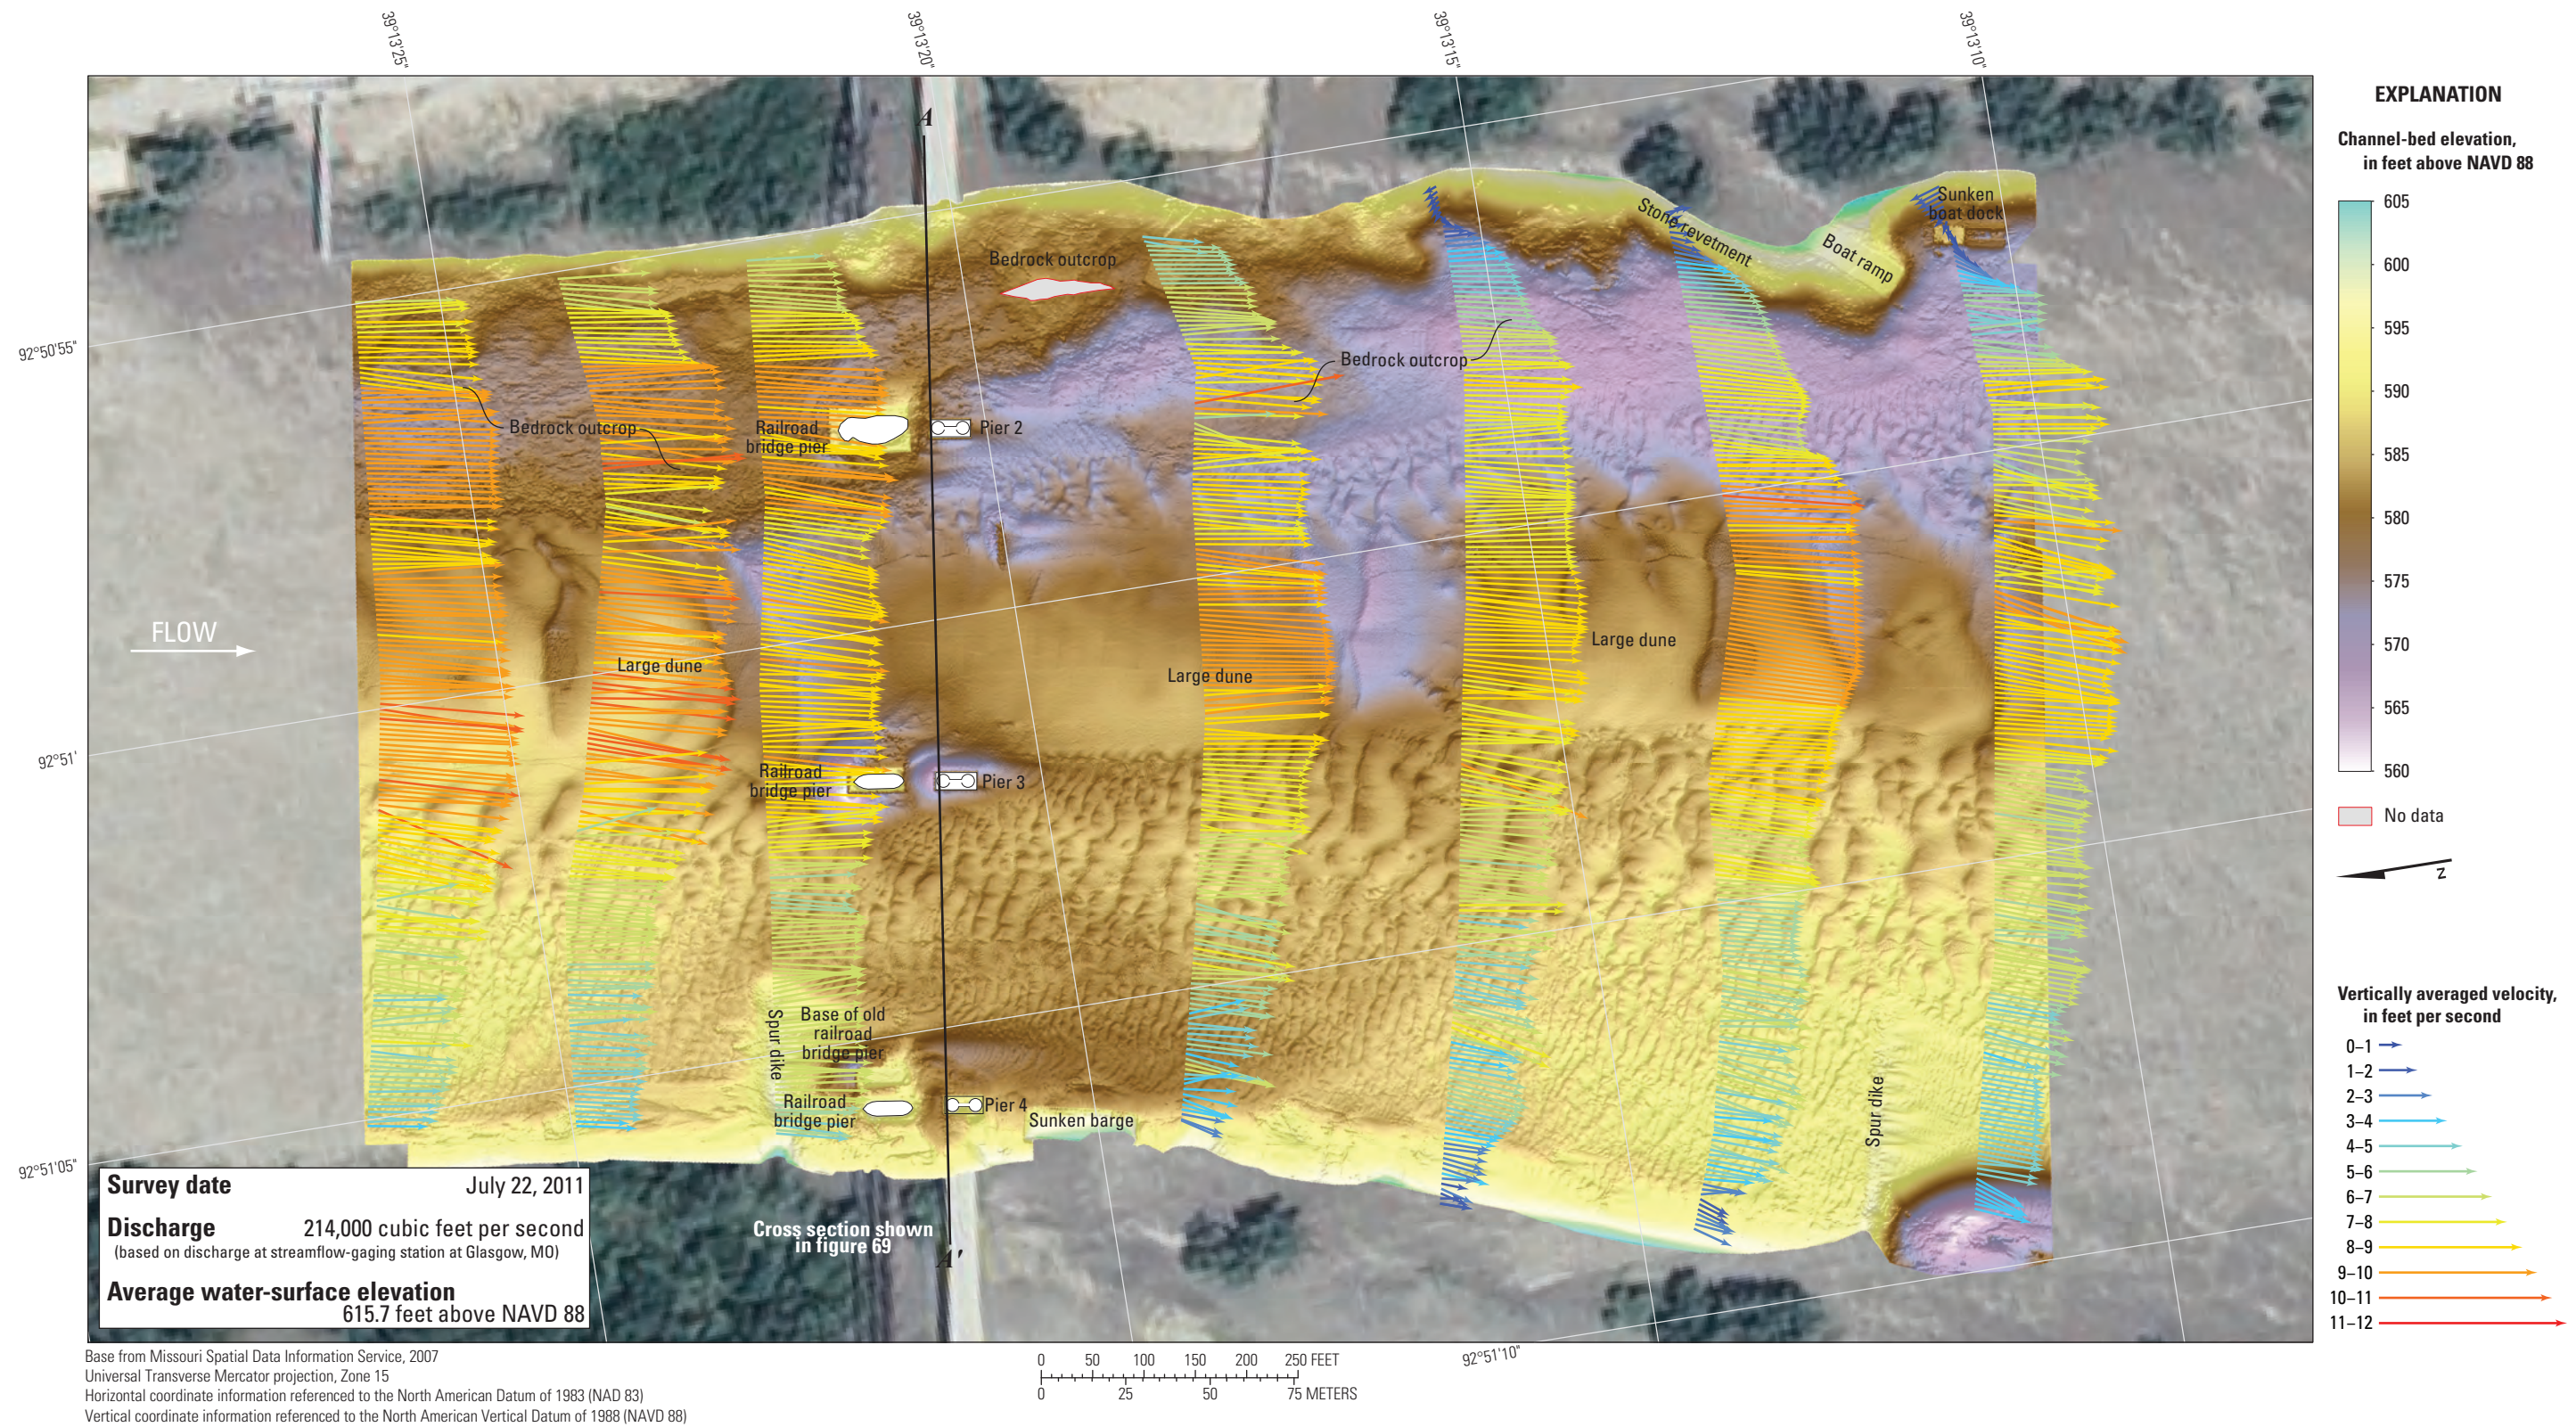
Figure 71. Bathymetry and vertically averaged velocities of the Missouri River channel in the vicinity of structure G0069 on State Highway 240 at Glasgow, Missouri.

The vertically averaged velocity vectors indicate mostly uniform flow in two of the transects, but moderate turbulence throughout most of the channel, with velocities ranging from about 4 to 11 ft/s (fig. 71). Velocities were higher in the thalweg, and lower in the shallow area on the right (west) side of the channel (fig. 71). The turbulence observed at various places in the channel (fig. 71) likely was caused by a combination of the substantial bend in the channel immediately upstream from the surveyed reach and the rapidly changing channel bed along the thalweg, as well as local disturbances from the piers and spur dikes in the reach.

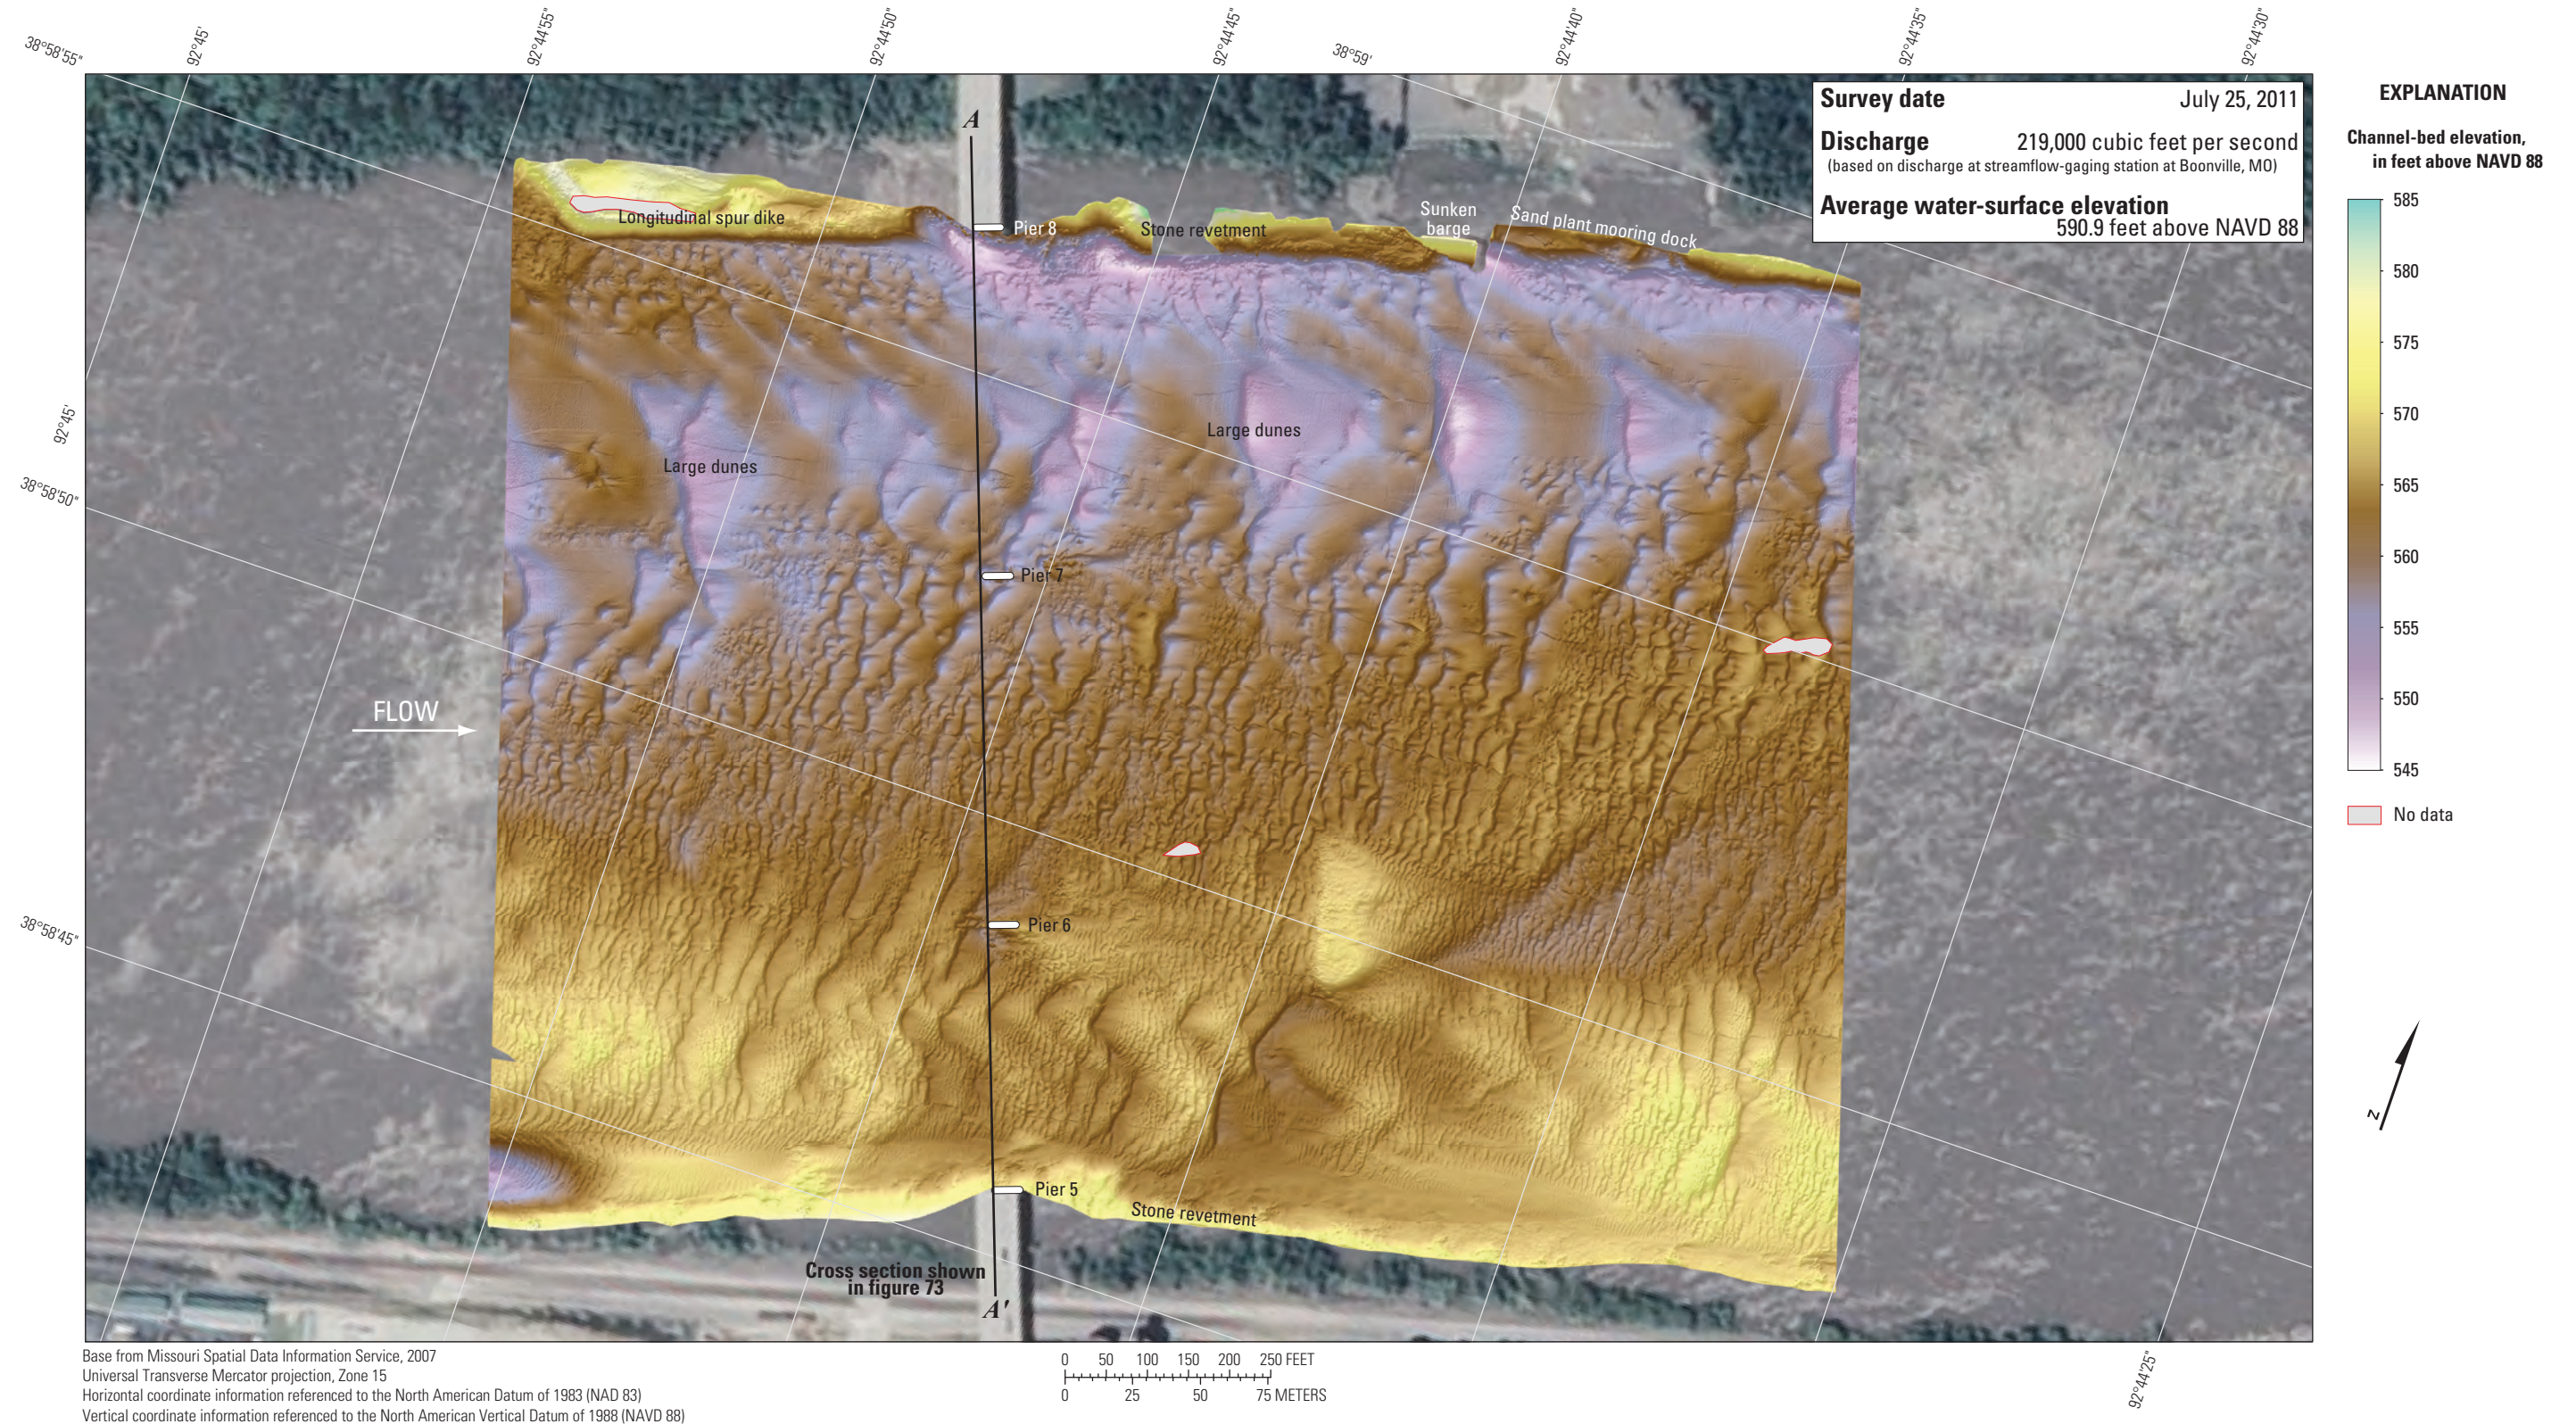
Figure 72. Bathymetric survey of the Missouri River channel in the vicinity of structure A4574 on State Highway 5 at Boonville, Missouri.

The survey area was about 1,640 ft long and about 1,250 ft wide, extending from bank to bank in the main channel (fig. 72). The upstream end of the survey area was about 620 ft upstream from the centerline of structure A4574 (fig. 62), and piers 5 through 8 were in the water, although piers 5 and 8 were on the edges of the surveyed area. The channel-bed elevations ranged from about 554 to 569 ft for most of the surveyed area (5 to 95 percentile range of the bathymetric data), except in the channel thalweg along the left (north) bank, where a series of large dunes and scour holes created local minimum channel-bed elevations ranging from 547 to 552 ft (fig. 72). Numerous medium and small dunes and ripples were present throughout the channel (fig. 72). A longitudinal spur dike and stone revetment were present on the left (north) bank, and stone revetment appeared to be present near the bridge on the right (south) bank (fig. 72).

Minor scour holes were observed near the central main channel piers 6 and 7. In the vicinity of main channel pier 7 (fig. 72), the scour hole had a minimum channel-bed elevation of about 556 ft (table 8), about 23 ft above the elevation of the bottom of the pier seal course of 533.00 ft (fig. 73; table 8). The minor scour hole near pier 6 had a minimum channel-bed elevation of about 559 ft (table 8). Both scour holes were difficult to discern from nearby dunes and ripples (figs. 72, 73).

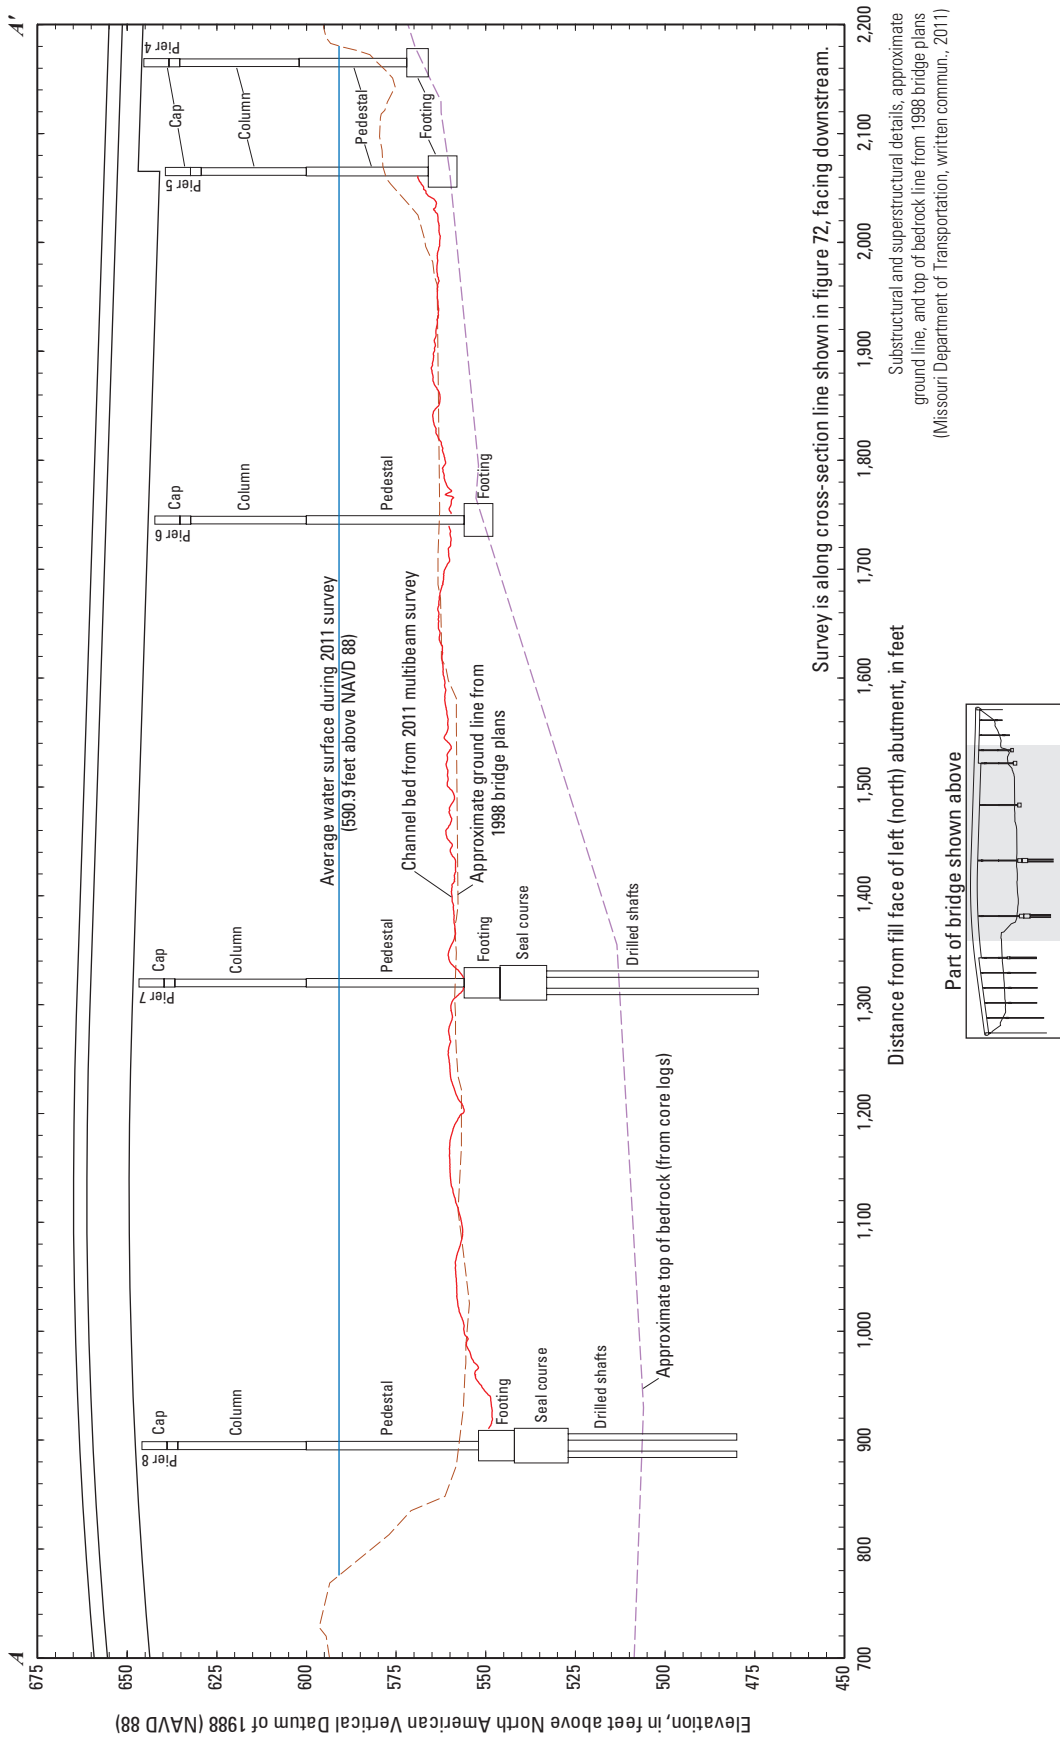
Figure 73. Key features, substructural and superstructural details, and surveyed channel bed of structure A4574 on State Highway 5 over the Missouri River at Boonville, Missouri.

Information from bridge plans indicates that pier 7 is founded on shafts drilled 39 ft into bedrock, with about 43 ft of bed material between the bottom of the scour hole and bedrock (fig. 73; table 8). Pier 6 is founded on a footing on bedrock, with about 8 ft of bed material between the bottom of the scour hole and bedrock (fig. 73; table 8). The surveyed bed generally was similar to the original ground line from bridge plans (1998), with localized areas of scour and deposition across the section (fig. 73).

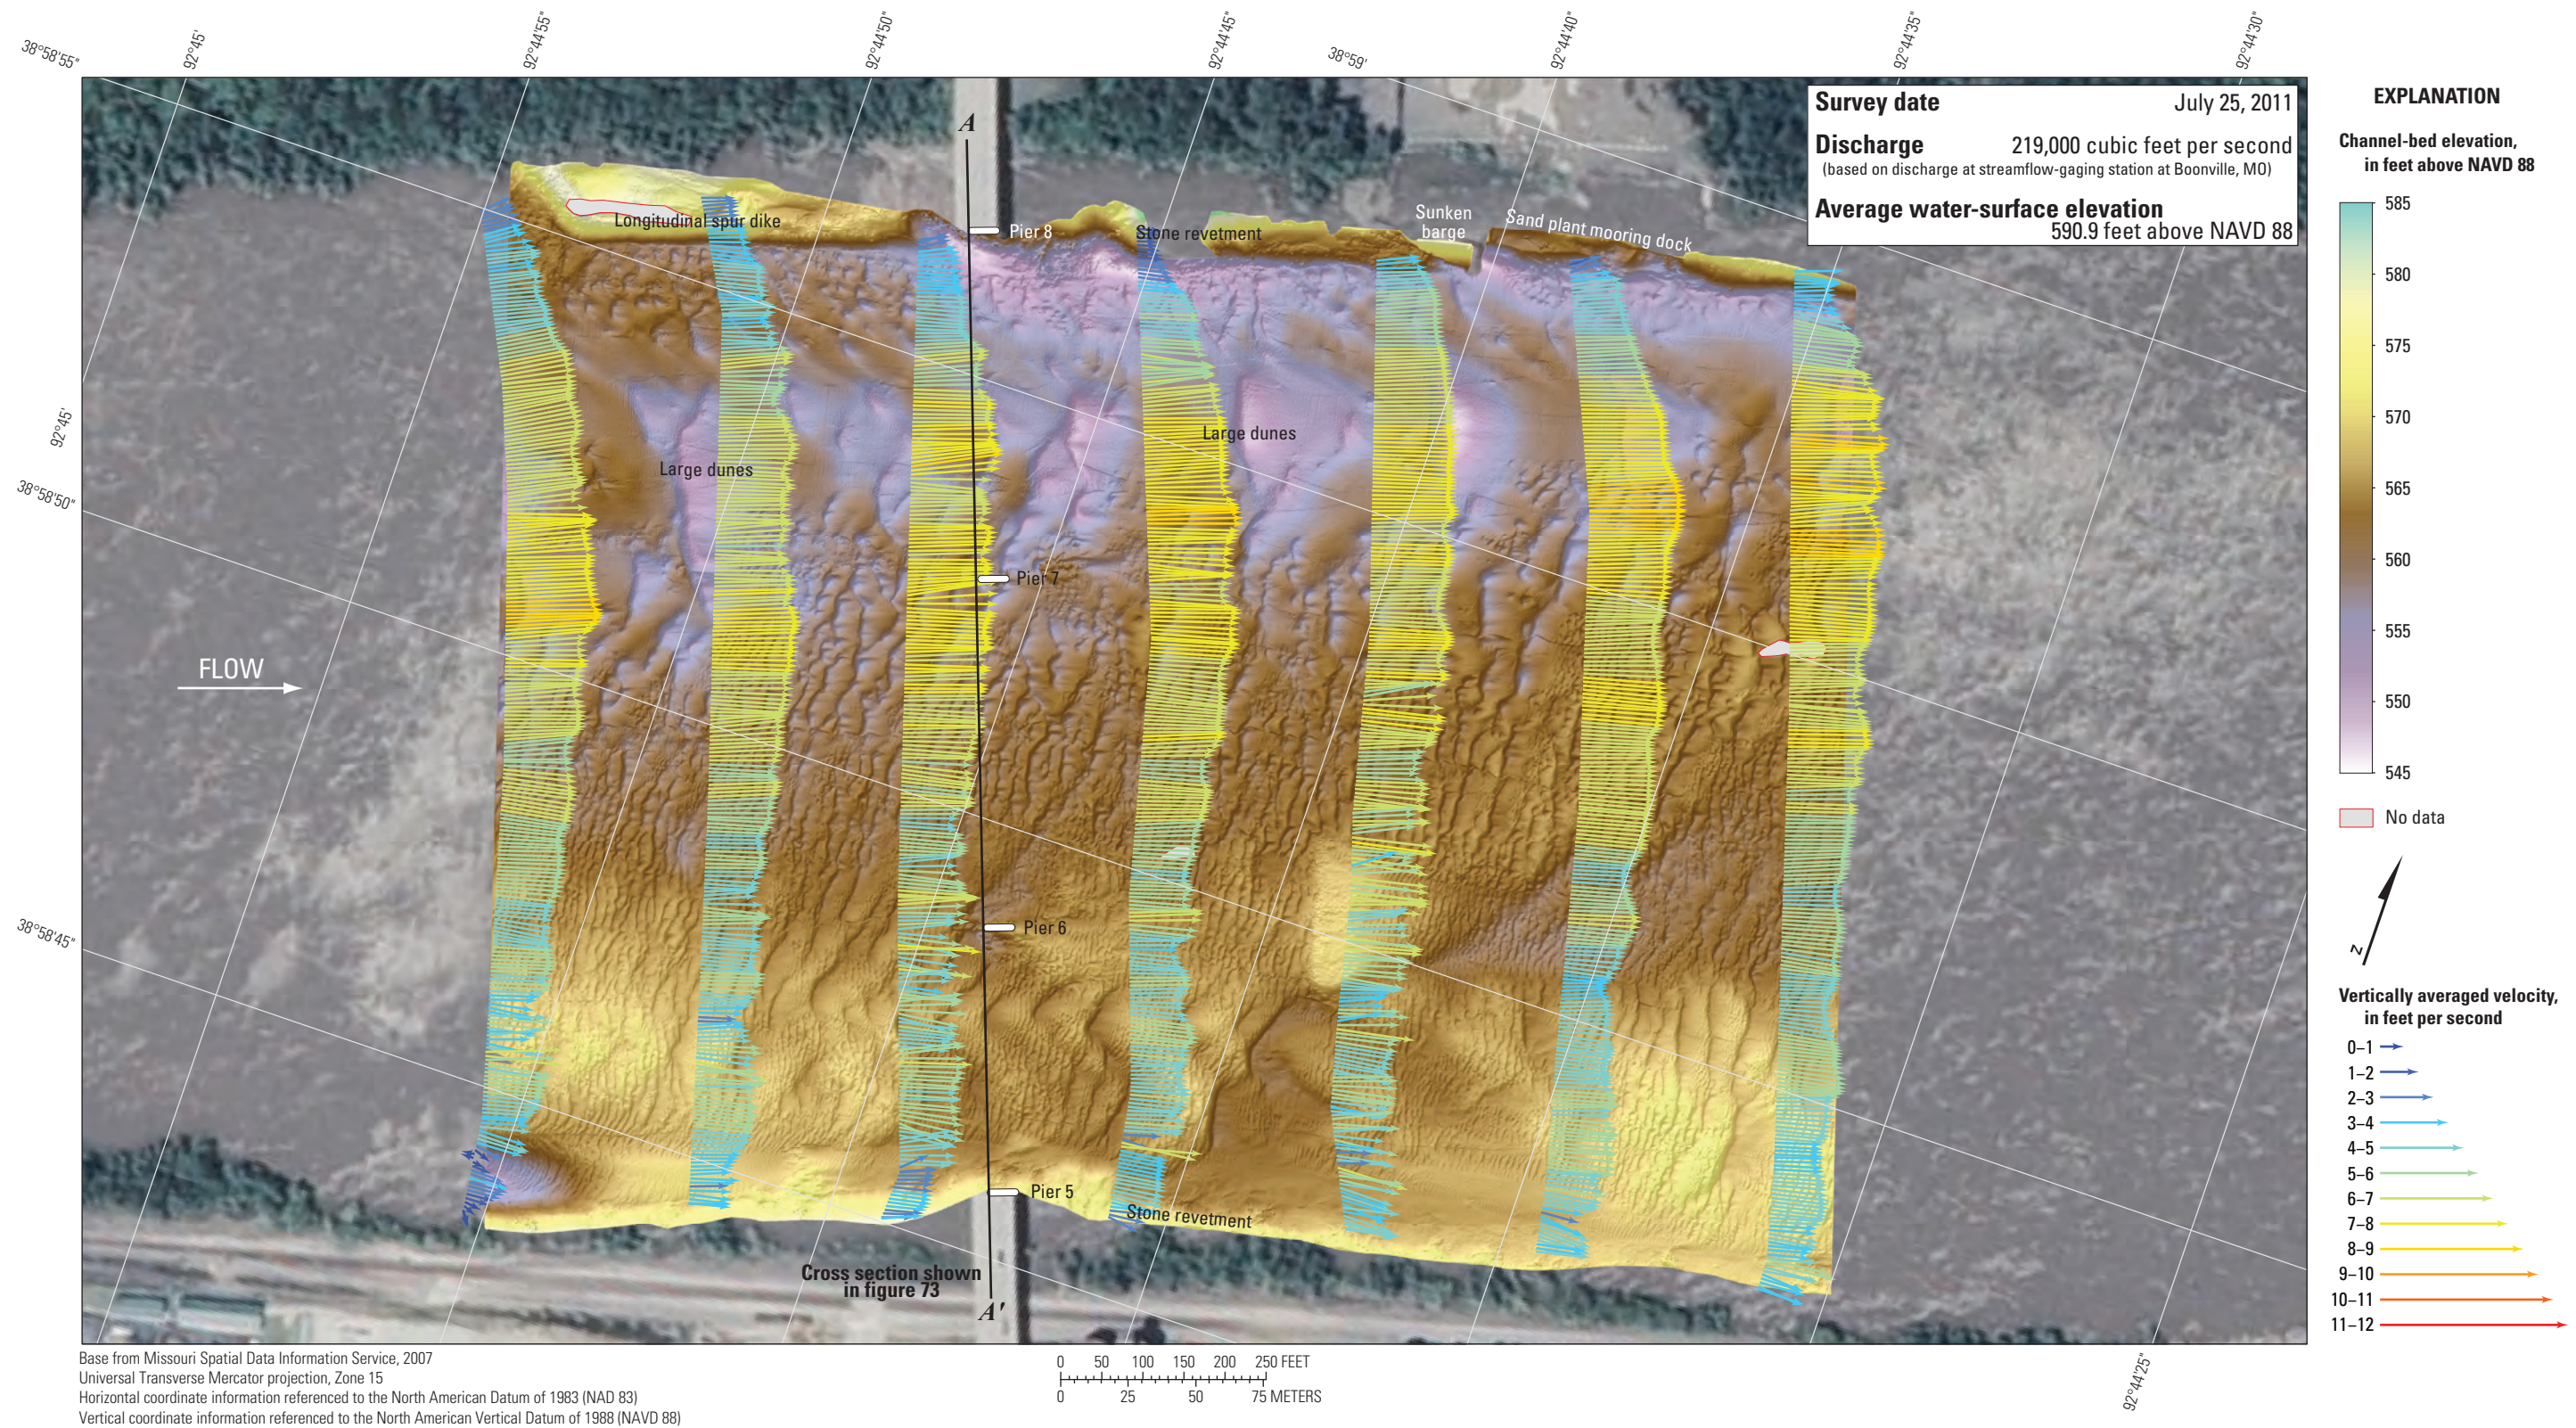
Figure 74. Bathymetry and vertically averaged velocities of the Missouri River channel in the vicinity of structure A4574 on State Highway 5 at Boonville, Missouri.

The vertically averaged velocity vectors indicate mostly uniform flow throughout most of the channel, ranging from about 4 to 9 ft/s (fig. 74), except along the banks. Moderate turbulence was observed in the channel thalweg at and downstream from the bridge (fig. 74), and local flow reversal and turbulence was observed along the right (south) bank (fig. 74). The bridge piers were aligned with flow, causing little to no evident turbulence downstream (fig. 74).
