Bathymetric and Velocimetric Surveys at Highway Bridges Crossing the Missouri River in and into Missouri during Summer Flooding, July–August 2011

Scientific Investigations Report 2012–5204

By Richard J. Huizinga

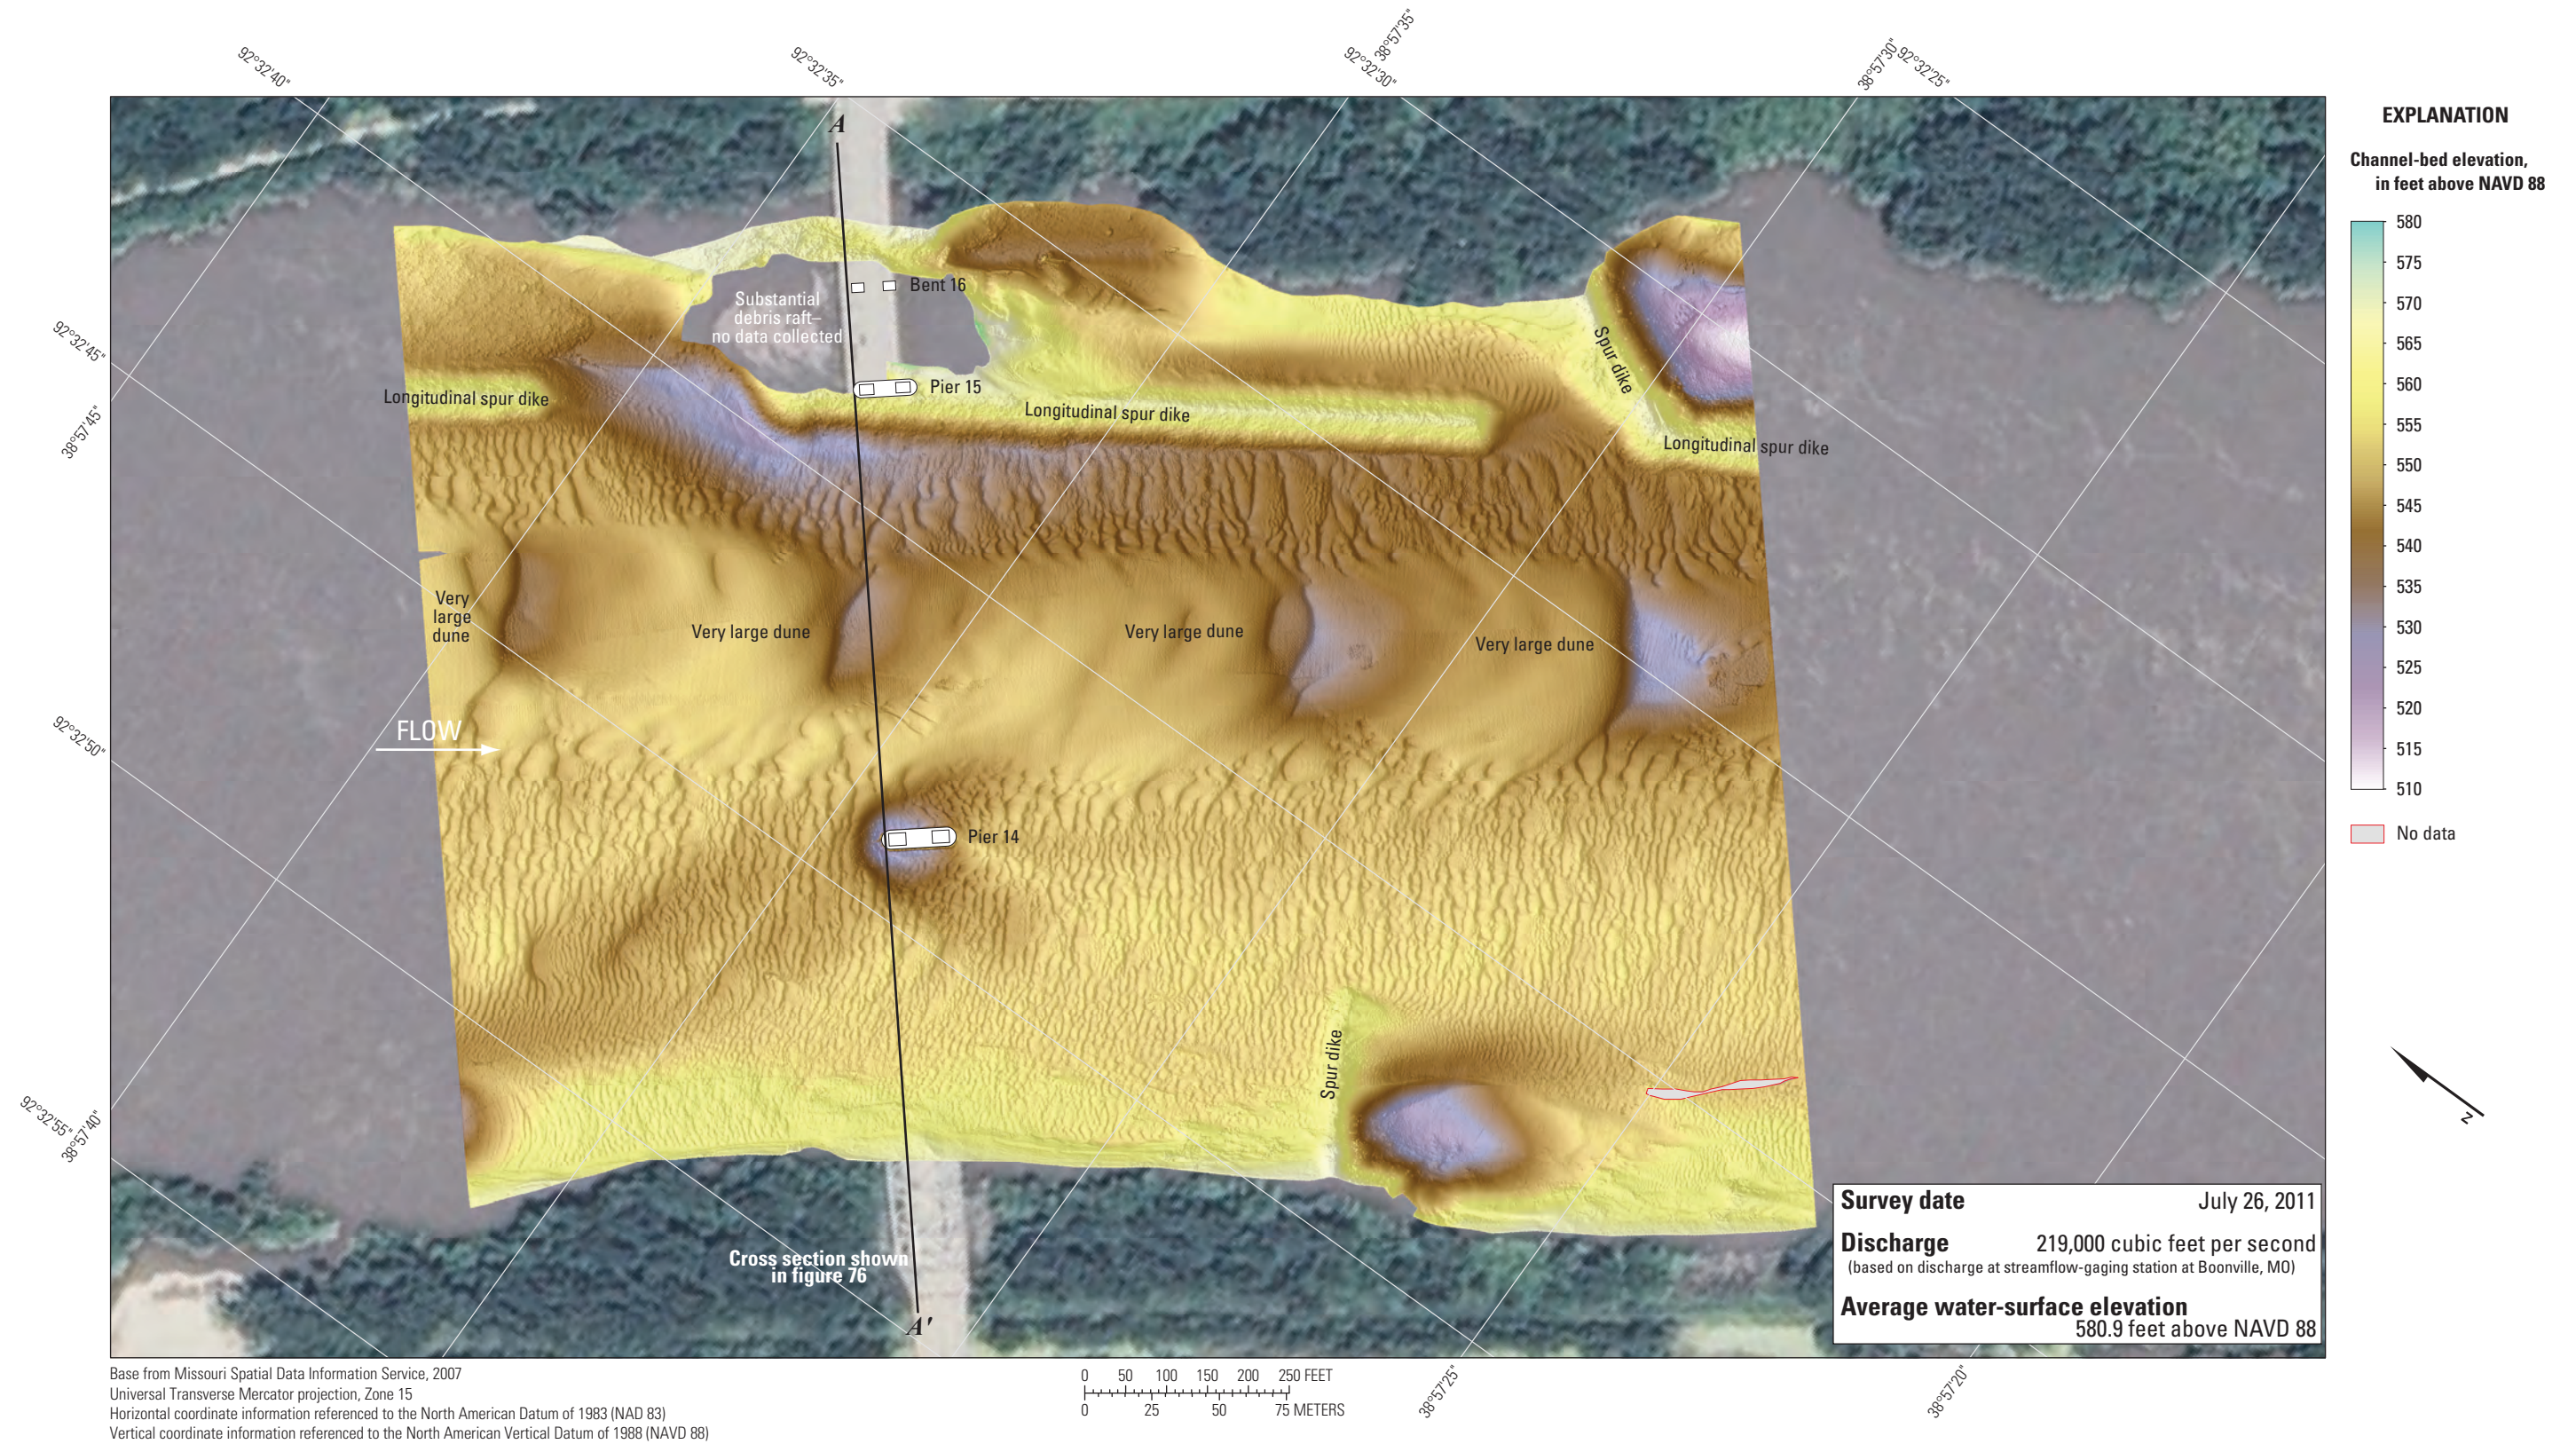
Figure 75. Bathymetric survey of the Missouri River channel in the vicinity of structure L0962 on Interstate 70 near Rocheport, Missouri.

The survey area was about 1,640 ft long and about 1,180 ft wide, extending from bank to bank in the main channel (fig. 75). The upstream end of the survey area was about 580 ft upstream from the centerline of structure L0962 (fig. 62), and piers 14 and 15 and bent 16 were in the water. The channel-bed elevations ranged from about 534 to 560 ft for most of the surveyed area (5 to 95 percentile range of the bathymetric data), except near pier 14, in the channel thalweg along the left (north) bank and downstream from the various spur dikes (fig. 75). A series of very large dunes was present in the middle of the channel, and numerous medium and small dunes and ripples were present throughout the rest of the channel (fig. 75). Several longitudinal spur dikes were present on the left (north) bank, and a spur dike was present on the downstream right (south) bank (fig. 75). A substantial debris raft was present on the left bank between pier 15 and bent 16, which created a shallow area that extended from the upstream end of the longitudinal dike to a point about 125 ft downstream from structure L0962 for which no bathymetric data could be collected (fig. 75). A single survey swath was

obtained between the left bank and the left side of the debris pile (fig. 75).

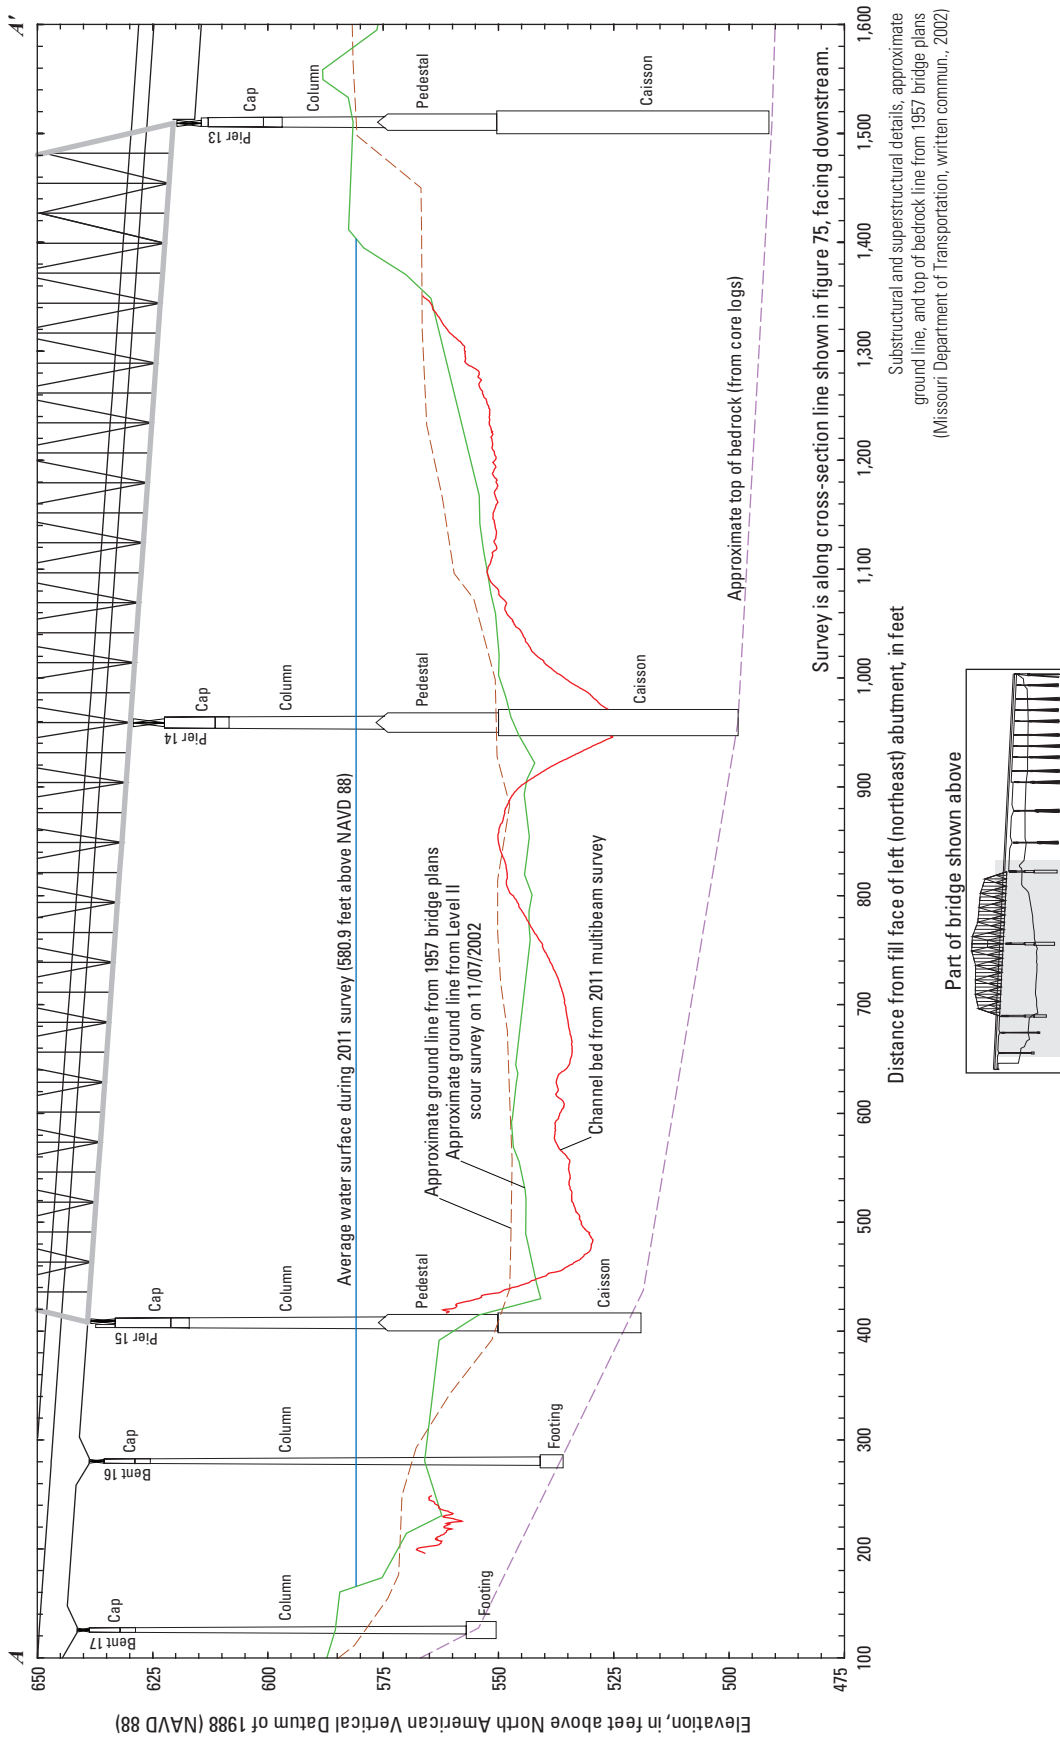
Figure 76. Key features, substructural and superstructural details, and surveyed channel bed of structure L0962 on Interstate 70 over the Missouri River near Rocheport, Missouri.

In the vicinity of main channel pier 14 (fig. 75), a substantial scour hole had a minimum channel-bed elevation of about 525 ft (table 8), about 19 ft below the average channel elevation upstream from the bridge (fig. 76; table 8). Information from bridge plans indicates that pier 14 is founded on a caisson on bedrock, with about 27 ft of bed material between the bottom of the scour hole and bedrock (fig. 76; table 8). Pier 15 is embedded in the longitudinal spur dike, and the minimum channel elevation at the toe of the dike was about 530 ft (figs. 75, 76; table 8). Pier 15 also is founded on a caisson on bedrock, with about 11 ft of material between the minimum channel elevation and bedrock (fig. 76; table 8); however, the rock of the spur dike will limit or prevent a local scour hole near pier 15. Bent 16 is founded on a footing on bedrock, likely with 20 ft or more of bed material between the channel bed and bedrock based on the minimum elevation of the single survey swath obtained near bent 16 (fig. 76). The surveyed bed was substantially different from the ground line from the Level II bridge scour assessment in 2002, with as much as 20 ft of scour in the channel thalweg and as much as 10 ft of scour between pier 14 and the right bank (fig. 76).

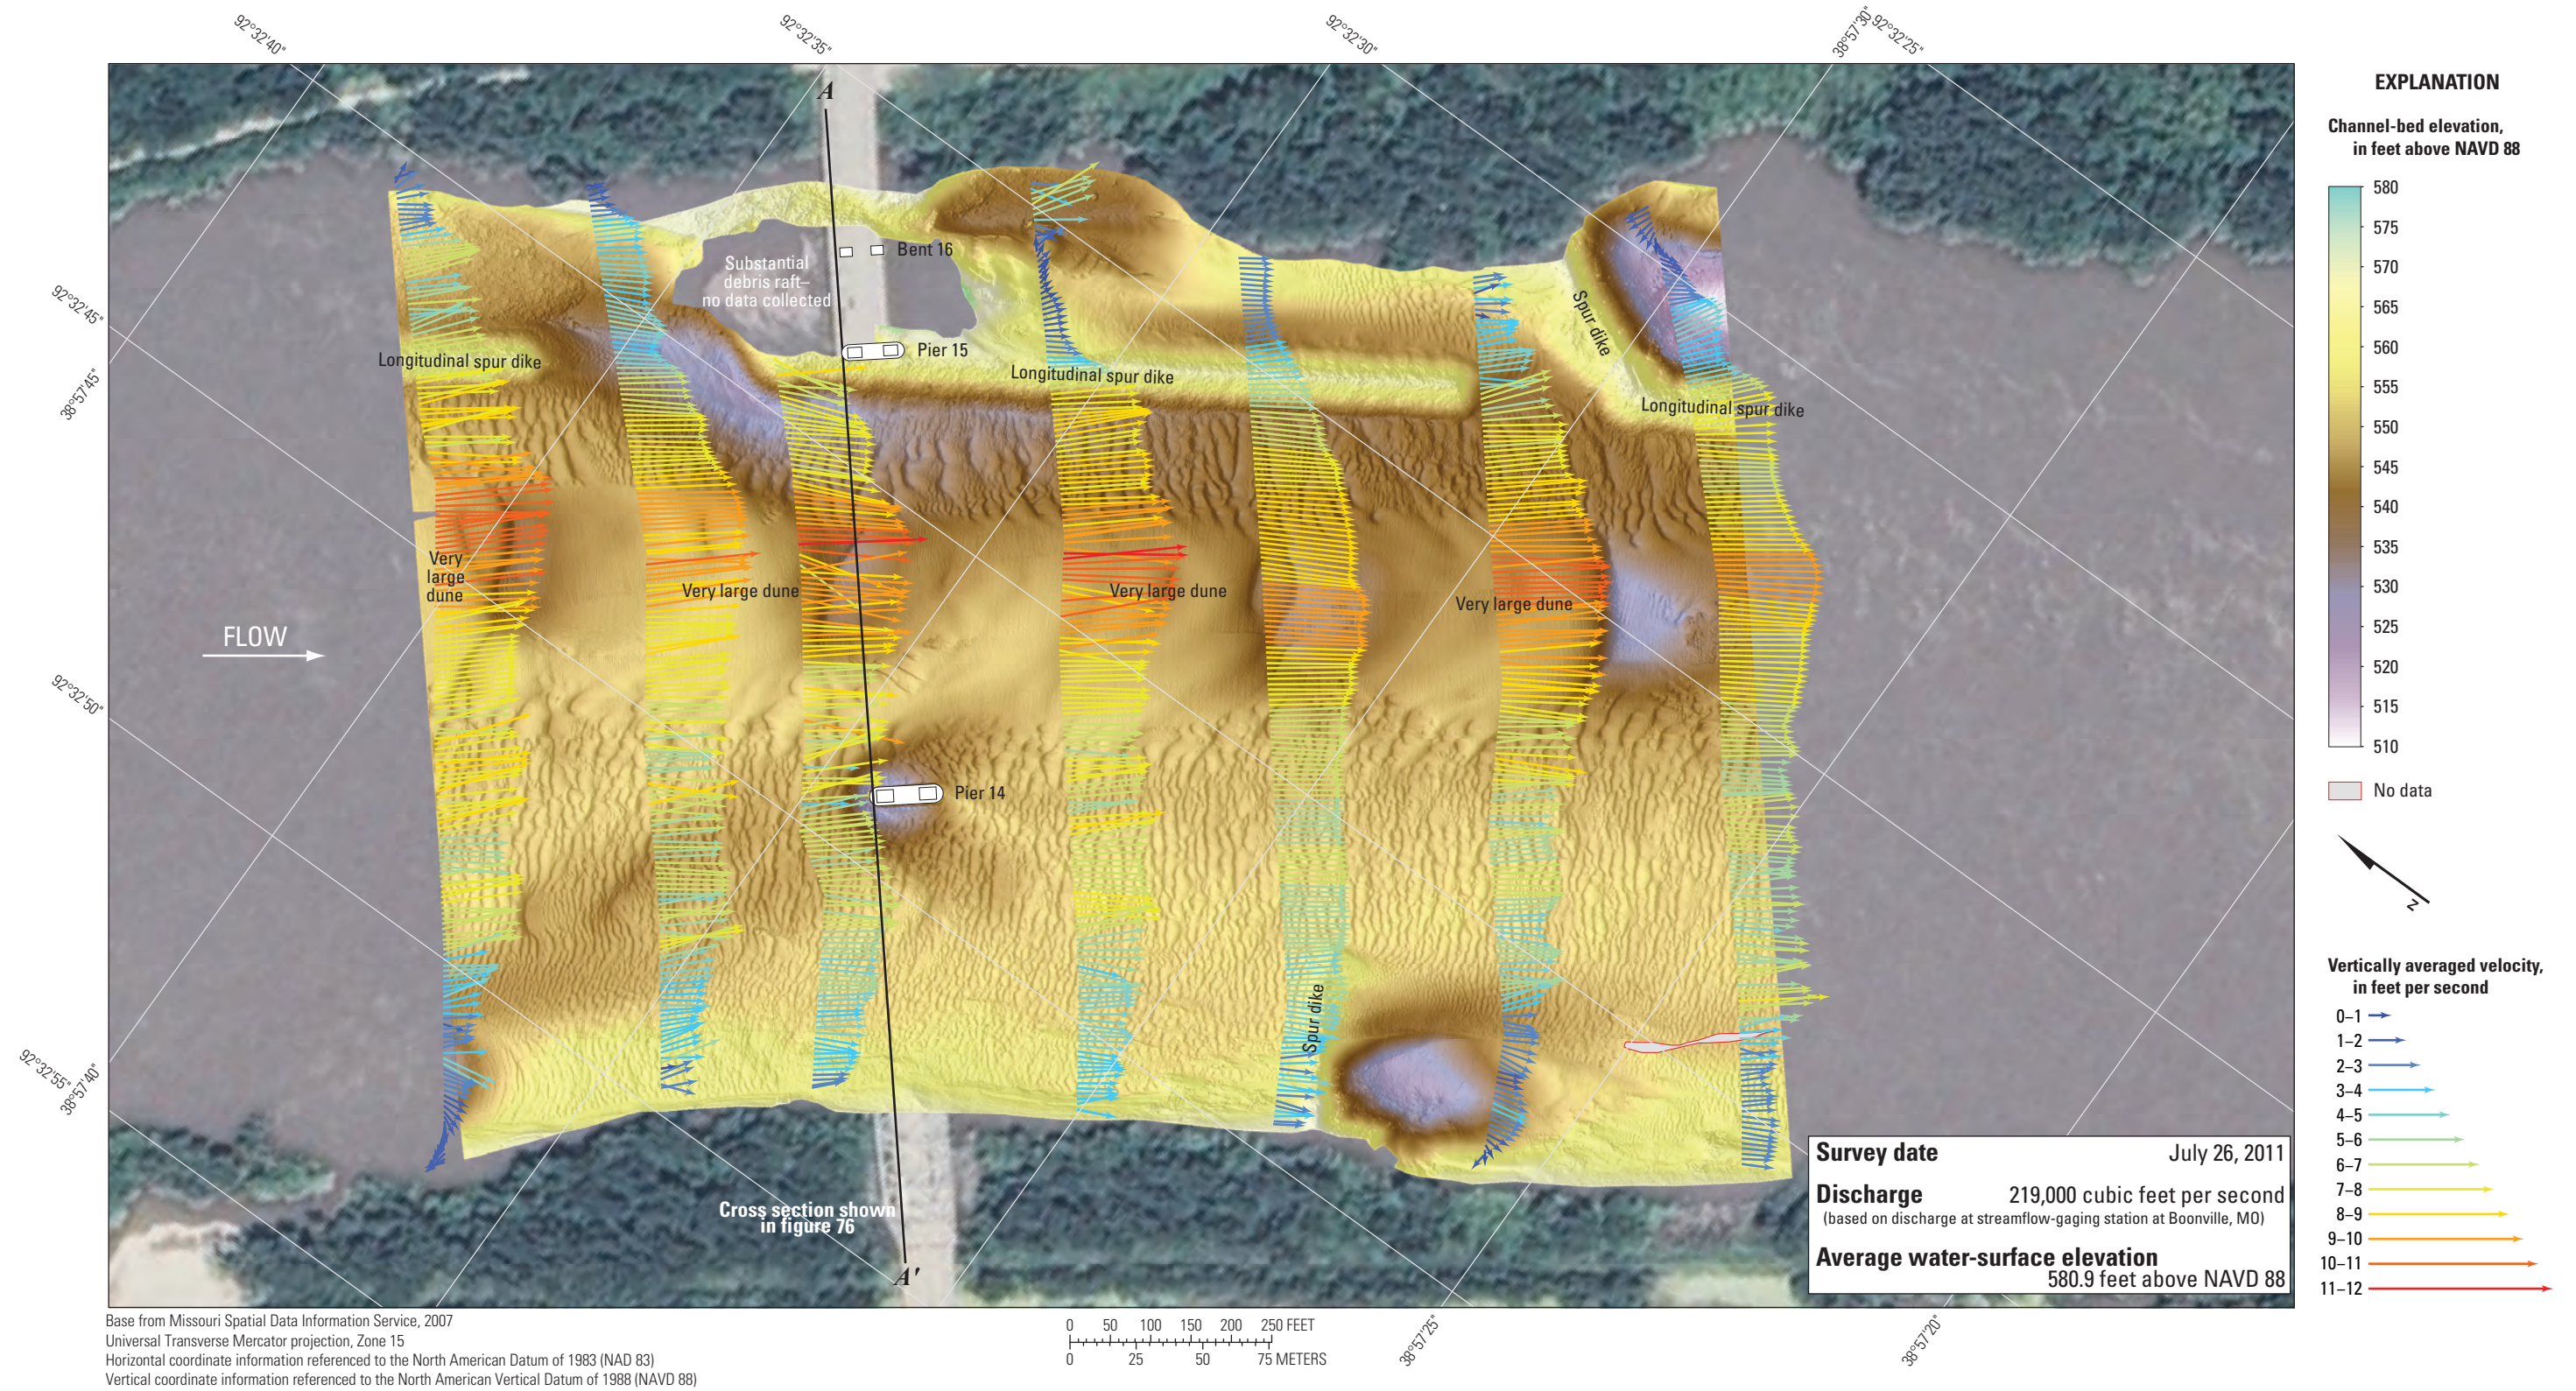
Figure 77. Bathymetry and vertically averaged velocities of the Missouri River channel in the vicinity of structure L0962 on Interstate 70 near Rocheport, Missouri.

The vertically averaged velocity vectors indicate areas of uniform flow with areas of substantial turbulence (fig. 77). Velocities ranged from about 4 to 11 ft/s for most of the channel (fig. 77), except in the vicinity of the spur dikes. Substantial turbulence was observed in the transect upstream from the bridge (fig. 77), and local flow reversal and turbulence were observed along the left (north) bank (fig. 77). Pier 14 was aligned with flow, causing no evident turbulence downstream (fig. 77).

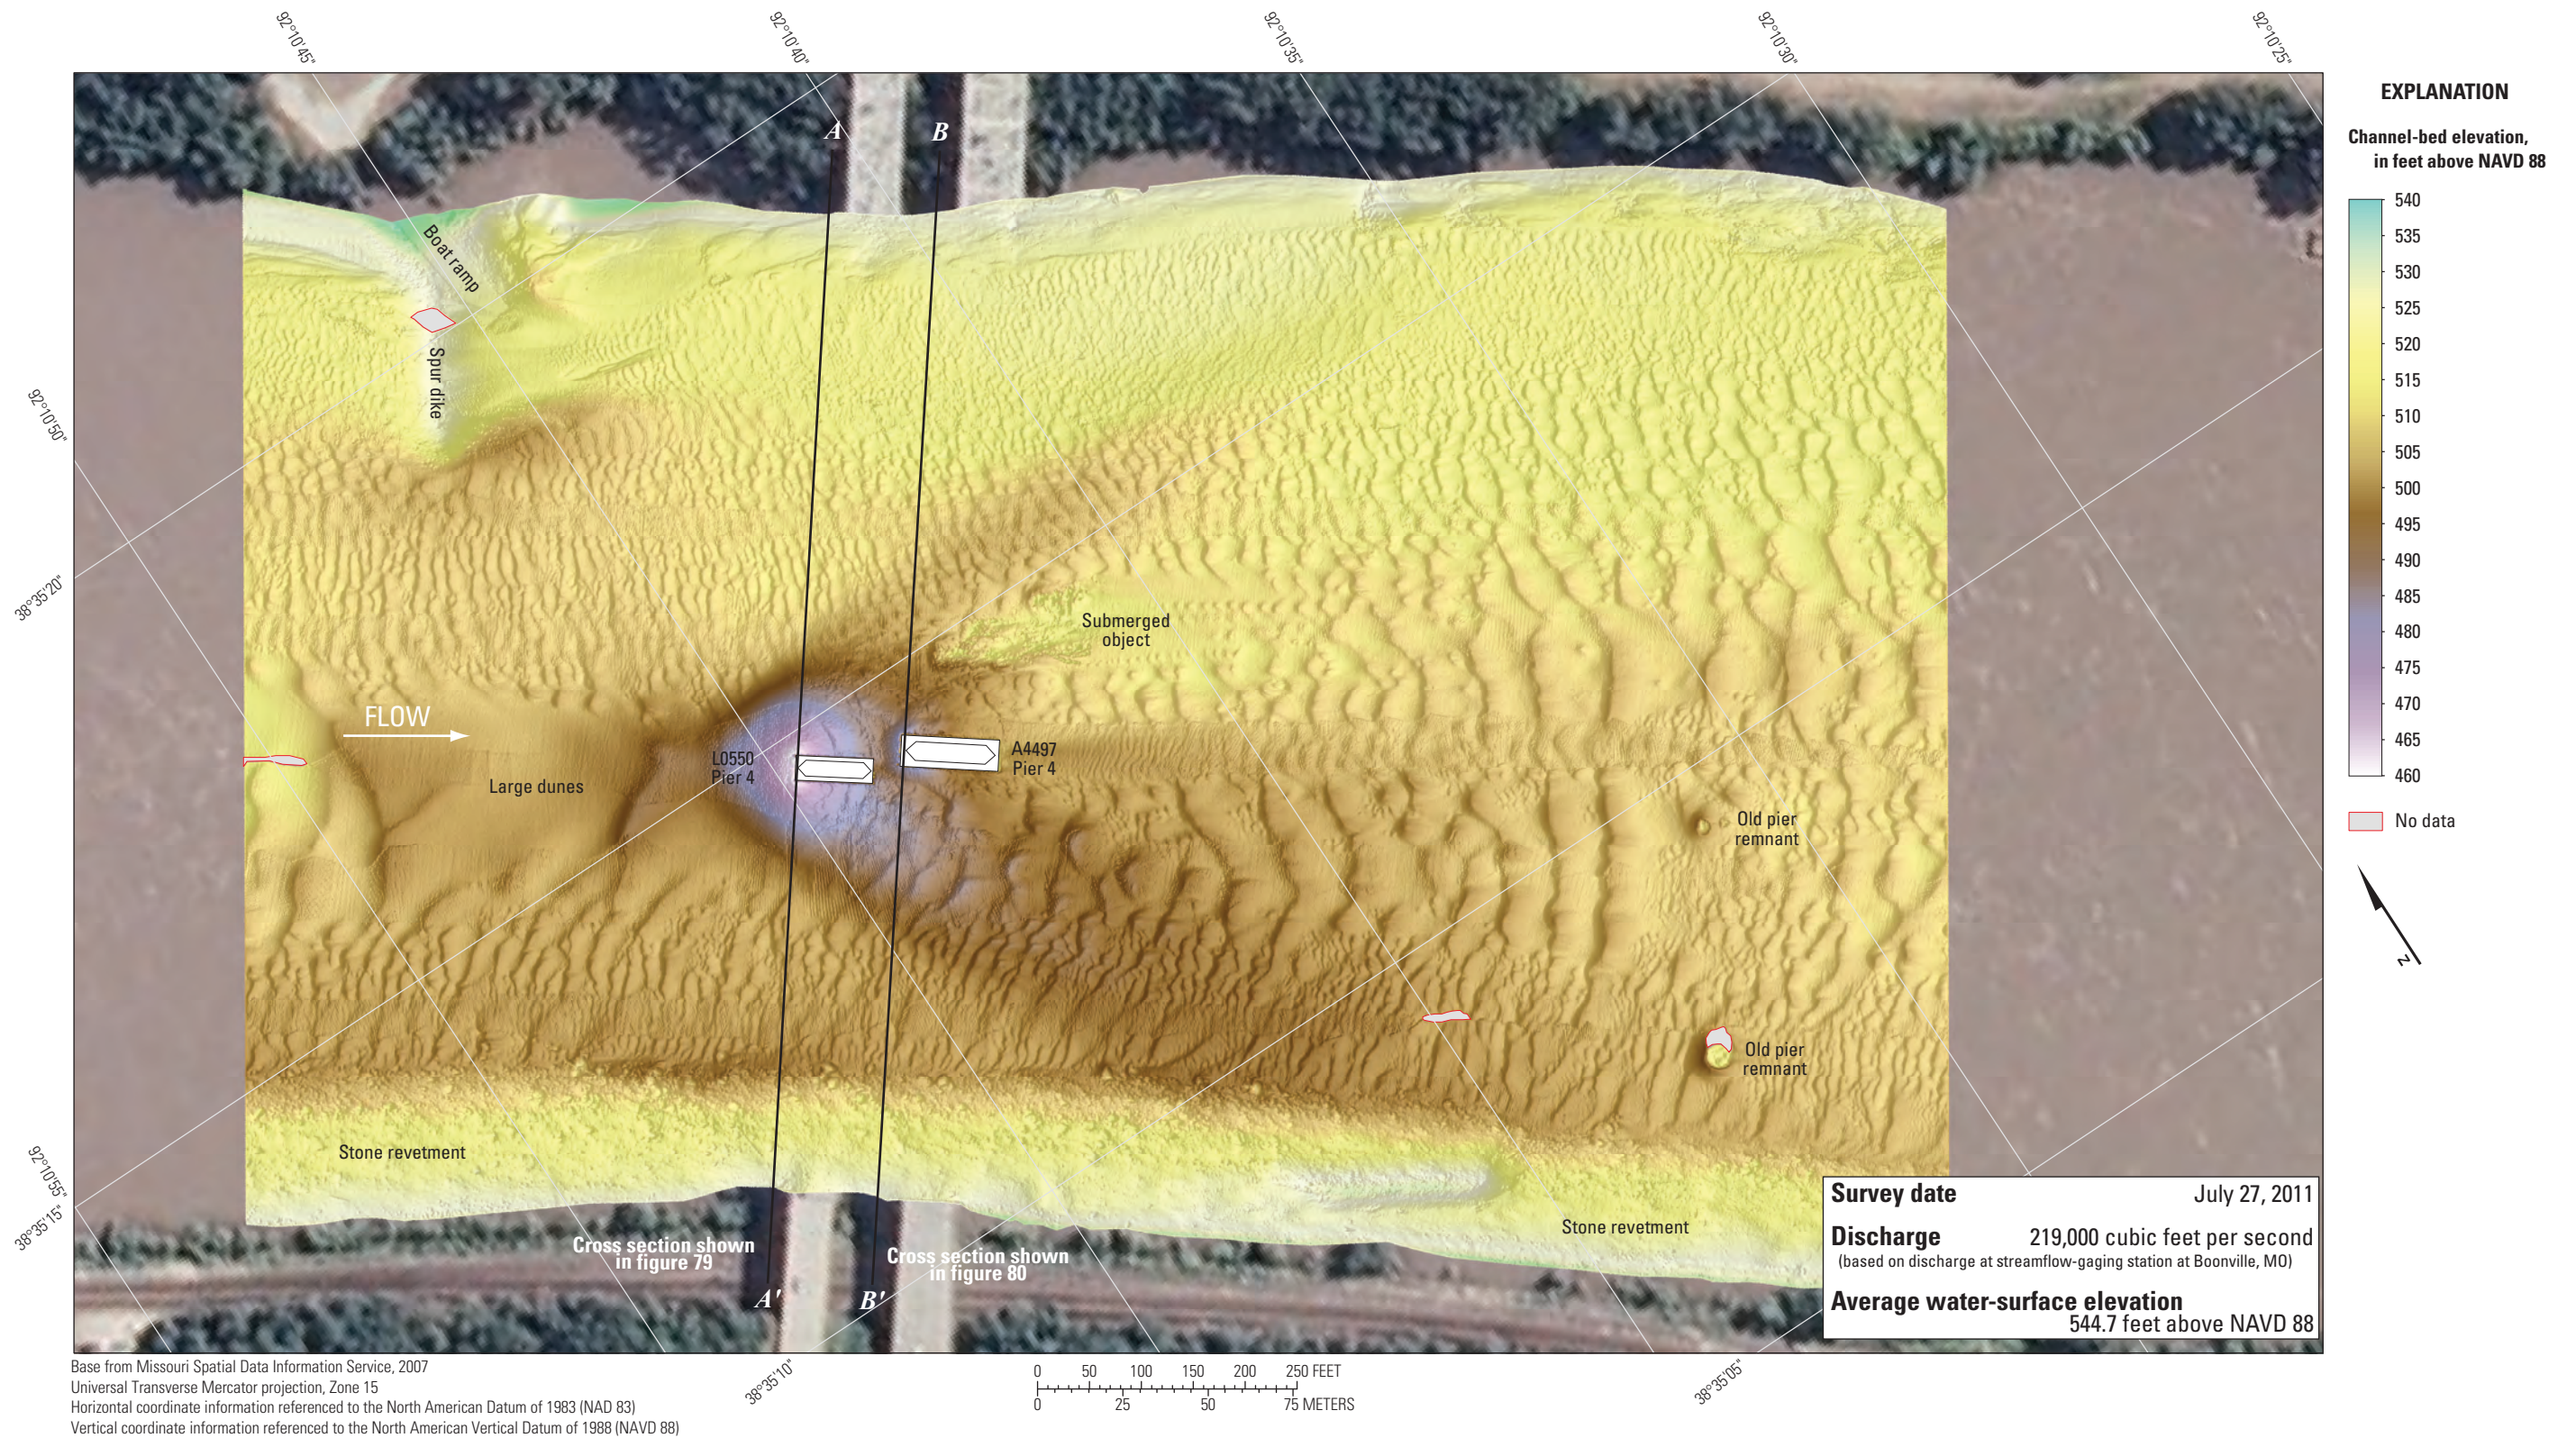
Figure 78. Bathymetric survey of the Missouri River channel in the vicinity of structures L0550 and A4497 on U.S. Highway 54 at Jefferson City, Missouri.

A substantial scour hole was observed near the main channel piers. In the vicinity of pier 4 of upstream structure L0550 (fig. 78), the scour hole had a minimum channel-bed elevation of about 463 ft (table 8), about 35 ft below the average channel elevation upstream from the bridge (fig. 79; table 8). Information from bridge plans indicates that pier 4 of structure L0550 is founded on a caisson on bedrock, with only about 4 ft of bed material between the bottom of the scour hole and bedrock (fig. 79; table 8). The scour hole near pier 4 of downstream structure A4497 was substantially affected by the upstream pier, with a minimum channel-bed elevation of about 481 ft (table 8), about 12 ft below the elevation of the bottom of the pier seal course of 493.50 ft (fig. 80; table 8). Pier 4 of structure A4497 is founded on shafts drilled 11 ft into bedrock, with about 22 ft of bed material between the bottom of the surveyed scour hole and bedrock (fig. 80; table 8). The surveyed bed was similar to the ground line from the Level II bridge scour assessment in 2002 in the channel to the left of pier 4 at both bridges, except for as much as 25 ft of scour along the toe of the right (west) bank compared to the Level II ground line (figs. 79, 80). In modern construction, bridge substructural elements usually are pinned or socketed to bedrock (American Association of State Highway Transportation Officials, 2012; Brown and others, 2010), but full exposure of usually buried substructural elements warrants special consideration and observation.

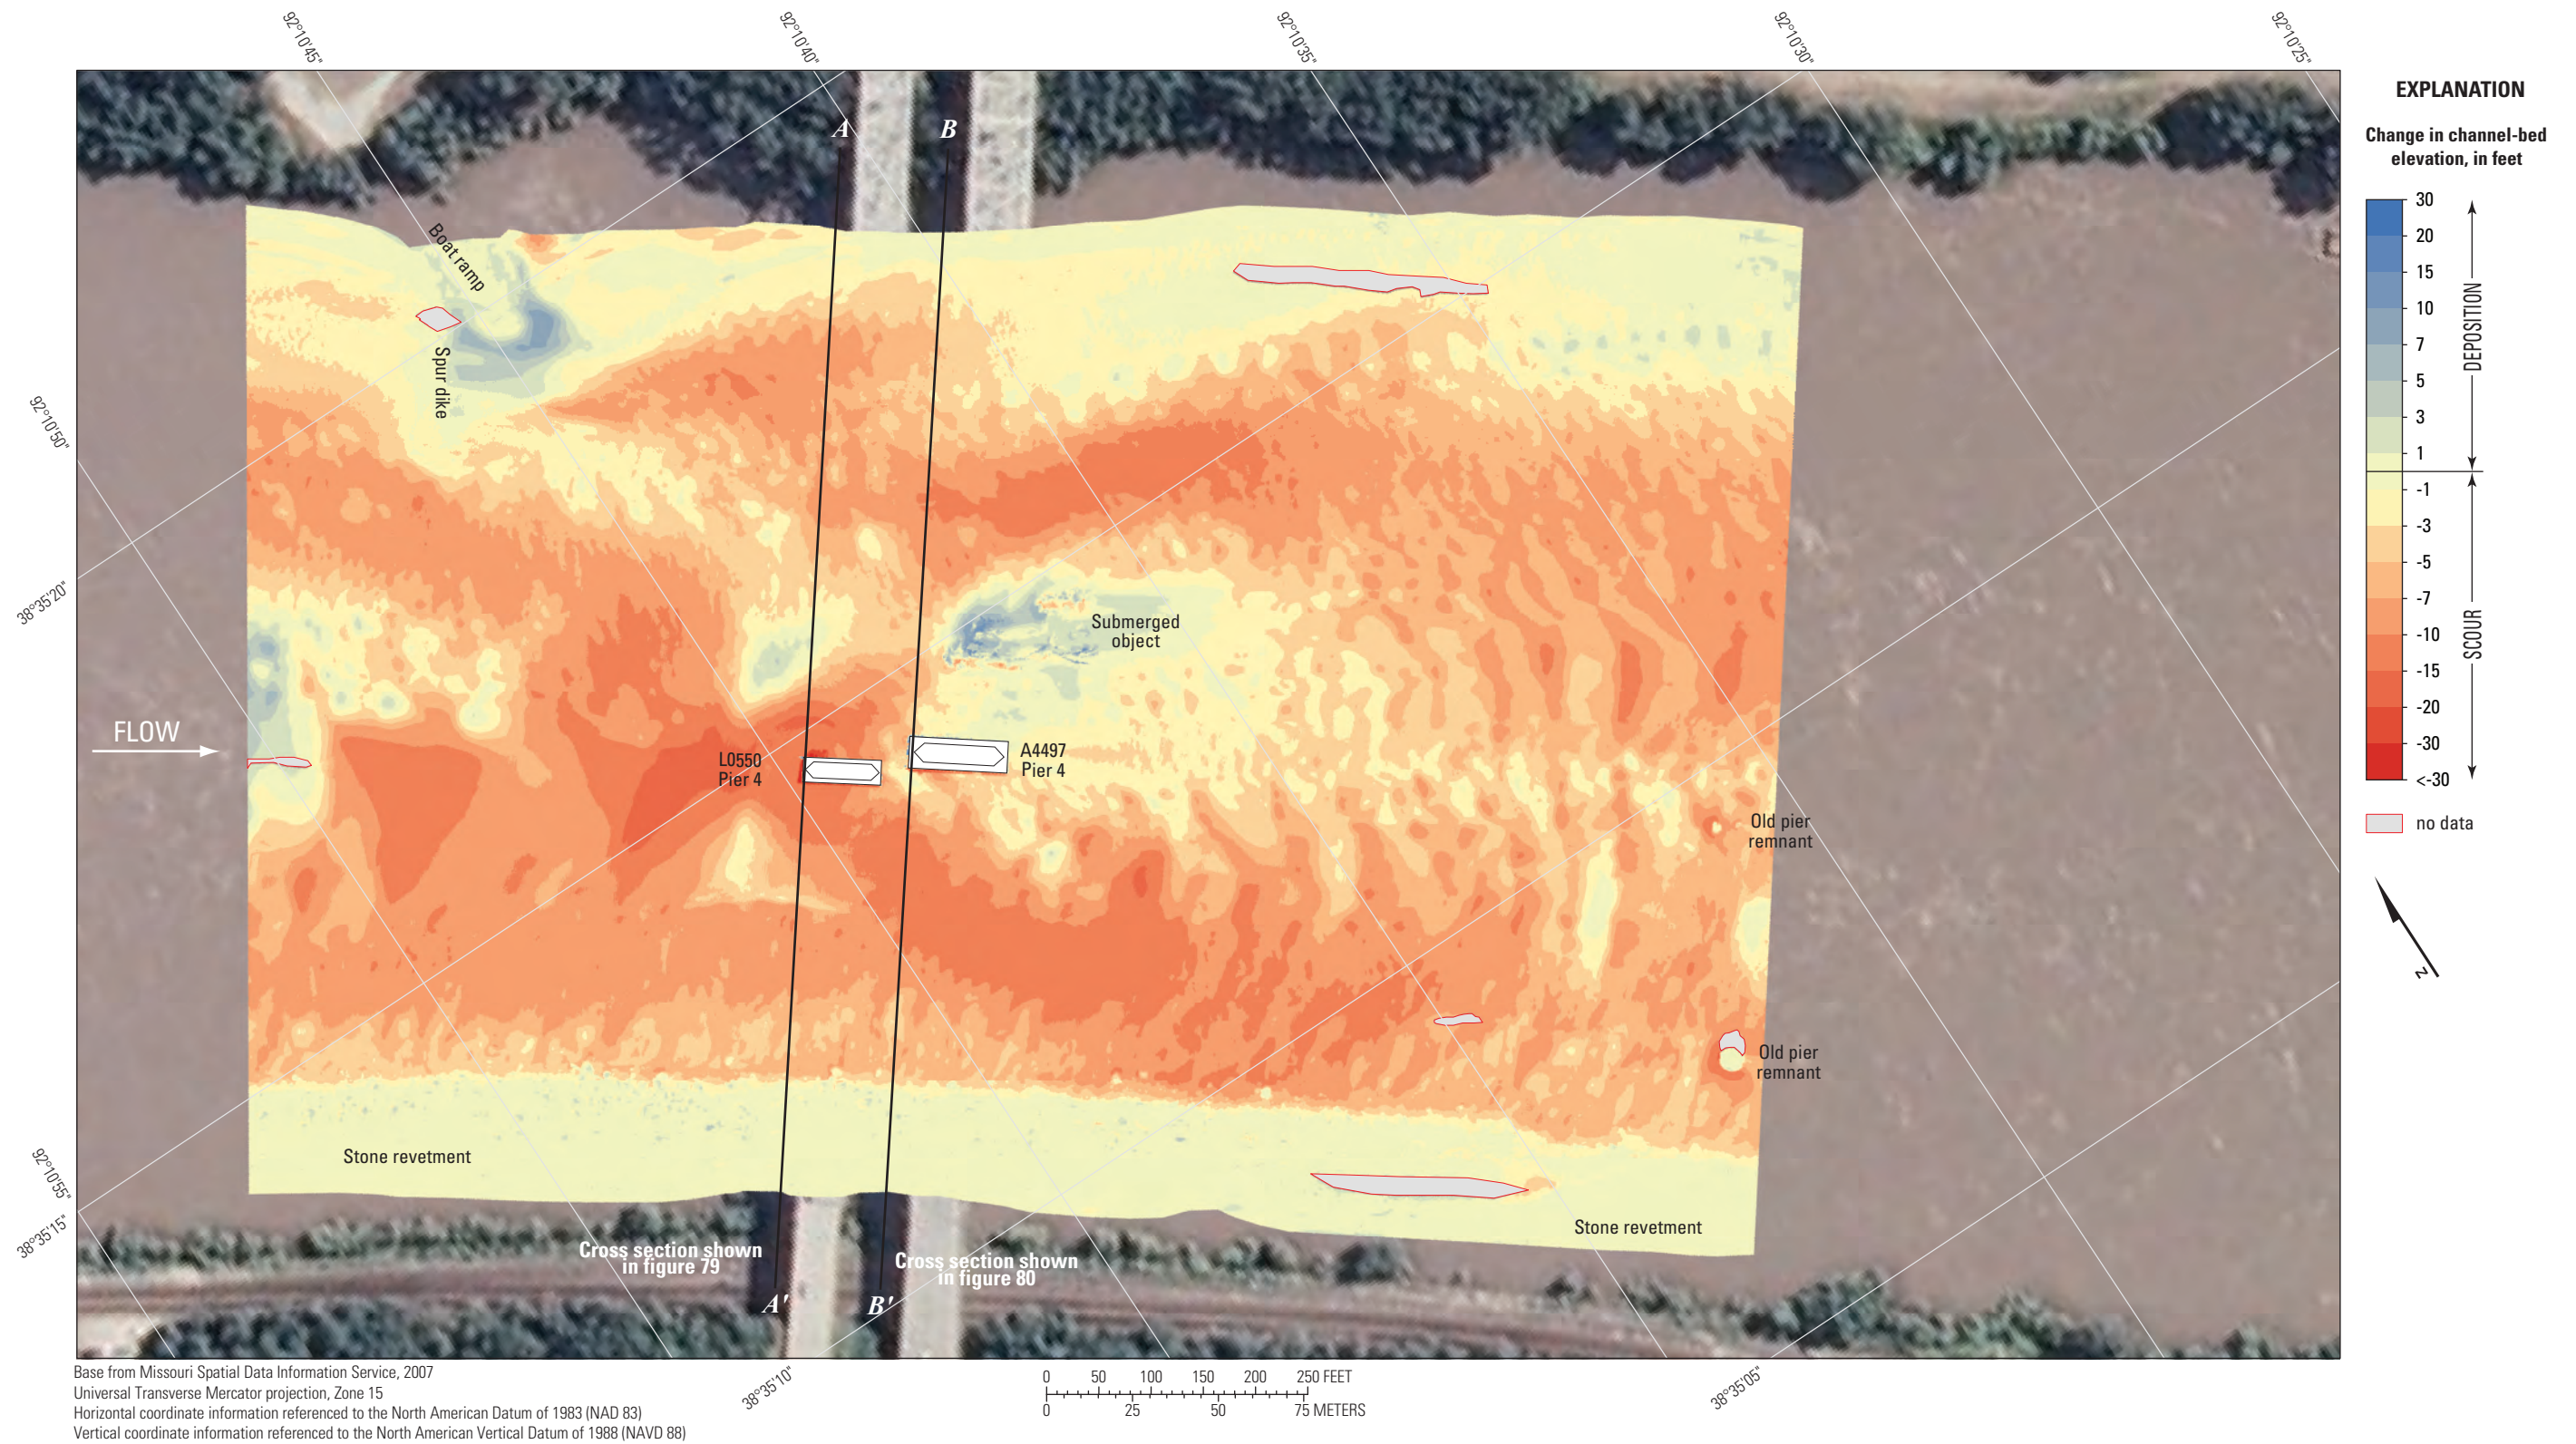
Figure 83. Difference between surfaces created from bathymetric surveys of the Missouri River channel in the vicinity of structures L0550 and A4497 on U.S. Highway 54 at Jefferson City, Missouri, on January 26, 2010, and July 27, 2011.

the left (north) bank and around the submerged object near the piers. The average difference between the March 2011 and July 2011 bathymetric surfaces is -5.40 ft (table 7), again indicating moderate to substantial scour overall. In both of the difference maps (figs. 83, 84), the appearance of substantial deposition or scour near the piers results from minor horizontal positional variances between the surveys; however, there was as much as 15 ft of additional scour near the upstream left side of pier 4 of upstream structure L0550 between the January 2010 and July 2011 scans (figs. 79, 83), and as much as 10 ft of additional scour between the March 2011 and July 2011 scans (figs. 79, 84). Although the January 2010 and March 2011 scans had similar water-surface elevations near the bridges, the flow rates were moderately different from each other (10,000 ft³/s difference; table 7), and substantially different from the July 2011 flood (more than 64,000 ft³/s difference; table 7).

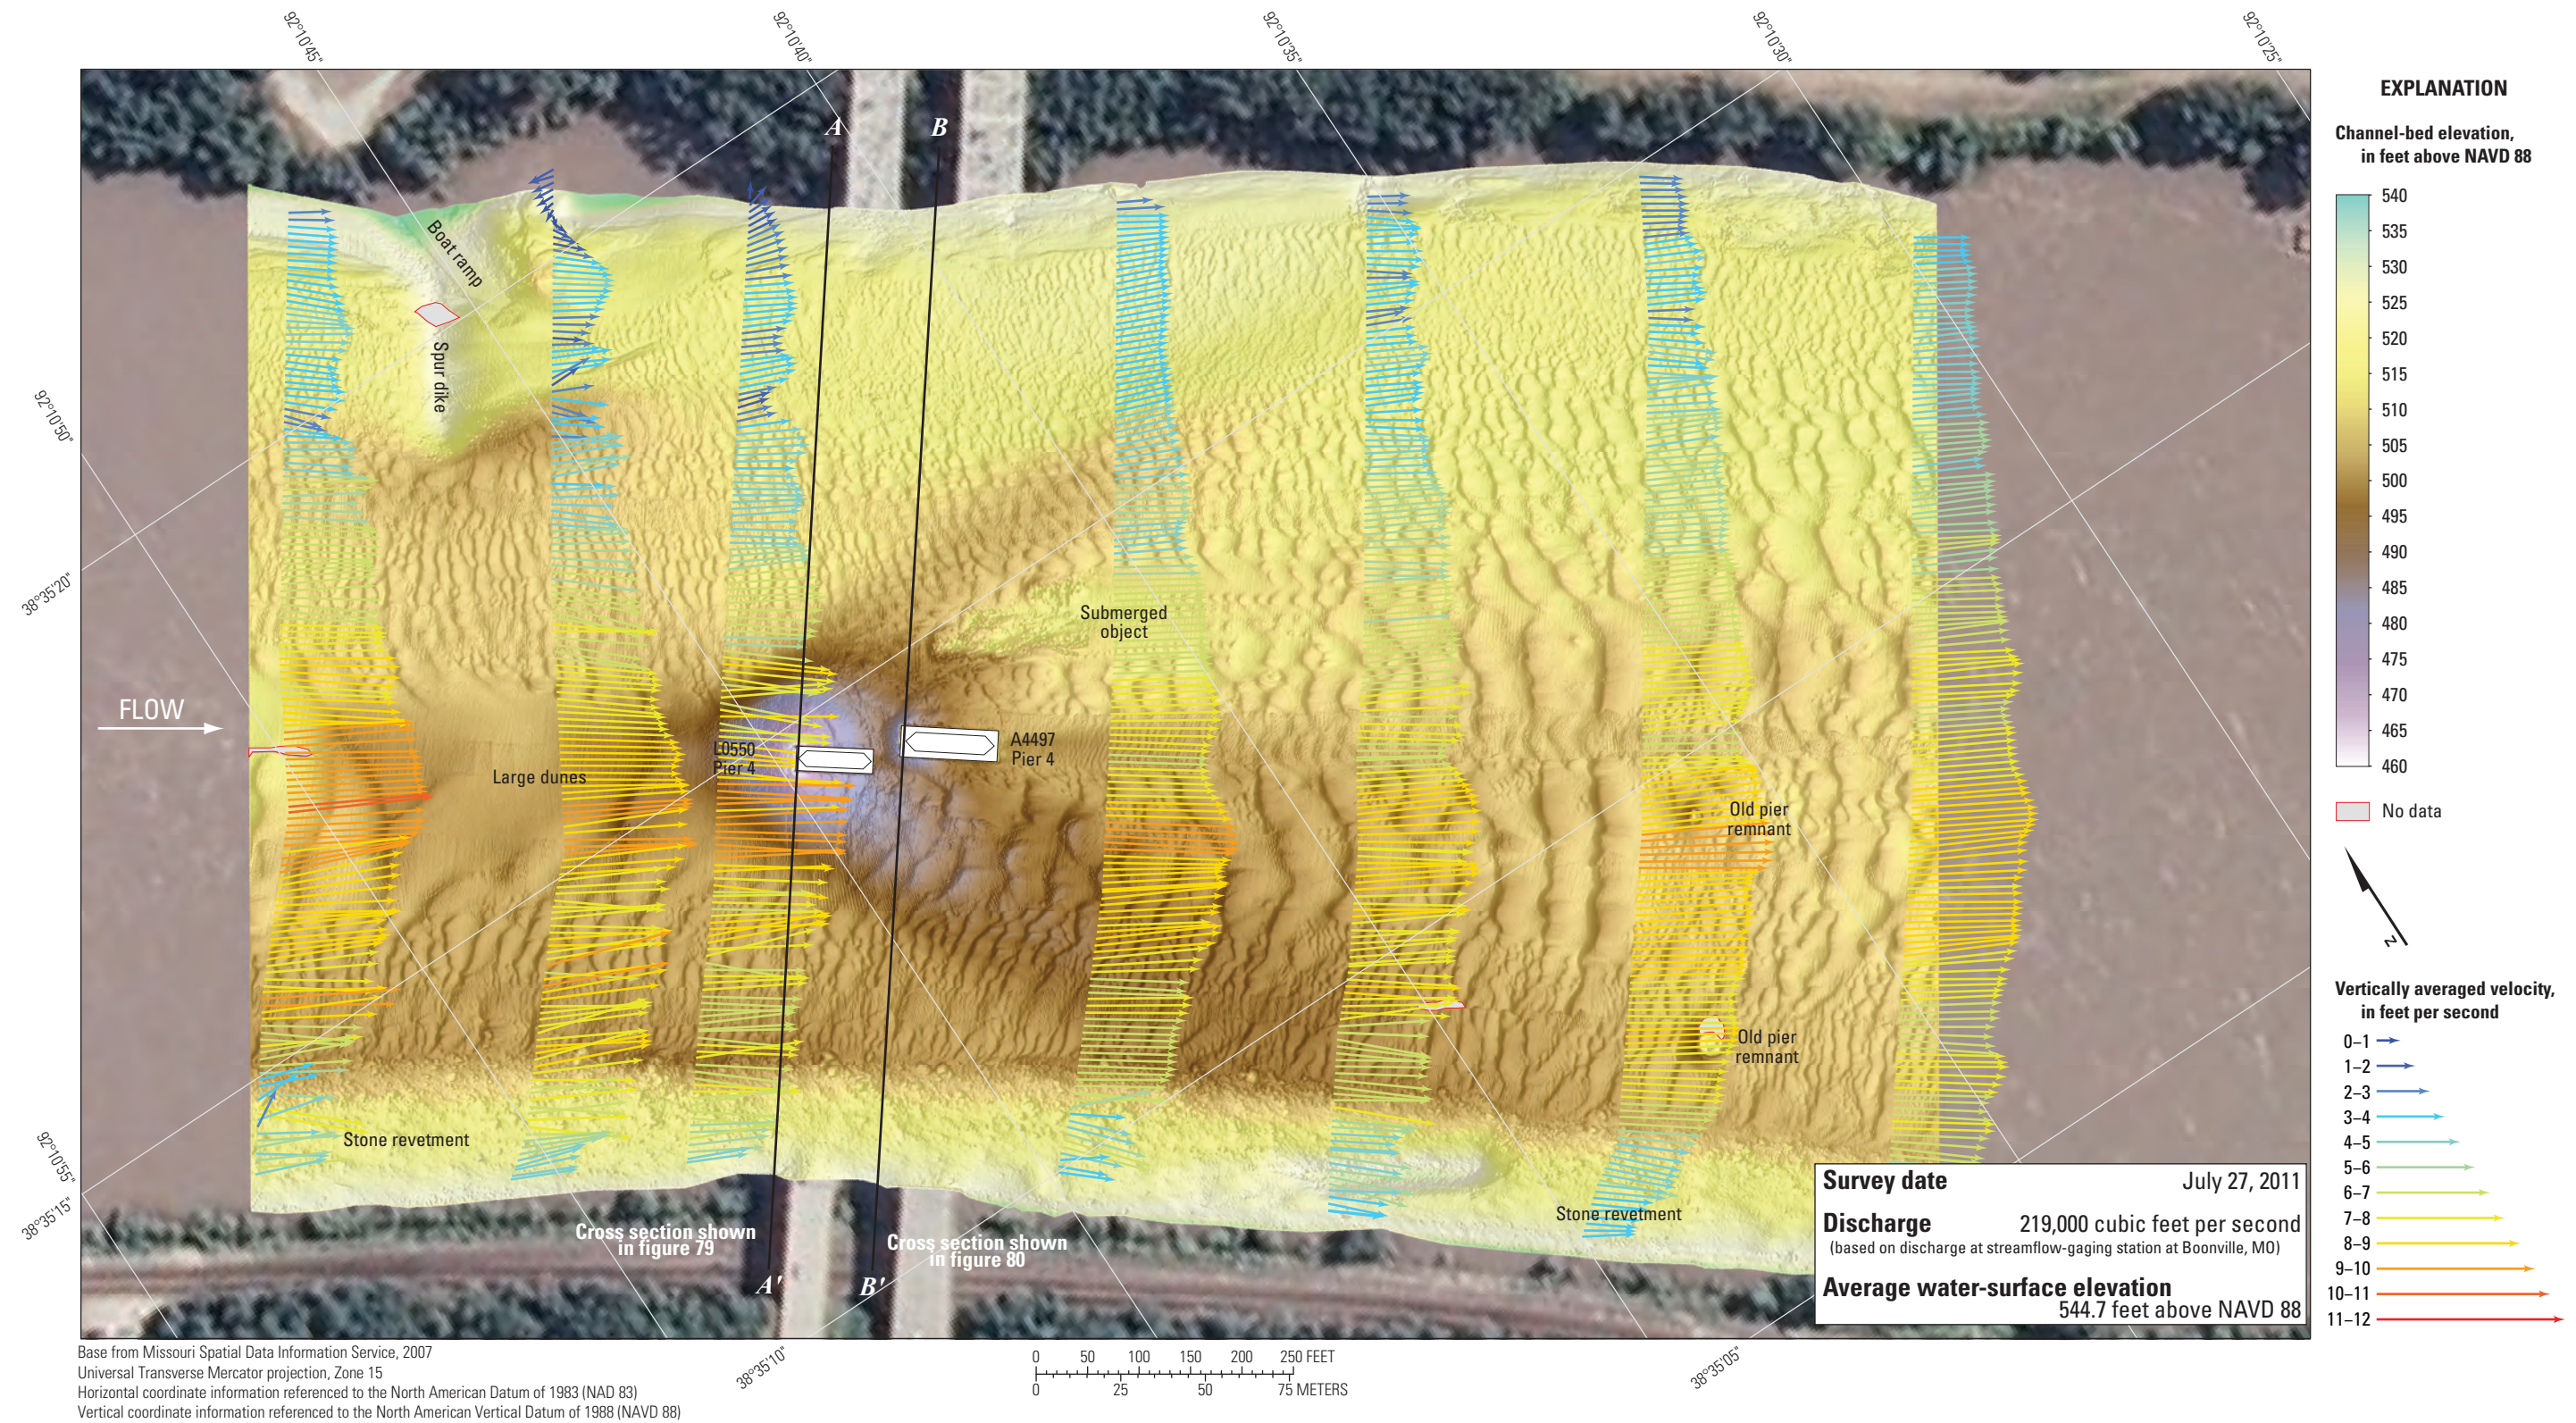
Figure 85. Bathymetry and vertically averaged velocities of the Missouri River channel in the vicinity of structures L0550 and A4497 on U.S. Highway 54 at Jefferson City, Missouri.

The vertically averaged velocity vectors indicate uniform flow in the downstream reach, and areas of substantial turbulence in the upstream reach, particularly near the spur dike on the upstream left (north) bank (fig. 85). Velocities ranged from about 3 to 10 ft/s for most of the channel (fig. 85), except in the vicinity of the spur dike, where low velocities and flow reversals were observed. Moderate to substantial turbulence also was observed in the transects upstream from the bridge (fig. 85). The piers of both bridges generally were aligned with flow, causing no evident turbulence downstream (fig. 85).
