Bathymetric and Velocimetric Surveys at Highway Bridges Crossing the Missouri River in and into Missouri during Summer Flooding, July–August 2011

Scientific Investigations Report 2012–5204

By Richard J. Huizinga

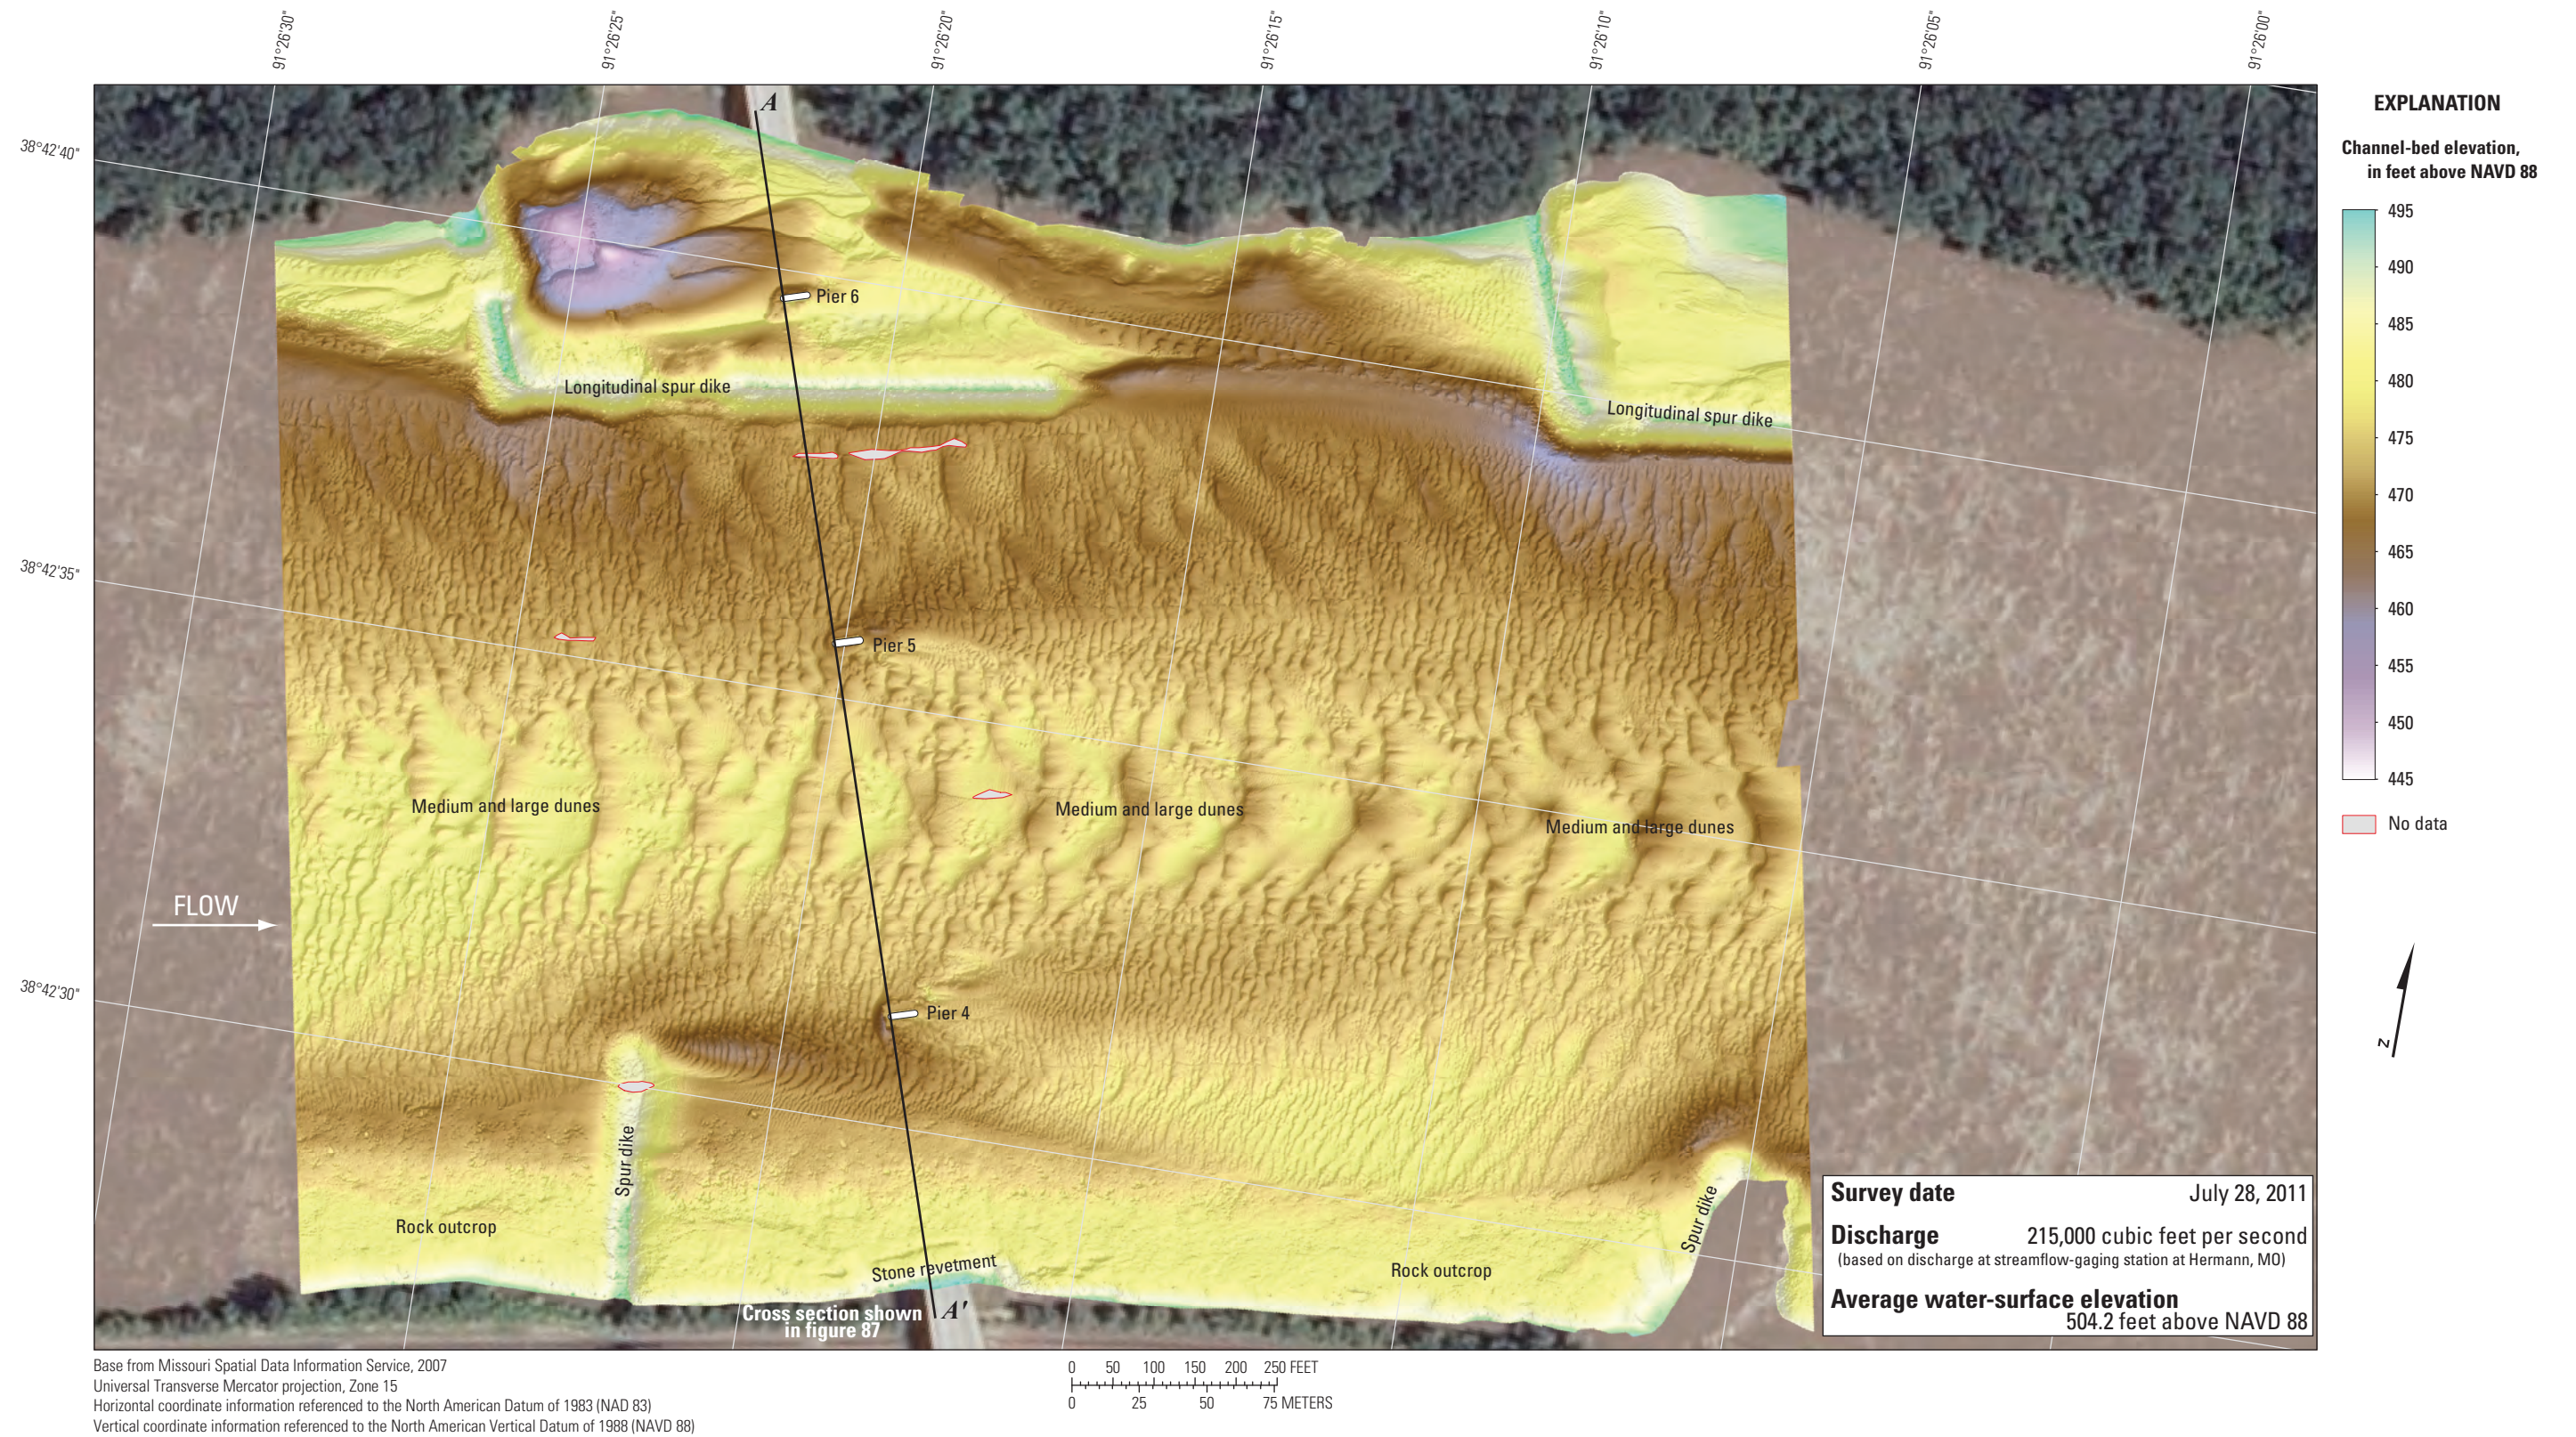
Figure 86. Bathymetric survey of the Missouri River channel in the vicinity of structure A6288 on State Highway 19 at Hermann, Missouri.

Minor scour holes were observed near all of the main channel piers in water. In the vicinity of main channel pier 6

(fig. 86), the scour hole had a minimum channel-bed elevation of about 467 ft (table 8), about 25 ft above the elevation of the bottom of the pier seal course of 442.00 ft (fig. 87; table 8). The minor scour hole near pier 5 had a minimum channel-bed elevation of about 464 ft (table 8), about 20 ft above the elevation of the bottom of the pier seal course of 444.50 ft (fig. 87; table 8); this hole was difficult to discern from nearby dunes and ripples, but the downstream top of the footing was evident (figs. 86, 87). The moderate scour hole near pier 4 had a minimum channel-bed elevation of about 462 ft (table 8), about 11 ft above the elevation of the bottom of the pier seal course of 451.50 ft (fig. 87; table 8); the upstream top of the footing was evident at this pier (figs. 86, 87). Information from bridge plans indicates that piers 4 through 6 are founded on shafts drilled as much as 27 ft into bedrock, with about 66 ft of bed material between the bottom of the scour hole and bedrock at pier 6, about 51 ft of material at pier 5, and about 19 ft of material at pier 4 (fig. 87; table 8). The surveyed bed generally was similar to the original ground line from bridge plans (2001), with localized areas of scour near pier 6 and to the right of pier 4 (fig. 87).

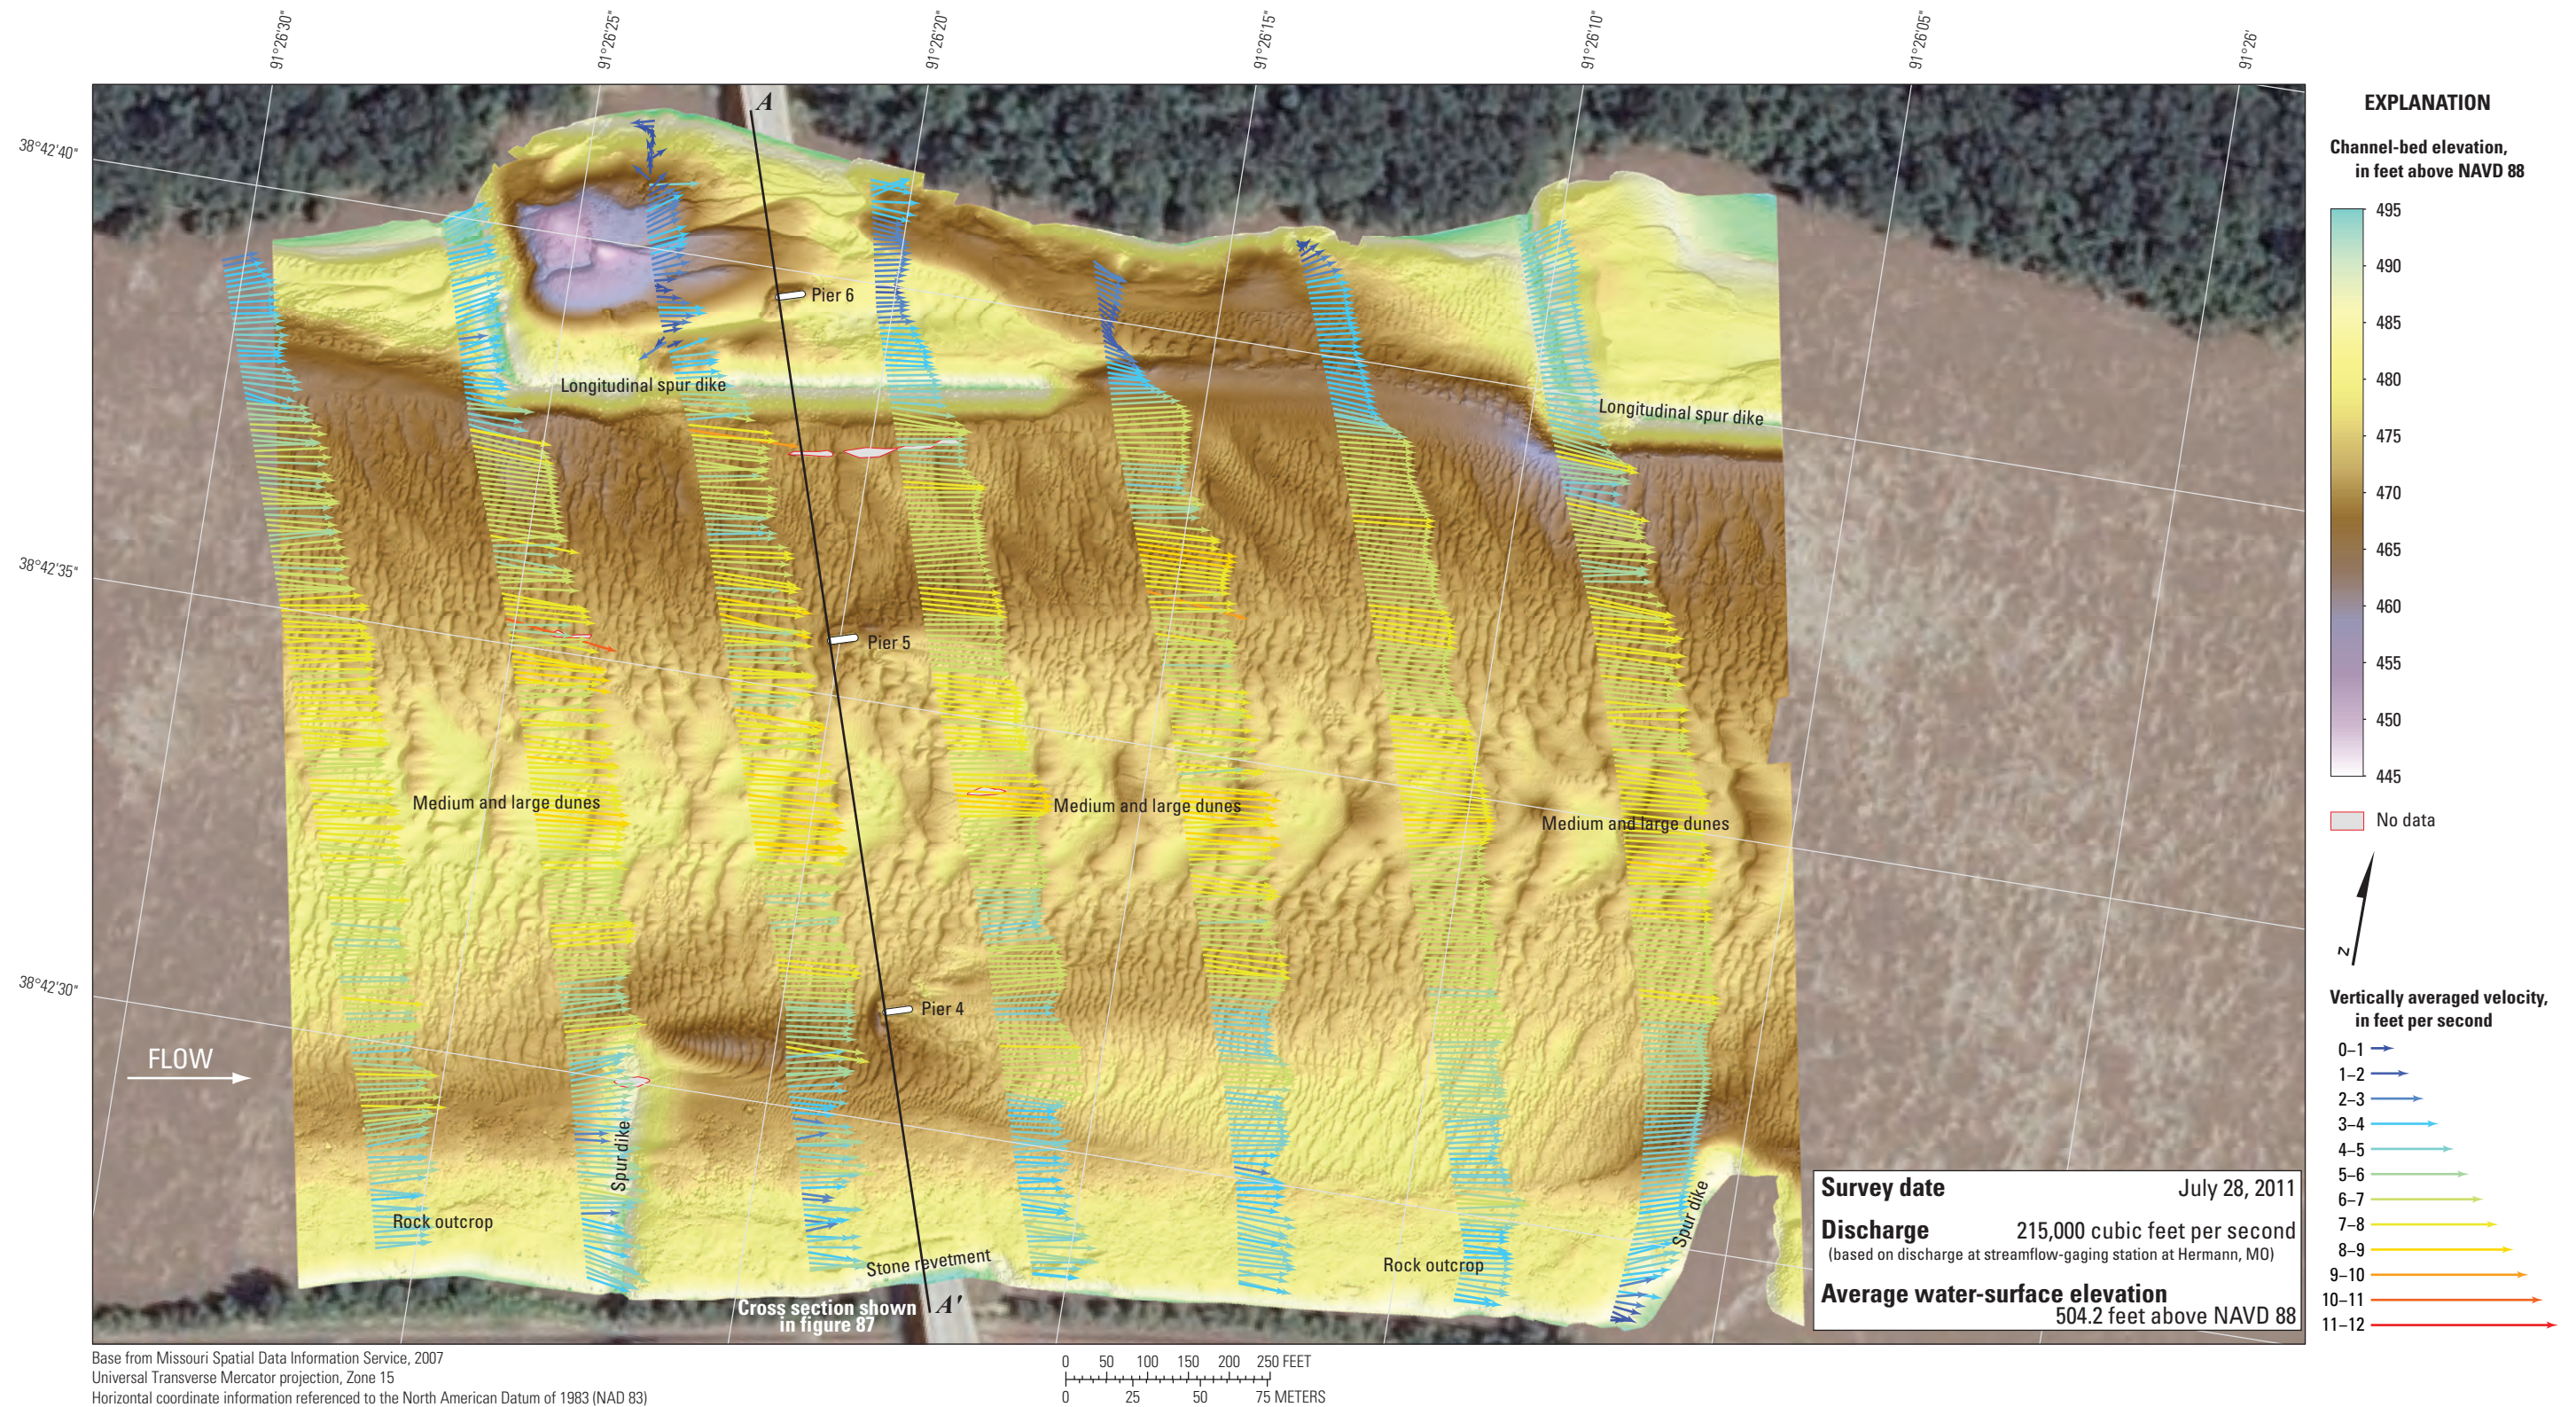
Figure 88. Bathymetry and vertically averaged velocities of the Missouri River channel in the vicinity of structure A6288 on State Highway 19 at Hermann, Missouri.

The vertically averaged velocity vectors indicate mostly uniform flow throughout most of the channel, ranging from about 4 to 8 ft/s (fig. 88), except behind the longitudinal spur dike on the upstream left (north) bank. Moderate turbulence was observed throughout the channel, with localized velocity spikes as high as 11 ft/s (fig. 88). Local flow reversal and substantial turbulence were observed behind the longitudinal spur dike on the left bank (fig. 88). The bridge piers were skewed to flow, but caused little to no evident turbulence downstream (fig. 88).

larger, deeper scour holes than shallow flow or lower velocities (figs. 28, 37, 41, 48, 67, 71, 88, and 102) in the absence of a spur dike or rock outcrop that might limit local scour (pier 2 in fig. 71) or a debris raft that might exacerbate local scour (pier 7 in fig. 102; upstream pier 15 in fig. 107).

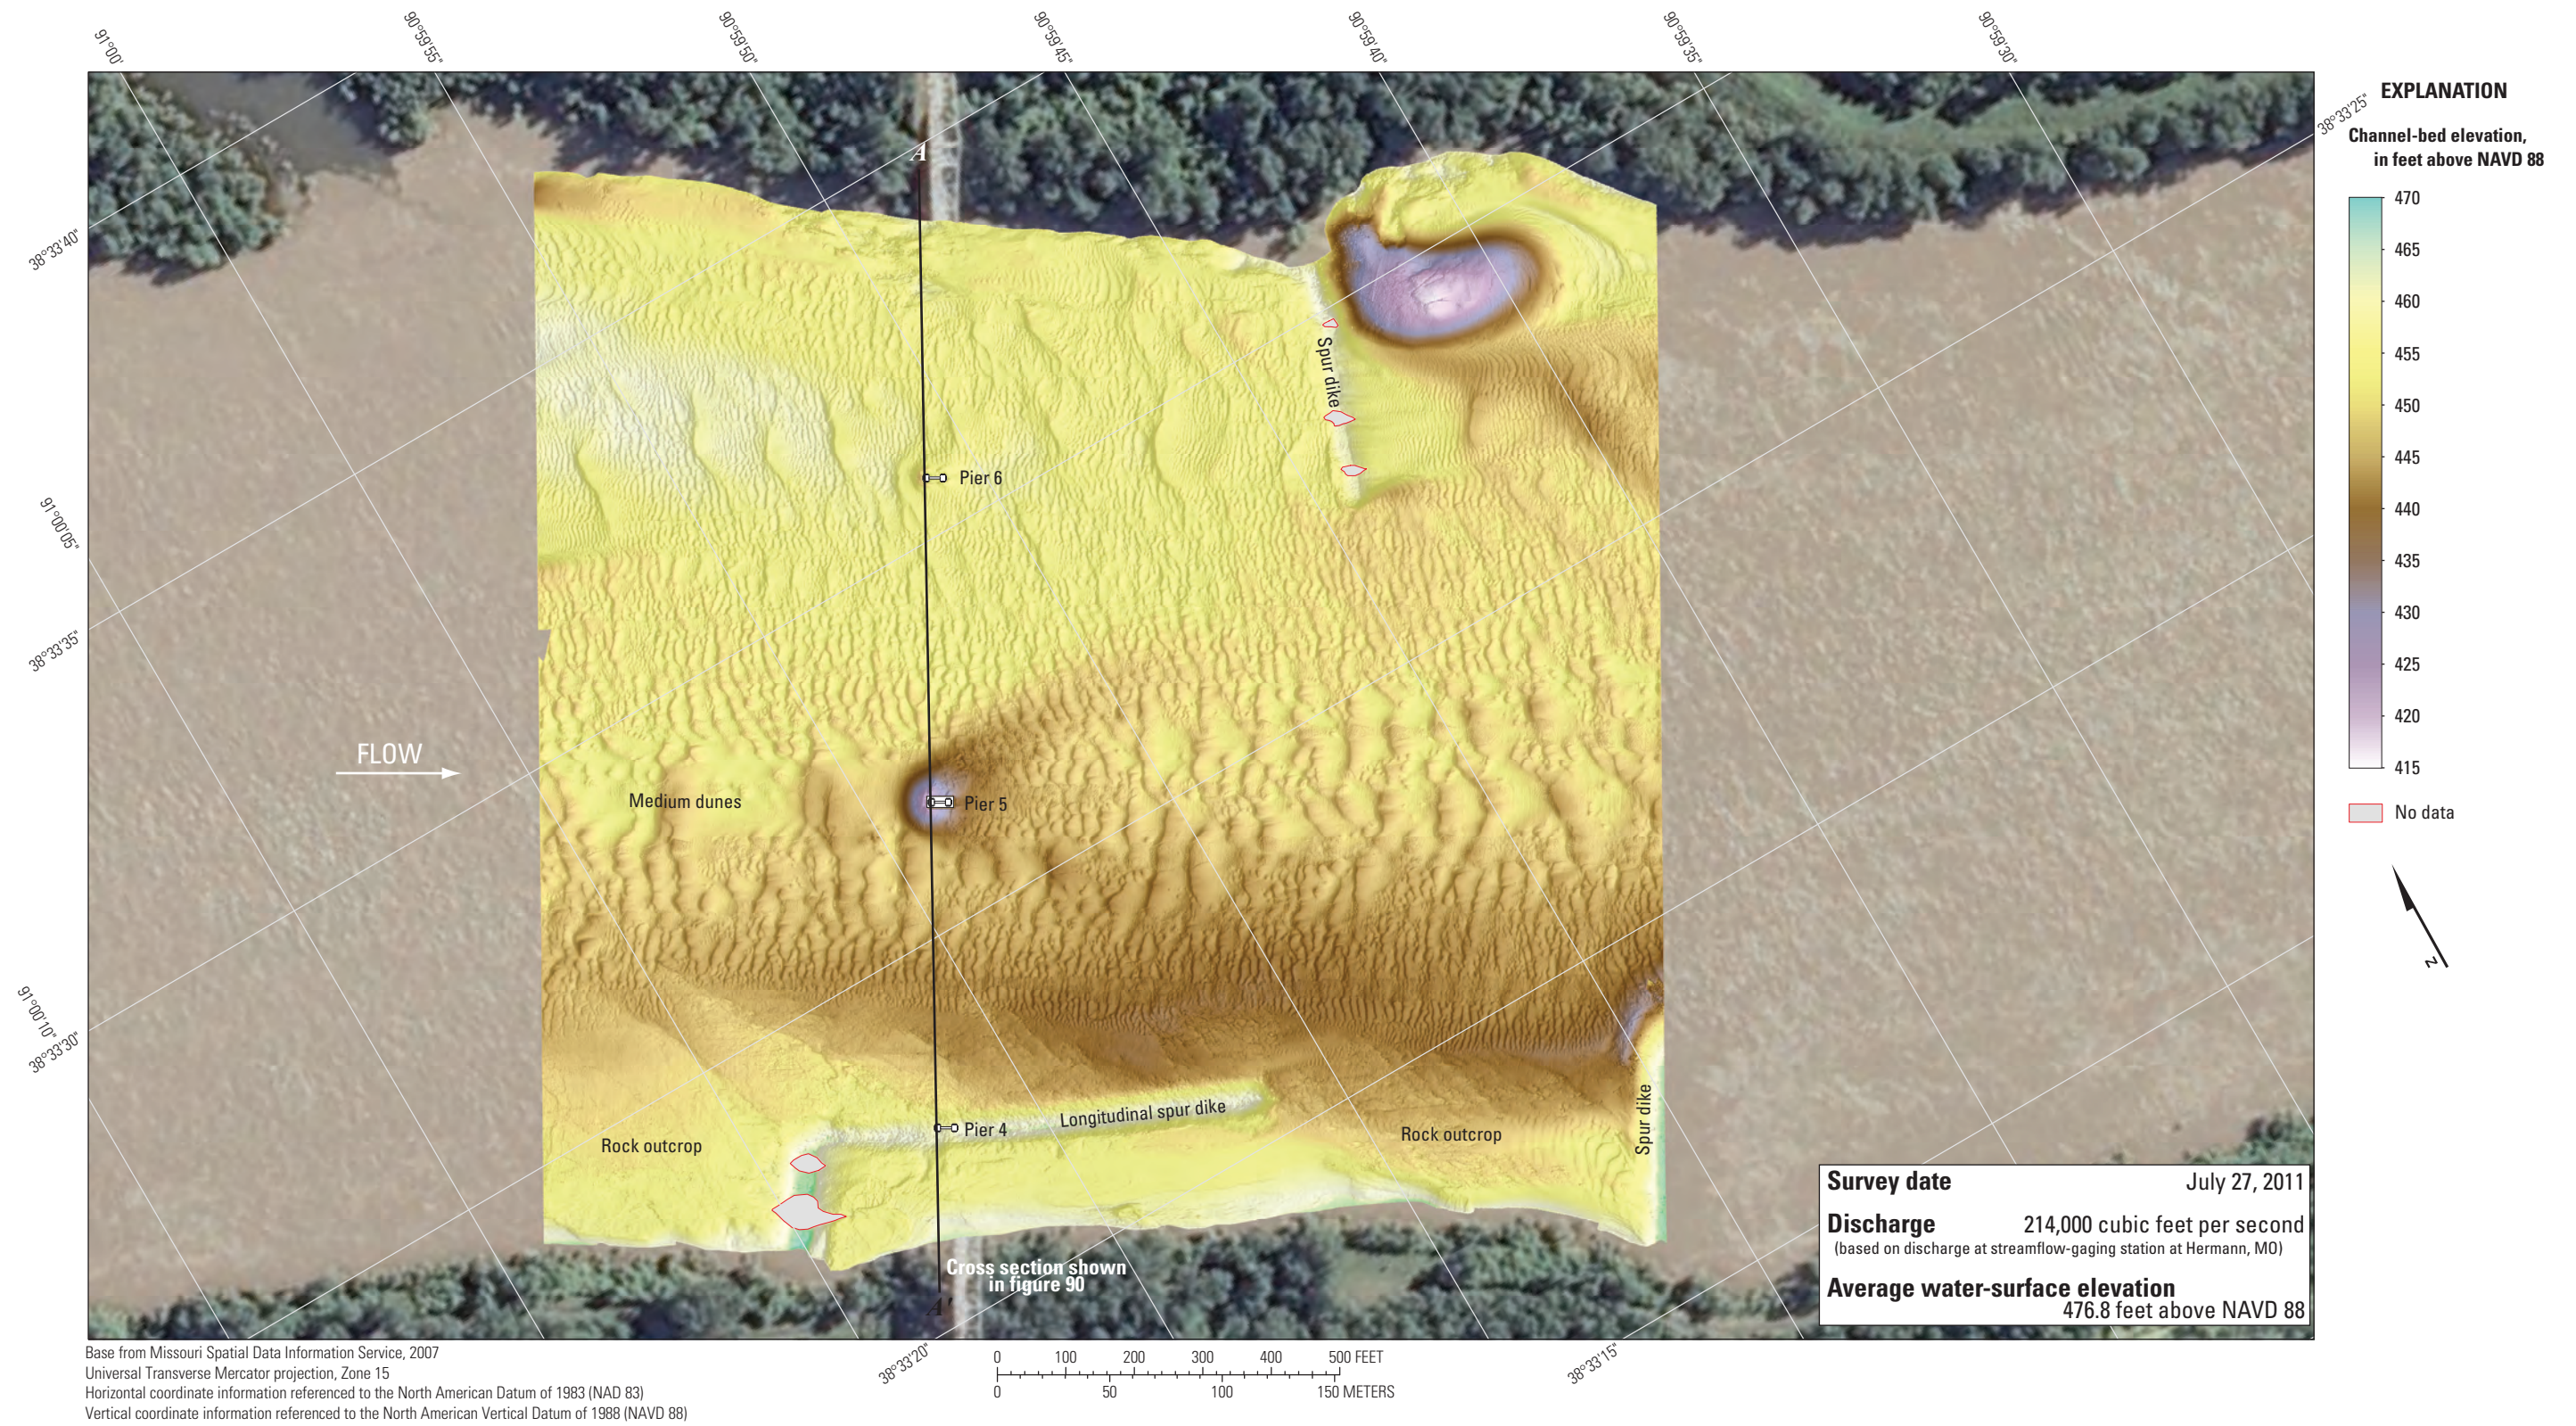
Figure 89. Bathymetric survey of the Missouri River channel in the vicinity of structure K0969 on State Highway 47 at Washington, Missouri.

Scour holes were observed near piers 5 and 6. There was a substantial scour hole in the vicinity of main channel

pier 5 (fig. 89), with a minimum channel-bed elevation of about 423 ft (table 8), about 23 ft below the average channel-bed elevation upstream from the pier (fig. 90; table 8). The moderate scour hole near pier 6 had a minimum channel-bed elevation of about 446 ft (table 8), about 8 ft below the average channel-bed elevation upstream from the pier (fig. 90; table 8); this hole was more difficult to discern from nearby dunes (figs. 89, 90). Information from bridge plans indicates that piers 5 and 6 are founded on caissons on bedrock, with about 56 ft of bed material between the bottom of the scour hole and bedrock at pier 6, and about 30 ft of material at pier 5 (fig. 90; table 8). Pier 4 was embedded in the longitudinal spur dike, and the minimum channel elevation at the toe of the dike was about 448 ft (figs. 89, 90; table 8). Pier 4 is founded on a footing on bedrock, and bedrock was exposed at the toe of the spur dike (fig. 90; table 8); however, the rock of the spur dike likely will limit or prevent a local scour hole near pier 4. The surveyed bed generally was below the ground line from bridge modification plans (1993), with areas of substantial scour on the left side of the channel, near pier 5, and between piers 4 and 5 (fig. 90).

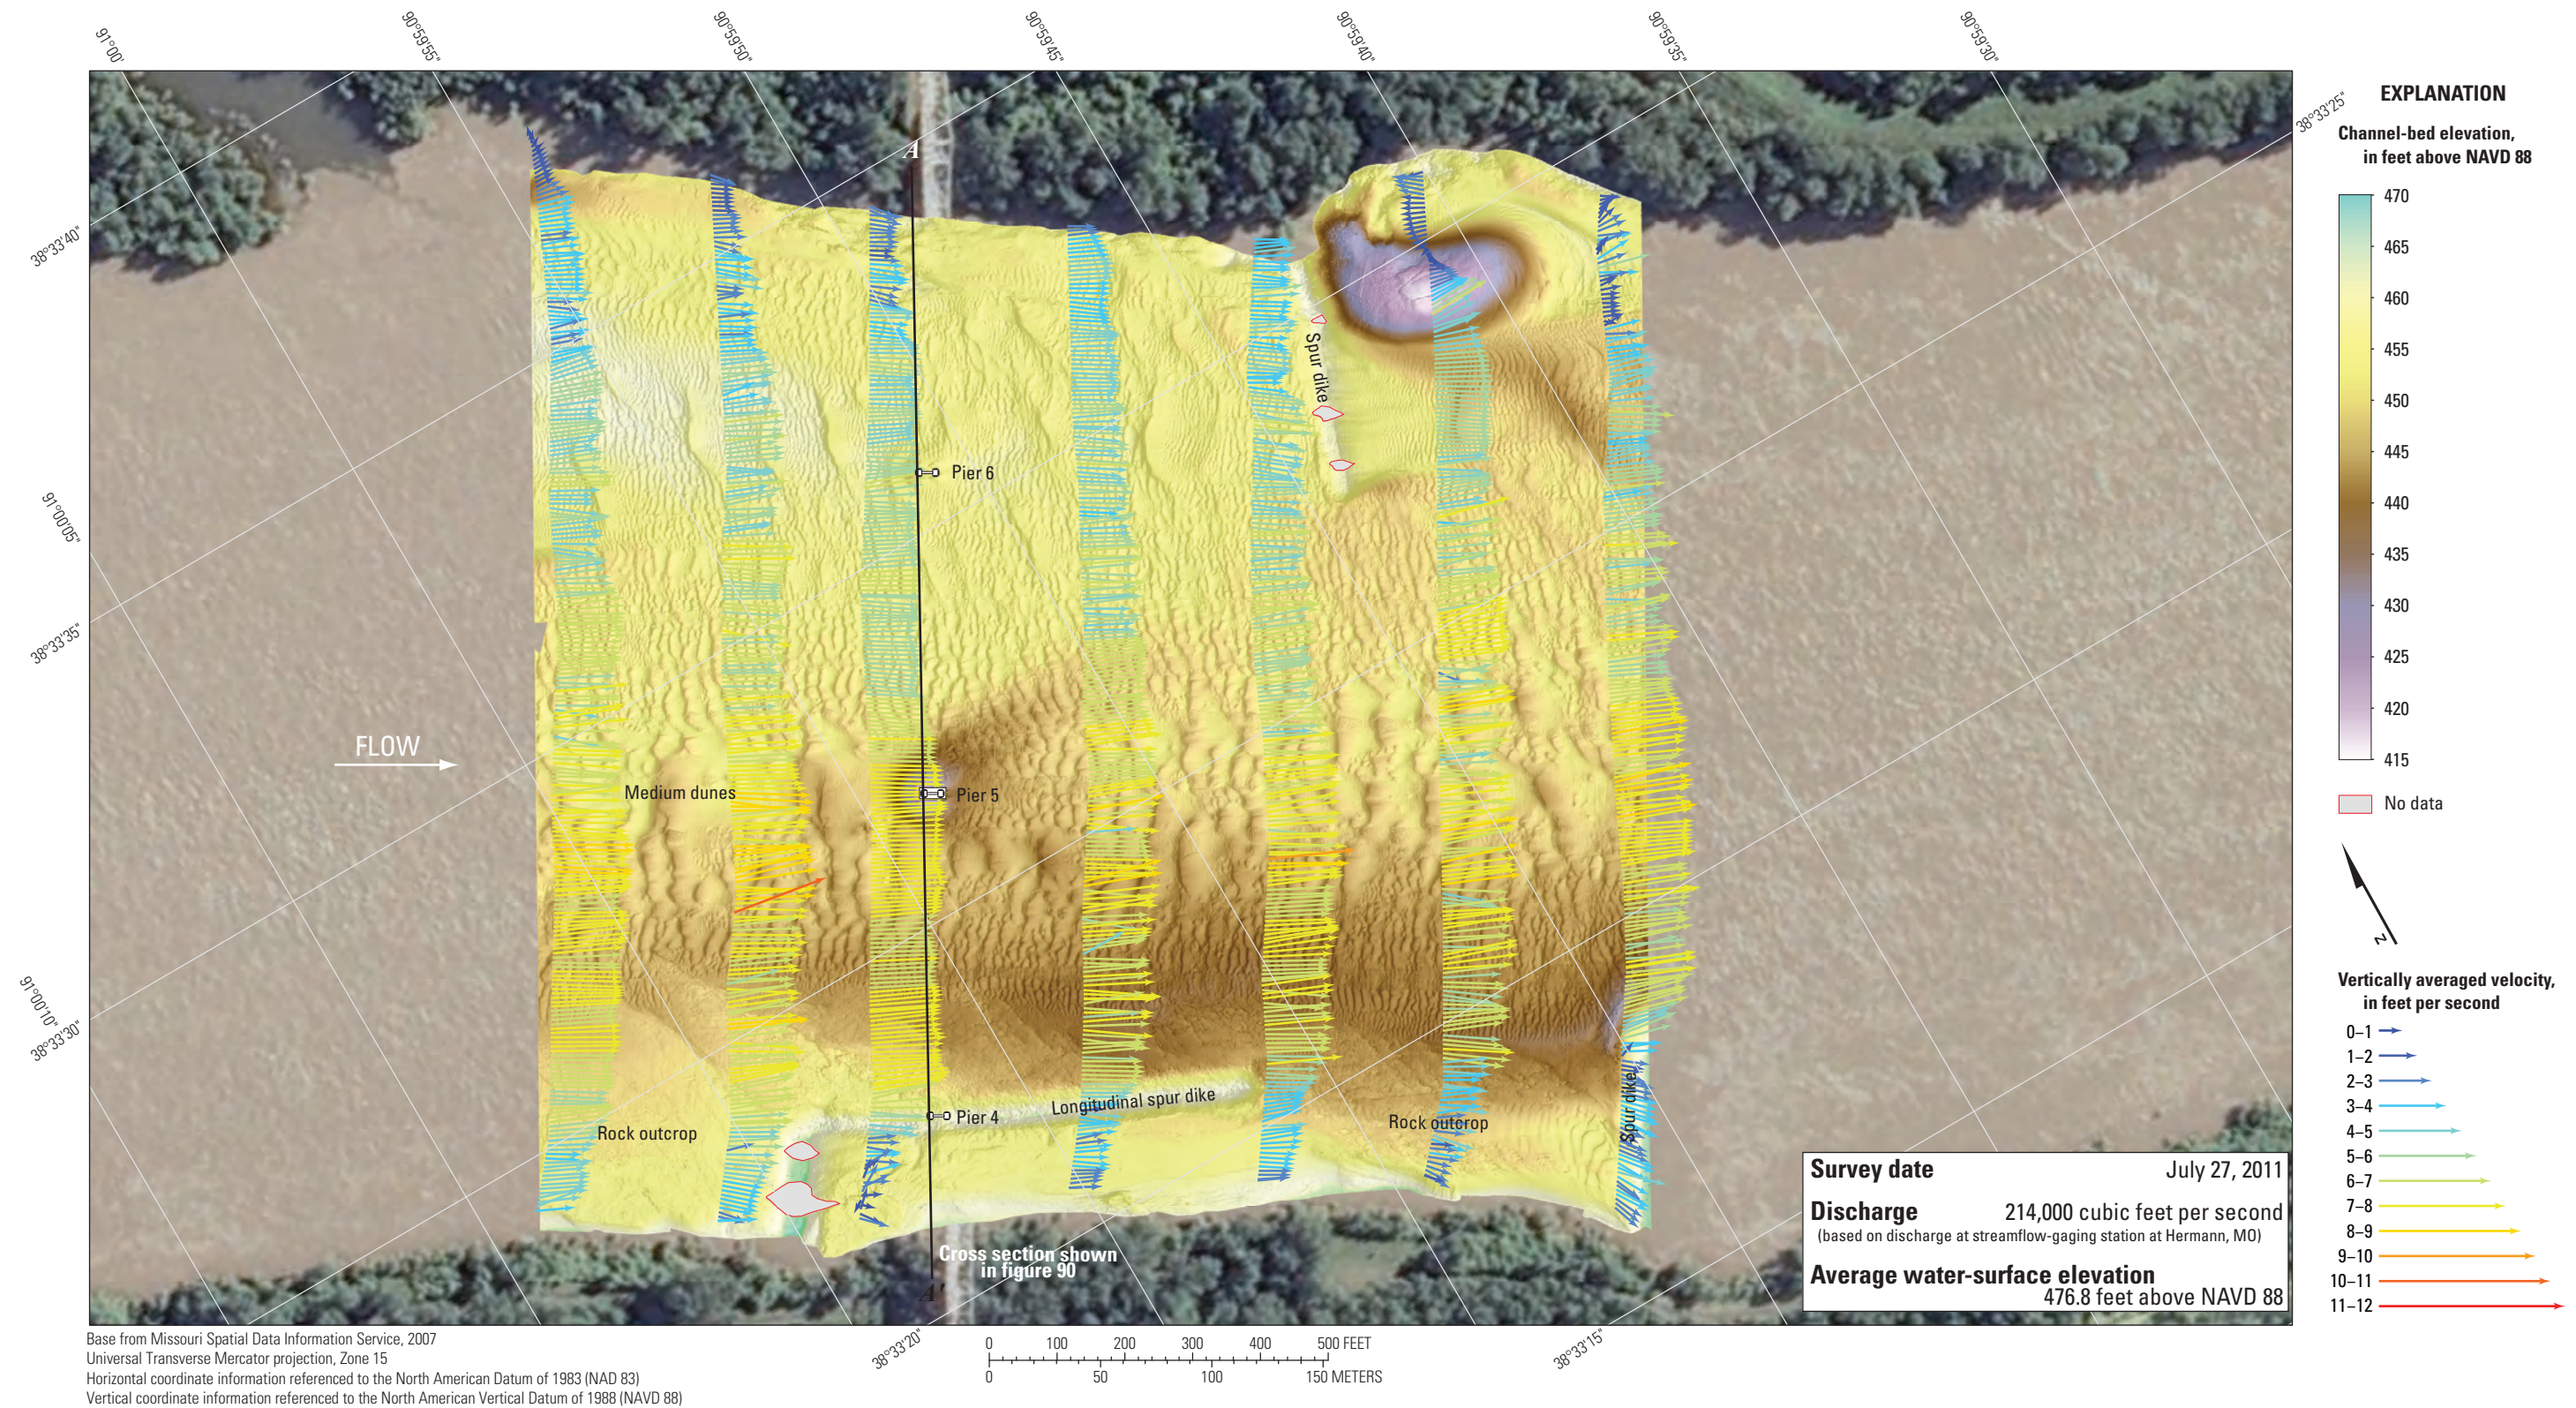
Figure 91. Bathymetry and vertically averaged velocities of the Missouri River channel in the vicinity of structure K0969 on State Highway 47 at Washington, Missouri.

The vertically averaged velocity vectors indicate moderate turbulence throughout the channel, with velocities ranging from about 3 to 9 ft/s (fig. 91). Localized velocity fluctuations as low as 2 ft/s and as high as 11 ft/s were observed (fig. 91). Local flow reversal and substantial turbulence were observed downstream from the various spur dikes on both banks (fig. 91). The bridge piers were aligned with flow, and caused little to no evident turbulence downstream (fig. 91).

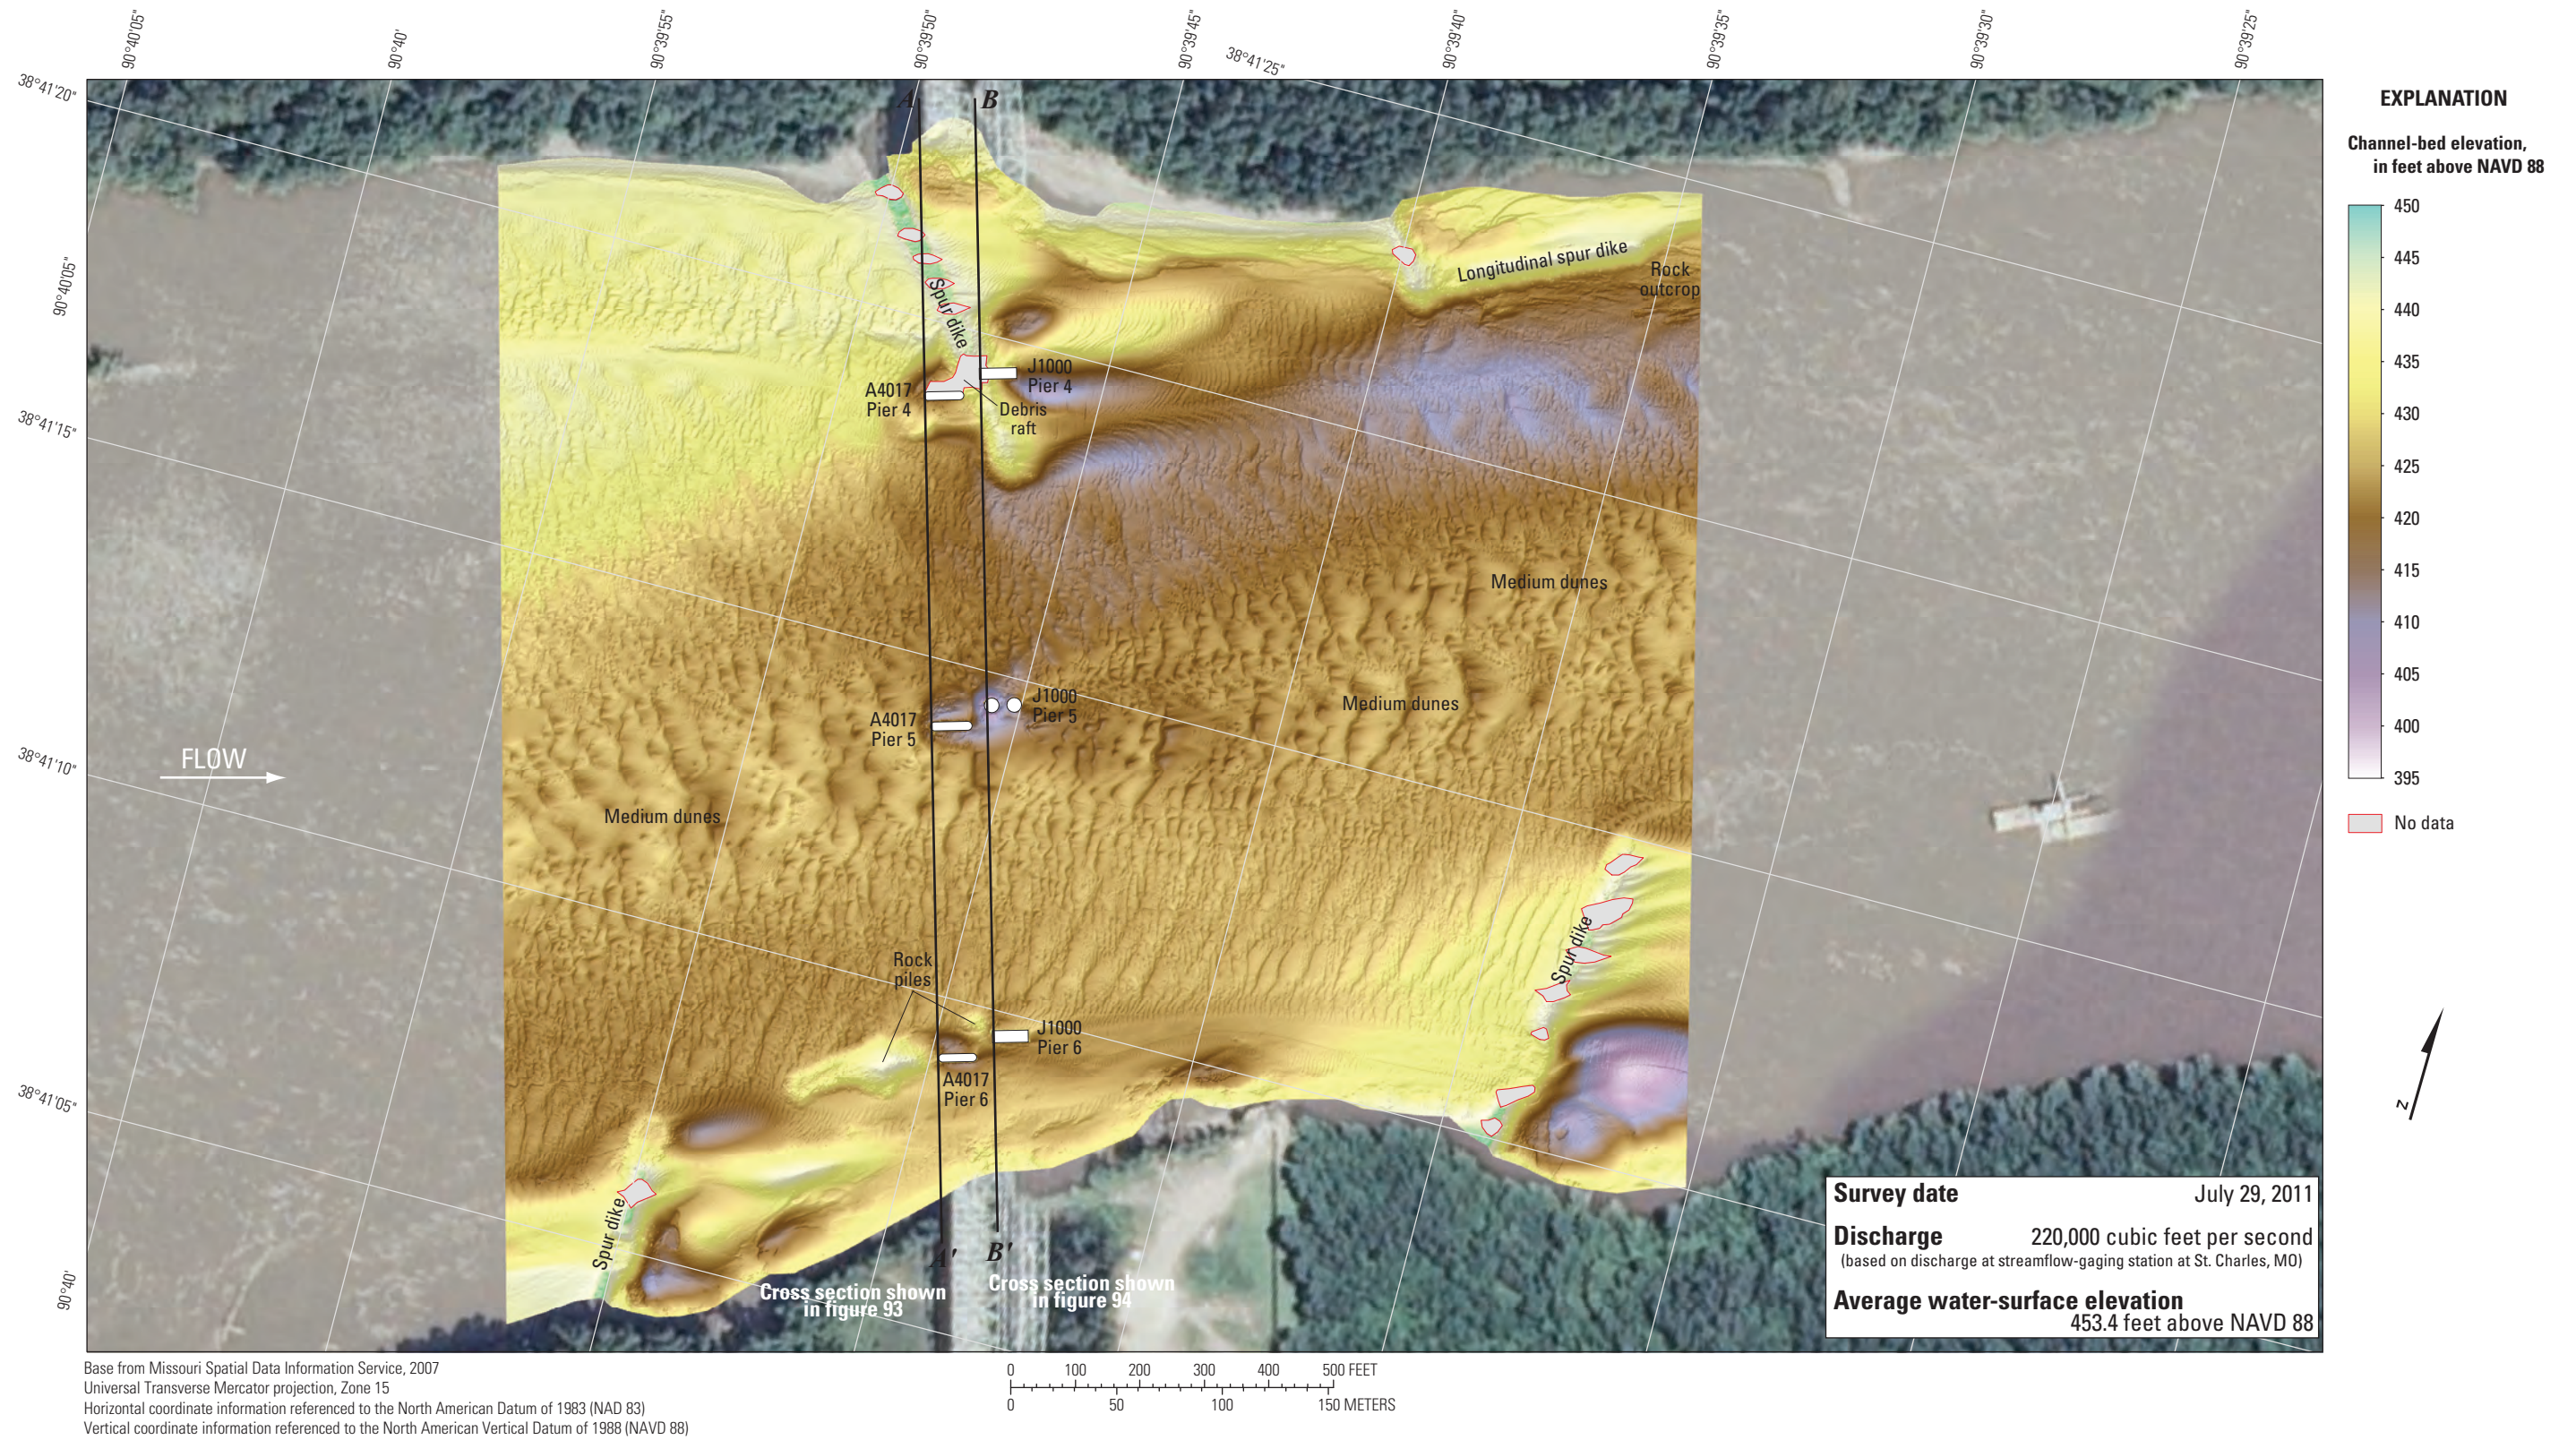
Figure 92. Bathymetric survey of the Missouri River channel in the vicinity of structures A4017 and J1000 on U.S. Highway 40 near St. Louis, Missouri.

In the vicinity of the left main channel piers (pier 4 at both structures, fig. 92), a localized deep scour hole near the end of the spur dike had a minimum channel-bed elevation of about 411 ft. A debris raft between the piers on the left side made it impossible to acquire bathymetry data in the area upstream from pier 4 of downstream structure J1000. At the upstream nose of pier 4 of upstream structure A4017, a local scour hole had a minimum channel-bed elevation of approximately 416 ft (table 9), about 13 ft below the average channel bed immediately upstream from the pier (fig. 93). Downstream from pier 4 of downstream structure J1000, another localized deep scour hole had a minimum channel-bed elevation of about 407 ft (fig. 92), which exposed the downstream right corner of the caisson of that pier. Information from bridge plans indicates that pier 4 of structure A4017 is founded on footings on bedrock, with about 11 ft of bed material between the bottom of the upstream scour hole and bedrock at the upstream pier (fig. 93; table 9). Pier 4 of structure J1000 is founded on a caisson on bedrock, with the bottom of the

In the vicinity of the central main channel piers (pier 5 at both structures, fig. 92), a discontinuous local scour hole had a minimum channel-bed elevation of approximately 403 ft (fig. 92; table 9), about 16 ft below the average channel bed immediately upstream from the piers. The minimum scour elevation was well above the bottom of the seal course elevation (383 ft) of the upstream pier (figs. 92, 93; table 9); however, the local scour hole exposed the upper part of the caissons of the downstream pier (figs. 92, 94). The central main channel piers were skewed to the approaching flow, which caused a wider scour hole with somewhat unique characteristics, similar to that observed at structures A4757 and L0568 on State Highway 291 in Kansas City. On the right (south) side of the upstream pier, the scour hole was slightly deeper, and extended beyond the downstream pier caissons, whereas the leeward left (north) side of the upstream pier had a local ridge of deposition (fig. 92). This deposition was eroded by the scour hole that formed upstream from the downstream pier caissons (fig. 92). Information from bridge plans indicates that pier 5 of upstream structure A4017 is founded on shafts drilled 26 ft into bedrock, with about 43 ft of bed material between the bottom of the scour hole and bedrock (fig. 93; table 9), whereas pier 5 of structure J1000 is founded on caissons on bedrock, with about 36 ft of bed material between the bottom of the scour hole and bedrock (fig. 94; table 9). The exposed caissons of the downstream pier is clearly seen in a point cloud visualization of the multibeam depth points obtained during the survey (fig. 95).

In the vicinity of the right main channel piers (pier 6 at both structures, fig. 92), local scour was affected by rock piles upstream from each pier. A moderate scour hole near pier 6 of upstream structure A4017 had a minimum channel-bed elevation of about 414 ft (table 9), but the rock piles upstream from the piers mitigated scour near the upstream nose of each pier (figs. 92, 93, 94). A minor scour hole near pier 6 of downstream structure J1000 had a minimum channel-bed elevation of about 418 ft (figs. 92, 94; table 9). Information from bridge plans indicates that pier 6 of upstream structure A4017 is founded on shafts drilled 13 ft into bedrock, with about 54 ft of bed material between the bottom of the scour hole and bedrock (fig. 93; table 9). Pier 6 of structure J1000 is founded on caissons on bedrock, with about 58 ft of bed material between the bottom of the scour hole and bedrock (fig. 94; table 9).

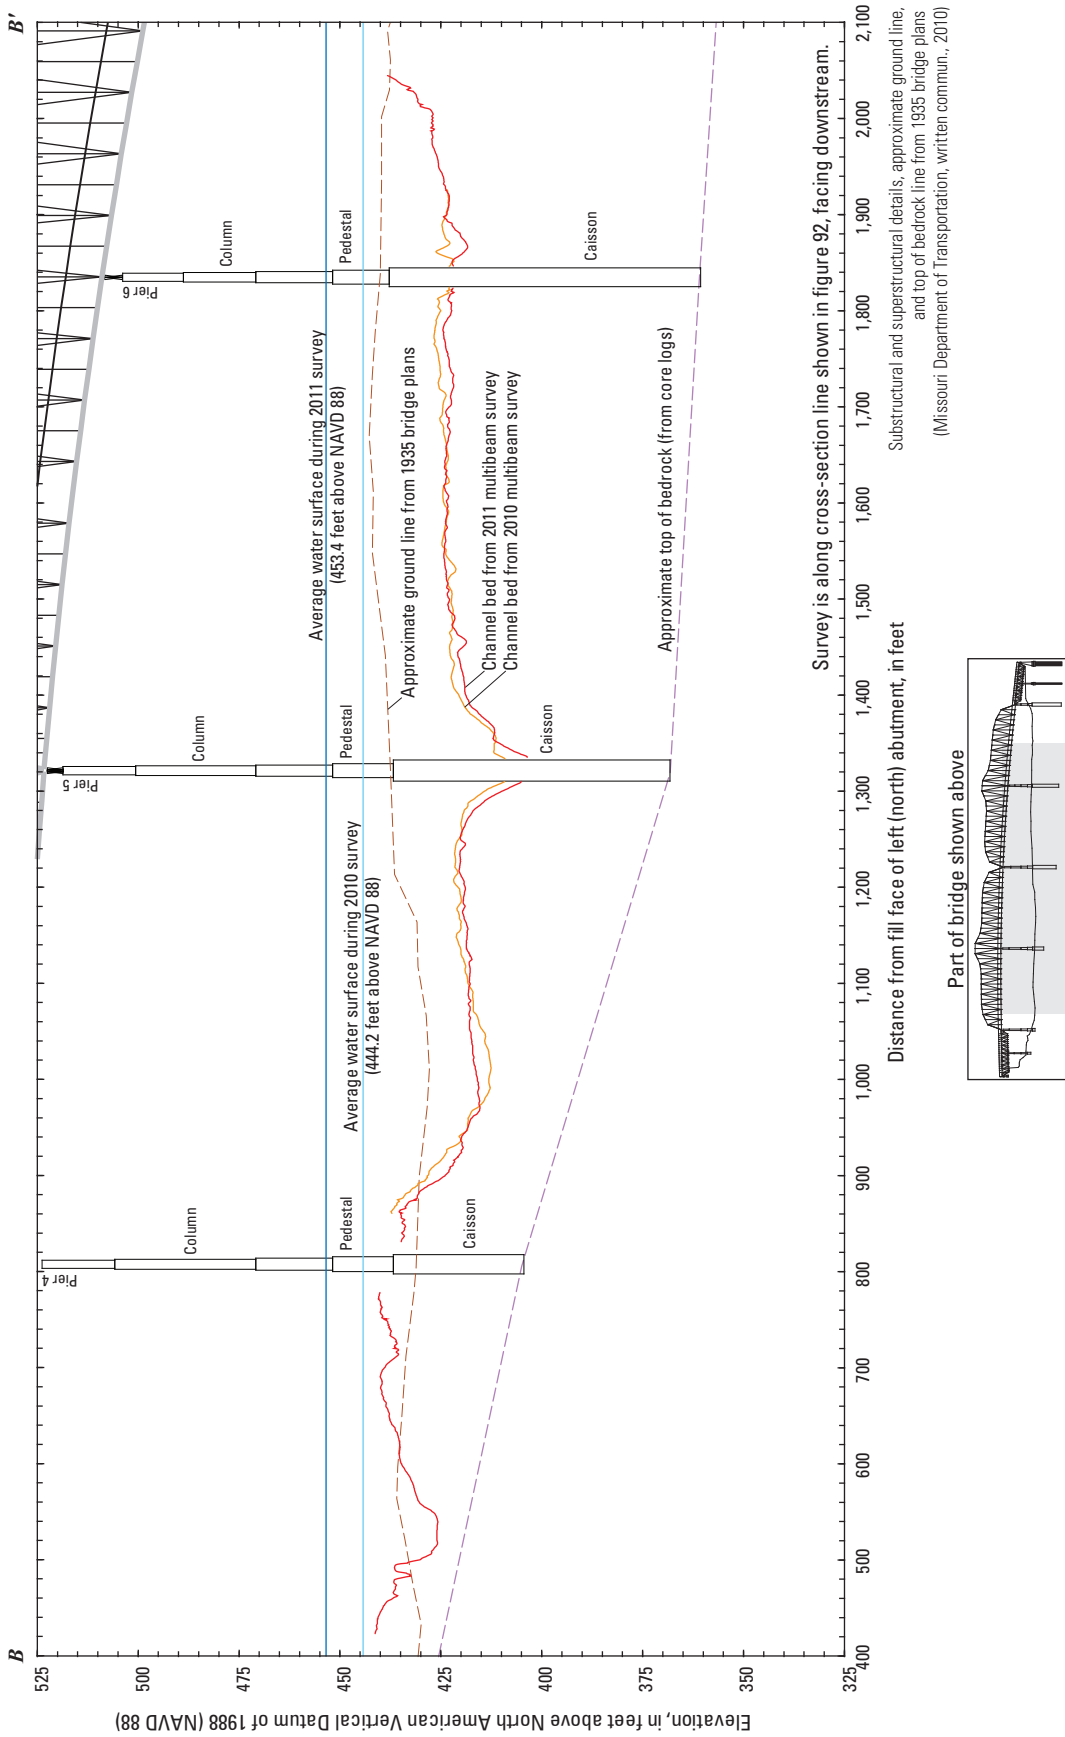
Figure 94 Key features, substructural and superstructural details, and surveyed channel bed of structure J1000 on U.S. Highway 40 over the Missouri River near St. Louis, Missouri.

local scour hole downstream from this pier was only about 2 ft above the bottom of the caisson and bedrock (table 9); however, the local scour hole likely was the result of flow over the spur dike and not directly caused by the pier, and the piers essentially were embedded in the rock of the dike (fig. 94), which will limit or prevent additional scour near both left main channel piers and minimize the effect of the local scour hole on the stability of the piers.
