Bathymetric and Velocimetric Surveys at Highway Bridges Crossing the Missouri River in and into Missouri during Summer Flooding, July–August 2011

Scientific Investigations Report 2012–5204

By Richard J. Huizinga

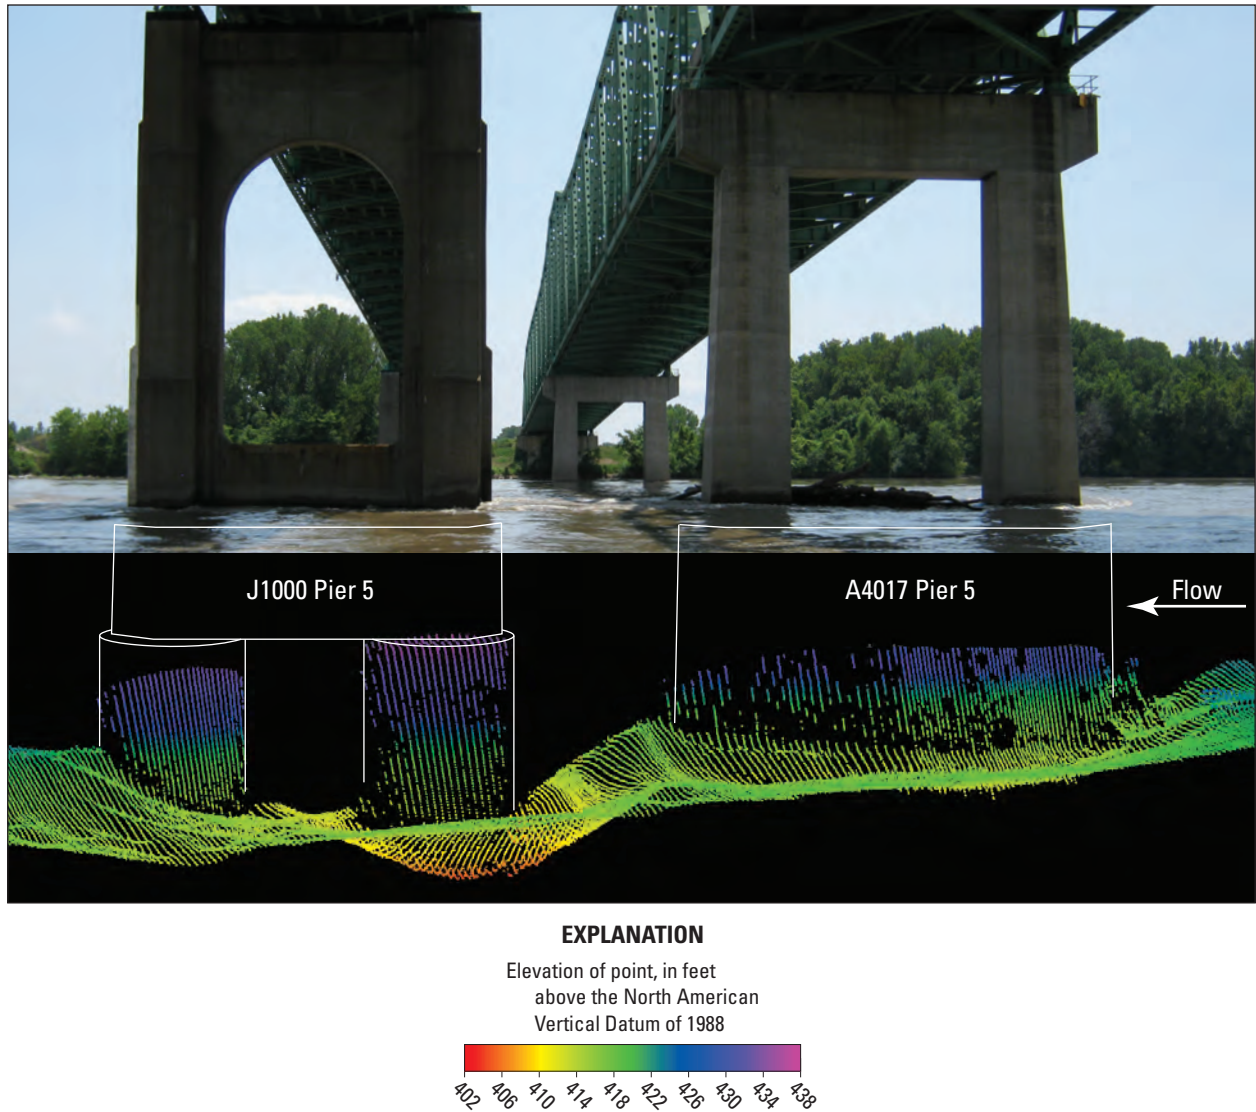
Figure 95. Point cloud visualization of the channel bed and left (north) side of the central main channel piers (pier 5) of structures A4017 and J1000 on U.S. Highway 40 over the Missouri River near St. Louis, Missouri.

In the vicinity of the central main channel piers (pier 5 at both structures, fig. 92), a discontinuous local scour hole had a minimum channel-bed elevation of approximately 403 ft (fig. 92; table 9), about 16 ft below the average channel bed immediately upstream from the piers. The minimum scour elevation was well above the bottom of the seal course elevation (383 ft) of the upstream pier (figs. 92, 93; table 9); however, the local scour hole exposed the upper part of the caissons of the downstream pier (figs. 92, 94). The central main channel piers were skewed to the approaching flow, which caused a wider scour hole with somewhat unique characteristics, similar to that observed at structures A4757 and L0568 on State Highway 291 in Kansas City. On the right (south) side of the upstream pier, the scour hole was slightly deeper, and extended beyond the downstream pier caissons, whereas the leeward left (north) side of the upstream pier had a local ridge of deposition (fig. 92). This deposition was eroded by the scour hole that formed upstream from the downstream pier caissons (fig. 92). Information from bridge plans indicates that pier 5 of upstream structure A4017 is founded on shafts drilled 26 ft into bedrock, with about 43 ft of bed material between the bottom of the scour hole and bedrock (fig. 93; table 9), whereas pier 5 of structure J1000 is founded on caissons on bedrock, with about 36 ft of bed material between the bottom of the scour hole and bedrock (fig. 94; table 9). The exposed caissons of the downstream pier is clearly seen in a point cloud visualization of the multibeam depth points obtained during the survey (fig. 95).

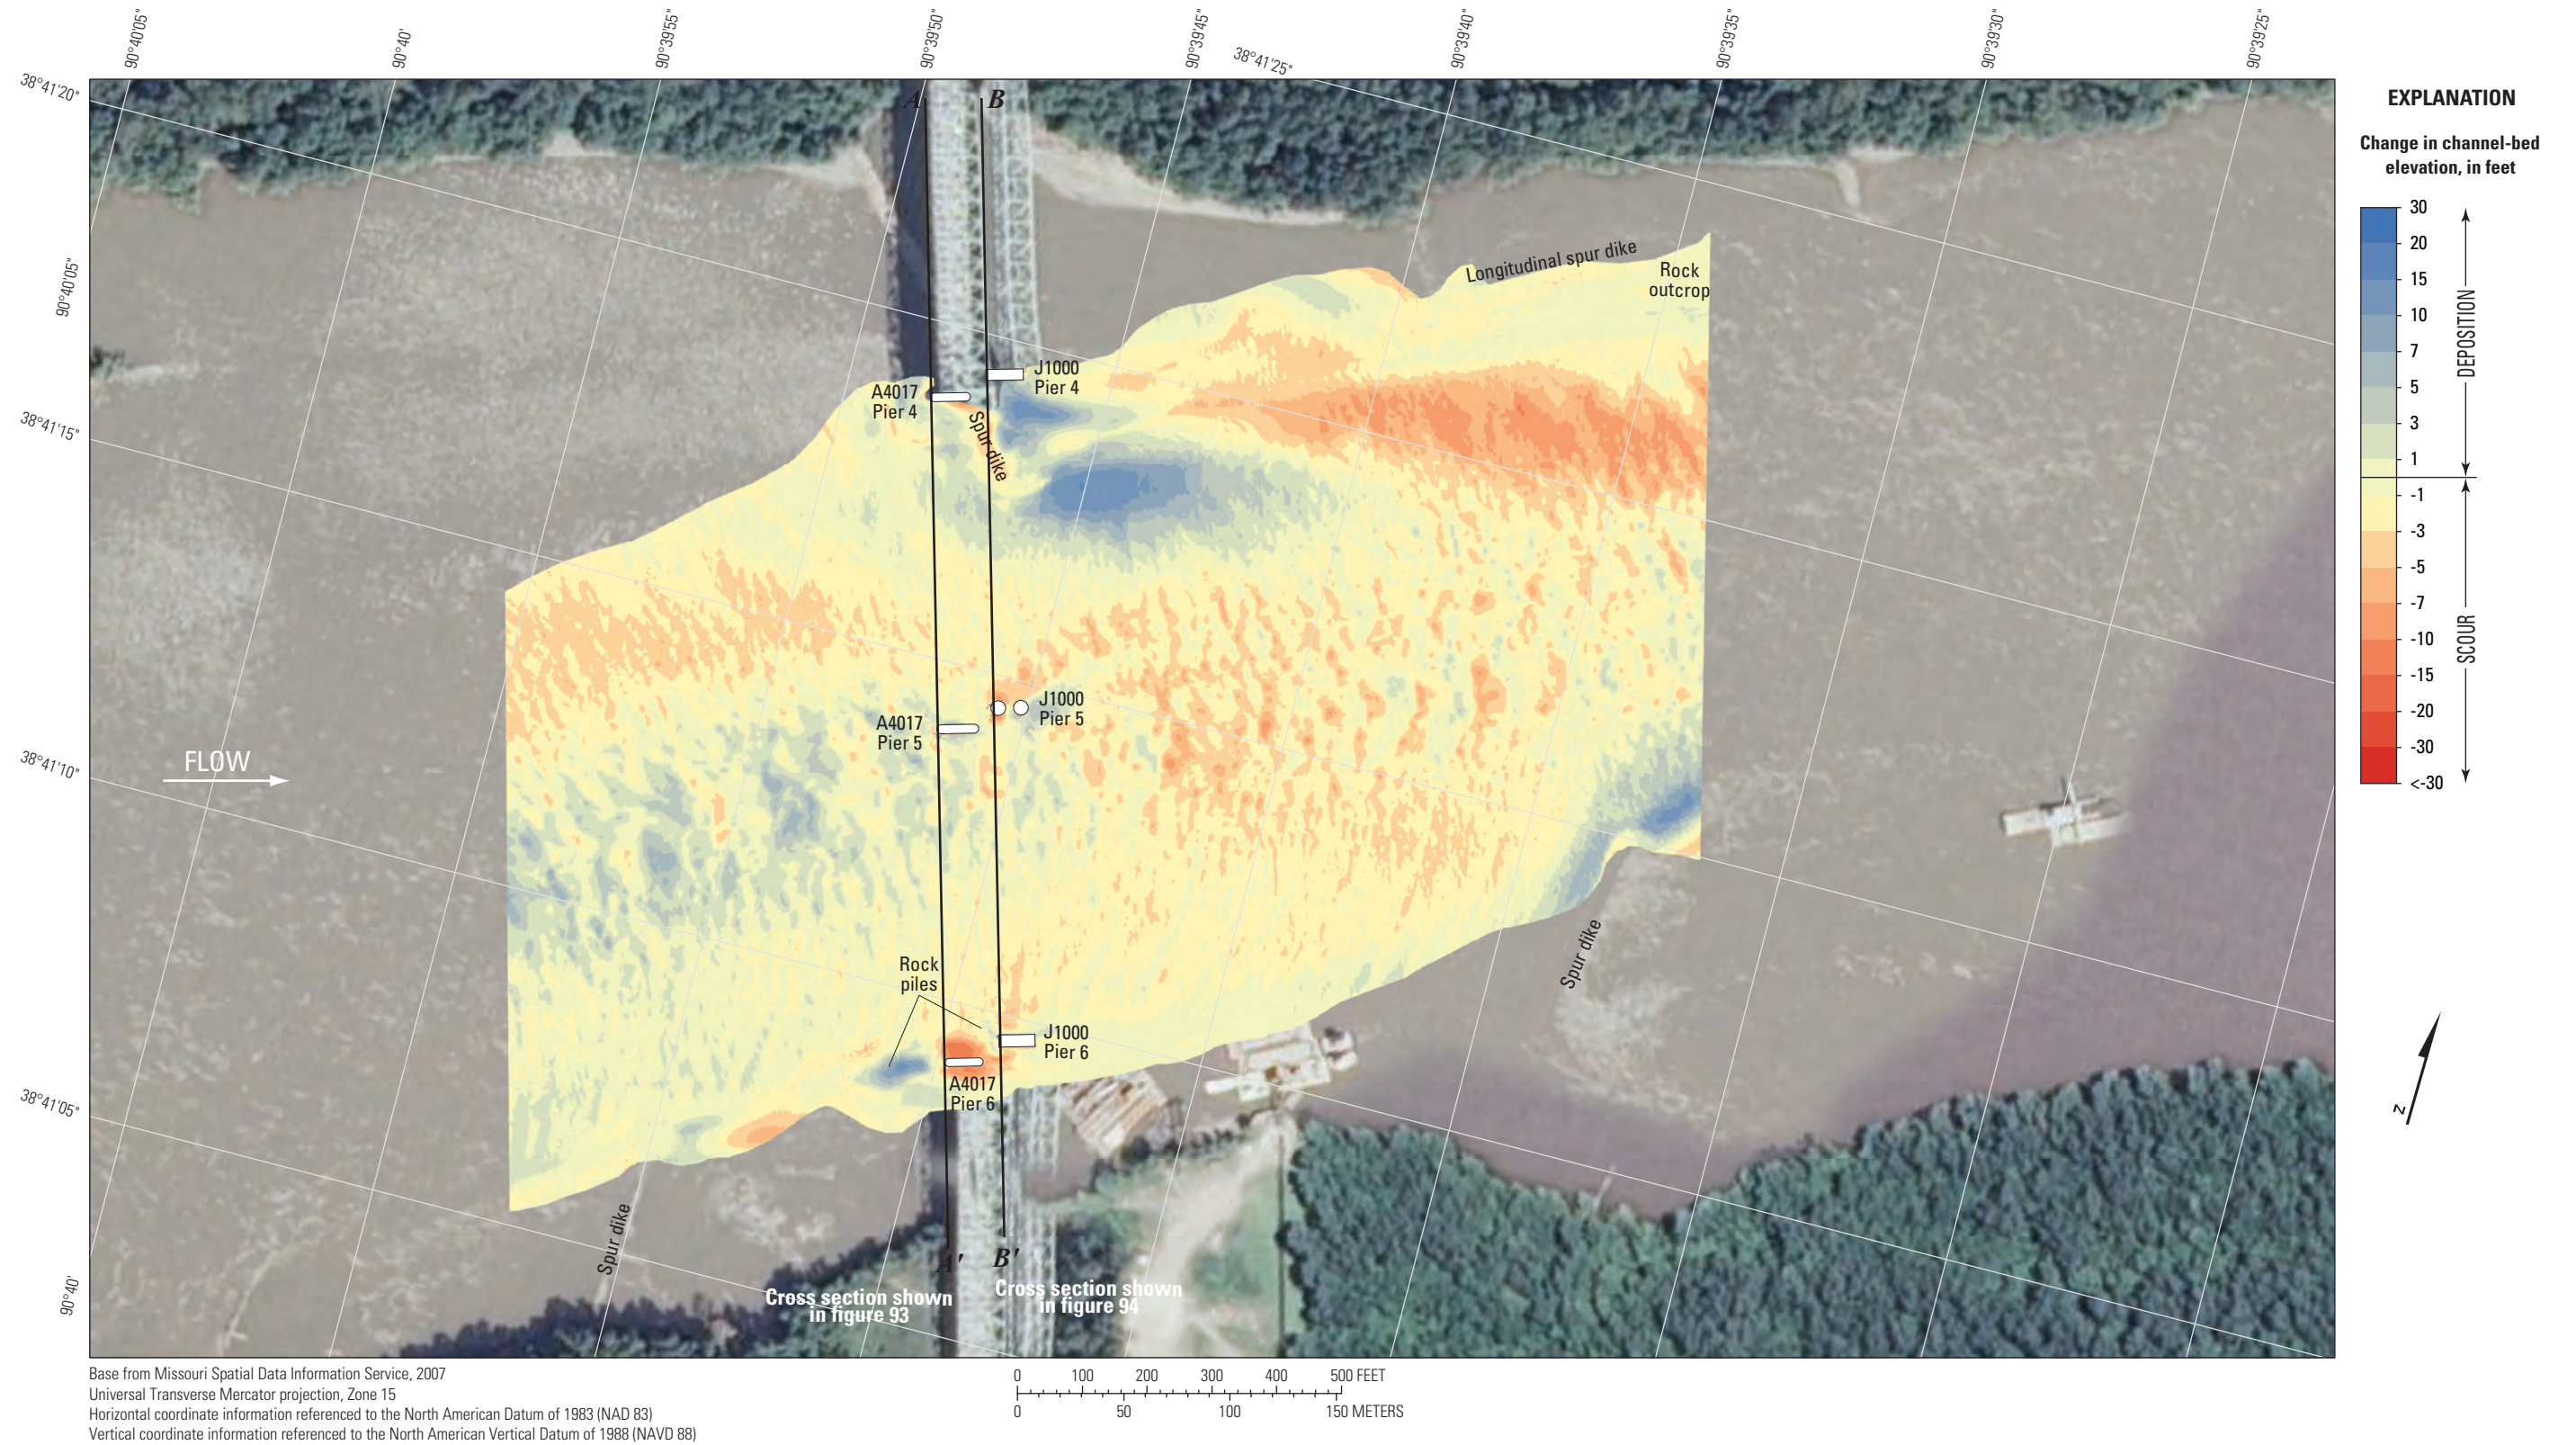
Figure 96. Difference between surfaces created from bathymetric surveys of the Missouri River channel in the vicinity of structures A4017 and J1000 on U.S. Highway 40 near St. Louis, Missouri, on October 18, 2010, and July 29, 2011.

The difference between the survey on July 29, 2011, and the previous survey on October 18, 2010 (fig. 96) indicates widespread areas of scour and deposition throughout the reach from 2010 to 2011, with an average difference of -0.38 ft between the bathymetric surfaces (table 7). There was

substantial deposition downstream from the spur dike on the left (north) bank near the left main channel piers (pier 4) and on the downstream right bank, whereas there was scour in the thalweg downstream from the bridges (fig. 96). In most of the channel, there was minor scour and deposition of less than 10 ft, with minimal net change between the surveys as indicated by the mean difference being near zero. The scour holes near pier 4 of upstream structure A4017 were of similar shape in the two surveys (fig. 93). Near the center main channel piers (pier 5), there was minor deposition near upstream structure A4017, and moderate scour near downstream structure J1000 (fig. 96). The scour hole near pier 5 of downstream structure J1000 was deeper and wider in 2011 than in 2010 (fig. 94). Near the right main channel piers (pier 6), there was moderate to substantial scour from a wider and deeper scour hole at upstream structure A4017 (fig. 94), with minor scour near

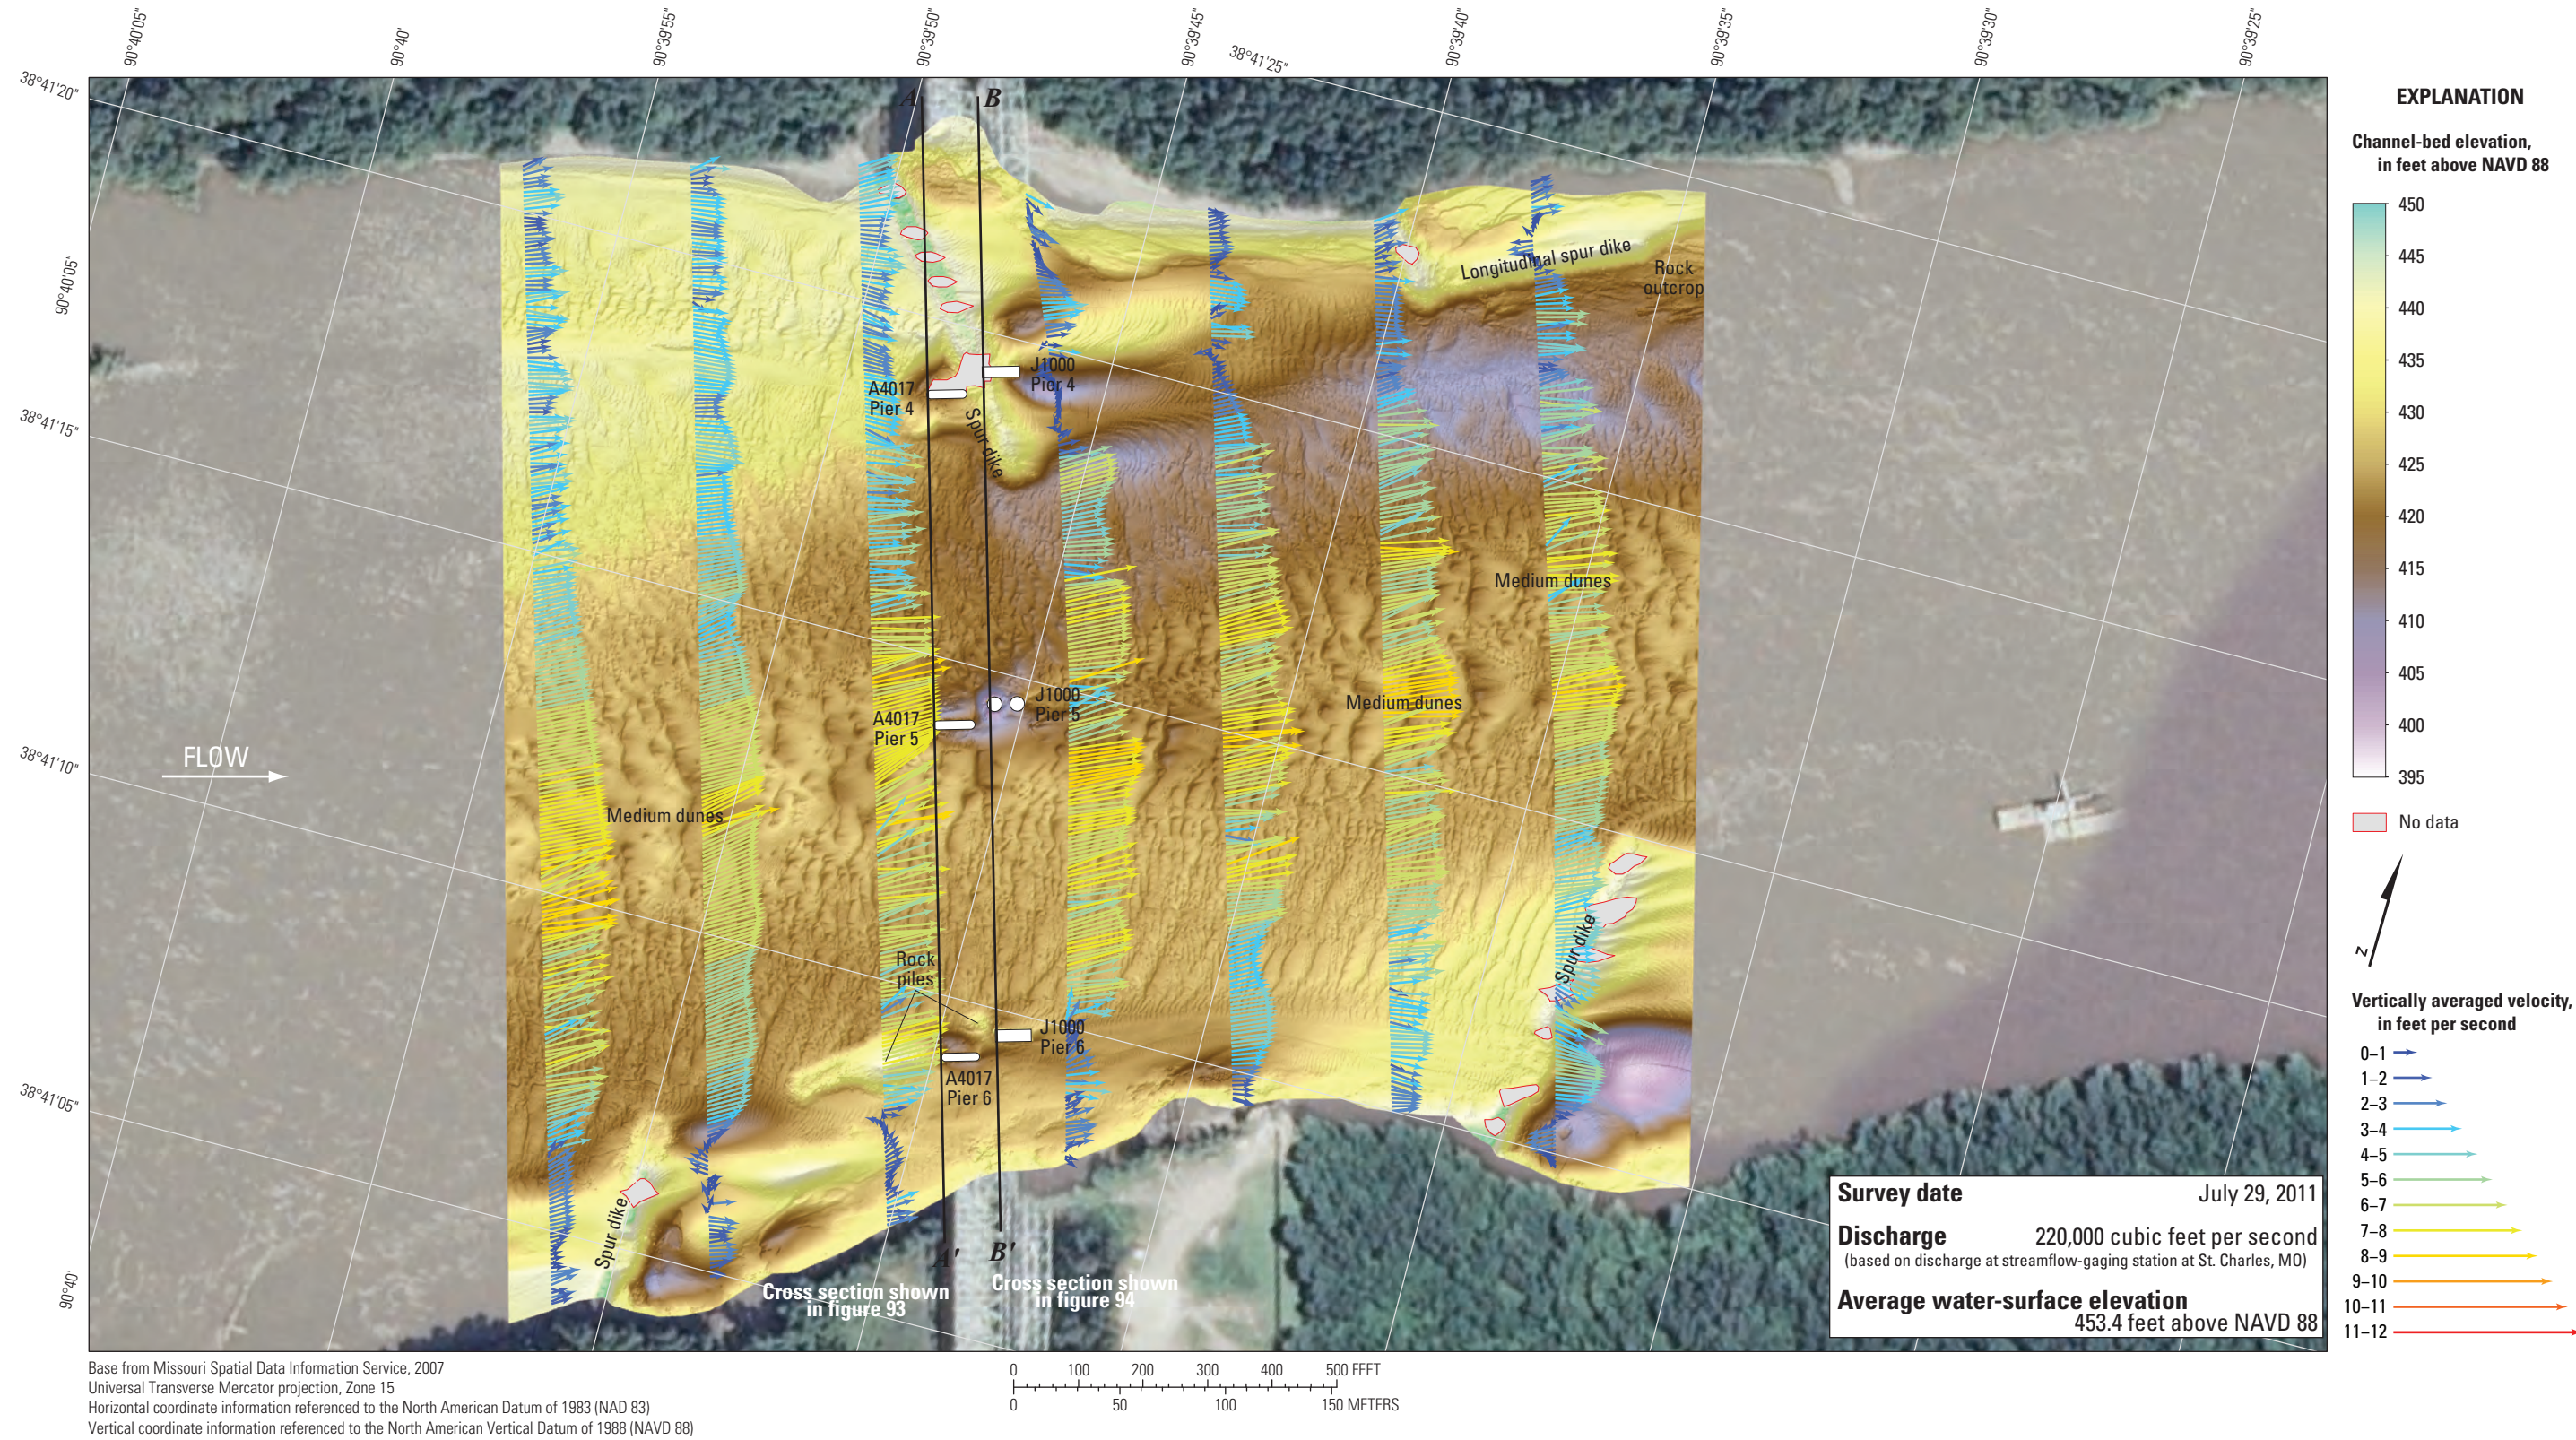
Figure 97. Bathymetry and vertically averaged velocities of the Missouri River channel in the vicinity of structures A4017 and J1000 on U.S. Highway 40 near St. Louis, Missouri.

The vertically averaged velocity vectors indicate moderate to substantial turbulence throughout the reach, with velocities ranging from about 2 to 9 ft/s (fig. 97). Flow was angled to the left (north) for much of the reach because of the bend in the river, and there were numerous flow reversals downstream from the various spur dikes (fig. 97). Substantial turbulence was observed in the vicinity of pier 5 of both bridges, likely exacerbated by the piers being skewed to flow and in staggered formation (fig. 97).

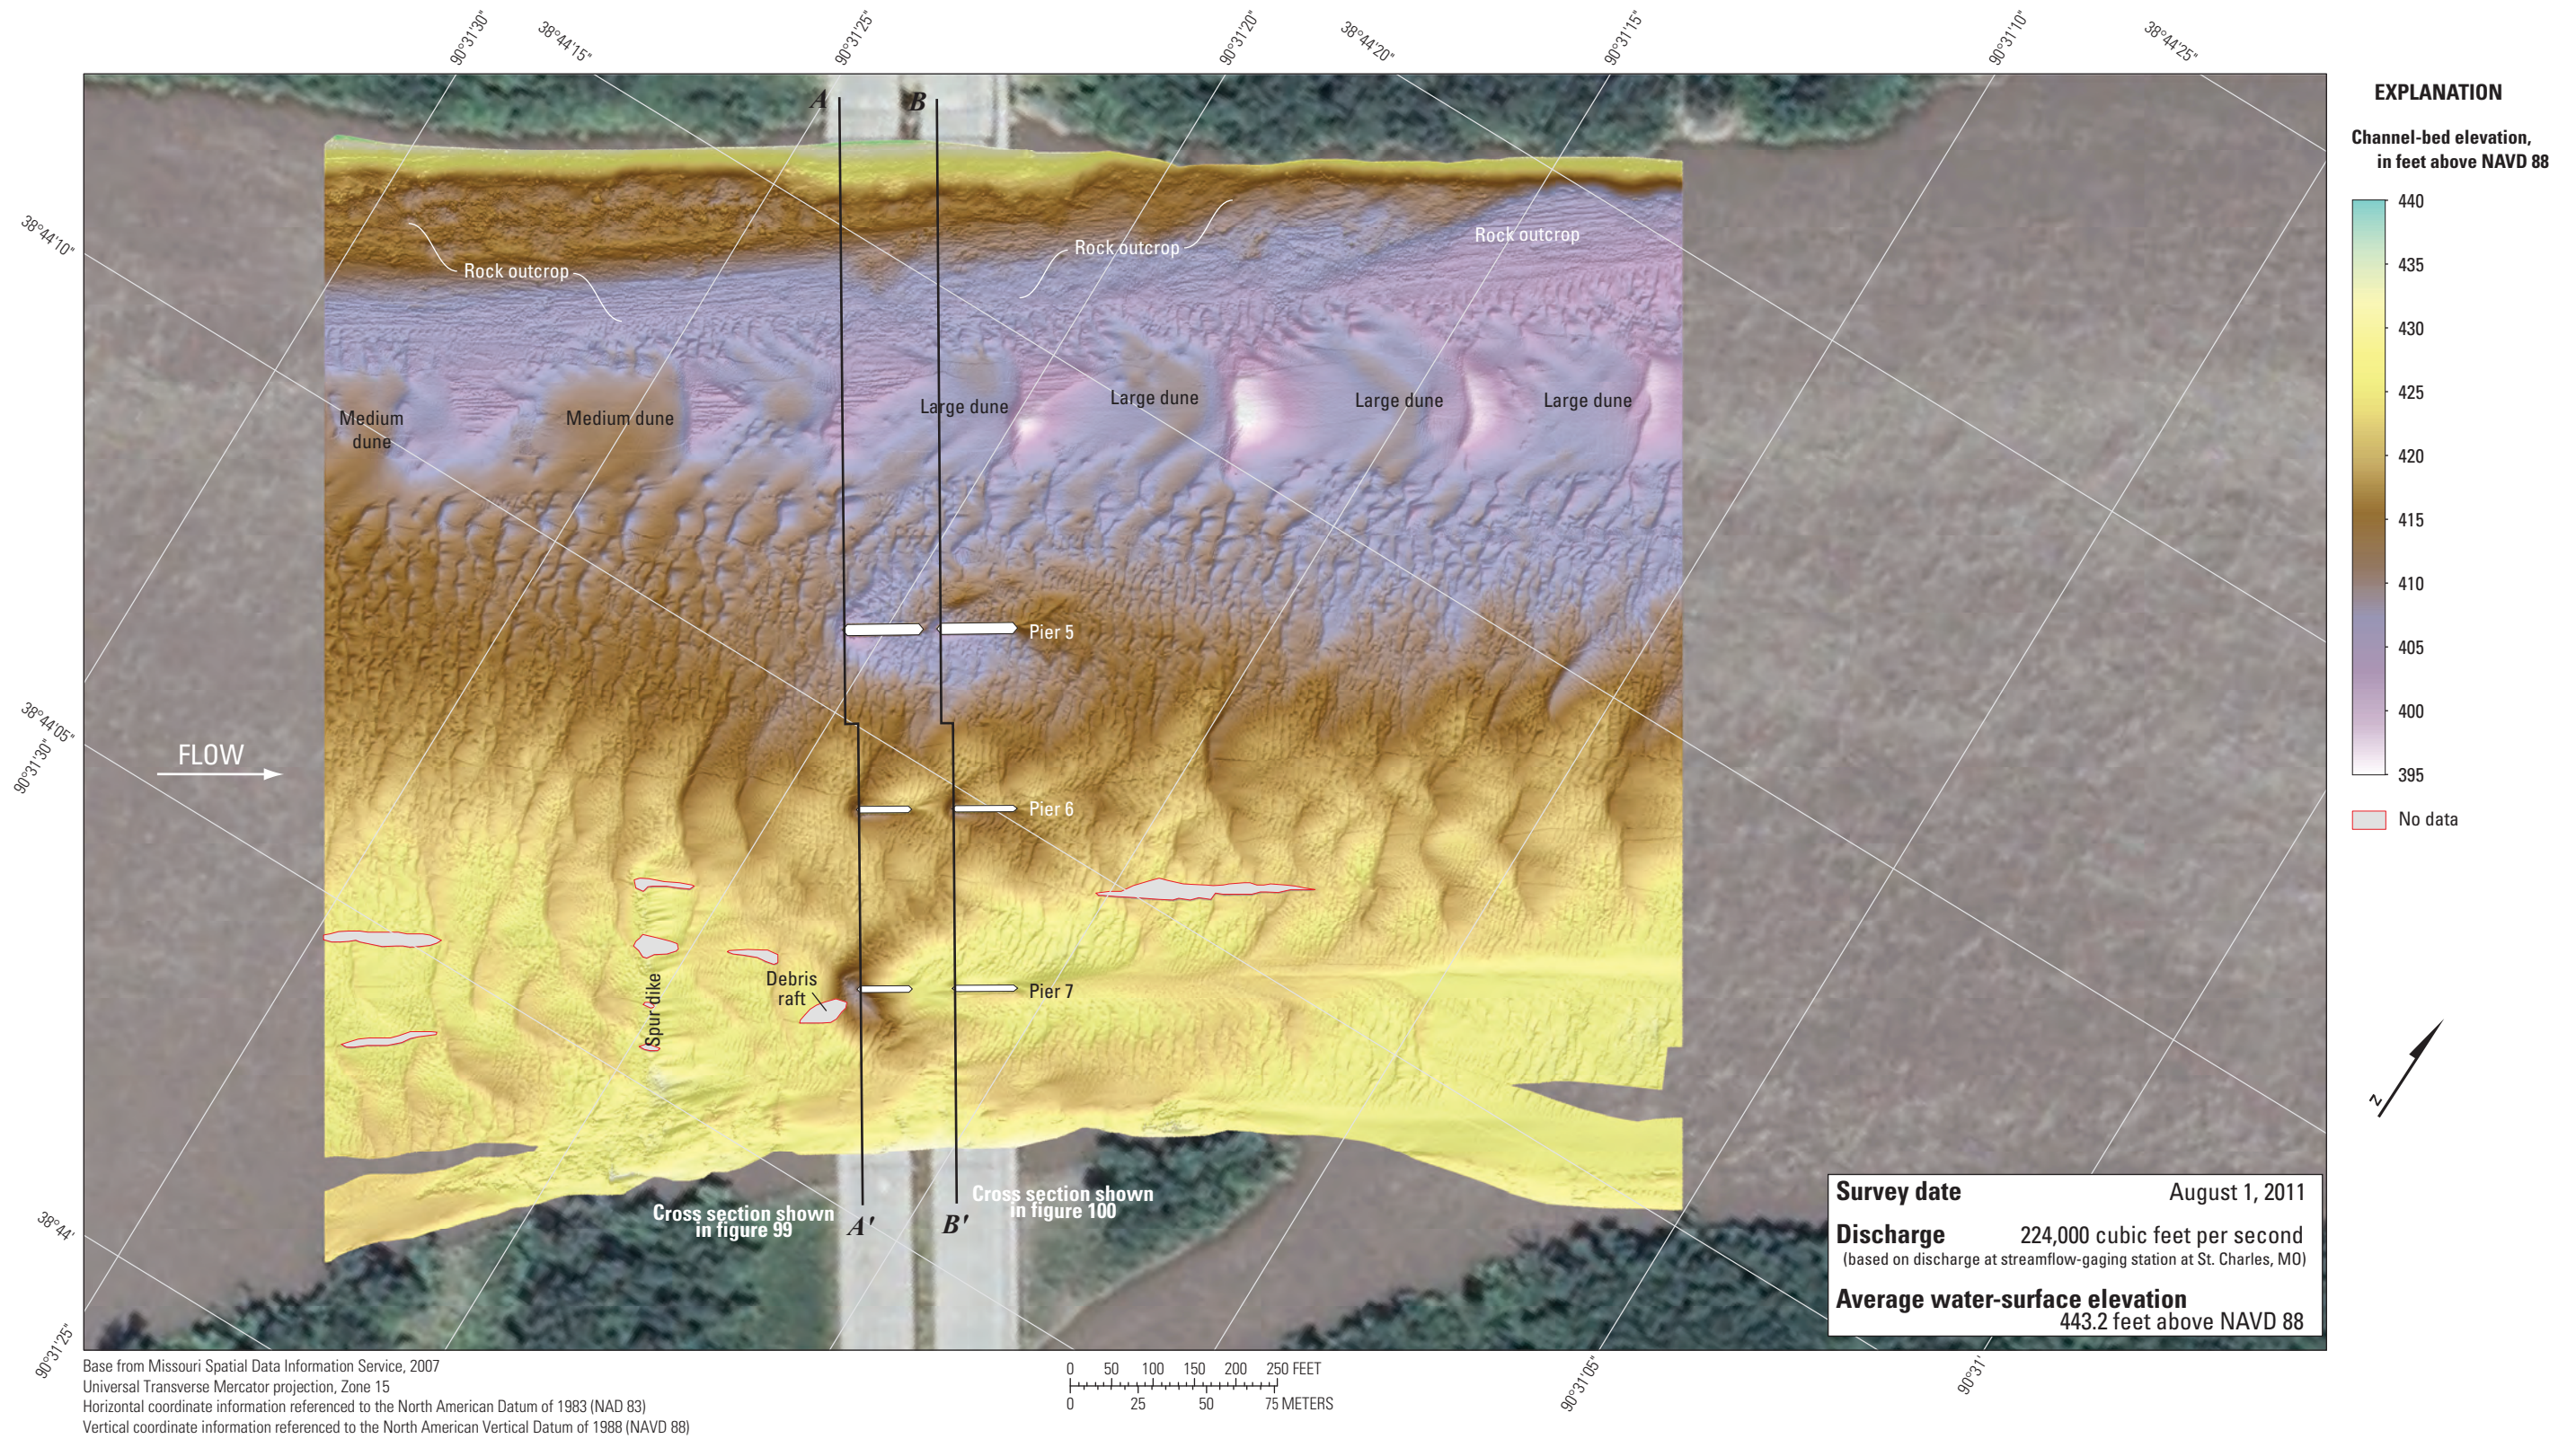
Figure 98. Bathymetric survey of the Missouri River channel in the vicinity of dual bridge structure A5585 on State Highway 364 near St. Louis, Missouri.

Scour holes were present in the vicinity of the main channel piers of structure A5585 (fig. 98), and generally there was more substantial scour associated with the upstream (eastbound) piers than the downstream (westbound) piers. The scour hole at upstream (eastbound) pier 5 had a minimum channel-bed elevation of about 401 ft (fig. 98; table 9), about 10 ft below the average channel bed immediately upstream from the pier, whereas the scour hole at downstream (westbound) pier 5 had a minimum channel-bed elevation of about 403 ft (fig. 98; table 9), about 8 ft below the average channel bed immediately upstream from the pier. The scour holes at pier 6 had a minimum channel-bed elevation of about 410 ft at both upstream and downstream piers (fig. 98; table 9), which was about 9 ft below the average channel bed immediately upstream from the upstream pier and about 8 ft below the average channel bed immediately upstream from the downstream pier. A moderate debris raft was present on the nose of upstream pier 7, which contributed to a scour hole with a minimum channel-bed elevation of about 410 ft (fig. 98; table 9), about 13 ft below the average channel bed immediately upstream from the pier. The scour hole at downstream pier 7 had a minimum channel-bed elevation of about 421 ft (fig. 98; table 9), only about 3 ft below the average channel bed immediately upstream from the pier.

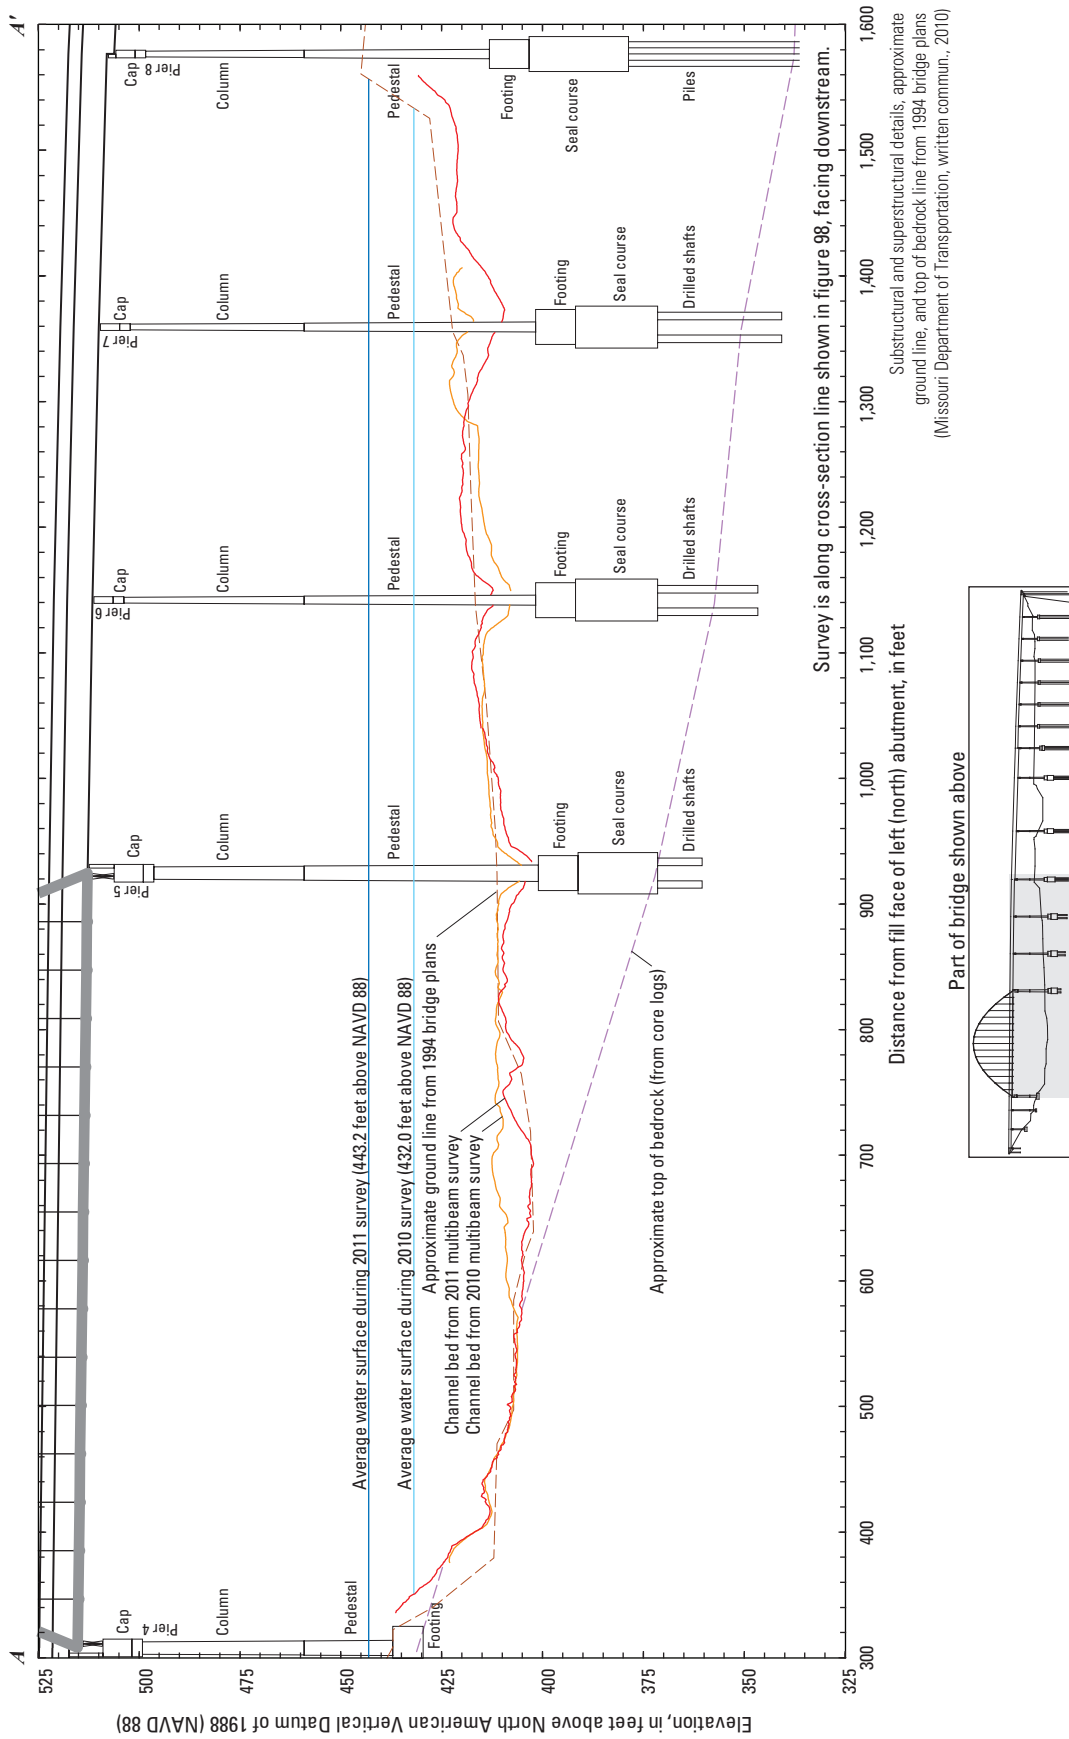
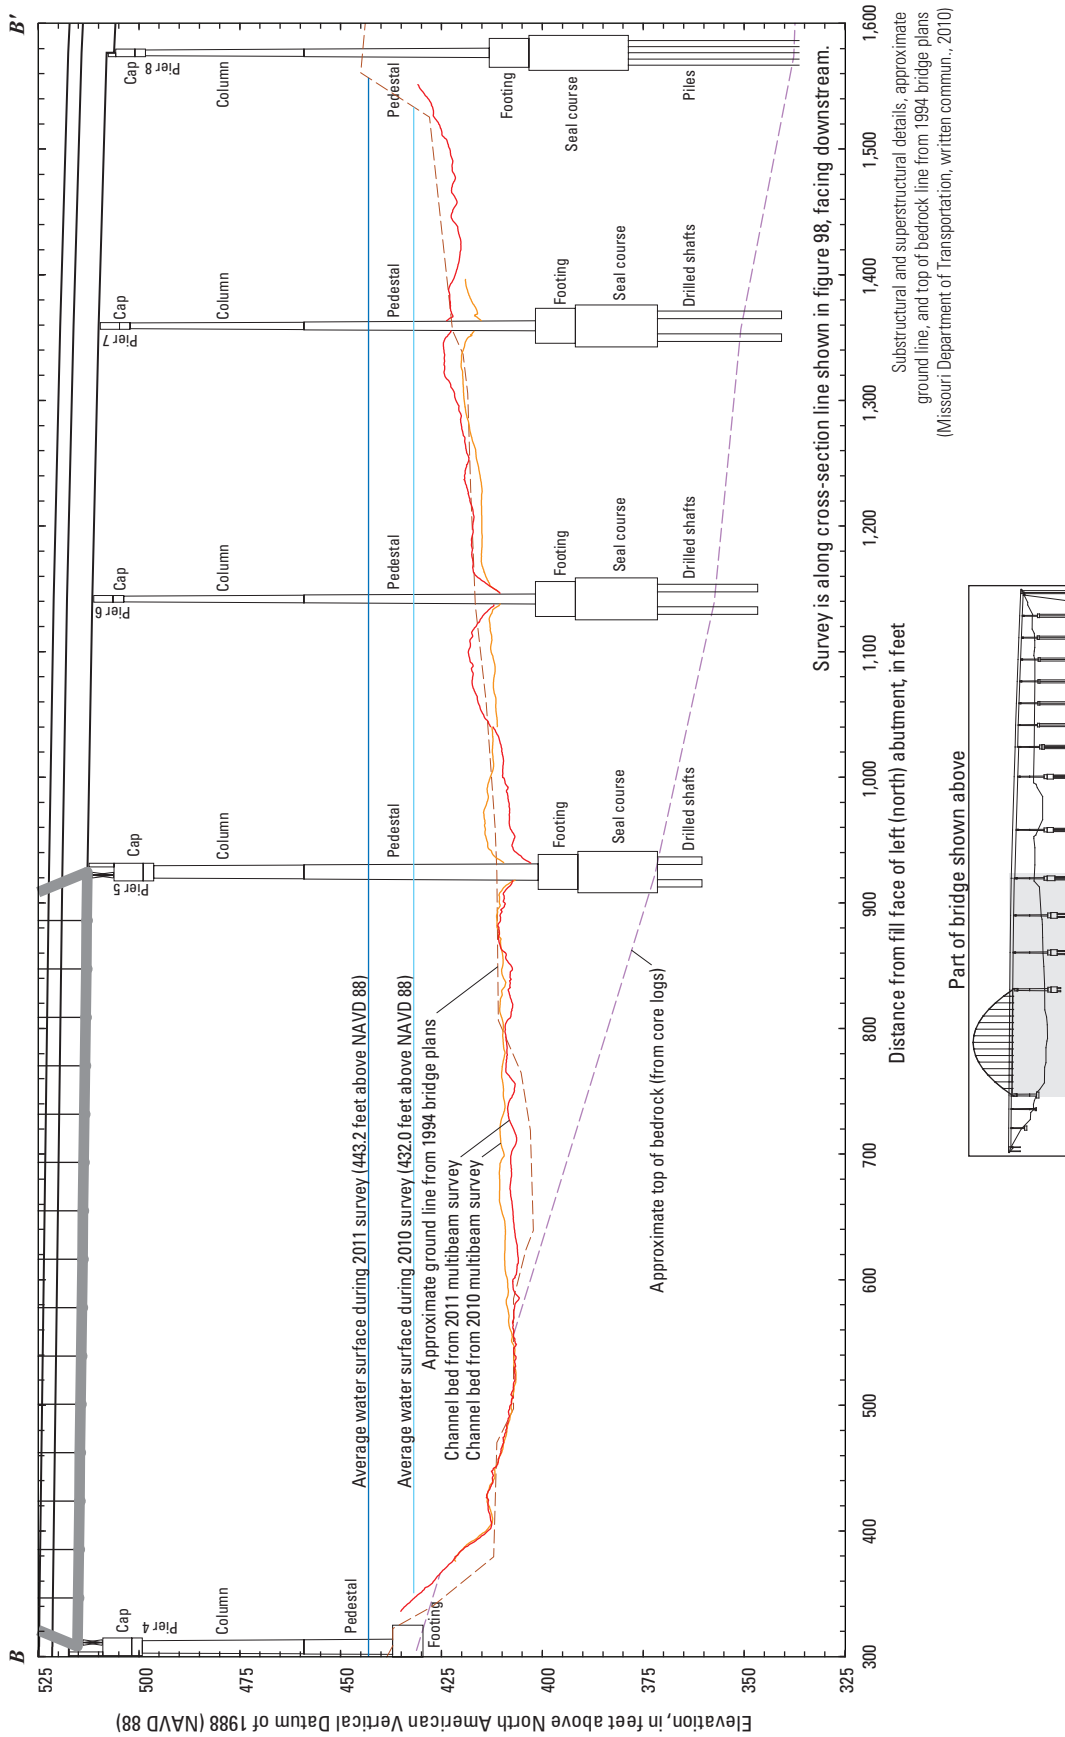
Information from bridge plans indicates that the main channel piers of both bridges of structure A5585 are founded on shafts drilled 11 ft into bedrock (figs. 99, 100; table 9). Depth of bed material between bedrock and the bottom of the various scour holes at dual bridge structure A5585 ranged from 29 to 70 ft because of the sloping bedrock in the area (figs. 99, 100; table 9). The minimum channel-bed elevation in each of the scour holes was substantially higher than the bottom of the seal course elevation at each pier of 371.62 ft (figs. 99, 100; table 9).

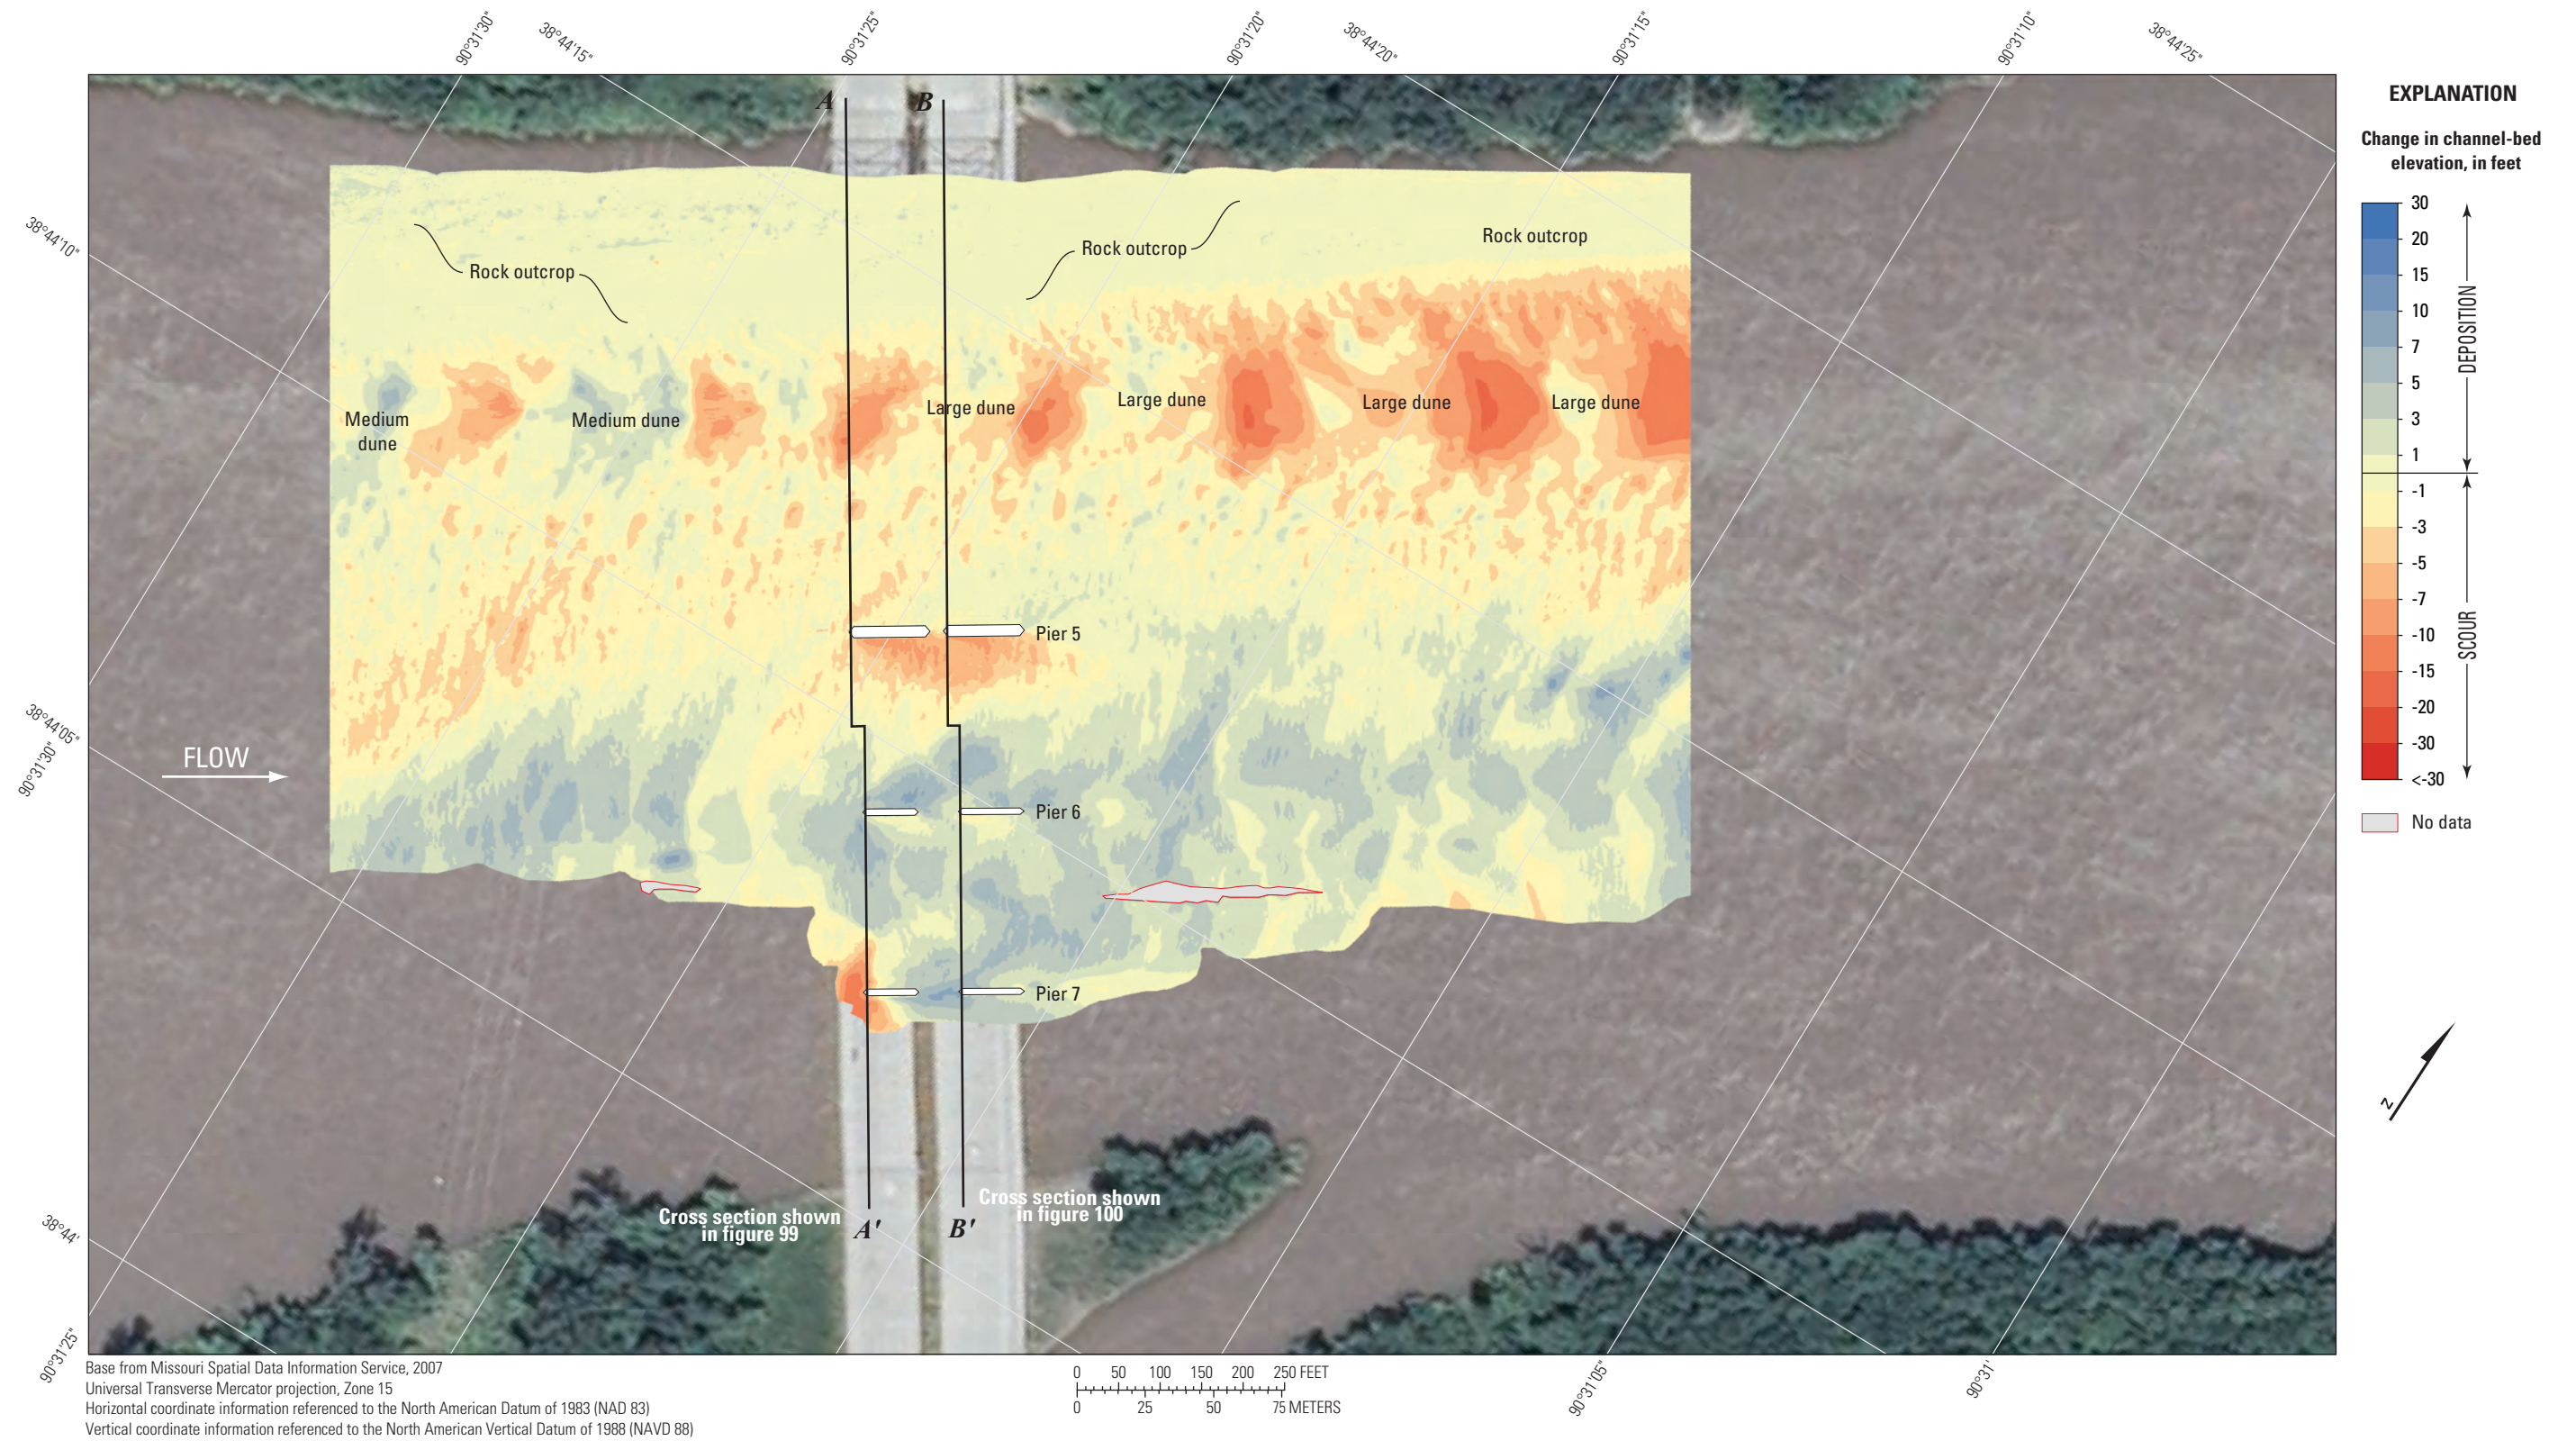
Figure 101. Difference between surfaces created from bathymetric surveys of the Missouri River channel in the vicinity of dual bridge structure A5585 on State Highway 364 near St. Louis, Missouri, on October 21, 2010, and August 1, 2011.

The difference between the survey on August 1, 2011, and the previous survey on October 21, 2010 (fig. 101) indicates widespread areas of scour and deposition throughout the reach from 2010 to 2011, with an average difference of -0.53 ft between the bathymetric surfaces (table 7). There was substantial deposition on the inside of the river bend on the right (south) bank, whereas there was substantial scour in the thalweg, particularly downstream from the bridges (fig. 101). Overall, there was minimal net change between the surveys as indicated by the mean difference being near zero despite the water-surface elevation difference of more than 11 ft and a flow difference of more than 132,000 ft³/s (table 7). The scour holes near pier 5 were deeper on the right (south) side of the piers in the later survey (fig. 101), whereas the scour holes near pier 6 were shallower (fig. 101). The scour hole near pier 7 was substantially deeper at the upstream end—likely because of the debris raft—but there was deposition from the middle of the upstream pier and downstream (fig. 101). The cross sections from the 2011 survey show the pattern of scour in the thalweg and deposition on the right (south) side of the channel compared to the 2010 survey (figs. 99, 100).
