Bathymetric and Velocimetric Surveys at Highway Bridges Crossing the Missouri River in and into Missouri during Summer Flooding, July–August 2011

Scientific Investigations Report 2012–5204

By Richard J. Huizinga

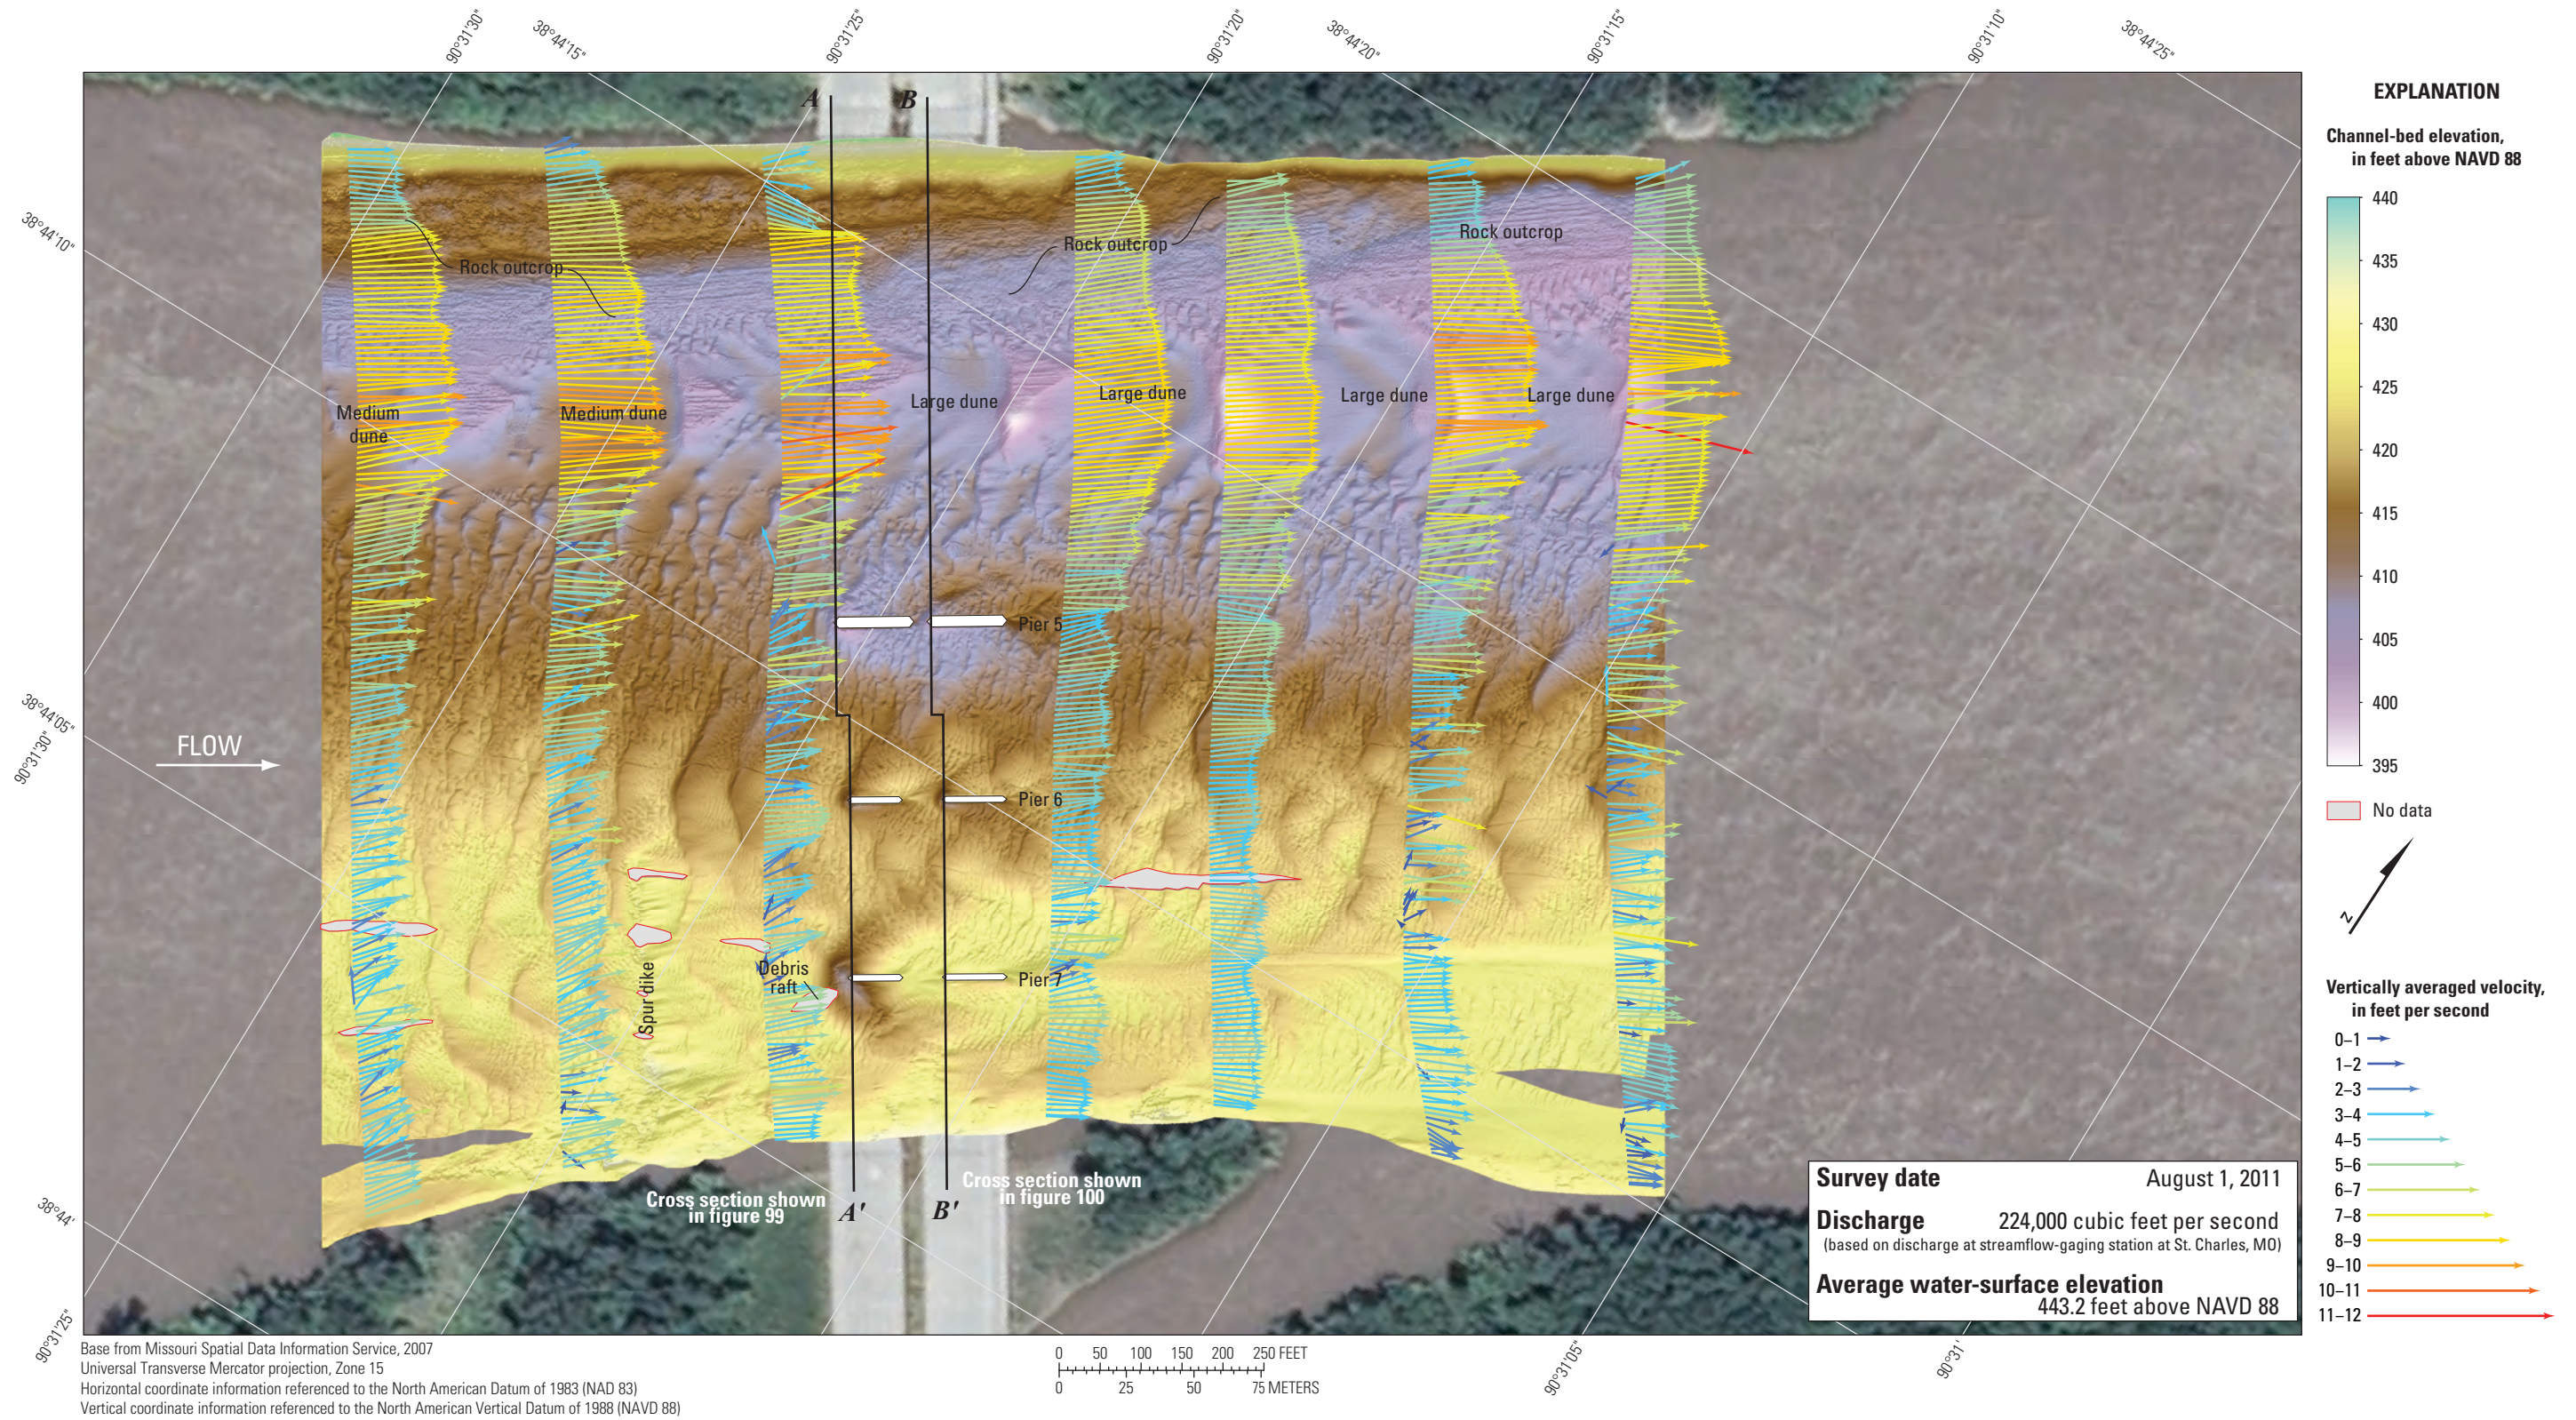
Figure 102. Bathymetry and vertically averaged velocities of the Missouri River channel in the vicinity of dual bridge structure A5585 on State Highway 364 near St. Louis, Missouri.

The vertically averaged velocity vectors indicate substantial turbulence throughout the reach, with velocities ranging from about 3 to 10 ft/s (fig. 102). Flow was angled to the left (north) in the upstream reach because of the bend in the river, and there were numerous local velocity minima on the right (south) side of the channel (fig. 102). Substantial turbulence was observed in the channel thalweg (fig. 102). Piers 5 through 7 were aligned with flow, resulting in minimal turbulence downstream (fig. 102).

larger, deeper scour holes than shallow flow or lower velocities (figs. 28, 37, 41, 48, 67, 71, 88, and 102) in the absence of a spur dike or rock outcrop that might limit local scour (pier 2 in fig. 71) or a debris raft that might exacerbate local scour (pier 7 in fig. 102; upstream pier 15 in fig. 107).

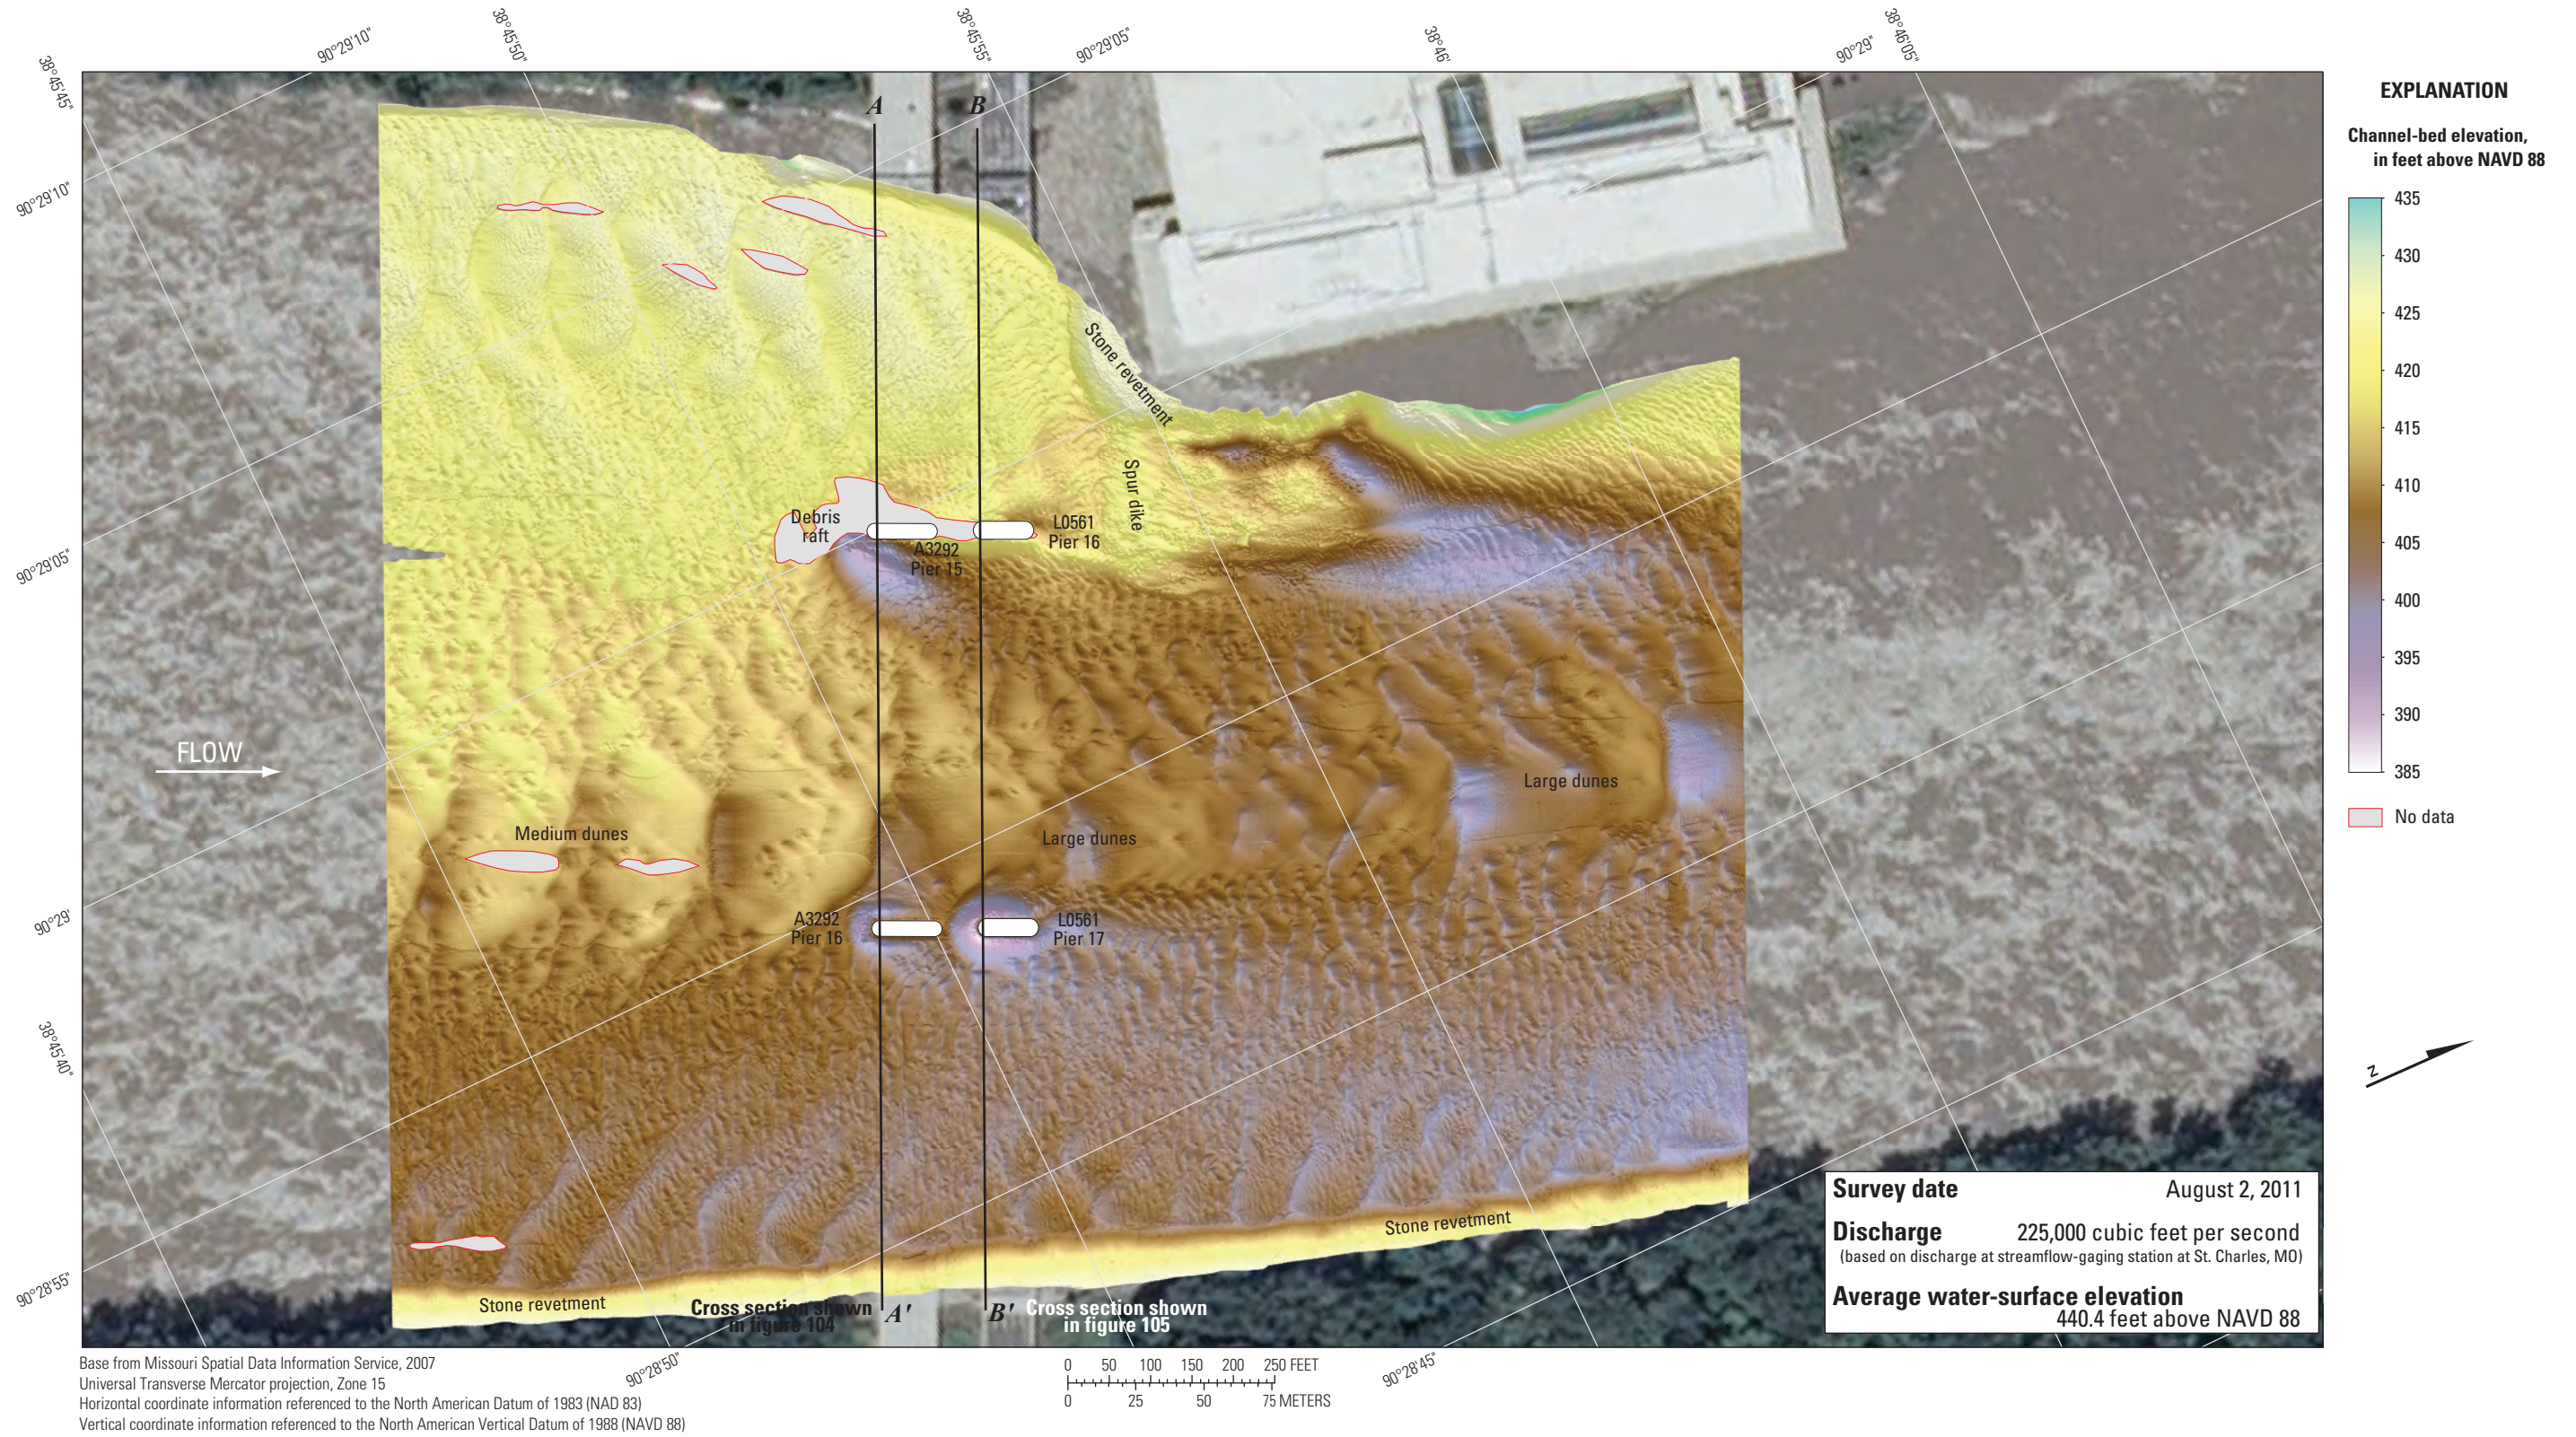
Figure 103. Bathymetric survey of the Missouri River channel in the vicinity of structures A3292 and L0561 on Interstate 70 near St. Louis, Missouri.

A substantial debris raft at the nose of pier 15 of upstream structure A3292 affected the scour near the left main channel piers (pier 15 of upstream structure A3292 and pier 16 of downstream structure L0561; fig. 103). The scour hole caused by the debris raft and piers had a minimum measured elevation of approximately 393 ft near the upstream nose of pier 15 of upstream structure A3292 (fig. 103), about 22 ft below the average channel bed immediately upstream from the raft, but well above the bottom of the seal course elevation of pier 15 of 378.00 ft (fig. 104; table 9). Information from bridge plans indicates that pier 15 of upstream structure A3292 is founded on shafts drilled approximately 16 ft in bedrock (table 9), with about 43 ft of bed material between the bottom of the scour hole and bedrock near the upstream pier (fig. 104). Pier 16 of downstream structure L0561 is founded on a caisson on bedrock (fig. 105; table 9), and the bottom of the local scour hole near this pier was about 57 ft above the bottom of the caisson and bedrock. It is likely that the shallow spur dike between the

Scour holes also were present in the vicinity of the right main channel piers of structures A3292 and L0561 (fig. 103). The scour hole at upstream pier 16 had a minimum channel-bed elevation of about 394 ft (fig. 104; table 9), about 17 ft below the average channel bed immediately upstream from the pier, whereas the scour hole at downstream pier 17 had a minimum channel-bed elevation of about 388 ft (fig. 105; table 9), about 18 ft below the average channel bed immediately upstream from the pier. Information from bridge plans indicates that pier 16 of upstream structure A3292 is founded on shafts drilled 17 ft into bedrock, with about 52 ft of bed material between the bottom of the scour hole and bedrock (fig. 104; table 9). Pier 17 of structure L0561 is founded on a caisson on bedrock, with about 45 ft of bed material between the bottom of the scour hole and bedrock (fig. 105; table 9).

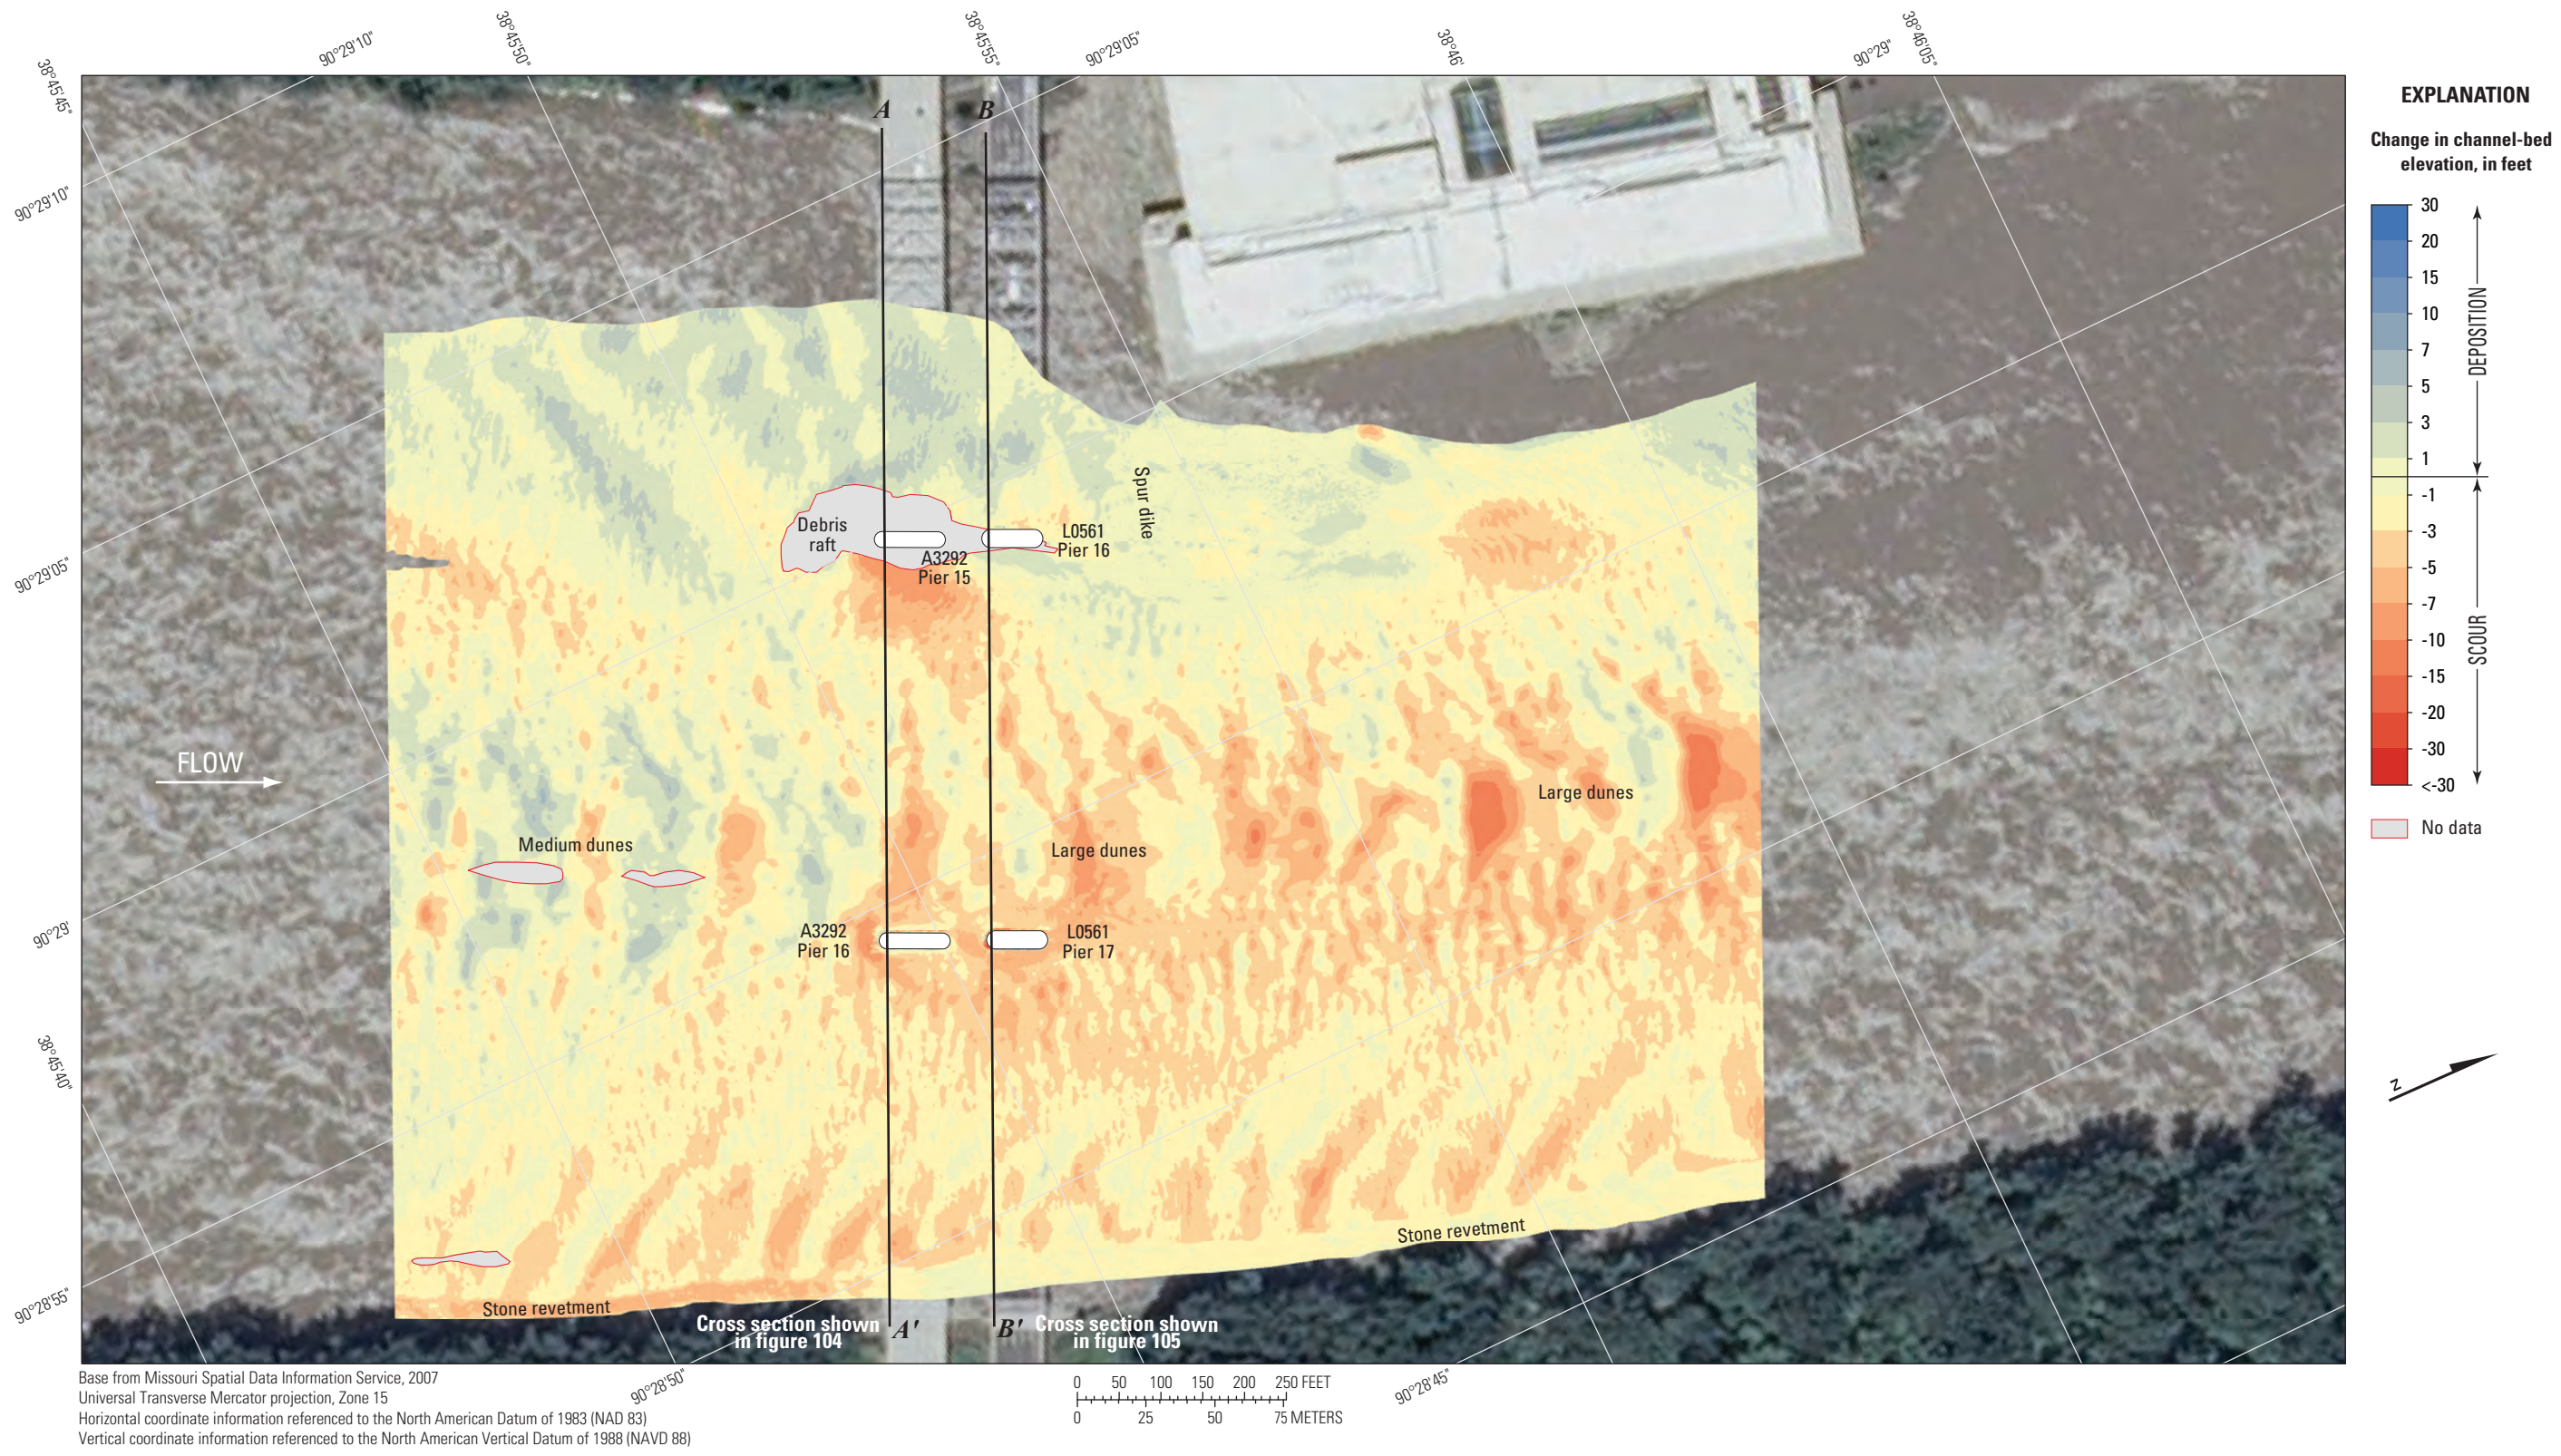
Figure 106. Difference between surfaces created from bathymetric surveys of the Missouri River channel in the vicinity of structures A3292 and L0561 on Interstate 70 near St. Louis, Missouri, on October 21, 2010, and August 2, 2011.

The difference between the survey on August 2, 2011, and the previous survey on October 21, 2010 (fig. 106) indicates a predominance of scour throughout the reach from 2010 to 2011, with an average difference of -1.72 ft between the bathymetric surfaces (table 7). There was moderate deposition on the inside of the river bend on the upstream left (north) bank, whereas there was substantial scour in the thalweg in the upstream reach, and throughout the channel in the reach at and downstream from the bridges (fig. 106), likely caused by the water-surface elevation difference of more than 10 ft and flow difference of more than 133,000 ft³/s (table 7). The scour holes near pier 15 of upstream structure A3292, and both right main channel piers were wider and deeper in the 2011 survey (figs. 104, 105, 106), whereas there was deposition around pier 16 of downstream structure L0561 (figs. 105, 106). The cross sections from the 2011 survey show the pattern of scour in the thalweg and deposition on the left (north) side of the channel compared to the 2010 survey (figs. 104, 105). The stone revetment on the upstream right (south) bank appears to have experienced scour (fig. 106), but this may be a function of positional variations between the surveys. Huizinga (2011) noted issues with horizontal positioning at this site during the survey in October 2010. As with several difference maps earlier in this report, the appearance of substantial deposition or scour at the faces of the piers result from minor horizontal positional variances between the surveys.

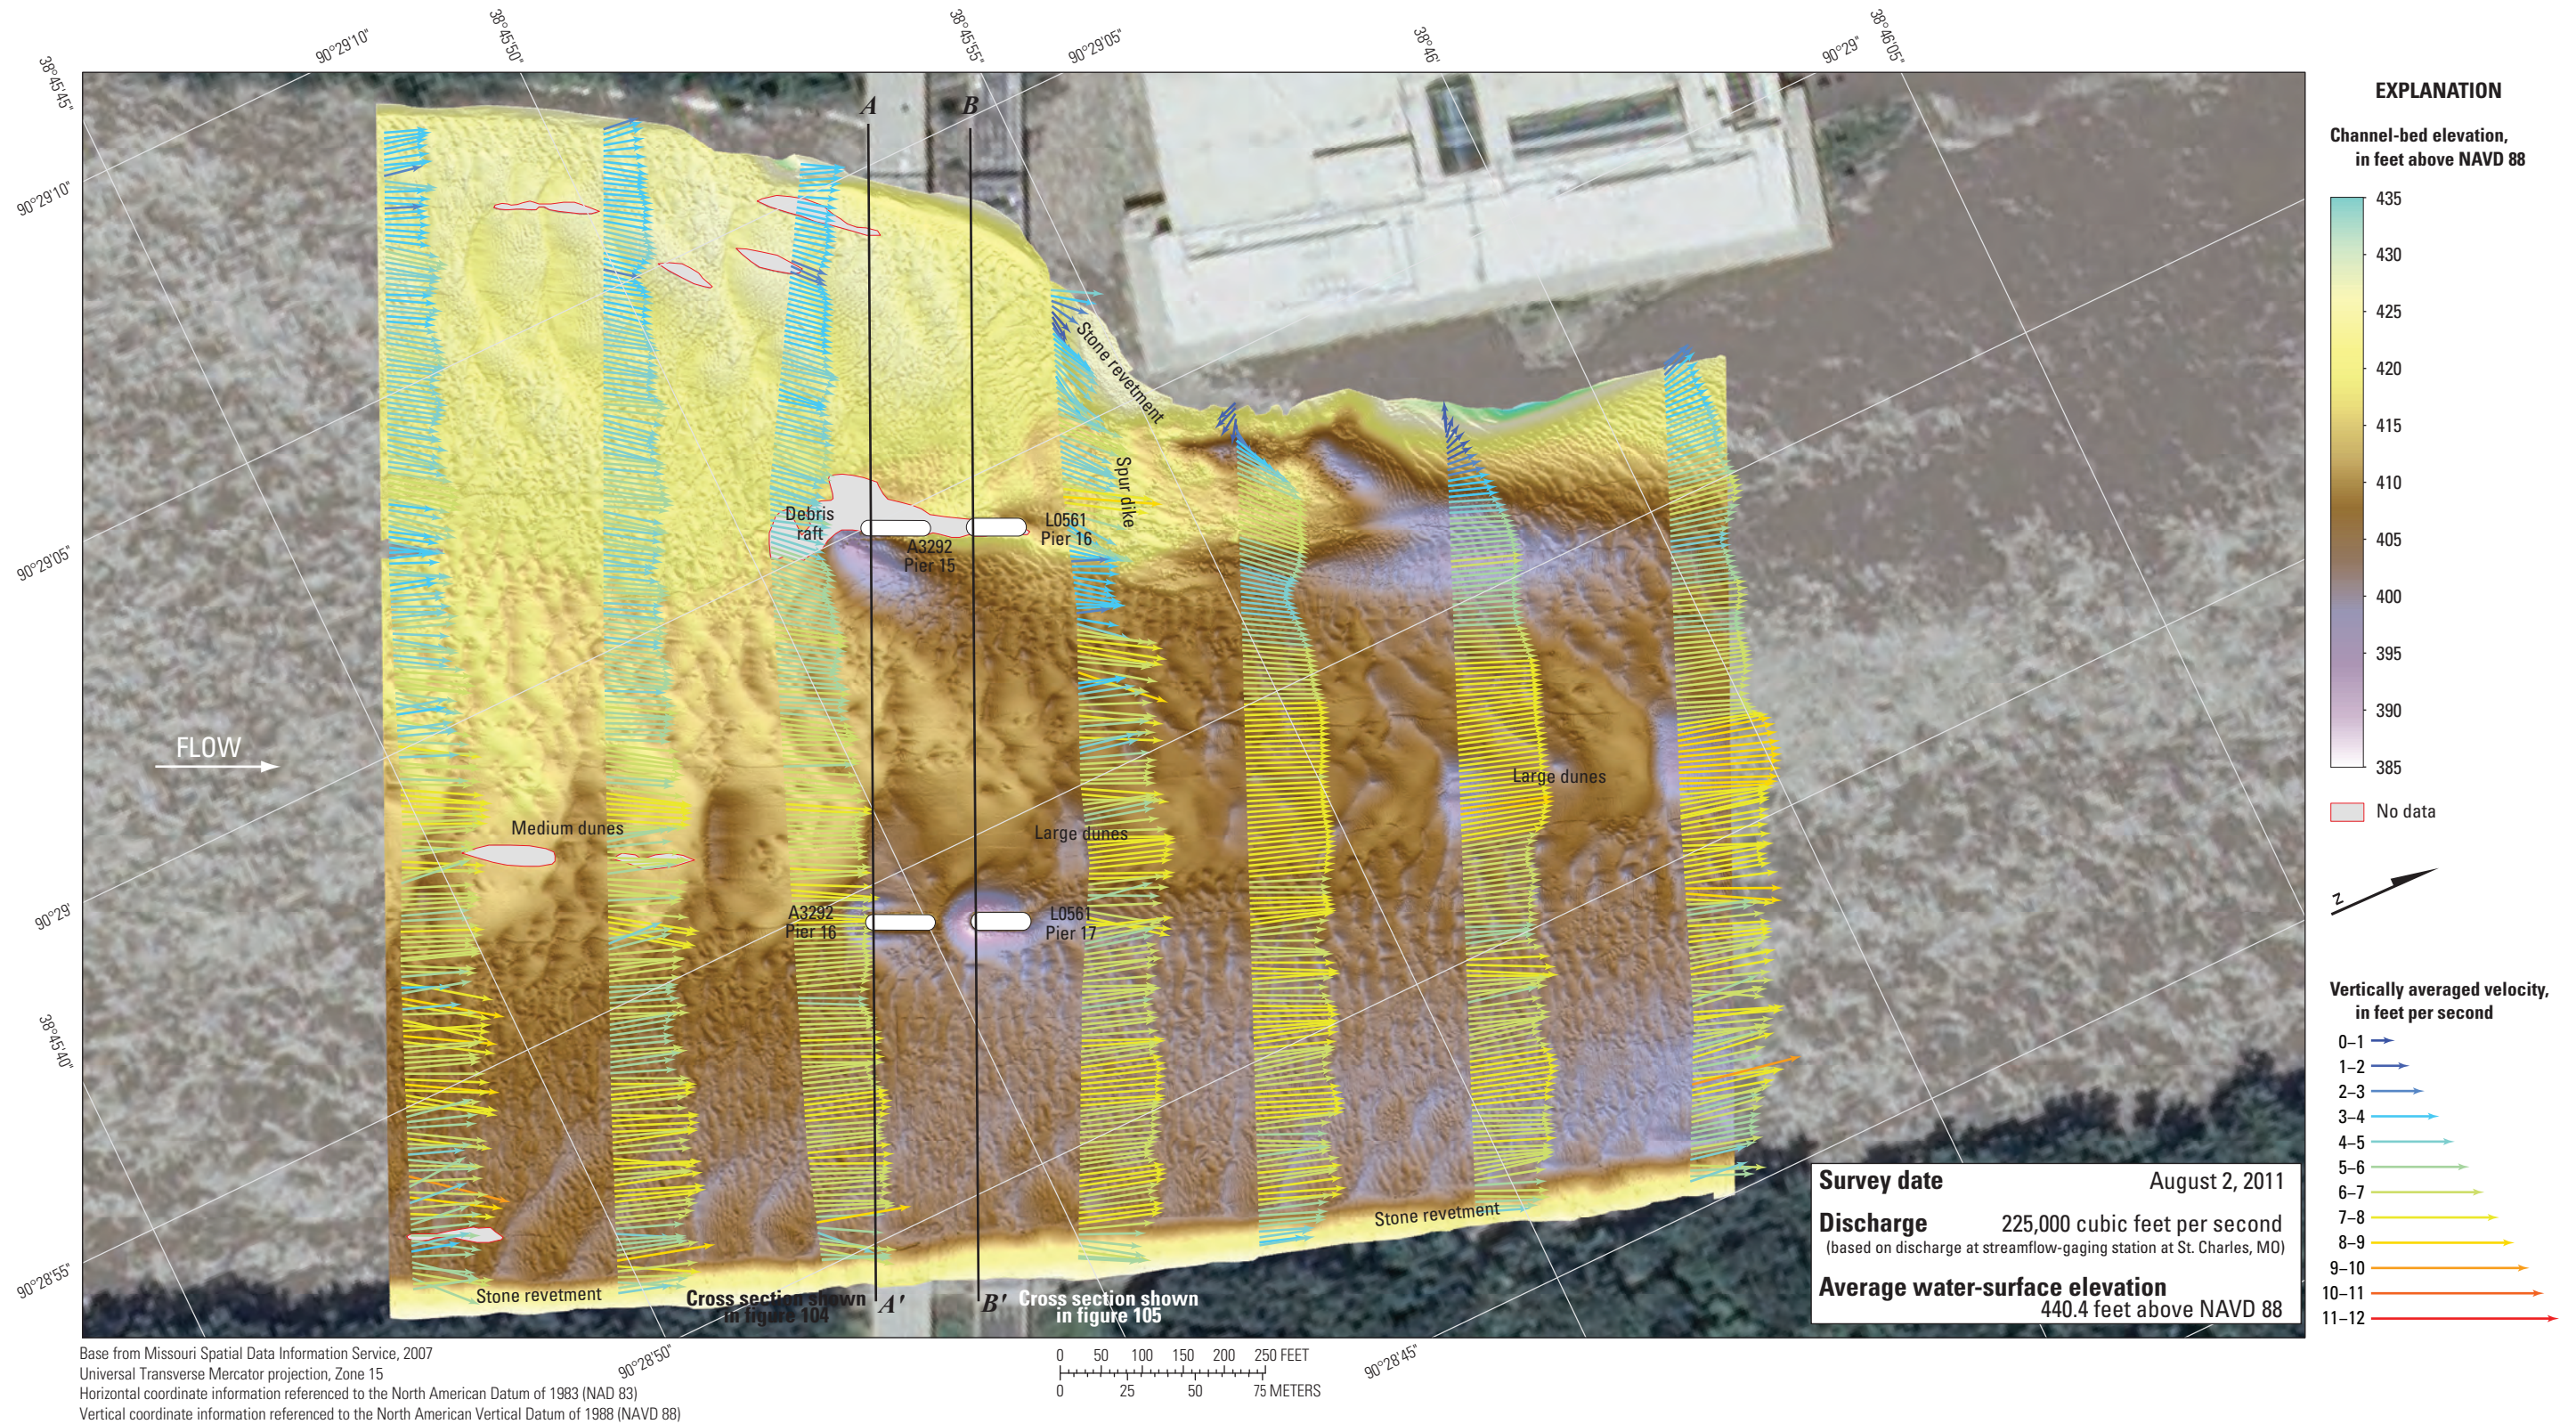
Figure 107. Bathymetry and vertically averaged velocities of the Missouri River channel in the vicinity of structures A3292 and L0561 on Interstate 70 near St. Louis, Missouri.

The vertically averaged velocity vectors indicate moderate to substantial turbulence in several transects, with velocities ranging from about 3 to 9 ft/s (fig. 107). Flow was angled to the right (south) in the upstream reach because of the bend in the river and the downstream contraction, and there was substantial turbulence and flow reversal near the contraction (fig. 107). Flow was mostly uniform in the reach downstream from the bridges, with minor turbulence in the channel thalweg of the downstream-most transect (fig. 107). The right main channel piers were aligned with flow, whereas the left main channel piers were not; moderate turbulence was observed downstream from all piers (fig. 107).

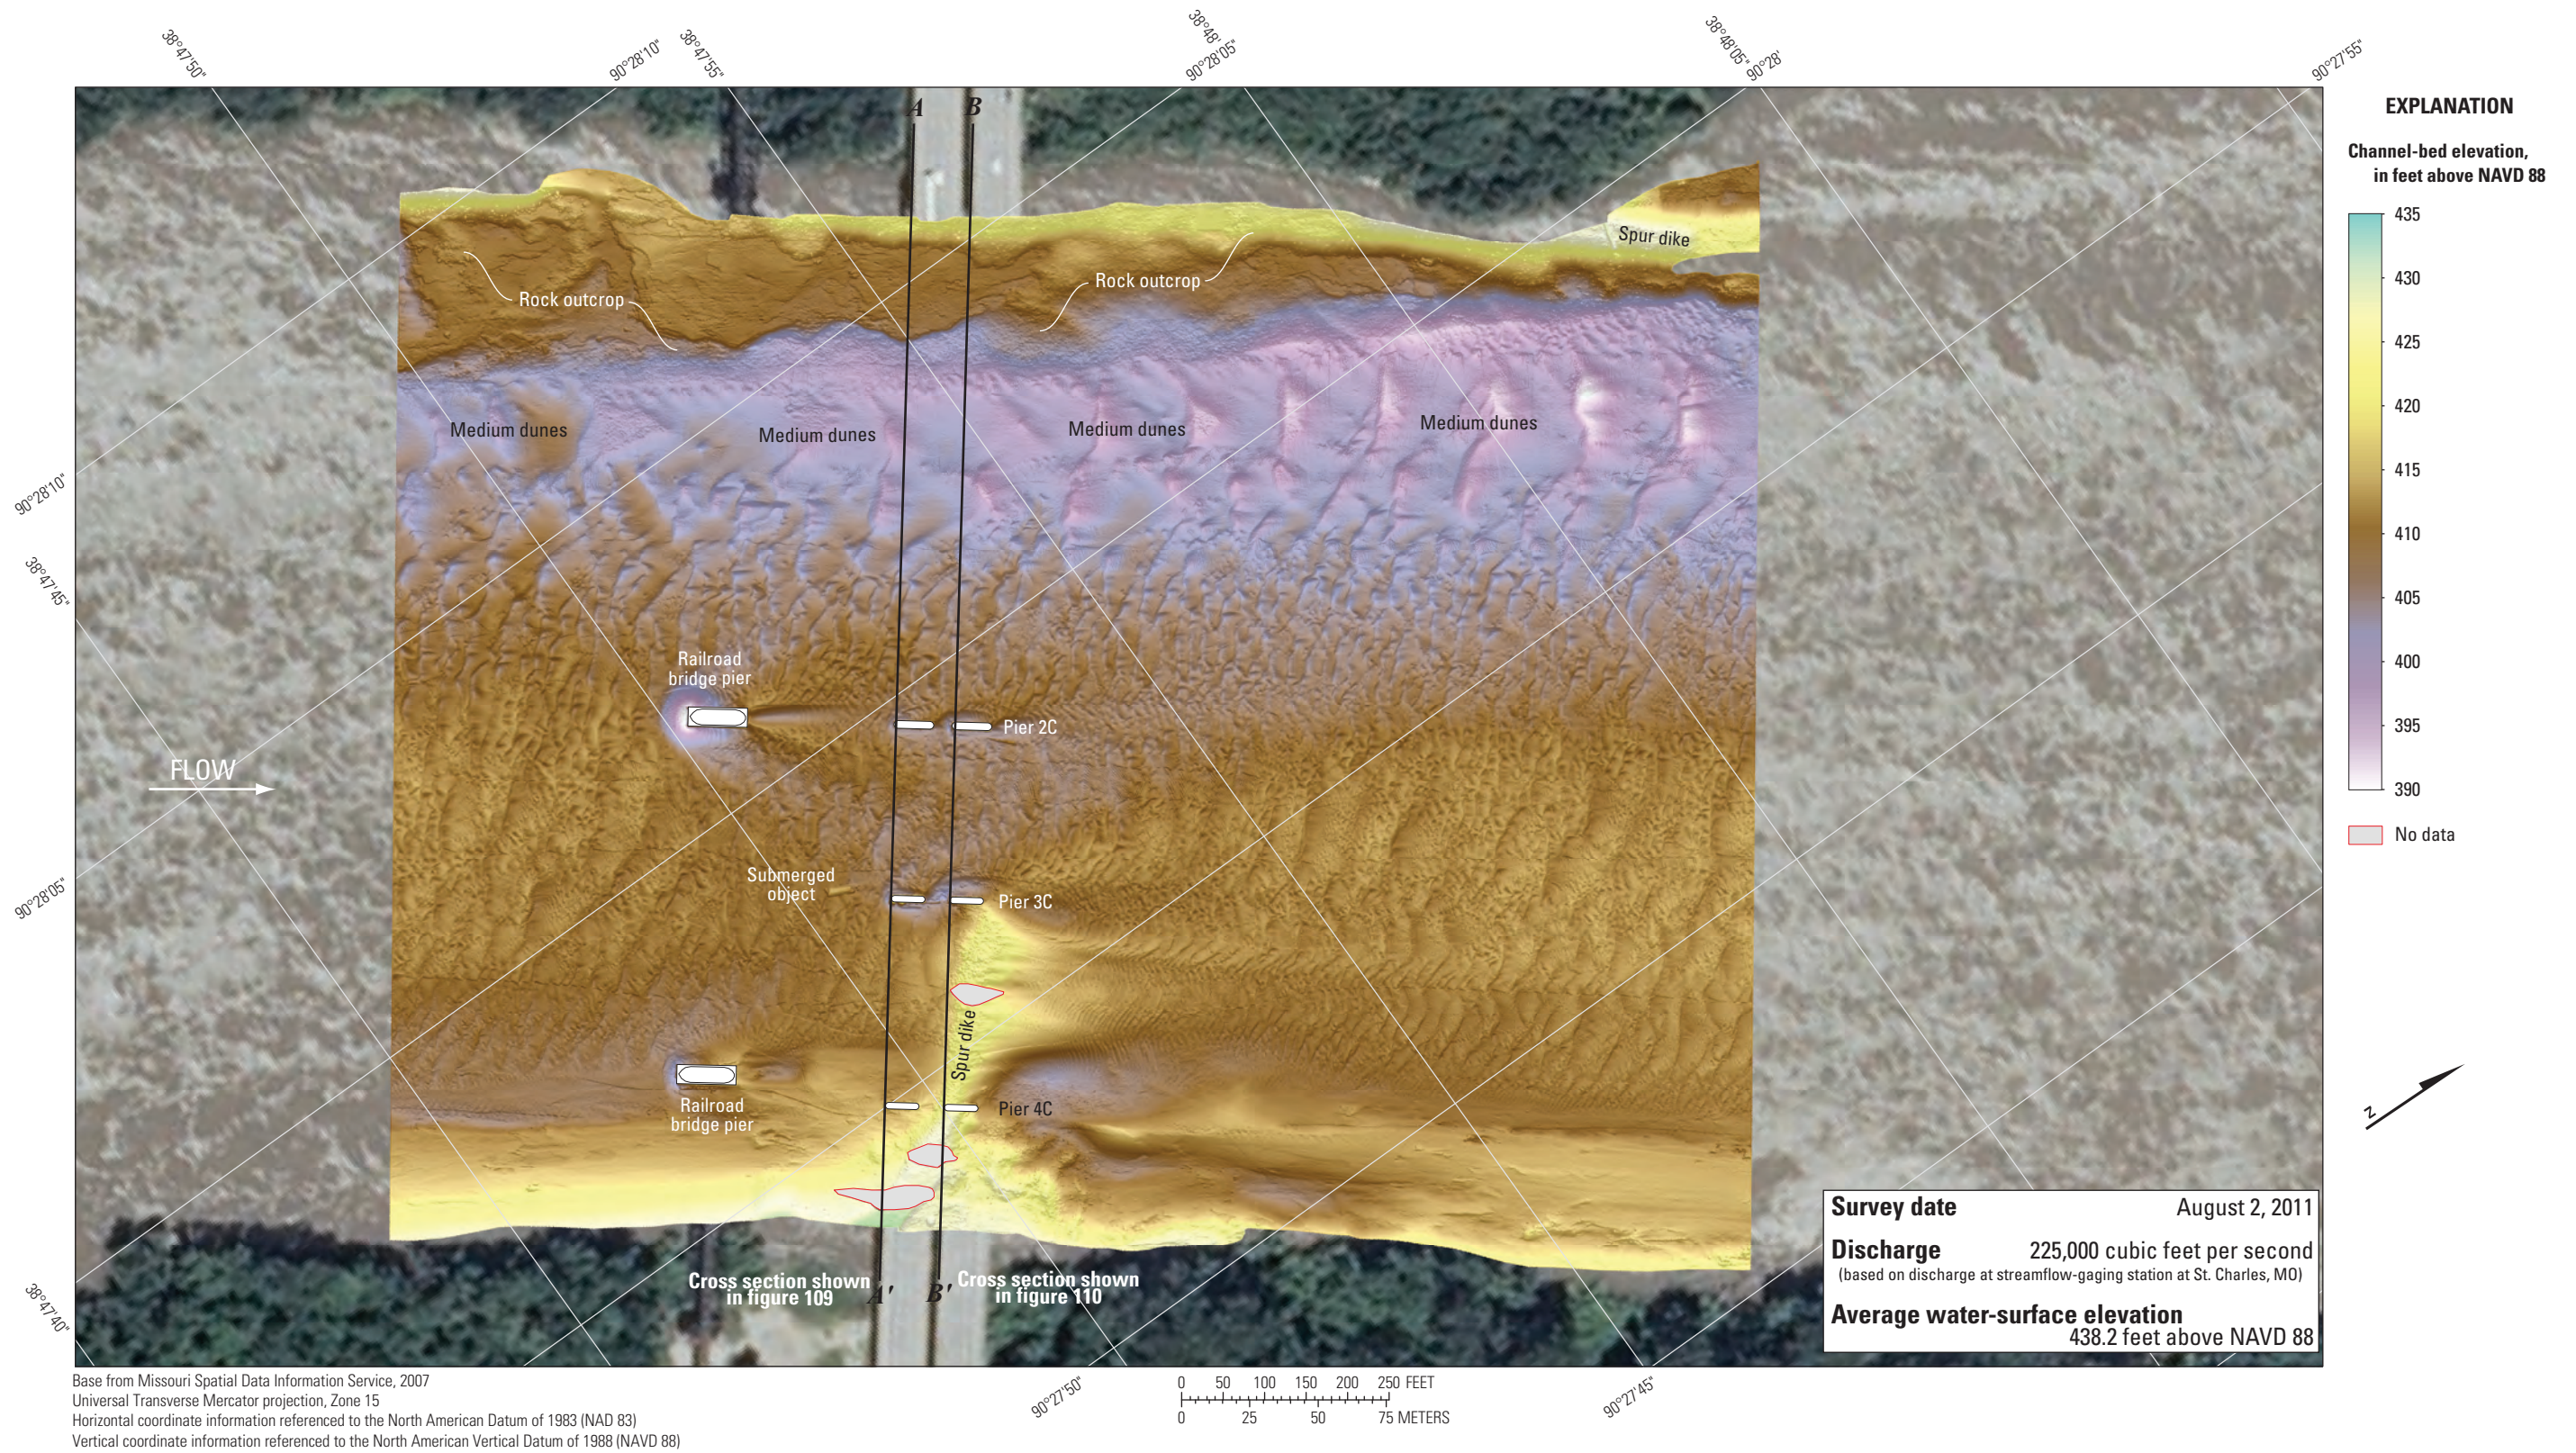
Figure 108. Bathymetric survey of the Missouri River channel in the vicinity of dual bridge structure A4557 on State Highway 370 near St. Louis, Missouri.

The survey area was about 1,640 ft long and averaged about 1,210 ft wide, extending from bank to bank in the main channel (fig. 108). The upstream end of the survey area was about 670 ft upstream from the centerline of structure A4557 (fig. 108). The channel-bed elevations ranged from about 399 to 417 ft for most of the surveyed area (5 to 95 percentile range of the bathymetric data), except near the piers and along the toe of the rock outcrop along the left (north) side of the channel, which had a minimum channel-bed elevation of approximately 392 ft (fig. 108; table 5). A series of medium dune features were observed in the channel thalweg, and numerous small dunes and ripples were detected throughout the rest of the channel (fig. 108). A spur dike was present under the downstream bridge on the right (south) bank (fig. 108).

Small scour holes were present in the vicinity of the main channel piers, except those near the spur dike on the right side of the channel (pier 4C at both bridges; fig. 108). At pier 2C, the scour hole at the upstream pier had a minimum channel-bed elevation of about 404 ft (fig. 108; table 9), about 4 ft below the average channel bed immediately upstream from the pier, and the scour hole at the downstream pier had a minimum channel-bed elevation of about 403 ft (fig. 108; table 9), about 6 ft below the average channel bed immediately upstream from the pier. At pier 3C, the scour hole at the upstream pier had a minimum channel-bed elevation of about 403 ft (fig. 108; table 9), about 5 ft below the average channel bed immediately upstream from the pier, whereas the scour hole at the downstream pier had a minimum channel-bed elevation of about 402 ft (fig. 108; table 9), about 6 ft below the average channel bed immediately upstream from the pier. There essentially was no scour hole around either upstream or downstream pier 4C (fig. 108); however, the spur dike adjacent to these piers caused a local deep hole that reached a minimum channel-bed elevation of about 403 ft (fig. 108; table 9). These piers essentially were embedded in the rock of the dike, which will limit or prevent additional scour near both of them. Material from the toe of the spur dike extended to downstream pier 3C, and may limit scour on the right (south) side of that pier as well.

A substantial scour hole was observed at the railroad bridge pier upstream from pier 2C (fig. 108). The hole had a minimum channel-bed elevation of 390 ft at the nose of the pier, about 20 ft below the average channel bed immediately upstream from the pier (fig. 108). A smaller scour hole also was present at the railroad bridge pier upstream from pier 4C, which had a minimum channel-bed elevation of 402 ft at

the nose of the pier, about 5 ft below the average channel bed immediately upstream from the pier (fig. 108). The scour holes at the railroad bridge piers did not appear to affect the scour at piers 2C or 4C of structure A4557 (fig. 108).

St. Louis and structure A3047 on U.S. Highway 61 near St. Louis, the spur dikes on the right bank under the bridges had a negligible effect on the shape of the scour holes of piers near them (figs. 108, 113), likely because there was no additional constriction of the flow—although the spur dikes created substantial turbulence (figs. 112, 116).
