Bathymetric and Velocimetric Surveys at Highway Bridges Crossing the Missouri River in and into Missouri during Summer Flooding, July–August 2011

Scientific Investigations Report 2012–5204

By Richard J. Huizinga

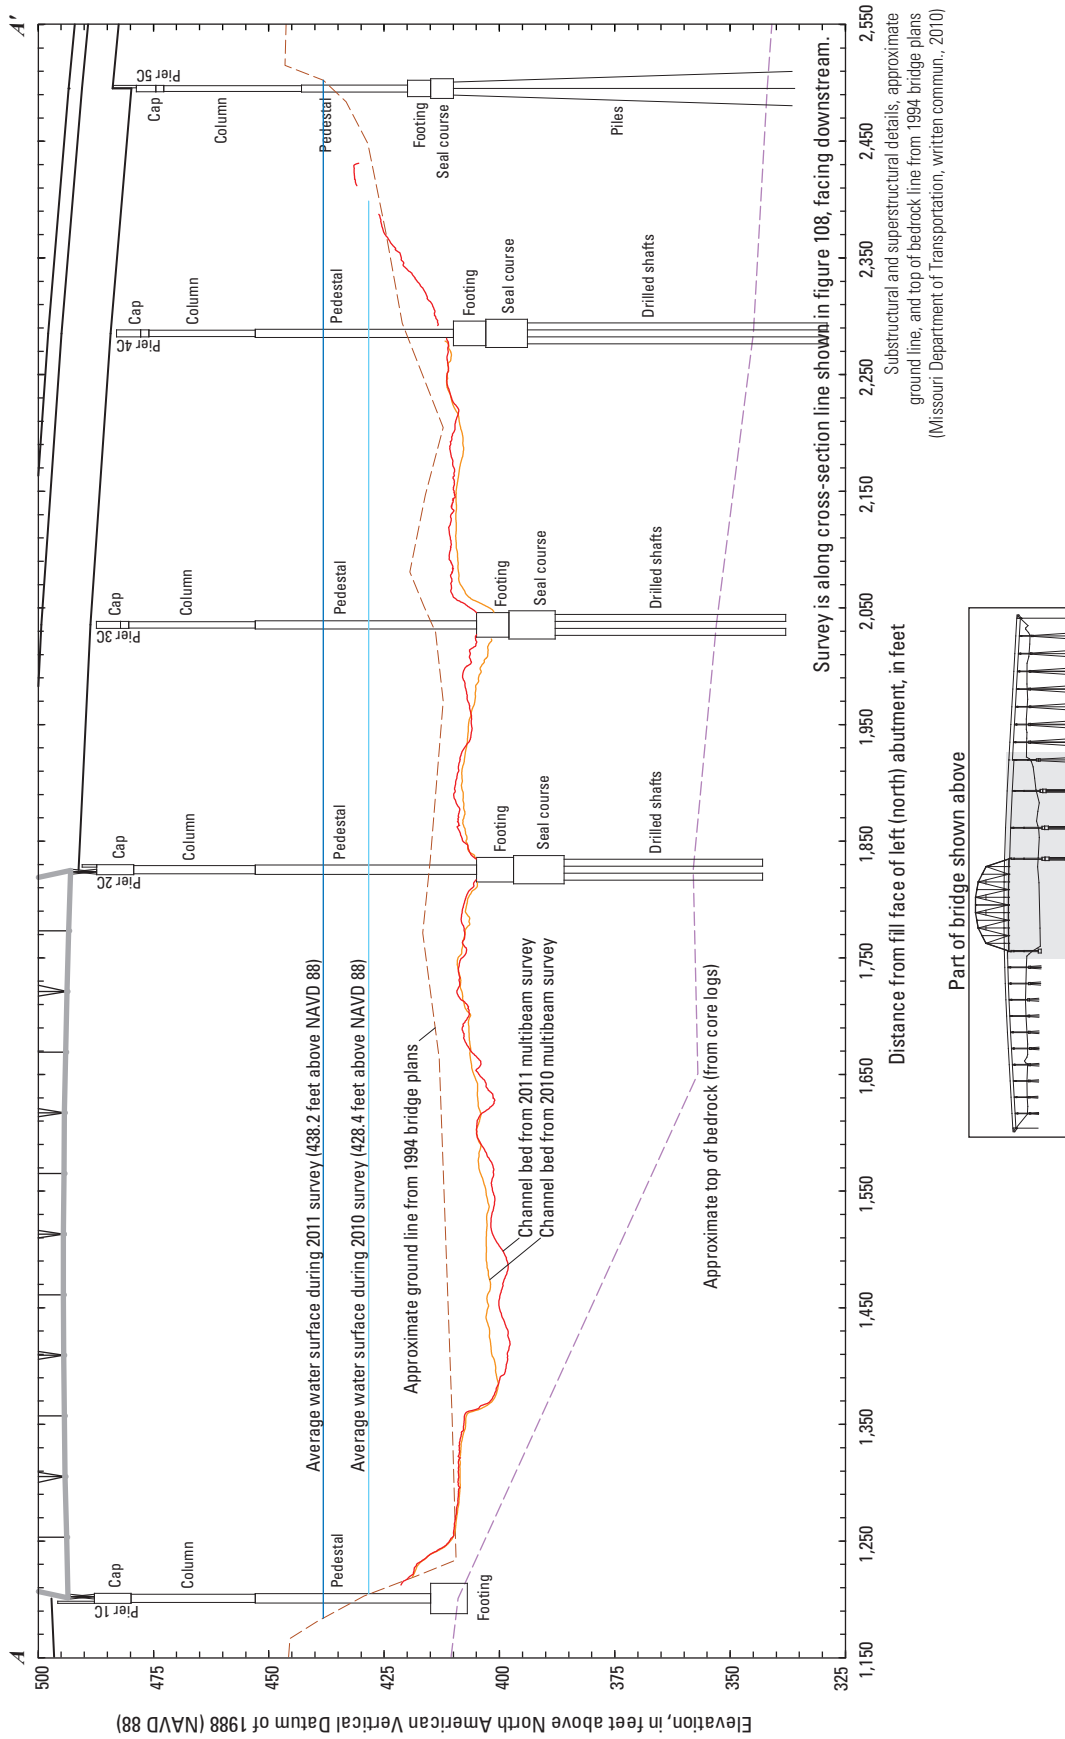
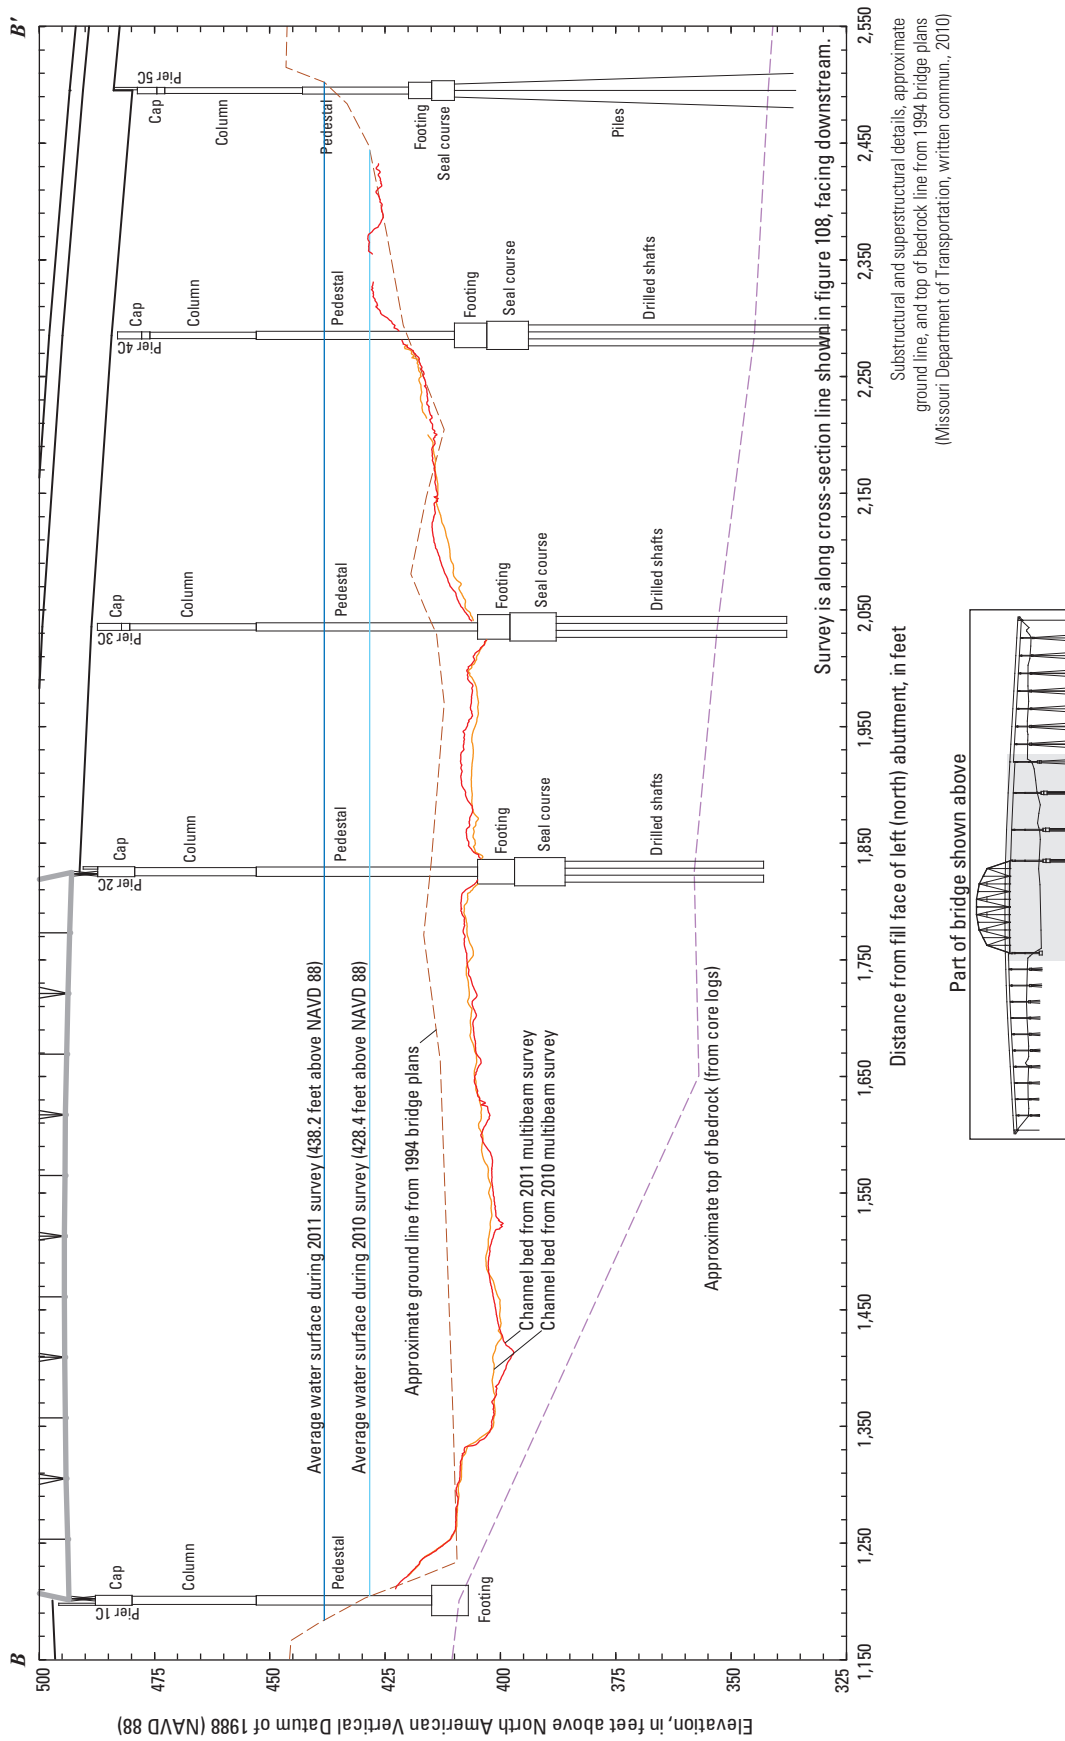
Figure 109. Key features, substructural and superstructural details, and surveyed channel bed along the upstream face of the dual bridge structure A4557 on State Highway 370 over the Missouri River near St. Louis, Missouri.

Information from bridge plans indicates that the main channel piers of both bridges of structure A4557 are founded on shafts drilled 15 ft into bedrock (figs. 109, 110; table 9). Depth of bed material between bedrock and the bottom of the various scour holes at dual bridge structure A4557 ranged from 45 to 66 ft because of the sloping bedrock and channel bed in the area (figs. 109, 110; table 9). The minimum channel-bed elevation in each of the scour holes was more than 9 ft higher than the bottom of the seal course elevation at each pier (figs. 109, 110; table 9).

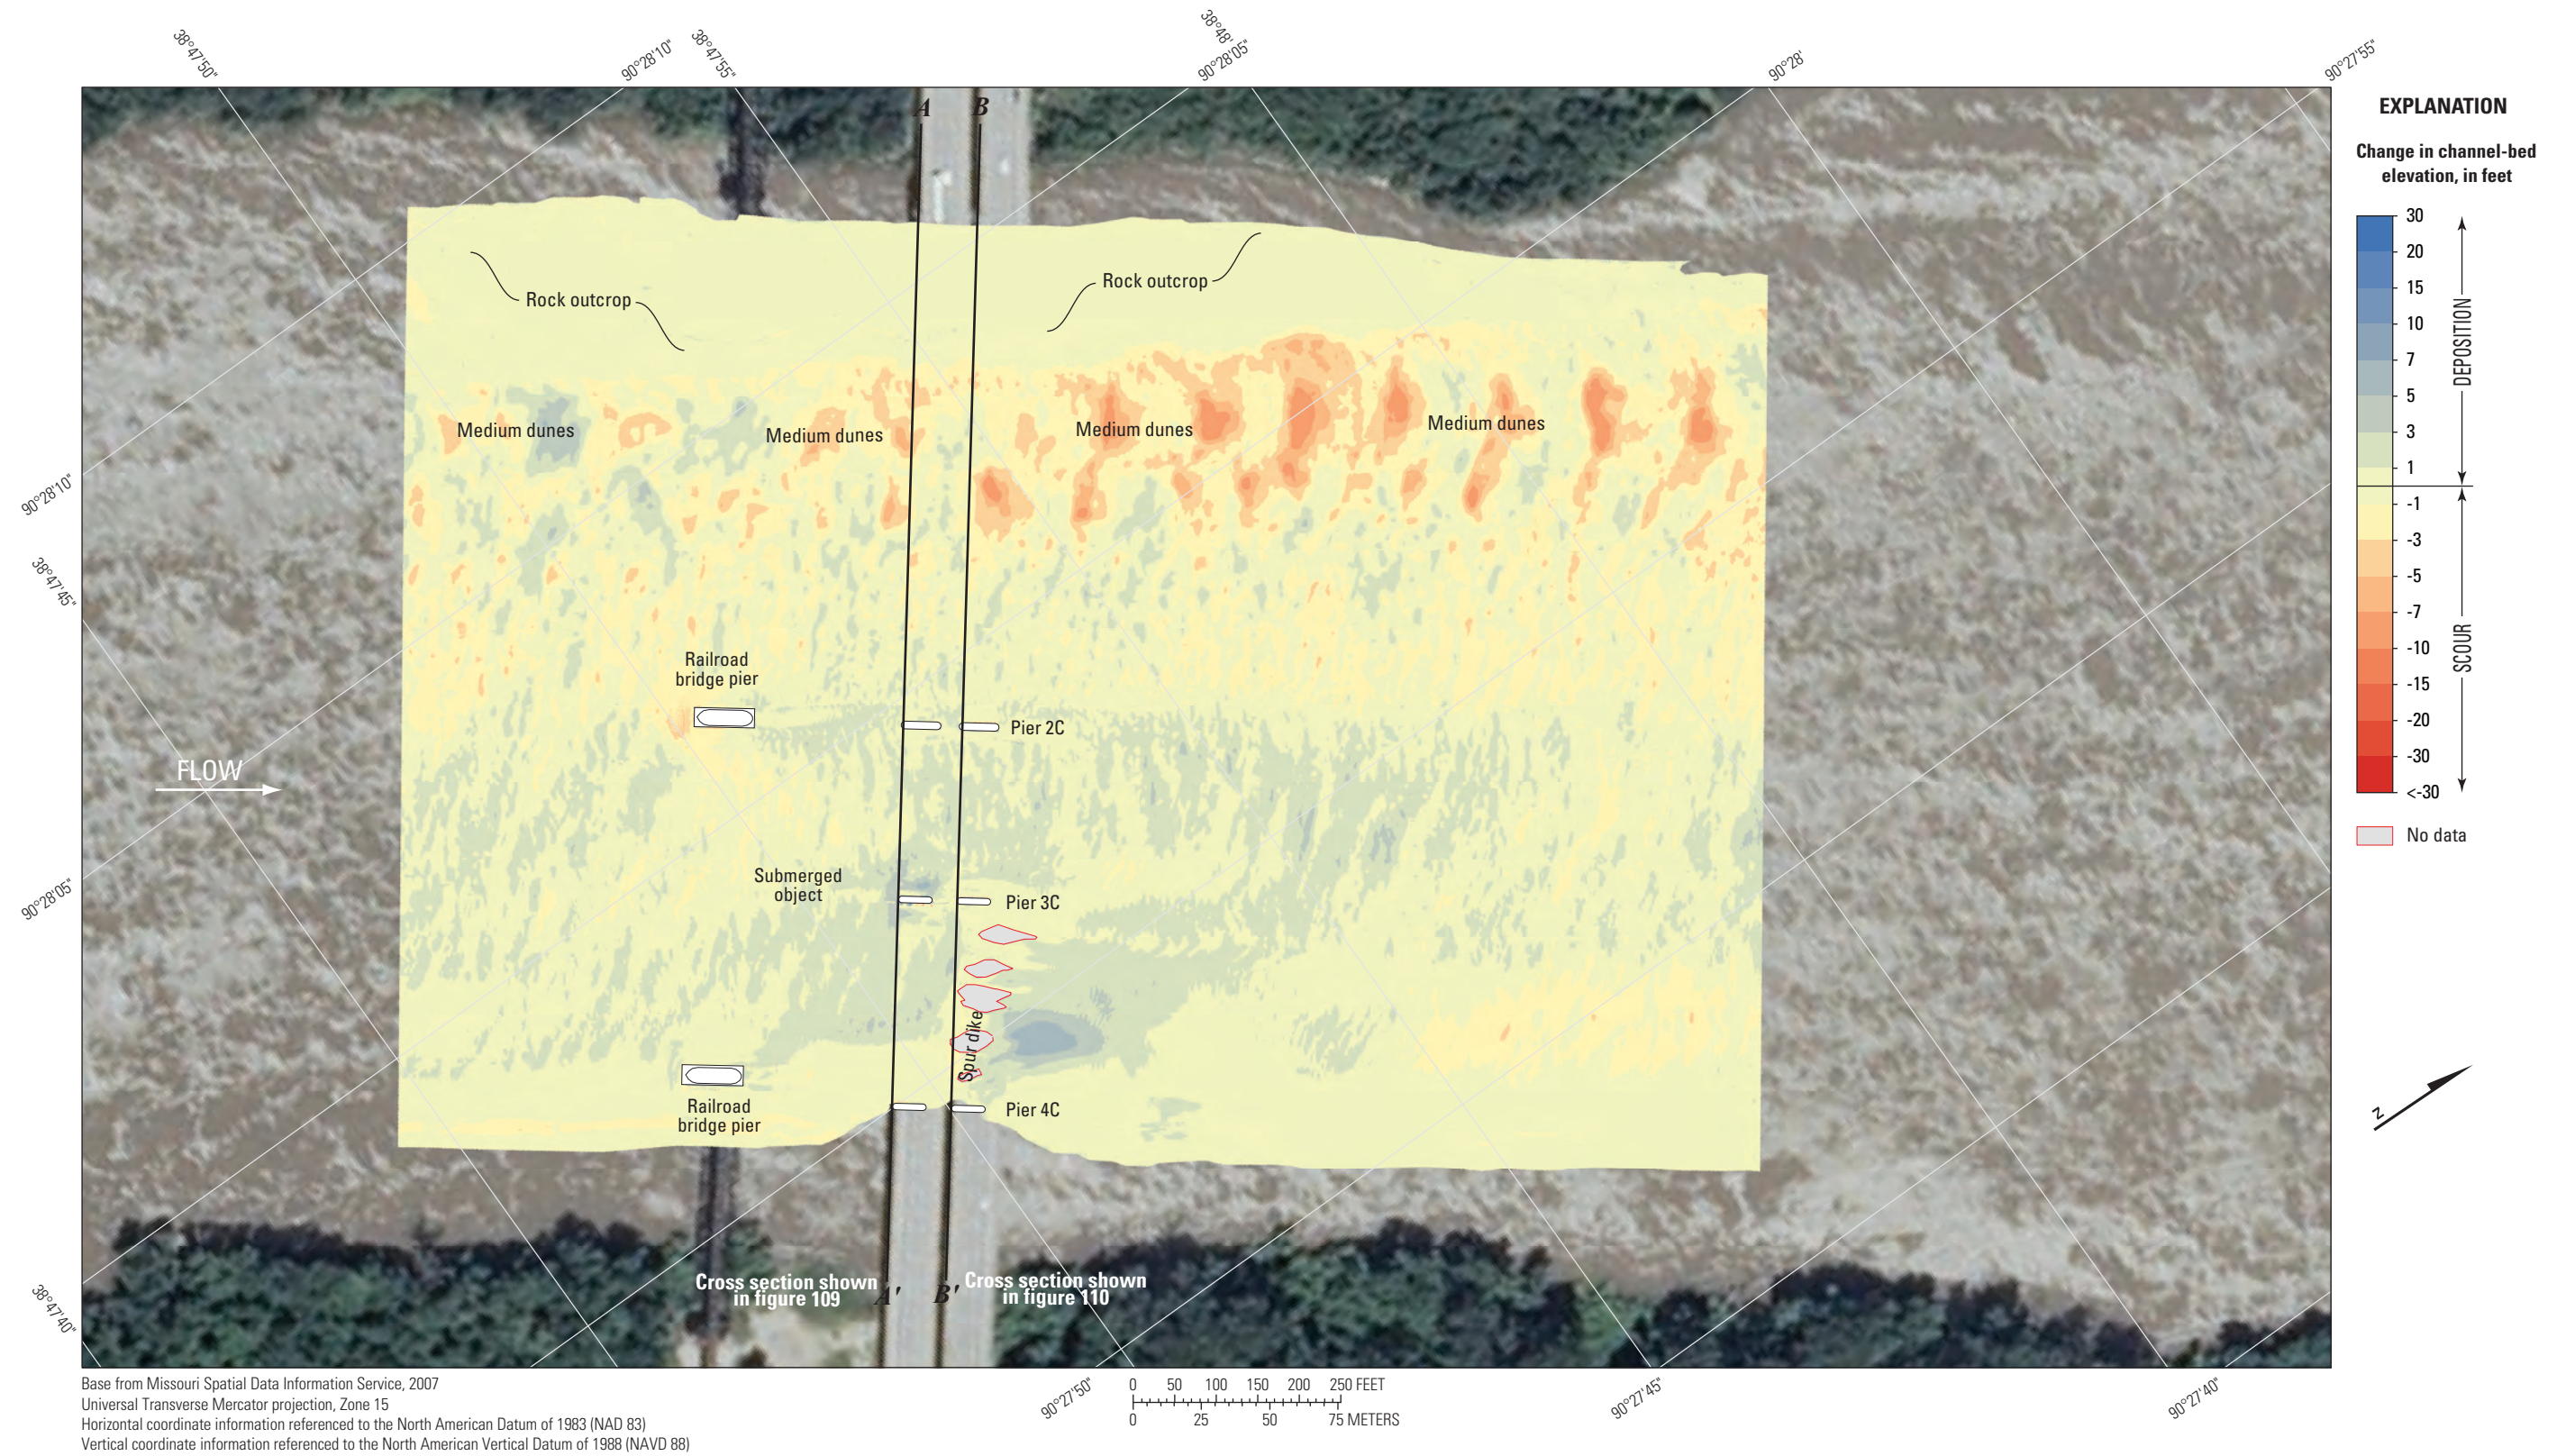
Figure 111. Difference between surfaces created from bathymetric surveys of the Missouri River channel in the vicinity of dual bridge structure A4557 on State Highway 370 near St. Louis, Missouri, on October 22, 2010, and August 2, 2011.

The difference between the survey on August 2, 2011, and the previous survey on October 22, 2010 (fig. 111) indicates little substantial change in the reach from 2010 to 2011, with an average difference of only -0.18 ft between the bathymetric surfaces despite the water-surface elevation difference of nearly 10 ft and flow difference of 135,000 ft³/s (table 7). There was moderate scour in the thalweg in the downstream reach, and widespread minor deposition throughout the middle and right (south) side of the channel (fig. 111). The scour holes near piers 2C and 3C were similar to or shallower in the 2011 survey than in 2010, whereas there was no change near pier 4C (figs. 109, 110, 111). The cross sections from the 2011 survey show the similarity of the channel between the 2010 and 2011 surveys, with balanced areas of minor scour and deposition (figs. 109, 110). The scour hole near the railroad bridge pier upstream from pier 2C was slightly deeper in 2011 than in 2010, whereas the hole near the railroad bridge pier upstream from pier 4C was nearly the same or slightly shallower in 2011 than in 2010 (fig. 111).

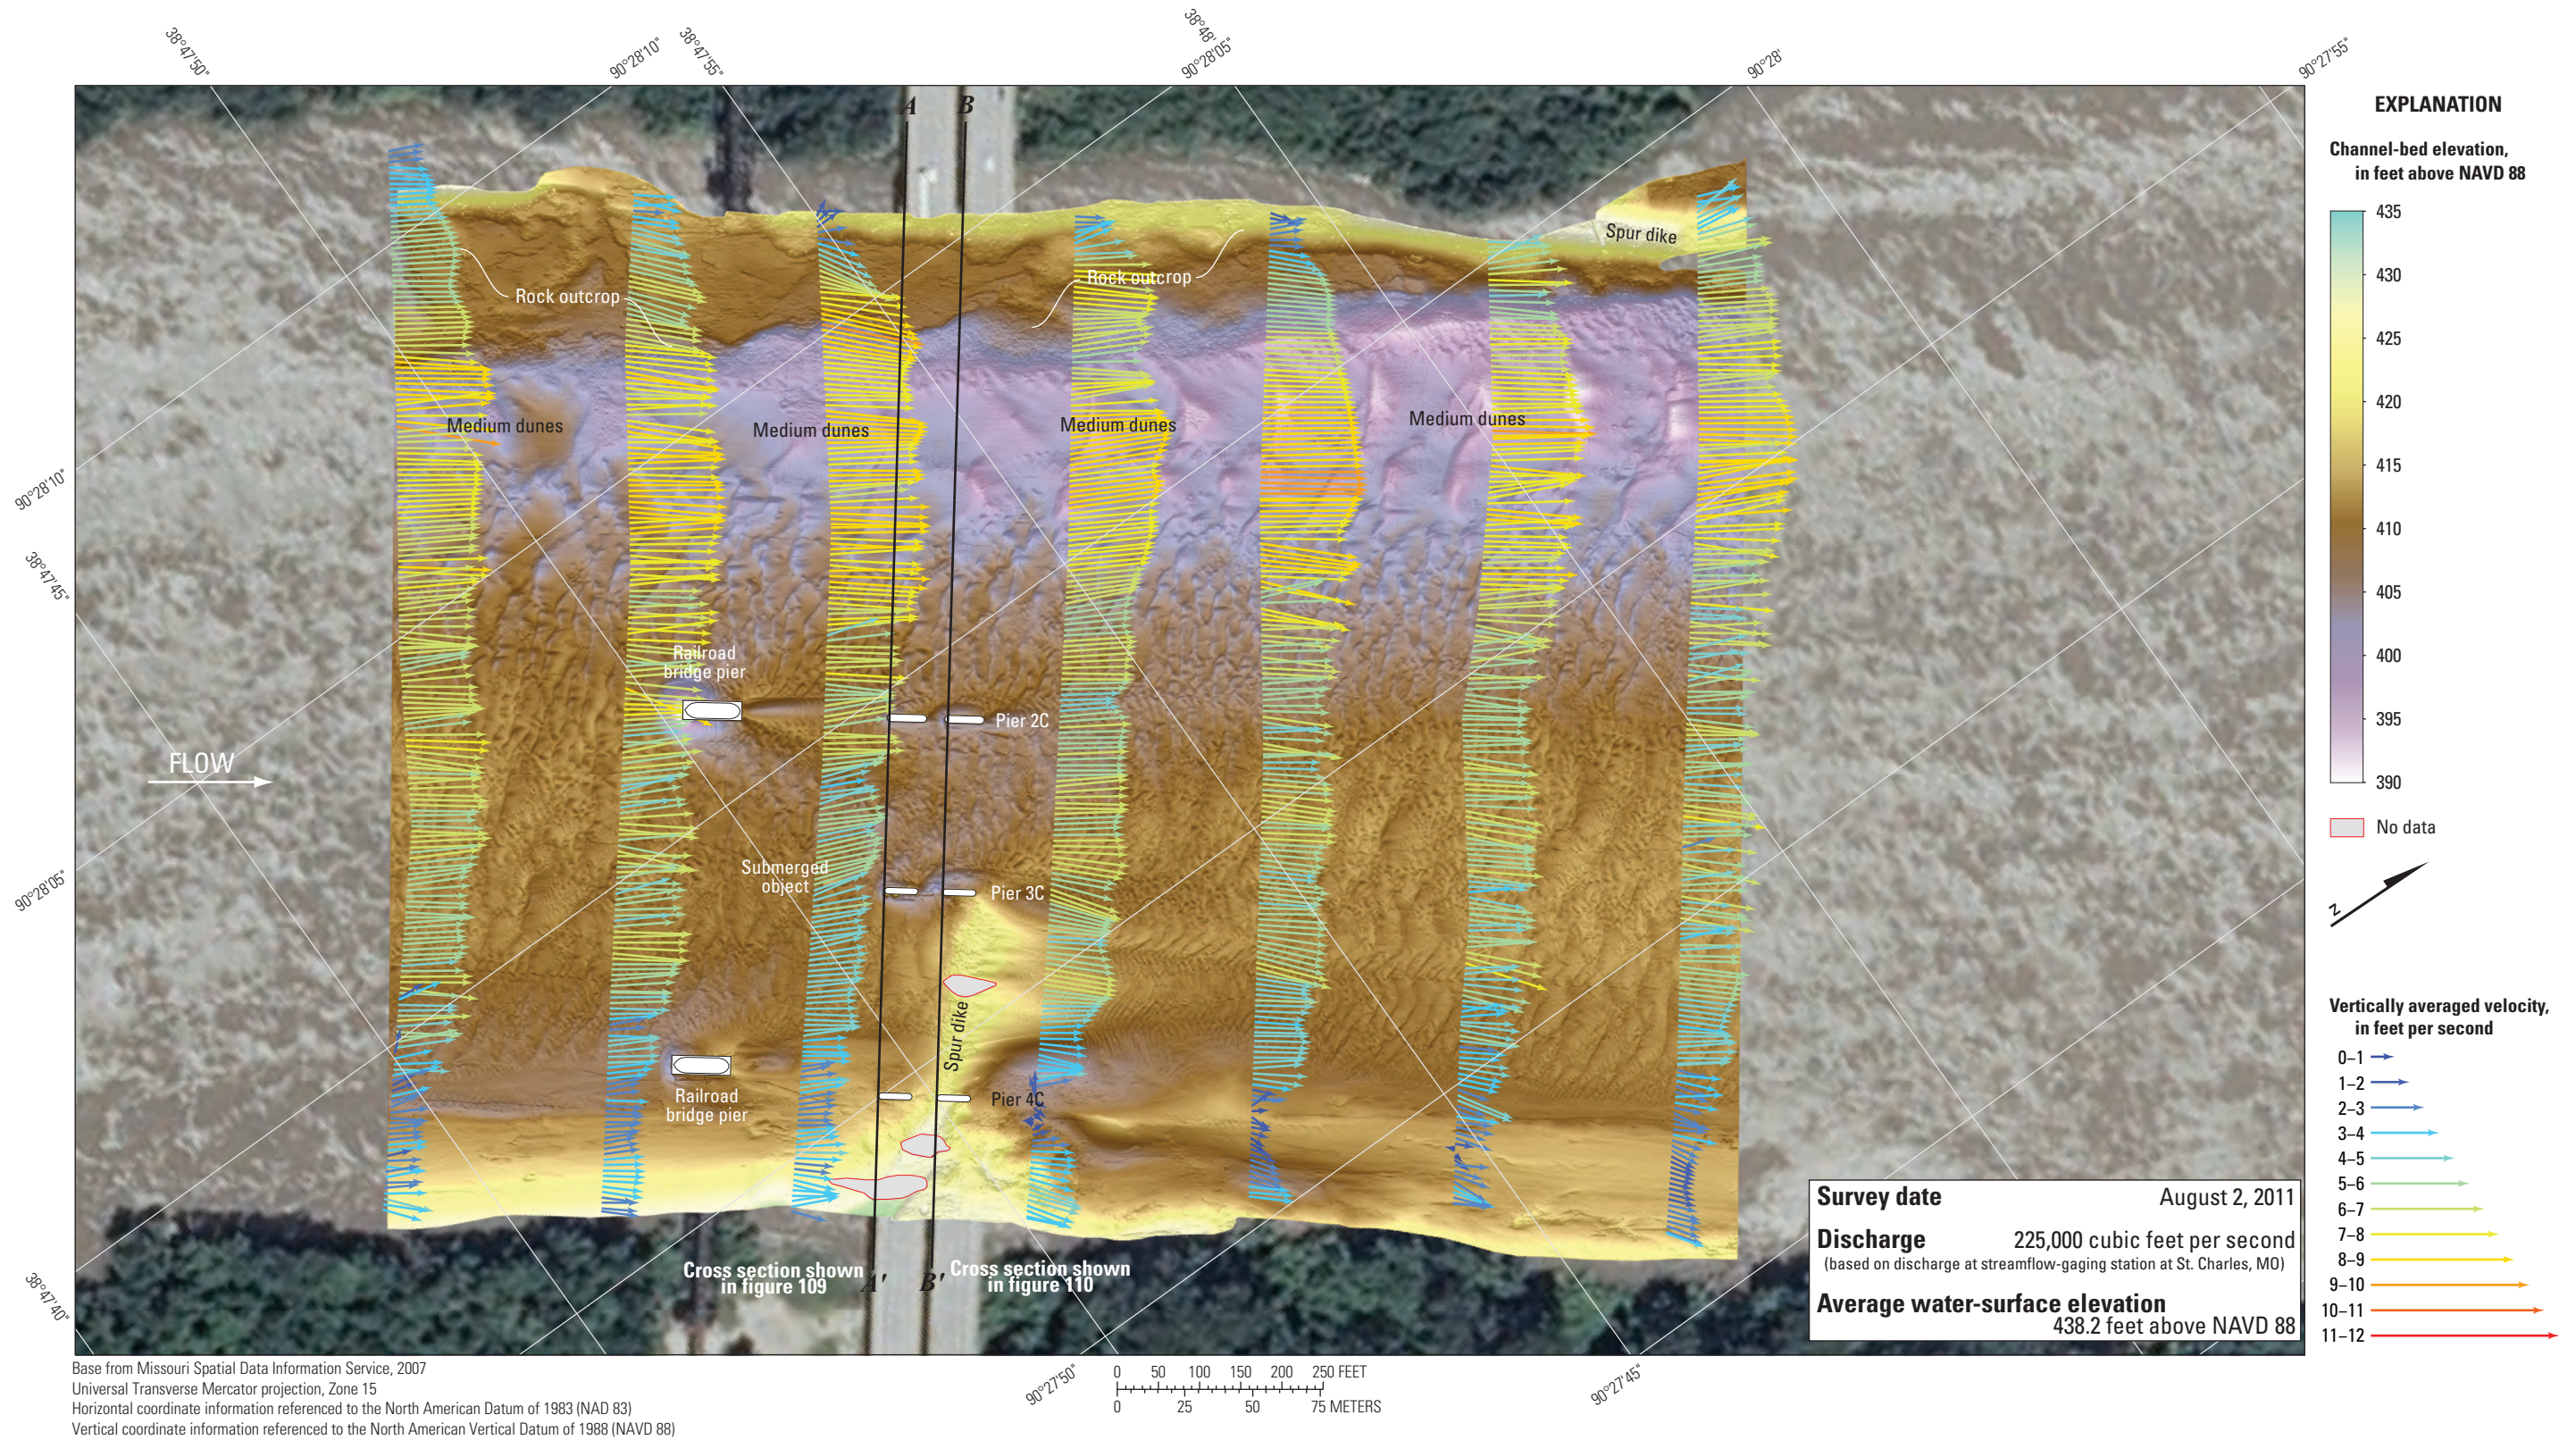
Figure 112. Bathymetry and vertically averaged velocities of the Missouri River channel in the vicinity of dual bridge structure A4557 on State Highway 370 near St. Louis, Missouri.

The vertically averaged velocity vectors indicate moderate to substantial turbulence in several transects, with velocities ranging from about 2 to 10 ft/s (fig. 112). There was substantial turbulence and flow reversal near the spur dike on the right (south) bank and near the left (north) bank where the rock outcrop had substantial variations (fig. 112). Flow was mostly uniform in the thalweg downstream from the bridges (fig. 112). All the piers were aligned with flow, and there was little to no turbulence observed downstream that can be directly attributed to the piers (fig. 112).

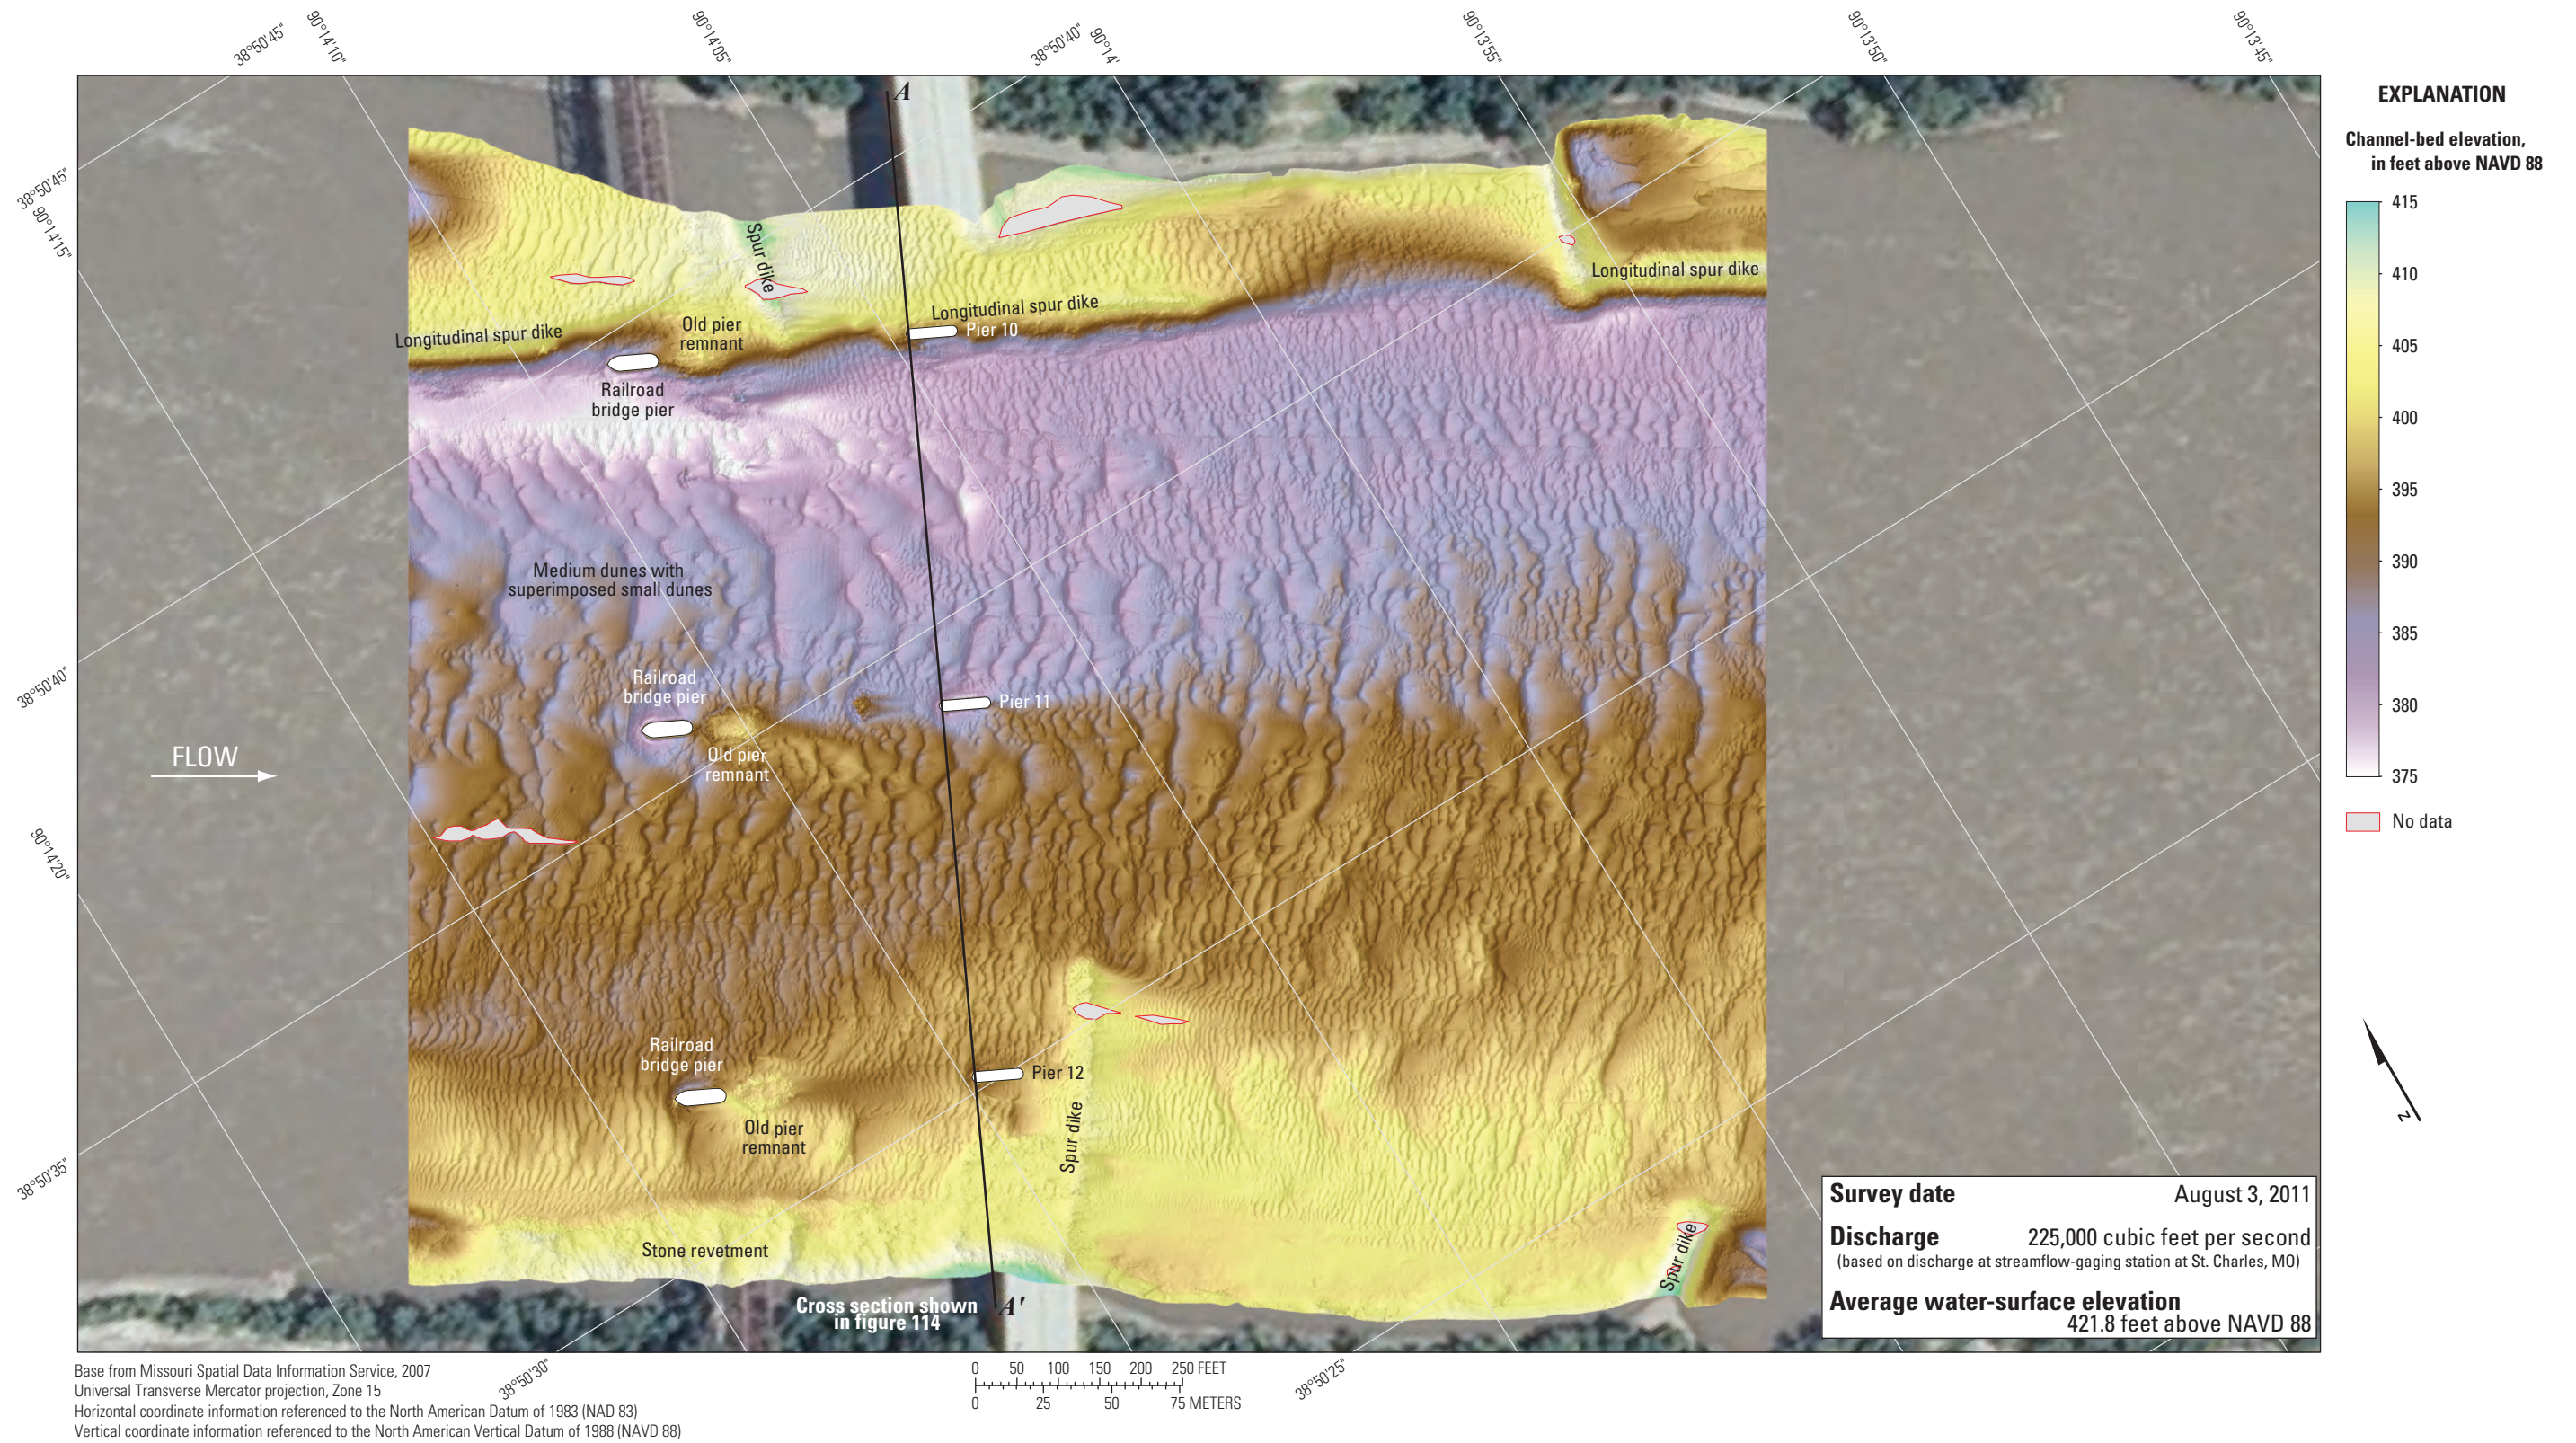
Figure 113. Bathymetric survey of the Missouri River channel in the vicinity of structure A3047 on U.S. Highway 67 near St. Louis, Missouri.

The survey area was about 1,640 ft long and about 1,360 ft wide, extending essentially from bank to bank in the main channel (fig. 113). The upstream end of the survey area was about 670 ft upstream from the centerline of structure A3047 (fig. 113). The channel-bed elevations ranged from about 381 to 404 ft for most of the surveyed area (5 to 95 percentile range of the bathymetric data) except in the upstream thalweg. A deep thalweg on the left (north) bank was about 10 to 15 ft deeper than the channel bed in the middle of the channel (fig. 113). In the vicinity of the spur dike on the right (south) side near the bridge, deposits reached an elevation of about 402 ft, and behind the longitudinal spur dike on the left (north) side near the bridge, deposits reached an elevation of about 408 ft (fig. 113). Numerous small dunes and ripples were detected throughout the channel, and a few medium dune features with superimposed small dunes and ripples were detected in the upstream channel thalweg (fig. 113). Stone revetment was present on the upstream right (south) bank (fig. 113).

Small to moderate scour holes were present in the vicinity of the main channel piers, except pier 10 near the longitudinal spur dike on the left (north) side of the channel (fig. 113). In the immediate vicinity of pier 10, the channel thalweg had a minimum channel-bed elevation of about 380 ft (fig. 113; table 9), which is about 34 ft above the bottom of the seal course elevation of 346.50 ft (fig. 114; table 9). Pier 10 was essentially embedded in the rock of a longitudinal spur dike, which will limit or prevent scour at this pier. At pier 11, the scour hole had a minimum channel-bed elevation of about 378 ft, about 7 ft below the average channel bed immediately upstream from the pier (fig. 113; table 9). At pier 12, the scour hole had a minimum channel-bed elevation of about 390 ft, about 6 ft below the average channel bed immediately upstream from the pier (fig. 113; table 9).

Scour holes also were observed near the railroad bridge piers upstream from structure A3047. The scour hole in the vicinity of the railroad bridge pier upstream from pier 10 was essentially indistinguishable from the channel thalweg (fig. 113); however, substantial scour holes were present in the vicinity of the railroad bridge piers upstream from piers 11 and 12. Scour near the upstream railroad bridge piers did not appear to have an effect on the piers of structure A3047 (fig. 113). The remnant of old bridge piers were observed in the channel downstream from the existing railroad bridge piers (fig. 113).

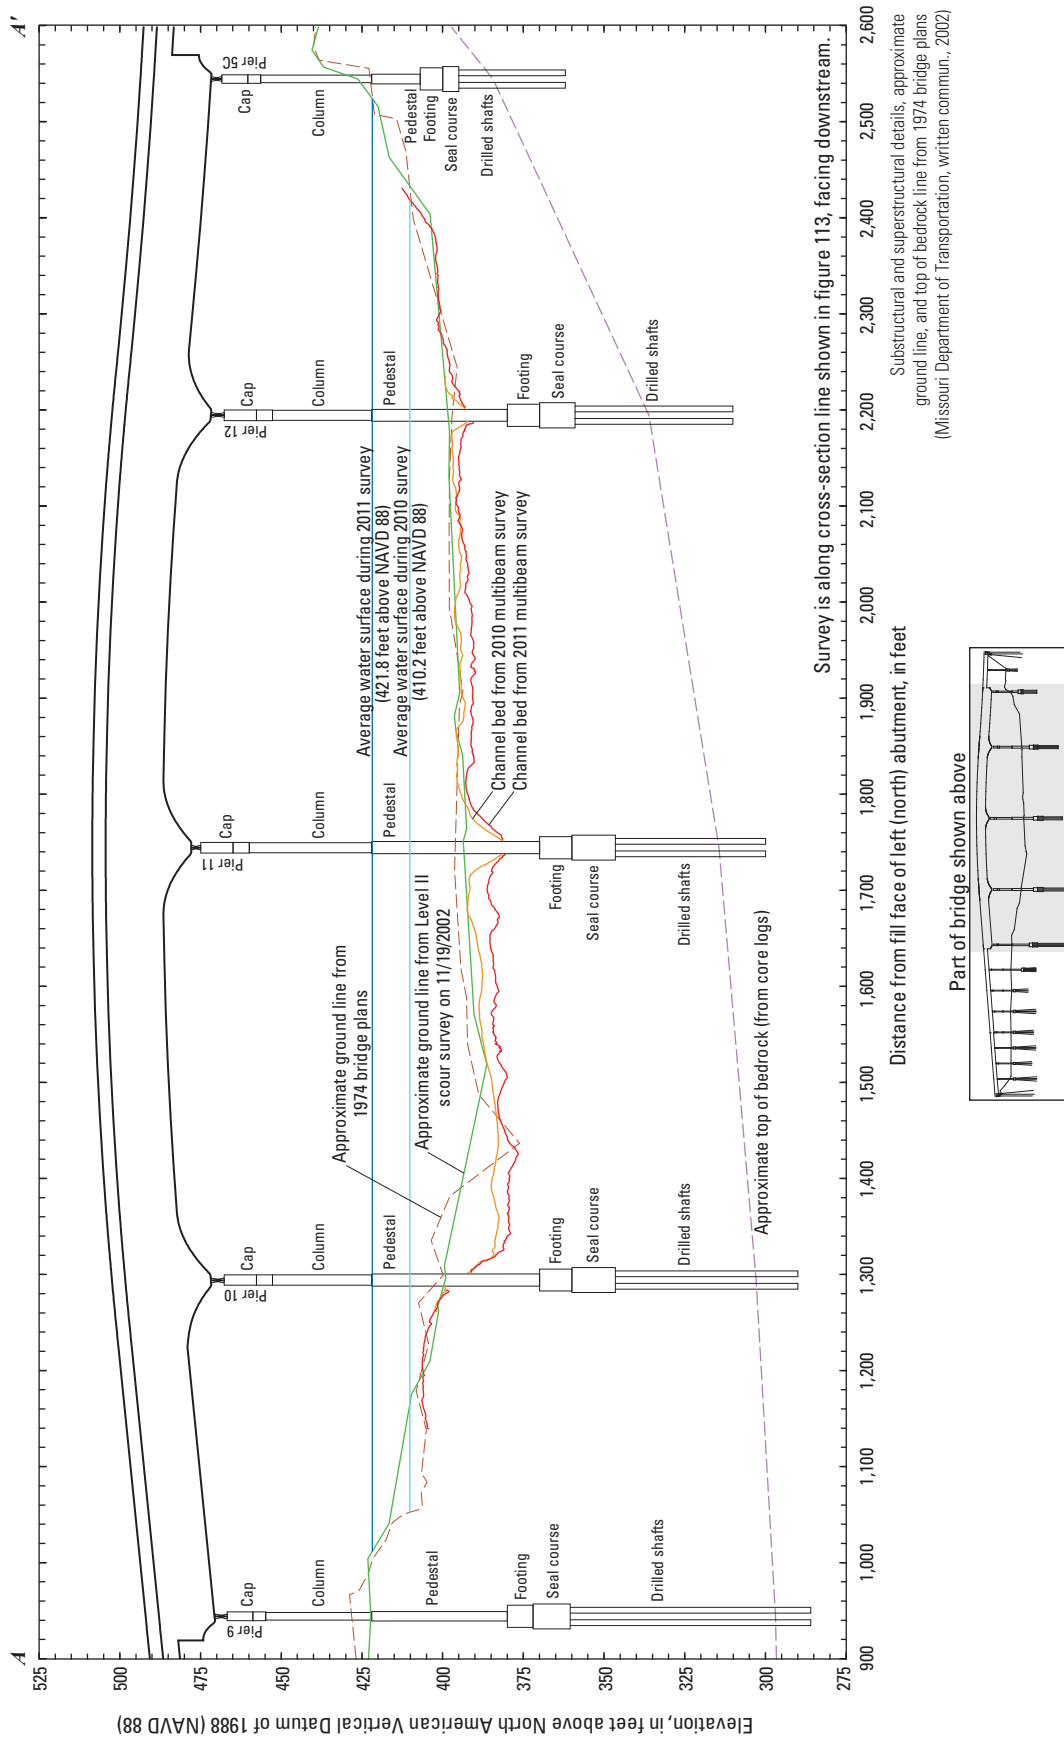
Figure 114. Key features, substructural and superstructural details, and surveyed channel bed of structure A3047 on U.S. Highway 67 over the Missouri River near St. Louis, Missouri.

Information from bridge plans indicates that pier 10 is founded on shafts drilled 13 ft into bedrock, with about 77 ft of bed material between the channel thalweg and bedrock at the bridge, and about 88 ft of bed material between the bed at the nose of the pier and bedrock (fig. 114; table 9). Pier 11 is founded on shafts drilled 15 ft into bedrock, with about 65 ft of bed material between the bottom of the scour hole and bedrock (fig. 114; table 9). Pier 12 is founded on shafts drilled 26 ft into bedrock, with about 54 ft of bed material between the bottom of the scour hole and bedrock (fig. 114; table 9).

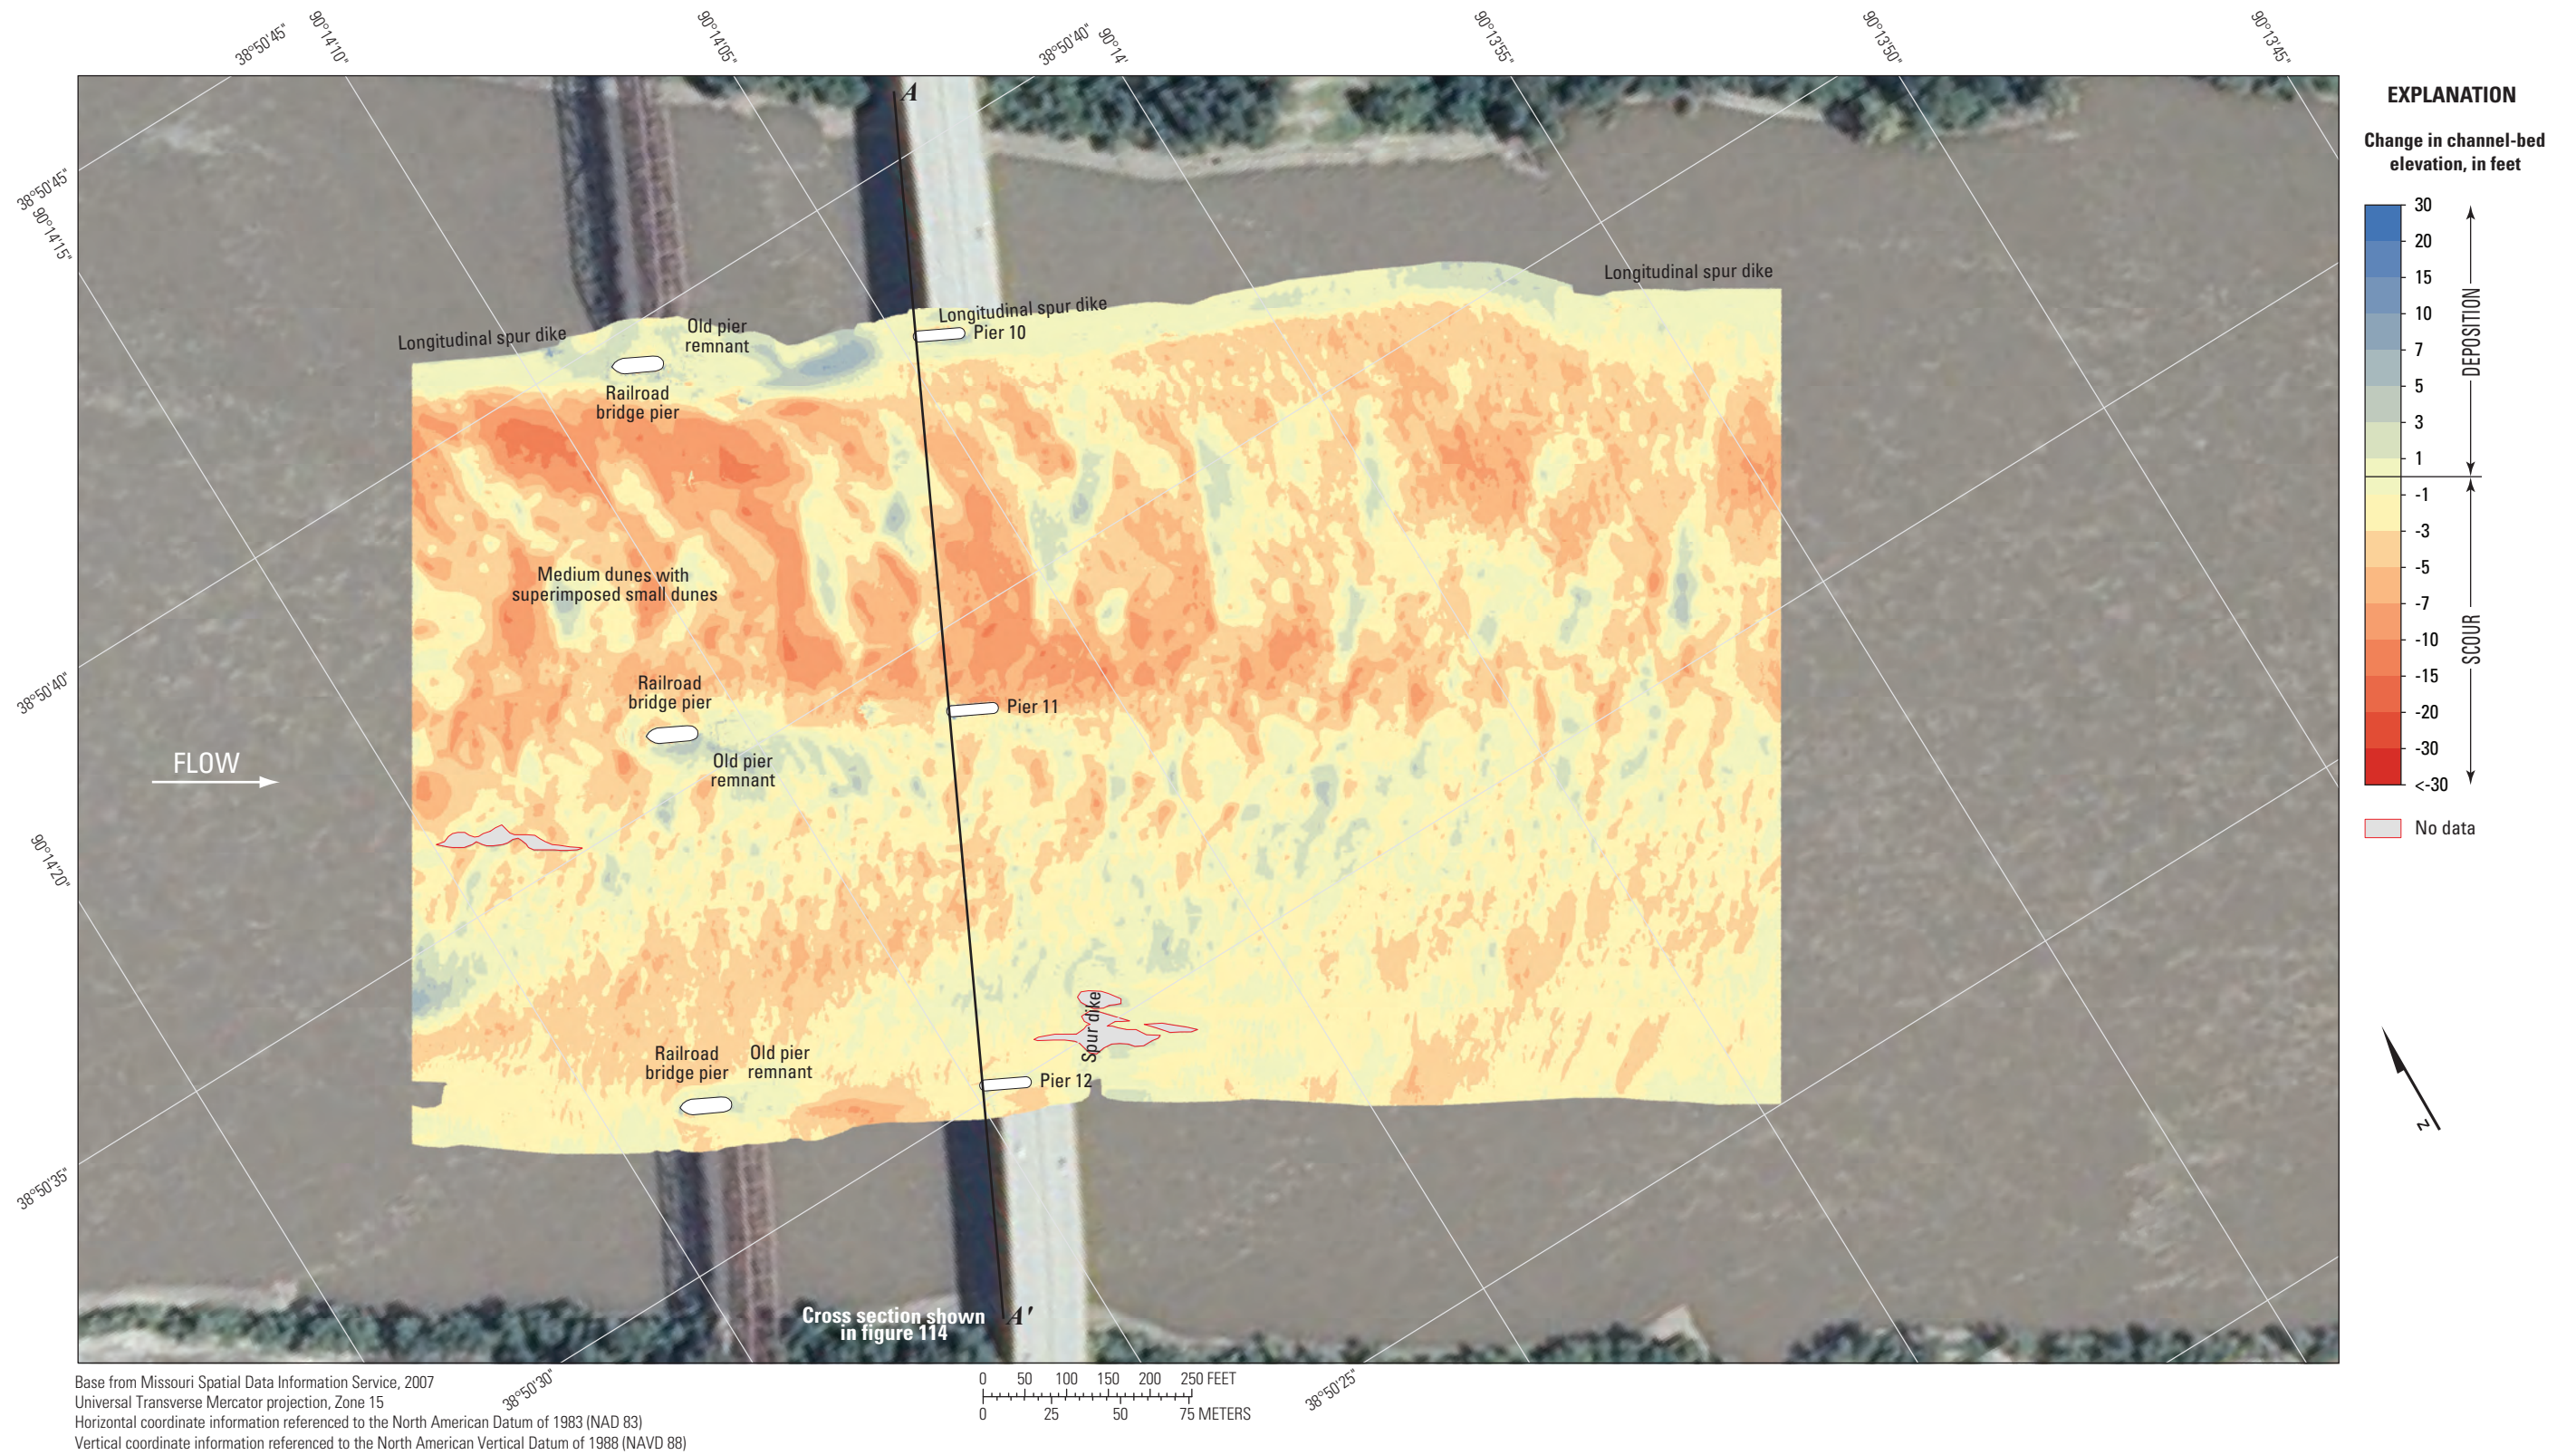
Figure 115. Difference between surfaces created from bathymetric surveys of the Missouri River channel in the vicinity of structure A3047 on U.S. Highway 67 near St. Louis, Missouri, on October 25, 2010, and August 3, 2011.

The difference between the survey on August 3, 2011, and the previous survey on October 25, 2010 (fig. 115) indicates widespread scour throughout the reach from 2010 to 2011, with an average difference of -2.69 ft between the bathymetric surfaces (table 7). There was a difference in water-surface elevation of nearly 12 ft and a flow difference of nearly 138,000 ft³/s between the surveys (table 7). There was moderate deposition on the right (south) side of the channel and in the areas behind the longitudinal spur dikes on the left (north) side, but there was moderate to substantial scour in the thalweg (fig. 115). The minimum elevation of the scour holes near piers 11 and 12 were similar to the 2010 survey, whereas the rest of the cross section from the 2011 survey shows the overall scour between the 2010 and 2011 surveys (figs. 114, 115). The scour hole near the railroad bridge pier upstream from pier 11 was slightly deeper in 2011 than in 2010, whereas the hole near the railroad bridge pier upstream from pier 12 was nearly the same or slightly shallower in 2011 than in 2010 (fig. 115).
