Bathymetric and Velocimetric Surveys at Highway Bridges Crossing the Missouri River in and into Missouri during Summer Flooding, July–August 2011

Scientific Investigations Report 2012–5204

By Richard J. Huizinga

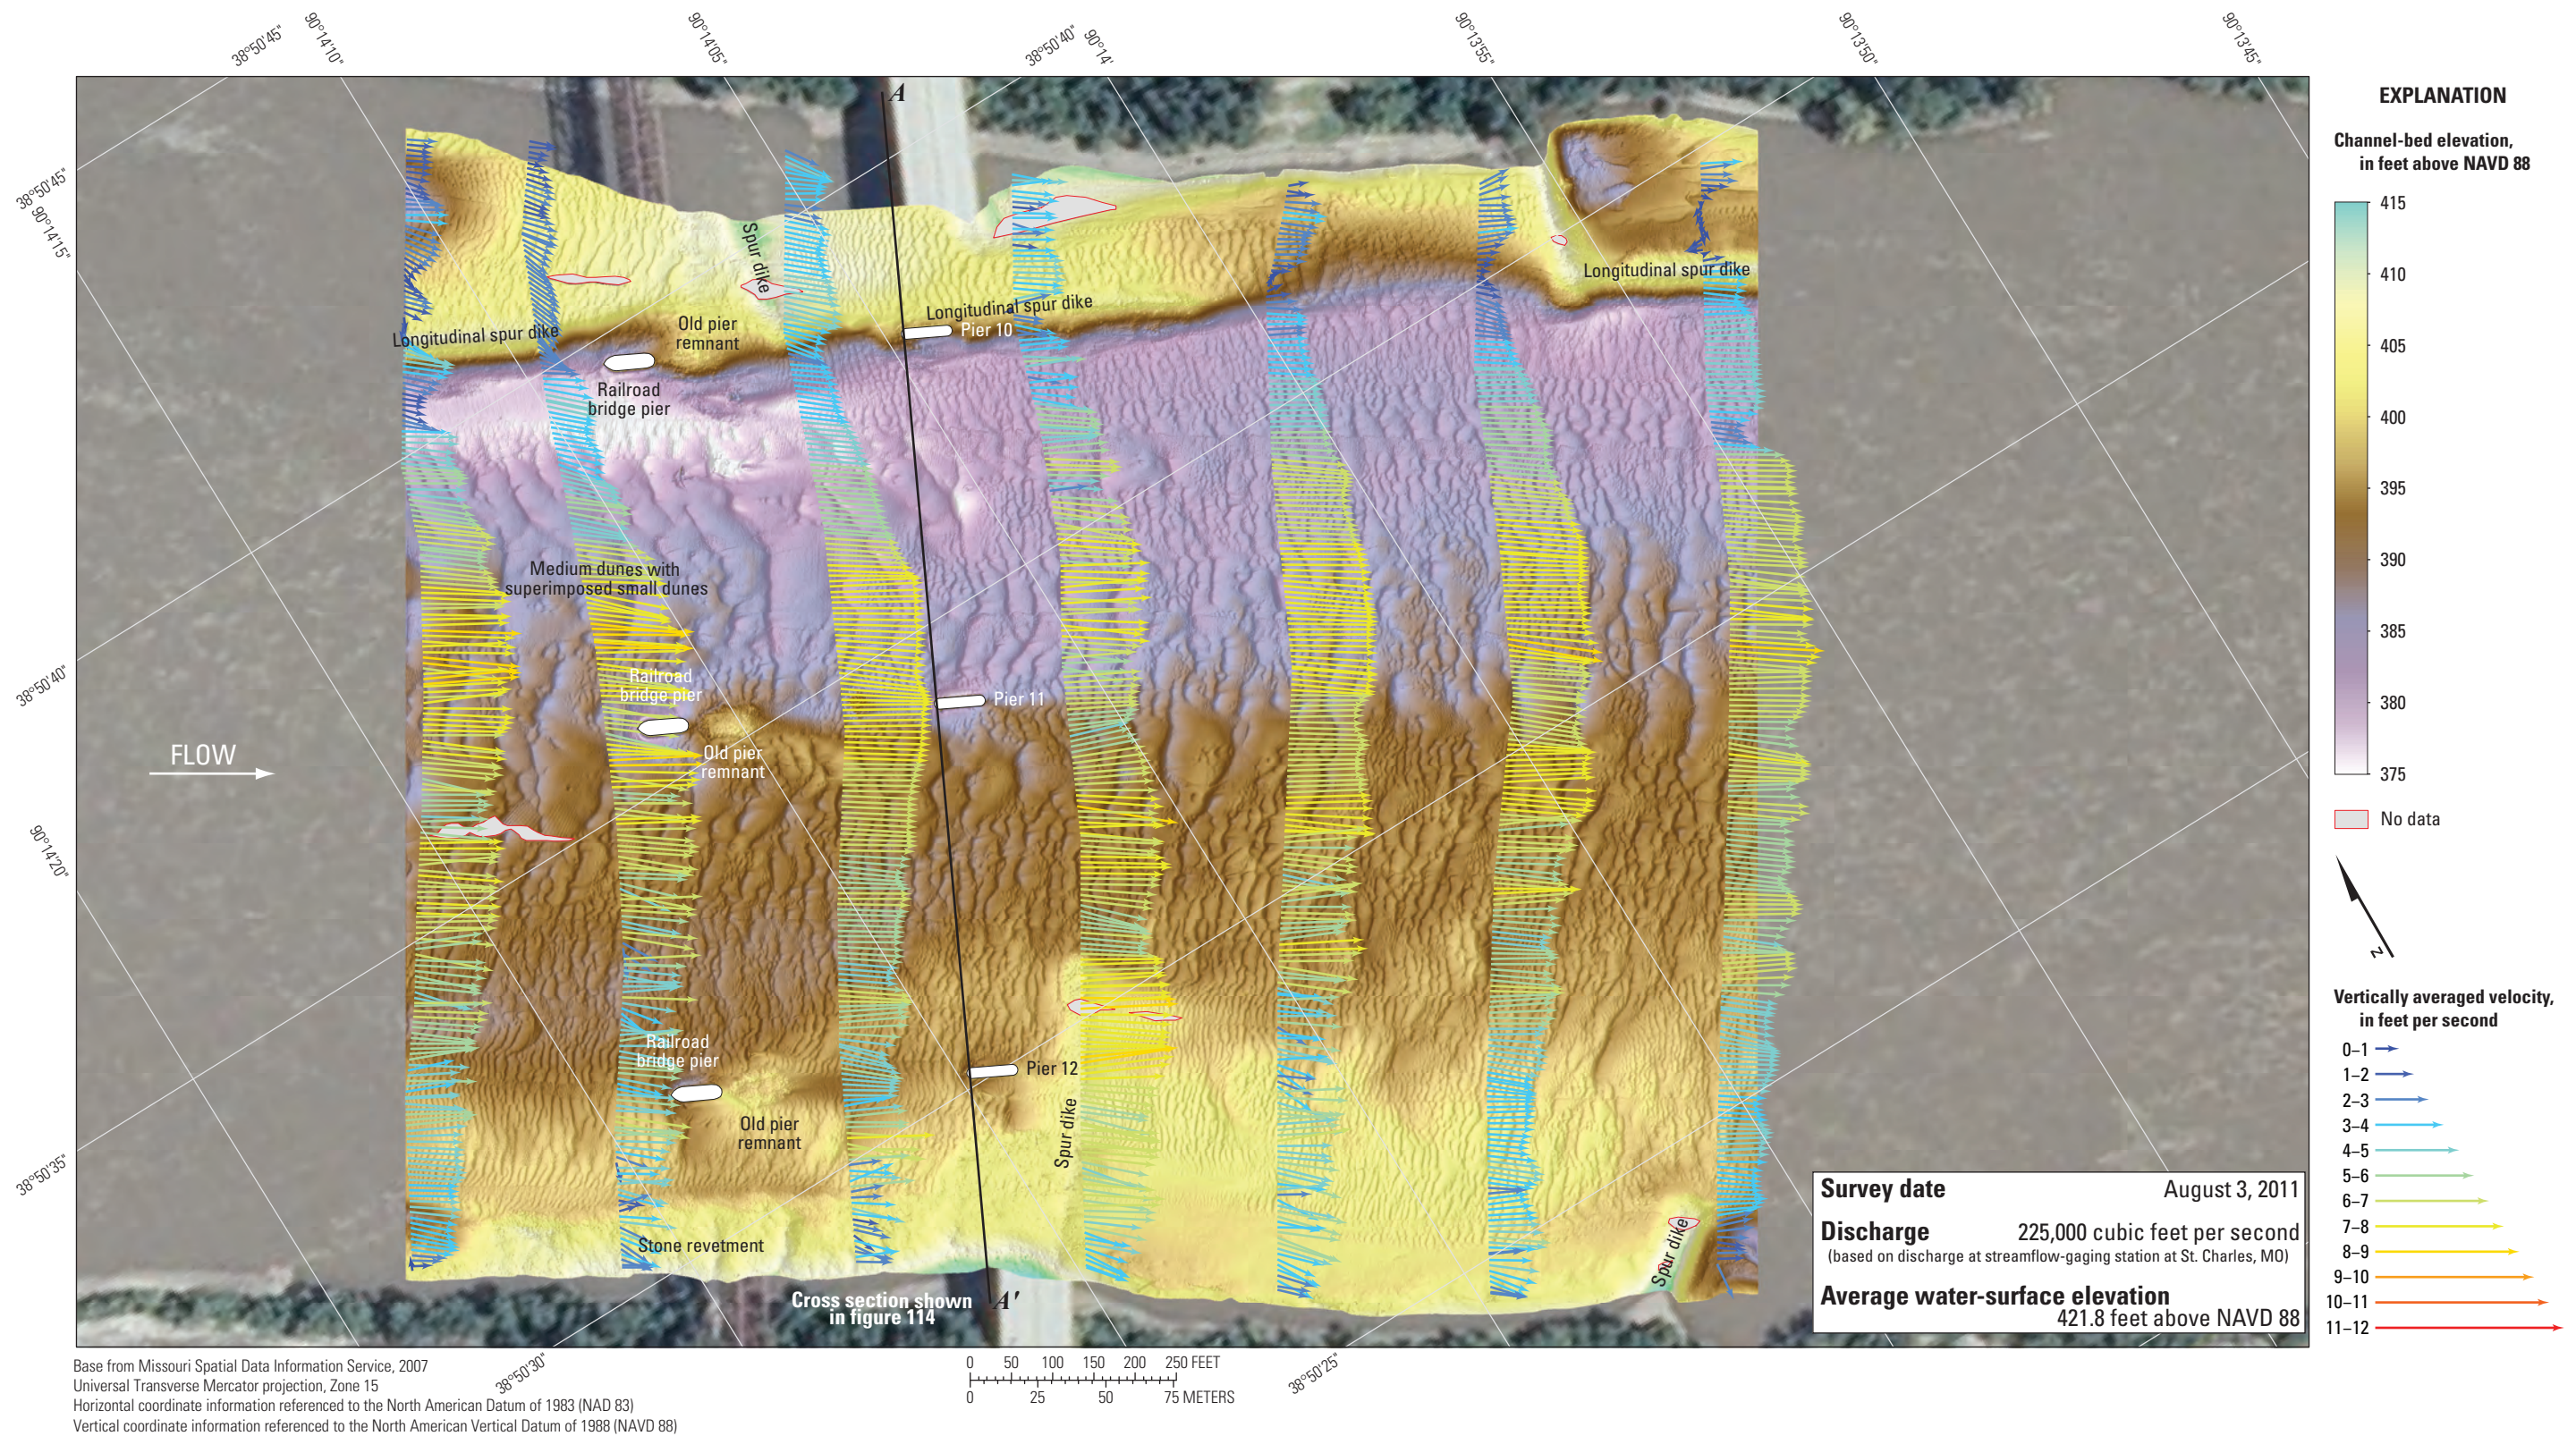
Figure 116. Bathymetry and vertically averaged velocities of the Missouri River channel in the vicinity of structure A3047 on U.S. Highway 67 near St. Louis, Missouri.

The vertically averaged velocity vectors indicate moderate to substantial turbulence in several transects, with velocities ranging from about 3 to 9 ft/s (fig. 116). There was substantial turbulence and flow reversal near the longitudinal spur dikes on the left (north) bank, and near the right (south) bank where the stone revetment had substantial variations (fig. 116). Flow was mostly uniform in the transects between the railroad bridge and structure A3047, and in the three downstream-most transects (fig. 116). All the piers were slightly skewed to flow, with minor turbulence observed downstream from the piers (fig. 116).
