Bathymetric and Velocimetric Surveys at Highway Bridges Crossing the Missouri and Mississippi Rivers on the Periphery of Missouri, June 2014

Scientific Investigations Report 2015–5048

By Richard J. Huizinga

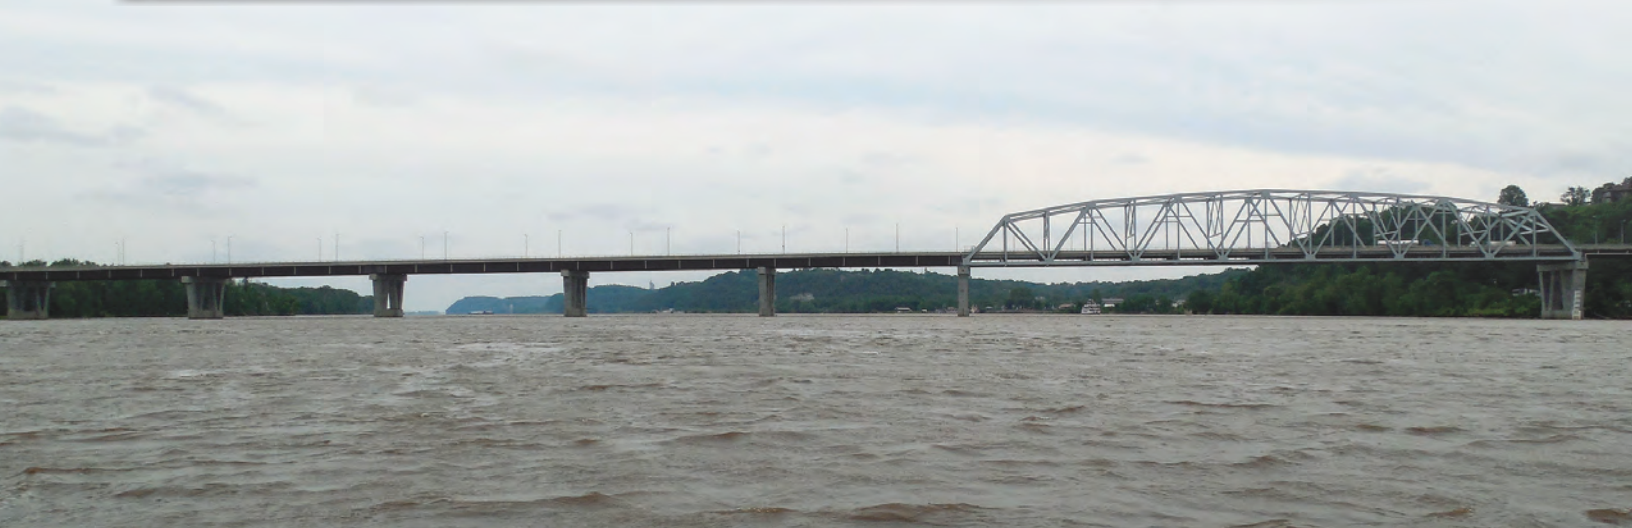
The survey area was about 1,640 ft long and about 1,870 ft wide, extending across the active channel from the left (northeast) bank to the right (southwest) bank (fig. 14). The upstream end of the survey area was about 700 ft upstream from the centerline of structure A5054, and piers 5 through 11 were in the water; however, pier 5 was in shallow water on the right bank. The channel-bed elevations ranged from about 427 to 449 ft for most of the surveyed area (5 to 95 percentile range of the bathymetric data), except in the vicinity of pier 6 through 8 and the thalweg of the channel in the upstream part of the reach (table 3). The left side of the channel between the left bank and the channel thalweg was filled with small and medium dune features, and small dunes and ripples were present in the thalweg. A spur dike on the downstream left side was barely visible above the average bed in the vicinity. The right bank seems to consist of smooth rock or hardpan clay throughout the reach, with no discernable dune features (fig. 14).

The minor scour hole in the vicinity of pier 11 was difficult to discern from nearby dunes and ripples, and there was no discernable hole near pier 5 on the right bank (fig. 14). Alternatively, piers 6 through 8 had well-defined, asymmetric scour holes indicative of being skewed to approach flow. Pier 8 seems to have part of the footing exposed in the bathymetric map (figs. 14, 1-4A, 1-4B), and piers 9 and 10 seem to be surrounded by partial riprap blankets or piles of rock (figs. 14, 1-3D, 1-3E, and 1-3F). Information from bridge plans (Missouri Department of Transportation, written commun., 2014) indicates that piers 5 through 8 are founded on shafts drilled 15 to 30 ft into bedrock, having about 17 to 24 ft of bed material between the channel bottom and bedrock (fig. 15; table 7). Piers 9 through 11 are founded on steel H-piles driven to refusal on bedrock, having 53 ft of bed material between the channel bottom and bedrock at pier 9, 79 ft of bed material at pier 10, and 89 ft of bed material at pier 11 (fig. 15; table 7). The surveyed bed was 5 to 15 ft lower along the upstream bridge face than the original ground line from 1996 bridge plans. The cross section along the upstream bridge face indicates partial footing exposure at piers 5 through 10 (fig. 15), although it is not evident on the map (fig. 14), and not readily apparent in the shaded TIN images (figs. 1-3, 1-4), except at pier 8. However, the top of the footing is evident at pier 7 in the shaded TIN images (figs. 1-4C, 1-4D), and the footing of piers 9 and 6 may also be evident in the shaded TIN images, but seem partly obscured by a submerged log at both piers (figs. 1-3E, 1-3F, 1-4E, 1-4F).

Figure 14. Bathymetric survey of the Mississippi River channel in the vicinity of structure A5054 on Interstate 72 at Hannibal, Missouri.

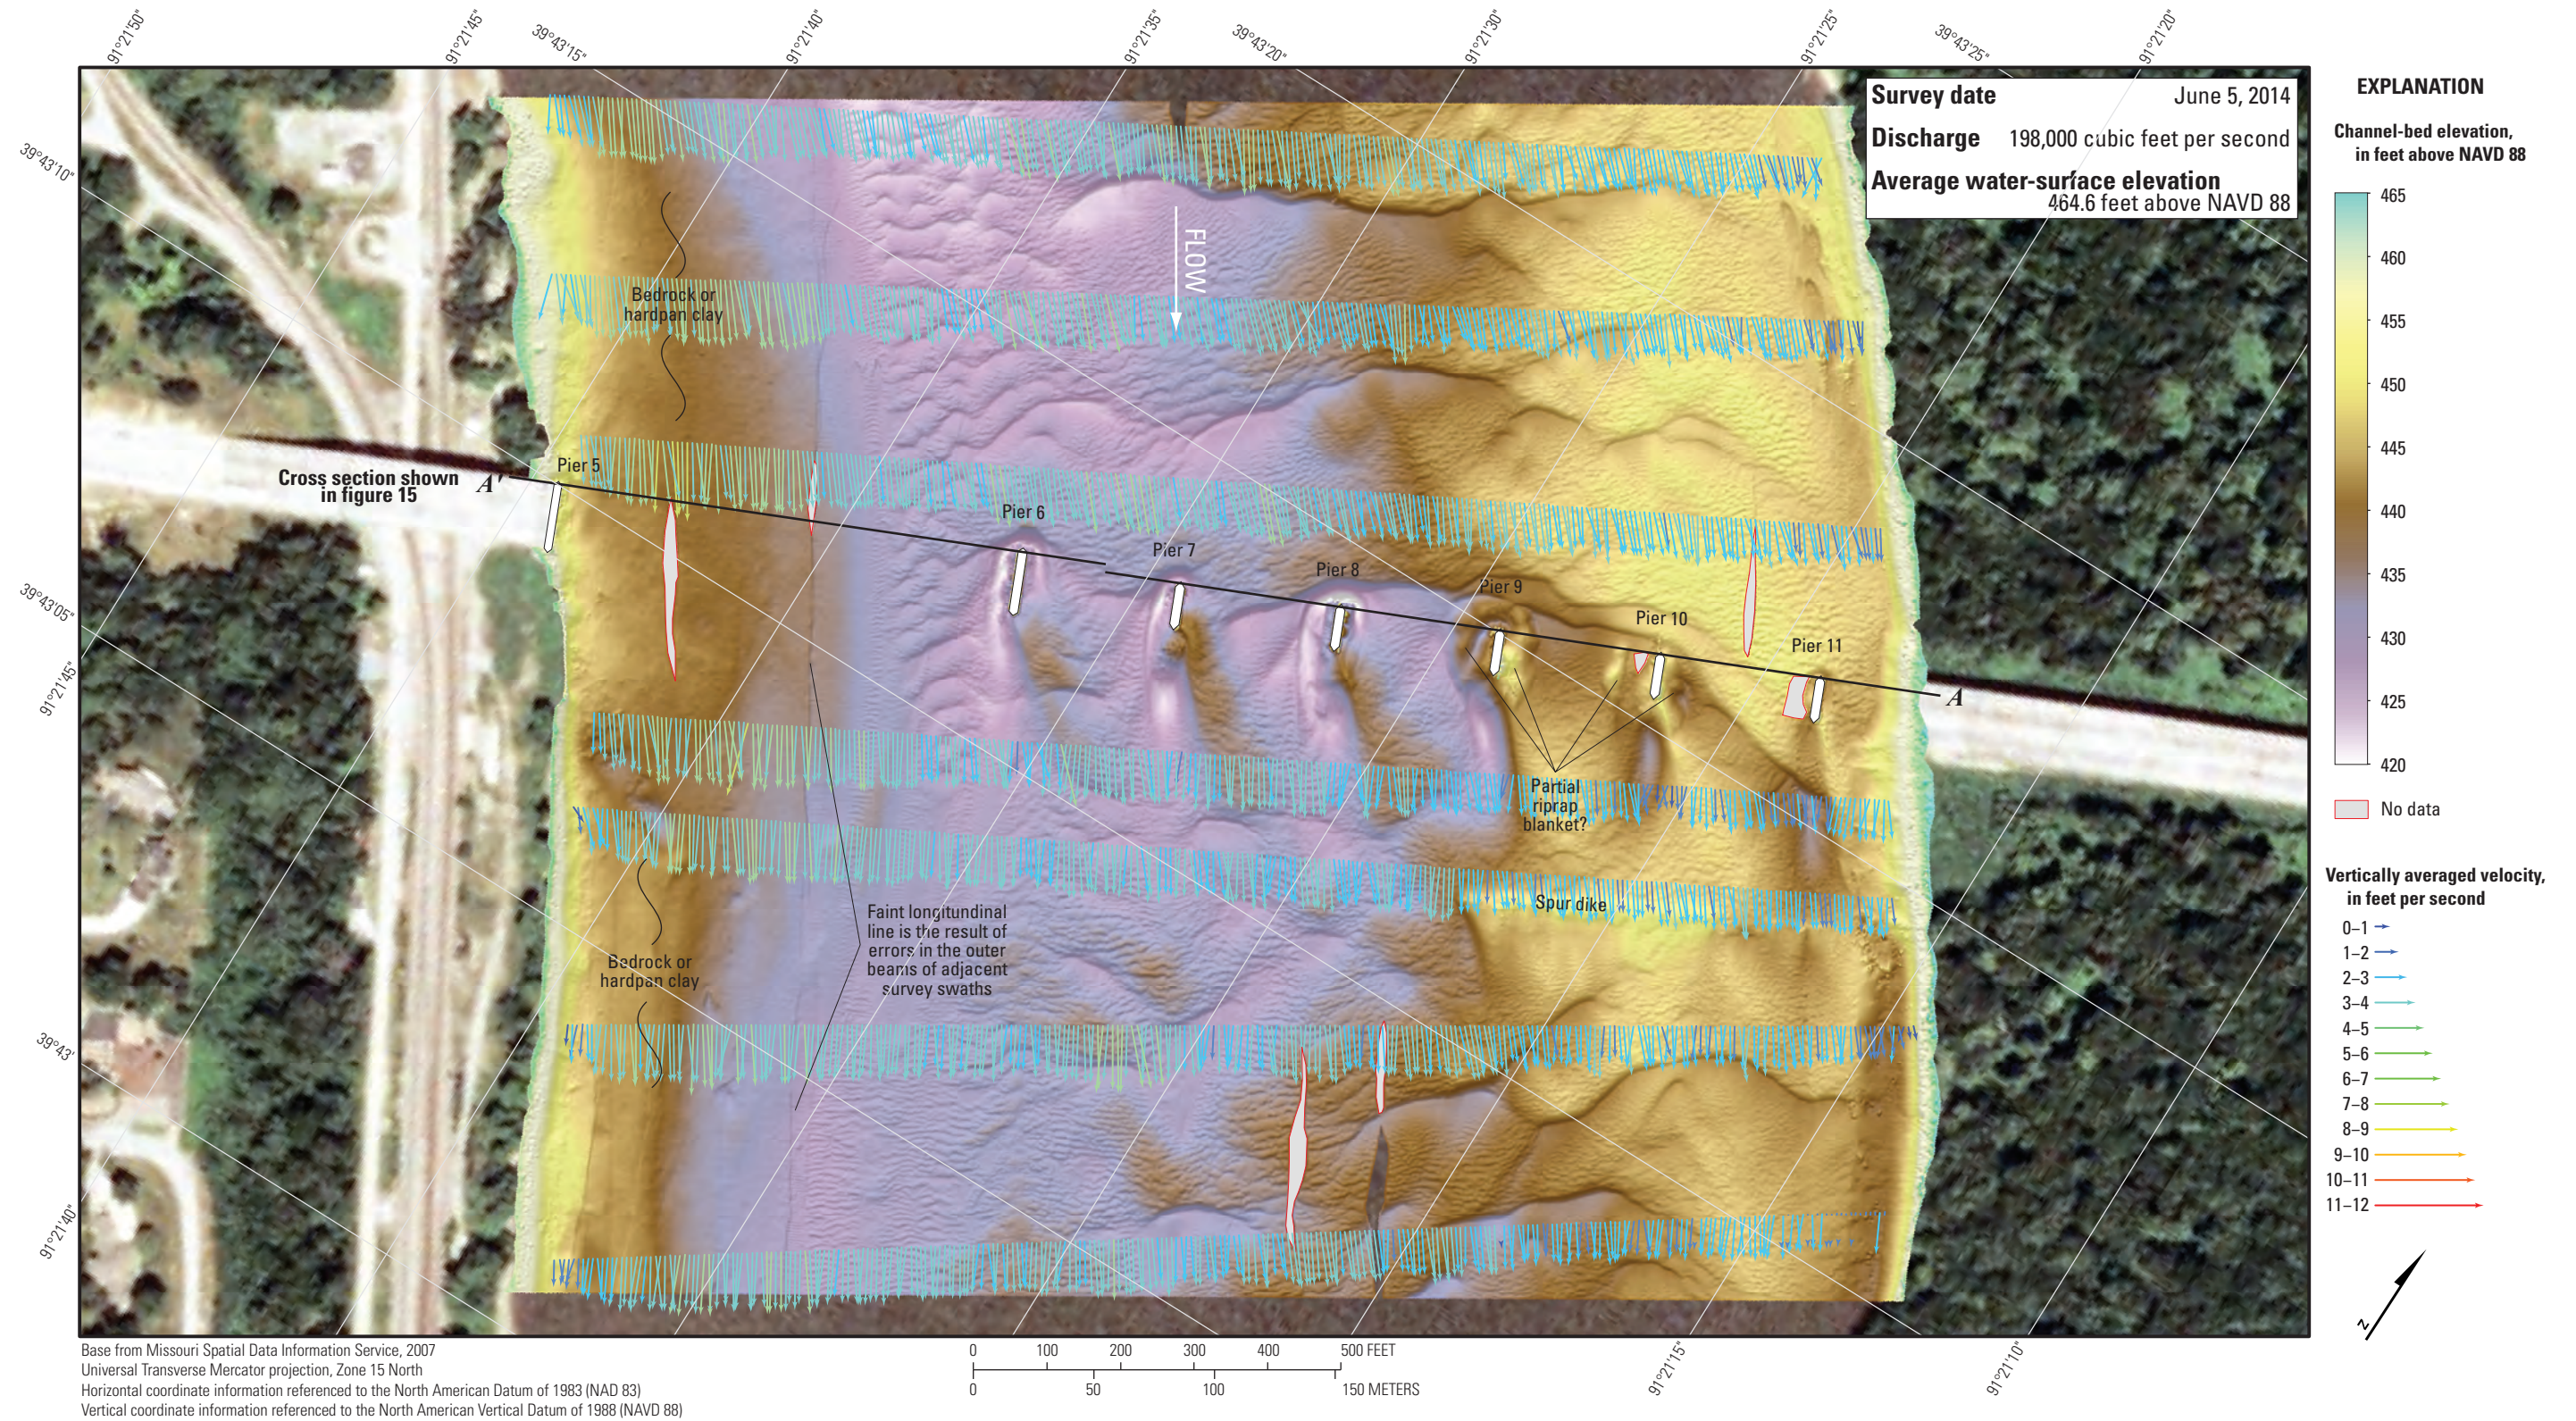
The vertically averaged velocity vectors indicate mostly uniform flow throughout most of the channel, ranging from about 4 to 8 ft/s (fig. 16). Areas of non-uniform flow caused by the skewed orientation of the piers is evident in the velocity sections downstream from the bridge, as well as near the spur dike on the right bank downstream from the bridge. Similar areas of non-uniform flow are apparent in the upstream sections as well, caused by a railroad bridge located about 1,130 ft upstream from the surveyed reach (fig. 16).

Figure 16. Bathymetry and vertically averaged velocities of the Mississippi River channel in the vicinity of structure A5054 on Interstate 72 at Hannibal, Missouri.

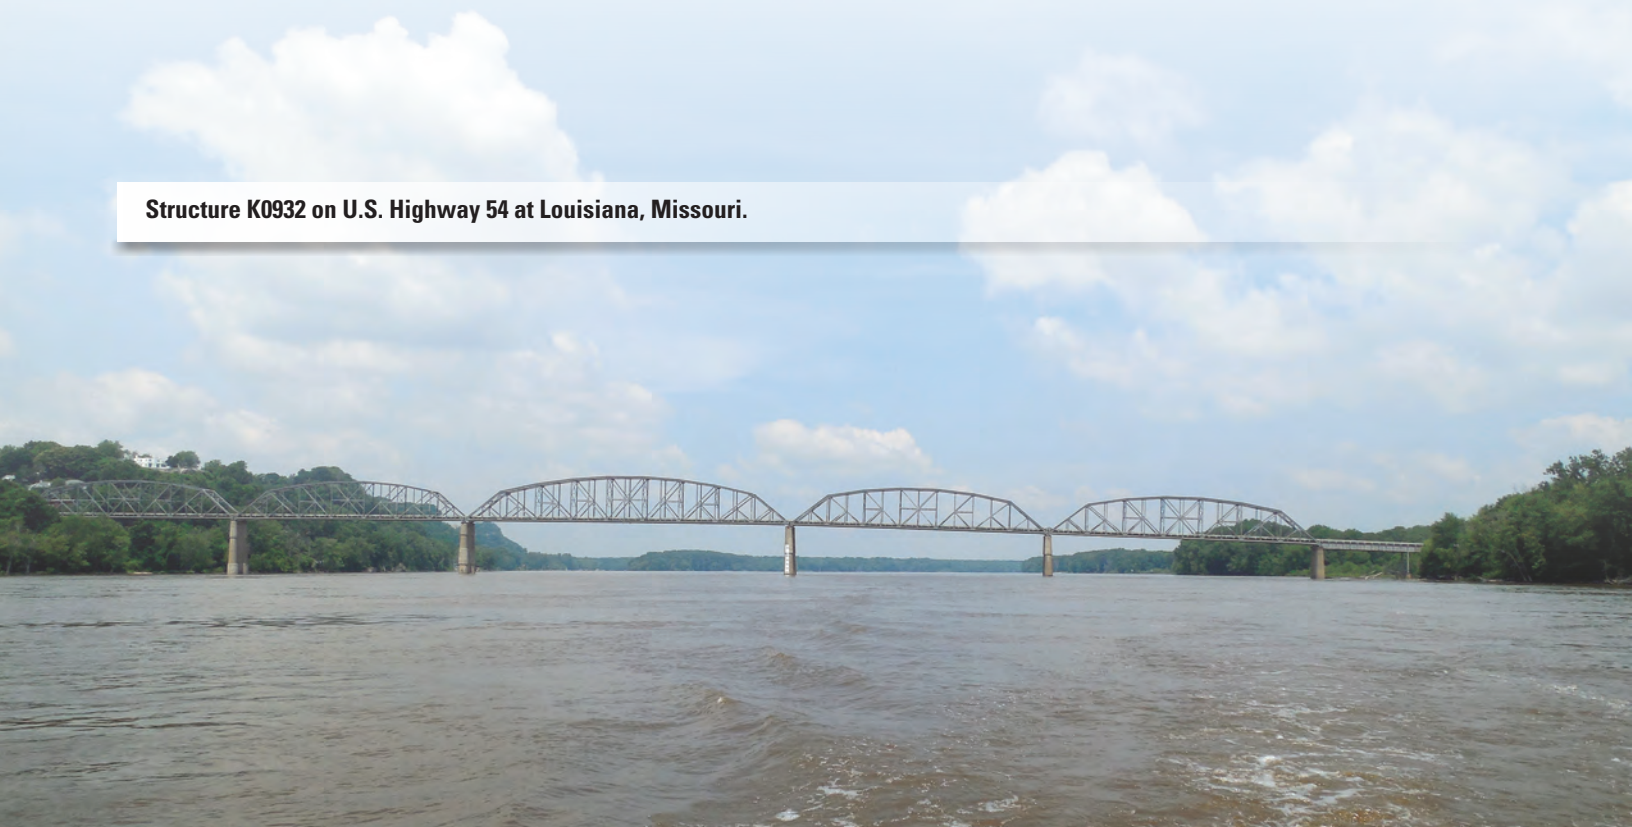
The survey area was about 1,640 ft long and ranged from about 1,670 ft wide at the upstream end to about 1,450 ft wide at the downstream end, extending across the active channel from the left (northeast) bank to the right (southwest) bank (fig. 17). The upstream end of the survey area was about 700 ft upstream from the centerline of structure K0932, and piers 1 through 5 were in the water; however, pier 5 was immediately upstream from a large spur dike near the left bank. The channel-bed elevations ranged from about 407 to 439 ft for most of the surveyed area (5 to 95 percentile range of the bathymetric data), except in the vicinity of pier 4 and downstream from the spur dike on the left bank immediately downstream from the bridge (table 3). The channel was filled with small and medium dune features, and small dunes and ripples were present near the left bank upstream from the bridge. The right bank seems to consist of smooth rock or hardpan clay throughout the reach, with partial dune features (fig. 17).

Piers 2 and 3 did not have a discernable scour hole, and were surrounded by riprap blankets (figs. 17, 1-5D, 1-5E, 1-6A, 1-6B) installed in the early 1990's (Dale Henderson, Missouri Department of Transportation, written comm., 2015). A moderate scour hole near pier 4 likely was exacerbated by

flow diverted by the nearby spur dike (fig. 17). Information from bridge plans (Missouri Department of Transportation, written commun., 2014) indicates that piers 2 through 4 are caissons founded on bedrock, having between 4 and 9 ft of bed material between the bottom of the scour hole (or minimum channel-bed elevation near the pier) and bedrock (fig. 18; table 7). Pier 1 is a footing founded on the exposed bedrock on the right bank (figs. 17, 18; table 7), and pier 5 is founded on steel H-piles driven to refusal on bedrock, having about 55 ft of bed material between the bottom of the scour hole and bedrock (fig. 18, table 7). In modern construction, bridge substructural elements usually are pinned or socketed to bedrock (American Association of State Highway Transportation Officials, 2012; Brown and others, 2010), but full exposure of usually buried substructural elements warrants special consideration and observation, even when designed to be exposed. The surveyed bed generally was lower than the original ground line from 1926 bridge plans, and is similar to the ground line from the Level II bridge scour assessment in 2002 (Huizinga and Rydlund, 2004; fig. 18), particularly on the right side of the channel; however, the ground line from the Level II bridge scour assessment was along the downstream side of the bridge and may have incorporated part of the downstream spur dike (fig. 17).

Figure 17. Bathymetric survey of the Mississippi River channel in the vicinity of structure K0932 on U.S. Highway 54 at Louisiana, Missouri.

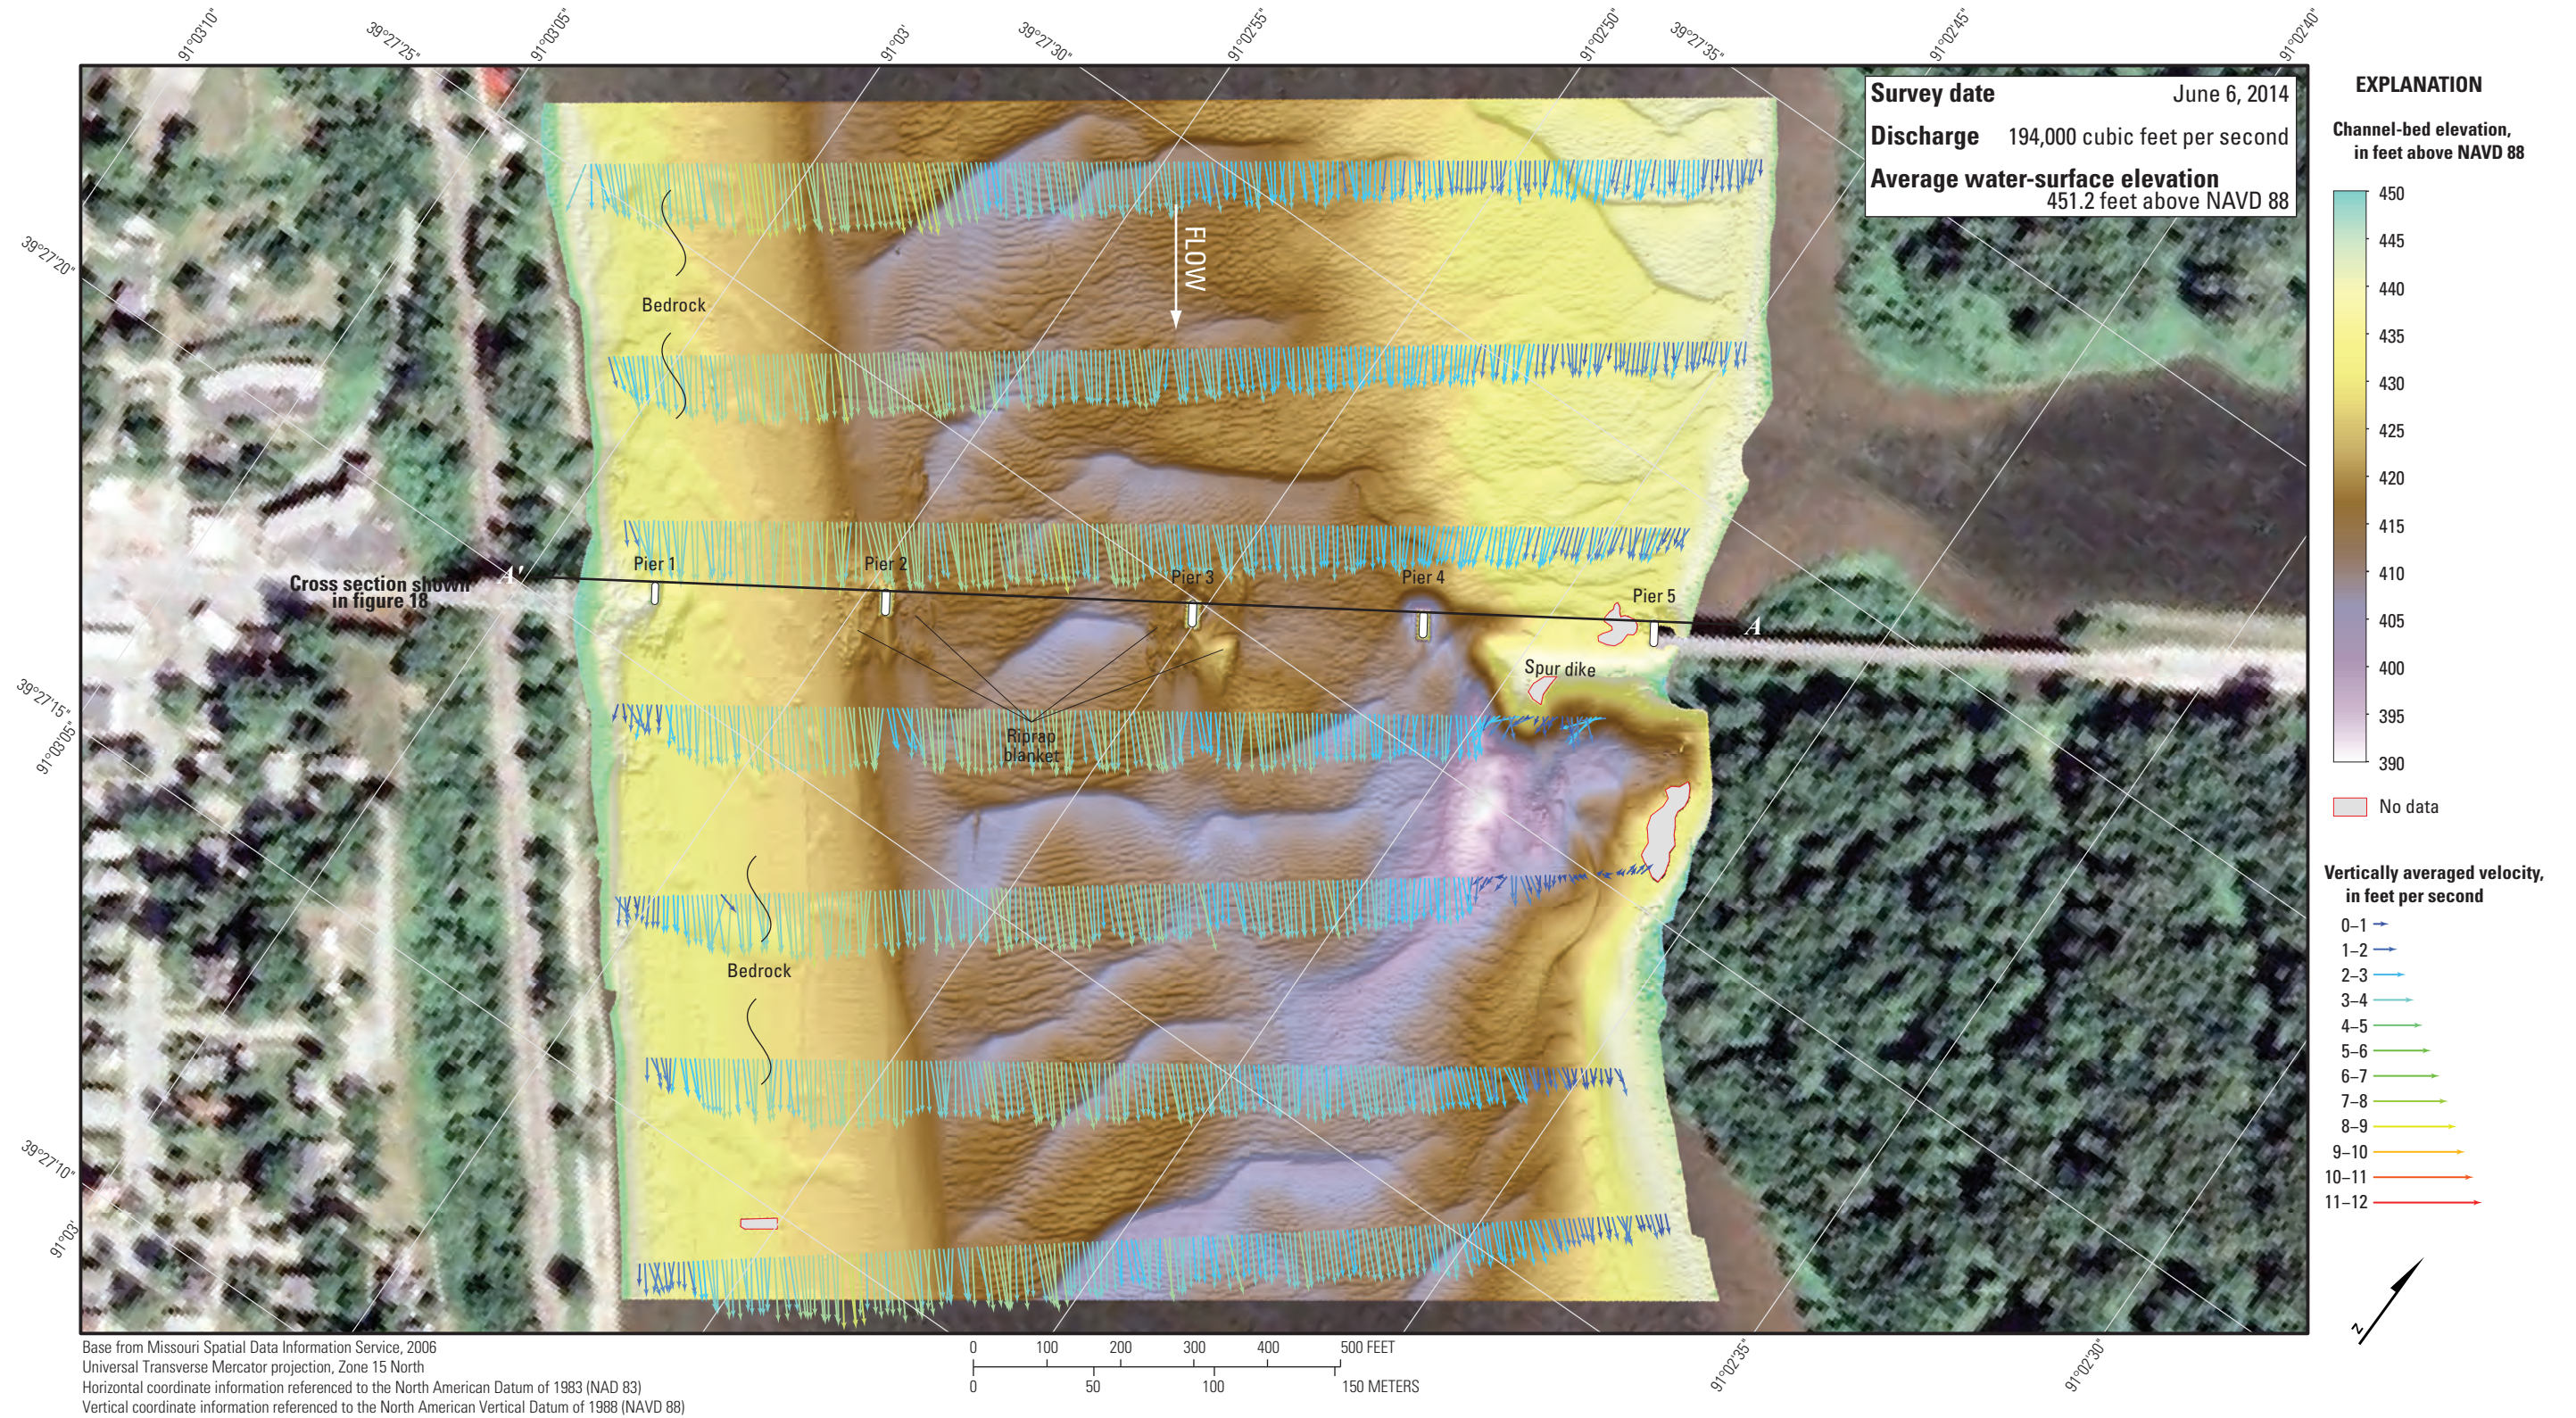
The vertically averaged velocity vectors indicate mostly uniform but variable flow throughout most of the channel, with velocities ranging from about 3 to 8 ft/s for most of the channel (fig. 19). Substantial non-uniform flow indicated by flow deflection and reversal was observed downstream from the spur dike on the left bank, along the banks, and downstream from piers 2 and 3 despite the piers being well-aligned with flow (fig. 19).

Figure 19. Bathymetry and vertically averaged velocities of the Mississippi River channel in the vicinity of structure K0932 on U.S. Highway 54 at Louisiana, Missouri.

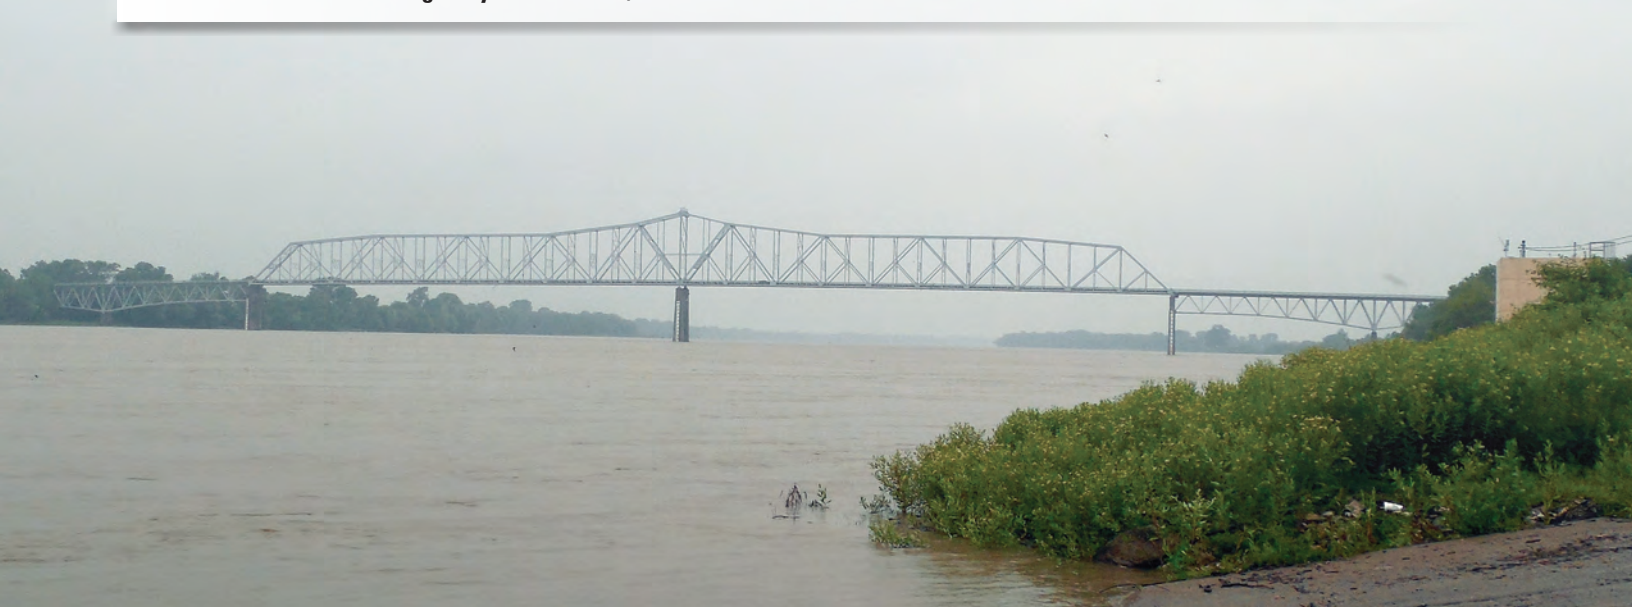
The survey area was about 1,640 ft long and about 1,840 ft wide, extending across the active channel from the left (northeast) bank to the right (southwest) bank in the main channel (fig. 20). The upstream end of the survey area was about 655 ft upstream from the centerline of structure L0135, and piers 10 through 13 were in the water; however, pier 13 was in shallow water on the left bank. The channel-bed elevations ranged from about 316 to 346 ft for most of the surveyed area (5 to 95 percentile range of the bathymetric data), except near pier 11 and in the thalweg along the left side of the channel (table 3). A series of medium to large dunes were present in the thalweg, with numerous medium and small dunes and ripples present throughout the rest of the channel. A bedrock outcrop was present on the left (northeast) bank, and stone revetment was present on the right bank (fig. 20).

In the vicinity of pier 11 (fig. 20), a substantial scour hole had a minimum channel-bed elevation of about 308 ft (table 7), which is about 16 ft below the average channel elevation upstream from the pier (fig. 21). Information from bridge plans (Missouri Department of Transportation, written commun., 2000) indicates that pier 11 is founded on a caisson on bedrock, having about 42 ft of bed material between the bottom of the scour hole and bedrock (fig. 21; table 7). In the

vicinity of pier 10 (fig. 20), a moderate scour hole had a minimum channel-bed elevation of about 330 ft (table 7), which is about 6 ft below the average channel elevation upstream from the pier (fig. 21). Pier 10 also is founded on a caisson on bedrock, having about 85 ft of bed material between the bottom of the scour hole and bedrock (fig. 21; table 7). Piers 12 and 13 are founded on footings on the exposed bedrock on the right bank, with no apparent scour hole near either (figs. 20, 21; table 7). In modern construction, bridge substructural elements usually are pinned or socketed to bedrock (American Association of State Highway Transportation Officials, 2012; Brown and others, 2010), but full exposure of usually buried substructural elements warrants special consideration and observation, even when designed to be exposed. The surveyed bed generally was lower than the original ground line from 1940 bridge plans between piers 9 and 10 and between piers 11 and 13, and higher than the original ground line between piers 10 and 11 (fig. 21). The surveyed bed was approximately the same as the bed from the Level II scour survey in 2000 (Huizinga and Rydlund, 2004), except on the left bank (fig. 21); however, the ground line from the Level II bridge scour assessment was along the downstream side of the bridge and may have incorporated part of the downstream spur dike (fig. 20).

Figure 20. Bathymetric survey of the Mississippi River channel in the vicinity of structure L0135 on State Highway 51 at Chester, Illinois.

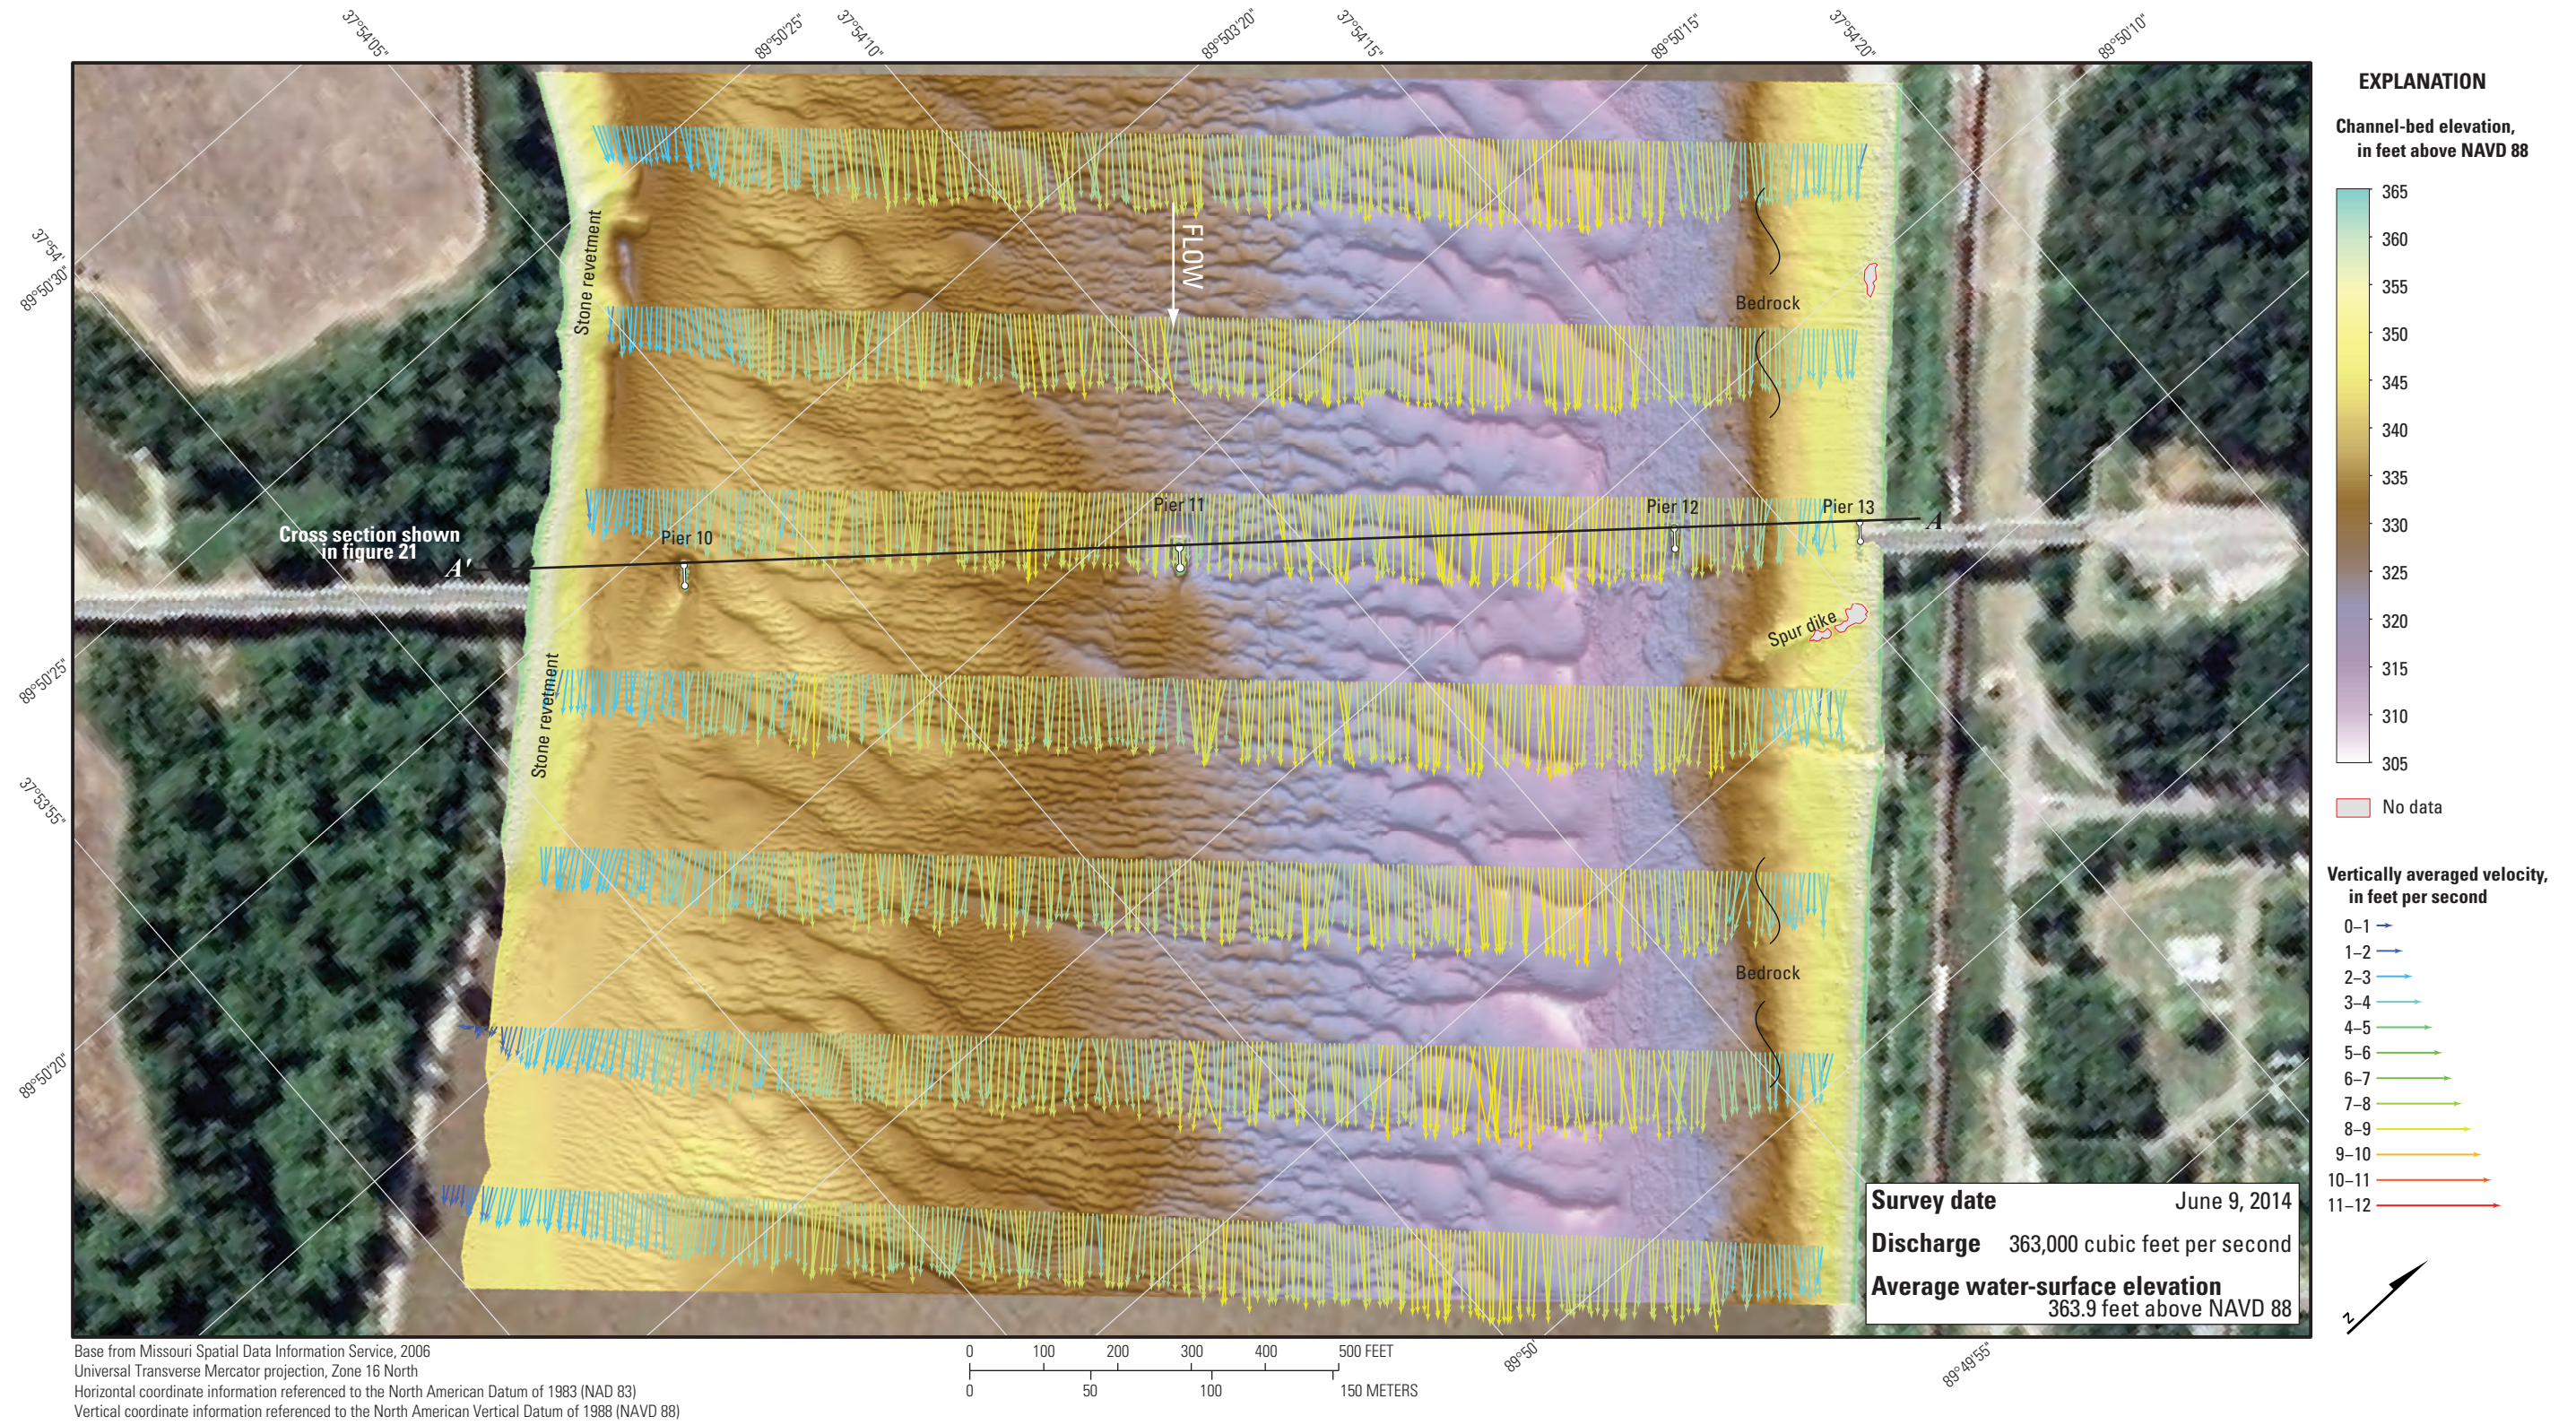
The vertically averaged velocity vectors indicate mostly uniform flow in the thalweg, with areas of shear along the right side of the channel (fig. 22). Velocities ranged from about 7 to 9 ft/s for most of the channel, with locally lower velocities and flow reversal along the banks and downstream from pier 10. Furthermore, flow approached pier 10 from the left, causing an asymmetric scour hole that is longer and slightly deeper on the left side (fig. 20). The other piers were mostly aligned with flow, causing minimal flow disturbance downstream (fig. 22).

Figure 22. Bathymetry and vertically averaged velocities of the Mississippi River channel in the vicinity of structure L0135 on State Highway 51 at Chester, Illinois.

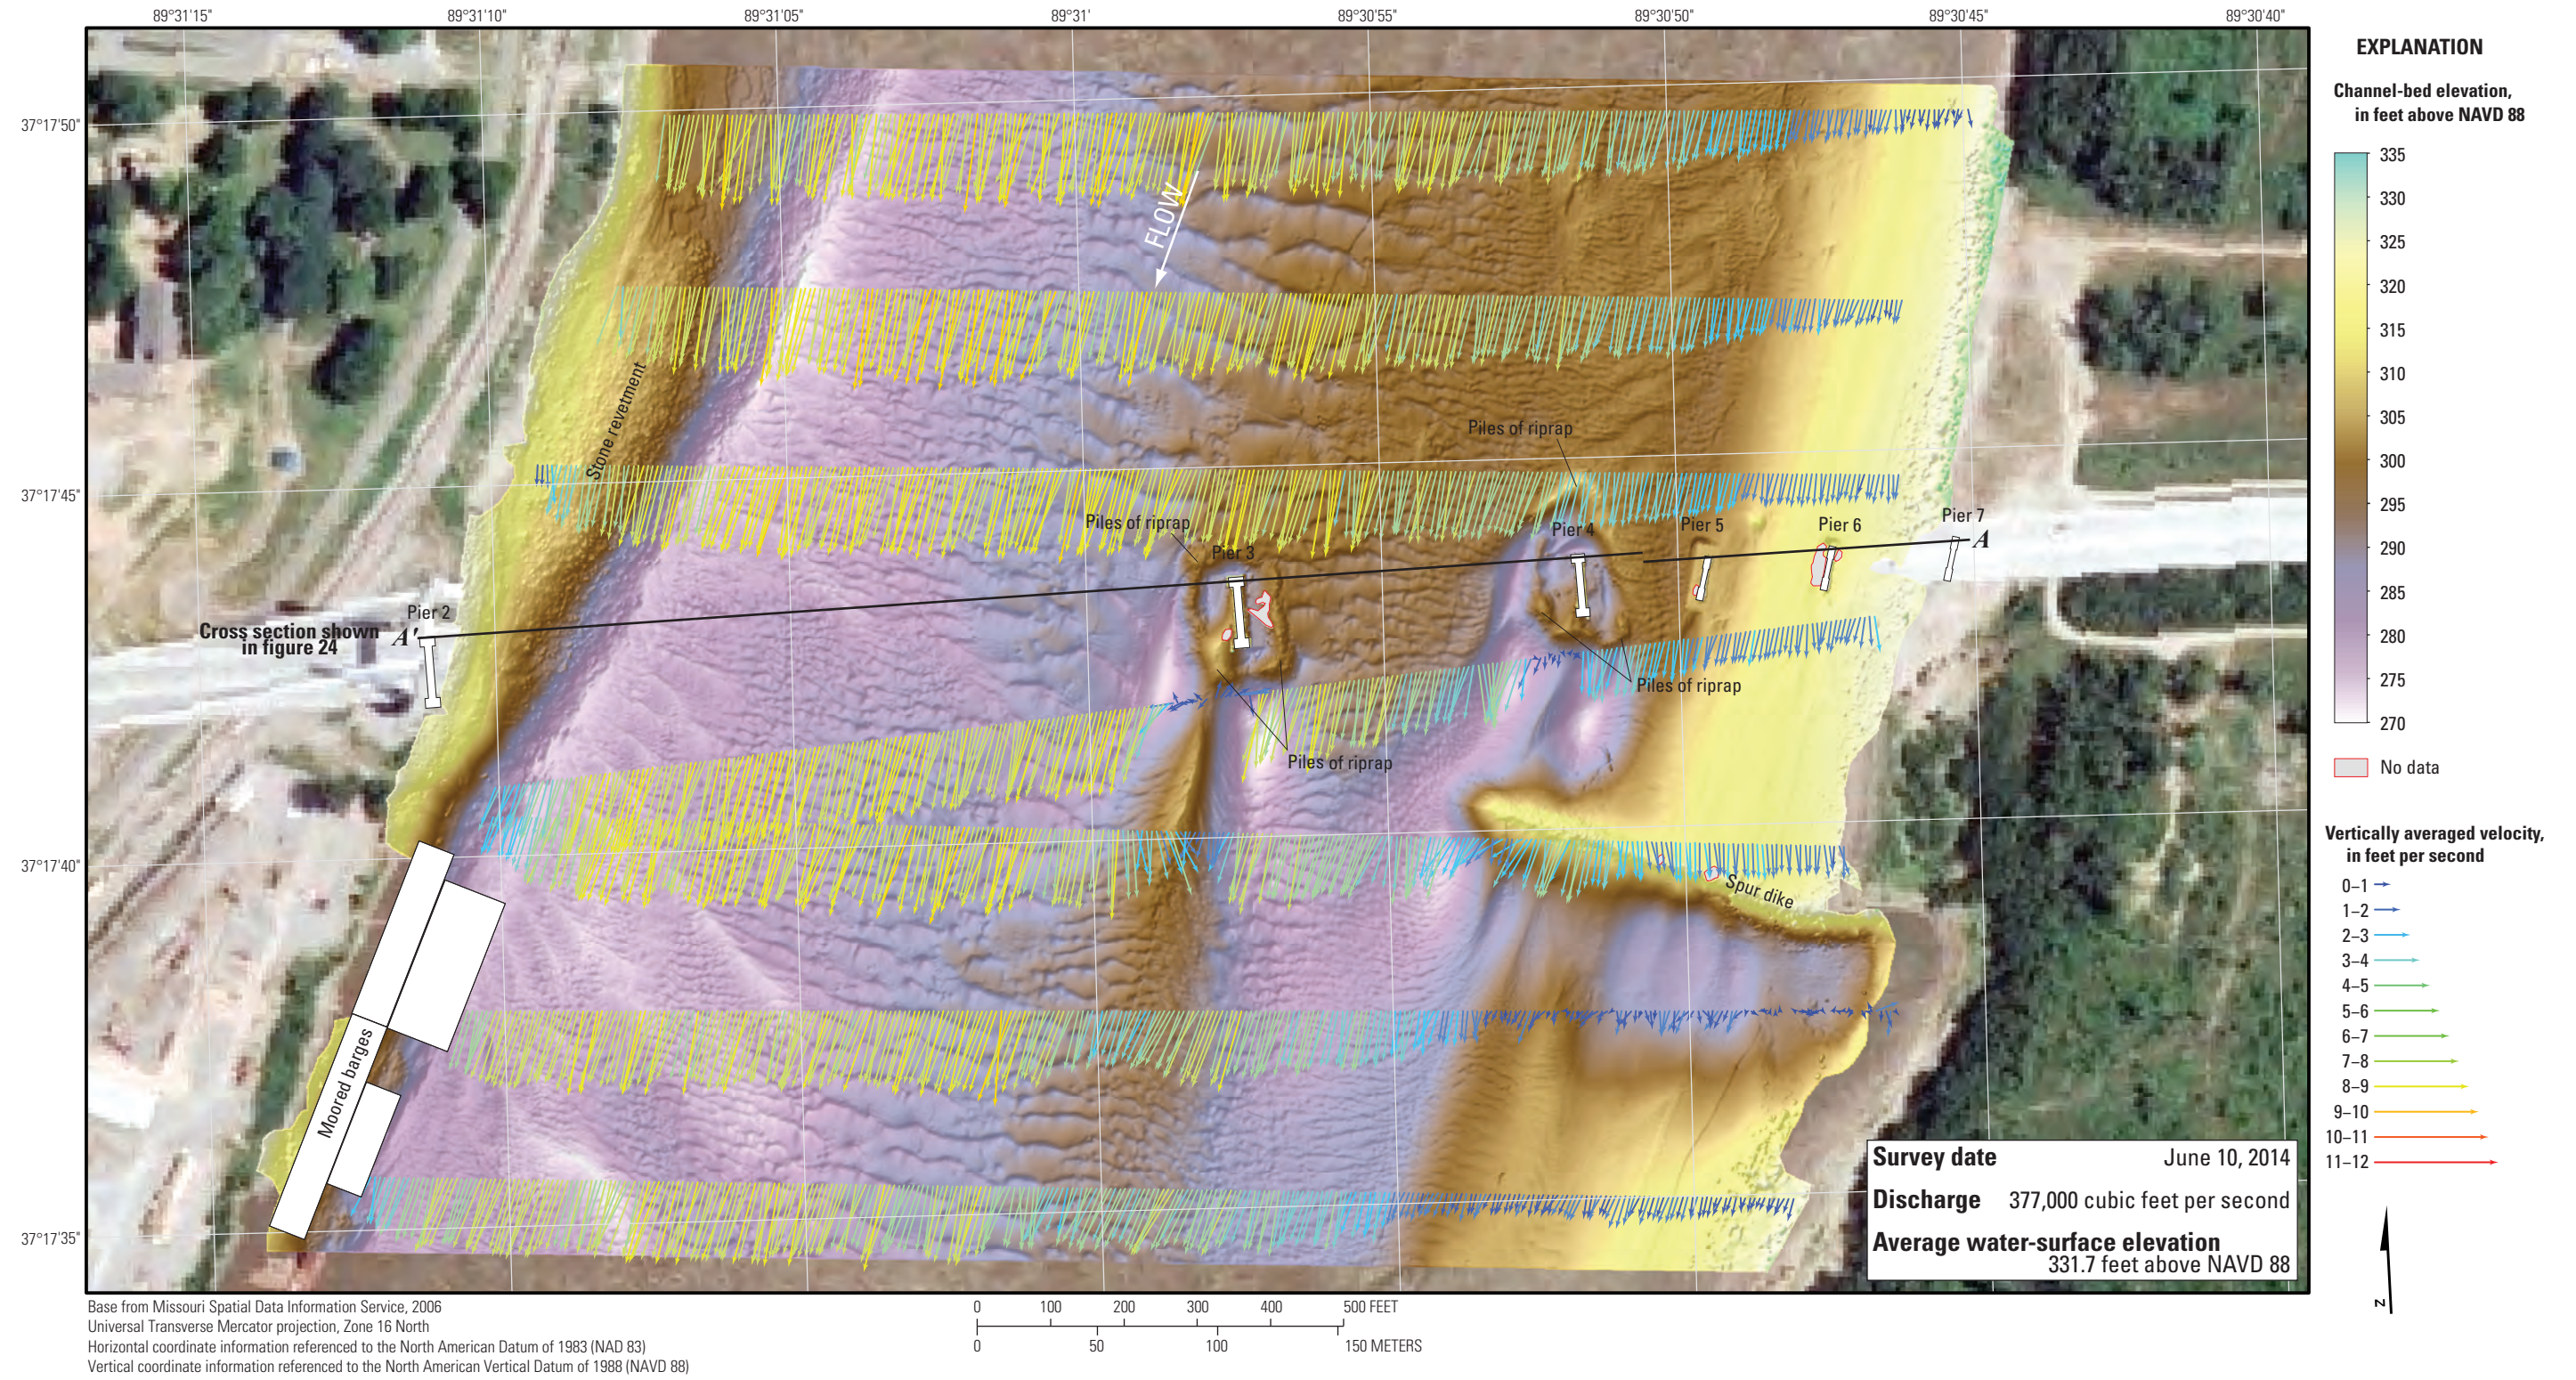
The vertically averaged velocity vectors indicate mostly uniform flow throughout the thalweg of the channel along the right bank, ranging from about 5 to 9 ft/s with minor variations in velocity across the sections (fig. 25). Moderate non-uniform flow was observed along the left side of the channel, particularly downstream from the spur dike on the left bank. Piers 3 and 4 were skewed to approach flow, causing substantial wake vortices with flow reversal and well-defined deposition ridges downstream (figs. 23, 25).

Figure 25. Bathymetry and vertically averaged velocities of the Mississippi River channel in the vicinity of structure A5076 on State Highway 34 at Cape Girardeau, Missouri.
