Bathymetric and Velocimetric Surveys at Highway Bridges Crossing the Missouri and Mississippi Rivers on the Periphery of Missouri, June 2014

Scientific Investigations Report 2015–5048

By Richard J. Huizinga

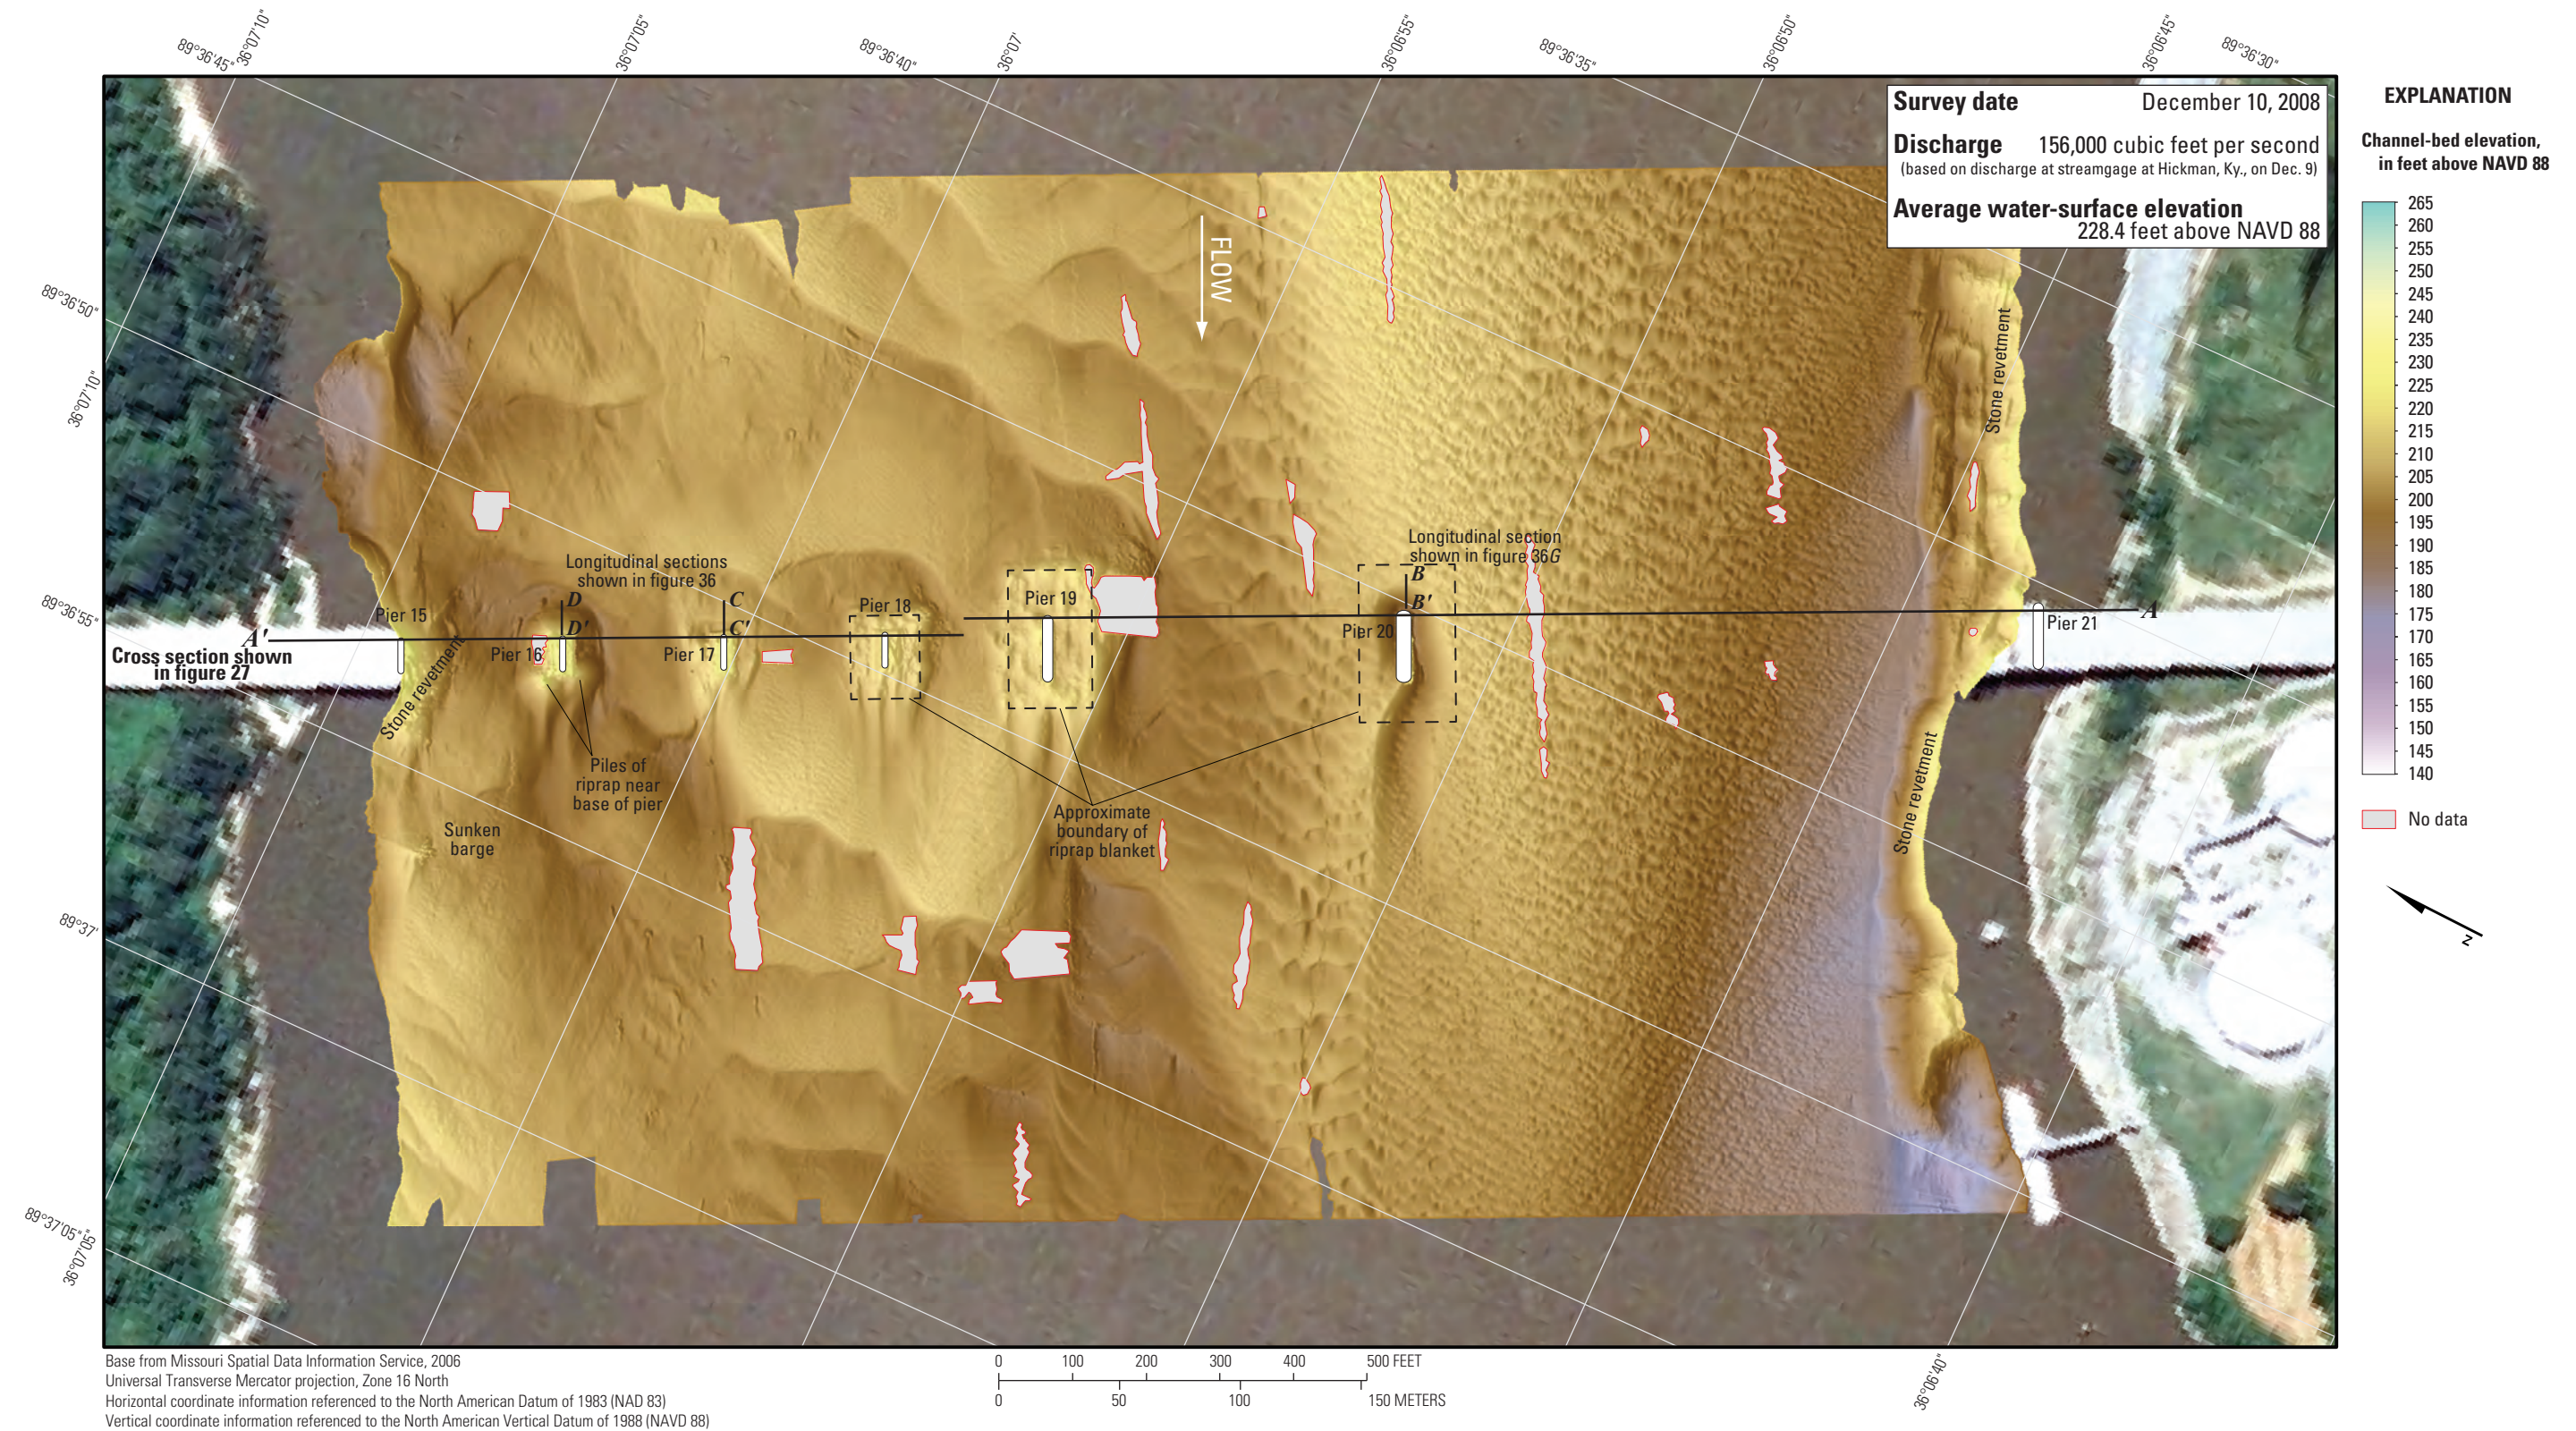
The 2008 survey area was about 1,525 ft long and about 2,380 ft wide, extending across most of the active channel from the left (southeast) bank to the base of the right (northwest) bank in the main channel (fig. 28). The upstream end of the 2008 survey area was about 690 ft upstream from the centerline of structure A1700, and piers 15 through 20 were in the water; however, pier 15 was in shallow water on the right bank, and not surveyed. A few medium to large dunes with few ripples were observed in the right side of the channel, and numerous small dunes and ripples were observed in the left side of the channel (fig. 28).

Figure 28. Bathymetric survey of the Mississippi River channel in the vicinity of structure A1700 on Interstate 155 near Caruthersville, Missouri, on December 10, 2008.

During the 2008 survey, a moderate to substantial scour hole observed near pier 20 (fig. 28) had a minimum channel-bed elevation of about 191 ft, about 20 ft below the average channel elevation upstream from the pier (fig. 28). The scour hole is asymmetric, which implies the pier is skewed to approach flow, likely the result of a substantial bend in the river upstream from the survey area and the bulge in the left bank downstream from the bridge (fig. 28). Similar to the 2014 survey, a discernable scour hole was not observed near pier 16 (fig. 28), the piles of riprap were observed, and the minimum channel-bed elevation near that pier was 192 ft, which is about 4.5 ft below the bottom of the seal course elevation for that pier (fig. 27; table 7). As in the 2014 survey, the riprap blankets around piers 18 and 19 were observed during the 2008 survey (fig. 28); the blanket around pier 20 was not observed, but apparently was covered in 15 to 20 feet of fluvial material deposited on top of the riprap blanket (fig. 27).

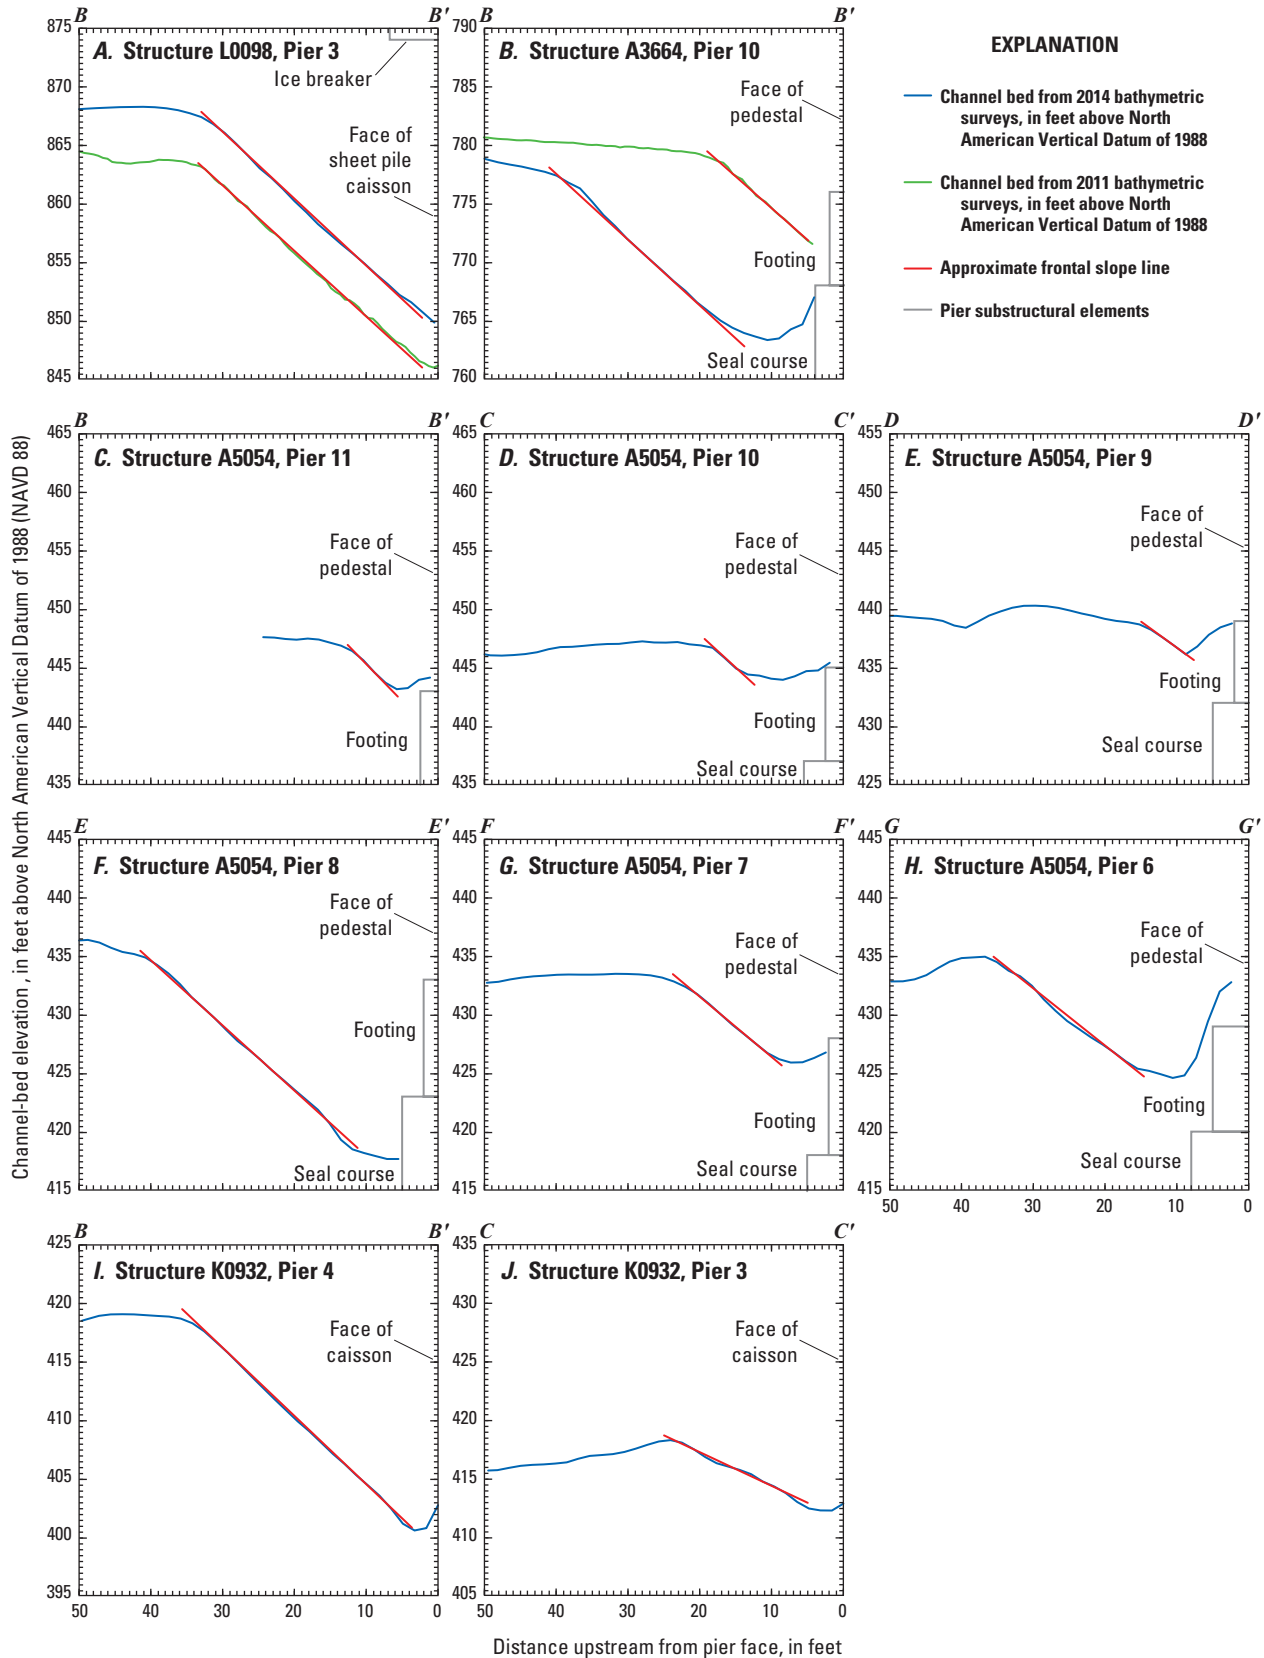
Figure 35. Longitudinal profiles upstream from selected piers at structures L0098 and A3664 over the Missouri River upstream from Kansas City, Missouri, and structures A5054 and K0932 over the Mississippi River upstream from St. Louis, Missouri.

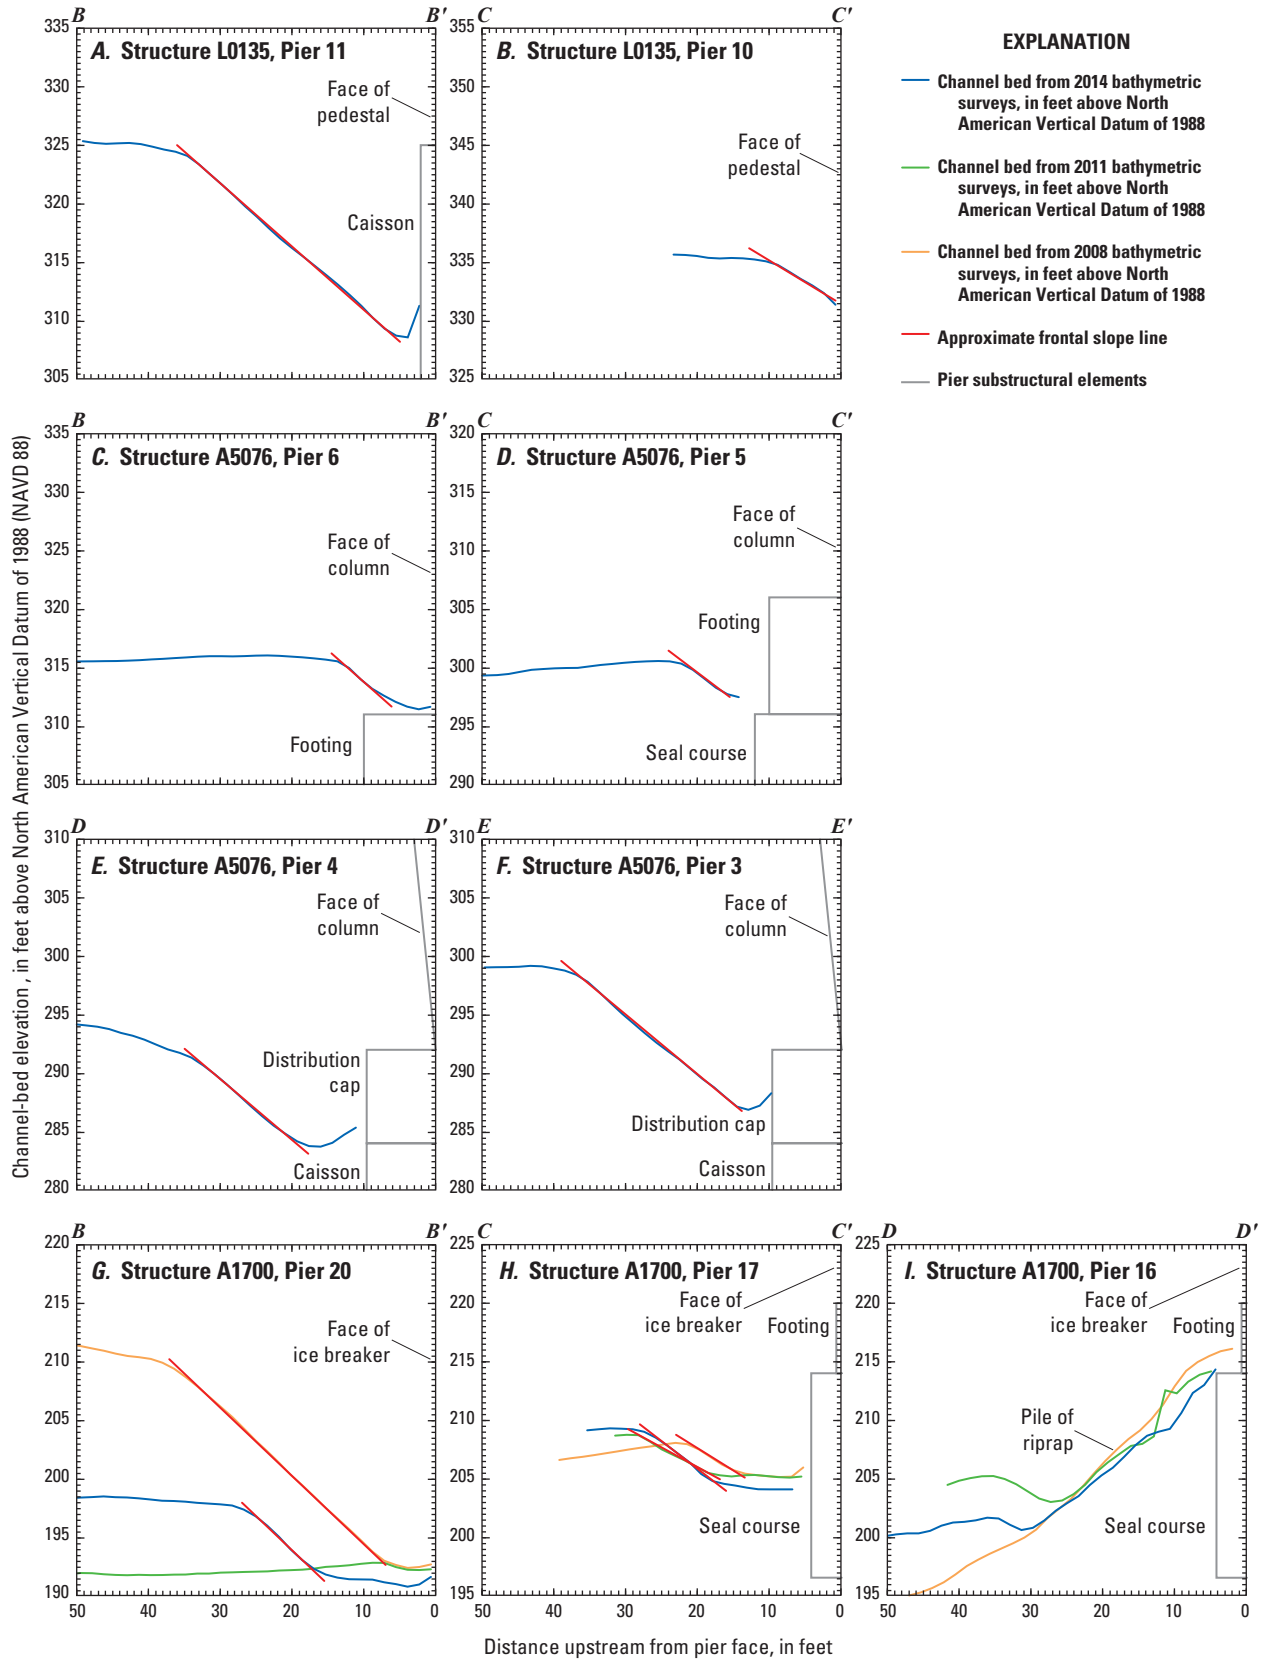
The approximate frontal slope (defined herein as run over rise for relatability to highway embankment slopes) of the well-defined scour holes ranged from 1.58 to 3.45 (figs. 35, 36; table 7); however, the hole with the largest slope value—or the shallowest frontal slope—(3.45 at structure K0932 pier 3 [figs. 17, 35J; table 7]) is at a pier surrounded by a riprap blanket and likely is not indicative of scour in a purely fluvial material. Similarly, the third largest slope value (2.22 at structure A5054 pier 9 [figs. 14, 35E; table 7]) is at a pier that also seems surrounded by riprap or rock. The second largest slope value (2.70 at structure L0135 pier 10 [figs. 20, 36B; table 7]) is at a pier in a lower velocity area of the channel. If the three largest slope values are not included, the frontal slopes ranged from 1.58 to 2.16, with a mean value of 1.86. Richardson and Davis (2001) noted that the side slope of a scour hole in cohesionless sand in air could range from 1.0 to 1.8 depending on the composition of the bed material and its dry angle of repose, and suggest using a value of 2.0 for design purposes to account for the wet angle of repose. The slope values determined in the current (2014) study generally are similar to the values noted in Richardson and Davis (2001), and to values determined for scour holes in the Kansas City and St. Louis, Mo., areas (Huizinga, 2010, 2011).

As discussed in the section titled “Structure A1700 on Interstate 155 near Caruthersville, Missouri,” the presence of a riprap blanket near pier 20 had a substantial effect on the size and depth of the scour hole observed at that pier in the three different surveys. The frontal slopes of the scour holes observed in the 2008 and 2014 surveys are very similar, whereas there is no discernable hole in the 2011 survey (fig. 36G). The bottom of the scour hole seemed to have coincident elevations in the 2008 and 2011 surveys, whereas the bottom of the scour hole is about 1 ft lower in the 2014

survey (fig. 36G). It is unknown if this difference is a function of minor horizontal or vertical position differences between the surveys, or an actual change in the elevation of the top of the riprap blanket near the front of the pier. The pile of riprap in front of pier 16 indicates a similar minor change between the three surveys (fig. 36I).

Figure 36. Longitudinal profiles upstream from selected piers at structures L0135, A5076, and A1700 over the Mississippi River downstream from St. Louis, Missouri.
